Safety Audit of Fatalities and Injuries Involving Guide Rail

Final Report
December 2006

H. Clay Gabler, Ph.D.
Douglas J. Gabauer

New Jersey
Department of Transportation
Bureau of Research
And
U. S. Department of Transportation
Federal Highway Administration

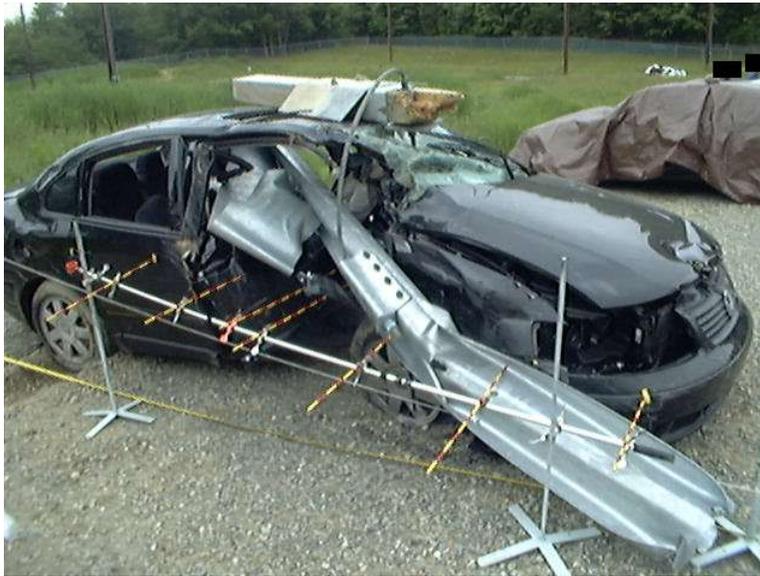
Figure 1. Collisions with Guide rail are not always forgiving. [NASS/CDS Case 2001-81-036 - Fatal Side Impact of 1999 VW Passat into Guide Rail End Treatment]

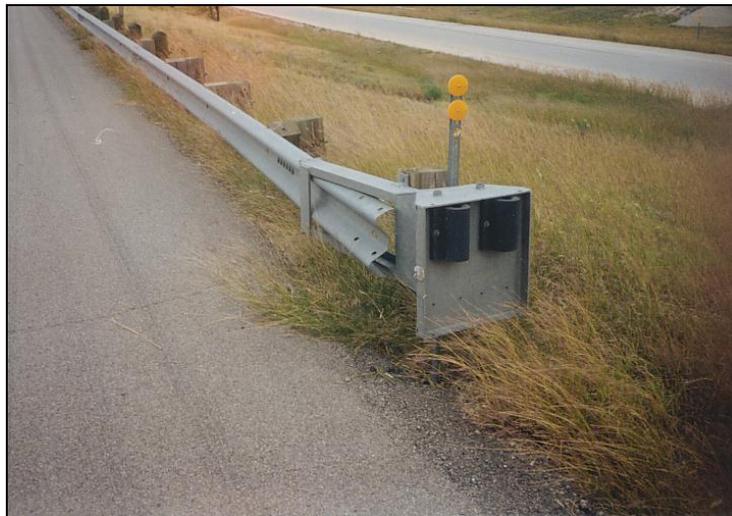
Figure 2. Improper Rail Installation for an Extruder End Terminal

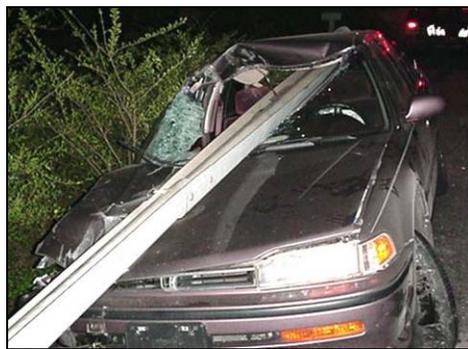
Figure 3. Poor End Terminal Performance: Vehicle Spearing

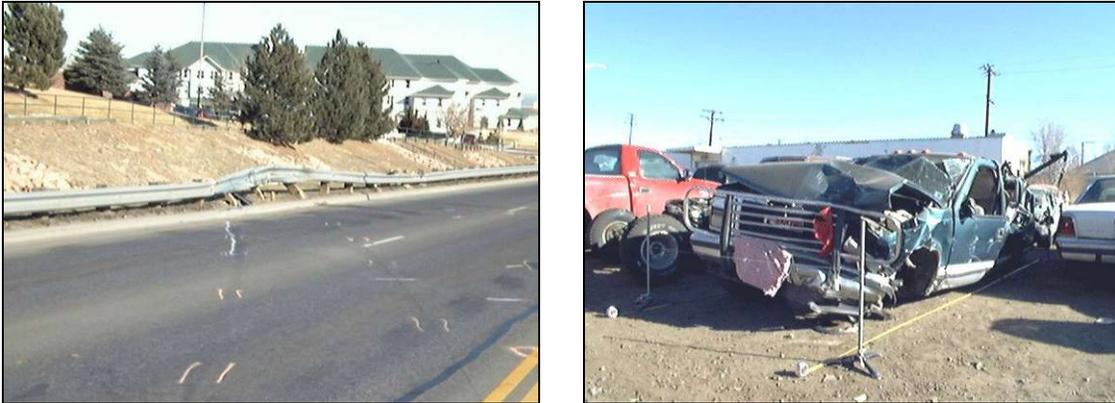
Figure 10 shows that 14% of all fatal guide rail collisions result in a rollover. One concern raised in the national literature is the possibility that a guide rail could act as a rollover trip hazard. In today's fleet, many light trucks have a center of gravity which is higher than the guide rail. When light trucks collide with guide rail there is a significantly greater chance of guide rail "vaulting" and roll-over [Stephens, 1996; Eskandarian, 2003]. Figure 11 presents an example of a sport utility vehicle (SUV) which vaulted over a guide-rail and then overturned.

Figure 11. Higher Center-of-Gravity SUVs can "vault" a guide rail system. In this 2001 case, a 1992 GMC Suburban became airborne on impact with a W-beam guide rail, overturned, and injured the driver. (Ref: NASS/CDS 2001-75-001)

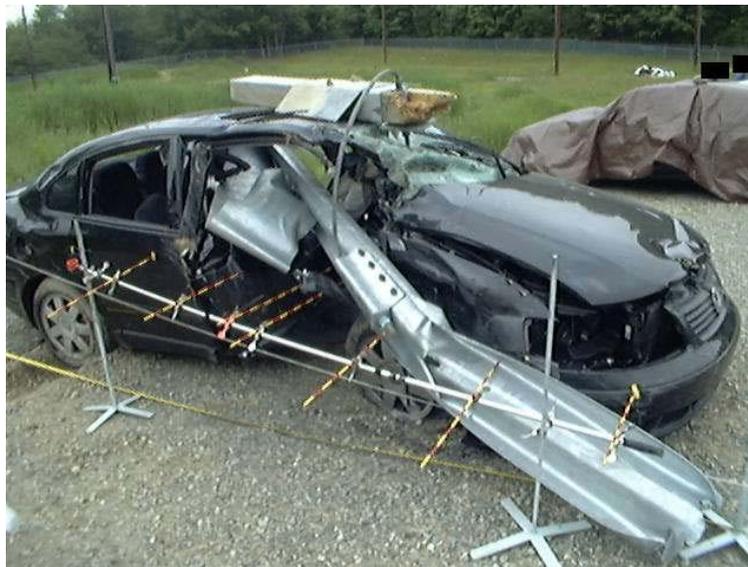
Figure 15 shows the outcome of a side impact of a car into a guide rail end treatment. In this case, extracted from the NHTSA National Automotive Sampling System / Crash Data System (NASS/CDS), a w-beam barrier end treatment speared through the passenger door of a 1999 VW Passat. The right front passenger was seriously injured but survived. The driver was fatally injured.

Figure 15. Guide Rail End treatments are not designed for Side Impact [NASS/CDS Case 2001-81-036]

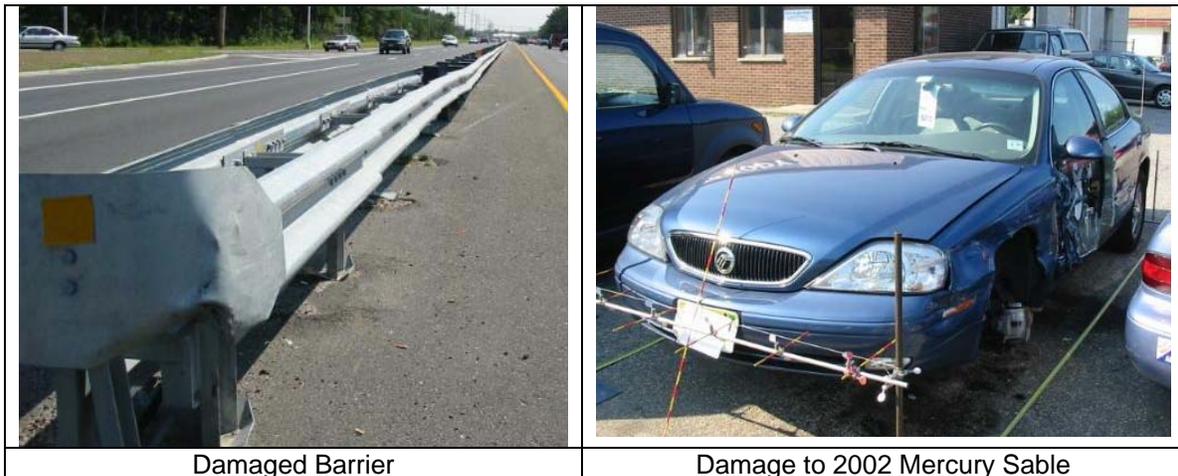
Case NASS-1: A 2002 Mercury Sable was eastbound on New Jersey State Highway 70 in Brick Township, New Jersey proceeding straight through an intersection. The vehicle drifted toward the median as it was exiting the intersection. The front left of the vehicle struck a w-beam (steel block-outs) guide rail end treatment in the median. The guide rail end treatment redirected the vehicle to continue in the eastbound direction. There was subsequent sideswipe damage to the vehicle on the driver's side. Neither the driver, a 78 year old male, nor the passenger, a 74 year old female had reported injuries. Both occupants were restrained with lap and shoulder belts and there was no airbag deployment. Figure 8 provides images of the vehicle damage and guide rail.

Figure 8. Barrier and Vehicle Damage in 2002 Mercury Sable – End Treatment Collision

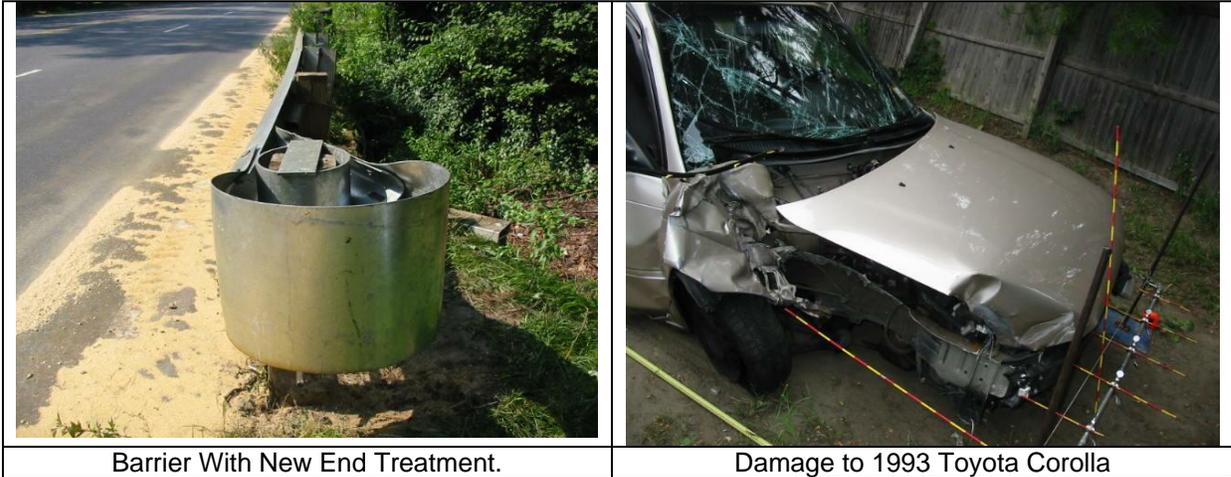
replaced before NASS investigators reached the crash site. Figure 9 provides the images of the vehicle and the replacement guide rail end treatment.

Figure 9. Replaced Guide Rail End Treatment and Damage to 1993 Toyota Corolla

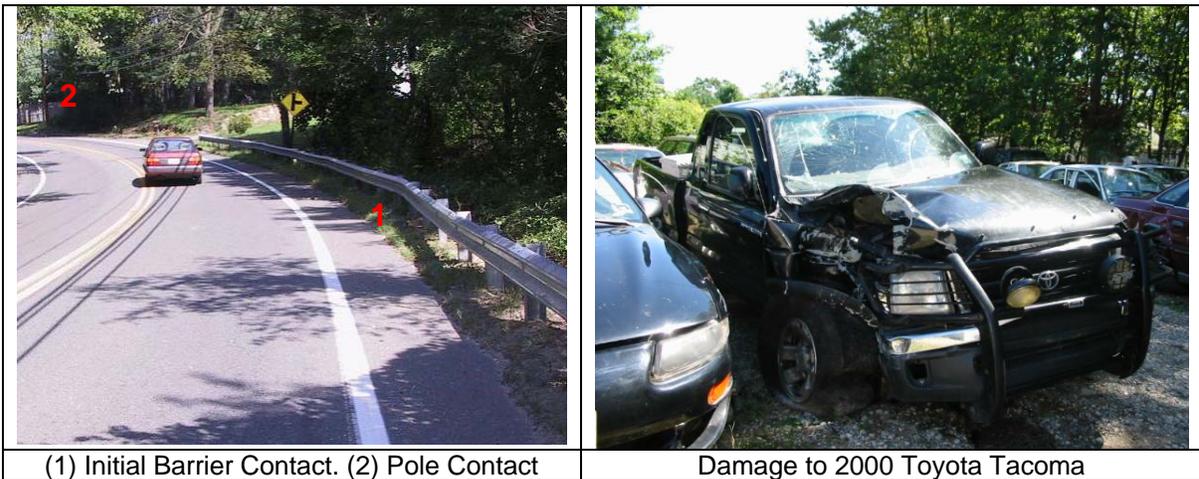
Case NASS-3: A 2000 Toyota Tacoma was traveling on Ocean County Road 636, a county road in Jackson Township, New Jersey. The vehicle exited the two-lane roadway to the right as it was negotiating a left curve. The vehicle contacted the w-beam guide rail (no block outs) then began following a path along the guide rail. The vehicle also struck a mailbox and continued on its path to climb a curb and strike a utility pole just off the roadway. The vehicle came to rest against the pole. The driver, a 21 year old male, had no reported injuries. He was restrained by the lap and shoulder belts as well as the deployed airbag. The pole was determined to be the most harmful event. The guide rail had succeeded in returning the vehicle to the roadway, but the driver was unable to negotiate the vehicle away from the roadside following the guide rail contact resulting in the subsequent collisions. Figure 10 provides the images of the barrier and the vehicle damage.

Figure 10. Barrier Damage and Utility Pole Contact (left) and Damage to Vehicle (right).

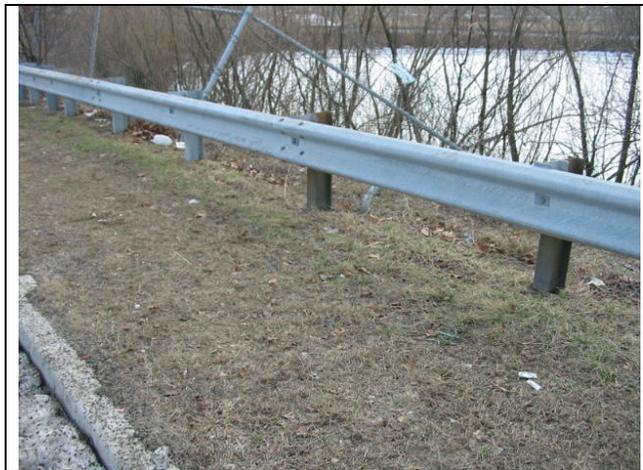
Case NASS-4: A 1994 Honda Civic was sitting at a red light on State Highway 37 in Dover Township, New Jersey, waiting to continue straight through the intersection. A 1993 Ford Tempo struck the Civic in the rear and both vehicles were forced into the intersection. The Honda Civic came to rest in the center of the intersection and the Tempo continued on through the intersection and exiting to the right side where the vehicle came to rest against a w-beam guide rail (steel block outs). The driver of the Tempo, a 79 year old male, sustained massive injuries to the chest resulting in 3 rib fractures on each side as well as hemothorax and pneumothorax (AIS 5). The driver of the Tempo passed away two days after the crash as a result of his injuries. A determination of which event caused the fatal injuries was not reported. The photographs taken from the scene show no damage to the guide rail at the point of contact and only show minimal paint transfer. We conclude that the injuries were the result of the initial impact with the Honda Civic, and not the guide rail. The guide rail was able to prevent the vehicle from continuing on down the embankment. Figure 11 shows the contact point on the guide rail for the Tempo. No photographs were available for the Ford Tempo.

Figure 11. Barrier which contained 1993 Ford Tempo after striking another vehicle.

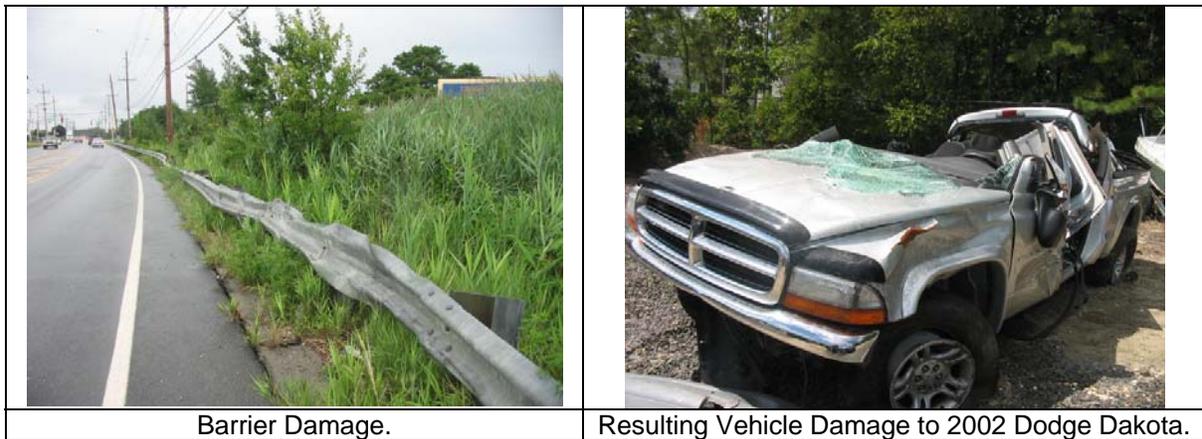
Case NASS-5: A 2002 Dodge Dakota was traveling on US 9, a State Highway in Lacey Township, New Jersey. The Dakota was negotiating a left curve and drifted off the roadway to the right. The vehicle struck a w-beam guide rail (wood block-outs) and began to rotate clockwise. The vehicle climbed the guide rail and began to rollover, landing with its left side. The vehicle completed one full rotation and landed on its wheels in a water hazard of approximately four feet in depth. It was not noted whether the driver, a 44 year old male was wearing a seat belt or if the air bags deployed. The driver suffered an open humerus fracture (AIS 3). The guide rail was determined to be the most harmful object. It was determined that the guide rail was unable to contain the vehicle and resulted in the vehicle vaulting the guide rail and causing the vehicle to rollover. Figure 12 shows the guide rail damage and the vehicle damage.

Figure 12. Barrier and Vehicle Damage in 2002 Dodge Dakota – Guide Rail Collision

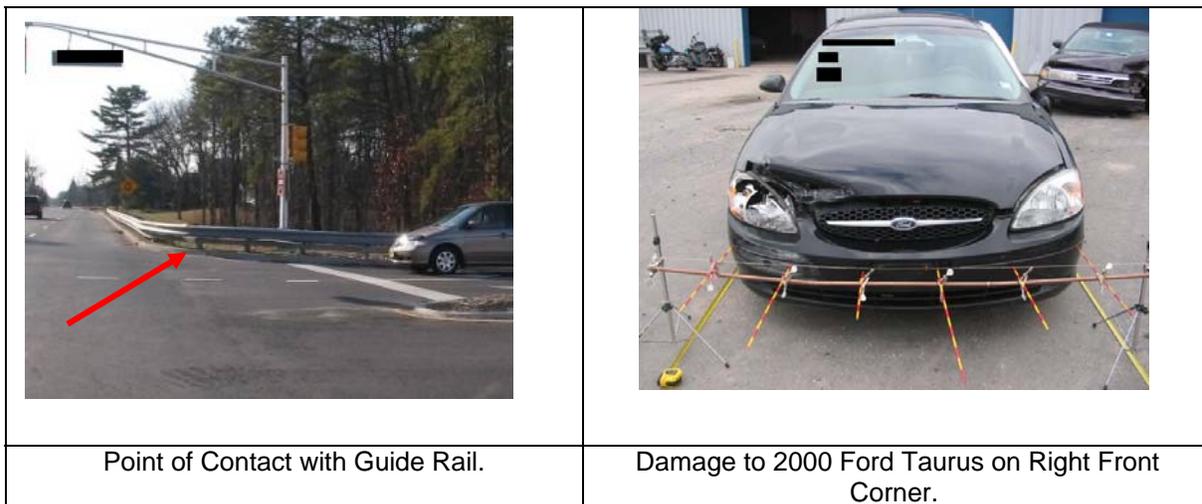
Case NASS-6: A 2000 Ford Taurus was passing through an intersection controlled by a traffic light on Ocean County Road 638 in Jackson Township, New Jersey. A 2004 Toyota Corolla was traveling in the opposite direction and made a left turn at the intersection striking the Taurus in the driver's side. The Corolla struck the Taurus in the left front quarter panel. The Corolla came to rest at the site of impact.

Figure 13. Barrier and Vehicle Damage in 2000 Ford Taurus – Guide Rail Collision

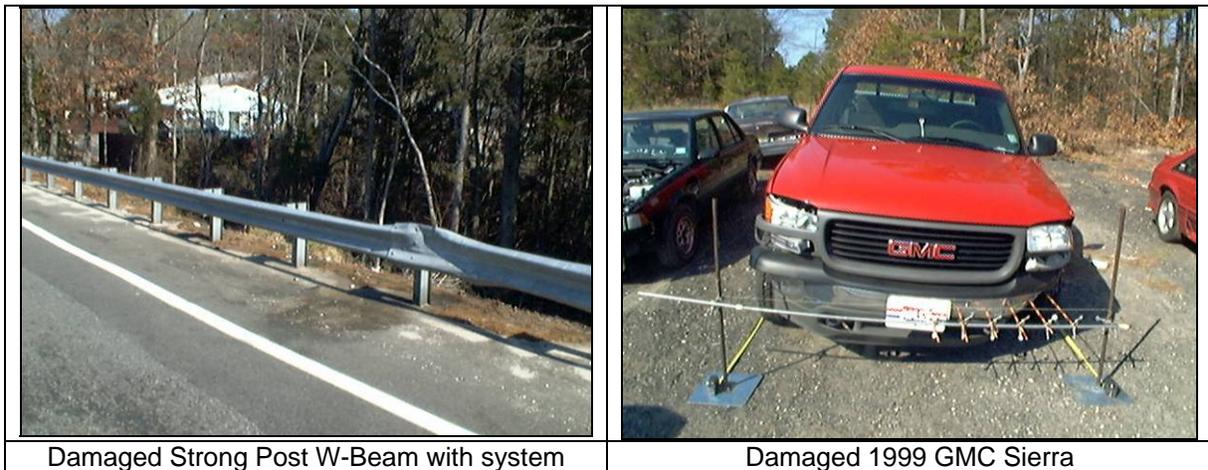
Case NASS-7: A 1999 GMC Sierra was struck by a 1992 Honda Civic which lost control while entering a curve on a two-lane roadway. As a result, the Sierra spun counterclockwise coming to a stop after hitting the strong post w-beam guide rail (steel block outs) on the east side of the road. The belted driver of the Sierra sustained only a minor leg injury (AIS 1). Note that the barrier prevented the vehicle from traversing a steep slope despite being impacted at a splice location. Figure 16 provides images of the vehicle and barrier damage.

Figure 16. Barrier and Vehicle Damage in 1999 GMC Sierra – Guide Rail Collision

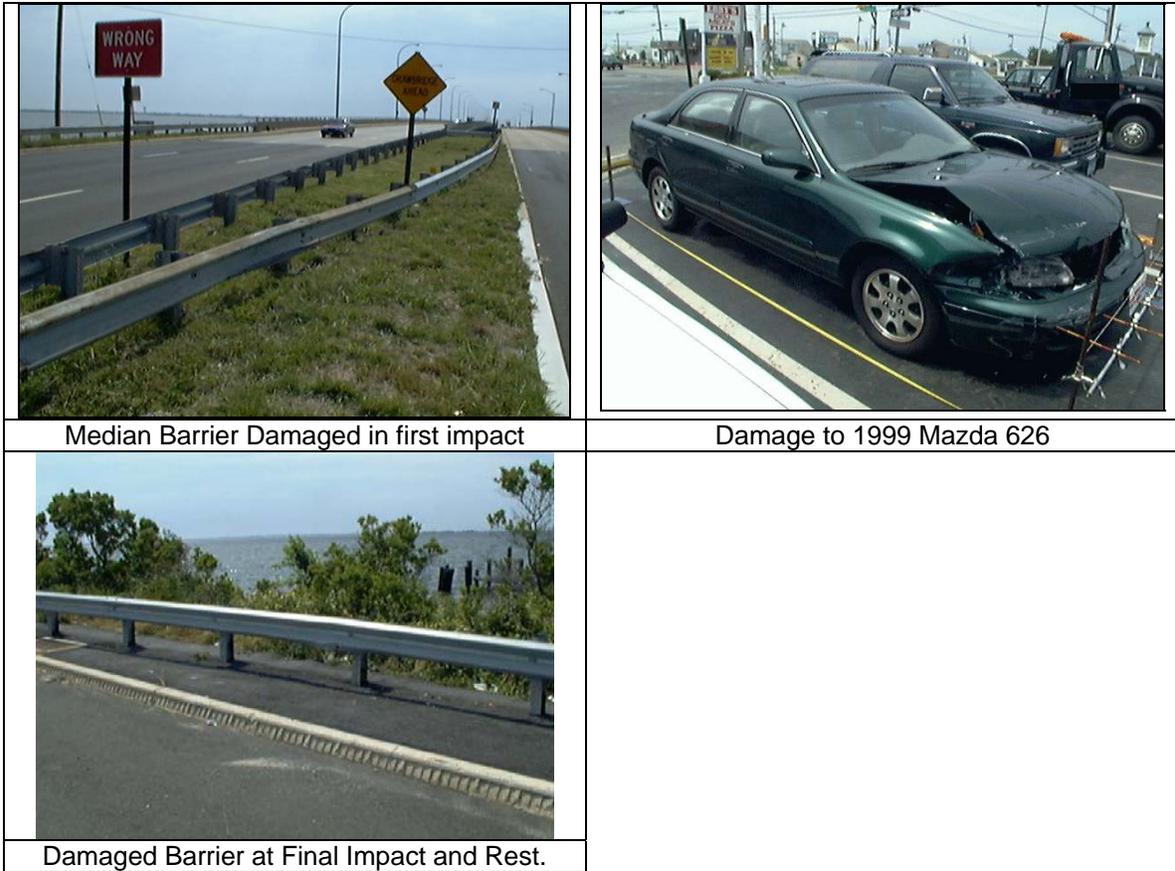
Case NASS-8: A 1999 Mazda 626 vaulted the median curb and the vehicle front engaged the guide rail located behind the curbing. The guide rail redirected the vehicle across three eastbound lanes of traffic and the vehicle became wedged under the guide rail off the right shoulder of the road. Belted but not subjected to an airbag deployment, the 55 year old driver sustained a concussion (AIS 2). It appears that some conditions may have been pre-existing as the driver blacked out just prior to the crash. Note that both guide rail prevented penetration but the post-impact vehicle trajectory from the first impact was not desirable. Figure 17 provides images of the initially impacted barrier and the resulting vehicle damage.

Figure 17. Barrier and Vehicle Damage in 1999 Mazda 626 – Guide Rail Collision

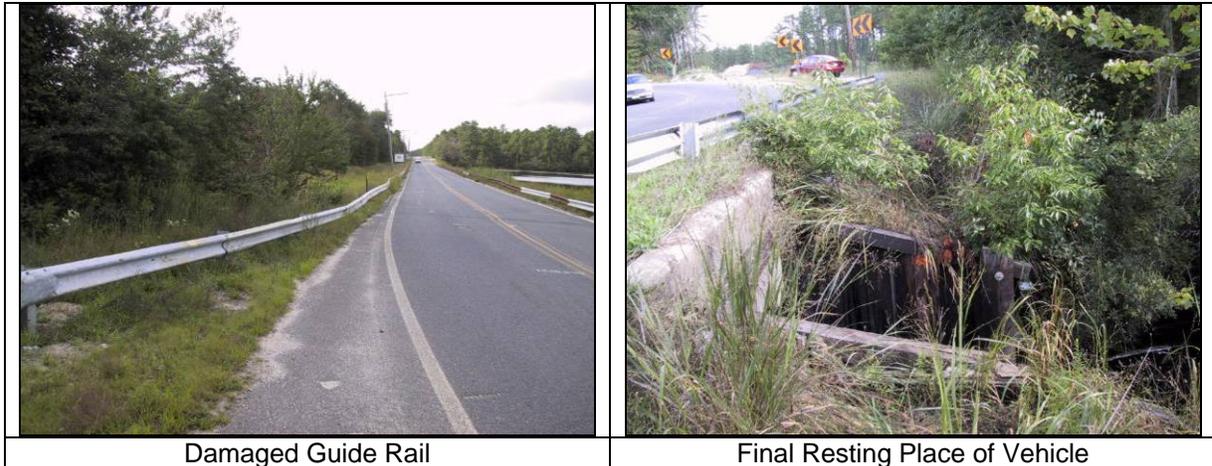
Case NASS-9: The driver of a 1992 Subaru Legacy failed to negotiate a 90-degree right hand curve on a two-lane road. Exiting the road to the left, the vehicle impacted and overrode the guide rail ultimately coming to rest suspended over a spillway of a nearby lake. No airbag was available in the vehicle and investigators could not determine belt usage by either occupant. The 83 year-old male driver suffered AIS 2 level injuries to the face while the 80 year-old female passenger suffered major head trauma (AIS 4). The combination of injuries resulted in fatality for both occupants. Note that there were no block outs present in the guide rail. Figure 18 provides images of the impacted guide rail and final resting place of the vehicle. There were no photos of the vehicle as the vehicle was not inspected.

Figure 18. Guide Rail at the Crash Location of 1992 Subaru Legacy

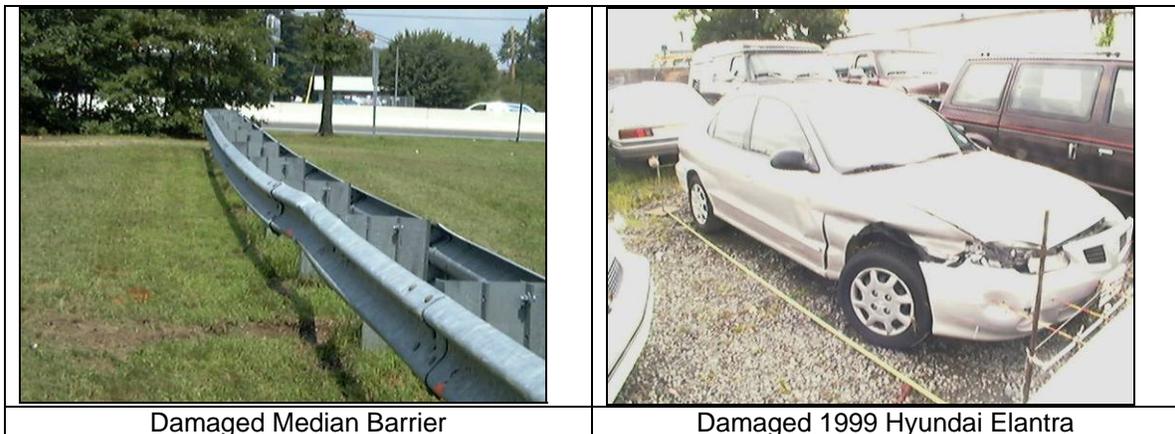
Case NASS-10: A 1999 Hyundai Elantra lost control while negotiating a U-turn exit. Leaving the roadway to the left, the Hyundai spun and the right side of the vehicle impacted a strong post w-beam median barrier (steel block outs). The 18 year-old belted female driver sustained minor injuries to the head (AIS 1) and minor cuts to the upper and lower extremities. Note that the airbag did not deploy in this collision and that the barrier properly contained the vehicle. Figure 19 provides images of the barrier and vehicle damage.

Figure 19. Barrier and Vehicle Damage in 1999 Hyundai Elantra – Median Barrier Collision

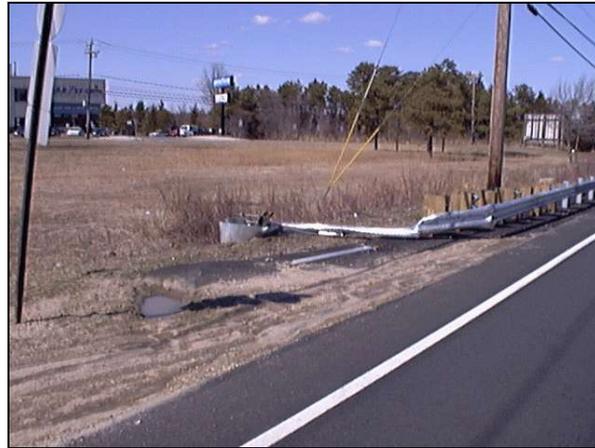
Case NASS-11: A 1987 Chevrolet Suburban lost control, skidded across an intersection, and struck the right front of a 1993 Buick Skylark traveling in the opposite direction. The Suburban then spun clockwise, and its left side impacted a guide rail end treatment situated on the roadway shoulder. The Suburban was not the subject vehicle and was not inspected by investigators. No information was collected regarding the Suburban or injuries to its occupants. The SRT 350 end terminal performed satisfactorily even though the impacting vehicle most likely was struck on the side. Figure 20 shows the damaged end terminal.

Figure 20. Barrier End Treatment Damage after collision with 1987 Chevrolet Suburban

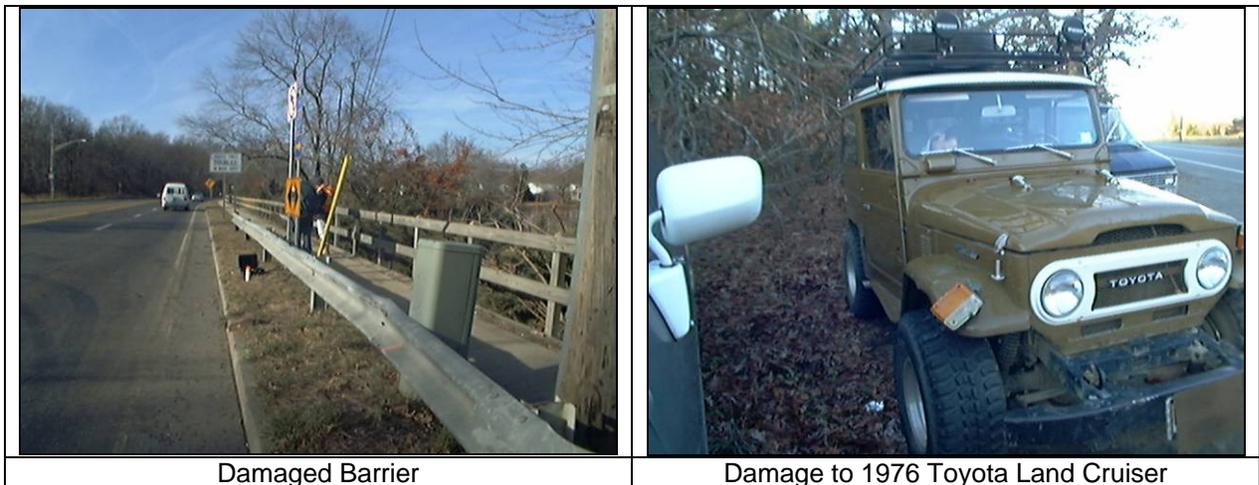
Case NASS-12: A 1976 Toyota Land Cruiser struck the rear of a stopped 2001 Volkswagen Jetta near an intersection. The Land Cruiser then departed the north side of the roadway impacting a strong post w-beam guide rail (no block outs) installed behind a curb. Both occupants of the Land Cruiser were belted (no airbag available) and no injuries were reported. Note that the barrier successfully contained the vehicle. Figure 21 provides images of the vehicle and damaged barrier.

Figure 21. Barrier and Vehicle Damage in 1976 Toyota Land Cruiser – Guide Rail Collision

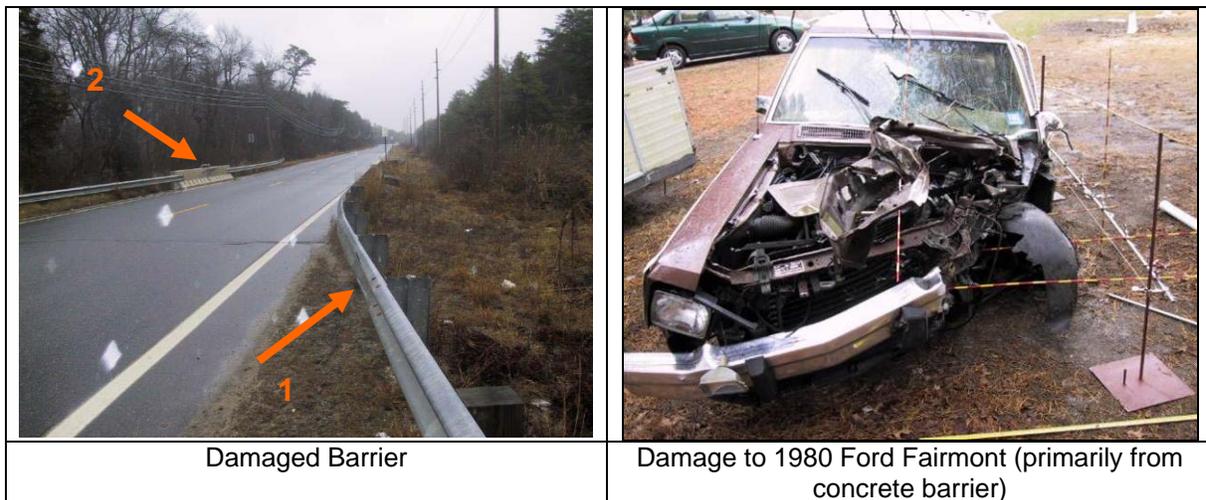
and a minor abrasion to the arm. Although the guide rail produced an undesirable post-impact vehicle trajectory, the vehicle was successfully contained. Figure 22 provides images of the vehicle damage and guide rail.

Figure 22. Barrier and Vehicle Damage in 1980 Ford Fairmont – Guide Rail Collision

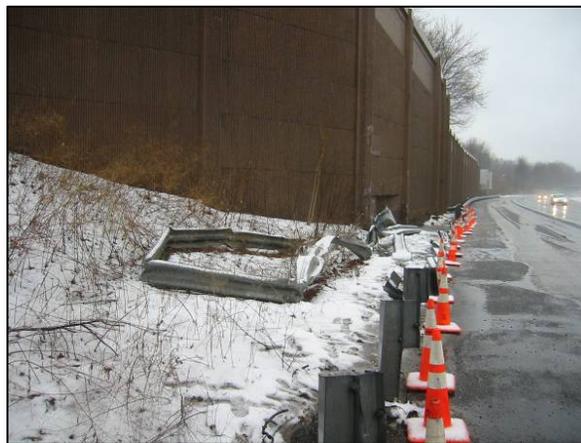
I-295 NB MP 28.3: A tractor trailer traveling on I-295 southbound (SB) crossed the unprotected median and impacted the strong steel post w-beam barrier (steel blockouts) shown in Figure 23. The unidentifiable end terminal (most likely a breakaway cable terminal) and roughly 400 feet of guide rail was damaged; the impacting heavy vehicle penetrated the guide rail and impacted the sound-wall that the guide rail was shielding. As the strong post w-beam barrier is tested to NCHRP test level 3, it is not designed to redirect heavy vehicles such as tractor trailers.

Figure 23. Strong Steel Post Barrier Damage at I-295 NB MP 28.3

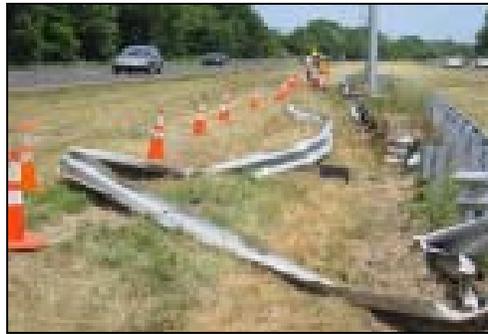
I-95 SB MP 6.3: A tractor trailer heading southbound on I-95 departed the roadway on the left and impacted a strong steel post w-beam barrier (steel blockouts) protecting an overhead sign support in the median. Based on tire ruts left at the scene, the impact angle was determined to be approximately 15 degrees. Although the barrier has not been designed to redirect heavy vehicles, it appears that the tractor trailer was brought to a controlled stop. A total of 150 feet of barrier was damaged.

Figure 24. Barrier Damage at I-95 SB MP 6.3

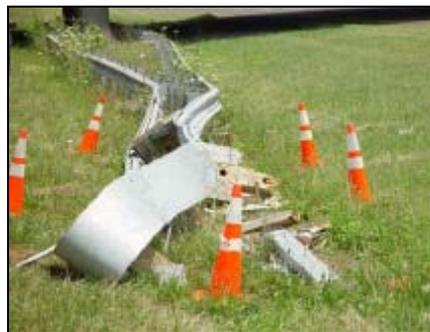
I-95 NB MP 8.1: The driver of a four door passenger sedan traveling northbound on I-95 lost control, departed the roadway on the left, and impacted a CAT 350 end terminal (shown in Figure 25) causing damage to the front of the vehicle. Approximately 32 feet of guide rail was damaged due to the impact. Based on the field investigation, the end terminal appeared to break away as intended with no evidence of vehicle spearing. According to the PAR, both occupants of the vehicle reported no injuries.

Figure 25. CAT 350 End Terminal Damage at I-95 NB MP 8.1

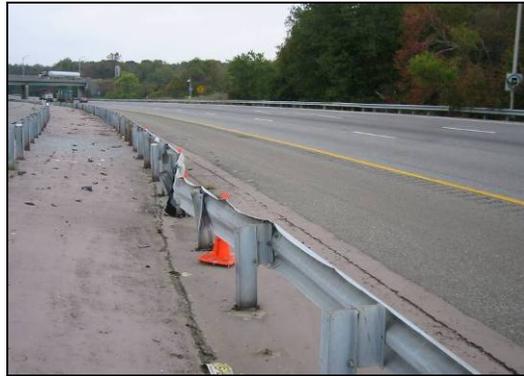
I-295 SB MP 14.3: A steel strong post w-beam roadside barrier (steel block-outs) located in the median (see Figure 26) was struck in two locations by a small passenger vehicle. The median width varies but is approximately 10 feet at the impact location and there is roughly a four foot differential in vertical alignment of the north and southbound lanes resulting in a 3:1 (H:V) slope of the median toward the southbound lanes. Note that the posts of the barrier were anchored in bituminous material. Based on tire marks on the pavement, the vehicle struck the barrier first at a 25 degree angle and then a 40 degree angle. There was no penetration in either case. Maximum barrier deflection was 20 inches for the 32 feet (7 post section) of total barrier damaged.

Figure 26. Barrier Damage at I-295 SB MP 14.3

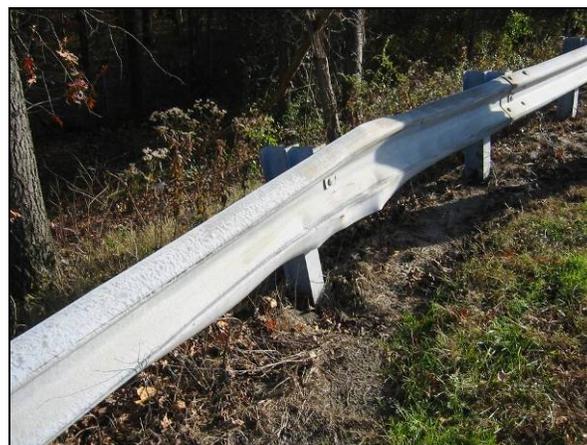
I-295 NB MP 64.5: A passenger vehicle traveling on I-295 NB departed the roadway to the right and impacted a strong steel post w-beam guide rail (steel blockouts) in two locations, first with the front of the vehicle followed by the rear of the vehicle. Barrier damage resulting from the second impact is shown in Figure 27. A total of 27 feet of barrier was damaged with a maximum deflection of 6 inches. Based on the PAR, there were no injuries sustained by the driver of the vehicle.

Figure 27. Secondary Impact Damage at I-295 NB MP 64.5

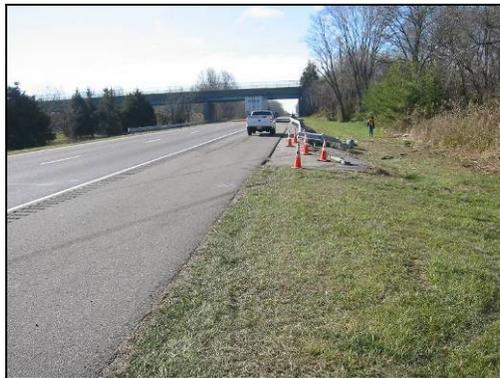
As designed, the posts of the terminal failed allowing penetration of the vehicle without the rail penetrating the occupant compartment. After the barrier impact, however, the vehicle rolled. The location of the tire marks suggest that the strut located between post 1 and 2 of the end terminal may have aided in tripping the vehicle as it was sliding sideways. Approximately 35 feet (9 post section) of barrier was damaged, which comprises essentially the entire end terminal. Note that based on the inspection of the damaged section the end terminal appeared to be installed to standard with the exception of the rail height (25 inches as opposed to 27.5 inches).

Figure 28. SRT 350 Damage Resulting in Vehicle Rollover and Driver Fatality on I-295 SB

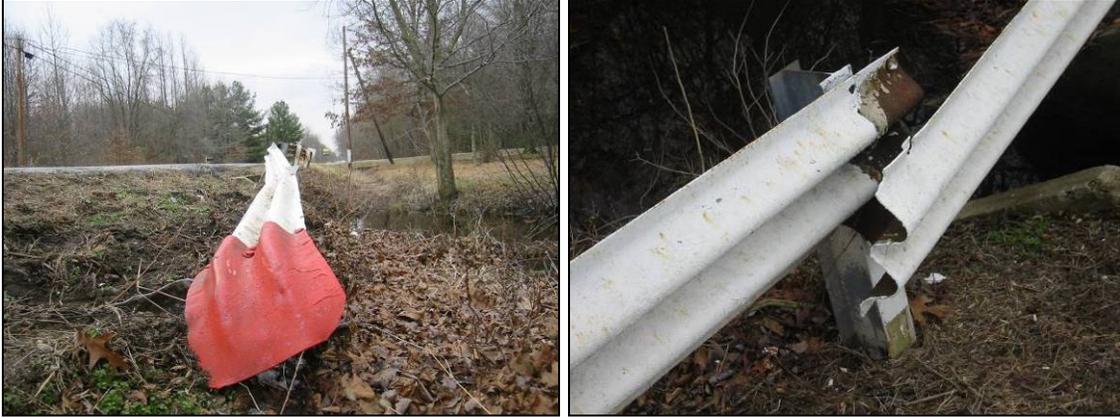
CR 551 EB MP 9.9: A vehicle impacted a non-standard strong post w-beam guide rail (see Figure 29) installed along the south roadside of County Route 551 (undivided, rural, 2-lane roadway). The purpose of the barrier was to shield vehicles from a concrete box culvert and associated stream. Boxing glove-type end terminals (without cable anchorage) provide a terminus for each end of the 60-foot barrier. The barrier is installed a slope of approximately 3:1 (H:V) with total length 8.5 ft; this slope abuts a near flat slope.

Figure 29. View of Damaged End Terminal (Left) and Failed Splice Location (Right)

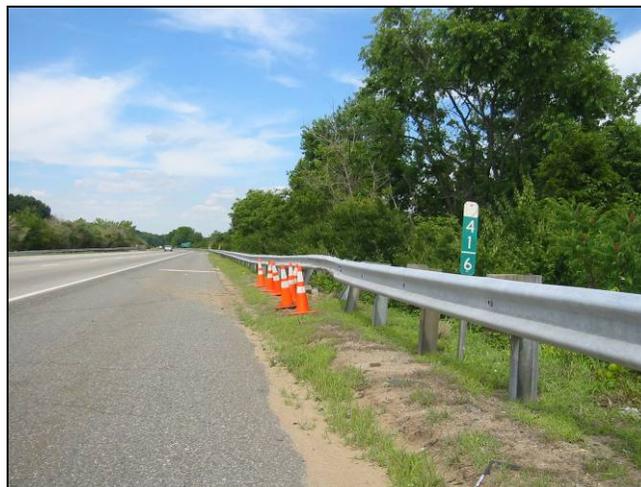
Figure 30. Barrier Damage at I-295 NB MP 41.6: View from South

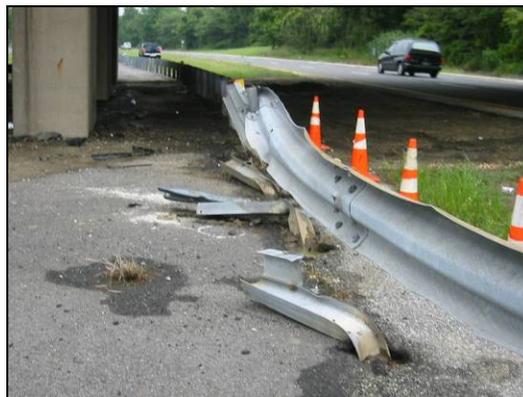
Figure 31. Barrier Damage at I-295 NB MP 25.1

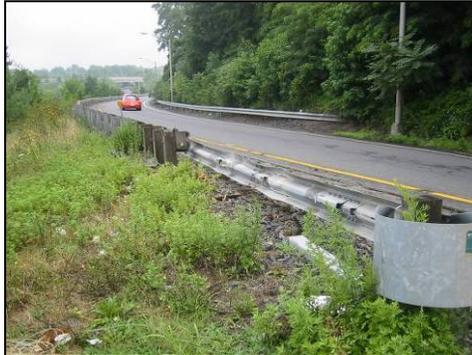
Figure 32. SRT 350 Damage at I-195 WB MP 0.14

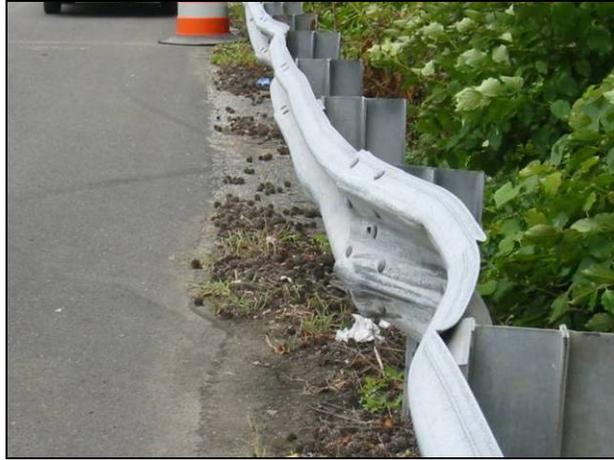
Figure 33. Initial Impact (Foreground) and Second Impact (Background) at State Highway 42 SB MP 12.2

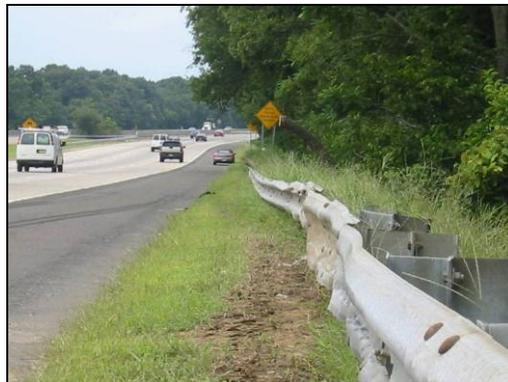
Figure 34. Barrier Damage at I-295 SB MP 43.9

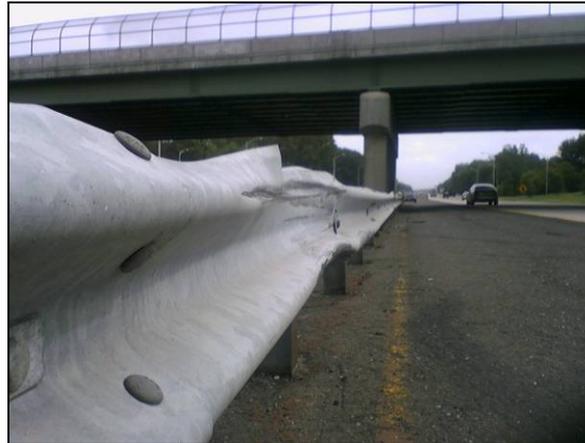
Figure 35. Barrier Damage at I-295 NB MP 19.3

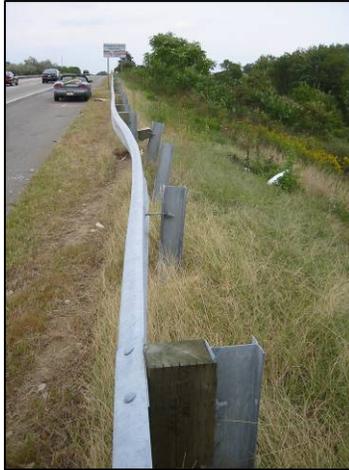
Figure 36. Barrier Damage at I-295 NB MP 41.3

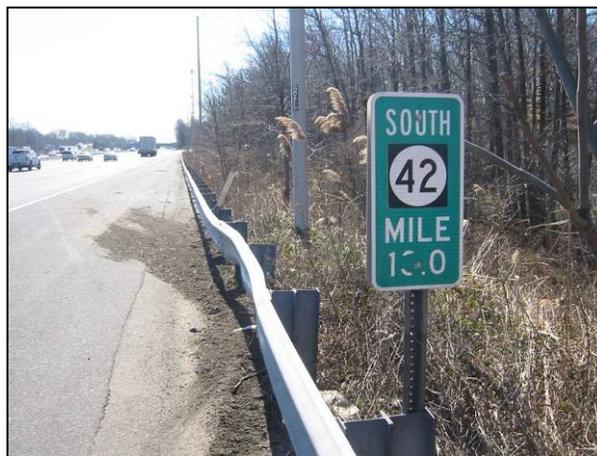
Figure 37. Damage from First Impact at State Highway-42 SB MP 13.0
