I/M/O the Board's Investigation Into Reliability Issues Related to New Jersey American Water's Swimming River Water Treatment Plant Pipe Bridge Collapse in Monmouth County

Prepared for
State of New Jersey Board of Public Utilities

February 15, 2013

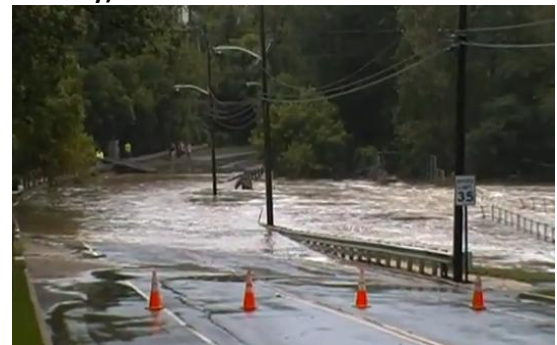
FIGURE 1
View of Inundated Pipe Bridge (to right of roadway)

Realizing that the pipe bridge may have sustained damage from the inundation and other impacts of the storm, NJAW initiated inspections of the pipe bridge. Four inspections and assessments were conducted of the bridge structure. The first one was conducted by NJAW staff; the second by NJAW's engineer-of-record¹ Hatch, Mott, McDonald (HMM), the third by TNJ and the fourth by the engineering firm, Wiss, Janney, Elstner Associates, Inc. A post-failure inspection was also performed by Ocean and Coastal Consultants Engineering. Results of the inspections indicated that the bridge exhibited a number of problems that questioned its short-term stability and longer-term reliability. The inspections however, found that the pipe bridge and its pipelines were fit for service. NJAW then retained HMM to assist with the bridge repair work which included evaluating damage and providing assessments, reviewing and evaluating long term alternatives for repairs to the pipe bridge, providing structural calculations, preparing cost estimates, assisting with permit requirements, coordinating and meeting with the NJDEP, reviewing and evaluating long term alternatives for repairs to the pipe bridge structure, and preparing a design report, design documents along with other related engineering services.

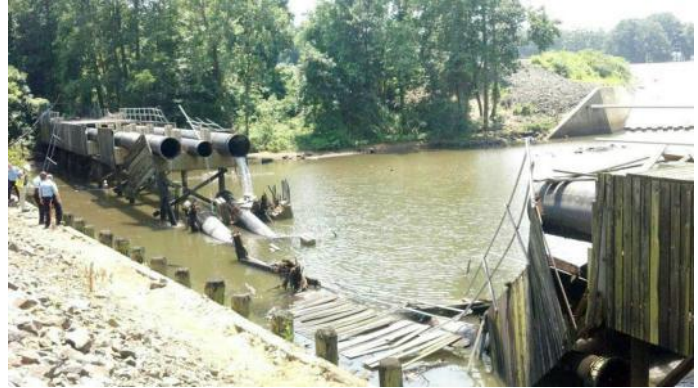
FIGURE 3

On June 29, 2012 at approximately 12:45pm, the SRWTP pipe bridge failed. The bridge failure was sudden and catastrophic, severing the three pipelines and disrupting water service. Figure 3 shows the failed pipe bridge and severed pipelines, a few days after the collapse.

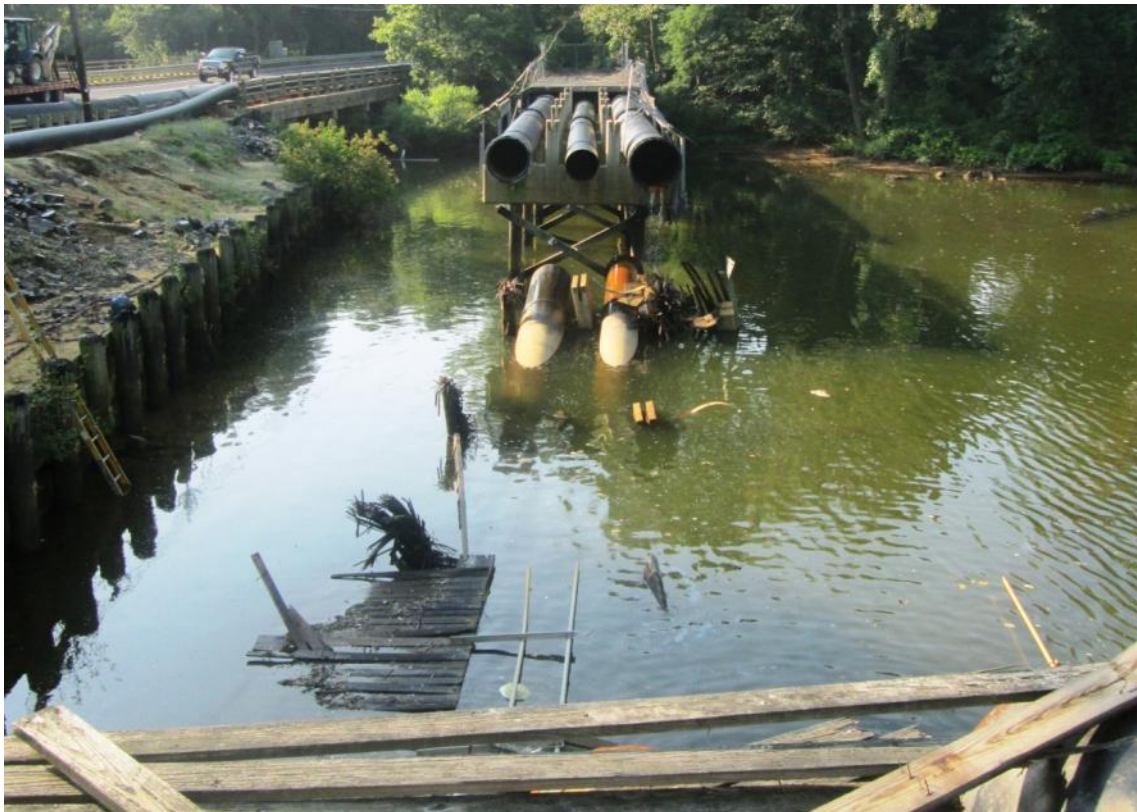
Swimming River Pipeline Bridge – August 2012. Note collapsed central portion

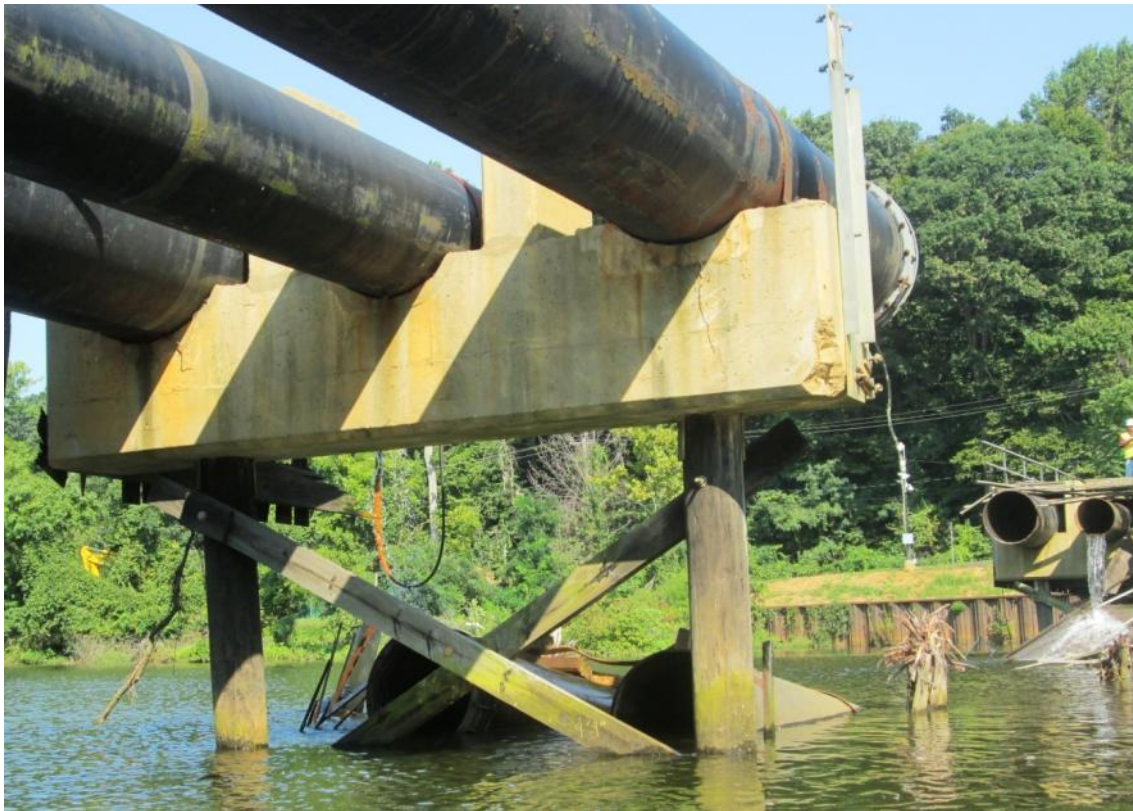
Collapsed portion of Swimming River Pipeline Bridge – View looking South. Note Swimming River Road Bridge over Swimming River and also emergency bypass lines installed on bridge and shoulder of Swimming River Road.

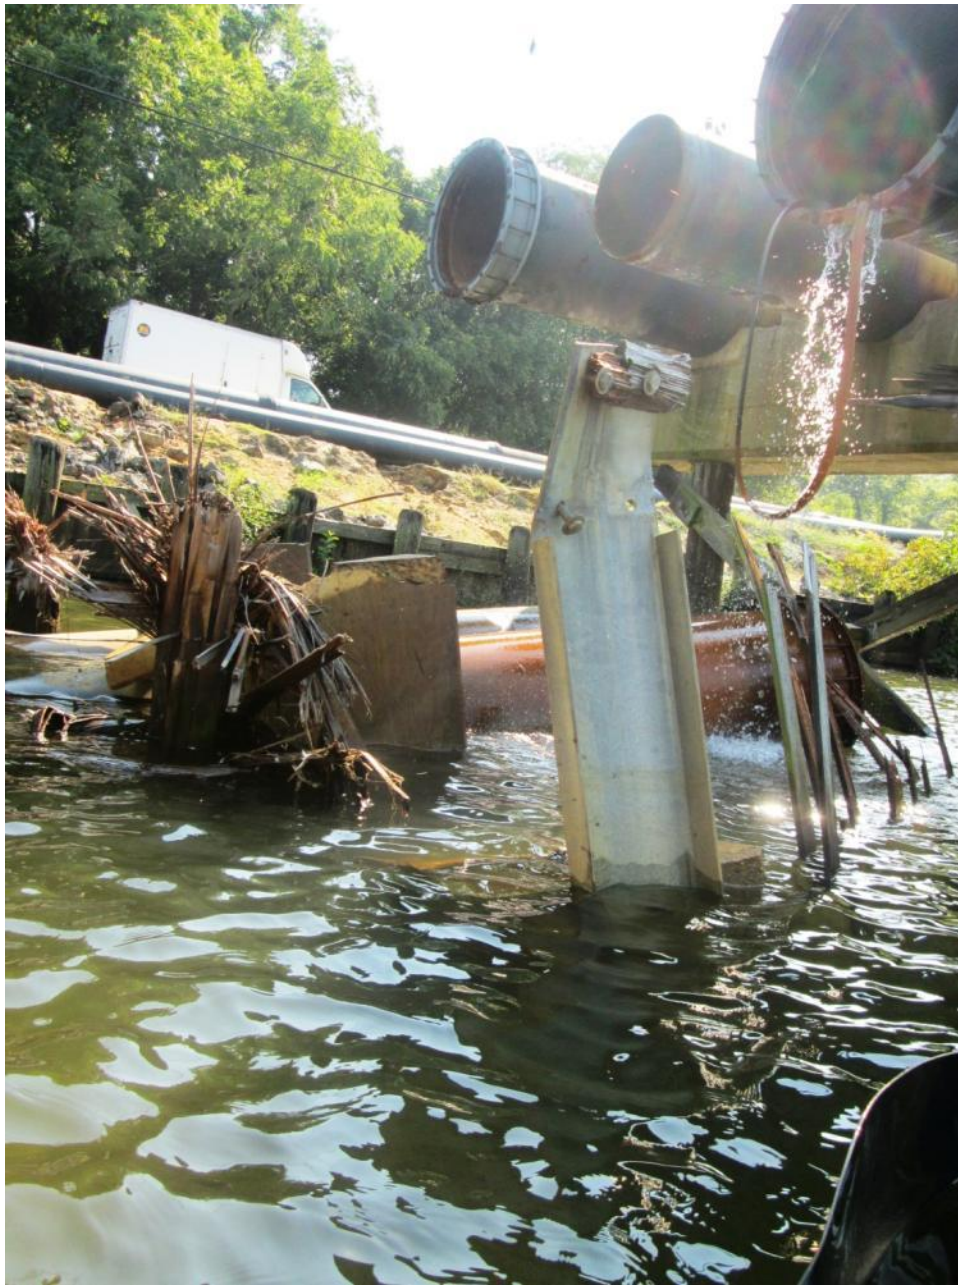
Timber Pile 5A East - Typical failed pile
