FHWA-NJ-2010-012

In Place Rehabilitation of Pipes Using Polymer Composites

FINAL REPORT
December 2010

Perumalsamy Balaguru, Ph.D.
Distinguished Professor
Director of Graduate Program
Department of Civil and Environmental Engineering
School of Engineering
Rutgers, The State University of New Jersey

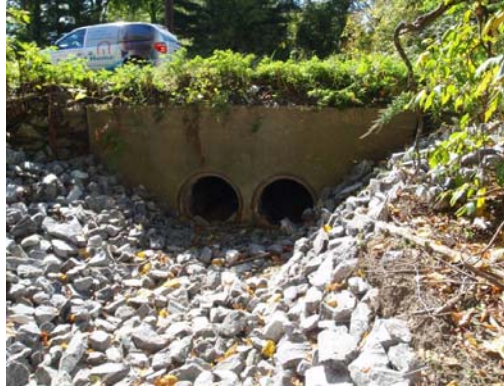
Pictures of the two culverts are shown in Figures 2, 3 and 4. The pipes were built in 2-foot segments and there were some misalignments between the segments due to settlement. The site was selected because: (a) the structure was easily accessible on both ends; (b) the length is reasonable, (c) traffic safety is not needed and (d) space is available next to the site for preparation of rehabilitation materials.

Figure 2. Clay pipe culvert: view of inlet side

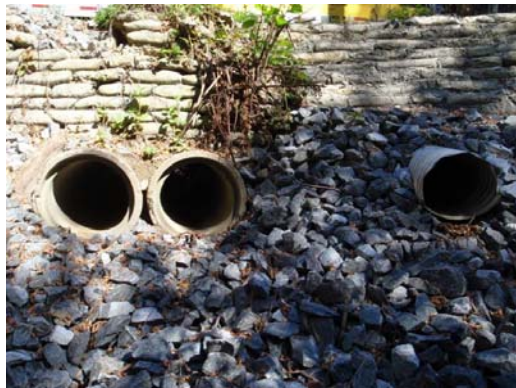
Figure 3. Clay pipe culvert: view of outlet side

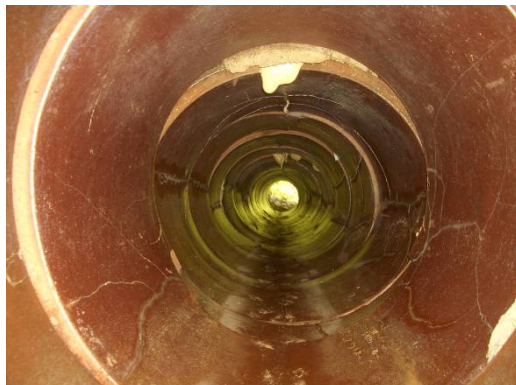
Figure 4. Clay pipe culvert: view of interior

The pipes were in reasonable condition. The joints between the pipes were deteriorated, and in certain locations, the joints had become misaligned due to settlement. This misalignment created gaps in the joints.

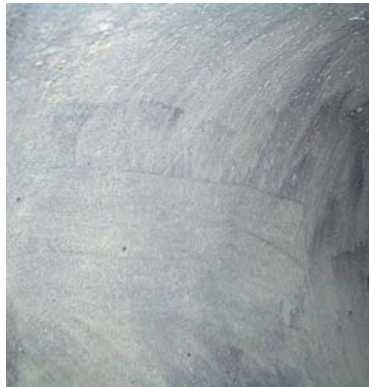
- (b) The second and more economical option was to use the composites with discrete or short fibers. For this system, 0.25 inch carbon fibers were mixed with an inorganic matrix, at a fiber loading of 1% by weight. This system provides a thin coating that can follow the contours of the pipe including the locations where the pipes were broken. A clay flower pot that was composed of material similar to the pipes in the field was coated in the laboratory. The coating adhered to the surface well and provided a continuous coated surface as shown in Figure 5.

Figure 5. Clay surface coated with inorganic polymer composite

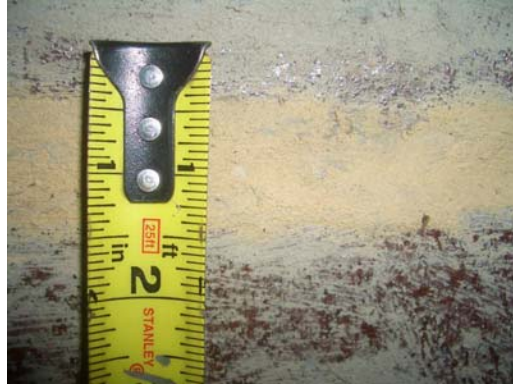
The repairs performed very well in terms of both adhesion and shrinkage free repair. Pictures taken after one year are shown in Figures 6 through 9. Figures 6 and 7 shows the repair of smaller gaps and Figure 8 shows a repair of a cracked corner of the pipe. Repair of a larger gap developed by settlement is shown in Figure 9.

Figure 6. Repair of a small gap caused by pipe settlement

1. Prepare a dry Portland cement mortar mix using a cement to mortar sand ratio of 1 to 2. Consider this as Mix 1.
2. Prepare Mix 2 by combining equal parts of Mix 1 and Quickrete set mortar.
3. Add 0.25 inch long carbon fibers to Mix 2 at the rate of 2% by weight to prepare the final dry mix.
4. Add water at the rate of 20% by total weight. The wet-mix should be of a very stiff consistency so that it can be applied to vertical and overhead pipe surfaces.
5. In the field, prepare only enough wet-mix that can be used within two hours of repair work.
6. Wet-mix can be prepared using a mortar mixer or by hand.

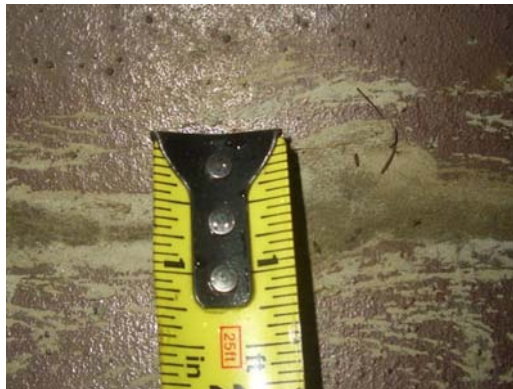
Figure 7. Repair of a winding small gap caused by pipe settlement

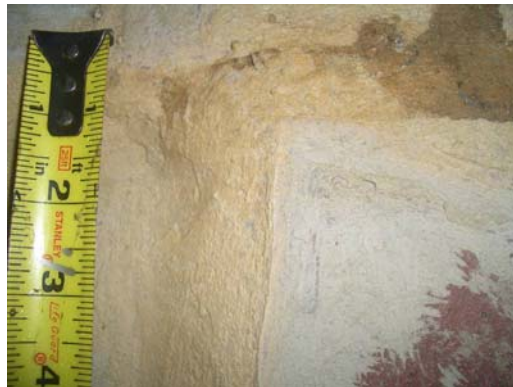
Figure 8. Repair of a cracked corner gap caused by pipe settlement

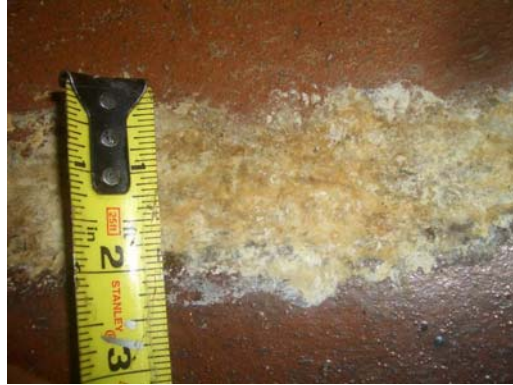
Figure 9. Repair of larger gap caused by pipe settlement

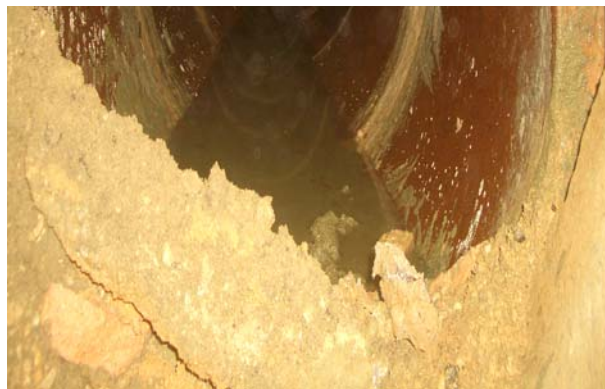
During late September 2009, there was local utility relocation construction work that was conducted perpendicular and above the twin pipe culverts. This utility relocation construction work resulted in a cave in of the twin pipe culverts, resulting in the pipes filling up with soil and other construction debris, as shown in Figure 10.

Figure 10. Damage caused to culvert by utility relocation work

Although Gloucester County water jetted the pipes clean within weeks of the cave-in, the research team couldn't apply the inorganic polymer coating because of the cold temperatures and wet conditions during the late fall of 2009.
