**Design and Fabrication of Orthotropic Deck Details**

FINAL REPORT

Vol. II

Sougata Roy, Ph.D.  
Former Principal Research Scientist  
ATLSS Center  
Lehigh University

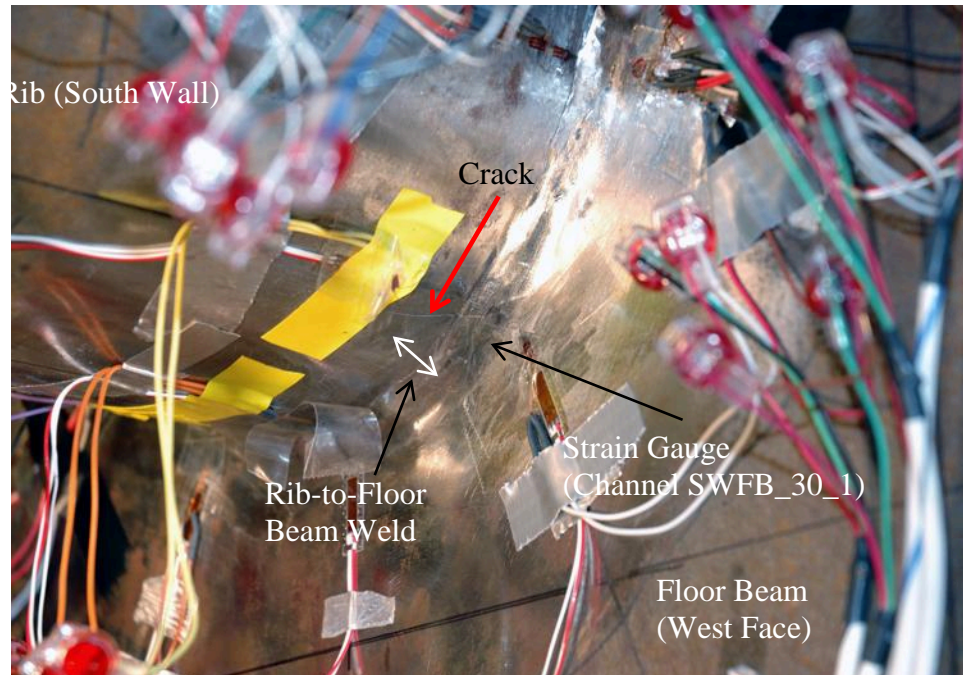
The first crack was detected after 734,126 cycles at the floor beam to rib connection to the south (compression side) of the rib at about 30 degrees from the rib soffit. The crack was detected on October 21, 2012 during the 12:00 PM inspection. The crack grew through the weld throat and propagated into the floor beam and the ribs on both side of the floor beam (Figure 164). The crack progressed about 0.8 in. (25 mm) into the floor beam web and about 0.7 in. (18 mm) into the rib wall. Similar crack was observed after 858,304 cycles in the floor beam to rib connection to the north side (tension side) of the rib at about 26 degrees from the rib soffit (Figure 165). The crack was detected on October 24, 2012 during the 8:00 PM inspection. This crack also grew through the weld throat and propagated into the floor beam and the rib. The crack progressed about 0.3 in. (8 mm) into the floor beam web and about 0.4 in. (10 mm) into the rib wall. A schematic of the cracks is shown in Figure 166. The fatigue test was terminated on October 27, 2012 after 1144818 cycles when the crack in the floor beam on the north side of the rib propagated through the hole and appeared at the edge of the drilled hole.

Figure 164. Crack at the floor beam-to-rib welded connection in the mock-up specimen MU1 – south west

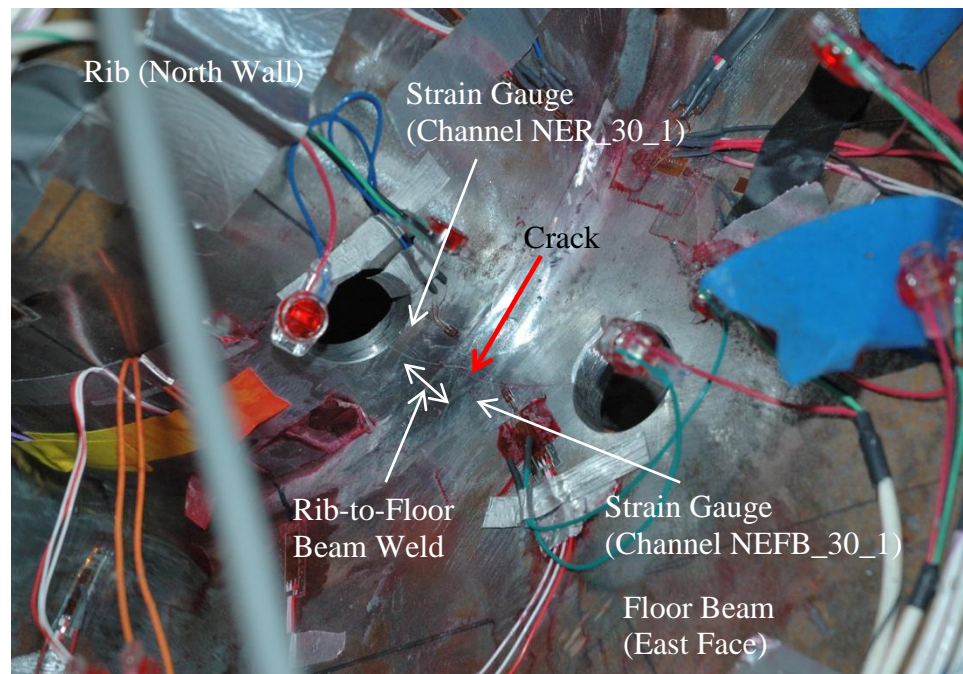
Figure 165. Crack at the floor beam-to-rib welded connection in the mock-up specimen MU1 – north east

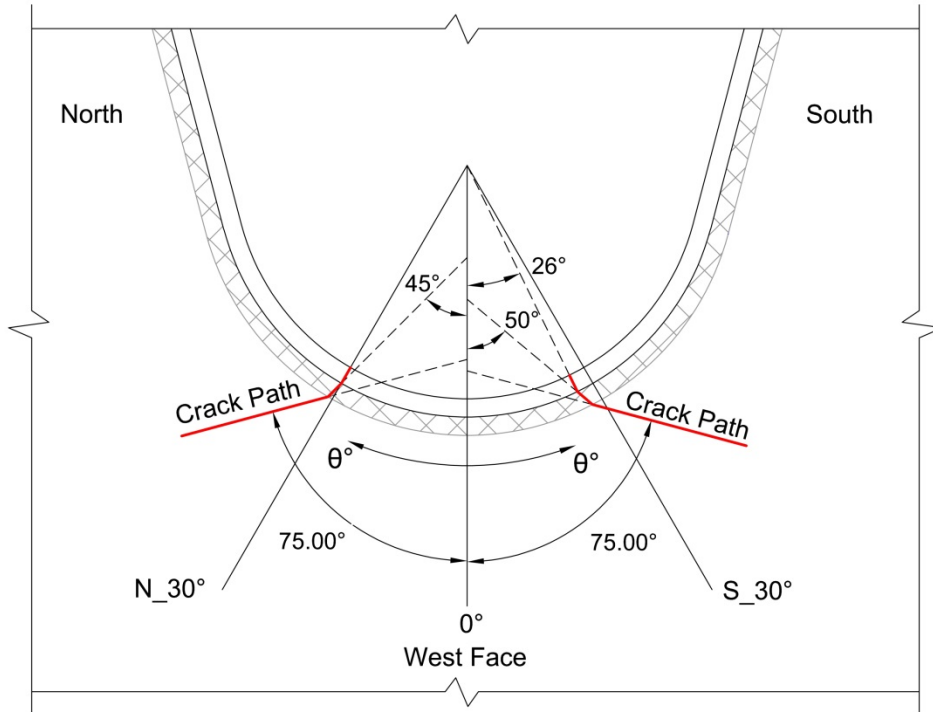
Figure 166. Schematics of cracks in mock-up specimen MU1

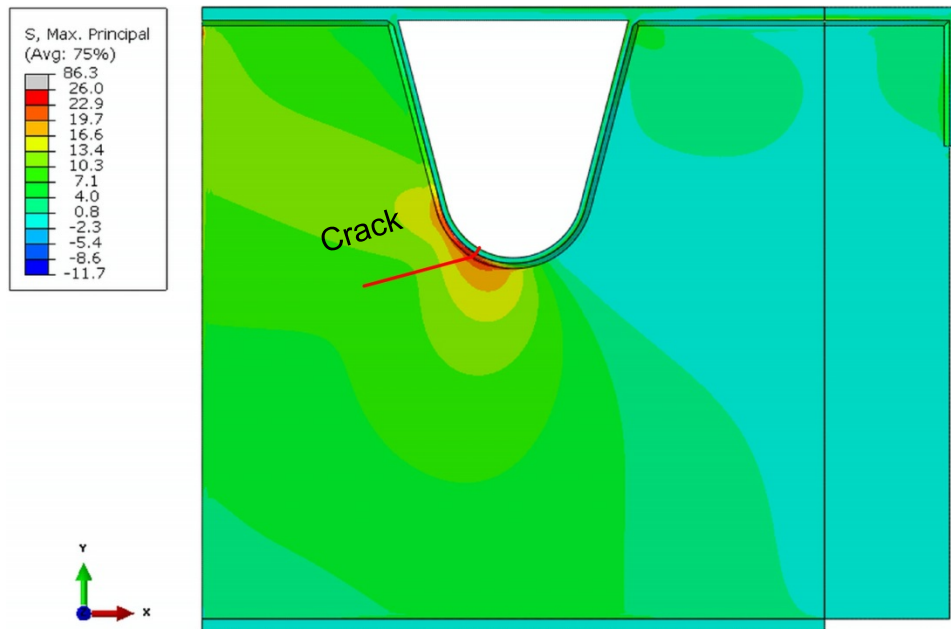
The contours of maximum and principal stresses in the floor beam as obtained from FEA results are presented in Figure 167 and Figure 168. Also marked on the figures are the crack paths. Significant stress concentrations were noted at the rib-to-floor beam weld toe near the crack origins. The larger (in magnitude) principal stress to the north and the south were tensile and compressive respectively. Direction of principal stresses on sections along the crack paths are shown in Figure 169 and Figure 170. Note that the sections have been extended to the edge of the specimen model, although in physical structure the crack length at the time of the test termination was much less. As is seen, the principal stresses were nearly normal to the crack path. Hence, it may be concluded that the fatigue cracks grew normal to the principal stresses, and the principal stresses were responsible for the observed fatigue cracking. It should be noted that although the south side welded connection was subjected to nominal compressive stress range, the local stress range at the weld was tensile in presence of high tensile residual stress in the order of yield strength of the material. As such, fatigue cracking was observed under compressive stress field at this location.

Figure 167. FEA contour of maximum principal stress in the floor beam web in MU1

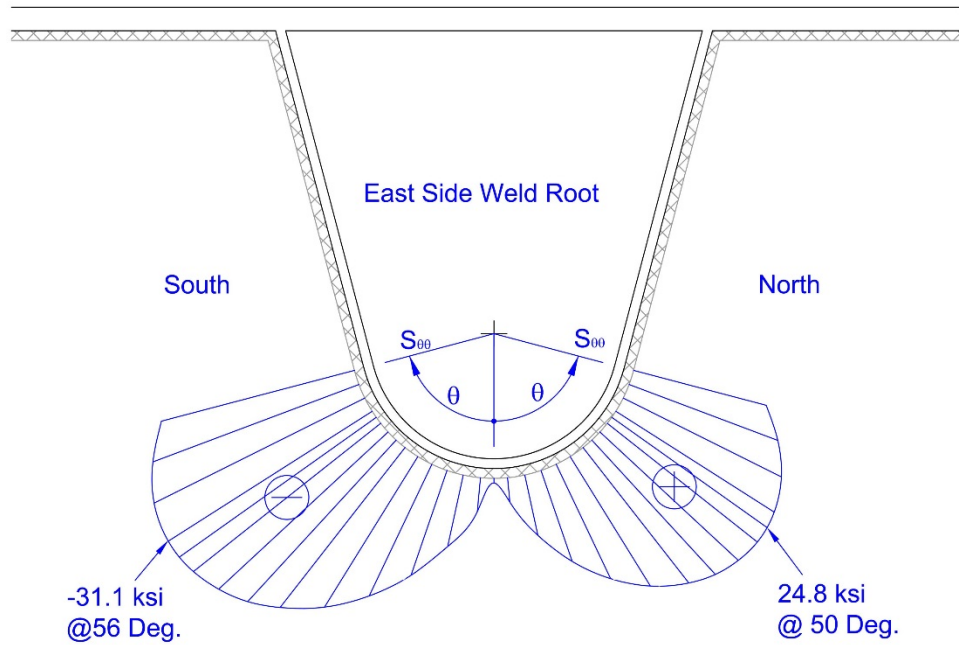
Figure 171 shows the distribution of the circumferential stresses along the weld root (tangential to the rib soffit) of the rib-to-floor beam connection. The circumferential stress is critical for crack growth from volumetric discontinuities at the weld root. As is

evident, the maximum tensile circumferential stress at the weld root was about 24.6 ksi and occurred at about 52 degrees from the rib soffit. The maximum compressive circumferential stress at the weld root was 31 ksi and occurred at about 58 degrees from the rib soffit. The circumferential stresses at the weld root at about 25 to 30 degrees from the rib soffit were estimated to be about 22 ksi compressive and 18 ksi tensile. These stresses would explain the observed fatigue cracking from the weld root on the south and the north sides.

Figure 171. Distribution of circumferential stress (tangential to weld toe) at the rib-to-floor beam weld root along circumferential path through the weld root

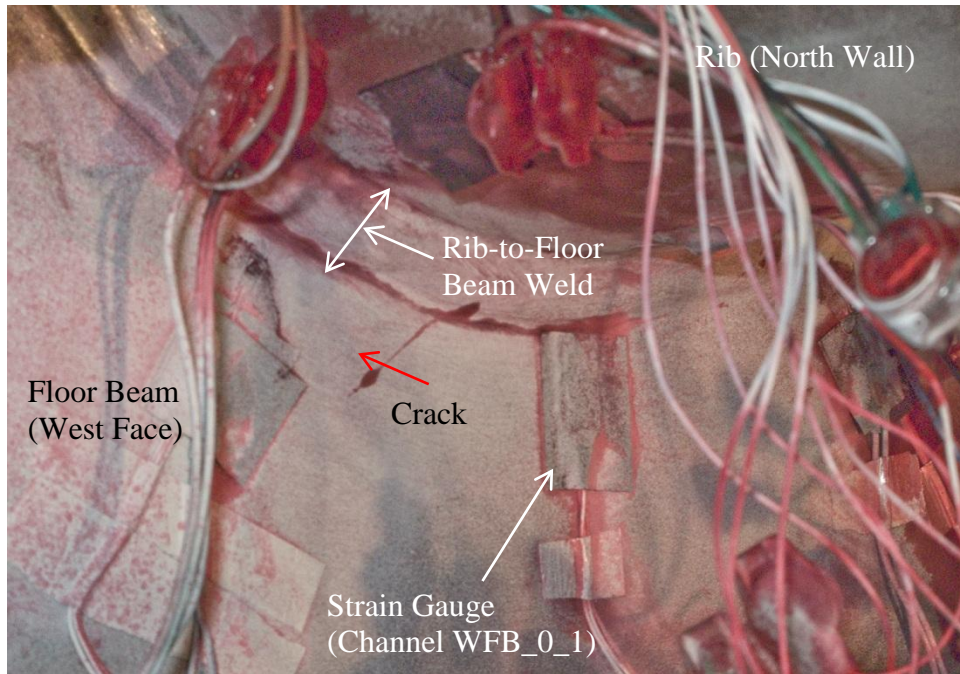
After 1,168,940 cycles two sets of cracks were detected at the floor beam to rib connection. The cracks were detected on November 10, 2012 during the 8:00 PM inspection. One set of cracks initiated on the north side from the weld root at about 8 degrees from the rib soffit (Figure 173) while the other set of cracks initiated on the south side from the weld root at about 30 degrees from the rib soffit (Figure 174). The cracks grew through the weld throat and propagated into the floor beam and the ribs on both side of the floor beam. The crack on the north side progressed about 0.4 in. (10 mm) into the floor beam web and about 0.6 in. (15 mm) into the rib wall, while the crack on the south side progressed about 0.3 in. (8 mm) into the floor beam web and about 0.7 in. (18 mm) into the rib wall. A schematic of the cracks is shown Figure 175. The fatigue test was terminated on November 13, 2012 after 1,296,259 cycles when the cracks propagated through the holes in both north and south sides and appeared at the edge of the drilled holes.

Figure 173. Crack at the floor beam-to-rib welded connection in the mock-up specimen MU2 – north west

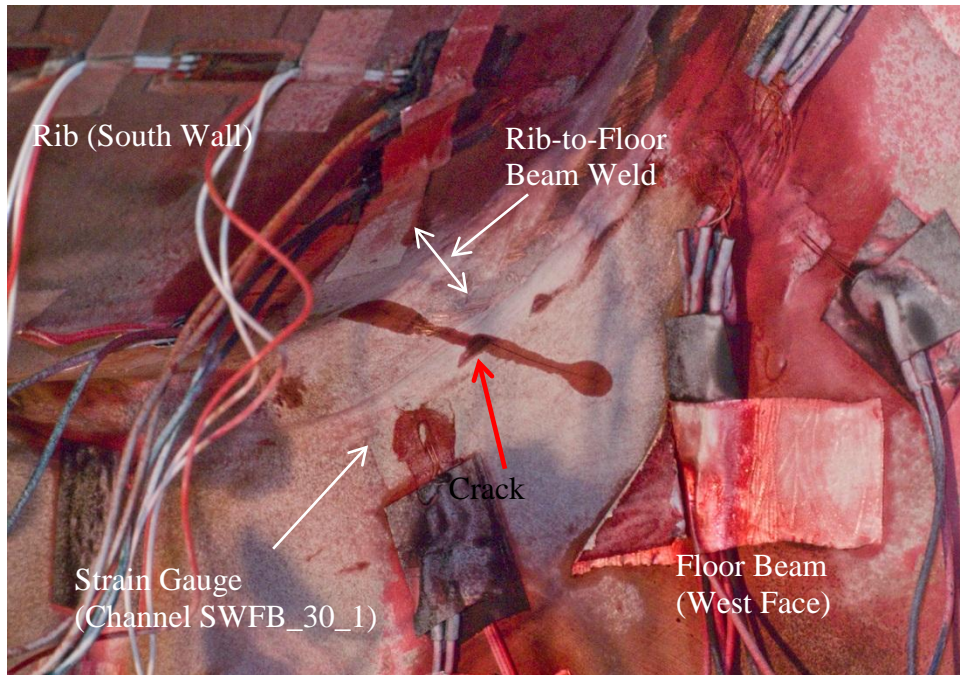
Figure 174. Crack at the floor beam-to-rib welded connection in the mock-up specimen MU2 – south west

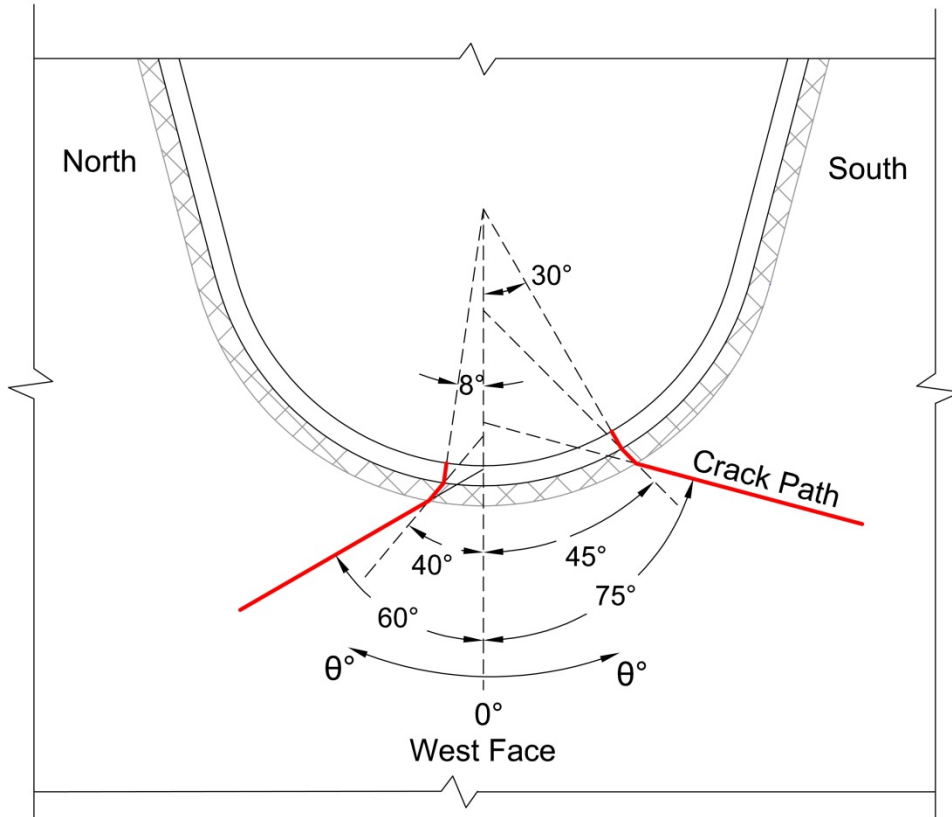
Figure 175. Schematics of cracks in mock-up specimen MU2

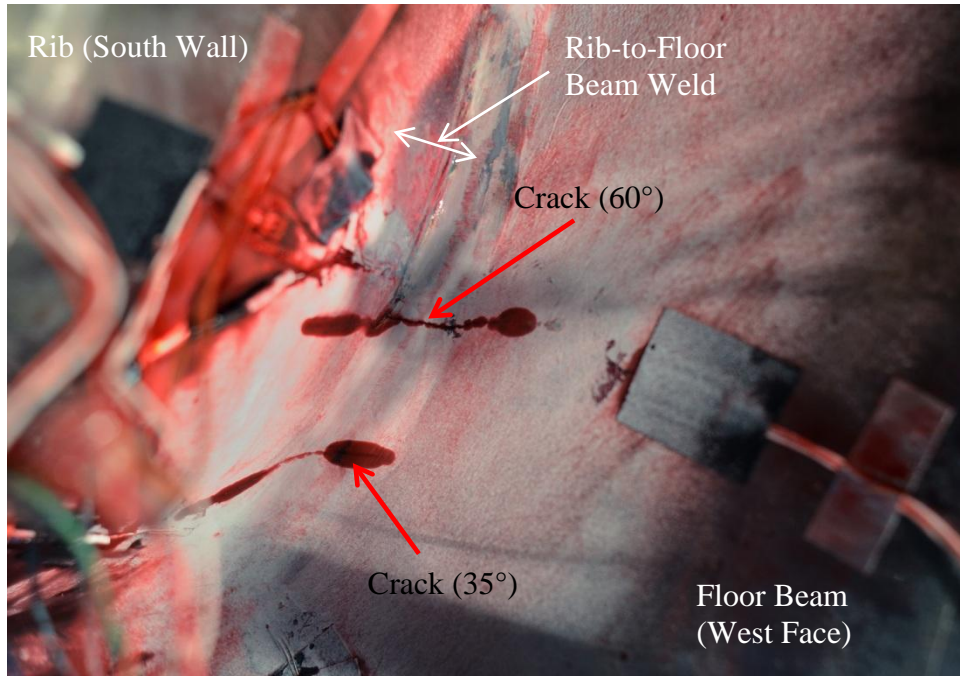
Figure 182. Crack at the floor beam-to-rib welded connection in the mock-up specimen MU3 – south west

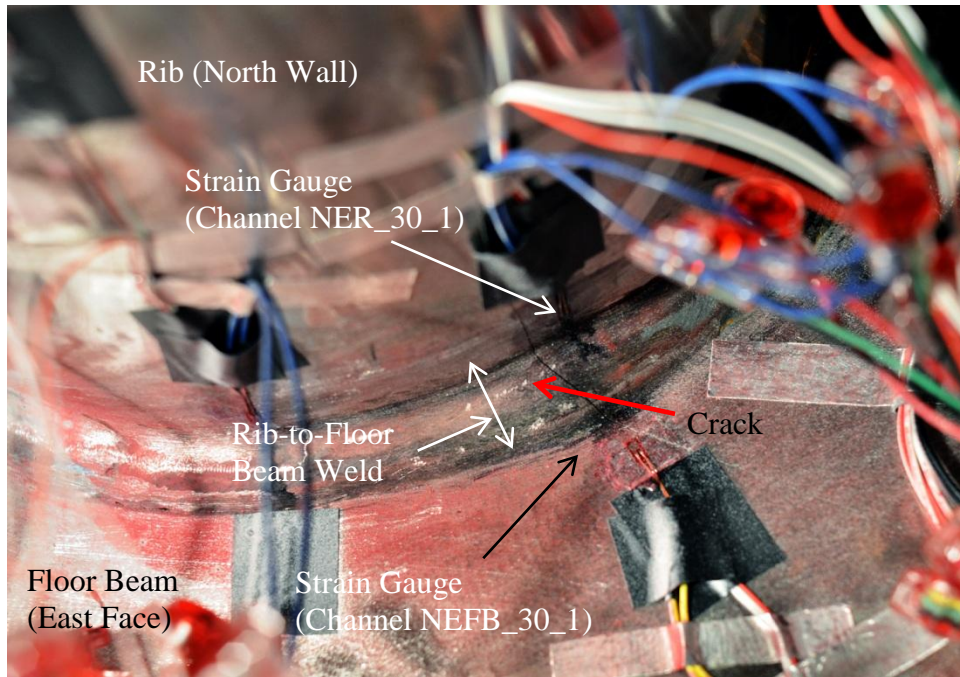
Figure 183. Crack at the floor beam-to-rib welded connection in the mock-up specimen MU3 – north east

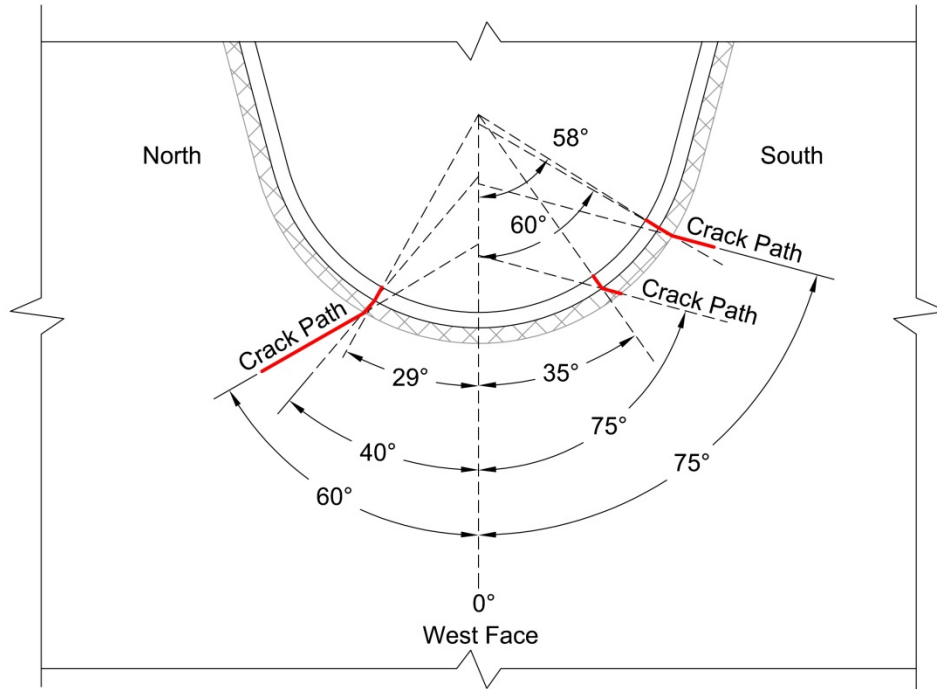
Figure 184. Schematics of cracks in mock-up specimen MU3

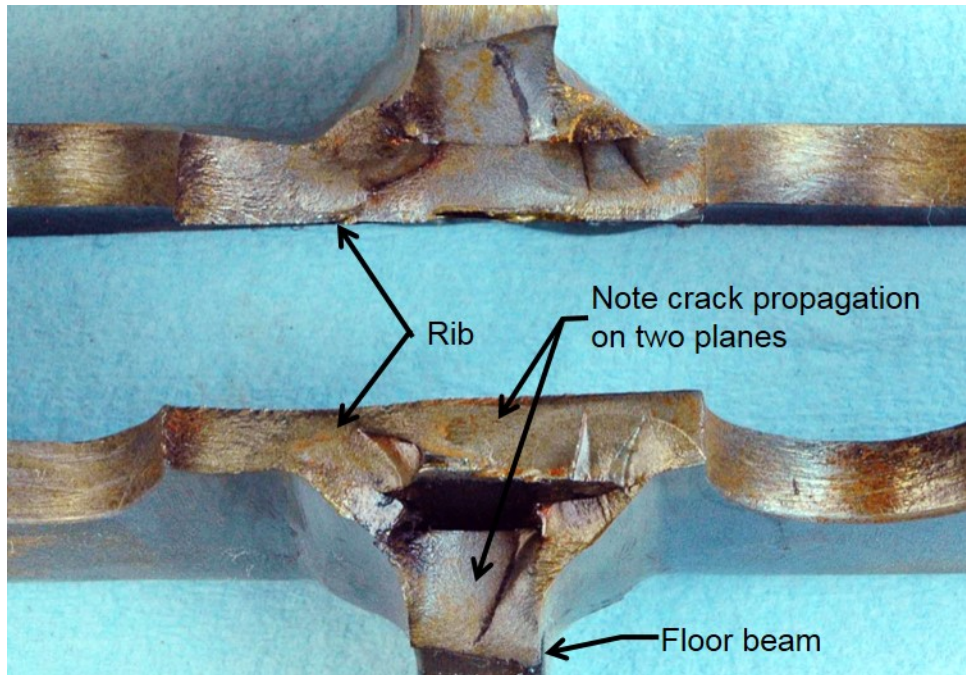
Figure 206. Mating fatigue fracture surfaces for the crack to the north of rib in MU1

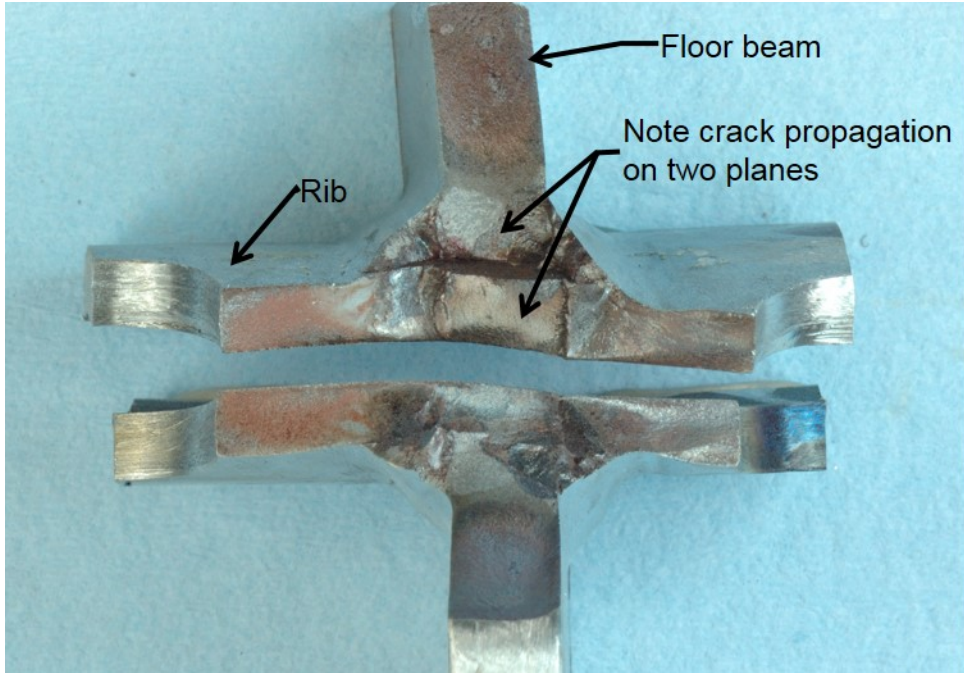
Figure 207. Mating fatigue fracture surfaces for the crack to the south of rib in MU1

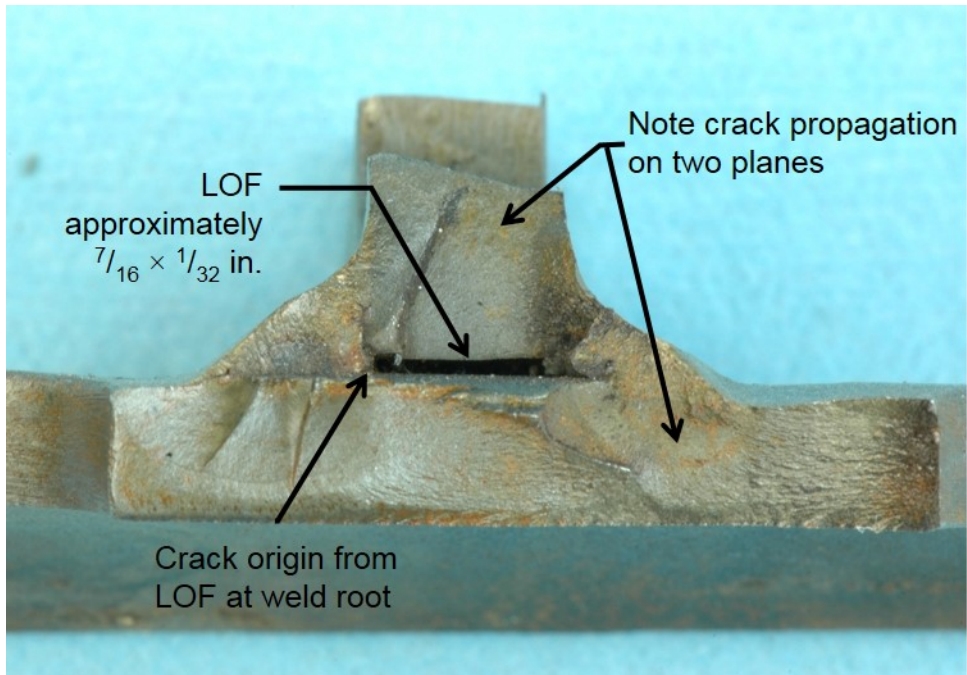
Figure 208. Fracture surface photographed perpendicular to the camera to clarify the LOF — crack to the north of rib

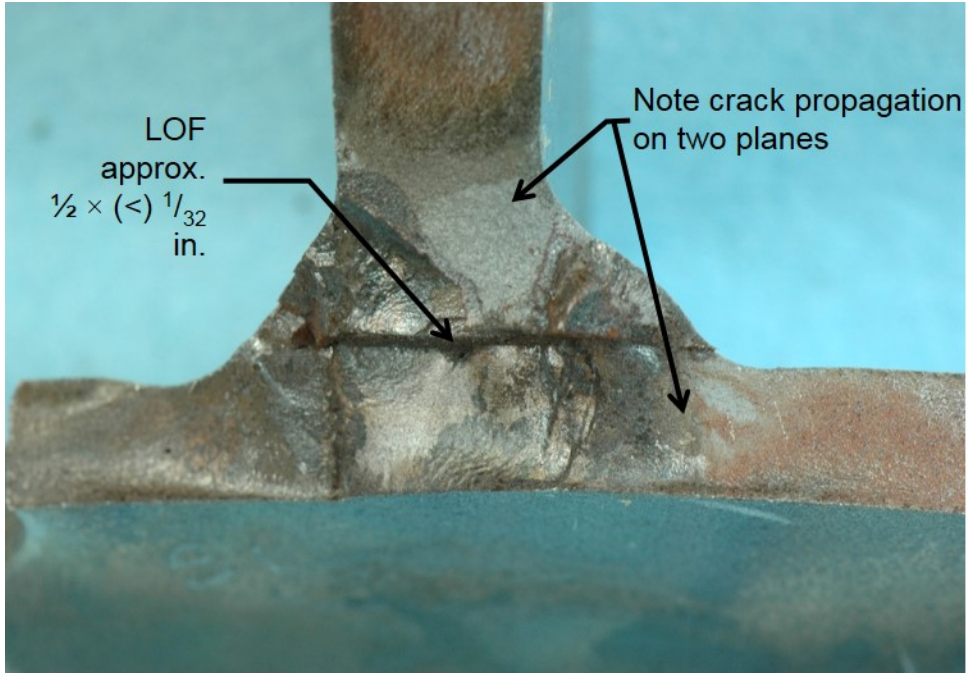
Figure 209. Fracture surface photographed perpendicular to the camera to clarify the LOF — crack to the south of rib

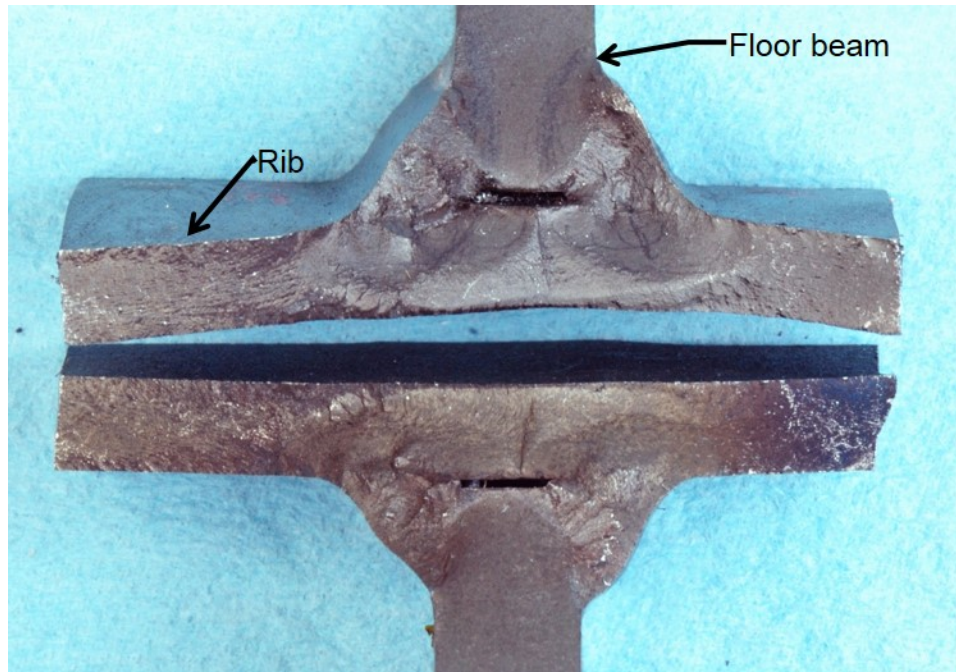
Figure 213. Mating fatigue fracture surfaces for the crack to the north of rib in MU2

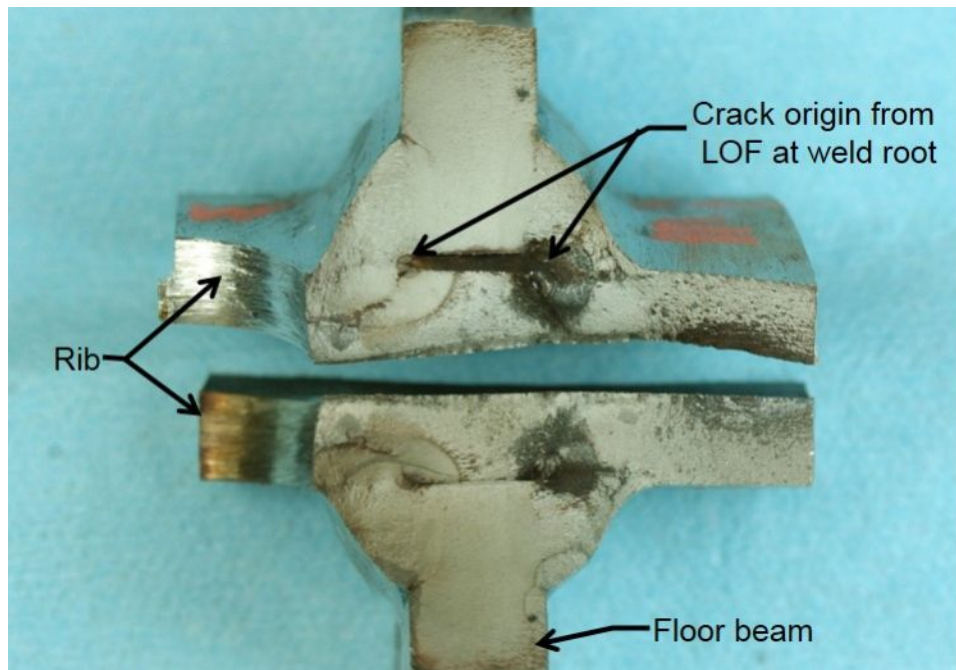
Figure 214. Mating fatigue fracture surfaces for the crack to the south of rib in MU2

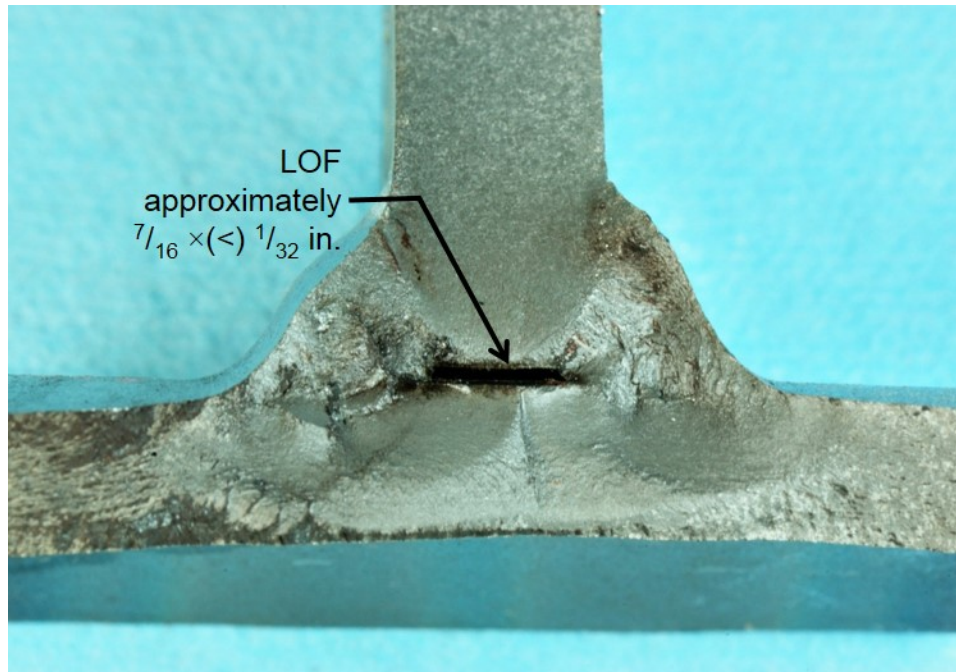
Figure 215. Fracture surface photographed perpendicular to the camera to clarify the LOF — crack to the north of rib in MU2

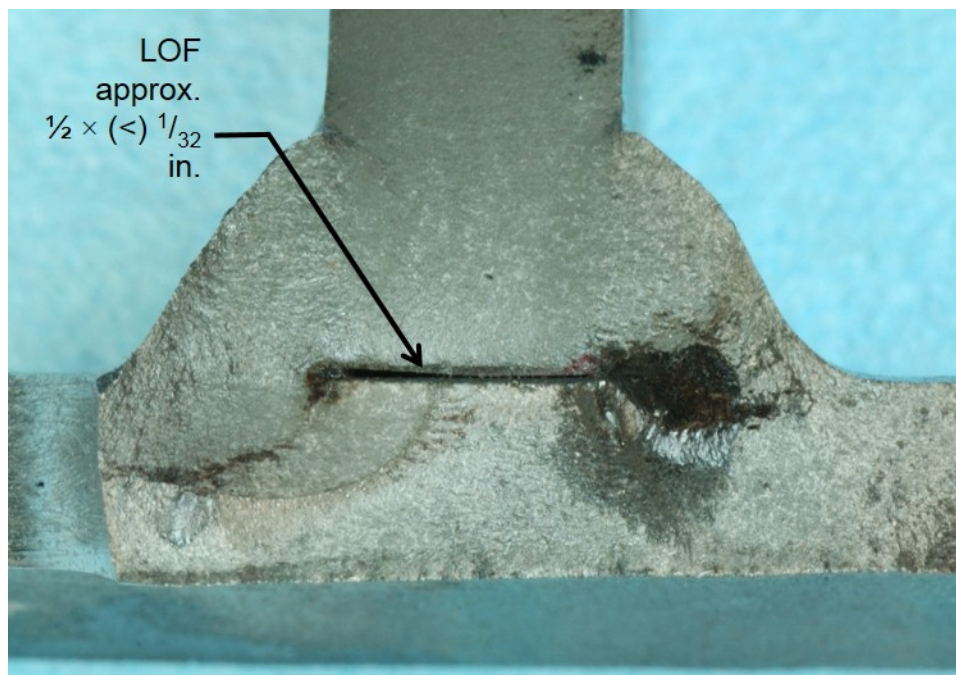
Figure 216. Fracture surface photographed perpendicular to the camera to clarify the LOF — crack to the south of rib in MU2

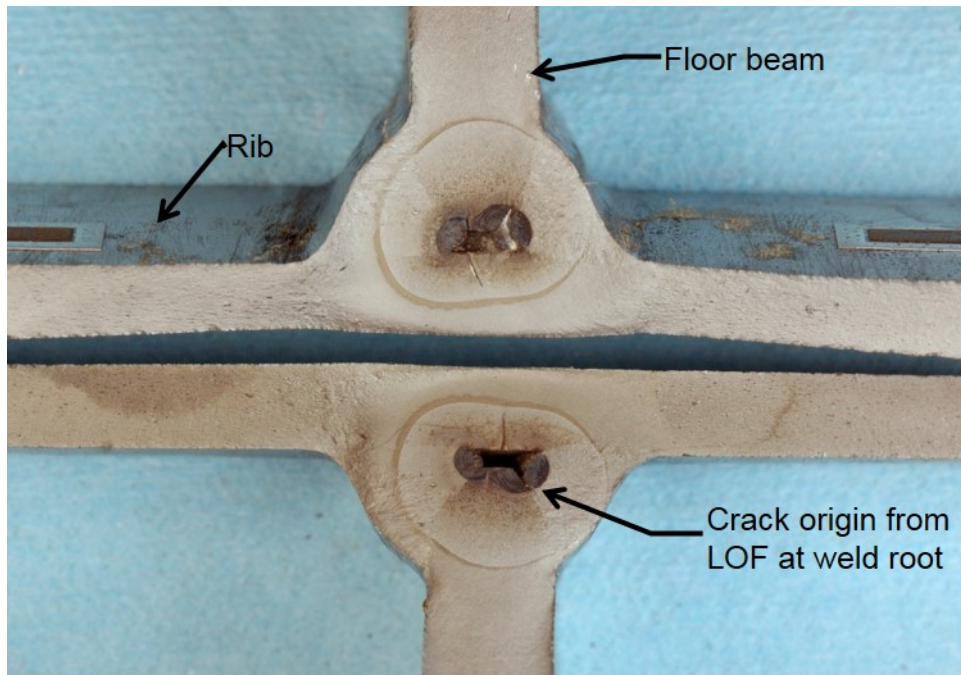
Figure 220. Mating fatigue fracture surfaces for the crack to the north of rib in MU3

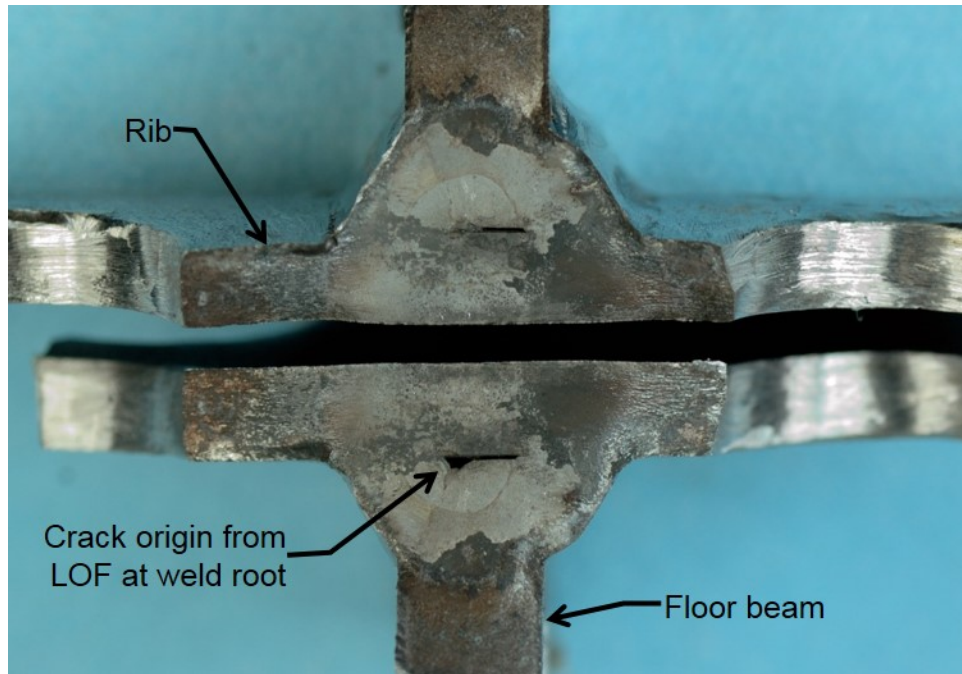
Figure 221. Mating fatigue fracture surfaces for the crack to the south of rib at 55 degrees from rib soffit in MU3

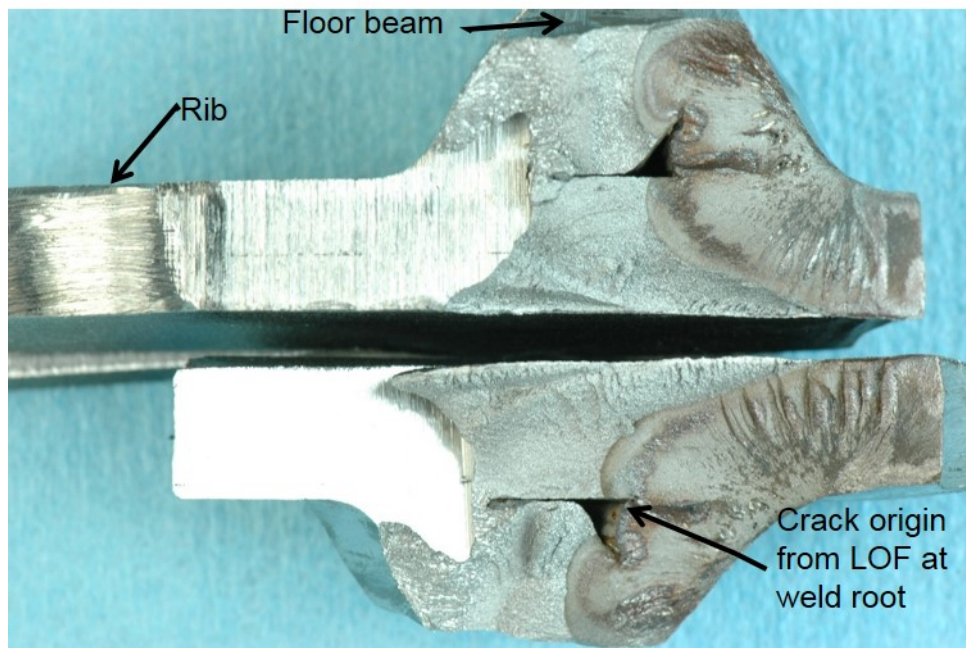
Figure 222. Mating fatigue fracture surfaces for the crack to the south of rib at 35 degrees from rib soffit in MU3

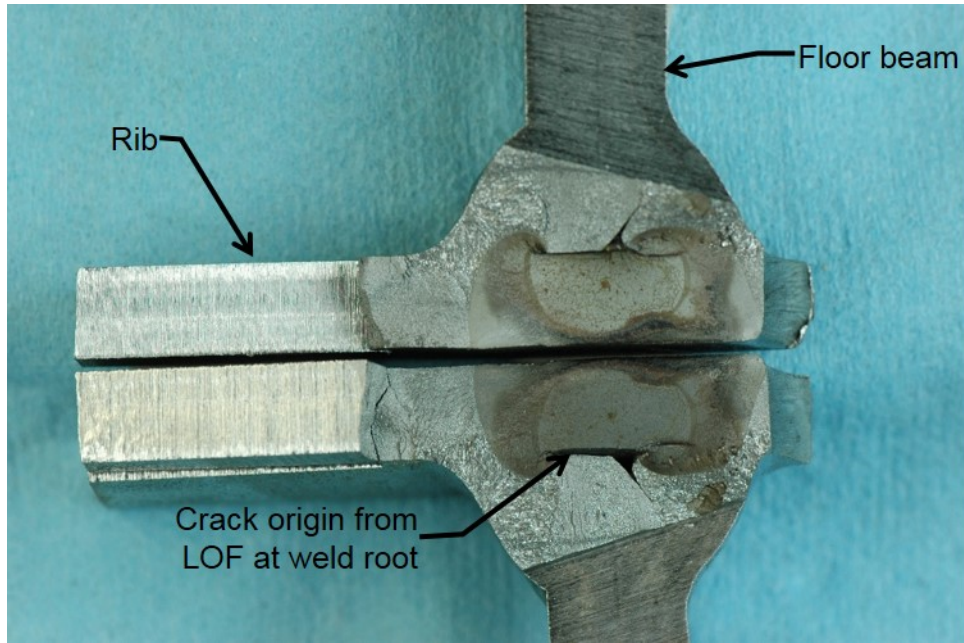
Figure 223. Mating fatigue fracture surfaces for the crack to the south of rib at 27 degrees from rib soffit in MU3

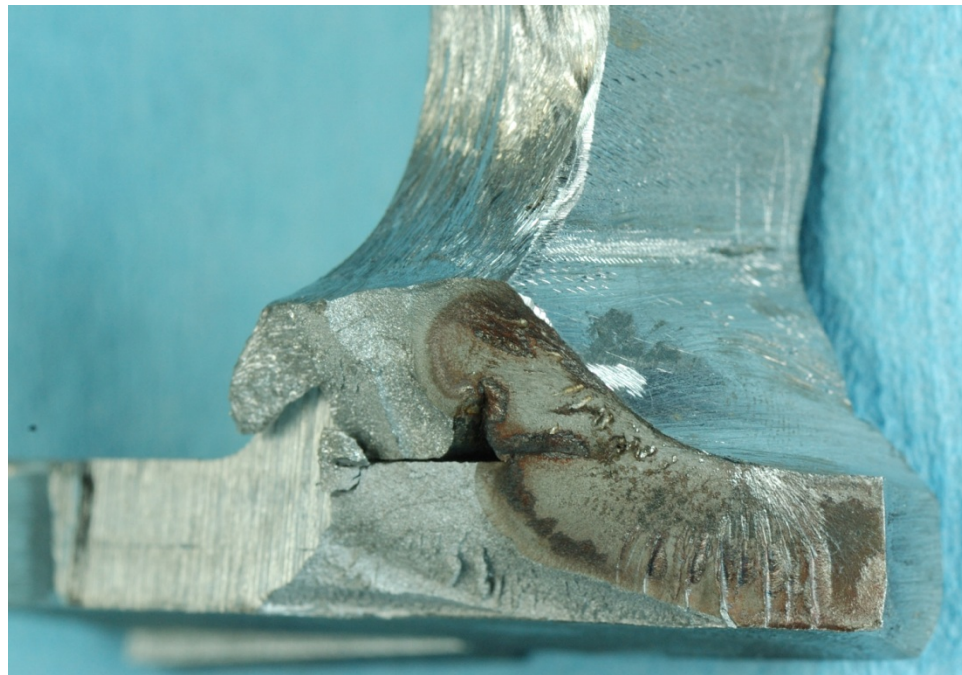
Figure 224. View of fracture surface to the south at about 35 degrees from the rib soffit in MU3 showing the deviation of fracture plane through the weld

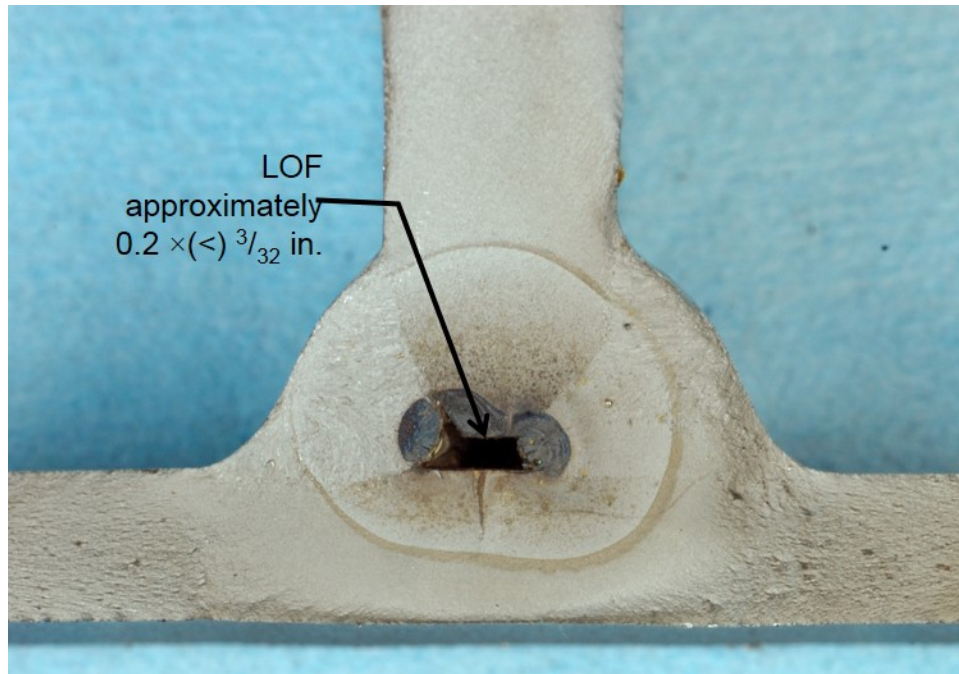
Figure 225. Fracture surface photographed perpendicular to the camera to clarify the LOF — crack to the north of rib in MU3

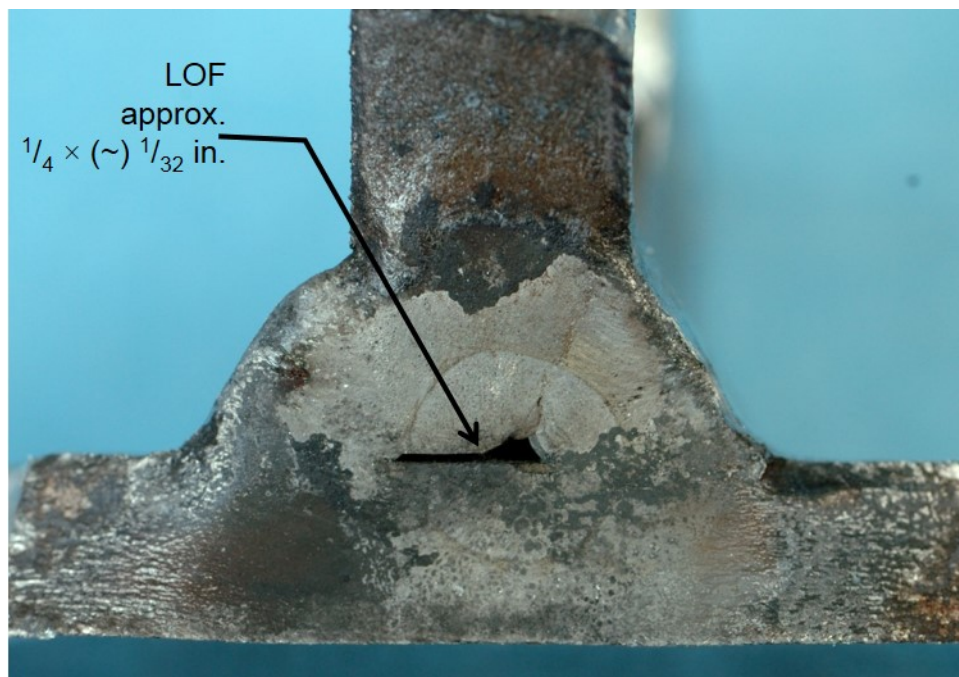
Figure 226. Fracture surface photographed perpendicular to the camera to clarify the LOF — crack to the south of rib in MU3 at 55 degrees from the rib soffit

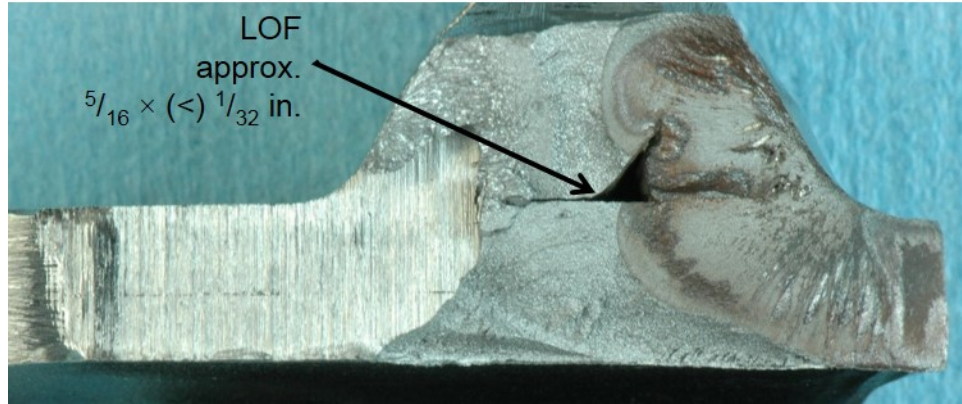
Figure 227. Fracture surface photographed perpendicular to the camera to clarify the LOF — crack to the south of rib in MU3 at 35 degrees from the rib soffit

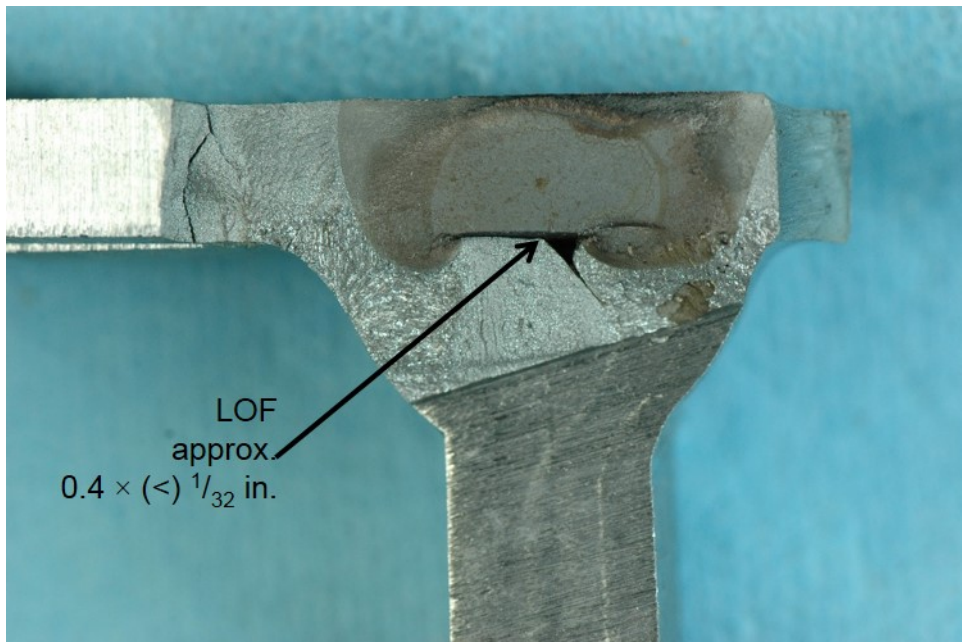
Figure 228. Fracture surface photographed perpendicular to the camera to clarify the LOF — crack to the south of rib in MU3 at 35 degrees from the rib soffit
