Delaware River
Joint Toll Bridge
Commission

SEVENTIETH ANNUAL INSPECTION REPORT 2007

RE: Consulting Engineer's Seventieth Annual Inspection Report-2007
DRJTBC Contract No. C-07-02A
Our Project Number 708070022

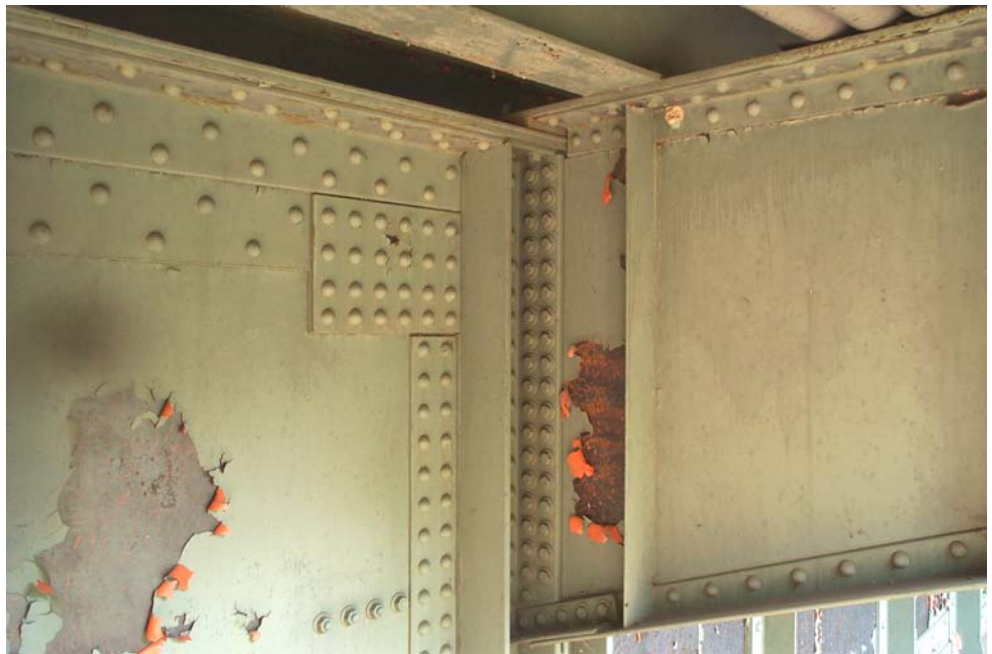
PHOTO 2 Typical Cantilever bracket (Floorbeam 3 at Span 1 shown), looking northeast.

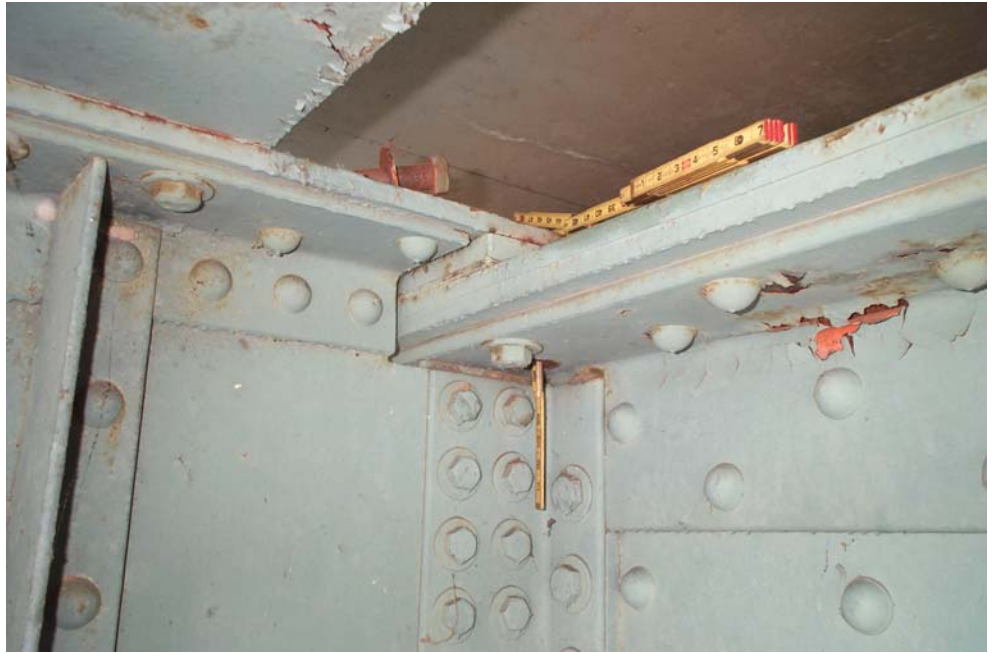
PHOTO 5 1 of 8 connection bolts is sheared at the tie plate connection over the north girder at the first floorbeam to the east of Pier 8, looking east.

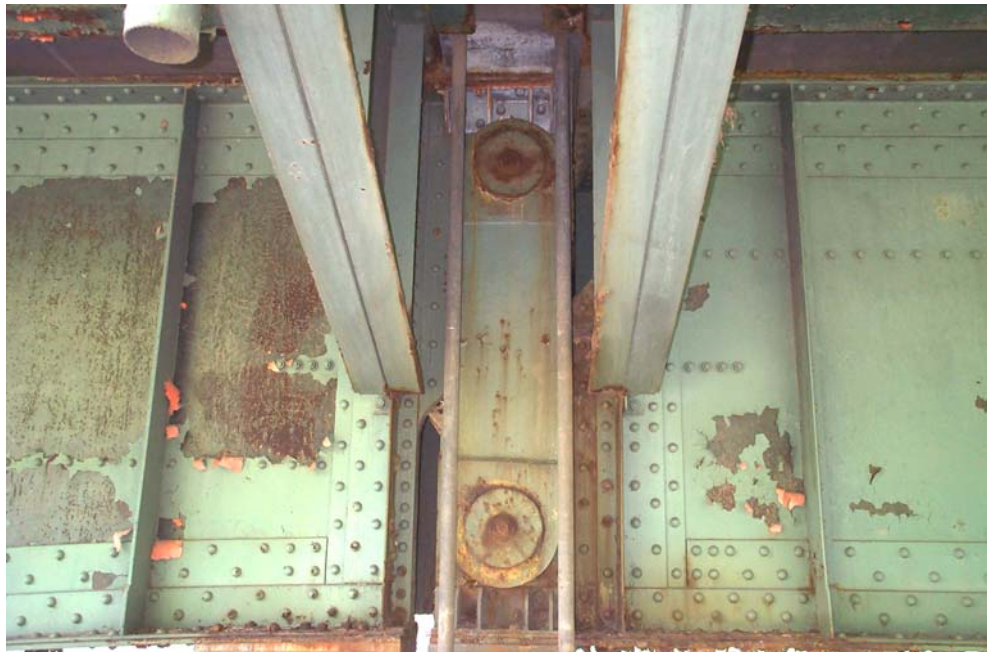
PHOTO 6 General view of the pin and hanger assembly (North girder at Span 1 shown), looking south. Note the light to moderate rust throughout assembly and seismic retrofit.
