Inorganic Protective Coatings and Fiber Reinforced Polymers Demonstration Project: Route 47 Wildwood Drawbridge Bridge House Rehabilitations

FINAL REPORT

October 2008

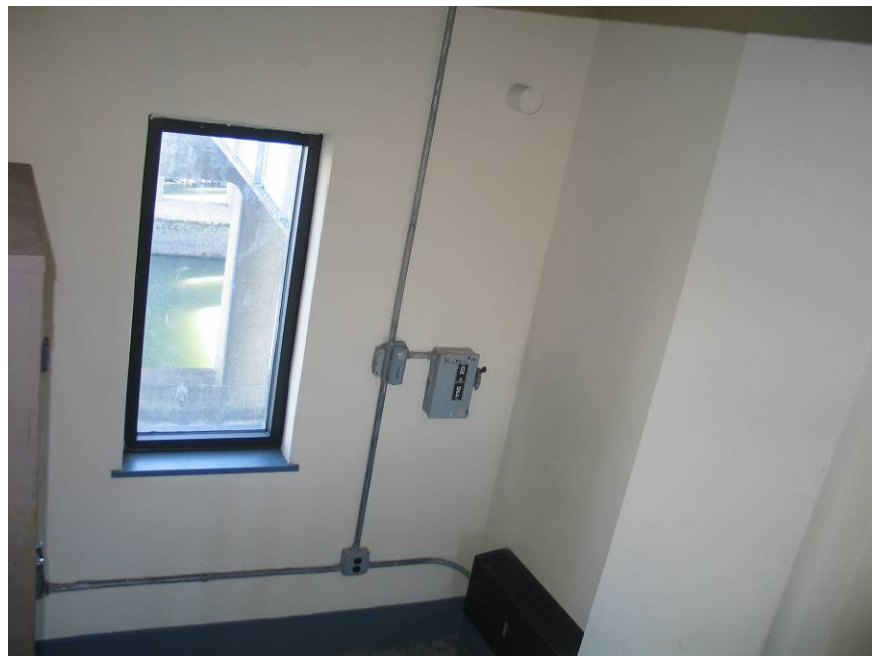
Figure 3 - Finished Inside Surface Including Treatment Around Window (North Tower)

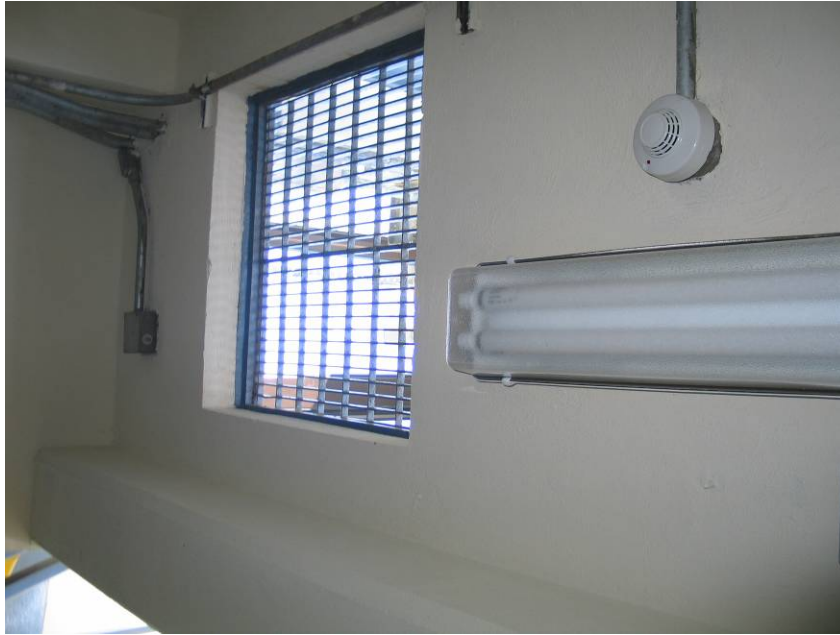
Figure 4 - Details Near Fixtures (North Tower)

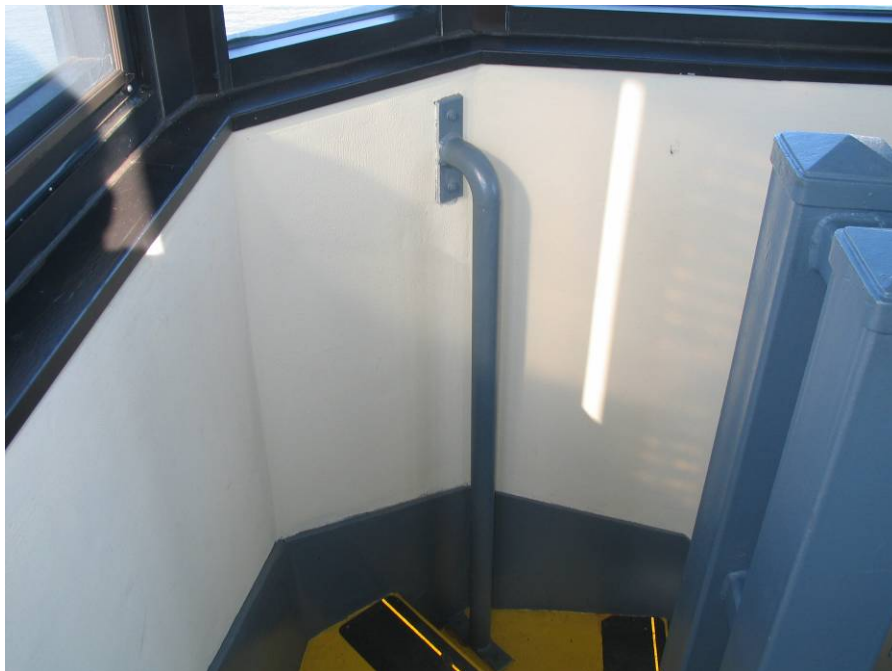
Figure 5 - Details Near Steps (South Tower)

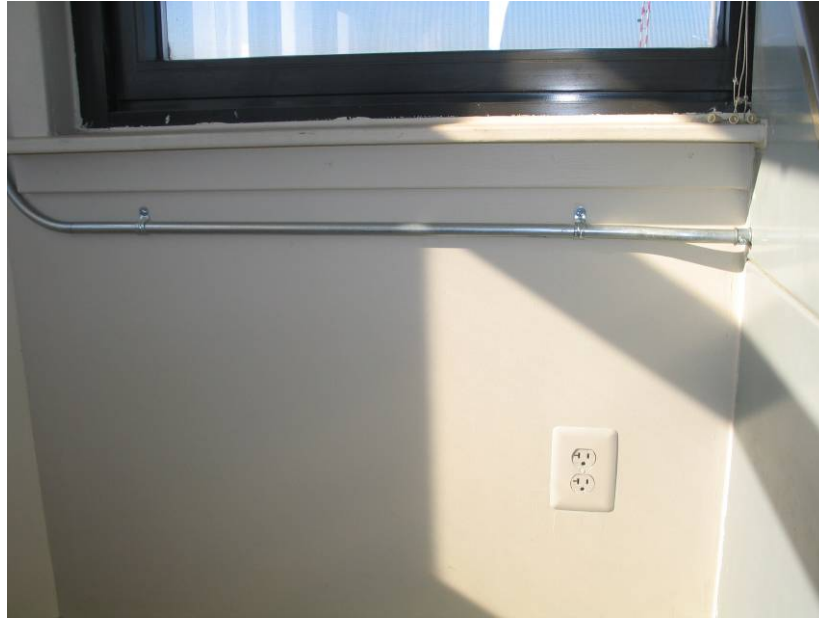
Figure 6 - Details Near a Large Window (South Tower)
