BREAKAWAY CABLE TERMINAL EVALUATION

FINAL REPORT

MAY 1980

Prepared By
New Jersey Department of Transportation
Division of Research and Demonstration
In Cooperation With
U.S. Department of Transportation
Federal Highway Administration
New Jersey State Library

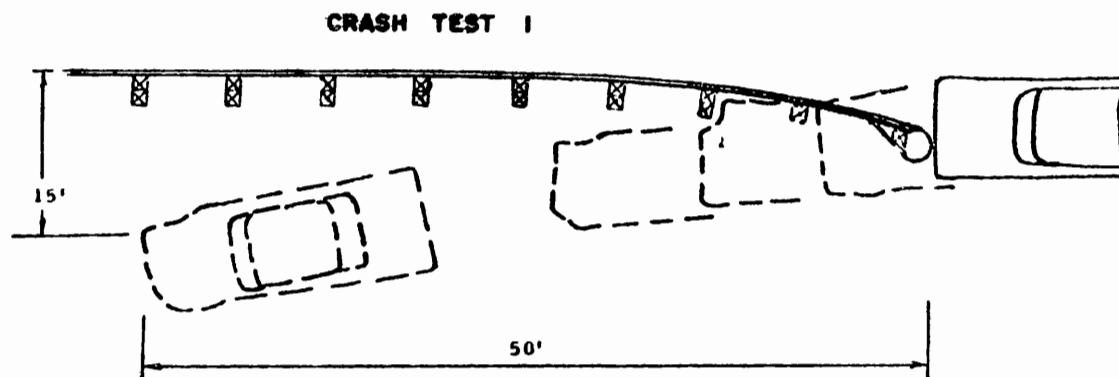
Figure 2

Test Installation .. Flared Terminal*
Posts 8 x 8 Timber
Post Spacing 6.25 ft
Rail Standard 12ga W beam
Length of Installation 87.5 ft
Ground Condition Dry

Test No. 130
Date 6-11-71
Vehicle 1965 Ford
Vehicle Weight .. 4138 lbs
Impact Speed 61 mph
Impact Angle 0 deg**

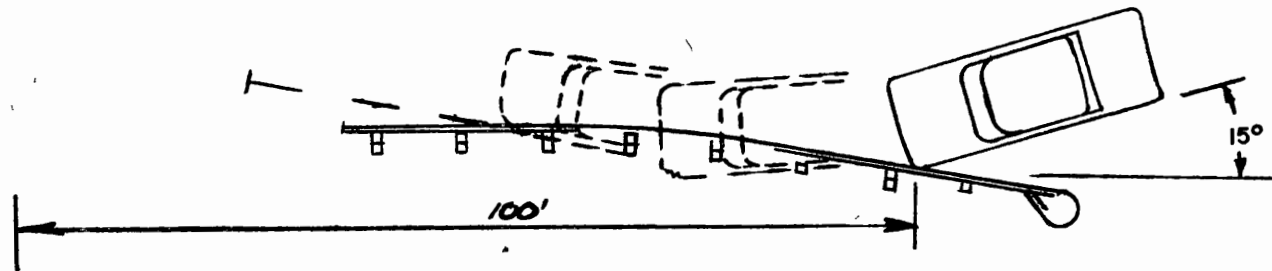
CRASH TEST 2

Test Installation ... Flared Terminal*
Posts 8 x 8 Timber
Post Spacing 6.25 ft
Rail Standard 12ga. W beam
Length of Installation 87.5 ft
Ground Condition Dry

Test No. 131
Date 7-17-71
Vehicle 1963 Ford
Vehicle Weight .. 4000 lbs
Impact Speed ... 59.4 mph
Impact Angle 15 deg

stop 108 feet from the initial point of impact. The cable anchor system, end posts, and foundation were not damaged in the test.

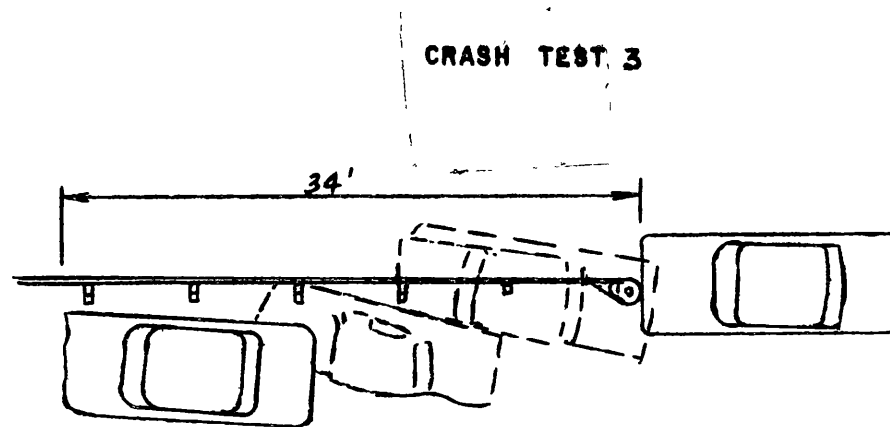
Figure 4.

The installation for the third test (Figure 4) was similar to the previous tests with the exception that steel diaphragms replaced the vermiculite concrete for stabilizing the terminal nose and the flat plate washers were eliminated from the first 6 posts to achieve rail separation from the post. The horizontal flare was eliminated; essentially, the BCT and guiderail installation were parallel to the roadway and column loaded.

Test installation ... Straight Terminal*
Posts 8 x 8 Timber
Post Spacing 6.25 ft
Rail Standard 12ga. W beam
Length of Installation 87.5 ft
Ground Condition Wet

Test No. 132
Date 8-16-71
Vehicle 1964 Ford
Vehicle Weight .. 4100 lbs
Impact Speed ... 58.5 mph
Impact Angle 0 deg

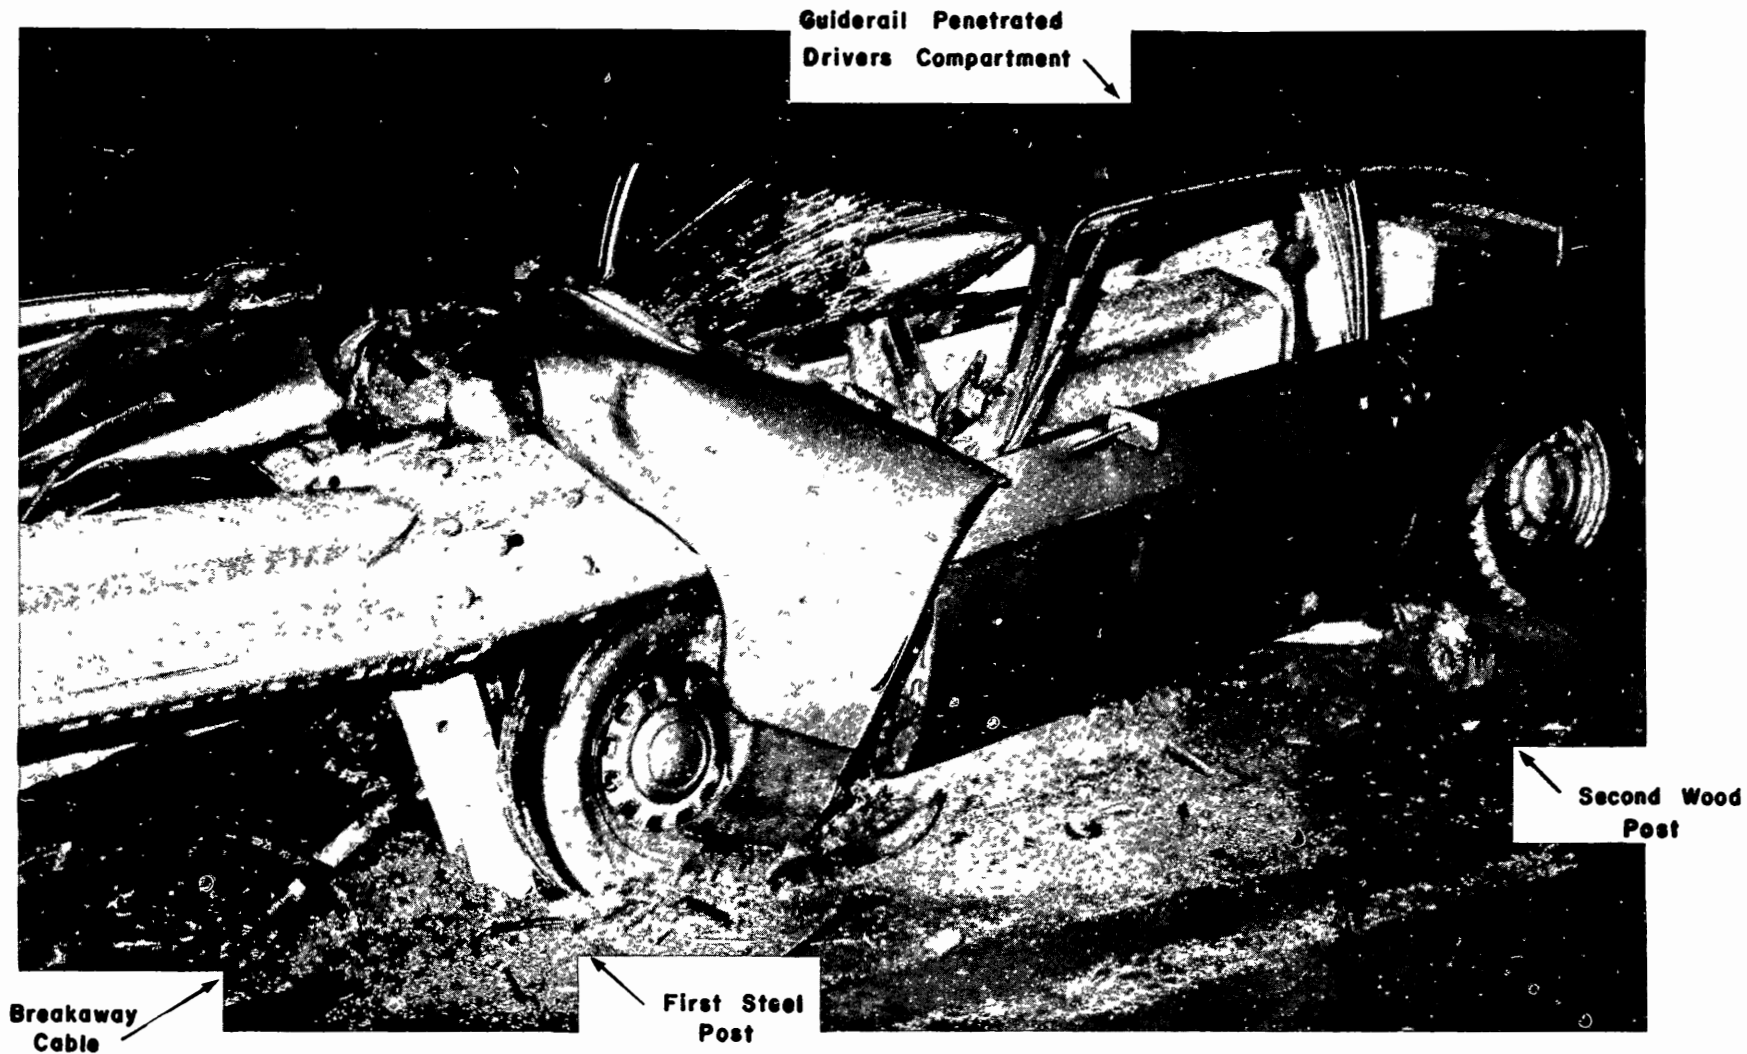
PICTURE 1
SPEARED CHEVROLET VEGA

The vehicle spearing phenomena occurred in three cases where the undiaphragmed BCT was installed on a straight guiderail section. (Accident cases #7,8,10) The vehicles were a subcompact, a compact and a van with small engines, and no substantial mass in the engine compartment to impact an object. Apparently, as a consequence of this condition the guiderail was able to penetrate vehicle. In large vehicles (Accident cases #11,12,13) air conditioning units, V-8 engines and other engine compartment components provide a substantial mass to impact the BCT and prevent spearing. Since the small vehicles do not possess a high engine compartment mass, the BCT must be designed to provide for this condition. Undiaphragmed BCTs apparently do not provide sufficient distribution of impact load for the lighter subcompacts. Instead, when the subcompacts impact the BCT, it appears that the flimsy unsupported buffer nose collapses and the guiderail becomes a spear. The diaphragmed buffer nose provides greater mass for load distribution during the small car impacts.

Case #10: A 1972 Chevrolet Vega impacted an undiaphragmed BCT. The BCT was located at the edge of the roadway on a straight guiderail section, i.e., without horizontal flare. The vehicle broke the first and second wood posts at ground level. The guiderail speared the vehicle into the driver's seat pushing the driver's seat backward. Picture #1 shows the speared Vega: Note position of guiderail. The vehicle was severely damaged. The rail remained straight and did not separate from the washerless retainer bolts on the steel posts. The driver was injured seriously.

The spearing potential of straight guiderail, parallel to the roadway, is definitely real. After three confirmed spearings, it is recommended that the Department avoid applications of BCTs on the straight guiderail. However, in areas where the BCT cannot be flared, and a straight installation is unavoidable, a desirable configuration would be one that has the undiaphragmed buffer end replaced by a diaphragmed buffer end and contains a 25 foot rail section to eliminate the splice stiffness. The steel diaphragmed buffer end was tested by Southwest Research Institute (Ref. 2, pg. 56) in straight end-on impacts with a 4000 lb. vehicle. The vehicle was not speared because the stiffened buffer end distributed the impact load over a larger area than the undiaphragmed buffer end.

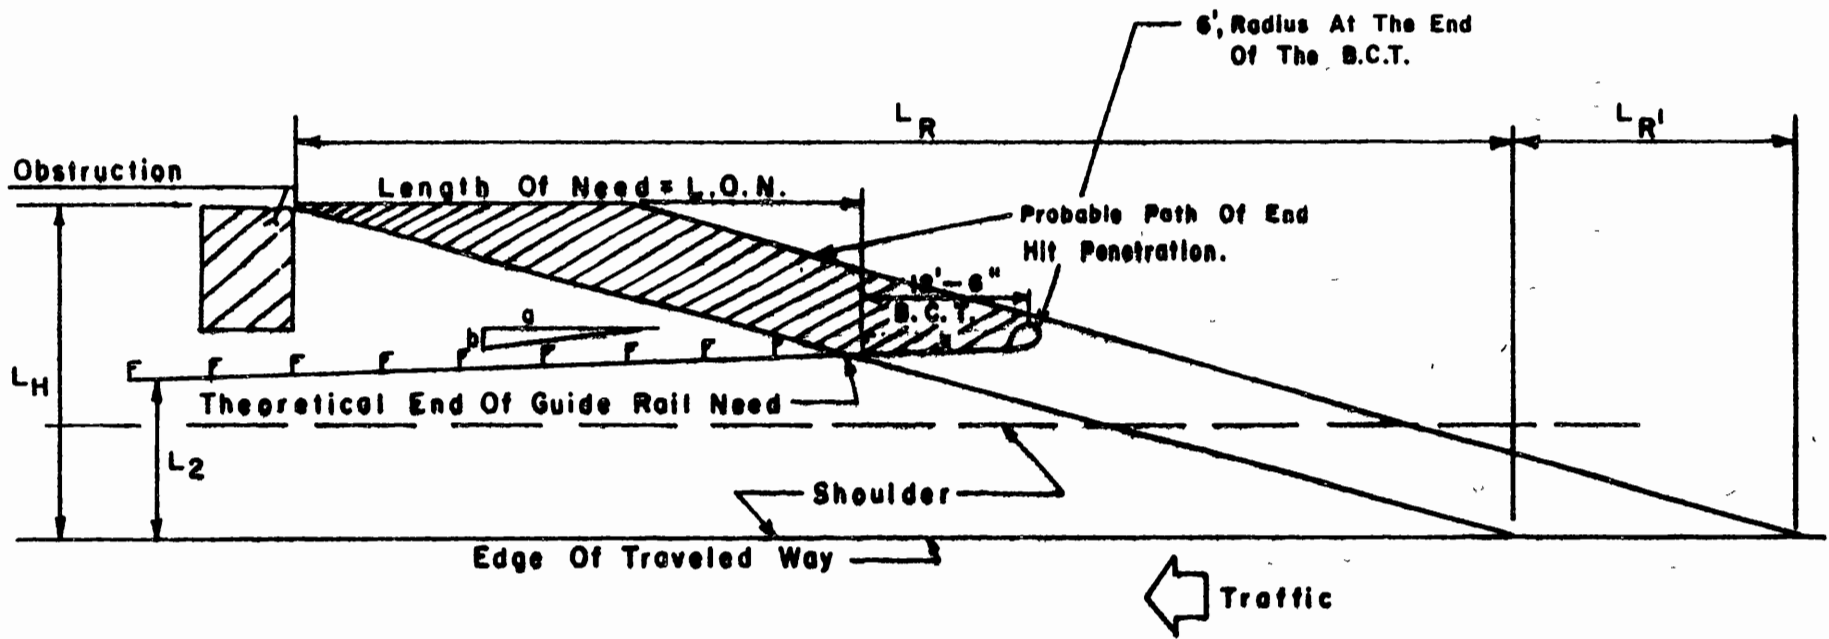
Figure 6 Recovery Area
 Probable Path Of End Hit Penetration

The probable vehicle path closely approximates the clear distance defined by the length of need as determined by the Department's guiderail guidelines. The determination of the Department's length of need and probable vehicle path are shown in Figure 6. The probable path and recovery area are shown by the cross-hatched area and are defined by the diagonal line from the edge of the traveled way through the theoretical end of guiderail need to the obstruction and the line parallel to the above line running tangent to a six foot radius from the end of the BCT to the depth of the obstruction.

2. Recovery areas immediately behind the BCT and along the probable vehicle path for expected end hit penetration should be free of obstructions. The minimum recovery area and probable area of vehicle penetration are defined from this study and Southwest Research Institute's research by the diagonal line from the edge of the traveled way through the point of theoretical end of guiderail need to the obstruction, and a line parallel to that line running six feet from the end of the BCT to the line of the obstruction. (See Figure 6 in text.) Engineering judgment should be exercised where sufficient recovery areas are not possible. Such solutions as extension of the length of need, clearing and regrading the site, removing and installing protective barriers should be considered.

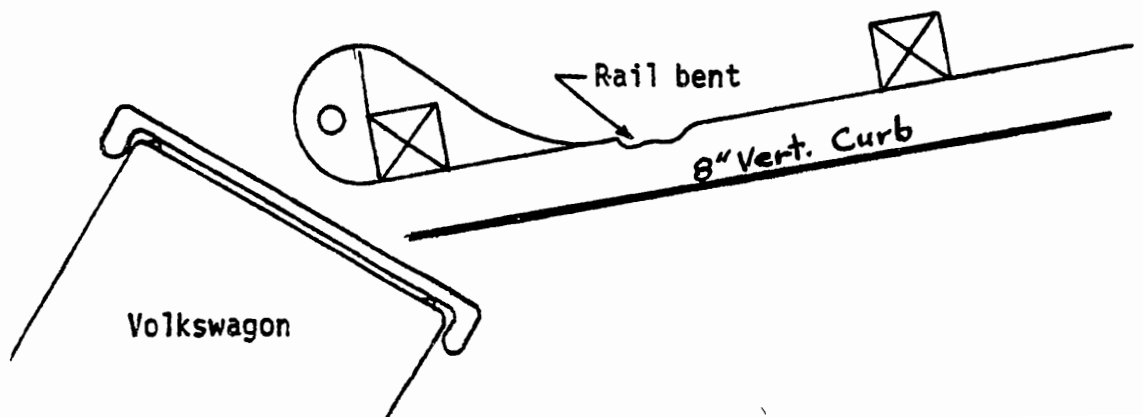
DAMAGE first post, rail, anchor cable in place, buffer not damaged

VEHICLE TYPE 1969 Volkswagon DAMAGE right front and under carriage

COMMENTS: The vehicle impacted the terminal at the buffer-end rail connection point striking the first post which broke away on a diagonal below and above the breakaway hole. The cable remained in place. This BCT is located behind a curb which probably caused the vehicle to vault impacting the BCT at the bumper level of the vehicle.

Vehicle was inoperative. Extensive damage to the undercarriage and front and right side occurred as the vehicle was contained by the bent rail.

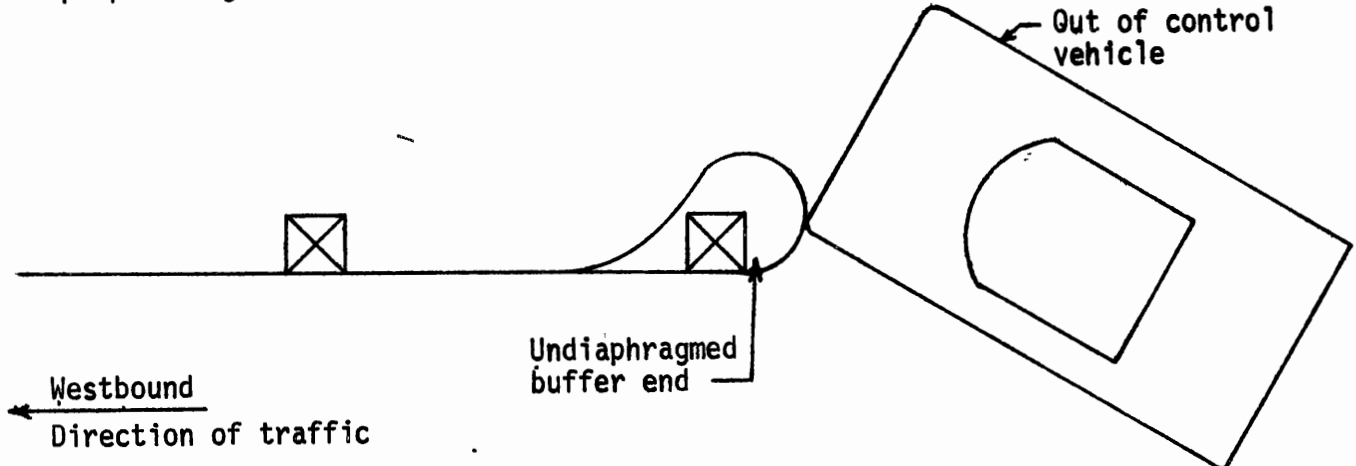
Probable Impact of BCT

DAMAGE buffer end, broke first post but did not release cable

COMMENTS: Minor accident - The vehicle's left front impacted the BCT and glanced off as shown below. The berm was not graded and caused the vehicle to ride over the buffer end. County was notified to grade berm to obtain proper height for BCT.

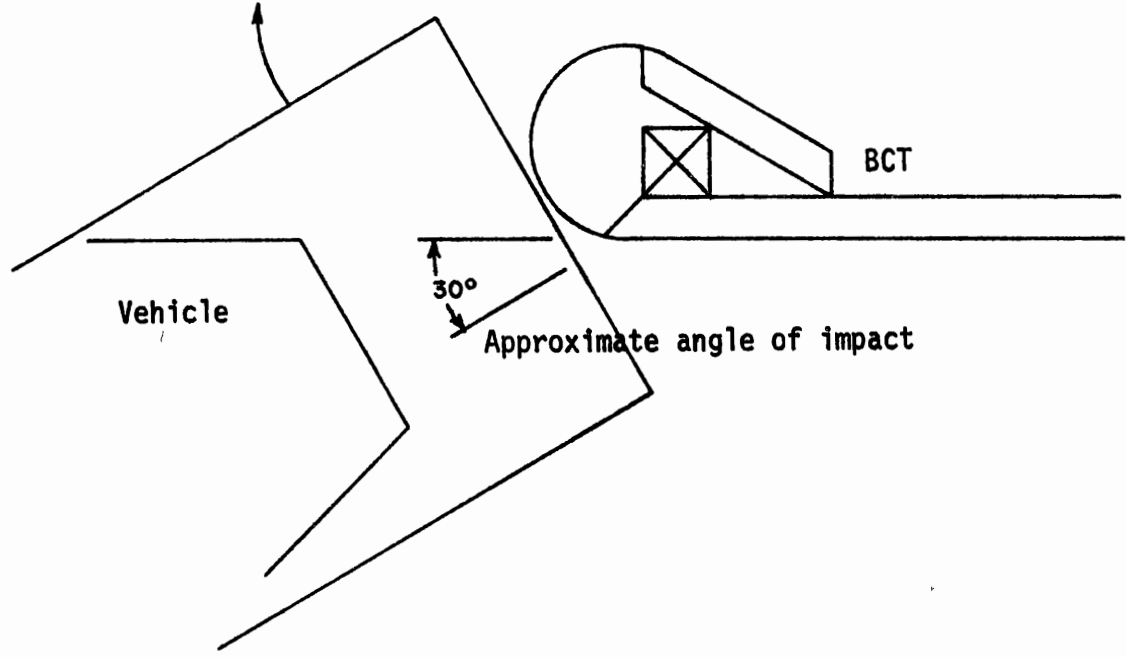
DAMAGE Buffer end was flattened and post was broken below breakaway
hole and at top of post

COMMENTS: (pictures of vehicle are not available)
Vehicle swung in this direction after impact

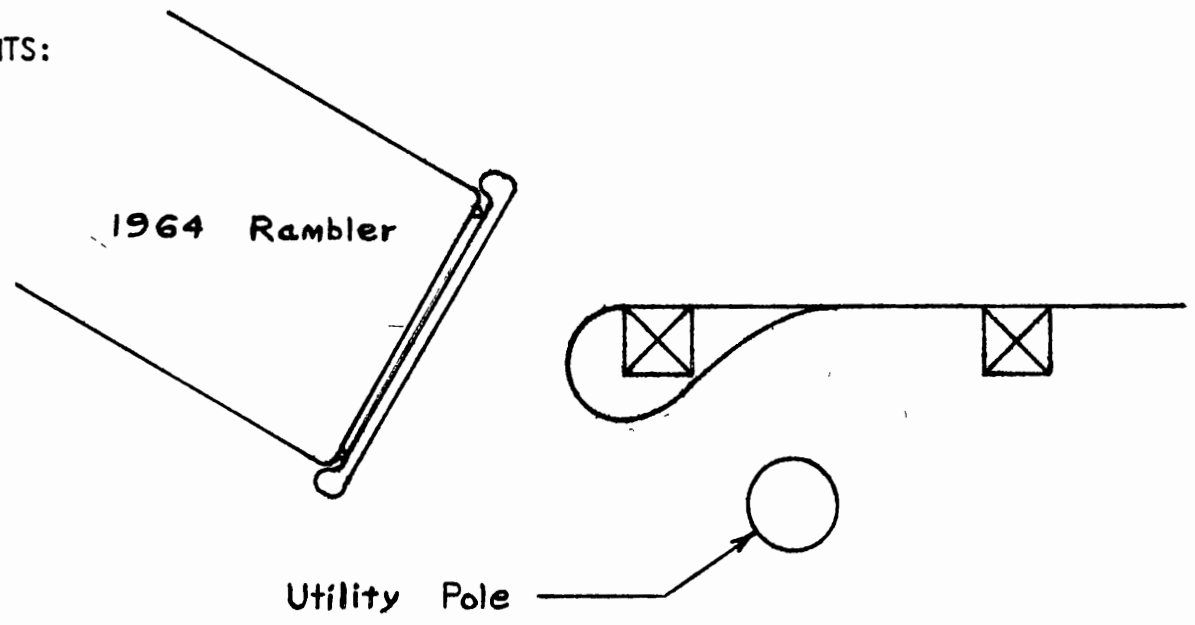
DAMAGE Broke first post, dislodged footing, crushed buffer end.

VEHICLE TYPE Rambler 1964 DAMAGE Front (hit pole)

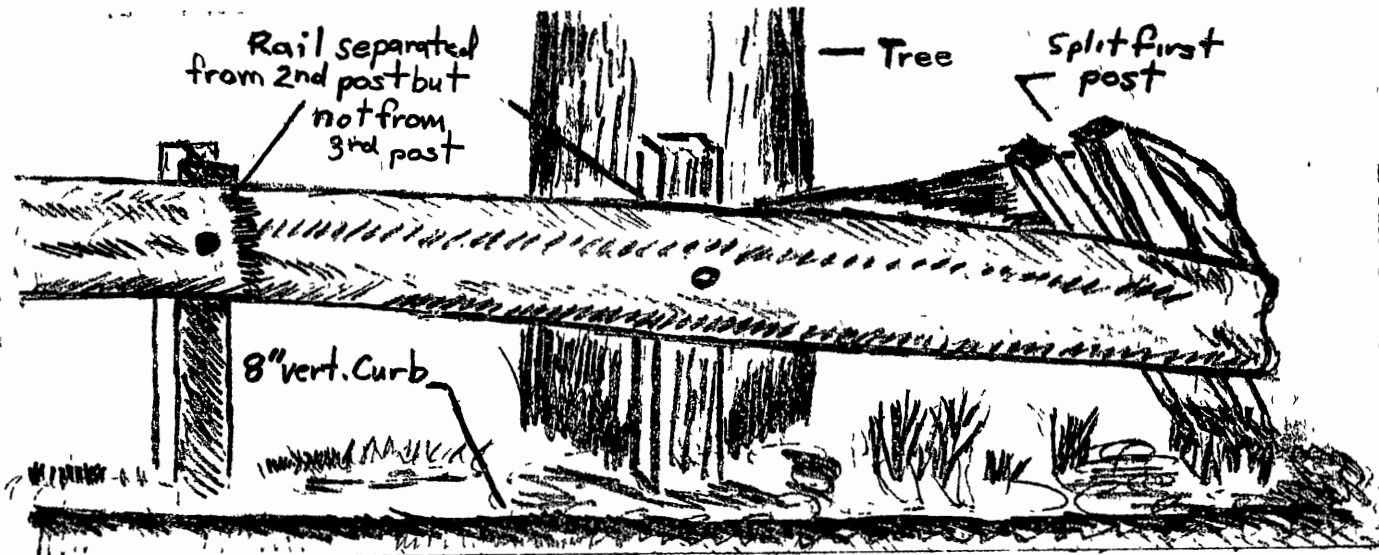
DAMAGE First post split down the center, guard rail pulled away from second post.

COMMENTS: Vehicle going eastbound impacted BCT on southside of road and swung across road onto private property on north side of road. (Foreman repaired BCT before Research personnel could take photos. Foreman pulled post out of concrete footing and replaced new post in old footing.)

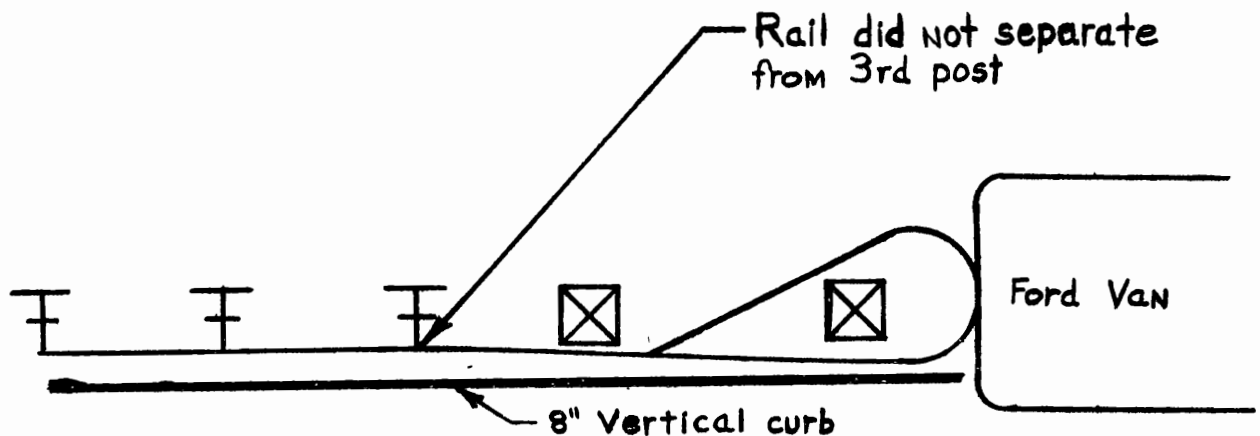
DAMAGE Unknown - Damaged BCT was removed before investigation

DAMAGE Speared "through grill of vehicle and out rear of driver's door"

COMMENTS: Straight guiderail

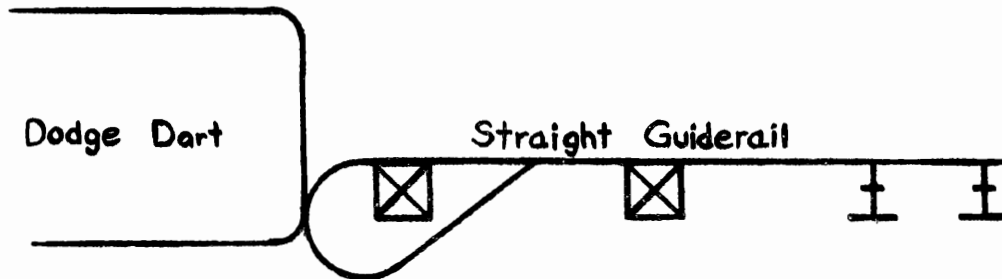
DAMAGE Broke off first two posts, crushed buffer end.

VEHICLE TYPE Dodge Dart DAMAGE Vehicle speared

COMMENTS: There is a high probability that anyone in the passenger's seat would have been killed. Vehicle went under guiderail and BCT.

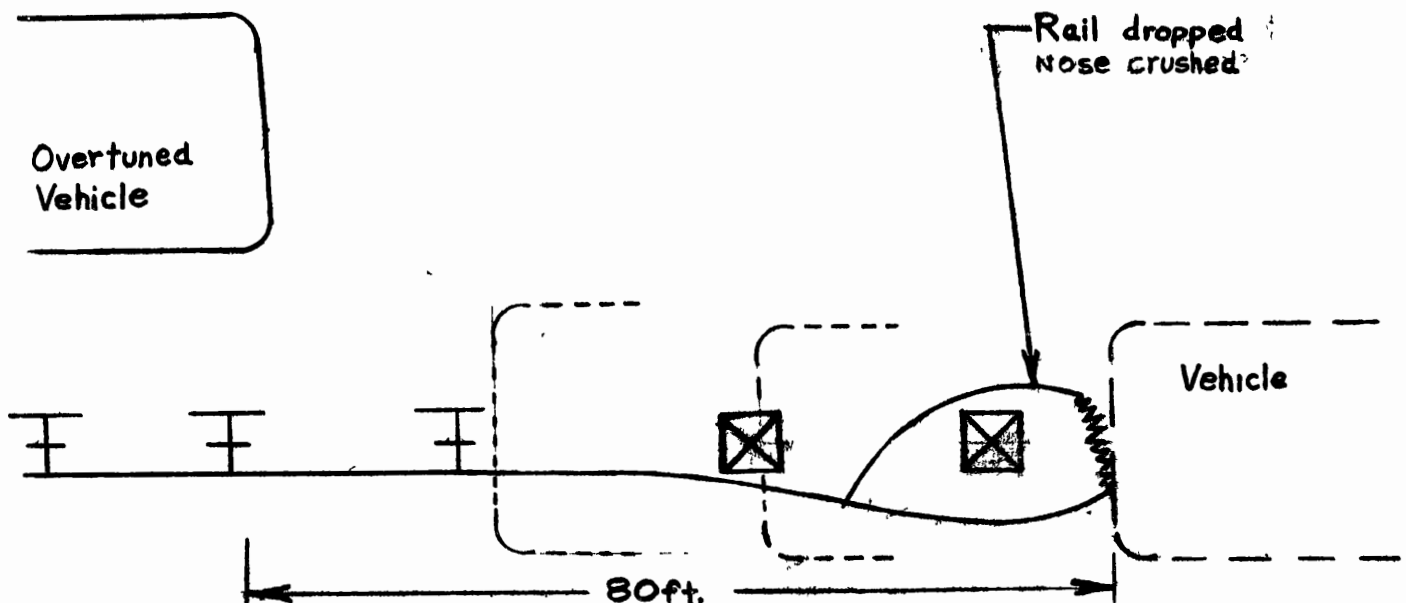
DAMAGE Broke both wood posts, bent over three steel posts, broke footing on first post.

COMMENTS: The vehicle hit the BCT and rode 80 ft. on top. Vehicle overturned and came to rest on the four wheels.

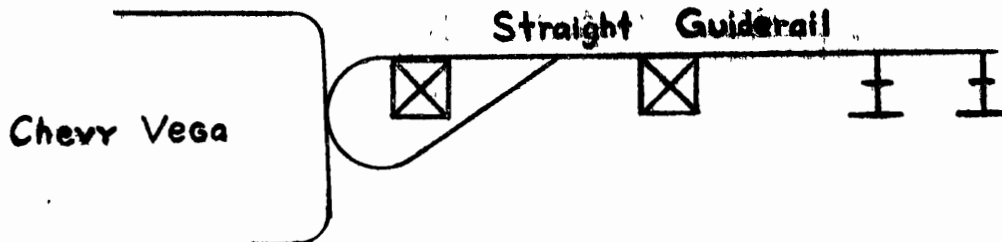
DAMAGE Impact broke off the first two posts. Buffer end was crushed and

COMMENTS: (The investigators did not pursue an inquiry into the driver's precise condition. However, the driver was not killed.) The BCT speared the vehicle and penetrated the driver's compartment to the front seat back. Guiderail was installed parallel to roadway.

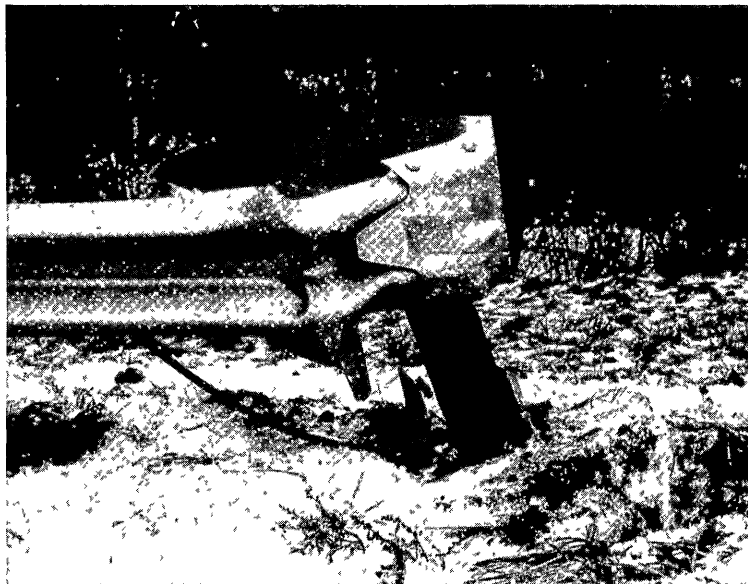
DAMAGE Did not break first post but pushed over post and footing and loosened second post footing.

Pushed over
footing

The concrete footing in the first post is essential for guiderail post anchorage in downstream impact conditions. Loose soil around the concrete footings should be adequately compacted to insure post anchorage.

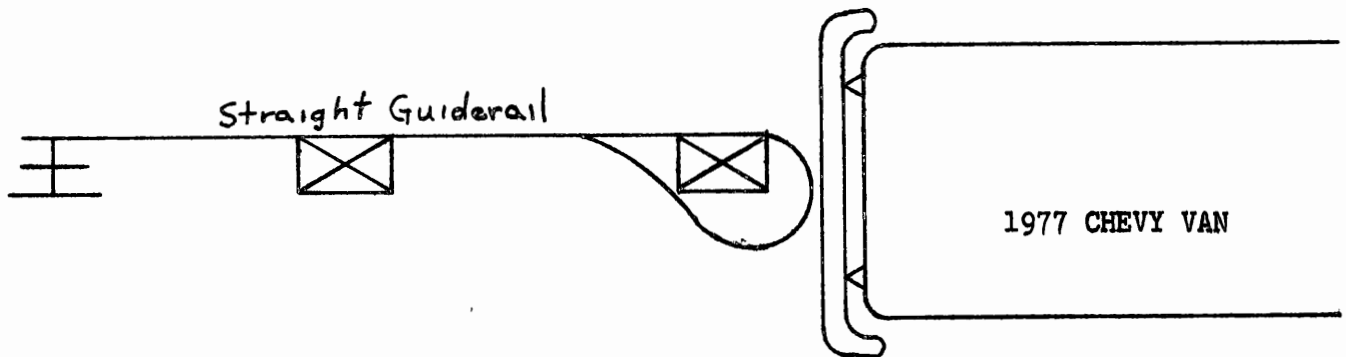
DAMAGE First post split (did not break at breakaway hole) and broke away.

COMMENTS: The bulk of the vehicle (air conditioning unit, radiator and V-8 engine) prevented guiderail penetration of the vehicle.

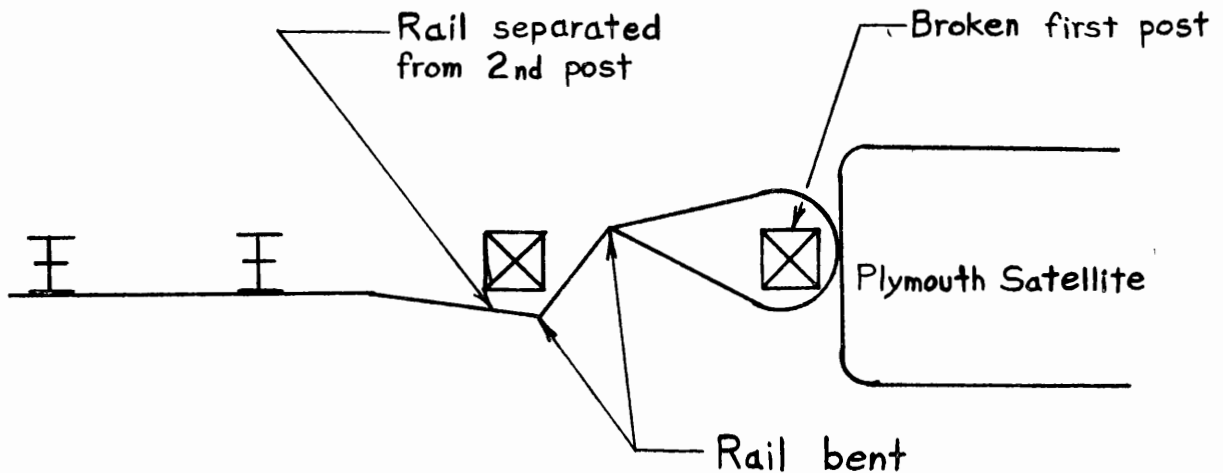
DAMAGE Broke first post, moved concrete footing (1st & 2nd post),

VEHICLE TYPE Plymouth Satellite DAMAGE Right front-penetration to firewall
