EMPIRE STATION COMPLEX

Neighborhood Conditions Study

February 2021

FOR
Empire State Development

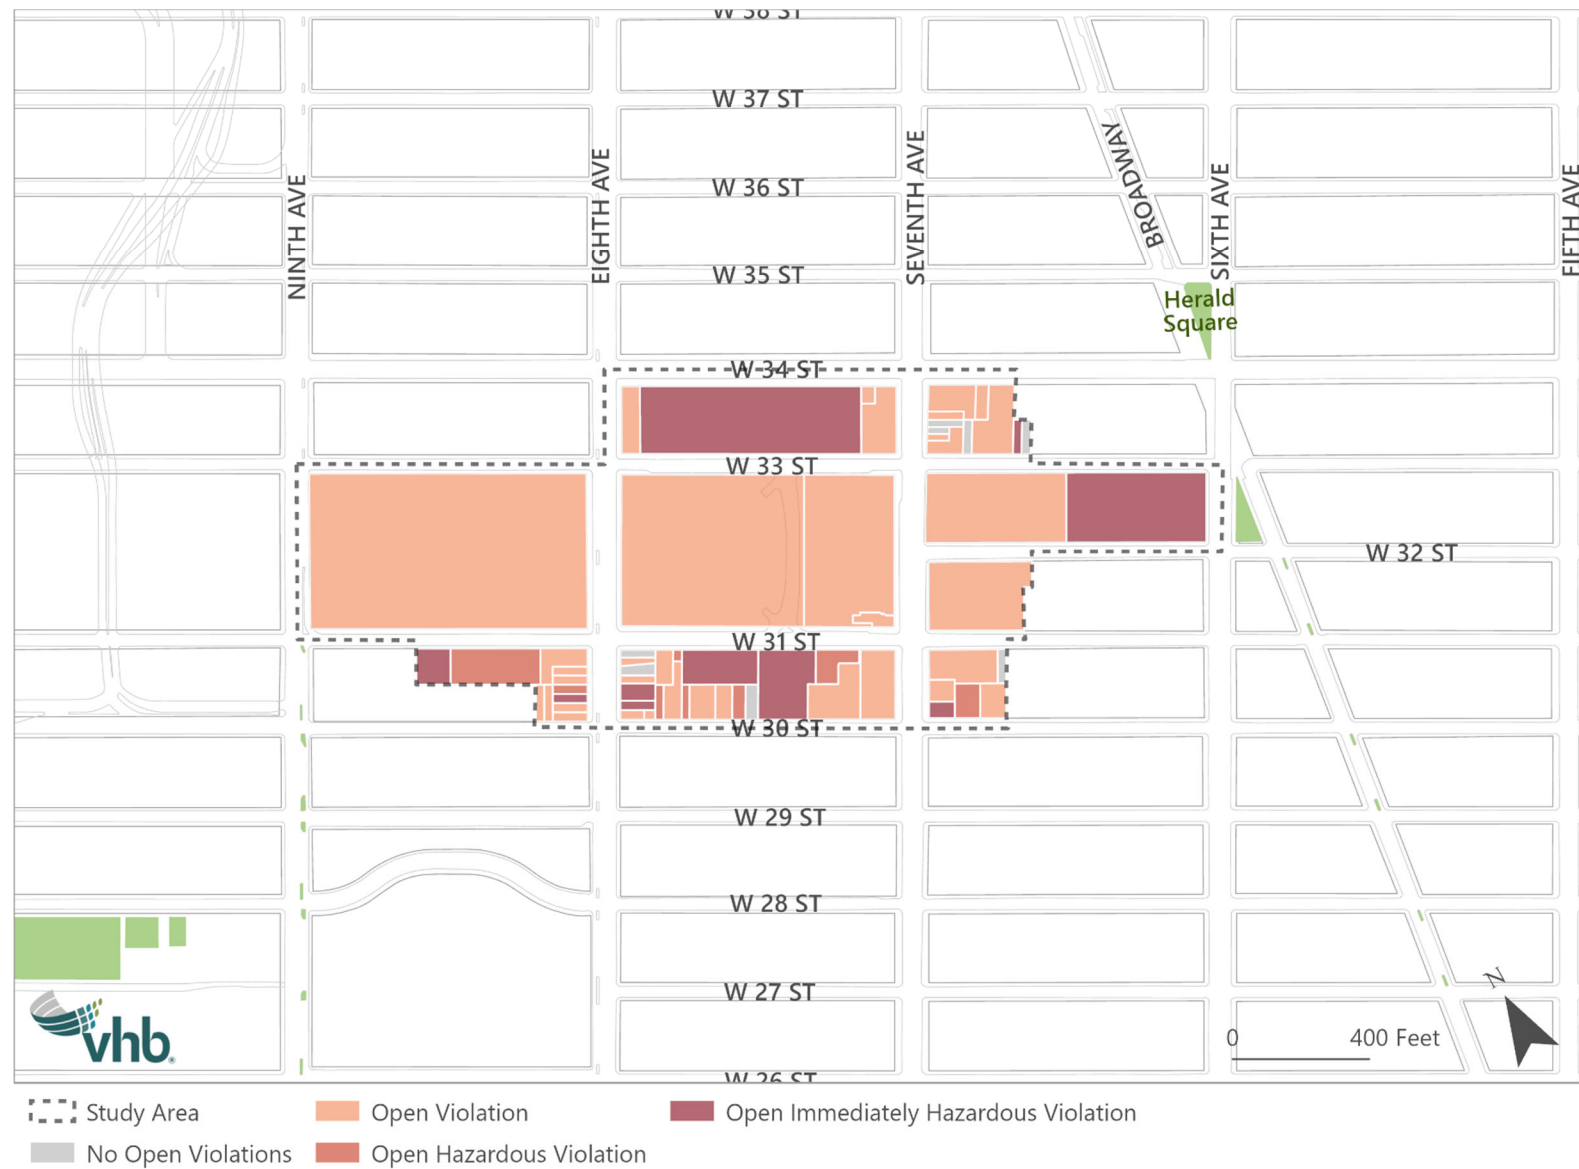
Figure E-5 Building Code Violations in the Study Area

- › [Block 754, Lot 38](#): "Failure to maintain exterior building wall. Defect is section of the building façade from second story to roof level has collapsed on to the sidewalk...leaving loose and exposed bricks."
- › [Block 780, Lot 2](#): "Openings – holes are not covered at the first floor and at the shaft at the second through fifth floors."
- › [Block 808, Lot 40](#): "Failure to maintain elevator or conveying system. Decking unsecured by lower left handrail."
- › [Block 809, Lot 53](#): "Failure to take required measures to provide safety measures to protect public from documented unsafe façade."

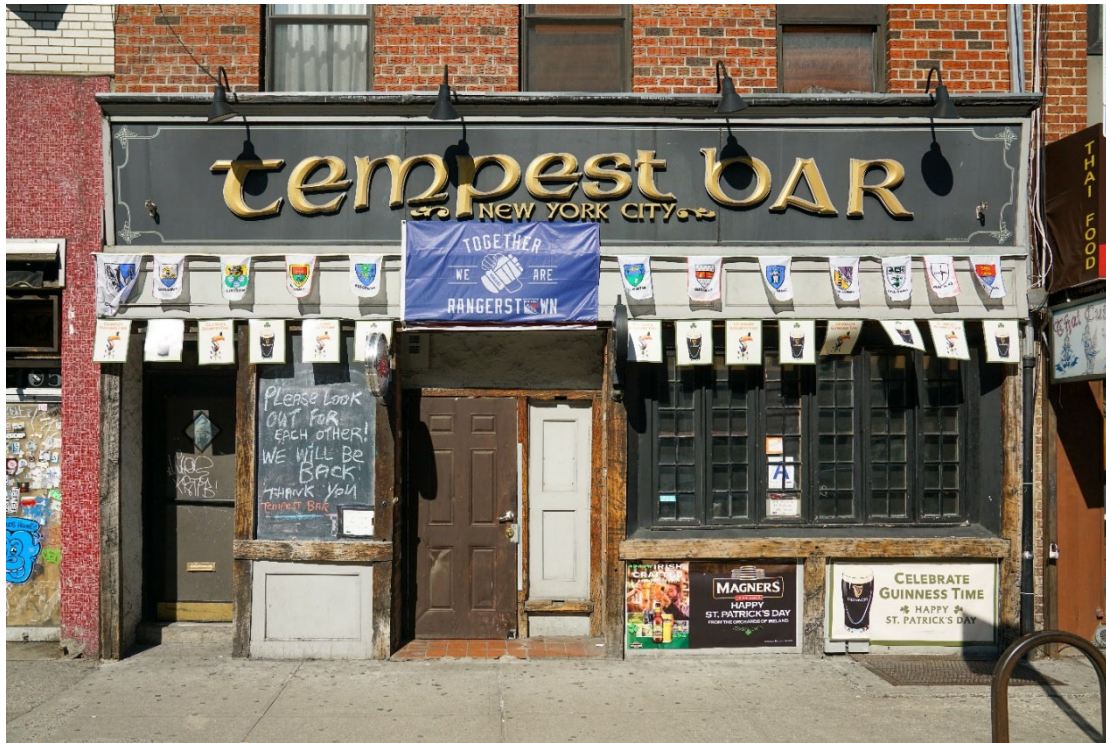
Figure 1-7 Block 754, Lot 38 Photographs

View facing west on 8th Avenue

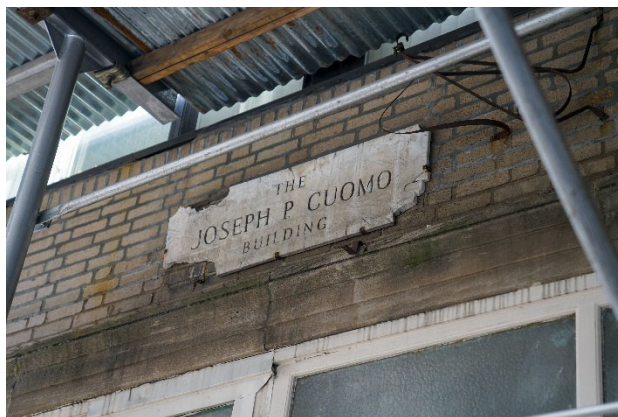
Figure 1-22 Block 780, Lot 9 Photographs

View of façade

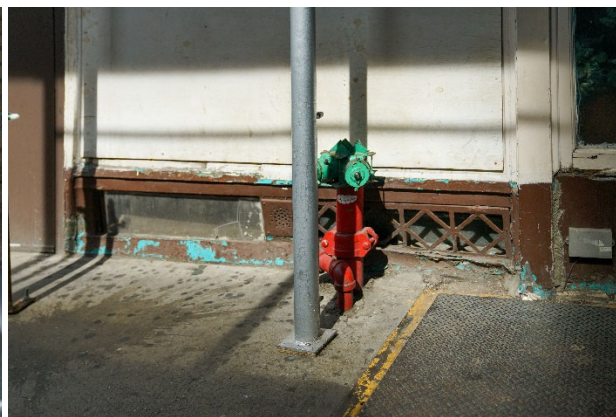
View of foundation

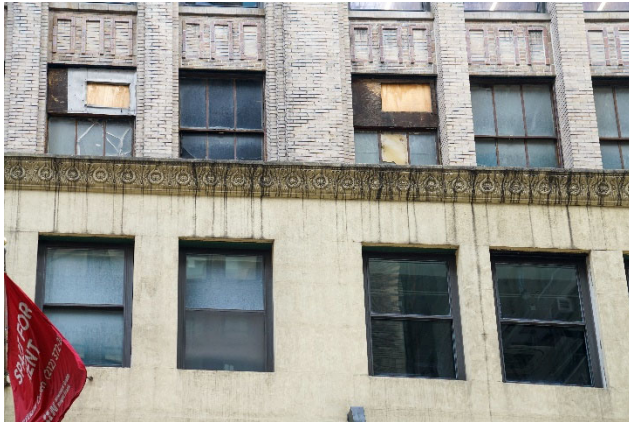
Figure 1-23 Block 780, Lot 10 Photographs

View of facade
