## **Work Zone Intrusion Alarm Effectiveness**

FINAL REPORT  
September 2010

Cathy Krupa  
Cambridge Systematics, Inc.  
Princeton Junction, New Jersey

New Jersey  
Department of Transportation  
Bureau of Research

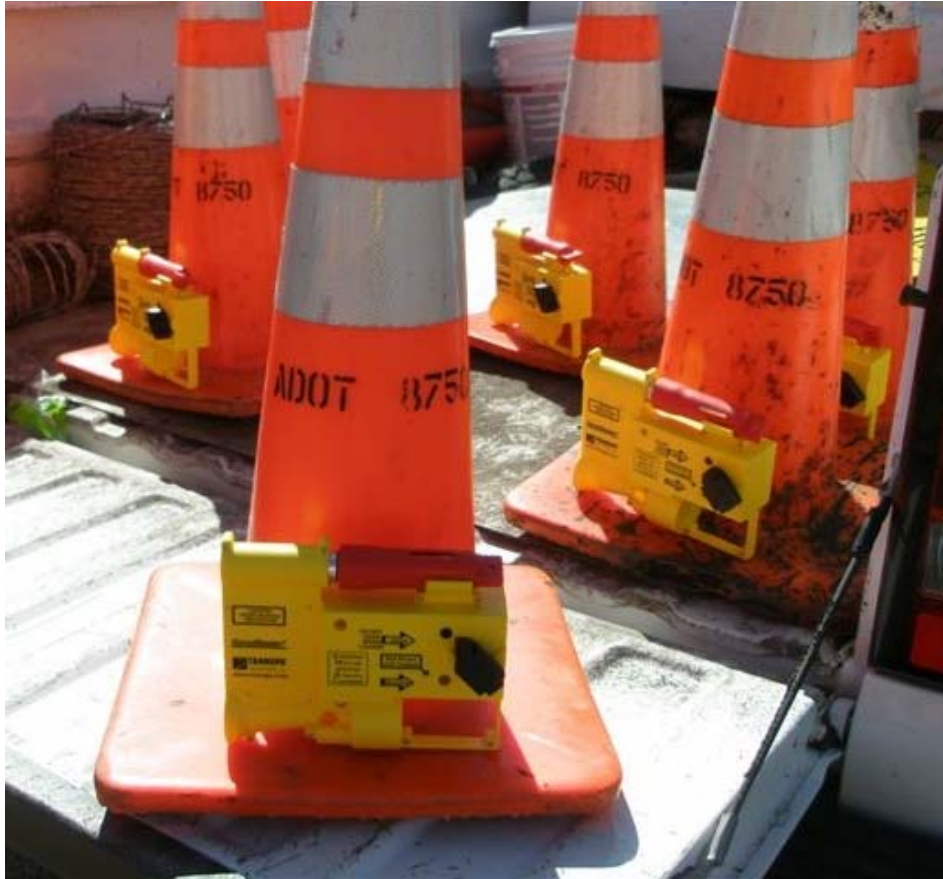
<sup>5</sup> Eight alarms were defective and could not be used. Defects are described in the next section. Note that the alarm shown in the figure is an older version with a different mounting method. The alarm used by NJDOT has an improved mounting bracket that allows the cones to be stacked with the device mounted in place.

Figure 1. Close-Up of SonoBlaster!<sup>®</sup> Work Zone Intrusion Alarm.

The mounting bracket supplied with the unit allows alarmed cones to stack for storage with the device mounted in place. The mounting bracket is installed on a standard traffic cone using supplied screws in holes that are drilled by the user in the cone base.
