Route 139 Rehabilitation: Pulaski Skyway Contract 2

FINAL REPORT
June 2017

1. Report No. FHWA-NJ-2017-012		2. Government Accession No.		3. Recipient's Catalog No.	
4. Title and Subtitle Route 139 Rehabilitation: Pulaski Skyway Contract 2				5. Report Date June 2017

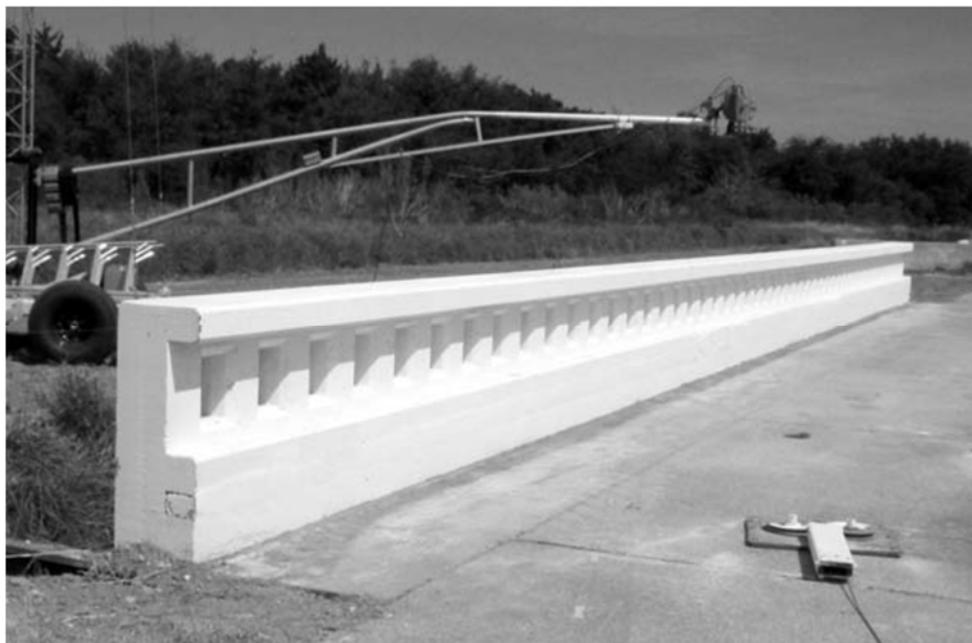
Figure 10. Texas F411 bridge rail ⁽²⁴⁾

Alberson et al. (2004) conducted the full-scale crash test and evaluation of the bridge balustrade TX F411 to Test Level 4 in accordance with R350, which is higher than those conducted by Bullard et al. in 2002. The TL-4 vehicle utilized was a single-unit box-van truck impacting the railing at 15 degrees and 49.7 mi/h (80 km/h). As a result, the F411 bridge balustrade performed acceptably for NCHRP Report 350 Test 4-12. Based on the performance, the F411 was suggested for use where containment of 18,000 lb. single-unit trucks is desired (see Figure 9). Figure 10 shows the constructed Texas F411 bridge rail that was tested. ⁽²⁴⁾

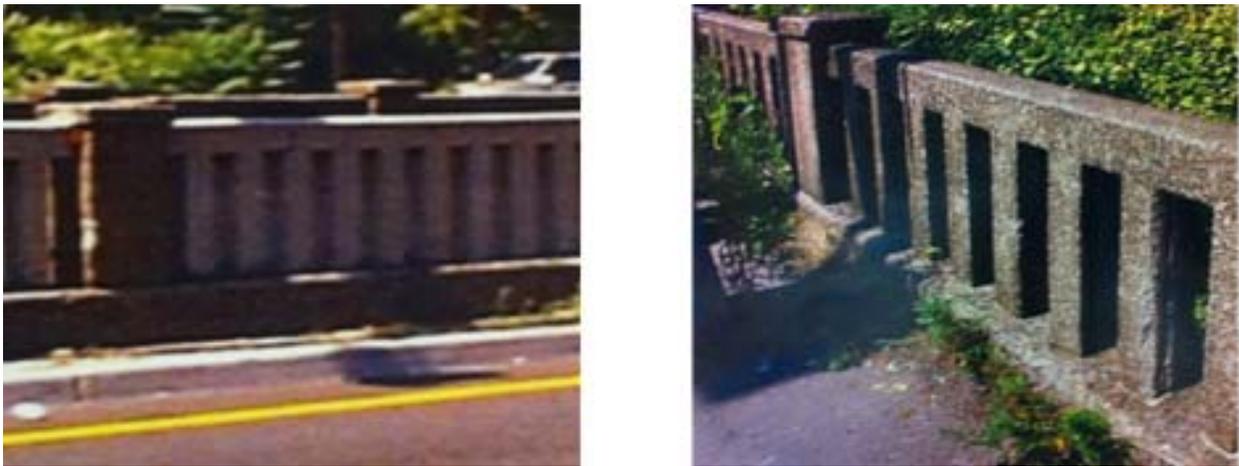
Figure 13. Existing open-faced balustrade on Route 139/Hoboken Viaduct

The Rt. 139/Hoboken Viaduct located in Jersey City Hudson County was constructed in 1932 as part of the Rt. 1/1&9 Historic Corridor with an open concrete balustrade along the length of the roadway. Figure 13 shows photos of existing balustrade on Rt. 139/Hoboken Viaduct. The original design features an open-faced balustrade with column to opening ratio of 1:1, approximately. NJDOT developed the preliminary design with only slight changes from original design (Figure 14(a)). The HPO approved the new concrete balustrade design but the new designed balustrade must also be shown to meet current crash test criteria of MASH TL-4.

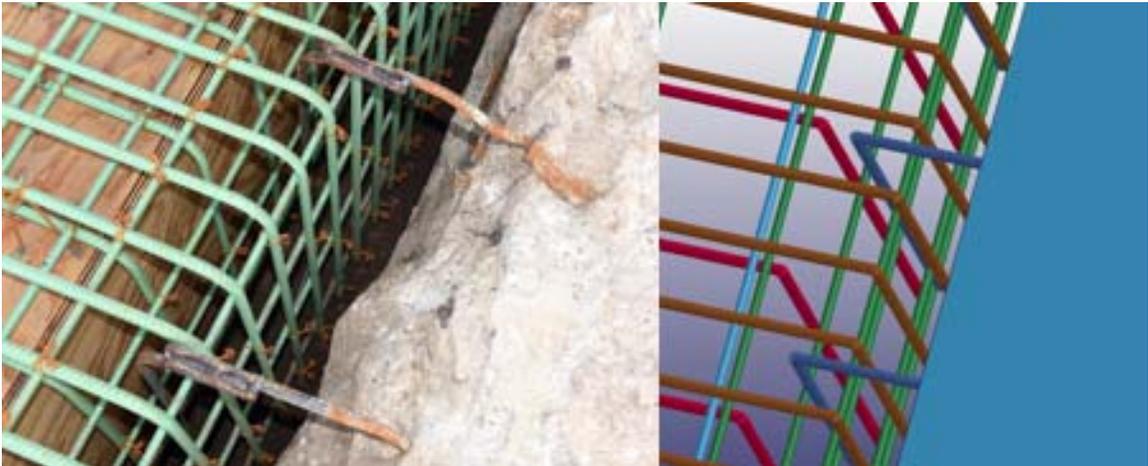
Figure 36 shows the deck bars. Because the rigid block concrete is preexisting, the deck bars are bent and developed in the wall portion of the setup. The bottom deck bars are placed at 8-in, and the top deck bars are placed at 4-in. They are placed at 4-in because in the barrier specifications, there is a 5-ft bar alternating with the regular deck reinforcement to provide additional strength to the connection with the deck. All of the longitudinal #4 bars are tied to the deck bars. After this part of the rebar assembly is finished, the vertical wall portion is then poured. This is shown in Figure 37.

Figure 36. Anchor bars welded to dowels and epoxy coated deck bars (TTI) and FEM representation

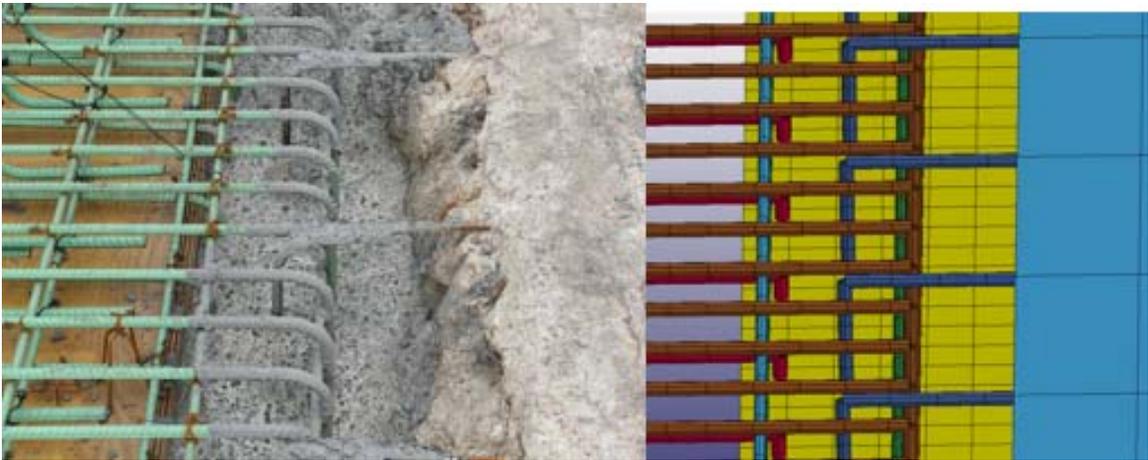
Figure 37. Filled wall portion of barrier setup (TTI) and FEM representation

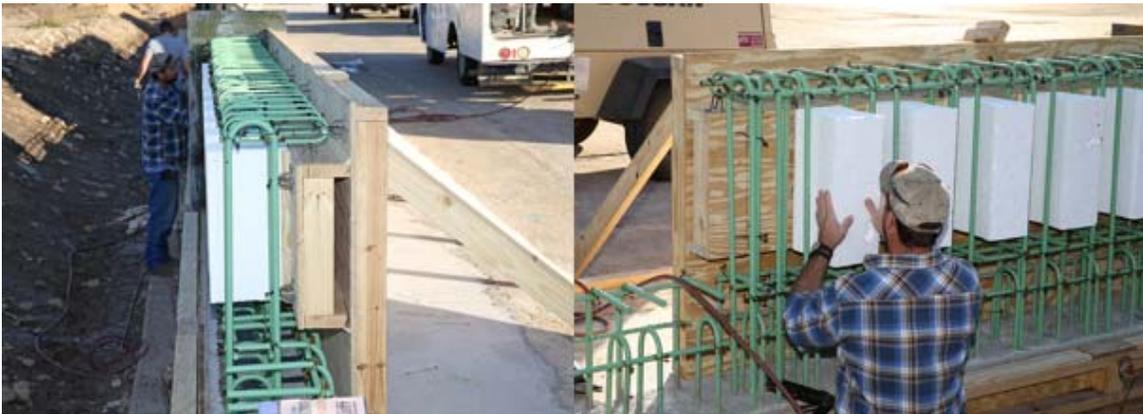
Figure 40. Vertical bars and top rail reinforcement secured to formwork (TTI)

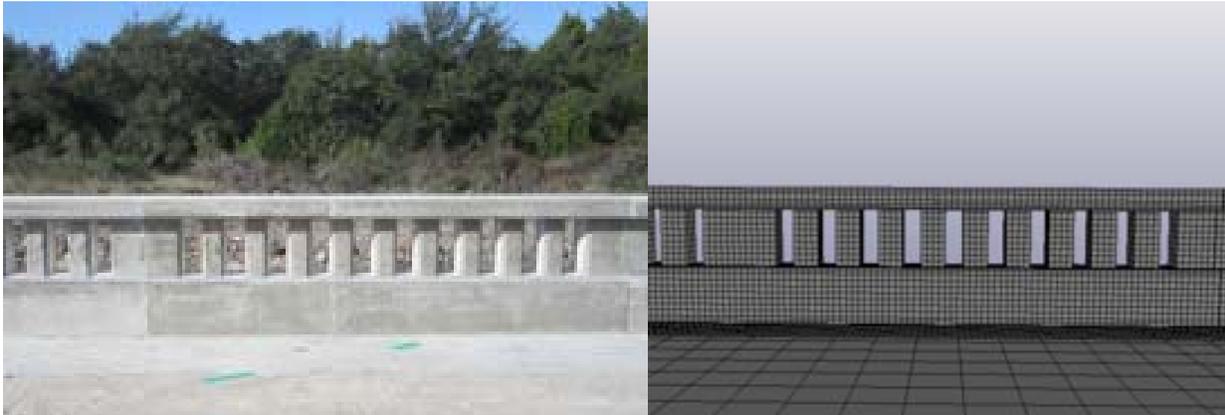
Figure 41. Fully constructed barrier (TTI) and FEM representation

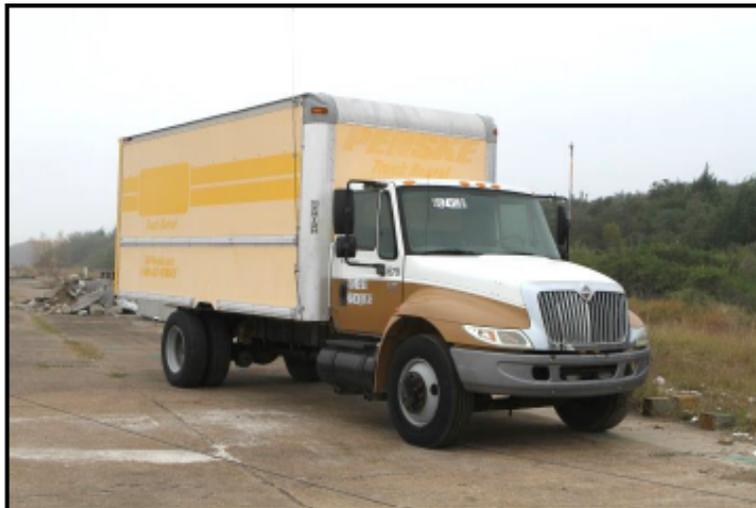
Figure 45. 10000S single unit truck tested (TTI)

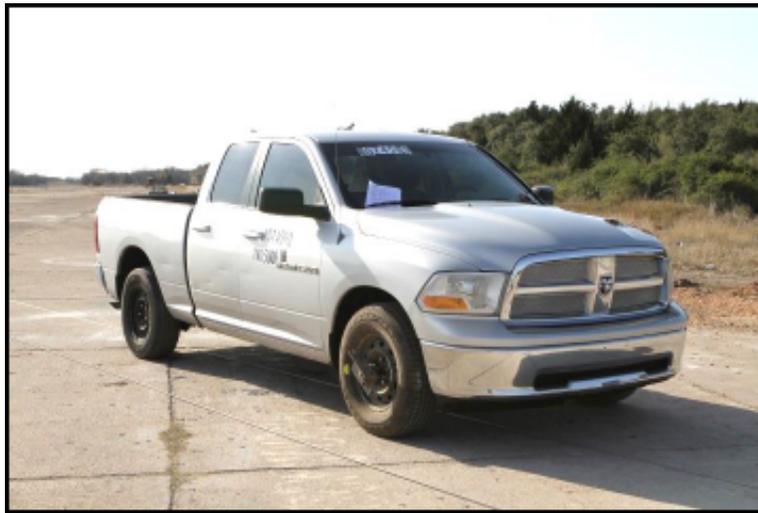
Figure 46. 2270P pickup truck tested (TTI)

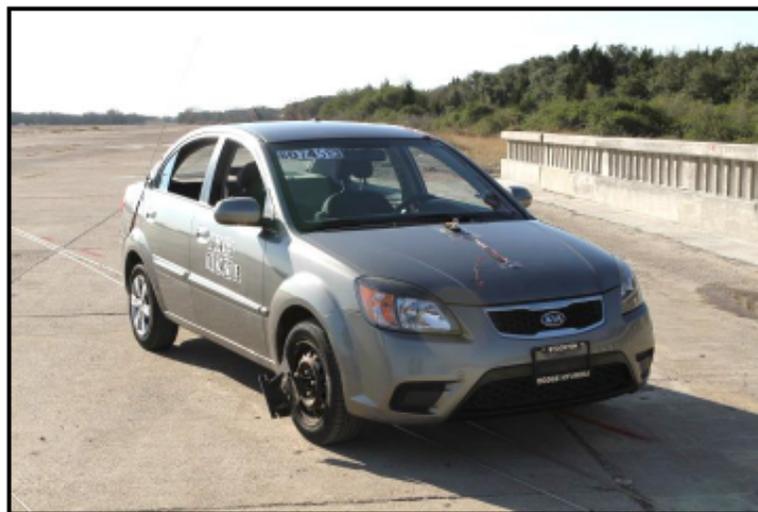
Figure 47. 1100C small passenger car tested (TTI)

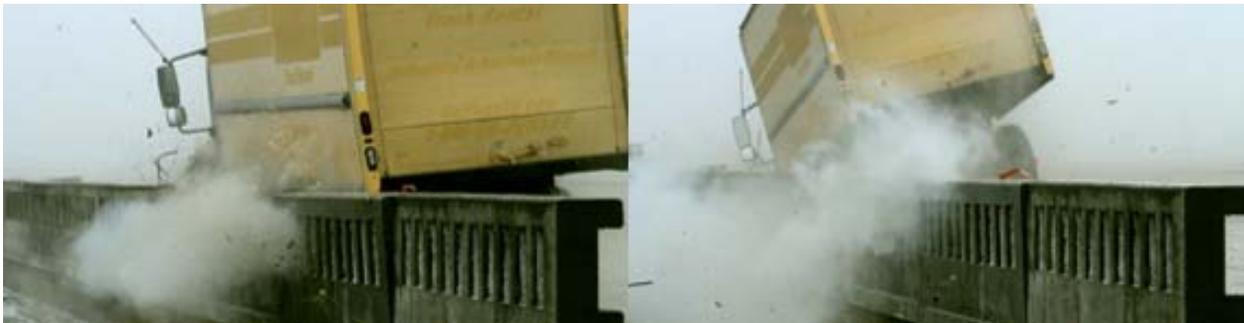
Figure 49. Maximum barrier deflection and permanent damage.

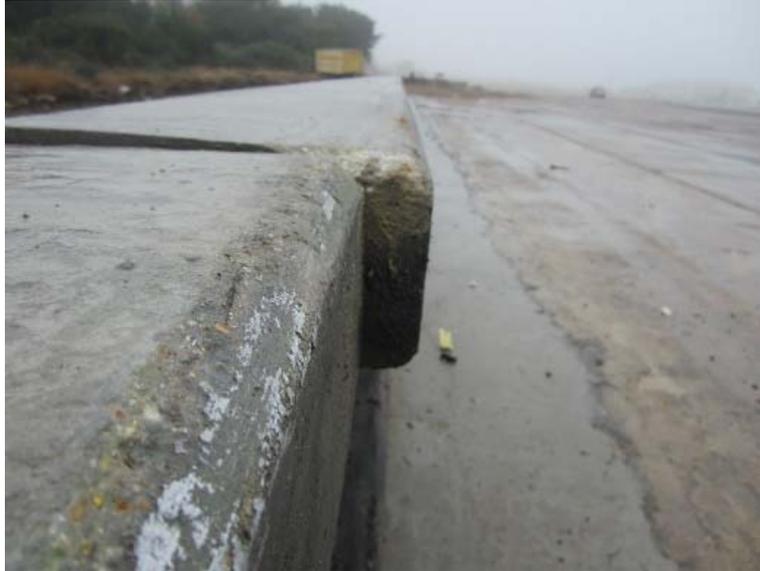
Figure 50. Permanent deflection of barrier after single unit truck test.

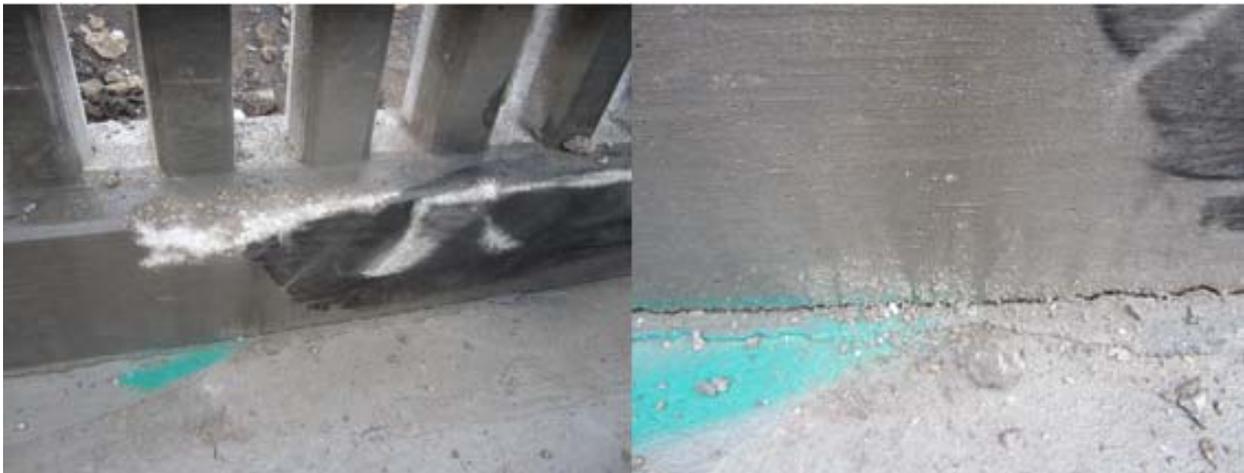
Figure 51. Barrier damage and crack at deck-barrier interface.

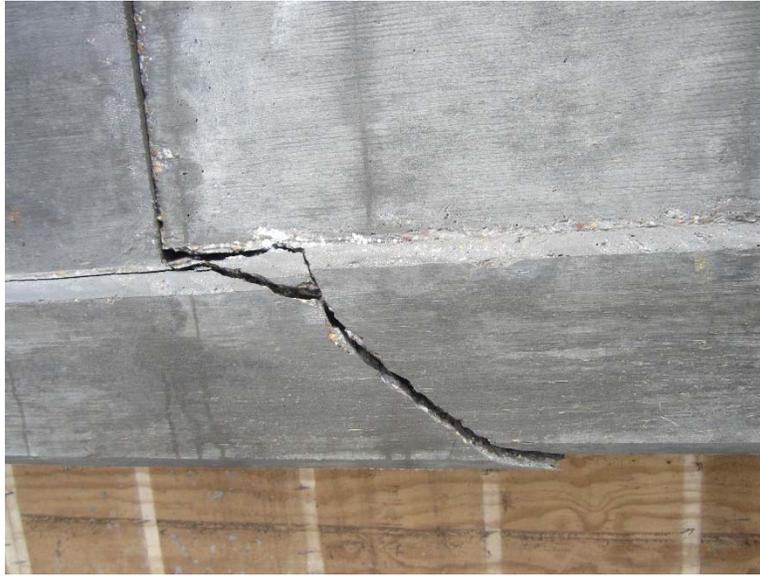
Figure 52. Crack in deck on non-impact side of barrier.

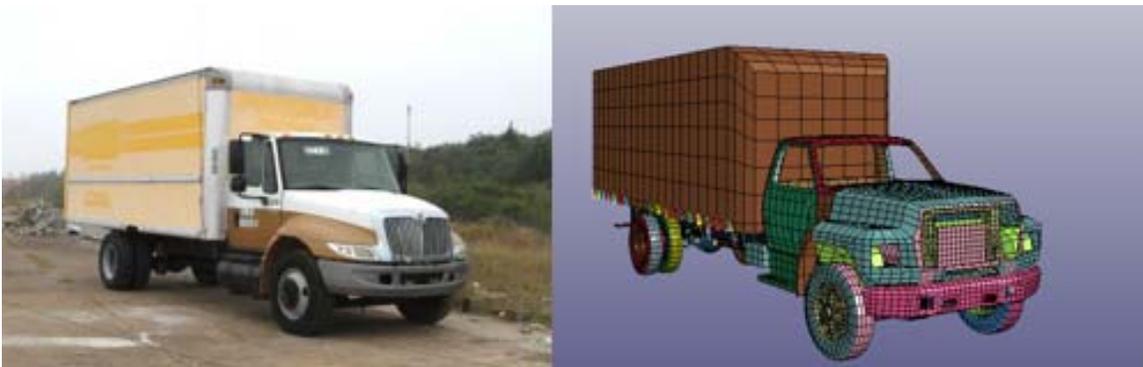
Figure 56. 10000S single unit truck and FEM representation

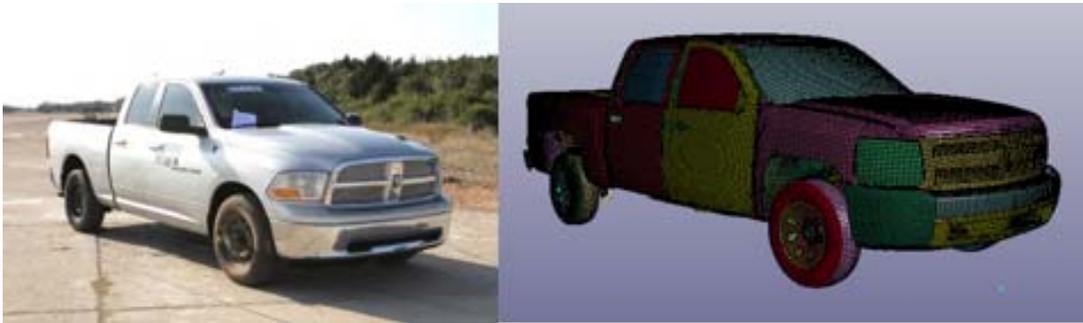
Figure 60. 2270P vehicle used and Chevy Silverado modeled
