Elimination of Weight Restriction on Amtrak, NJ Transit, and Conrail Lines

REPORT
May 2012

¹Rutgers Infrastructure Monitoring and
Evaluation (RIME) Group
(ICS Center)
Rutgers, The State University of New
Jersey

New Jersey
Department of Transportation
Bureau of Research
And
U. S. Department of Transportation
Federal Highway Administration

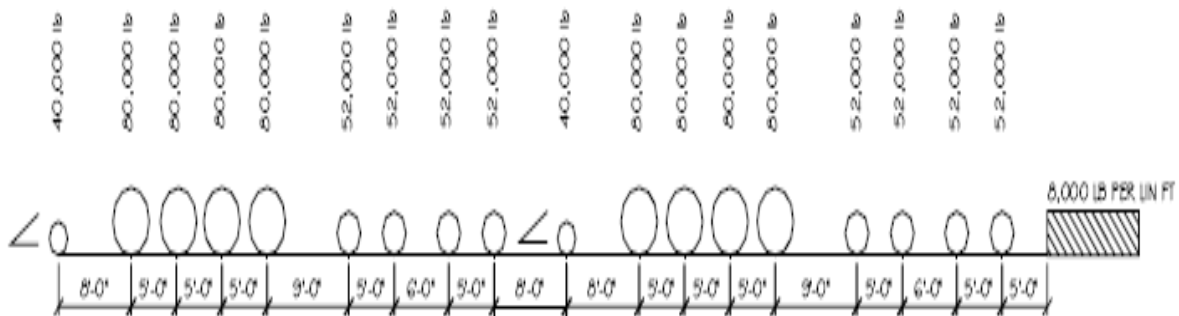
Figure 1. Cooper E loading⁽³⁾

In Wisconsin, railroad bridges were evaluated to determine the impact of rail car weight increase.⁽³⁾ Field investigations and load ratings were conducted to determine the conditions of the bridges and provide recommendations for safe operation of the 286-kips rail cars on the bridges. A total of 26 sample bridges were inspected and load-rated. Most of the bridges were timber bridges, but three steel bridges and one concrete bridge were also investigated in the study. In the load rating, a Cooper E80 load and a 286-kips rail car load were used to determine the maximum load effects and stresses. The configuration of the Cooper E80 load and 286-kips rail car load are shown in Figure 1 and Figure 2, respectively. As required by AREMA, the bridges were load-rated with two levels of rating conditions, normal and maximum.

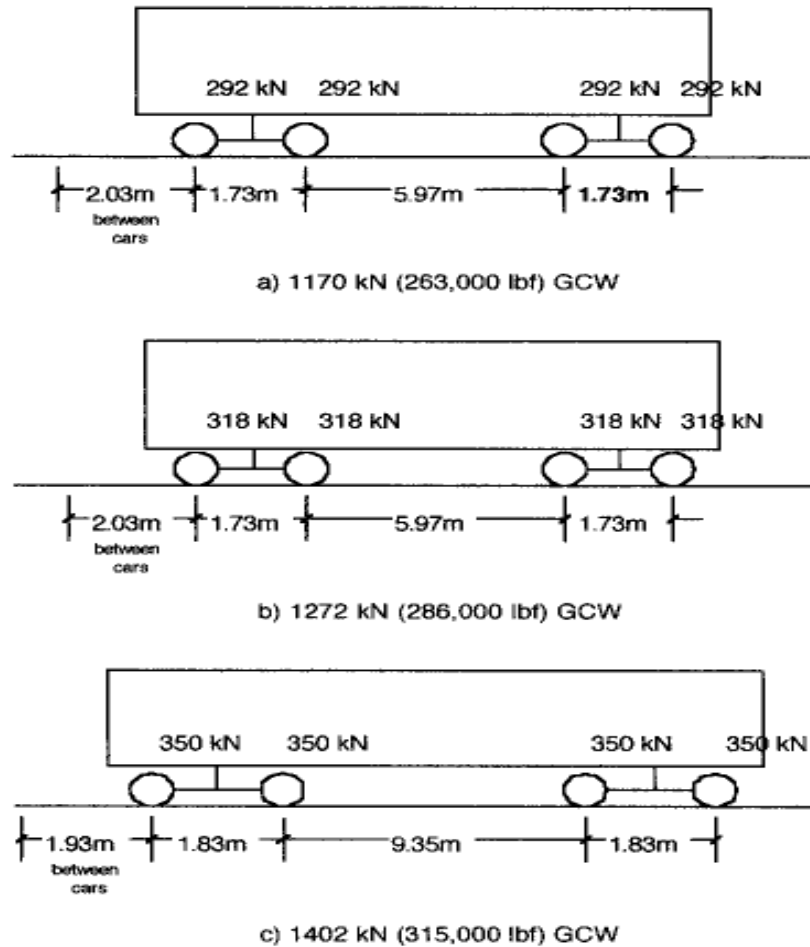
Figure 2. Rail car loading configurations⁽⁴⁾

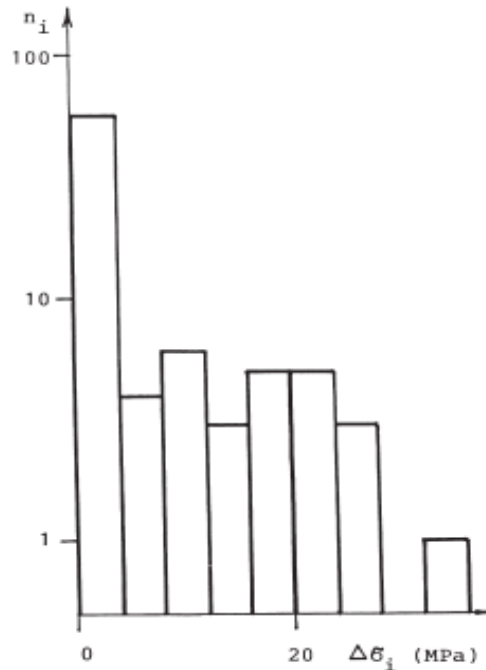
Figure 3. Sample of stress spectrum in steel railroad bridge.⁽⁵⁾
 ($\Delta\sigma$ = Stress range, n = Number of cycles)

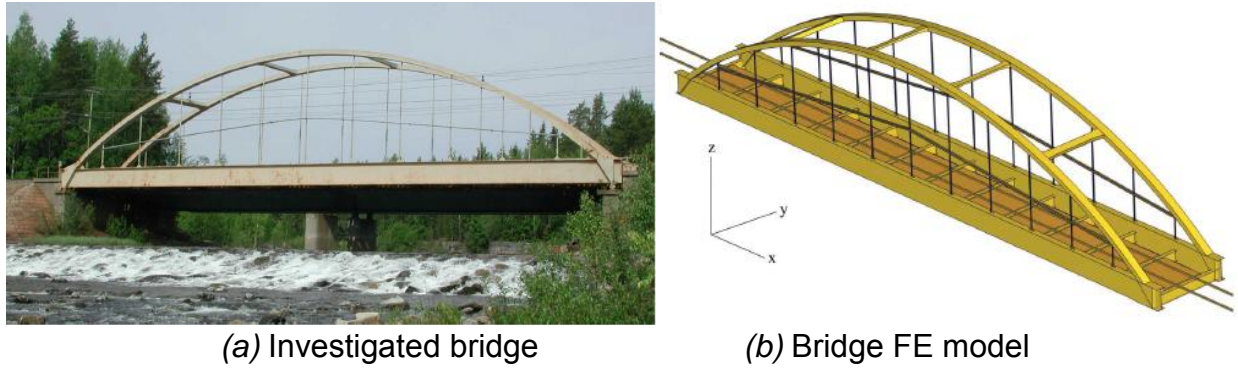
Figure 14. Tied-arch bridge⁽¹⁷⁾

Malm and Andersson investigated the dynamic effects of train passages on a tied-arch bridge.⁽¹⁷⁾ The bridge investigated is 147.6-ft long and used for both passenger and freight train traffic. The bridge consists of two hollow arches without ballast. The finite element (FE) model shown in Figure 14 was developed using the general-purpose FE program, ABAQUS. The developed model was used to compare the field test results with the simulation results and to better understand the bridge behavior under moving-train loading. Dynamic characteristics and the structural behavior of the bridge were investigated with the model, as well as with the field tests.

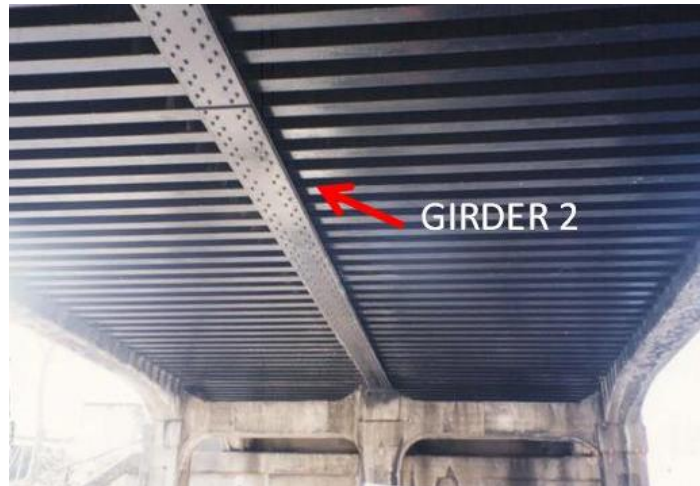
Figure 22. General view of Span 2 superstructure and underside of Girder 2 of the Main Line MP 15.95 Bridge⁽²⁵⁾

As shown in Figure 22, the controlling superstructure member was designated as Girder 2, Span 2, as noted in the Inspection Report Cycle 2.⁽²⁵⁾ Span length is 44.8 feet. Girder 2 is a riveted plate girder with three cover plates on top and bottom. The angles on top and bottom are riveted into the web plate, and the flanges are riveted into the angles. It has a depth of 69 in. and a width of 15 in. Figure 23 shows the cutoff points and the location of maximum moment where the methodology for load-rating checks and calculations covered in the inspection reports was applied.

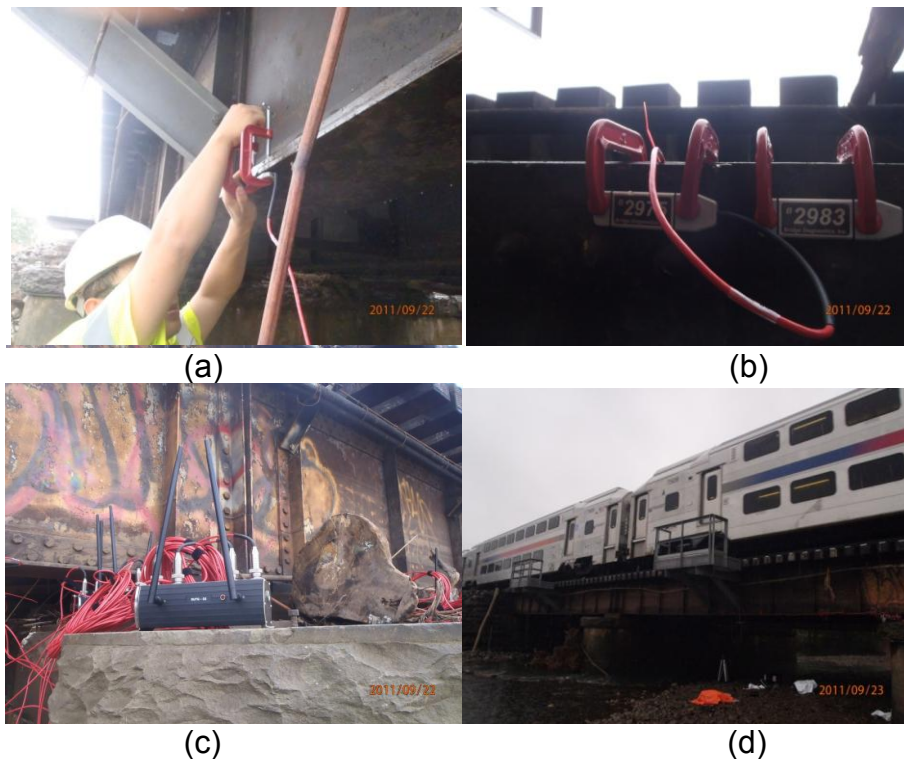
Figure 40. Sensor installation of the Raritan Valley Line MP 31.15 (Middle Brook) Bridge: (a) Sensor installation, (b) Installed sensors on the bottom of girder, (c) Junction nodes on the pier, (d) Tested train on the bridge

Figure 41 and Figure 42 show a layout of the bridge and locations of the strain transducers that were installed on Span 2 and Span 3 of the Raritan Valley Line MP 31.15 Bridge, respectively. It is noted that the reference Section A-A shown in Figure 41 is taken at the midspan section (Girders G7 and G8), while reference section B-B is taken at the first cutoff point (about 5 ft from the support end of the girder), and reference section C-C is taken at the second cutoff point (about 8 ft and 8.5 in. from the support of the girder). For Span 3, sensors are installed at the midspan of each girder under the active track (G5 through G8). Table 18 and Table 19 show a summary of the tested train information for the tests performed on 9/30/2011 and 9/23/2011, respectively.

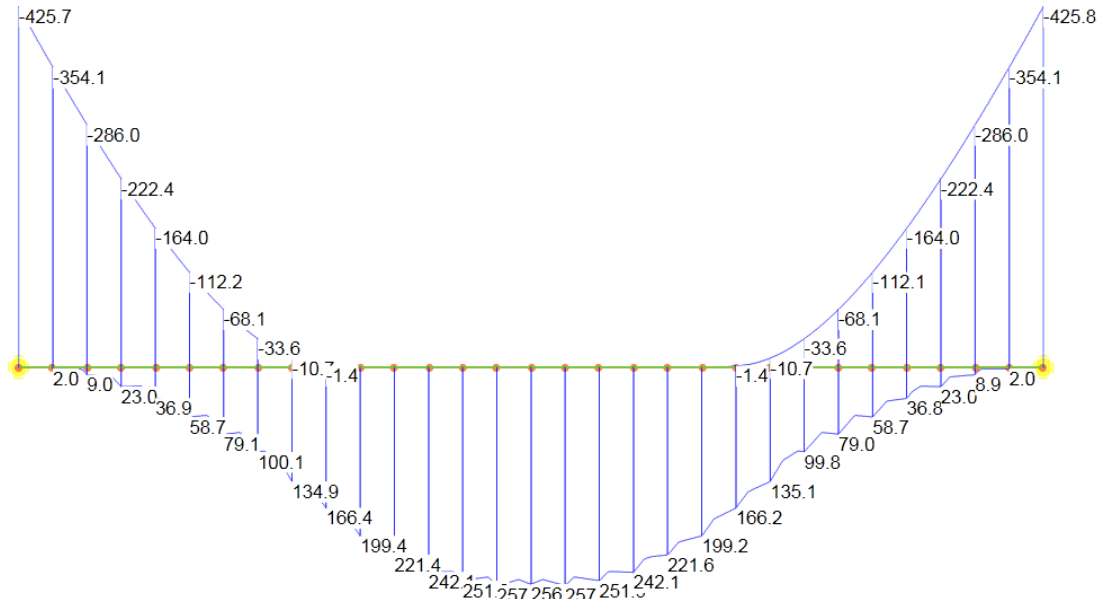
Figure 48. Moment envelope diagram for Main Line MP 15.95 (per girder)

The RT also investigated the section modulus from testing for all five bridges. Taking the Main Line MP 15.95 Bridge as an example, first, the RT found the maximum strain value caused by locomotive cars at various critical locations from the testing data. Then the RT calculated the moment envelope using simple beam analysis method shown in Figure 48 to get the corresponding moment at corresponding critical locations. For this bridge, the loaded length is 43.33' for Girder 2 (center girder) and the boundary condition is taken as fix-fix. The carload is PL-42 locomotive. Then we calculated the section modulus at each critical location in Table 22.

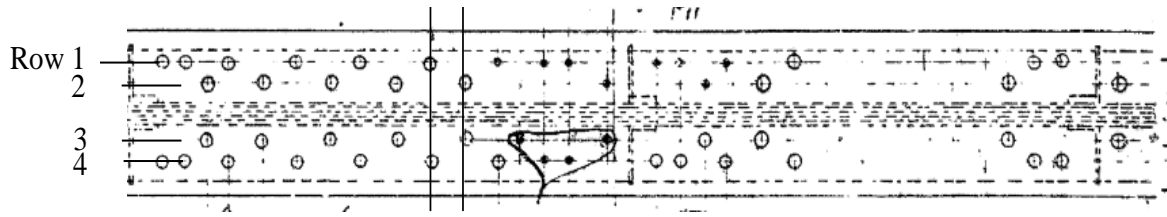
Net: $I_H = 4 \times 1.69 \times 51.85^2 + 2 \times 3 \times 48.75^2 + 2 \times 1.75 \times 43^2 + 2 \times 1.75 \times 37^2 = 43693$

Figure 49. Calculation of net section from inspection report⁽²³⁾

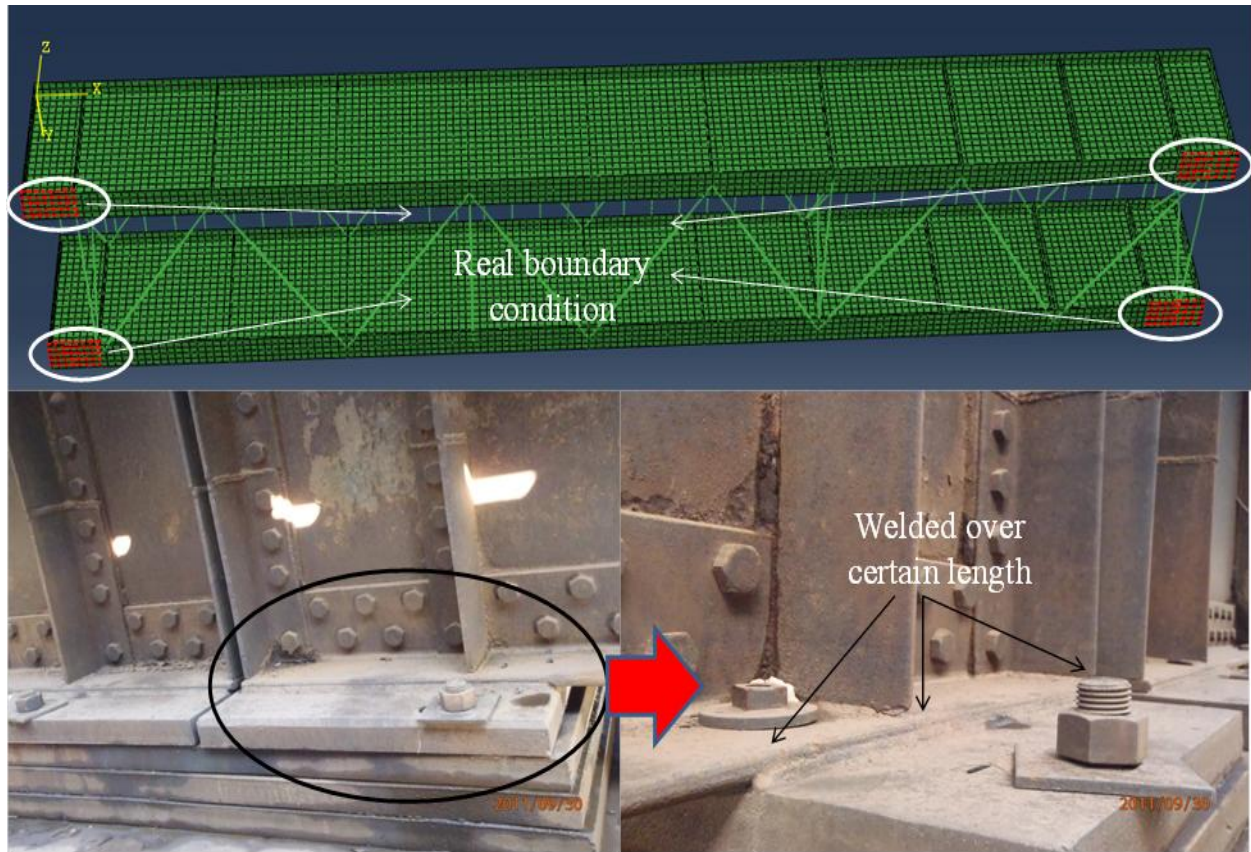
Figure 50. Boundary condition of Raritan Valley Line MP 31.15

Another source of the uncertainty is the different boundary condition assumed in the simple beam analysis and the real bridge. From the field inspection by the Rutgers team, we found that the boundary condition is not exactly simply supported and the girders end are welded to the support over a certain length (see Figure 50). Since the bridge is not exactly simply supported which has unexpected restraint at the support, the real moment in the girder will be lower than the calculated value from simple beam analysis. Therefore the tested strain is lower than the calculated value. However in the FE model, the Rutgers team sets the boundary condition of the bridge model the same as the real boundary condition that reflect the real condition of the bridge. So the FE model is more accurate than the simple beam analysis to simulate the real behavior of the bridge condition under traffic load.

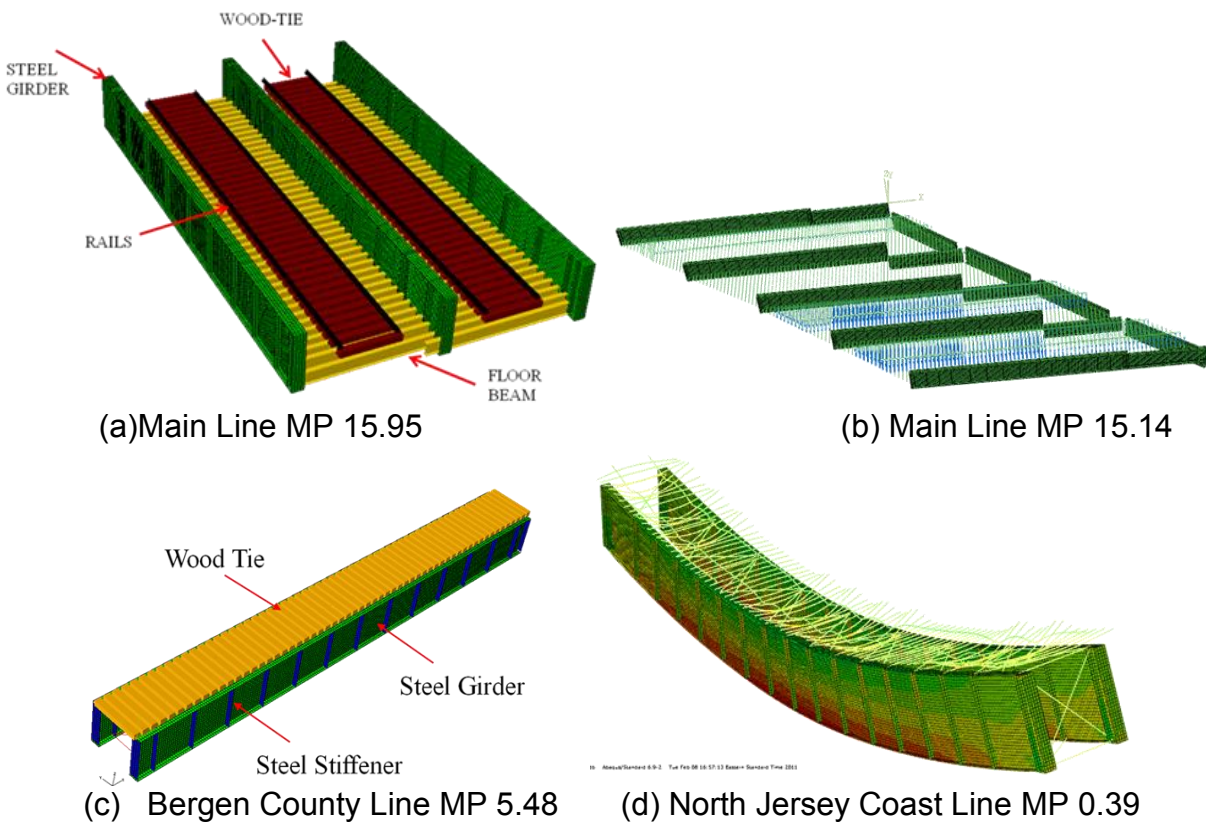
Figure 51. FE Model for four of the selected bridges: (a) Main Line MP 15.95, (b) Main Line MP 15.14, (c) Bergen County Line MP 5.48, (d) North Jersey Coast Line MP 0.39

To improve the analysis results, various modeling features were considered in the three-dimensional FE model, such as: 1) element types, 2) material behavior, 3) boundary conditions, and 4) interaction between the floor beams and steel girders.

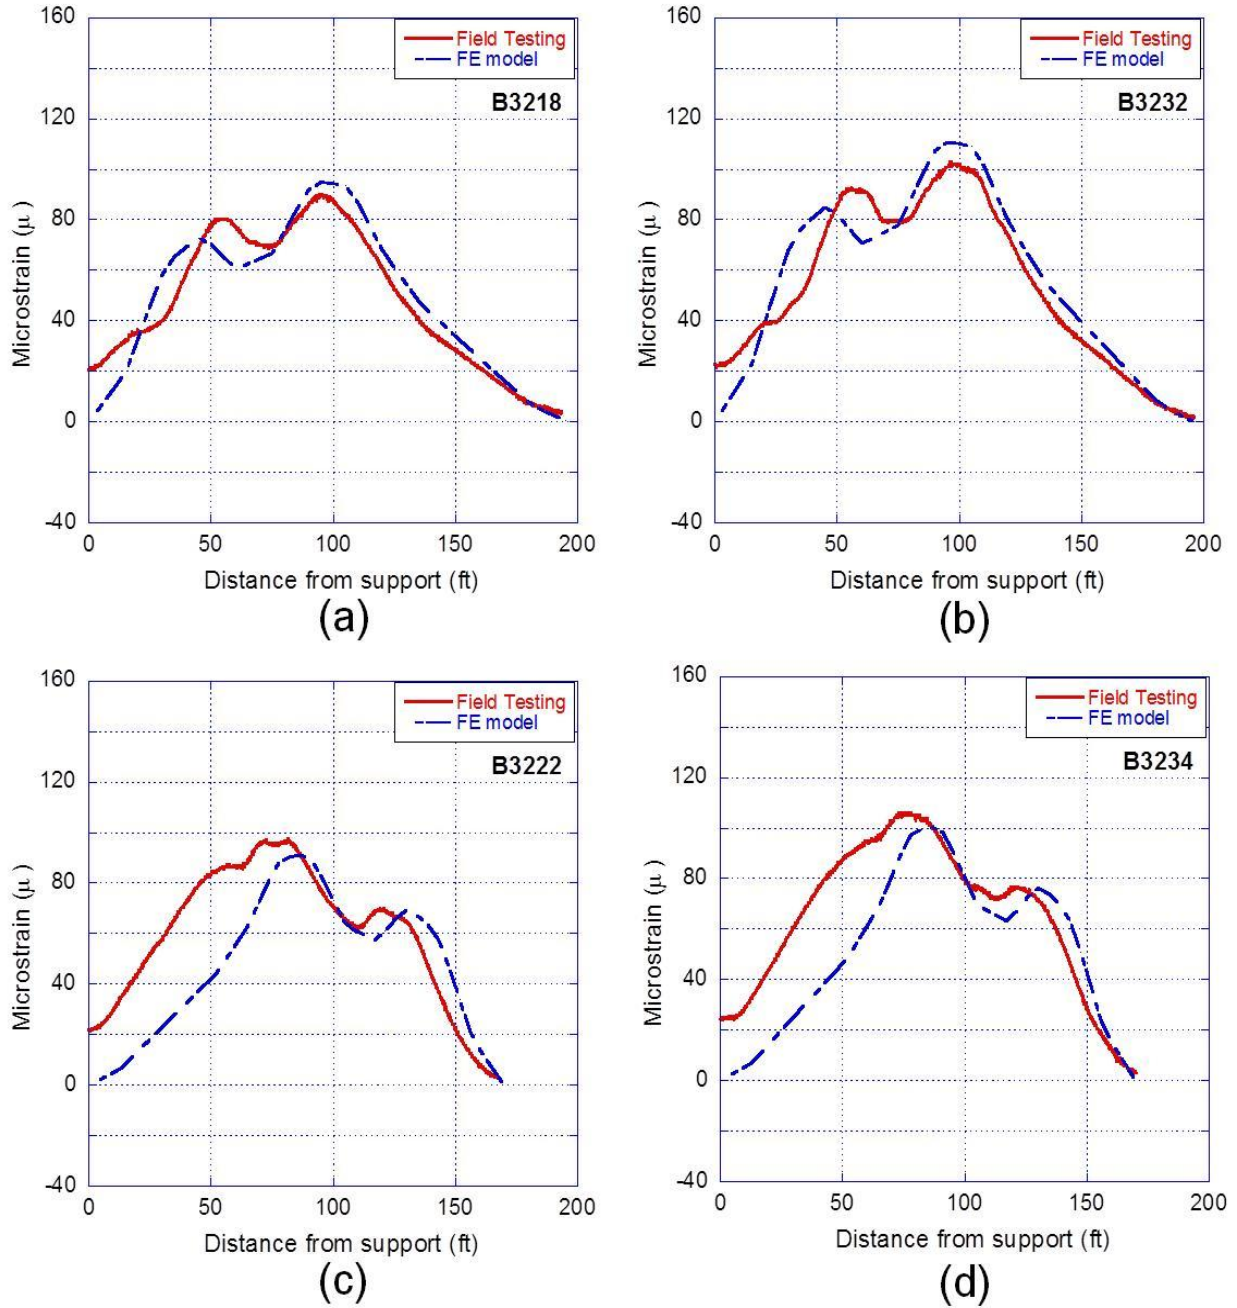
Figure 72. Comparison of strain data at cutoff locations of girders: (a) B3218 (Test Run#1), (b) B3232 (Test Run#1), (c) B3222 (Test Run#1), and (d) B3234 (Test Run#1) for the North Jersey Coast Line 0.39 (River Draw) Bridge

Table 39 shows that the average difference between FE model and field-testing is 7.15% that is below 10%. The differences can be attributed to the dynamic impact during the test. The above discussion suggests that the FE model results are in good agreement with those from the field tests.

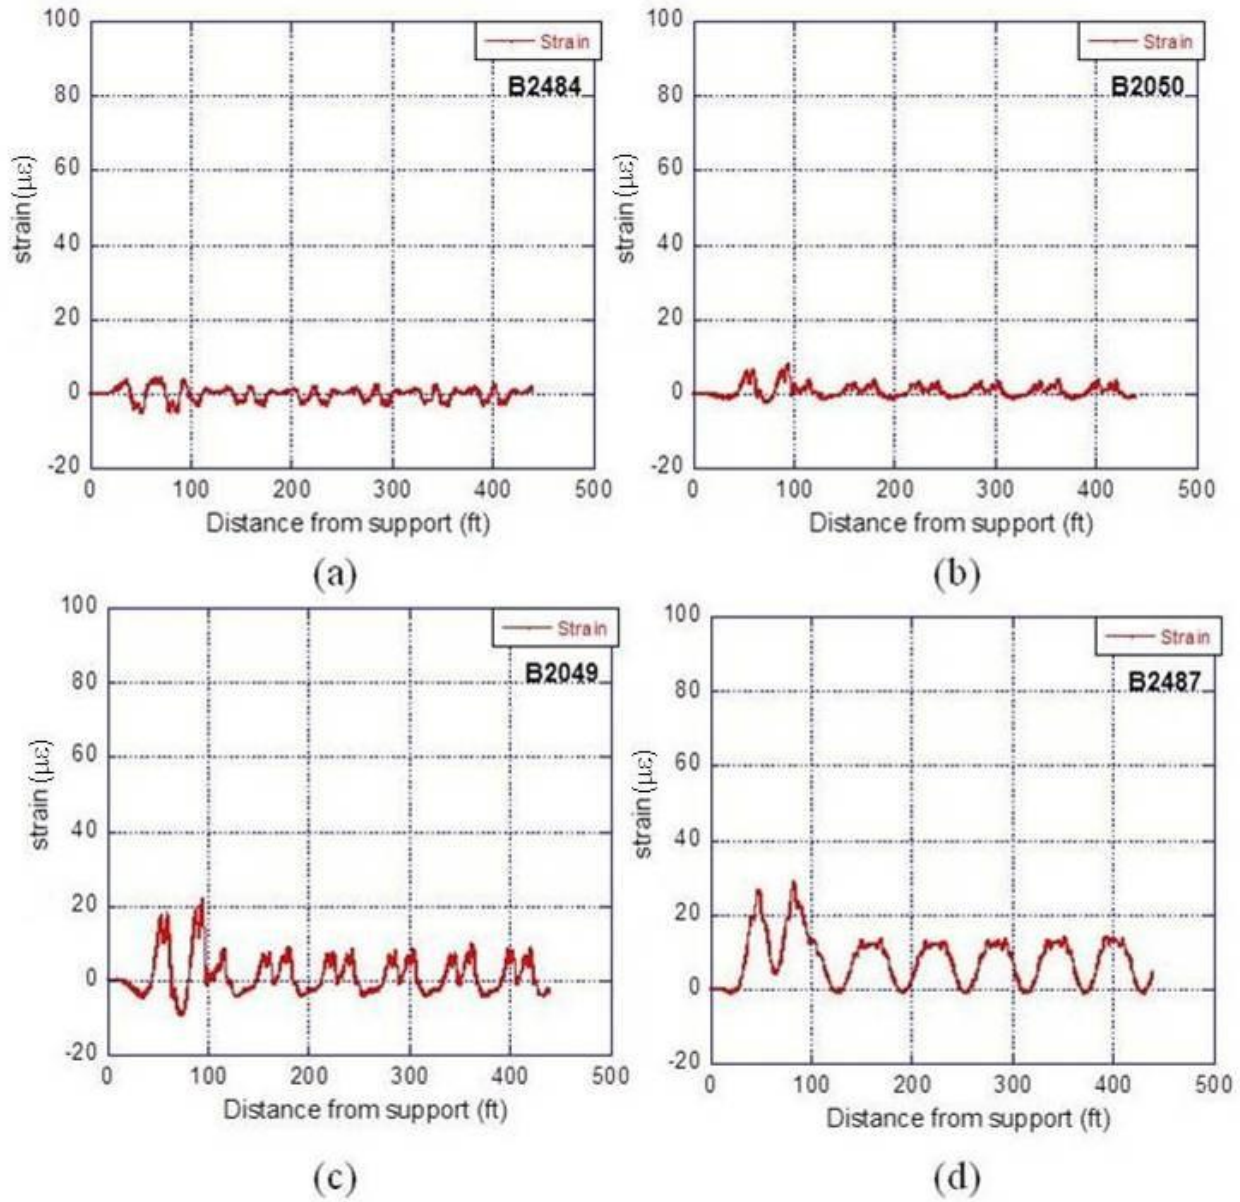
Figure 84. Strain data from run 2: (a) B2484, (b) B2050, (c) B2049, and (d) B2487

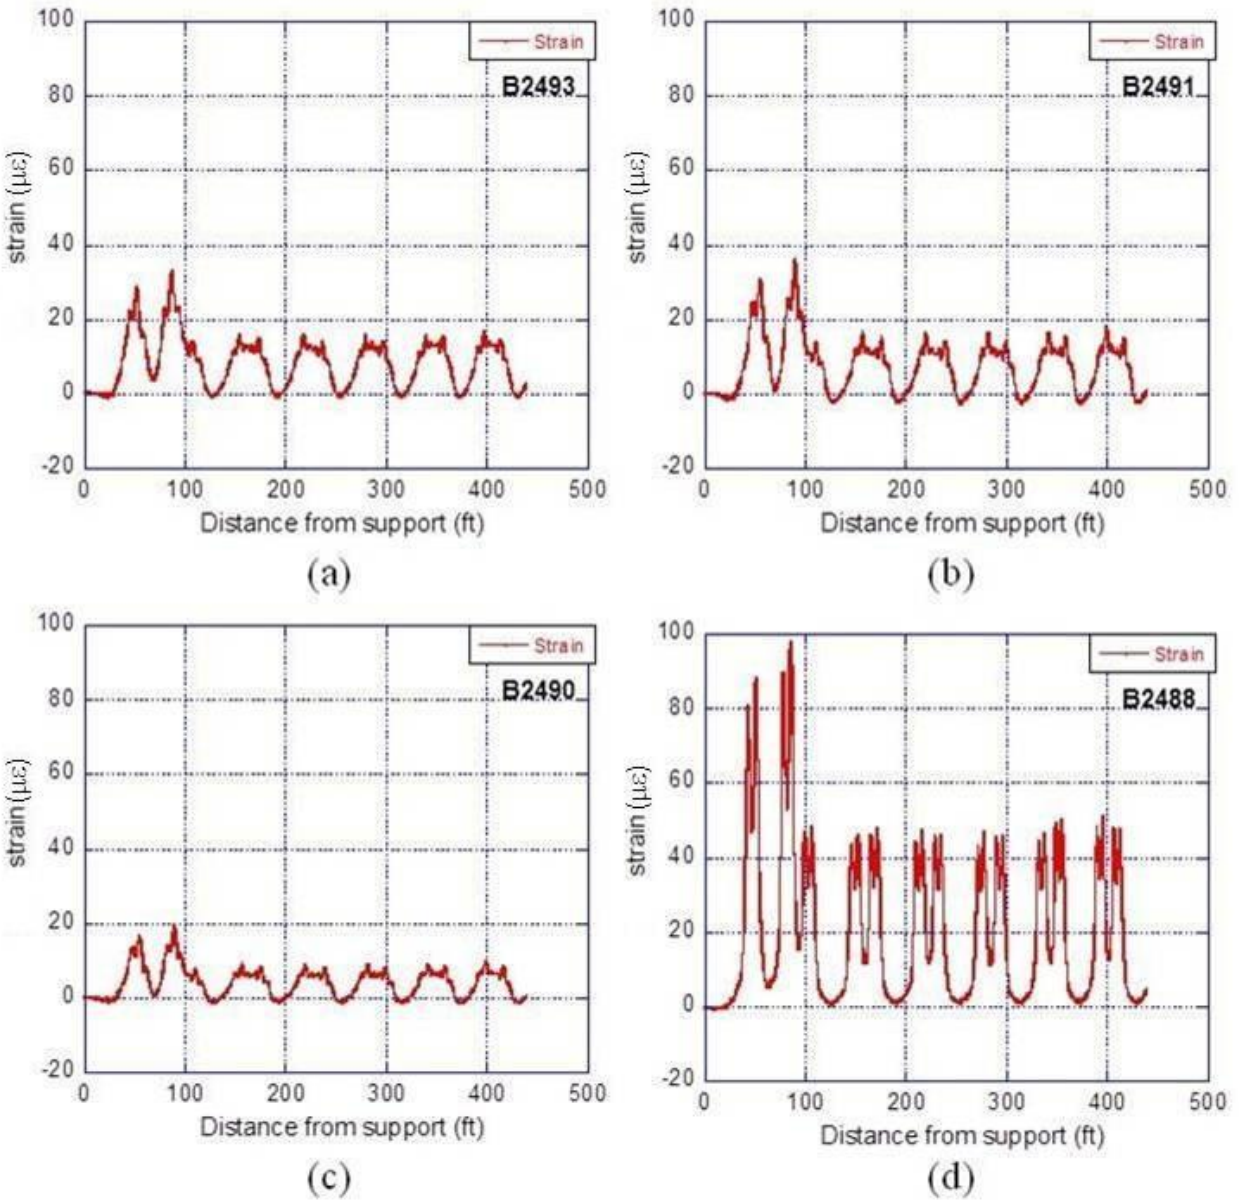
Figure 85. Strain data from run 2: (a) B2493, (b) B2491, (c) B2490, and (d) B2488

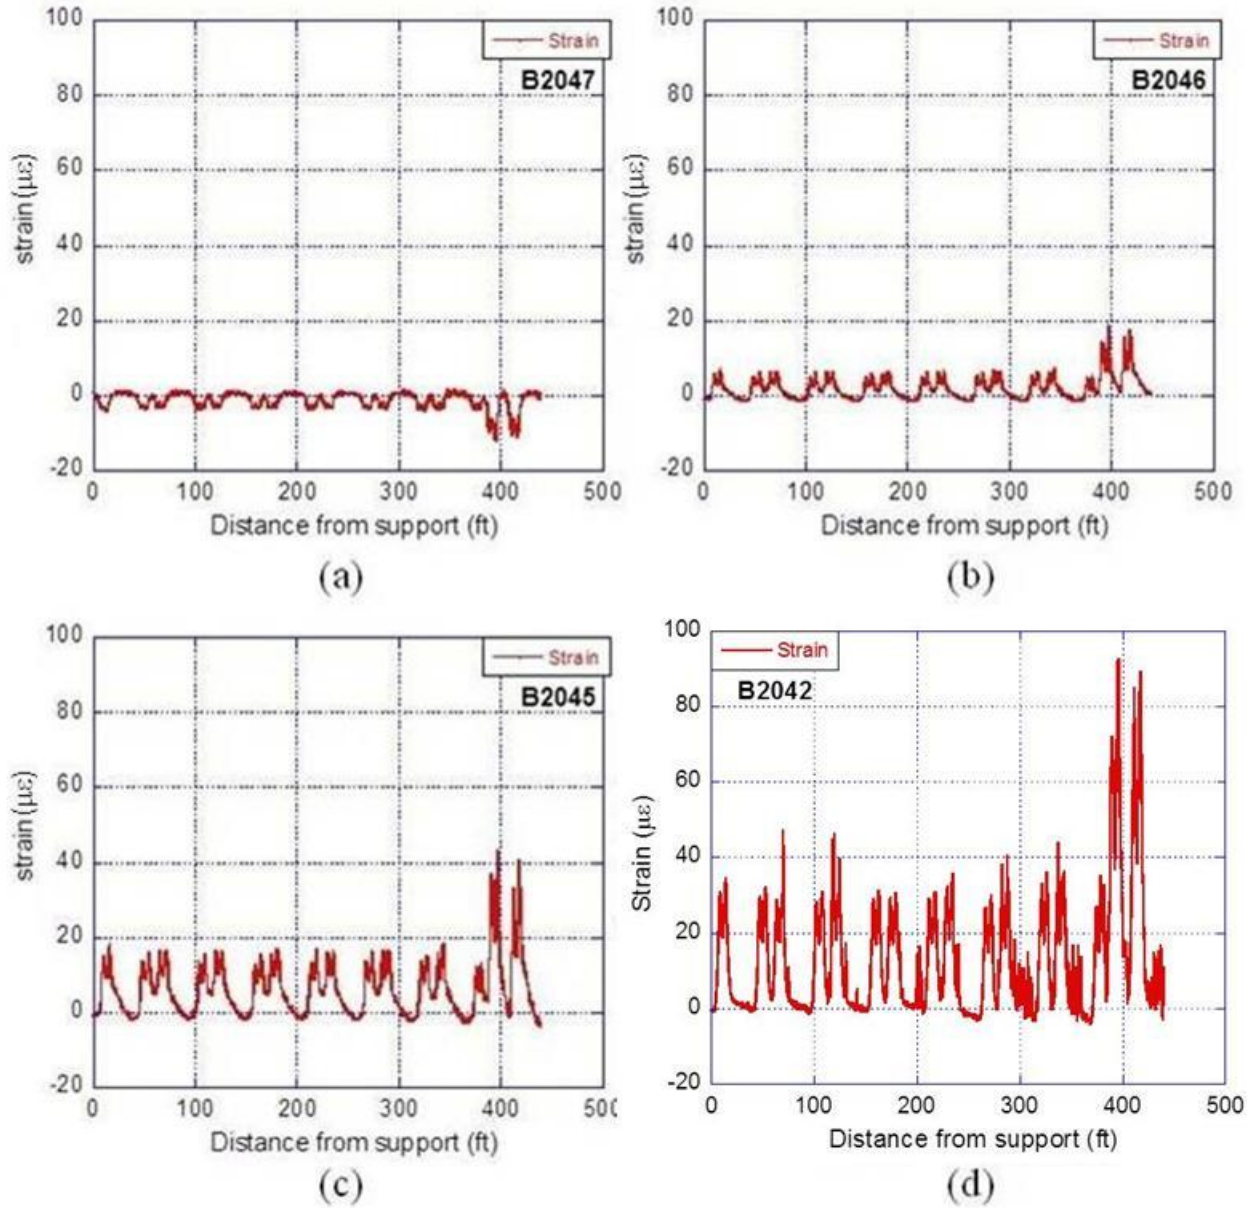
Figure 86. Strain data from run 3: (a) B2047, (b) B2046, (c) B2045, and (d) B2042

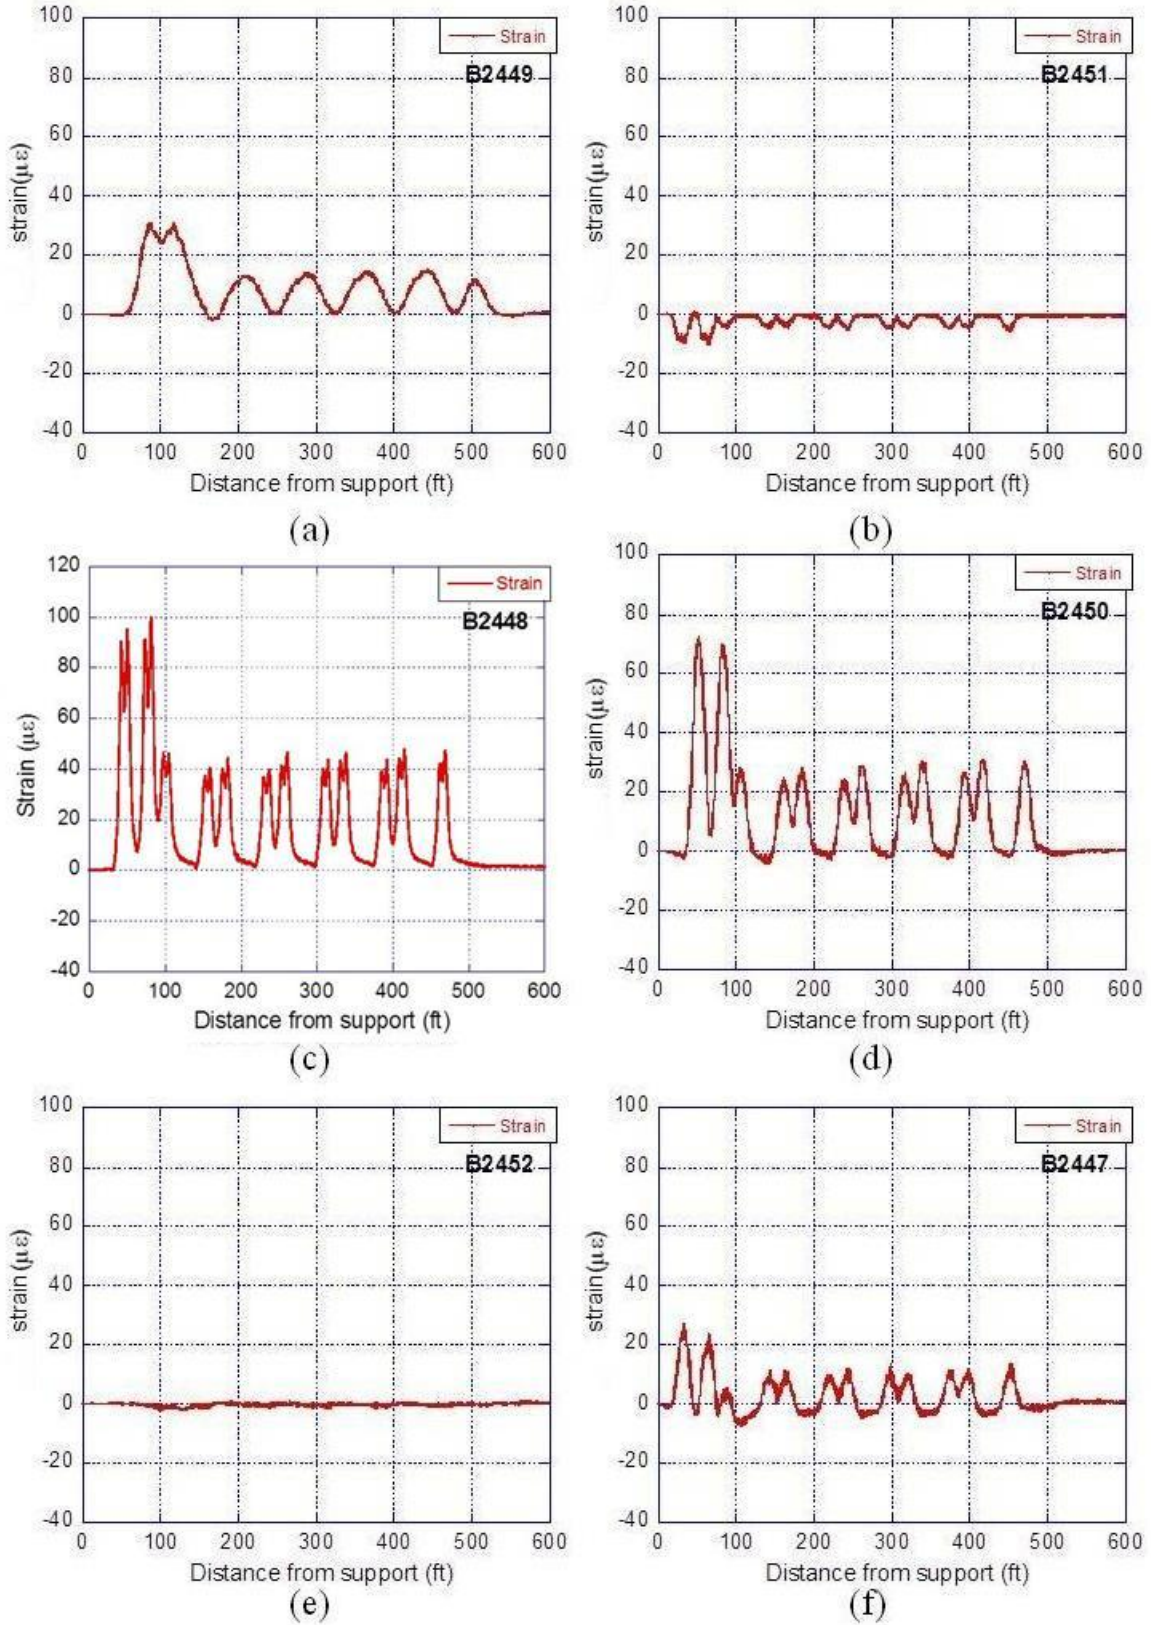
Figure 92. Strain data from run 1: (a) B2449, (b) B2451, (c) B2448, (d) B2450, (e) B2452, and (f) B2447

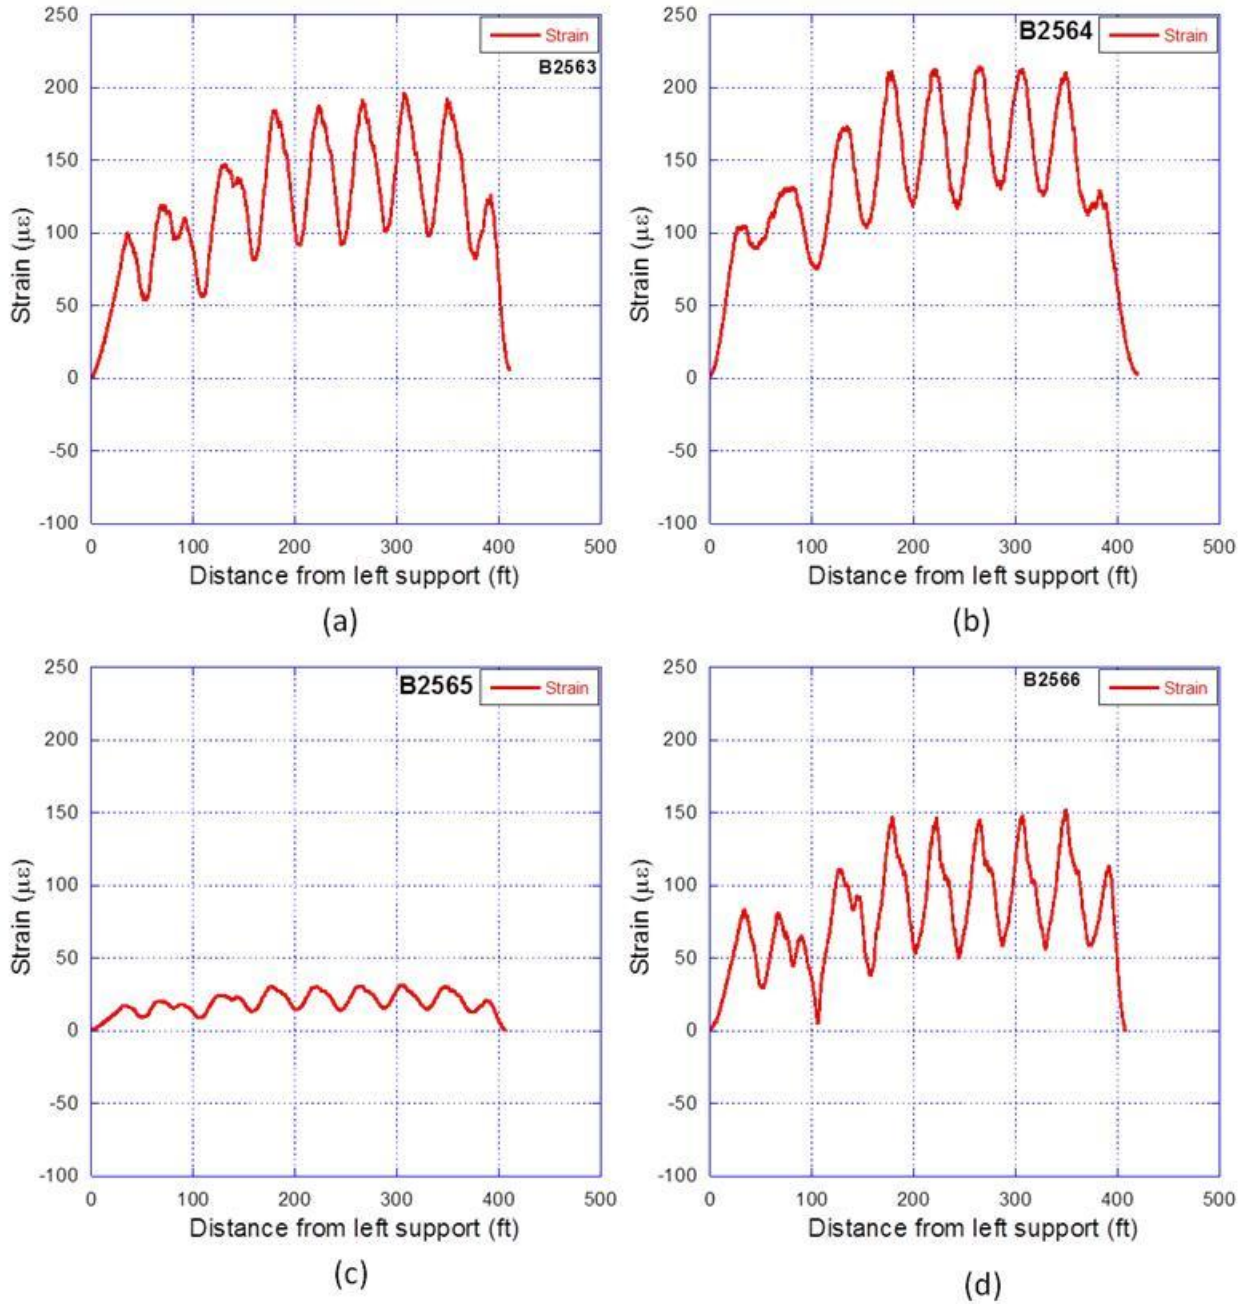
Figure 102: Strain data during Test Run #5 at strain transducer station (a) B2563, (b) B2564, (c) B2565, and (d) B2566

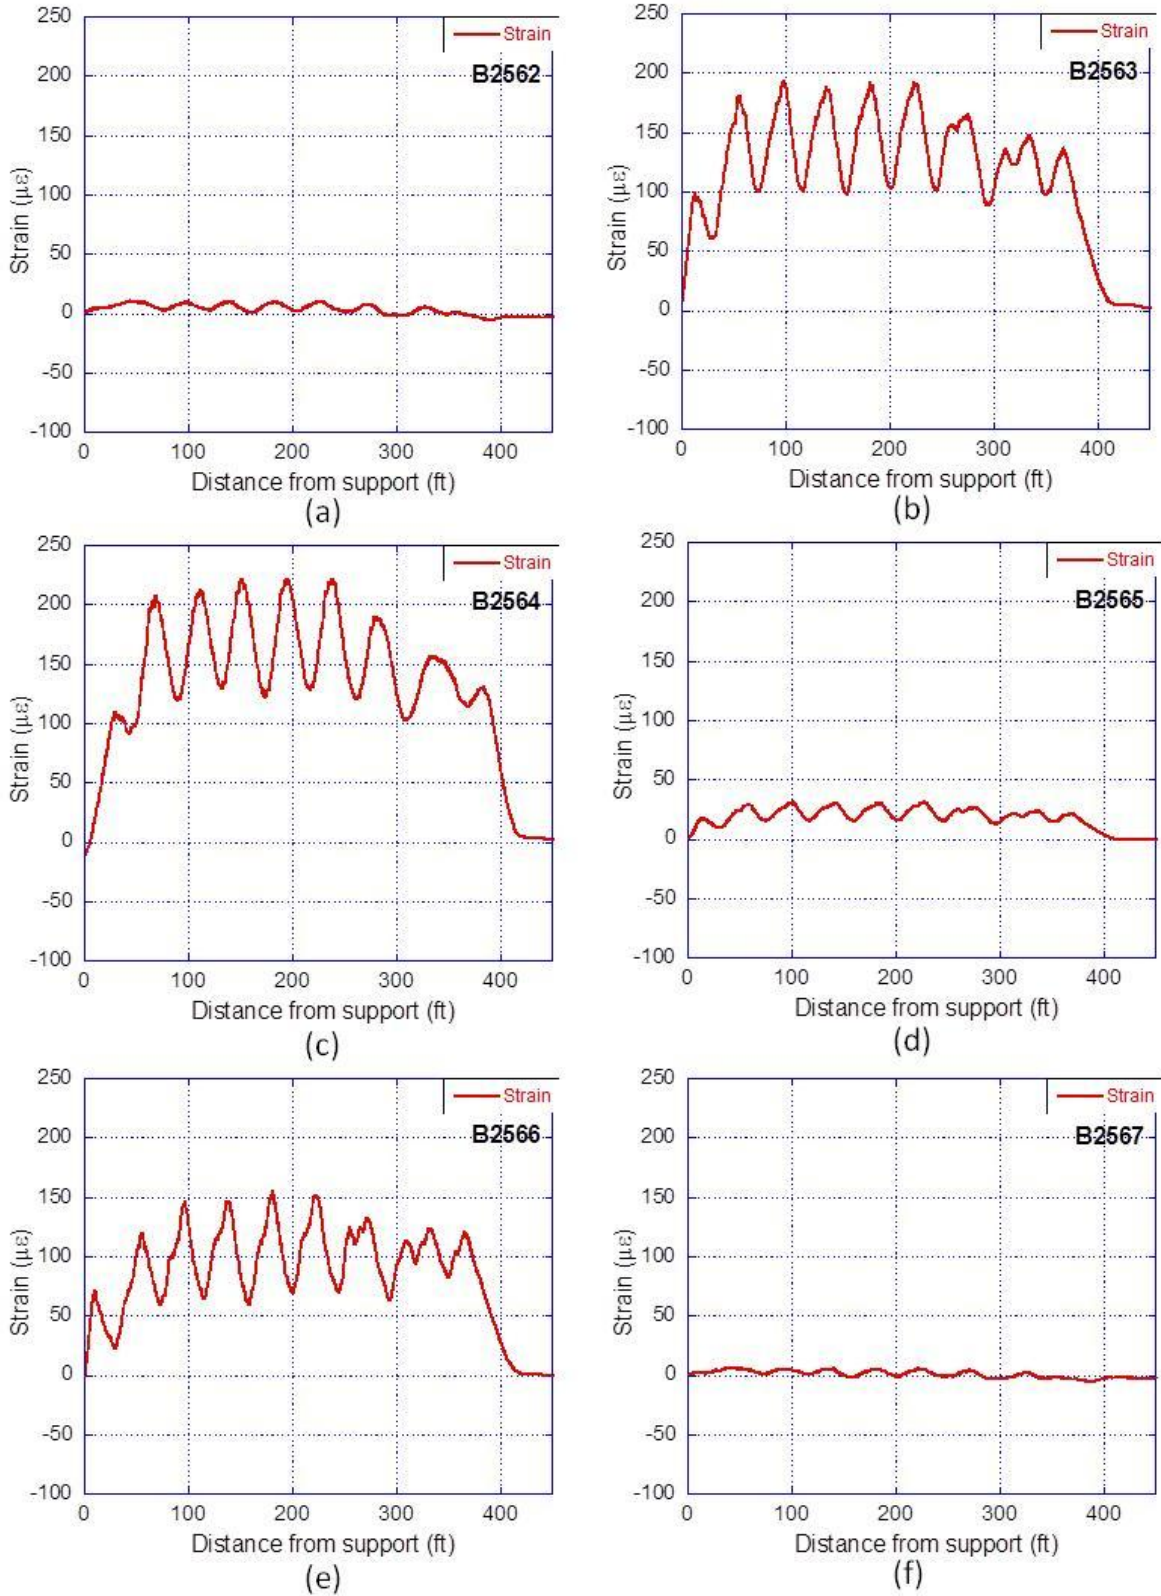
Figure 130. Strain data from Run 16: (a) B2562, (b) B2563, (c) B2564, (d) B2565, (e) B2566, and (f) B2567

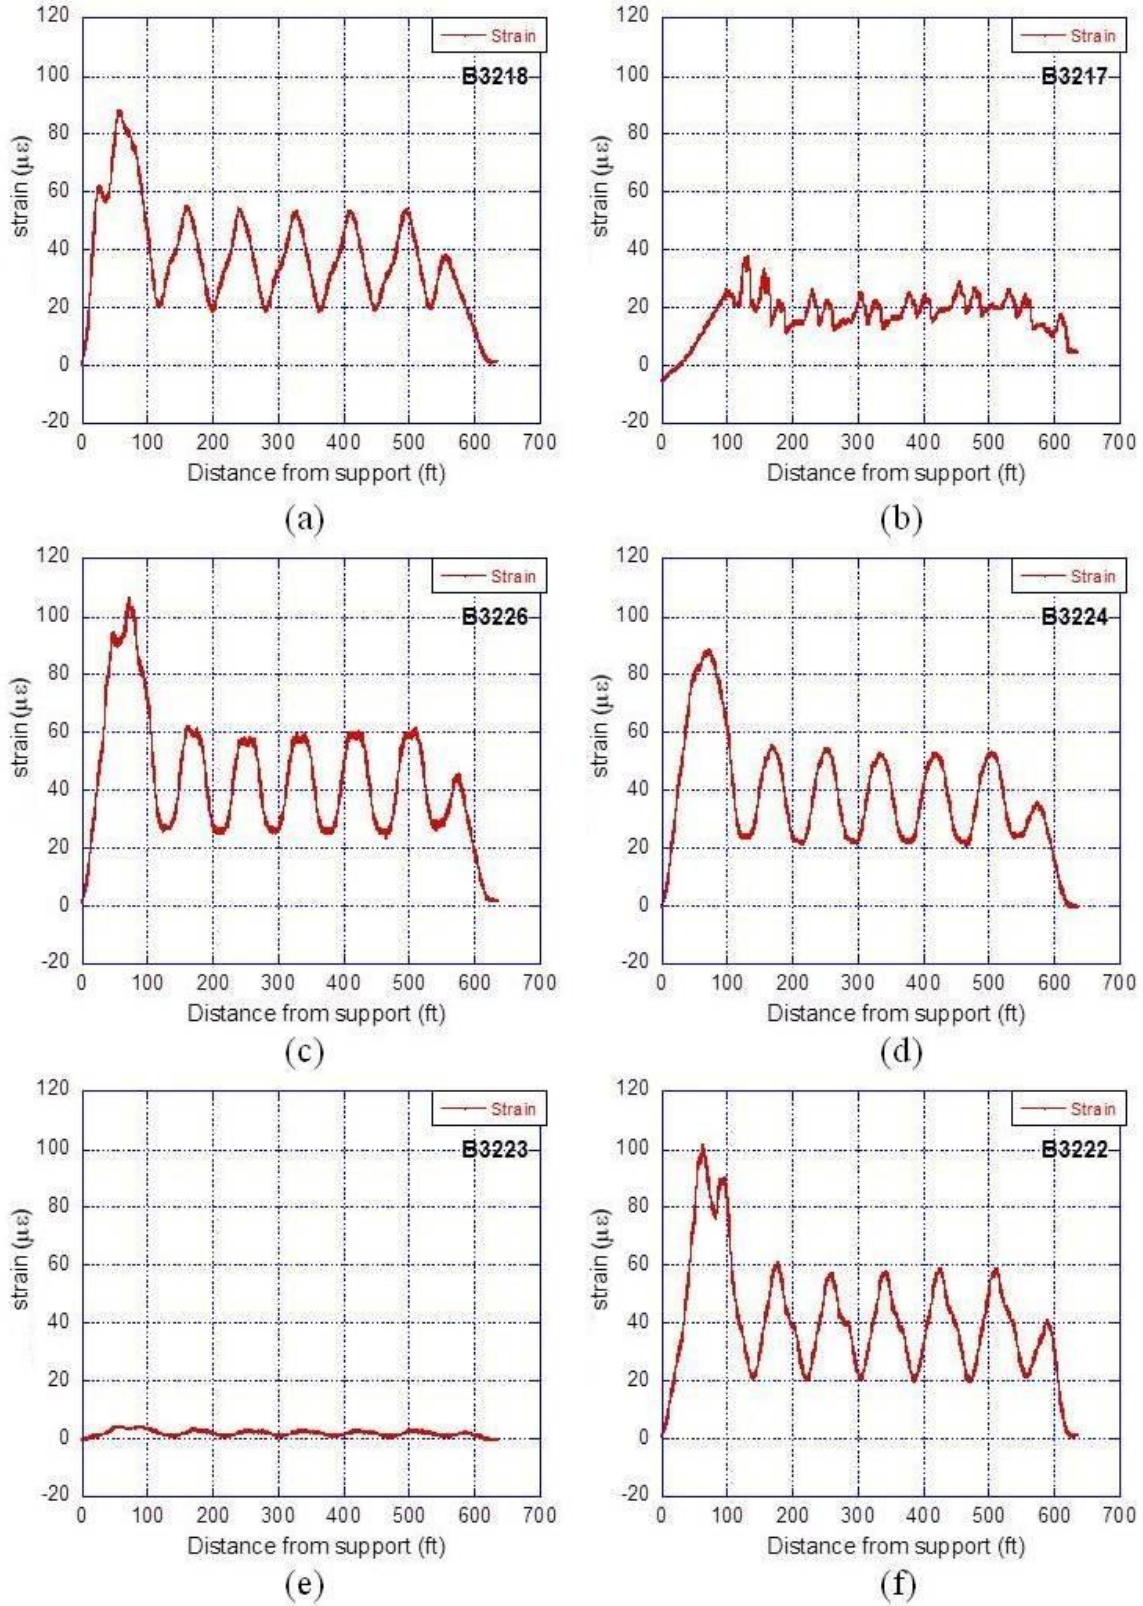
Figure 185. Strain data from Run 6: (a) B3218, (b) B3217, (c) B3226, (d) B3224, (e) B3223, and (f) B3222
