PAVEMENT HEATING

Project 7722

Progress Report 1970-1971

**New Jersey Department of Transportation
Division of Research and Development
Bureau of Instrumentation Services**

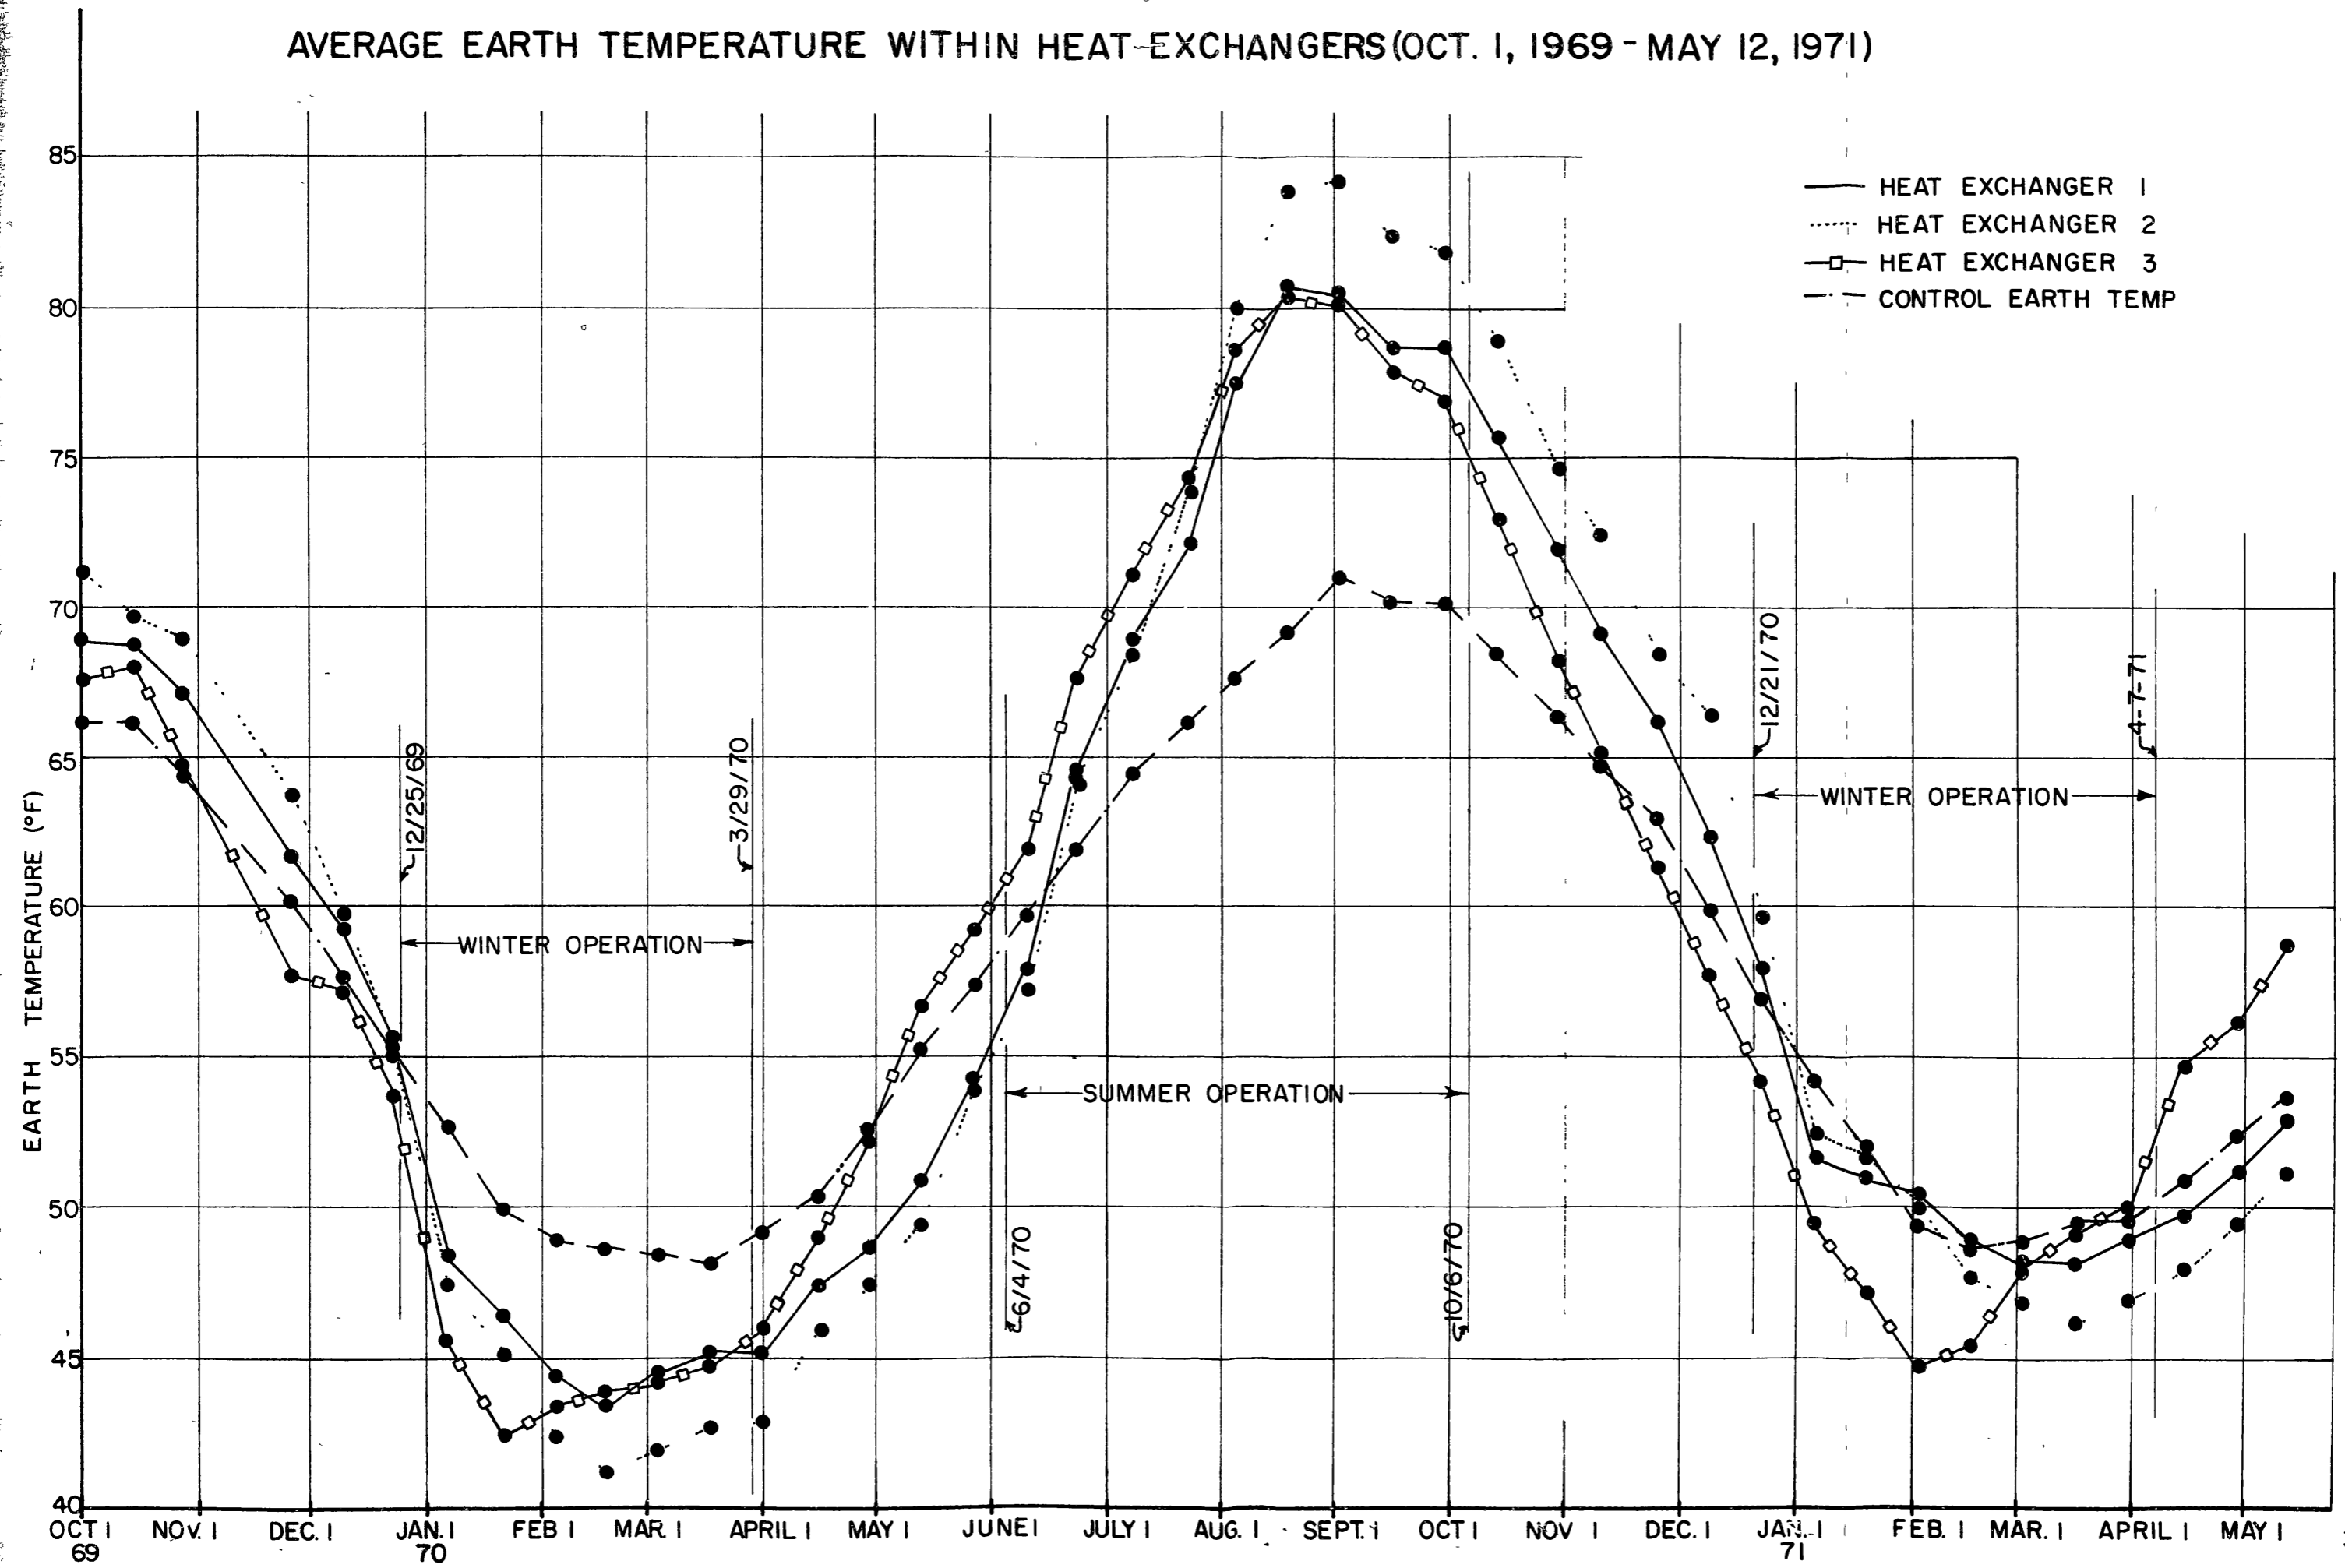
FIG. 8

HEAT STORED IN THE EARTH WITHIN HEAT EXCHANGERS
(OCT. 1, 1969 - MAR. 12, 1971)

The benefits of summer operation for 715 hours for 1970 were minimal due to the rapid rate of stored heat loss during non-operation in the fall (Fig. 8, page 39). The rate of stored heat loss during non-operation in the fall approached the rate of heat storage during

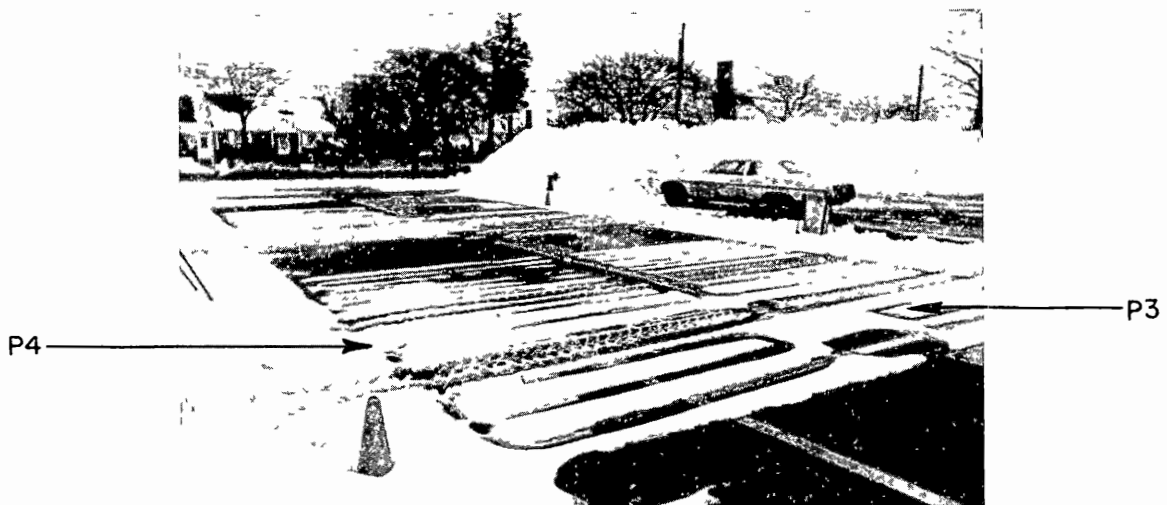
FIGURE 11. STORM #3

Panel #3 (Portland Cement Concrete) & Panel #4 (Bituminous Concrete)
4:15 P. M. - January 2, 1971
(Operated 50 hours) (Air Temp. 35.0°F)

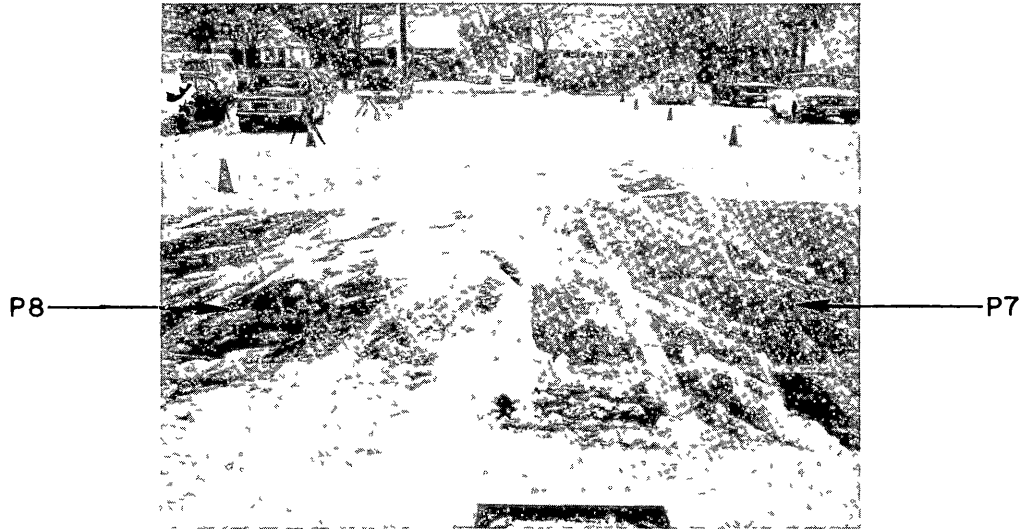
FIGURE 16. STORM #8

Panel #7 (Portland Cement Concrete) & Panel #8 (Bituminous Concrete)
11:00 A. M. - March 4, 1971
(Operated 2 hours) (Air Temp. 29.7°F)

At 11:00 A. M., all panels were fully snow covered except P7 (60W) and P8 (60W) which were 80% clear and wet, and P7 (40W) and P8 (40W), which were 60% clear and wet (Fig. 16, page 44). Melting was observed on P1 (6"), P5 (6") and P5 (18") (Fig. 14, page 43). Air temperature was 29.7°F.
