Beneficial Use of Dredged Material to Enhance Salt Marsh Habitat in New Jersey

Monitoring and Project Assessment

January 2023

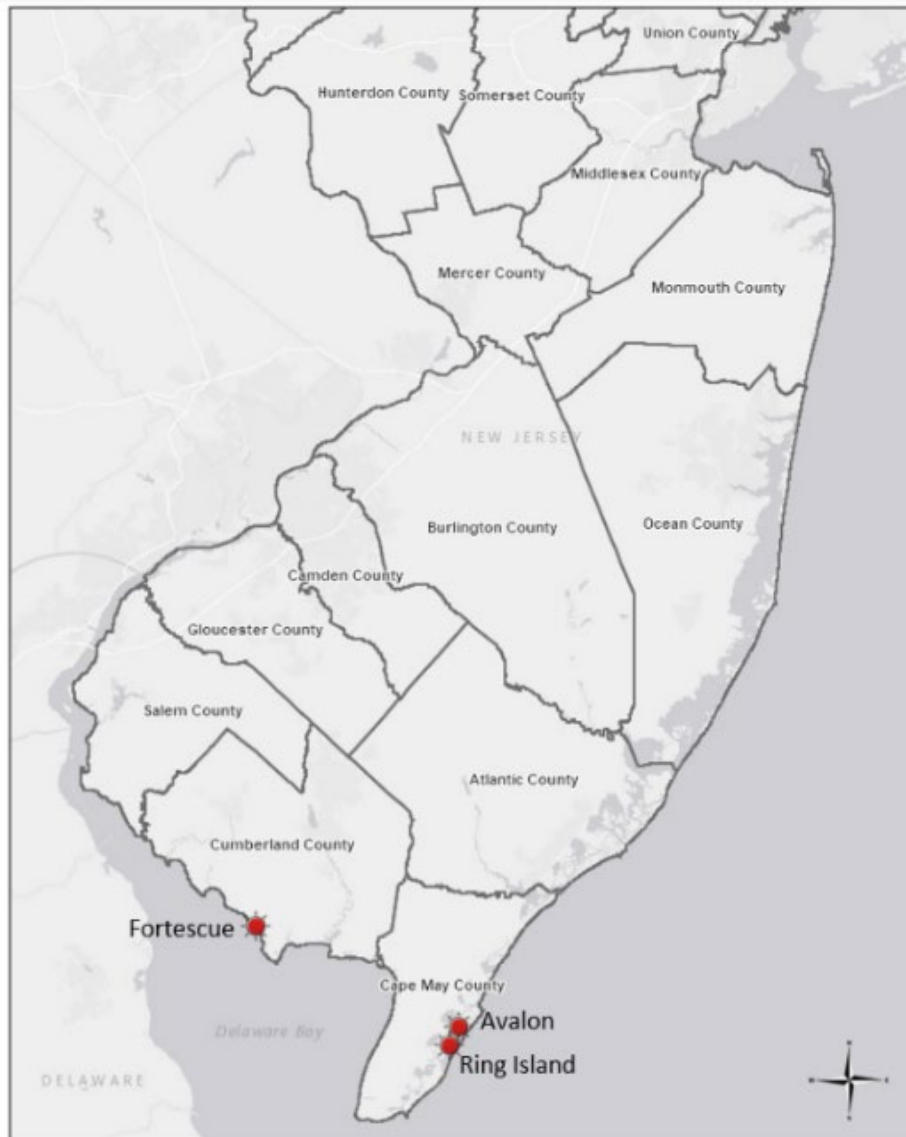
Figure 1. Pilot beneficial use of dredged material projects were implemented at three locations in Cape May and Cumberland Counties, New Jersey.

Between August 2014 and April 2017, **enhancement** pilot projects were constructed at two locations – Ring Island and Avalon – in the Cape May Wetlands Wildlife Management Area and at a third location in the Fortescue Wildlife Management Area in Fortescue (Cumberland County; Figure 1). The marsh enhancement techniques included **thin-layer placement (TLP)** of dredged material on the platform of a vegetated, **stressed marsh** (Ring Island, Avalon, and Fortescue) and the filling of degraded and expanding pool-panne complexes with TLP on the surrounding stressed marsh platform (Avalon). Additional project components included the creation of **Elevated Nesting Habitat (ENH)** for birds at Ring Island and dune restoration and beach restoration projects at Fortescue. Table 1 shows a summary of the projects.

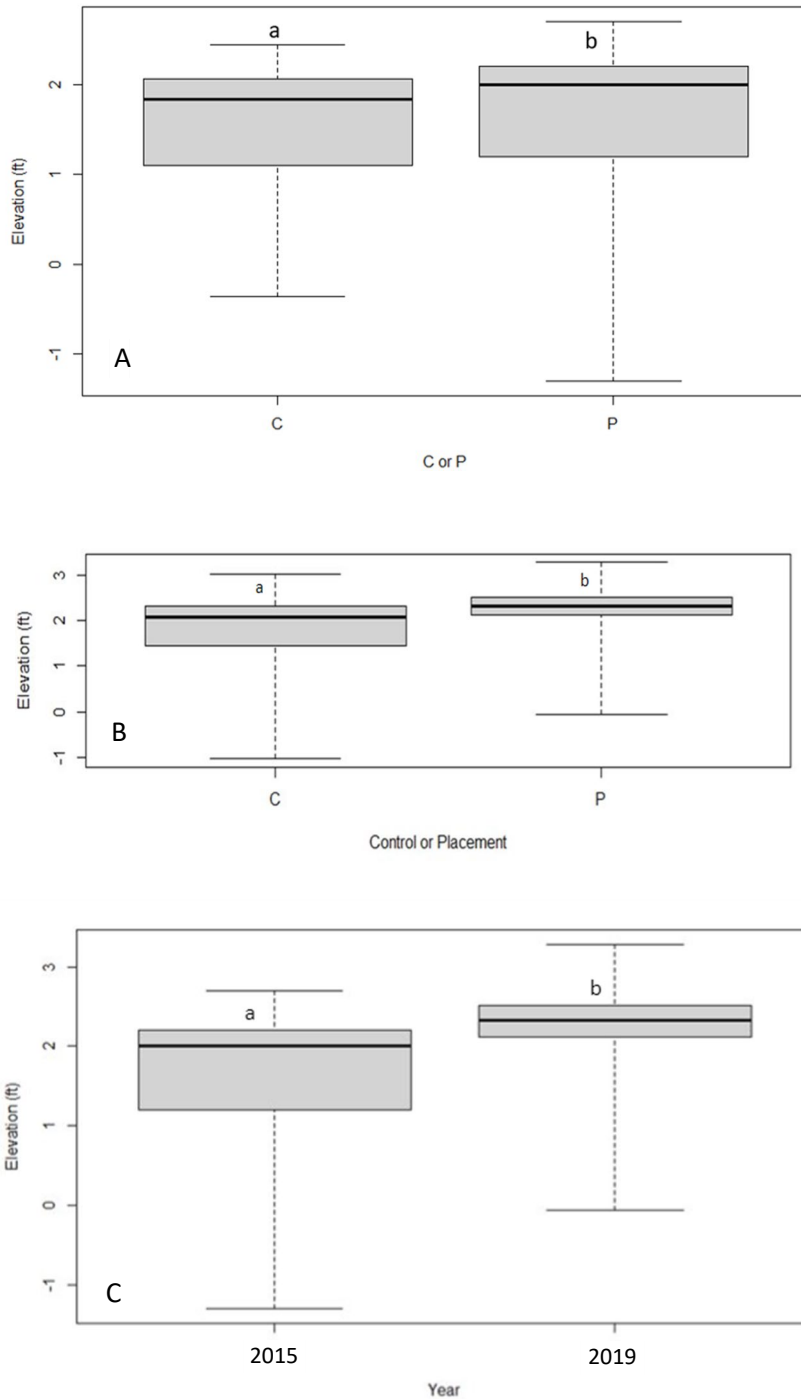
Figure 14. Box and whisker plots include the minimum, quartiles, median, and maximum elevation of A) baseline conditions (2015) between Control (C) and Placement Areas (P), B) four years post-placement (2019) conditions between Control and Placement Areas, and C) change between baseline conditions (2015) and four years post-placement conditions (2019) in only Placement Areas in Avalon.

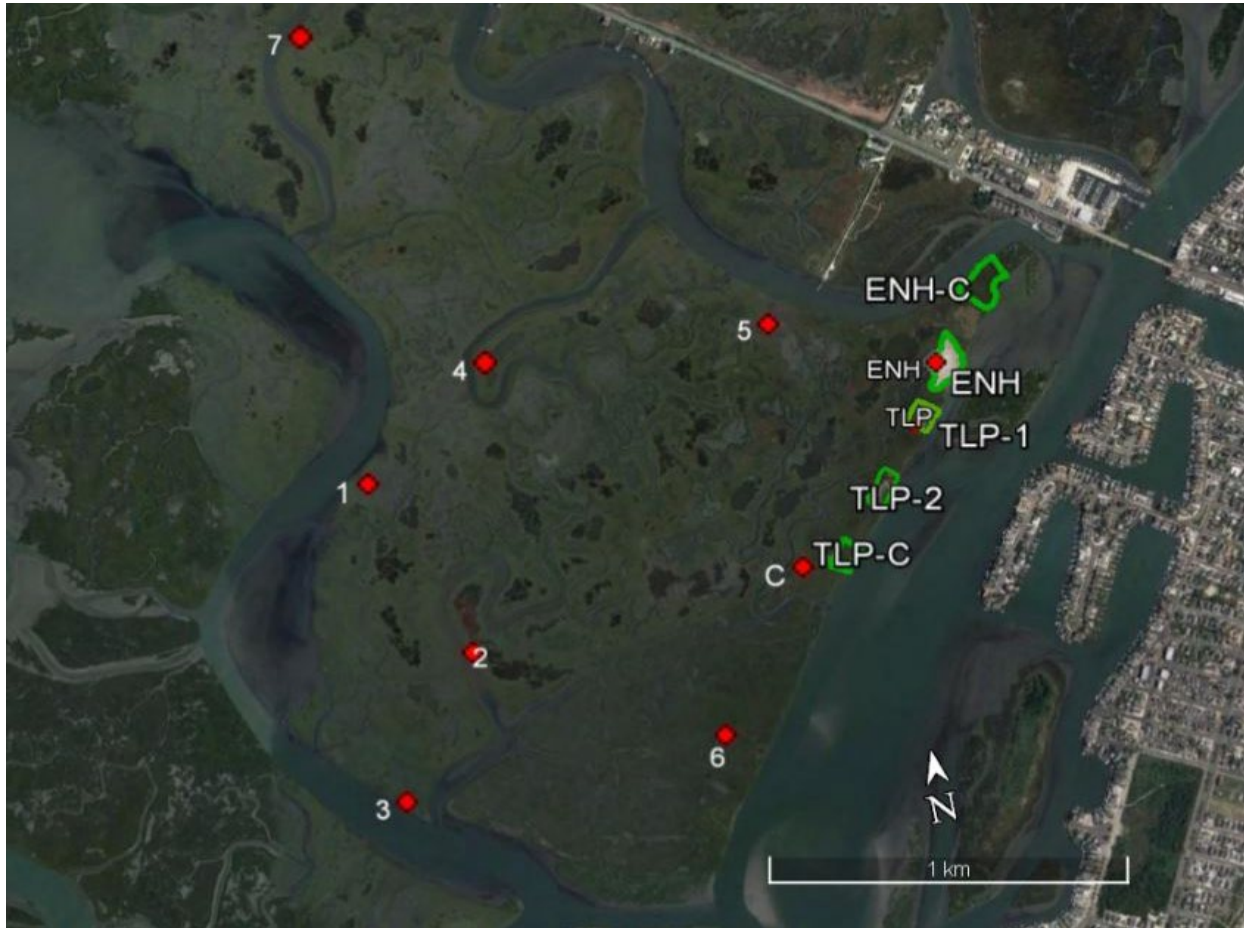
Figure 53. Ring Island point-count locations for avian surveys indicated by red dots (N= 10; 2015-2017): Thin Layer Placement site (TLP), Elevated Nesting Habitat (ENH), and eight control points (C, 1-7). Four of these points (TLP, ENH, C, and 5) were surveyed in 2018-2019. Areas surveyed for wildlife use and nesting (2015-2019) indicated by green polygons: Thin Layer Placement areas (TLP 1 & 2), Elevated Nesting Habitat (ENH), and two Control sites (TLP-C and ENH-C). TLP point-count location is located within TLP-1.

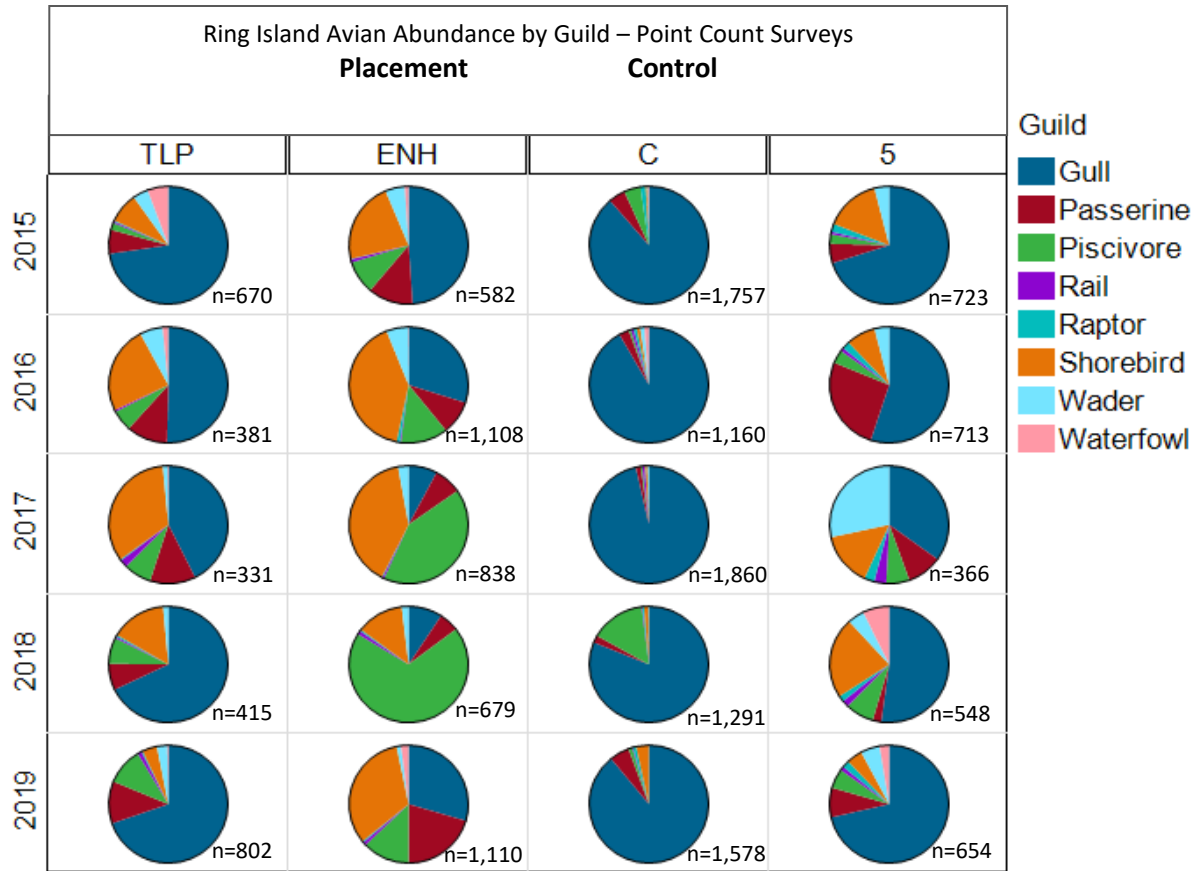
Figure 54. Avian abundance by guild at Ring Island placement points (left) and control points (right) 2015-2019; n =total birds counted during surveys.

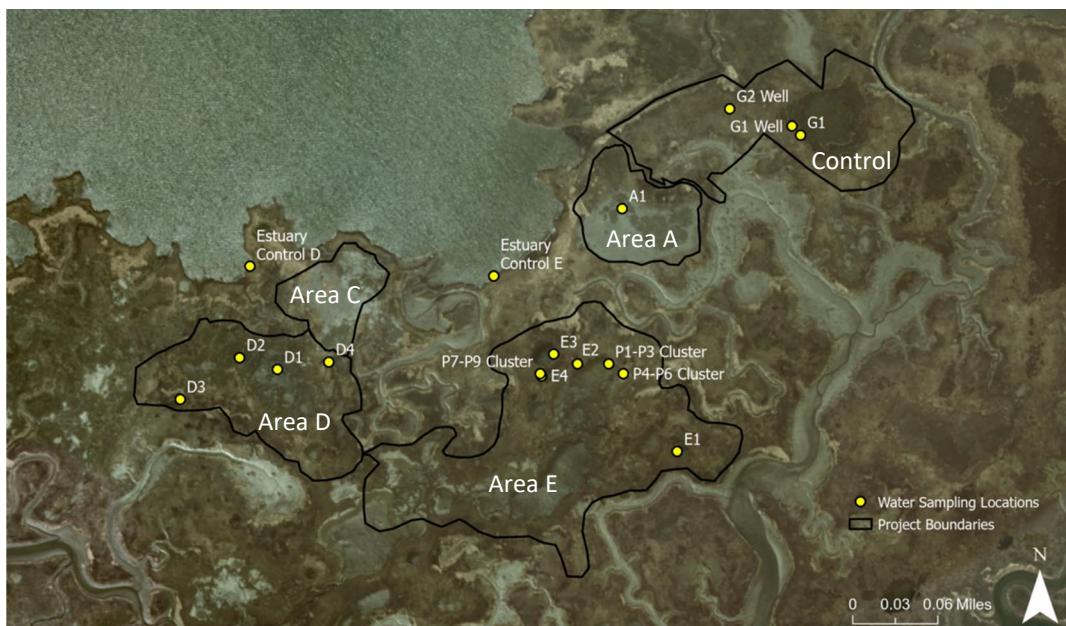
Figure 59. Map of sampling locations for groundwater and surface water.

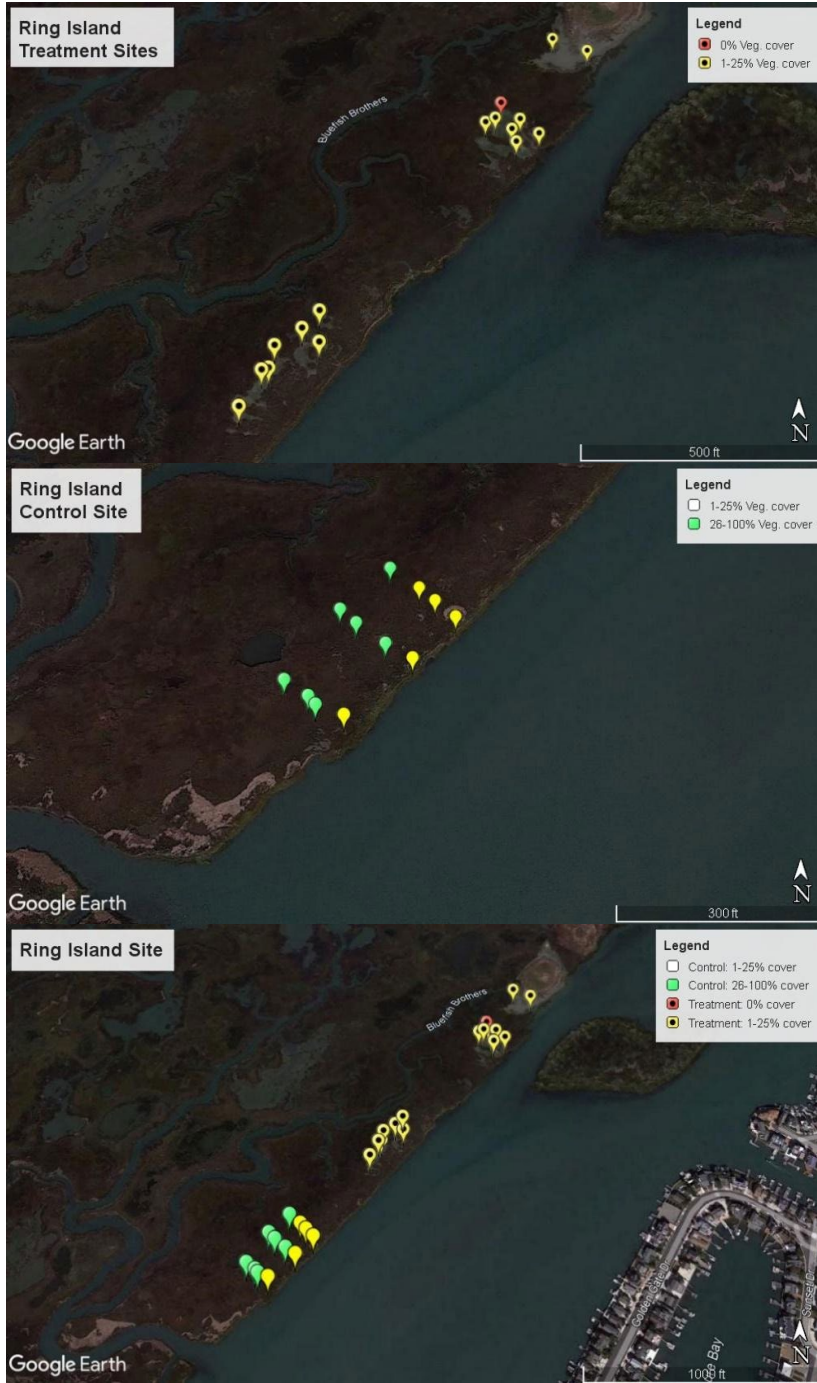
Map of plot recovery levels at Ring Island. Top map is a close-up of all Ring Island treatment sites. The center map is a close-up of the Ring Island control site, and the bottom map is the entirety of the Ring Island site in relation to the town of Stone Harbor and the back bay geography. Plots with black dots in the center of the icon are treatment plots, those without dots are control plots. Level of recovery is indicated by color, with 0% vegetation cover represented by red icons, 1-25% vegetation cover represented by yellow icons, and 26-100% vegetation cover represented by green icons.

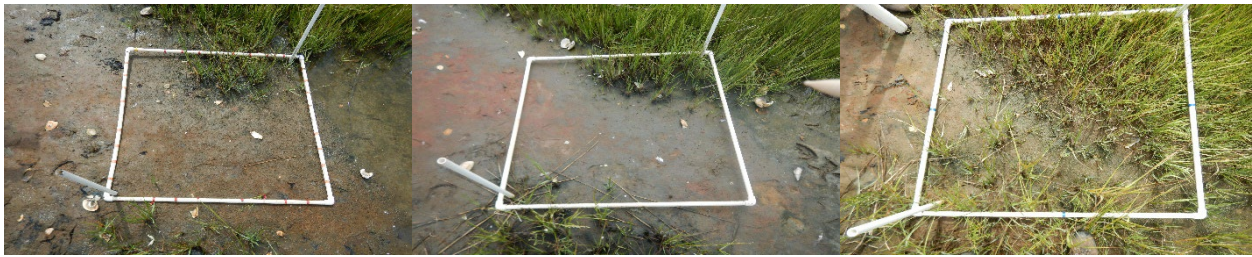
Timeseries of plot 23 placement area 1 at Ring Island From left to right This was still predominantly bare in PP3 (left), the plot was initially colonized by *Spartina alterniflora* which gradually expanded into the plot from the edges in PP4 (middle) and PP5 (right).

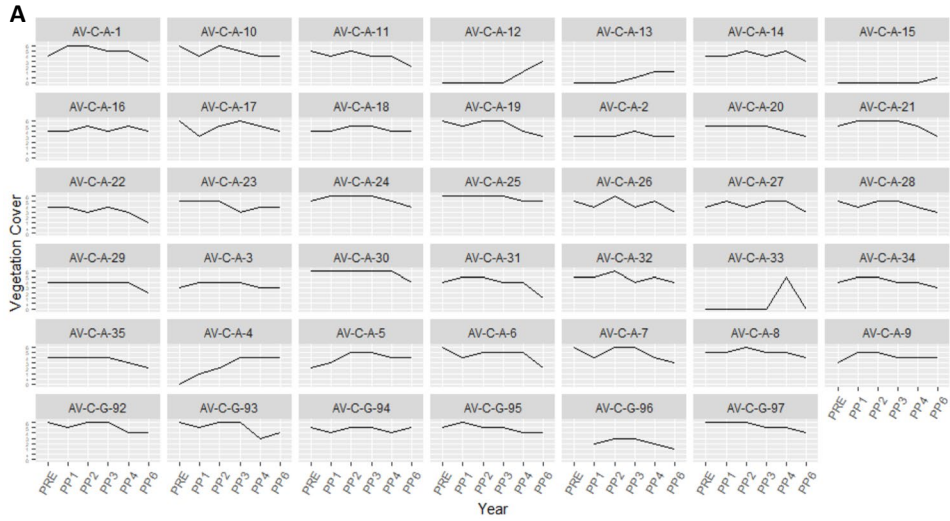
Vegetation percent cover change in individual A) control and B) treatment plots at Avalon over time.

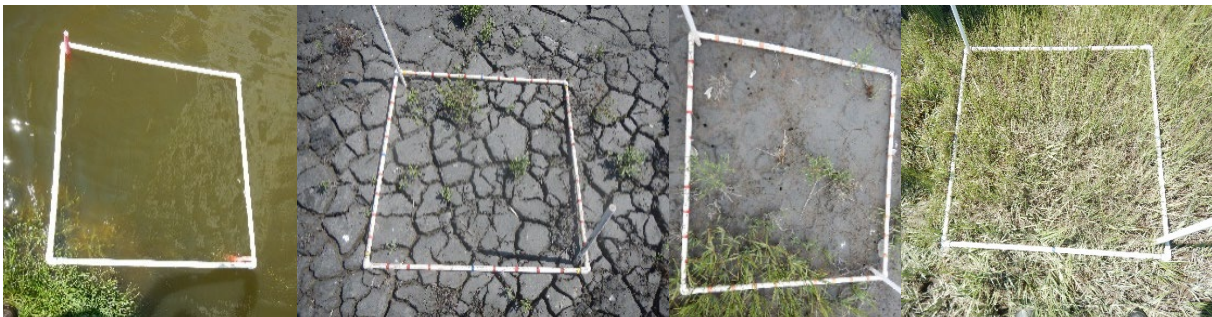
Timeseries of plot #71 in Avalon placement area E. This plot started as a pool prior to placement PRE (left). The plot was considered bare the first 2 years post placement. In PP2 (middle left) the plot was colonized by *Salicornia* sp. In PP3 (middle right) *Spartina alterniflora* began to establish and by PP4 (far right), the plot is fully vegetated by *Spartina alterniflora*.

6. *Salicornia* sp. (commonly called sea beans, glasswort, or pickleweed) were the first plants to recolonize the placement areas but were subsequently replaced by *Spartina alterniflora* (smooth cordgrass) and *Distichlis spicata* (saltgrass) as a result of planting and natural recruitment.

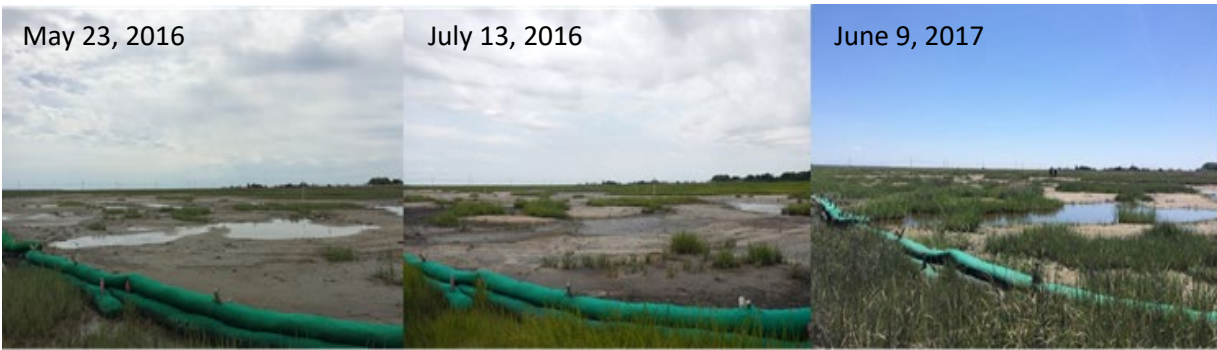
Successional photos taken from a permanently established photo point at the Fortescue project site in 2016 and 2017 (PP1 and PP2, respectively).

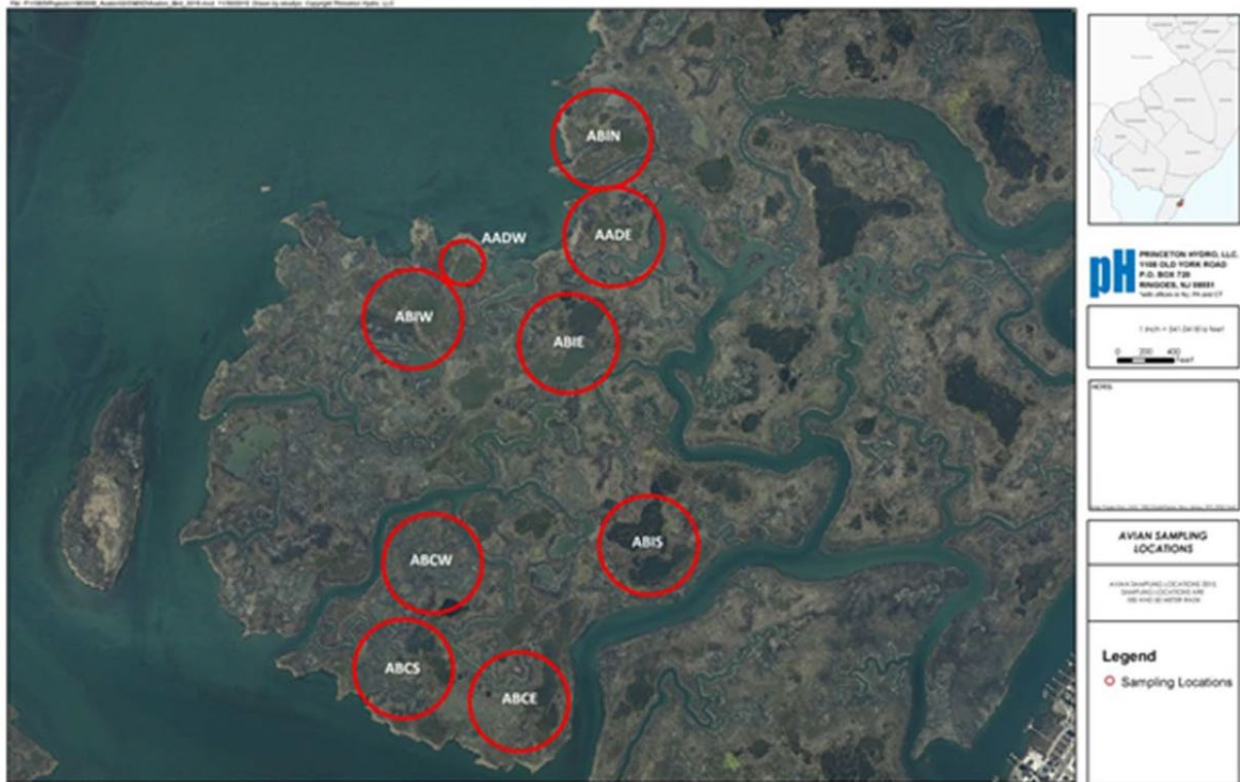
Map of monitoring locations for avian counts in Avalon. All birds within the red circles were considered part of the analysis. Site names are coded for location (e.g., A = Avalon), the timing of placement (i.e., before or after; B or A, respectively), site descriptor (i.e., control, impact, or demo; C, I, or D, respectively), and cardinal direction (e.g., N = north).

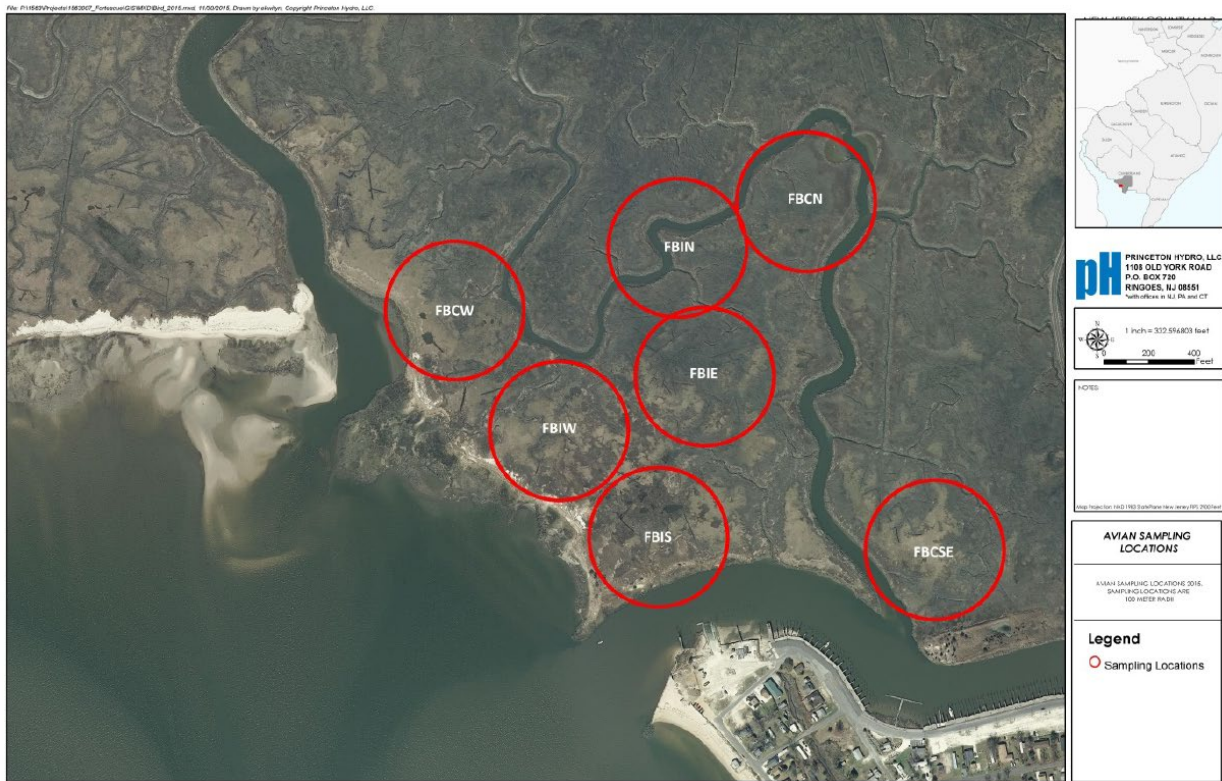
Map of monitoring locations for avian counts in Fortescue. All birds within the red circles were considered part of the analysis. Site names are coded for location (e.g., F = Fortescue), the timing of placement (i.e., before or after; B or A, respectively), site descriptor (i.e., control or impact; C or I, respectively), and cardinal direction (e.g., N = north).

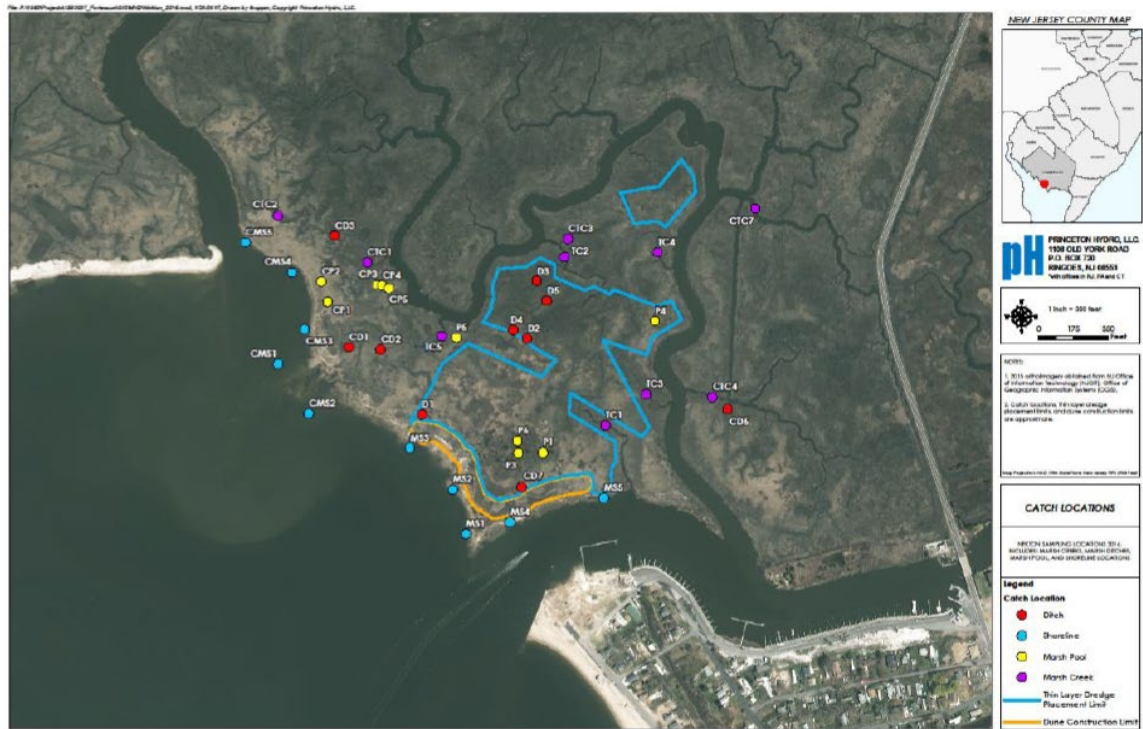
Nekton by treatment and habitat sampling locations at Fortescue, New Jersey 2016. Maps created by Thomas Hopper of Princeton Hydro, LLC.
