NJDOT Report No. 72-007-7716

TWO-WIRE EMERGENCY CALL SYSTEM

FINAL REPORT

Bureau of Operations Research
Division of Research and Development
New Jersey Department of Transportation

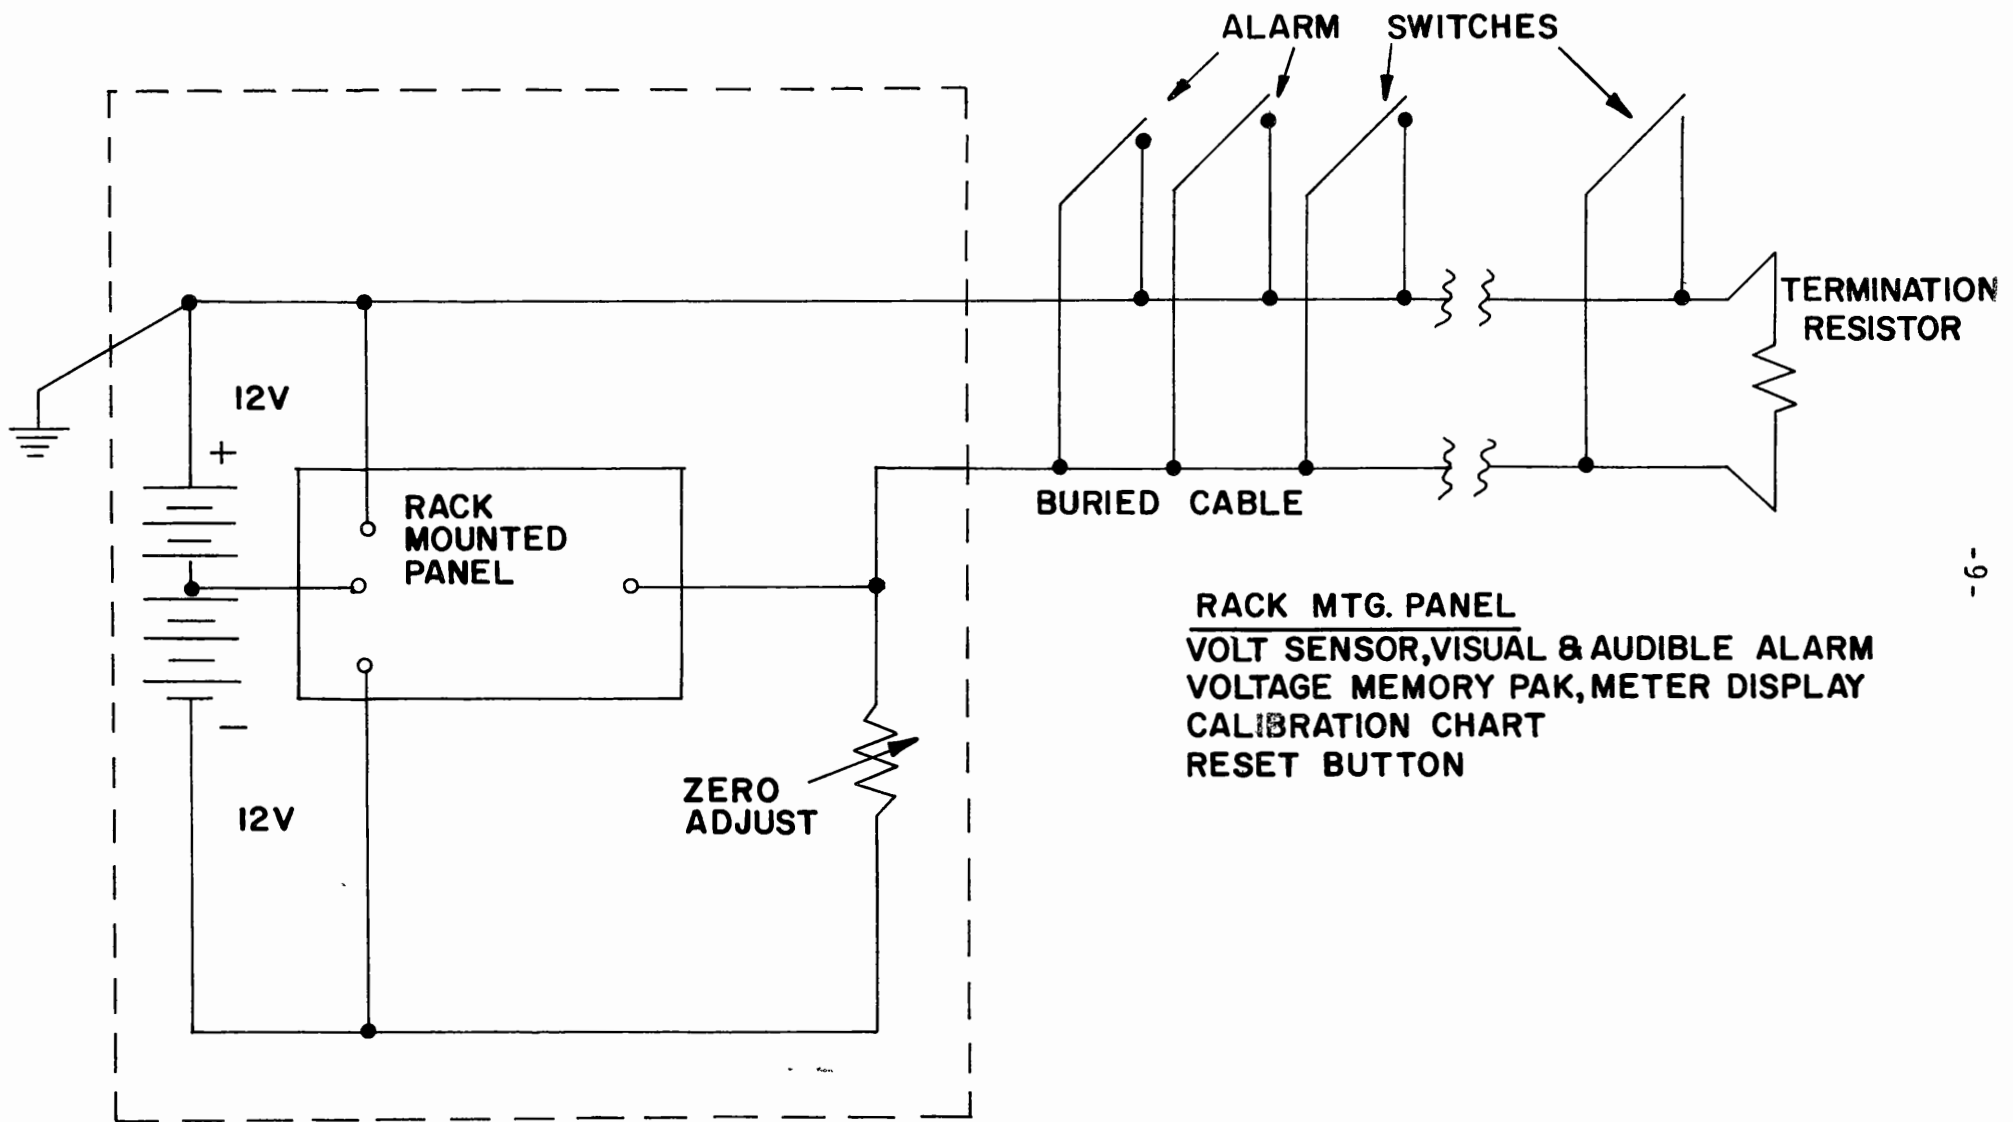
FIGURE 4

and was turned off by one of the push buttons after the necessary information was recorded. The other indicator lamp warned that a break in the two-wire cable had occurred making the system inoperative. By use of a known terminating resistance at the end of each segment, a continuous, low current flowed through the segment. Any break in the conductor would interrupt the current flow, causing the warning lamp to be actuated. The remaining push button was used for testing the electrical monitoring circuitry. Typical connections for one segment of the system are shown in Figure 4 with detailed monitoring circuitry shown in Figure 5.

CONNECTIONS FOR ONE LEG OF THE SYSTEM.

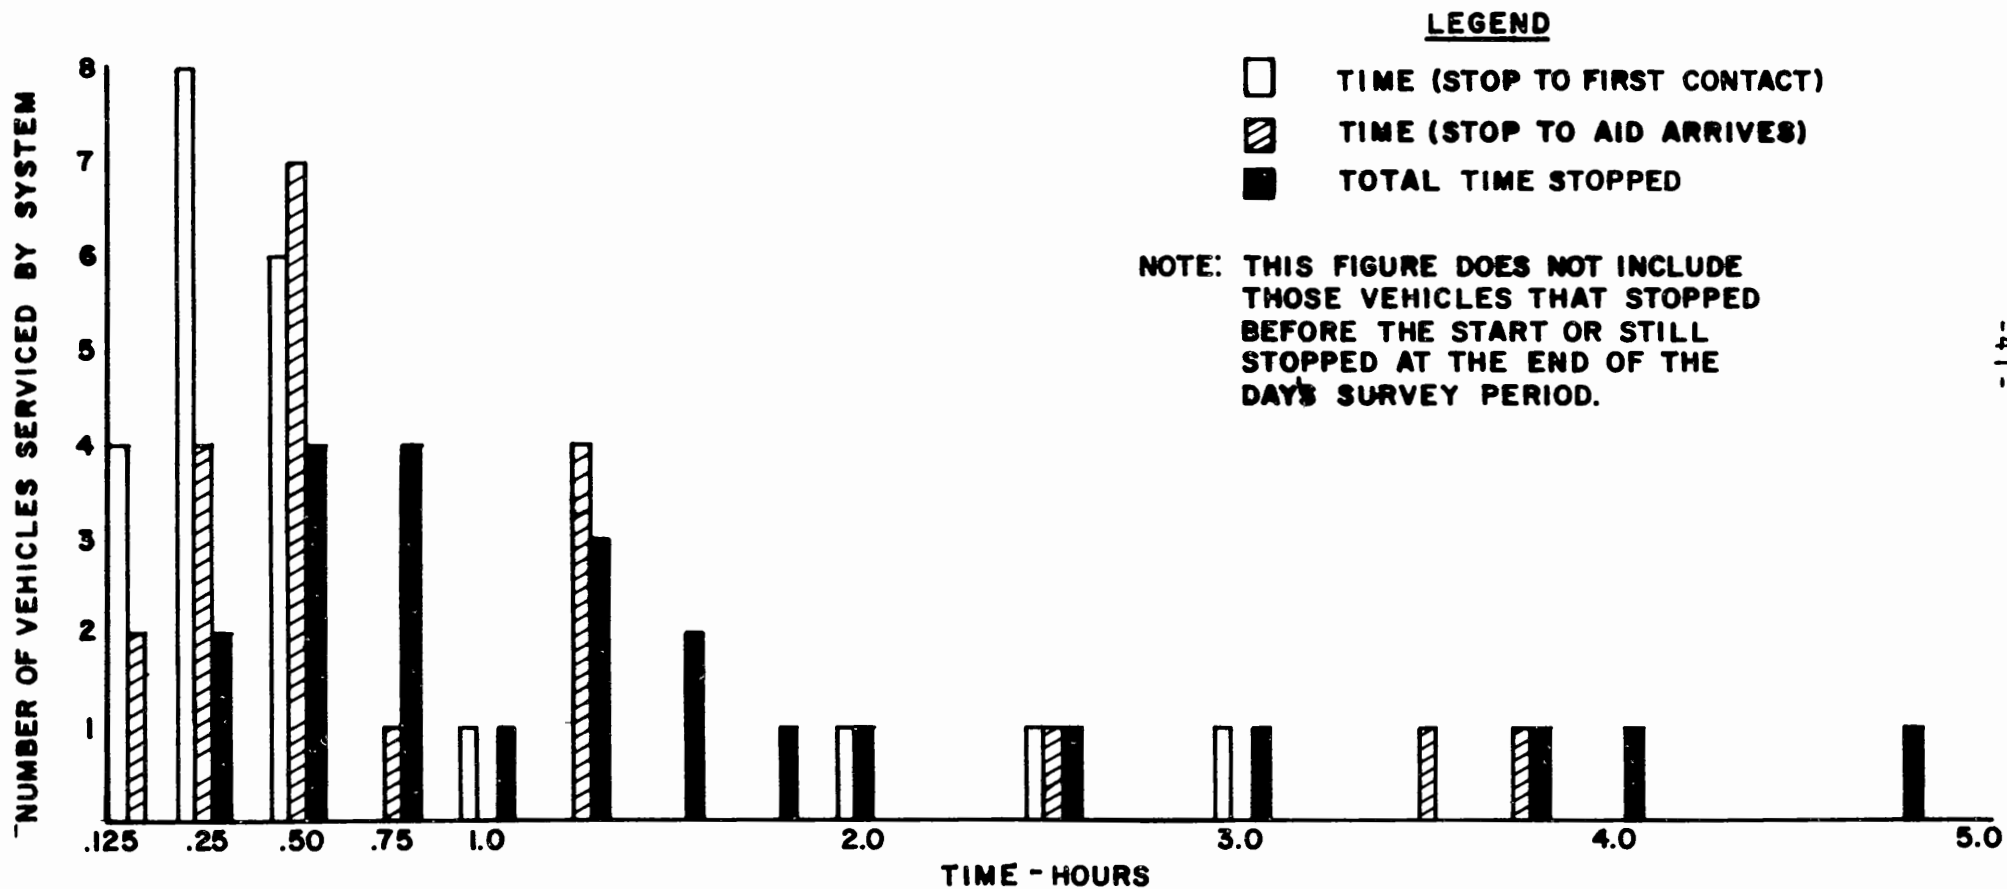
FIGURE 15

times for first contact, aid arrives, and total stopped time for vehicles which needed aid and were serviced by the system during the 1971 survey.

2-WIRE EMERGENCY CALL
 USE OF EMERGENCY CALL
 I-287 TEST SECTION
 1971 FIELD SURVEY

The distribution of times for motorists awaiting aid (utilizing the call system) are shown in Figure 15. If it is assumed that one-half hour is a reasonable time for the operating personnel to respond to a call, and if the failure of the operating personnel to respond to all calls within that time could be overcome, the average time to first contact could be reduced by 18 minutes (Table I and Figure 15). Similarly, if the aid that is requested to respond to motorist can arrive within one hour after being notified of the need (a maximum of 1-1/2 hours after the time the motorist stopped), the average time stopped until aid arrives could be reduced by 15 minutes (Table I and Figure 15). It follows that a reduction of 15 minutes in the average time from stop until aid arrives would result in a similar reduction in the average total stopped time (Table I and Figure 15). The increased number of serious problems (mechanical) in 1971 over 1970 (50 vs. 28, see Table I) at least partially explains the longer average stopped time for 1971.
