FATIGUE PERFORMANCE OF VARIABLE MESSAGE SIGN & LUMINAIRE SUPPORT STRUCTURES

Volume II – Fatigue Testing and Failure Analysis of Aluminum Luminaire Support Structures

FINAL REPORT
May 1998

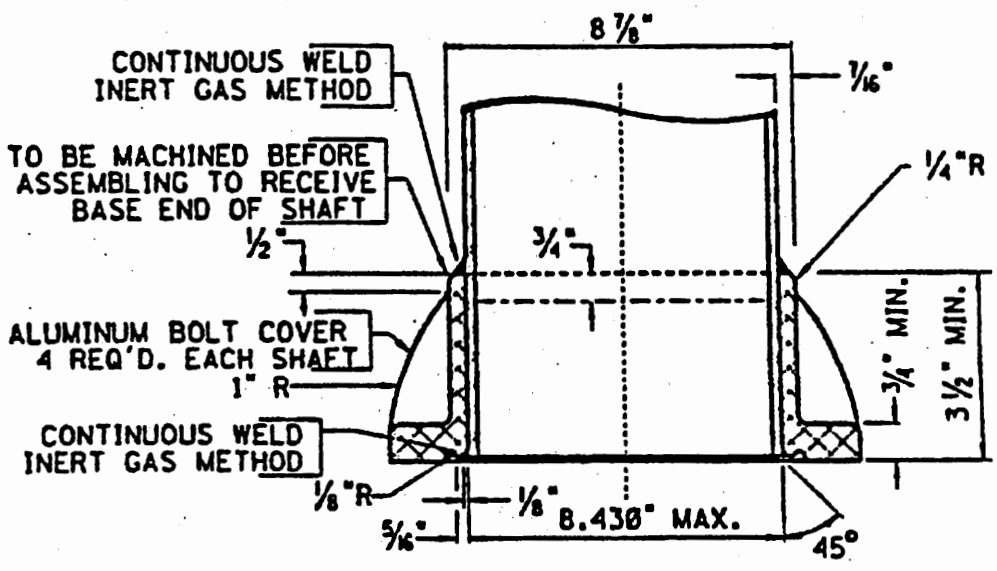
Figure 1-3 Shoe Base to Pole Connection.

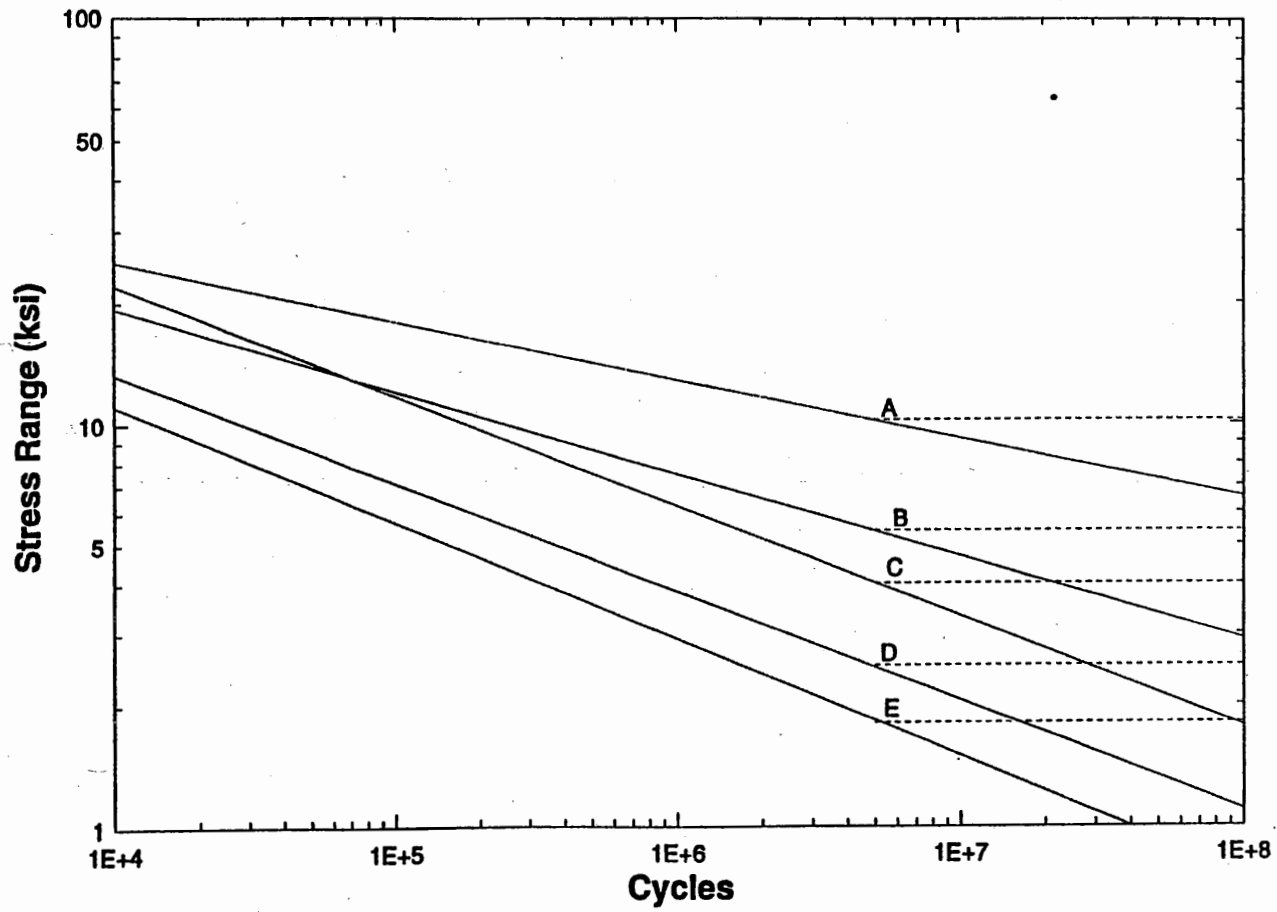
Figure 2-13 shows the constant amplitude fatigue limits (CAFL) of aluminum for each category as horizontal dashed lines. When constant amplitude tests are performed at stress ranges below the CAFL, noticeable cracking does not occur. Luminaire support structures experience what is known as long-life variable-amplitude loading, i.e. very large numbers of random amplitude cycles greater than the number of cycles associated with the CAFL. In this case, the fatigue design consists of making sure that the upper bound stress range, as defined by the recommended fatigue design load ranges, is less than the CAFL. If this is true, then the fatigue life should be essentially infinite.

Figure 2-13 S-N Curves for Aluminum.

Fatigue tests are performed at a number of different stress ranges and the data are generally plotted with the logarithm of the nominal stress range on the ordinate and the logarithm of the number of cycles to failure on the abscissa (even though the number of cycles is the dependent variable). The relationship used to represent the lower bound to aluminum detail test data is referred to as an S-N curve (Figure 2-13). An S-N curve is an exponential equation of the form:

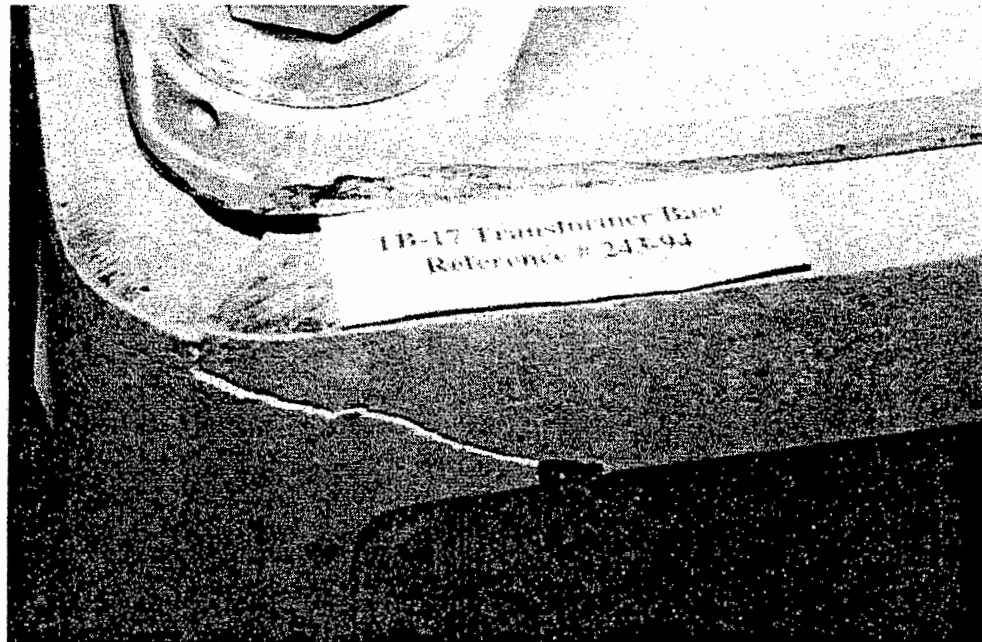
The videotape was a valuable tool in examining the failures. Many of the cracks in the transformer bases occurred at the top where the shoe base bolted on (Figure 3-2). This may have been partly due to an error at the time the support standards were erected. Figure 3-3 describes the proper hardware, as specified by the manufacturer, to install the transformer bases. In many cases the heavy half-inch thick galvanized steel washer that helps to stiffen the transformer base around the long-slotted bolt holes were not installed. According to Hapco this leads to approximately a 50% reduction in the strength of the transformer base.

Figure 3-2 Cracked Transformer Base where Shoe Base Bolts on.

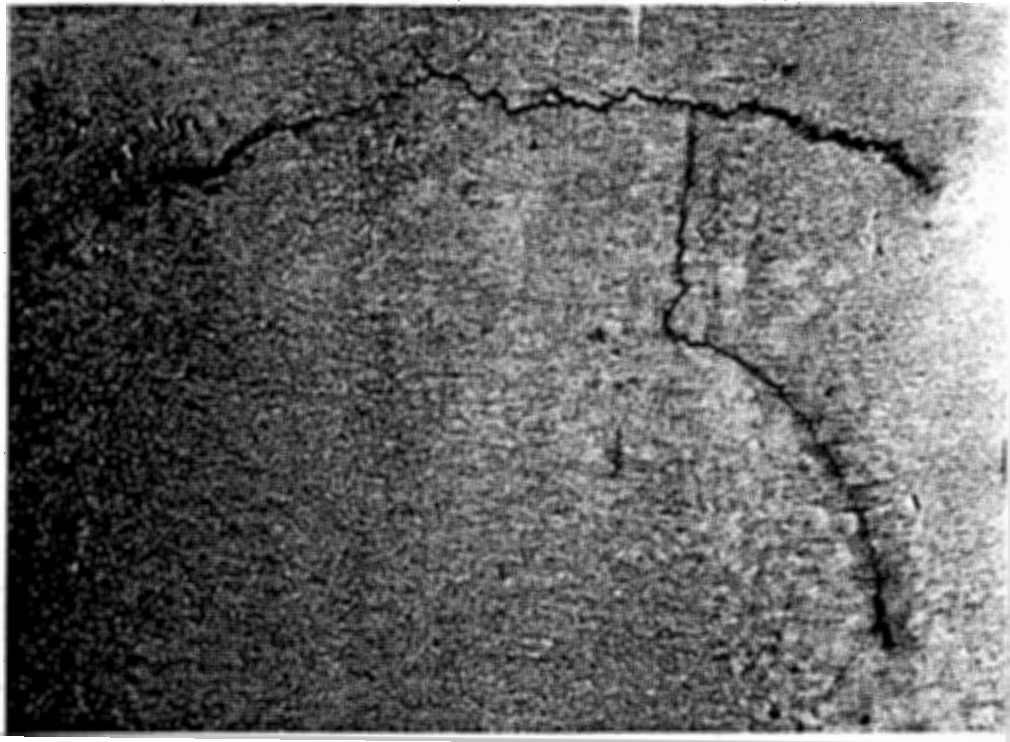
Specimen S-6 developed cracks in two places. The first crack started to form in the side of the transformer base wall opposite the access hole (Figure 3-14). After the test this crack was cut out and a definite change in thickness was noticed in the transformer base wall (Figure 3-15). The thinner wall was caused by excess grinding on the side of this transformer base. There may have also been an attempt at a weld repair in the base metal of this transformer base. Apparently there was a surface defect in this base. Instead of discarding it a repair was attempted and this was the origin of the first fatigue crack. The second crack in this base originated at the back of the finger tabs that are used to bolt the structure to its foundation (Figure 3-16). This crack appeared to originate out of the radius at the back of the finger tabs.

Figure 3-14 Fatigue Crack in Wall of Transformer Base of Specimen S-6

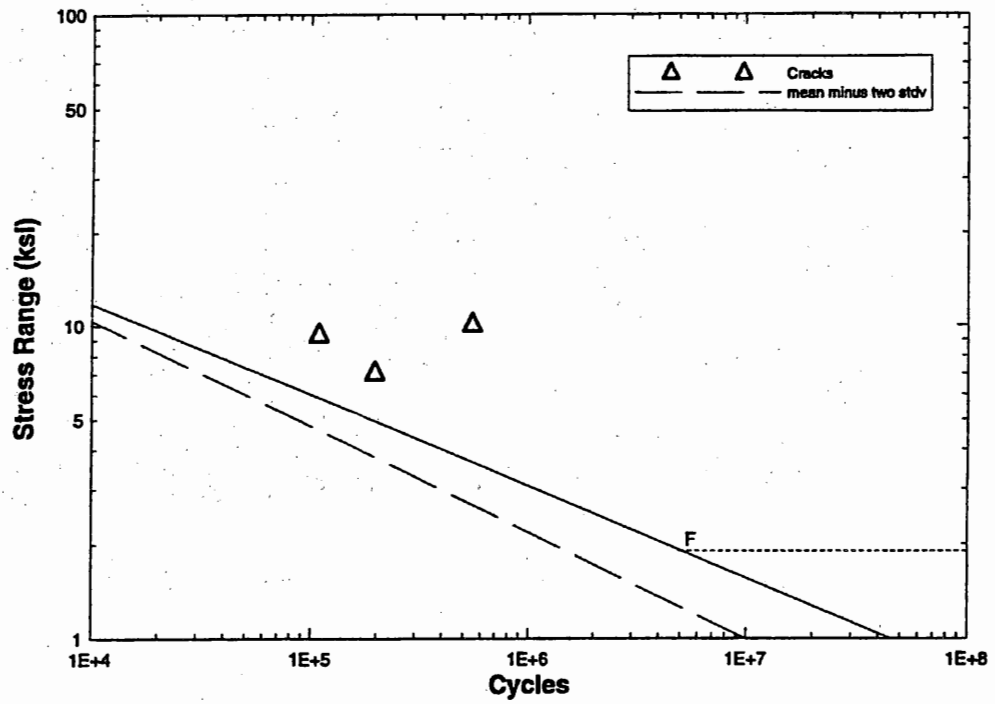
Figure 3-23 shows an S-N plot of the shear-induced cracks compared to category F. As can be seen in this figure when the cracks are shear induced the detail has a fatigue strength below Category F.

Figure 3-23 S-N Curve for Shear Stress Range Induced Cracks
