FATIGUE PERFORMANCE OF VARIABLE MESSAGE SIGN & LUMINAIRE SUPPORT STRUCTURES

Volume I – Fatigue Related Wind Loads on Highway
Support Structures

FINAL REPORT
April 1998

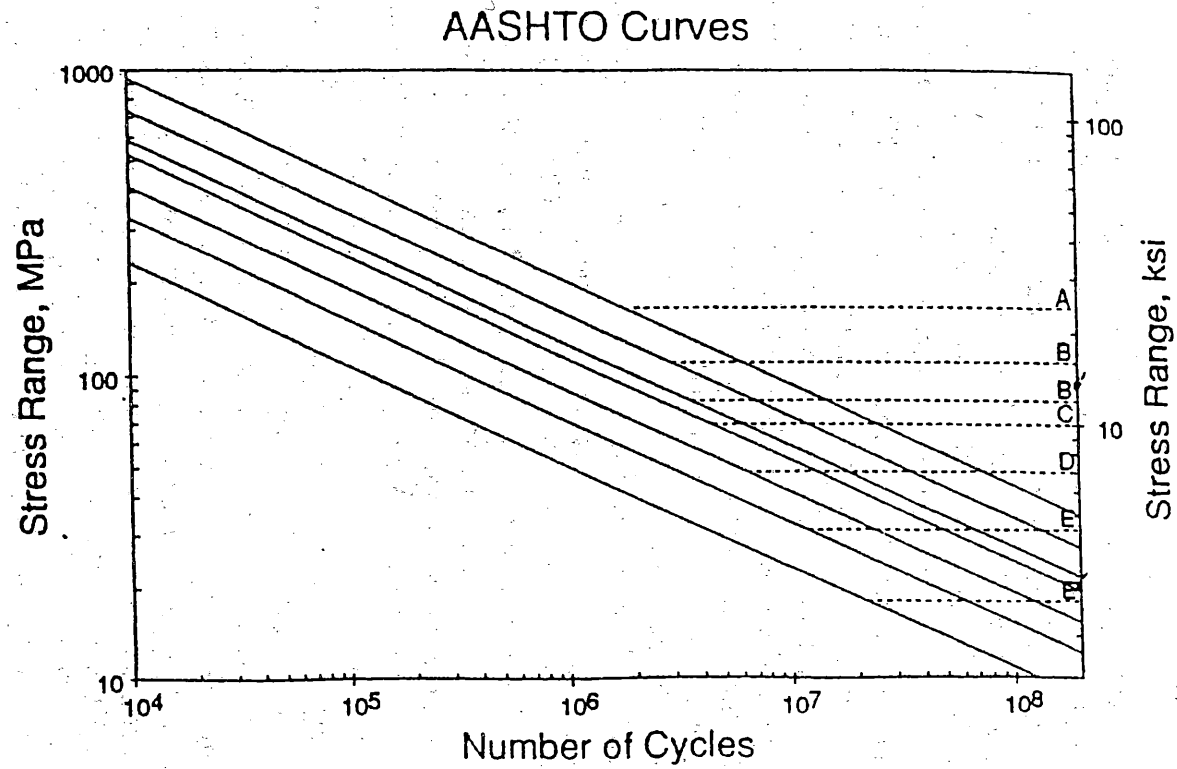
Figure 2-4 AASHTO S-N Curves for Steel.

Figure 2-4 shows the constant amplitude fatigue limits (CAFL) for each category as horizontal dashed lines. When constant amplitude tests are performed at stress ranges below the CAFL, noticeable cracking does not occur. Sign support structures experience what is known as long-life variable-amplitude loading, i.e. very large numbers of random amplitude cycles greater than the number of cycles associated with the CAFL. In this case, the fatigue design consists of making sure that the upper bound stress range, as defined by the recommended fatigue design load ranges, is less than the CAFL. If this is true, then the fatigue life should be essentially infinite.

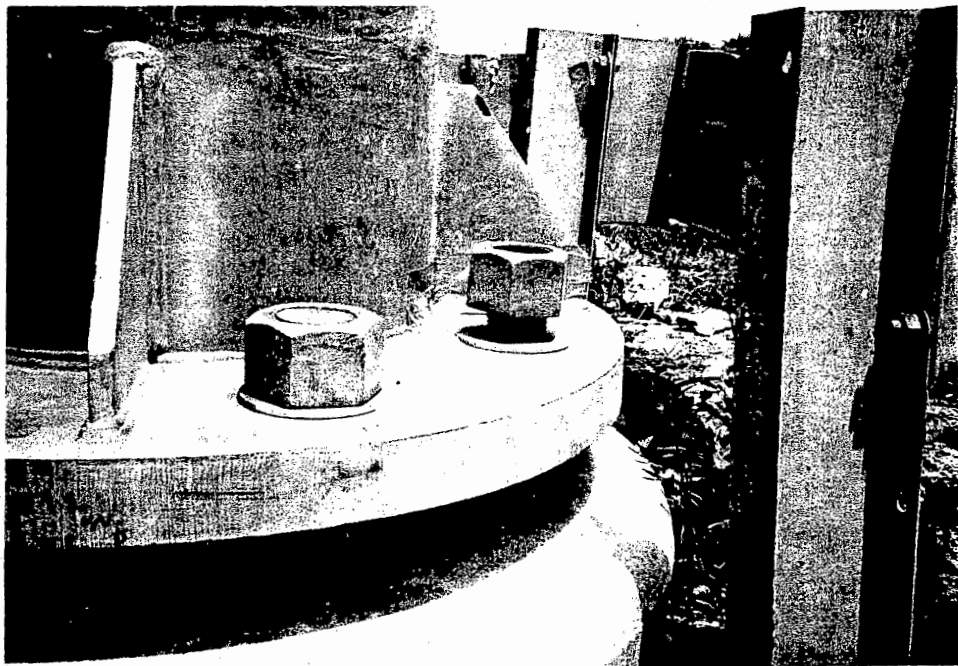
Figure 3-6 Top Nut Loosened by Hand after being Tightened.

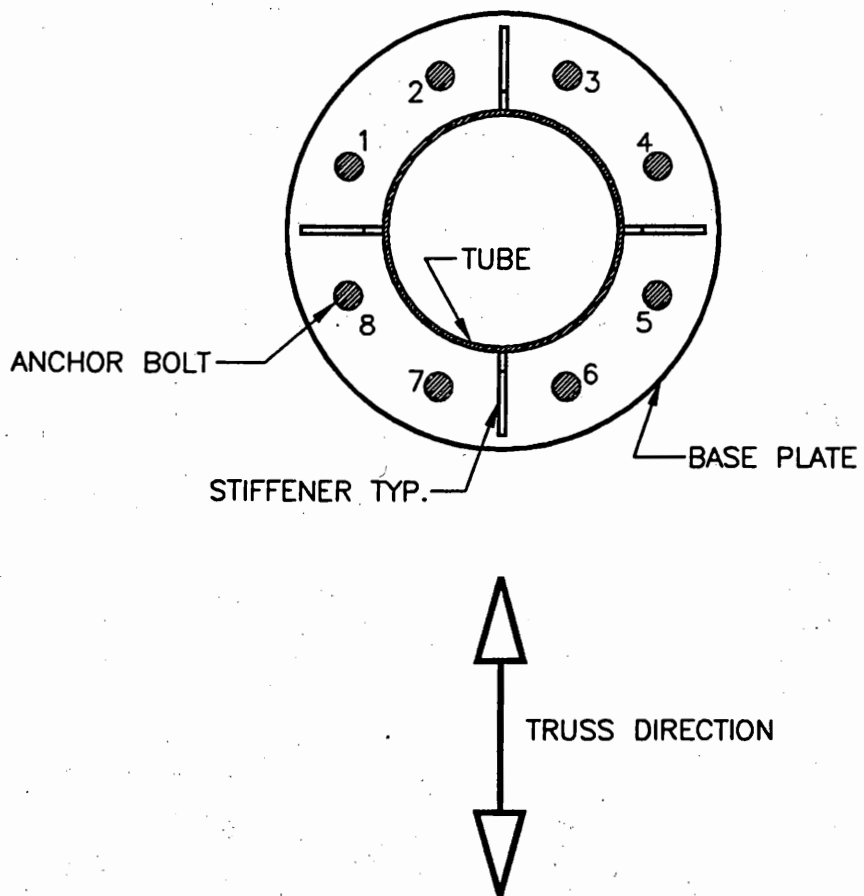
Figure 3-9 Anchor Bolt Numbering Scheme.

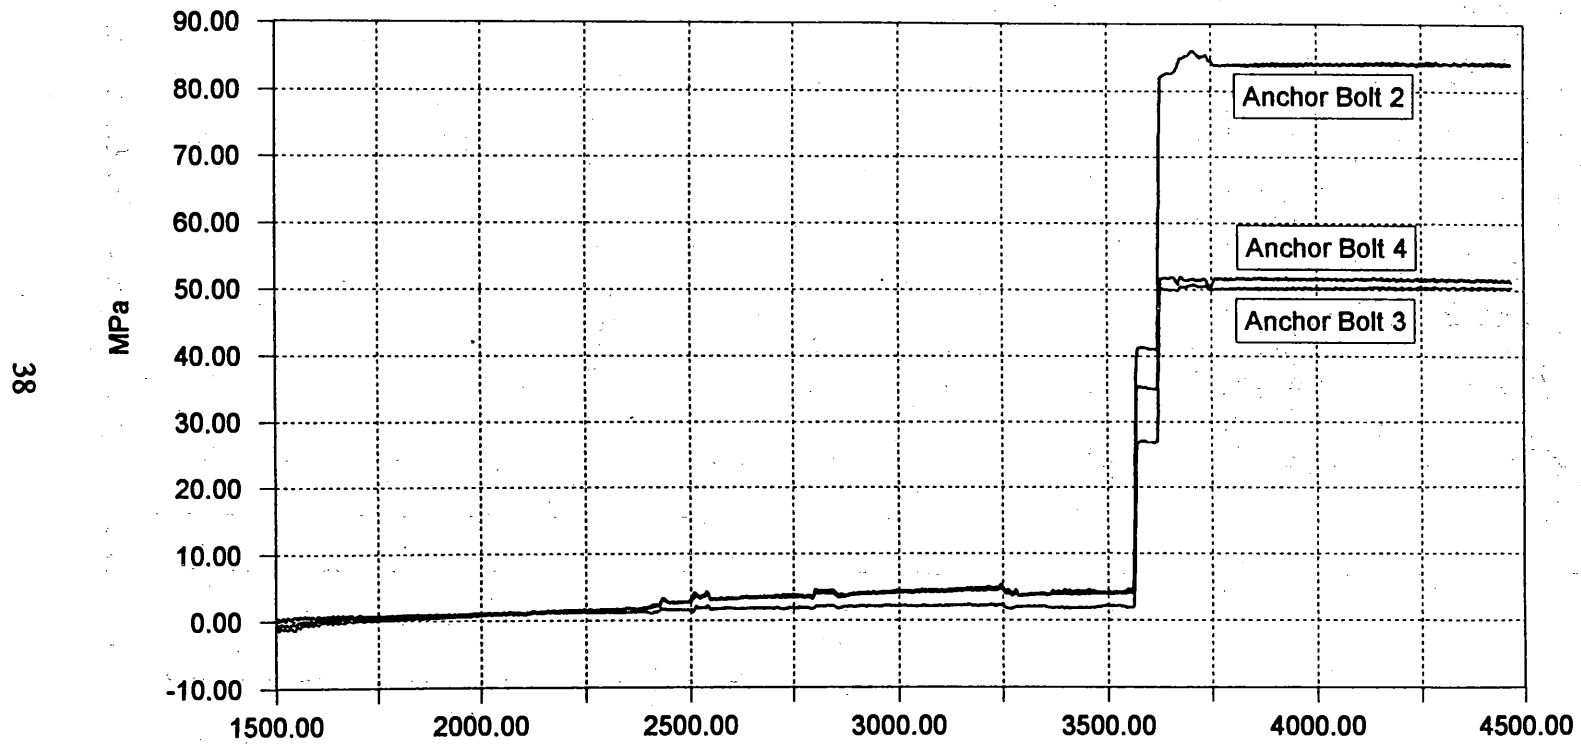
Dead Load Axial Stress in Anchor Bolts from Weight of Truss and VMS Box

Figure 3-10 Axial Dead Load Stress in Anchor Bolts.

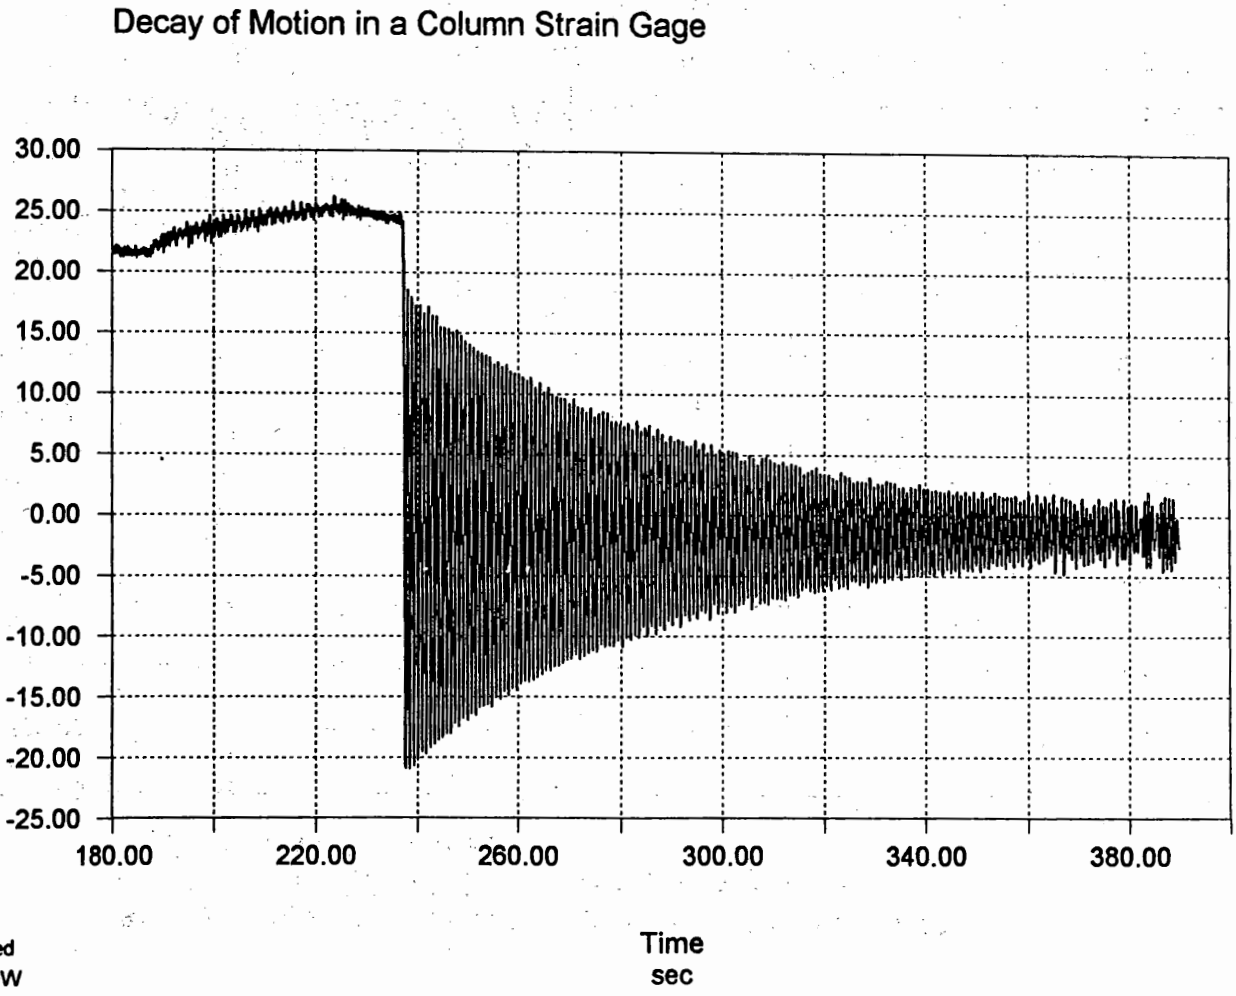
Figure 3-20 Damping of Motion in a Column Strain Gage.

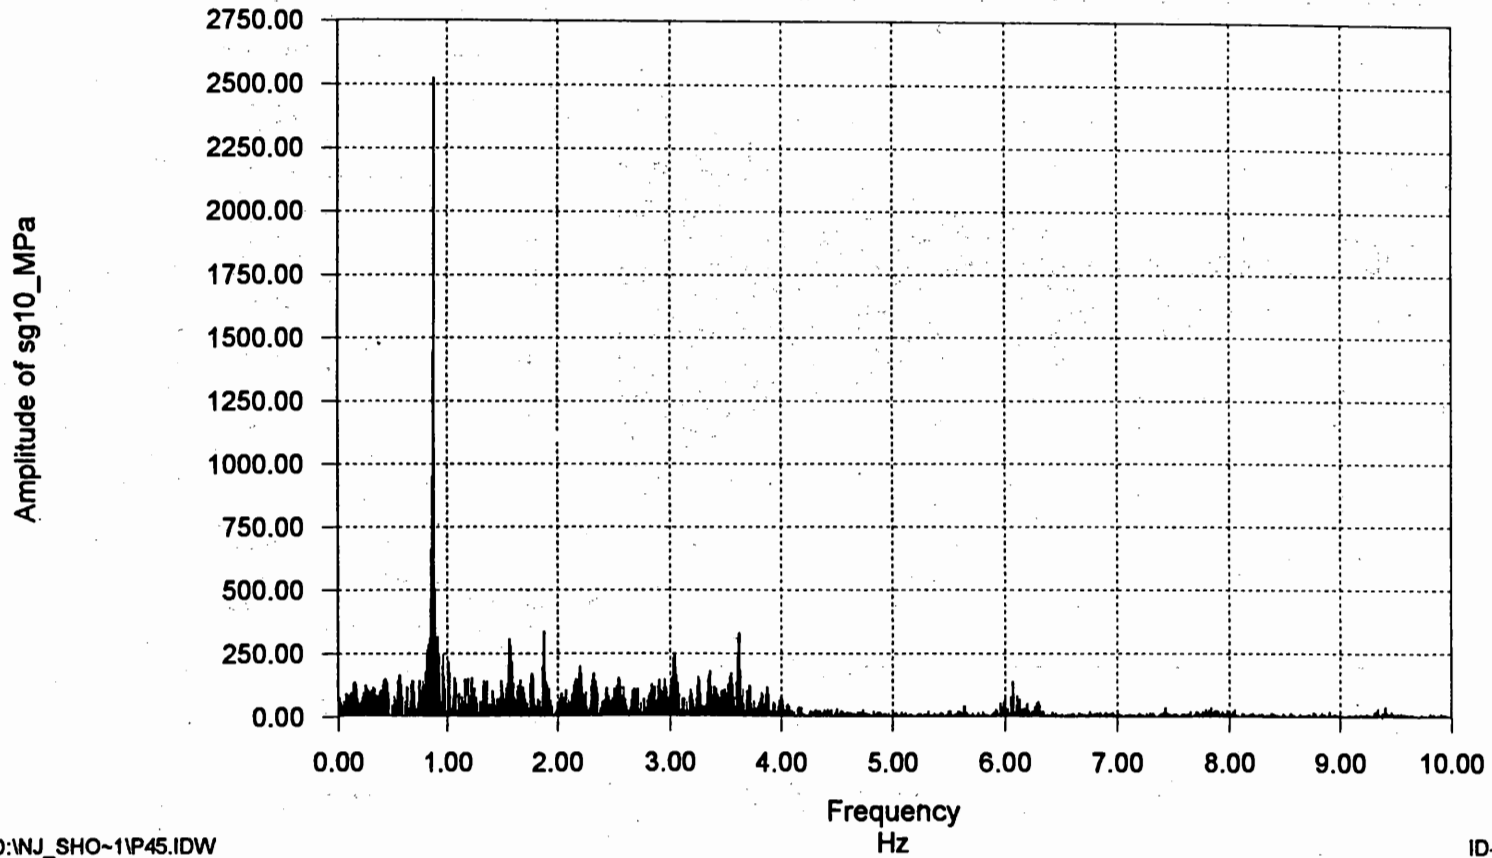
Amplitude Spectrum of sg10_MPa Time: 211.95 to 314.40
FFT Size: 2048 FFT Window Type: Rectangle/None
Peak of 2524.09 at 0.87 Hz.

Figure 3-21 FFT Indicating Natural Frequency in the "Twisting Mode".

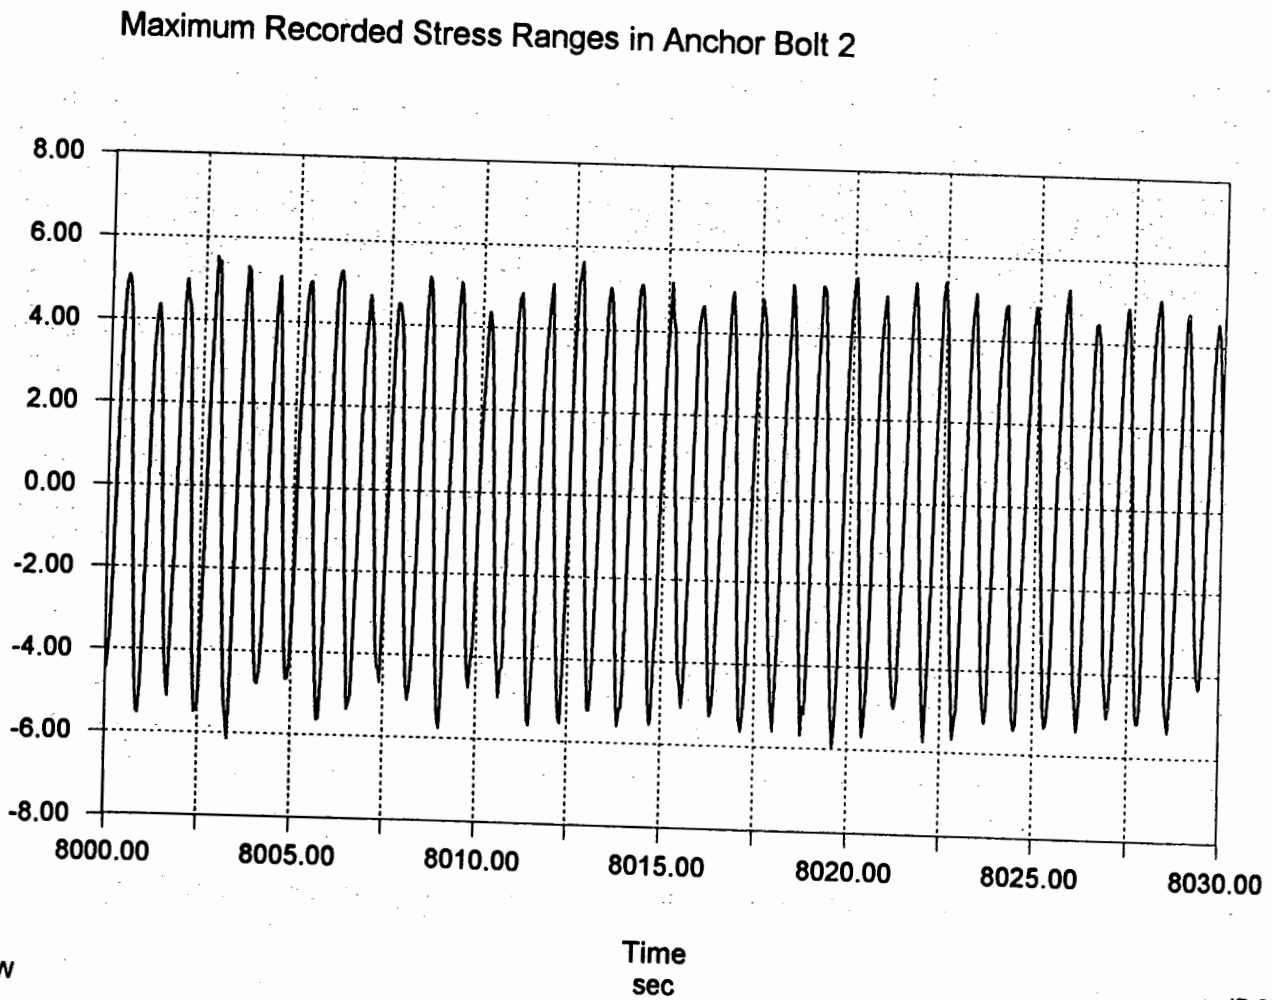
Figure 3-43 Maximum Recorded Axial Stress Ranges in Anchor Bolts.
