Implementation of Weigh-in-Motion (WIM) Systems

FINAL REPORT

February 2009

1. Report No. FHWA-NJ-2009-001	2. Government Accession No.	3. Recipient's Catalog No.	
4. Title and Subtitle Implementation of Weigh-in-motion (WIM) Systems		5. Report Date February 2009

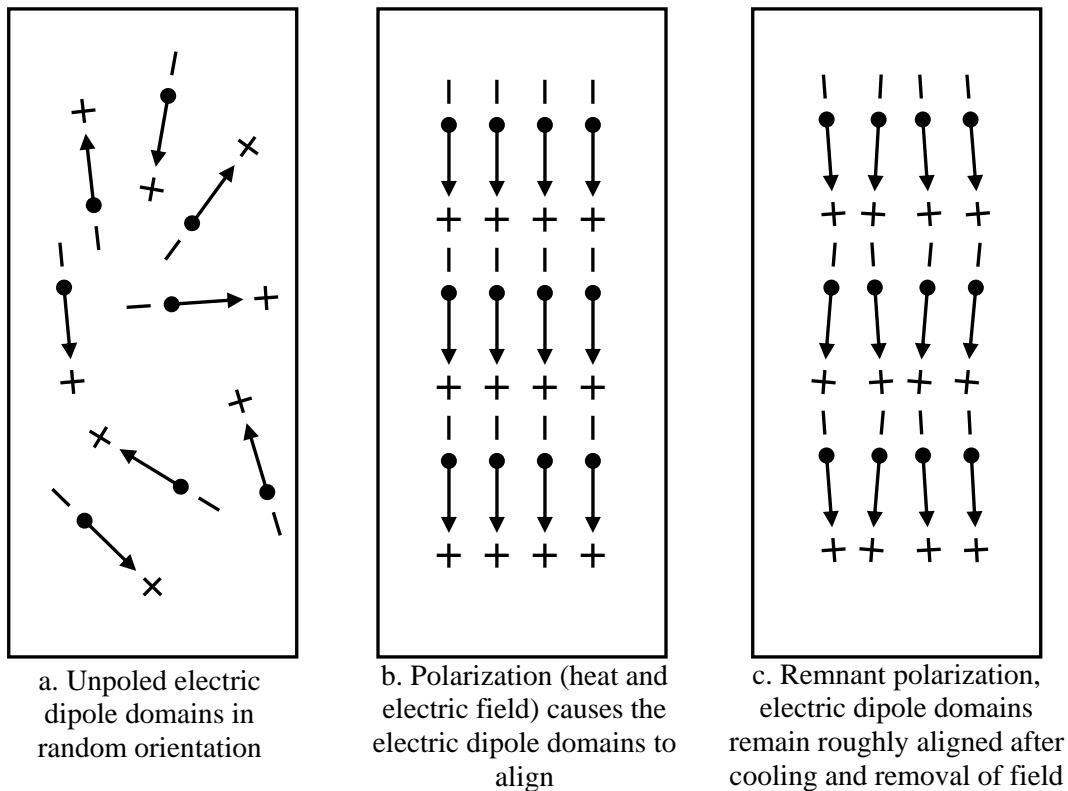
Figure 1 Diagram detailing the poling process and remnant polarization.

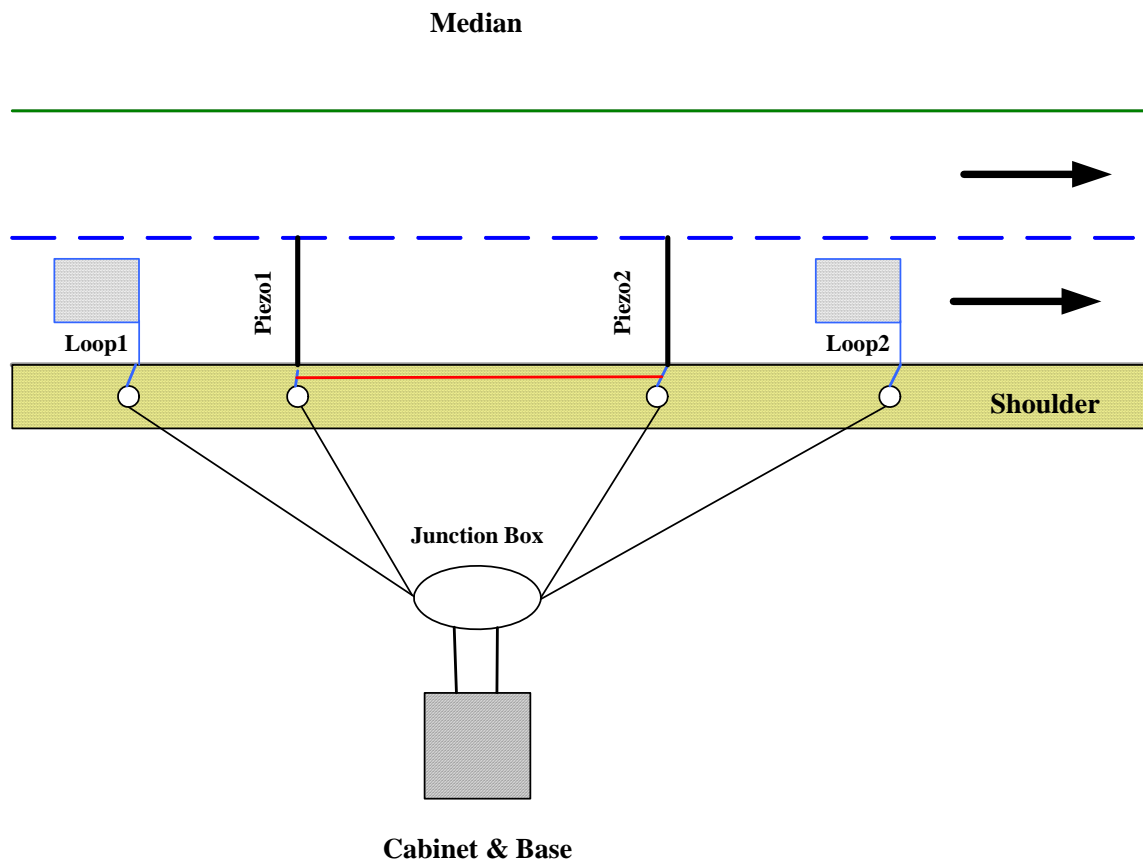
For the purposes of this effort, only Piezoelectric sensors; Ceramic, Polymer, and Quartz have any direct bearing on the research work performed. Therefore, a brief description of each technology is included in the following section. Site installations for either of the three are basically the same, and can consist of two piezoelectric sensors, two sensors plus an inductance loop (as it appears in Figure 3), or one piezoelectric sensor and two inductance loops.

Figure 3 Example of a typical piezoelectric WIM system layout

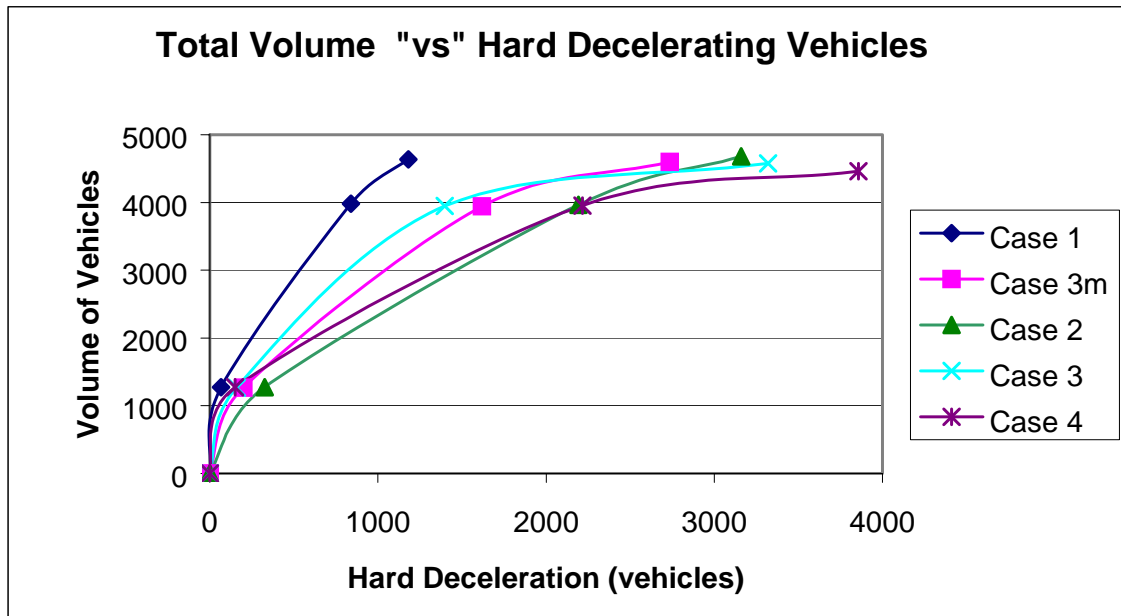
representation of all cars which decelerated at a rate greater than 0.3g and trucks greater than 0.2g during the simulation. Thus, the hard decelerations or hard braking was a very important factor to consider when evaluating a weigh stations' feasibility. In the simulations, it was found that even without a weigh station there were a number of vehicles hard decelerating at higher traffic volumes. For example, at a volume of 4600 vehicles per 2 hour period, the percentage of vehicles hard braking was approximately 25%.

Figure 6 Chart detailing the cars which decelerated at a rate greater than 0.3g and trucks greater than 0.2g for each weigh station configuration.

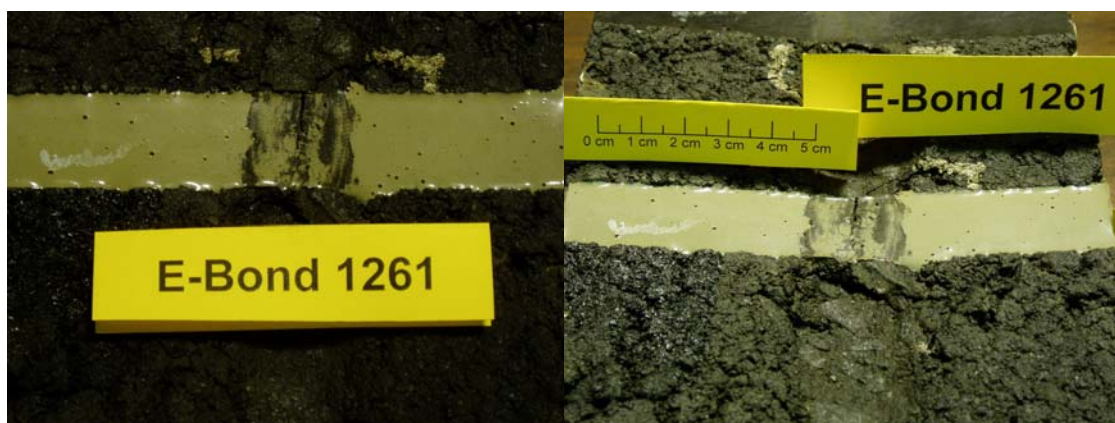
Figure 14 Photograph of APA Test rutting results of E-Bond 1261.

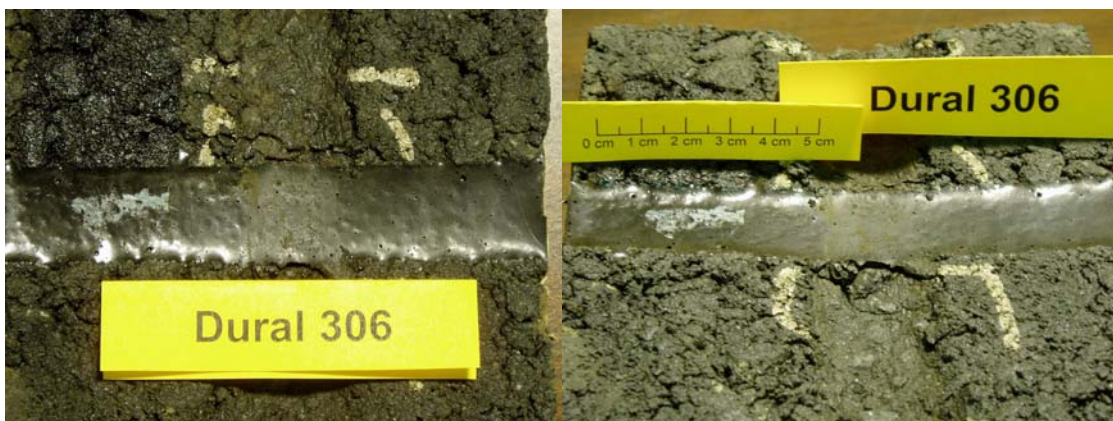
Figure 15 Photograph of APA Test rutting results of Dural 306.

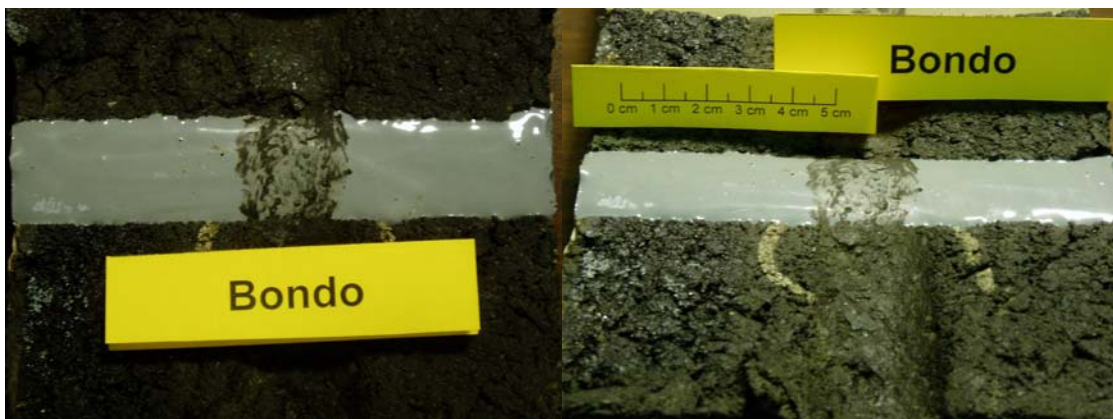
Product:	BONDO 7084
Properties	
Pot Life	17-25 minutes
Initial Cure	45 minutes
Traffic Ready	1 hour
Final Cure	1 hour
Viscosity	Unknown
Compressive Strength	Unknown
Tensile Strength	17.2 MPa (2500 psi)
Adhesive/Bond/Shear Strength	13.8 MPa (2000 psi)
Mixing Ratio	1:1 by volume
Flash Point	Not Available, assume >93°C (>200°F)
Other Observations	Bondo 7084 is very thick and extremely difficult to work with , rigidity may cause issues if the road ruts, however there was no delamination in APA tests.
Measured Delamination from 20,000 Cycle APA Test	0 mm (0in)
	0.69 mm (0.027 in)
Type of Delamination	None / Asphalt Cracking

Figure 17 Photograph of APA Test rutting results of Bondo 7084.

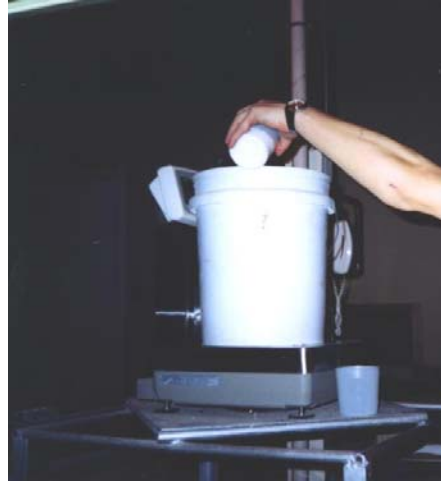
Figure 20 Addition of salt to form brine solution to ensure test would be performed under worst case environmental effects.

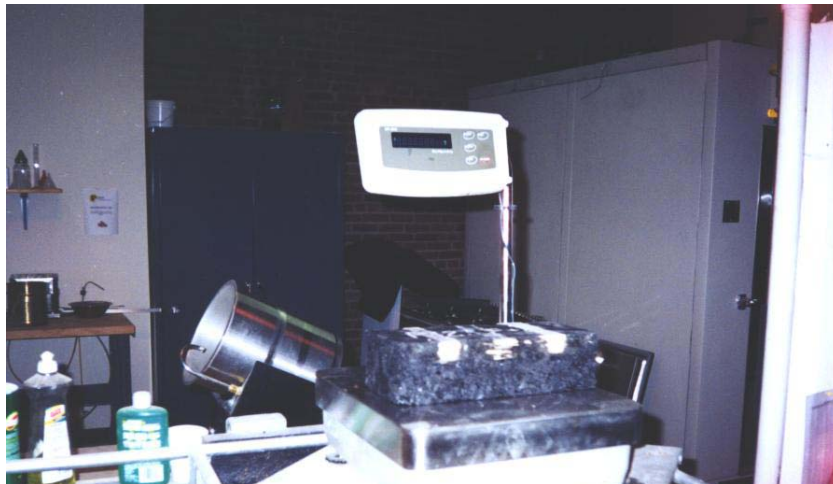
The saturated surface-dry mass of each sample was determined and is shown in Figure 21. Each brick was then subjected to vacuum conditioning for 15 minutes. The vacuum was then removed and the samples were allowed to sit in the solution for another 5 minutes. The samples were then removed from the vacuum container and the saturated surface-dry mass was re-measured and compared to the original measurement. The saturation for two HMA bricks was 62% and for the HMA third brick it was 66%. Therefore, within an acceptable tolerance of 55-80% according to T-283, all the samples had roughly the sample level of saturation and the testing was continued.²⁹

Figure 21 Weighing of samples to determine saturated surface dry (SSD) weight.

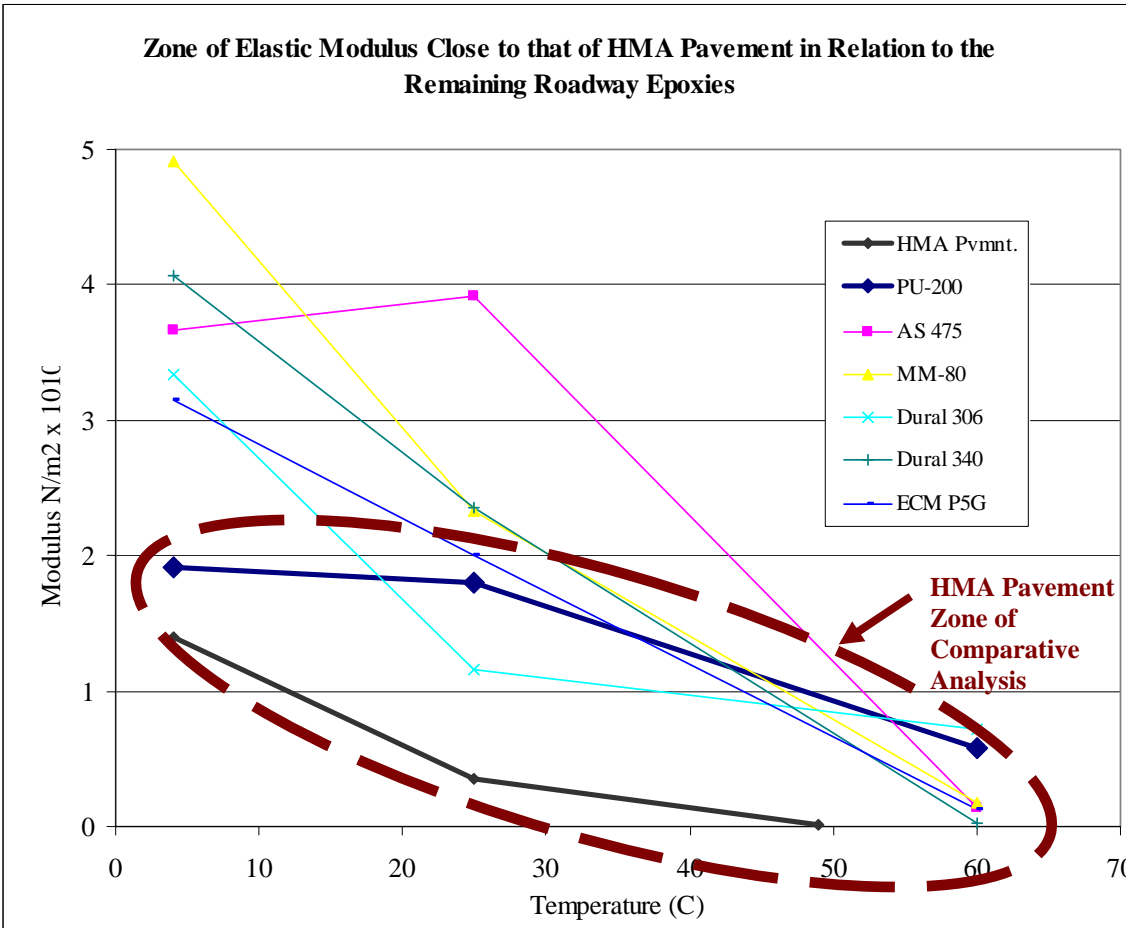
The above materials were eliminated from Figure 25 and plotted along with HMA modulus in Figure 26. HMA has a typical range of 14,000 MPa (2,000,000 psi) at 0°C (32°F); 3,500 MPa (500,000 psi) at 21°C (70°F); and 150 MPa (20,000 psi) at 49°C (120°F).³¹ Ideally, the roadway epoxy properties should match that of the HMA pavement, however based on the testing data all the epoxies have higher modulus than HMA at all temperatures. At higher temperatures all the six remaining epoxies fall within the HMA comparative zone of elastic modulus. However at 25°C (77°F) only the PU-200 and the Dural 306 fall within this zone; whereas at 4°C (40°F) only PU-200 remains within this HMA comparative zone of Elastic Modulus.

Figure 26 Zone of Elastic Modulus close to that of HMA pavement in relation to the remaining roadway epoxies

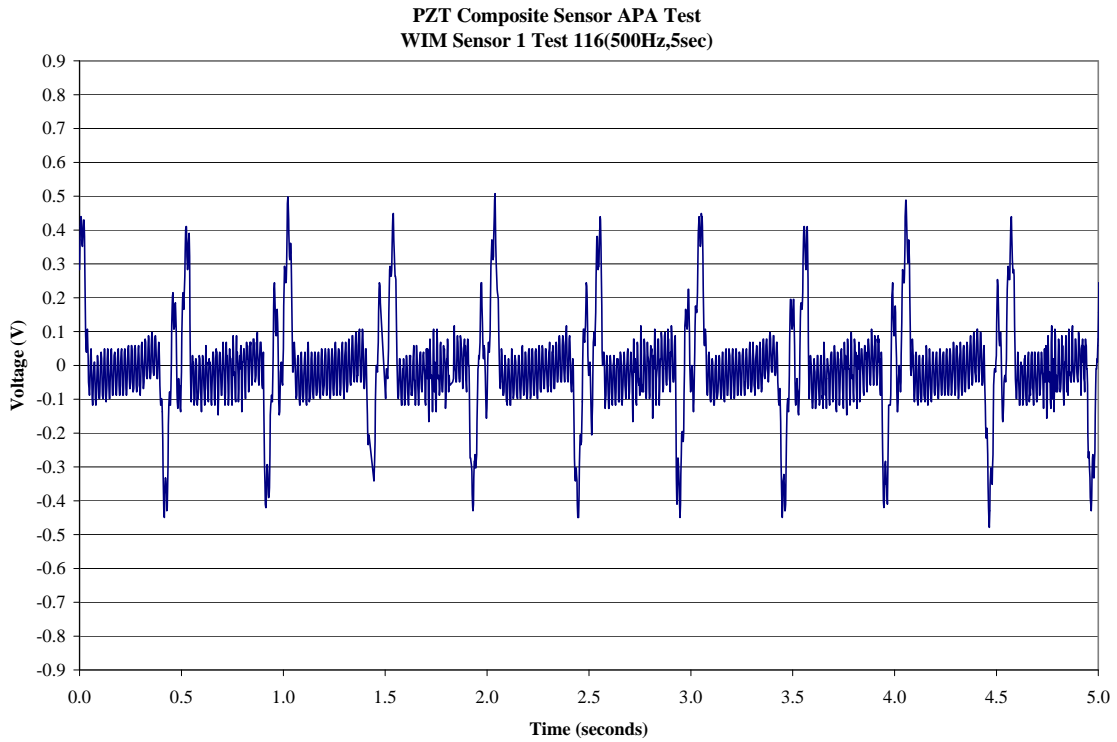
Figure 28 APA testing of fourth prototype sensor, sensor assembly one (WIM1).

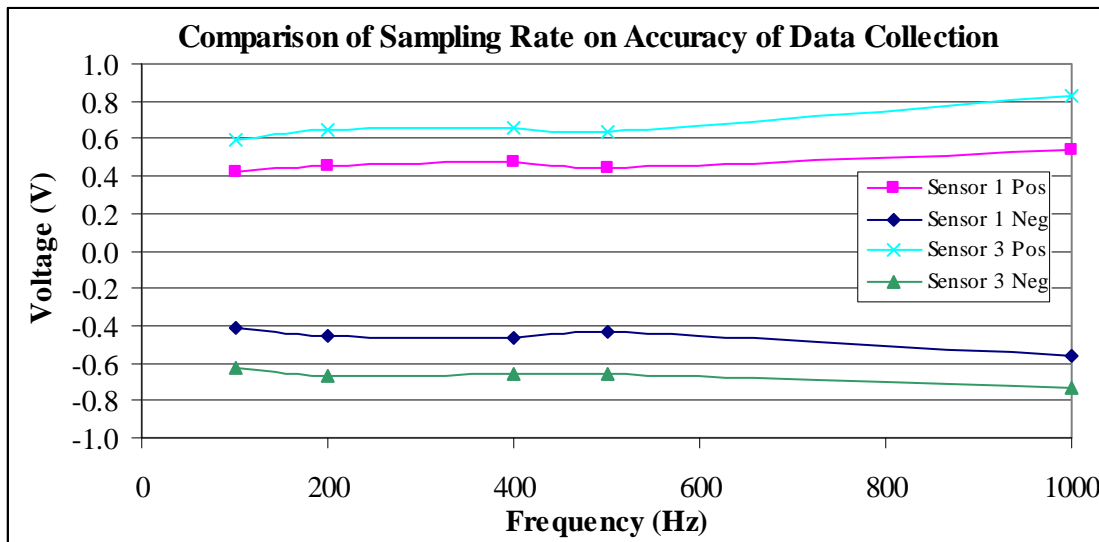
Figure 30 Comparison of sampling rate on the voltage output.

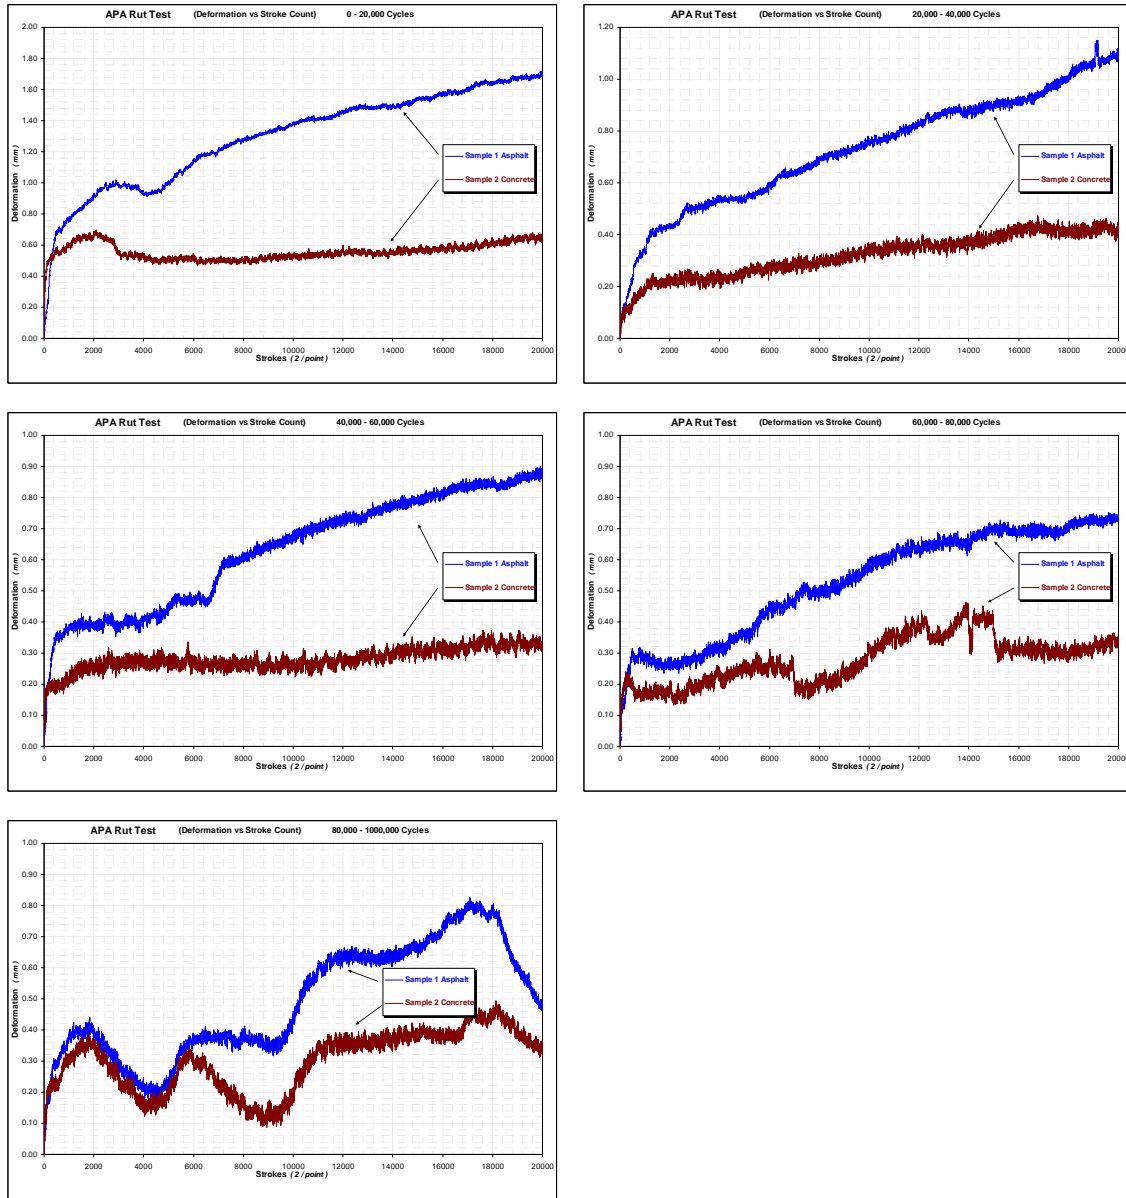
Figure 32 Graphs of the raw results of the five (5) APA load wheel tests.

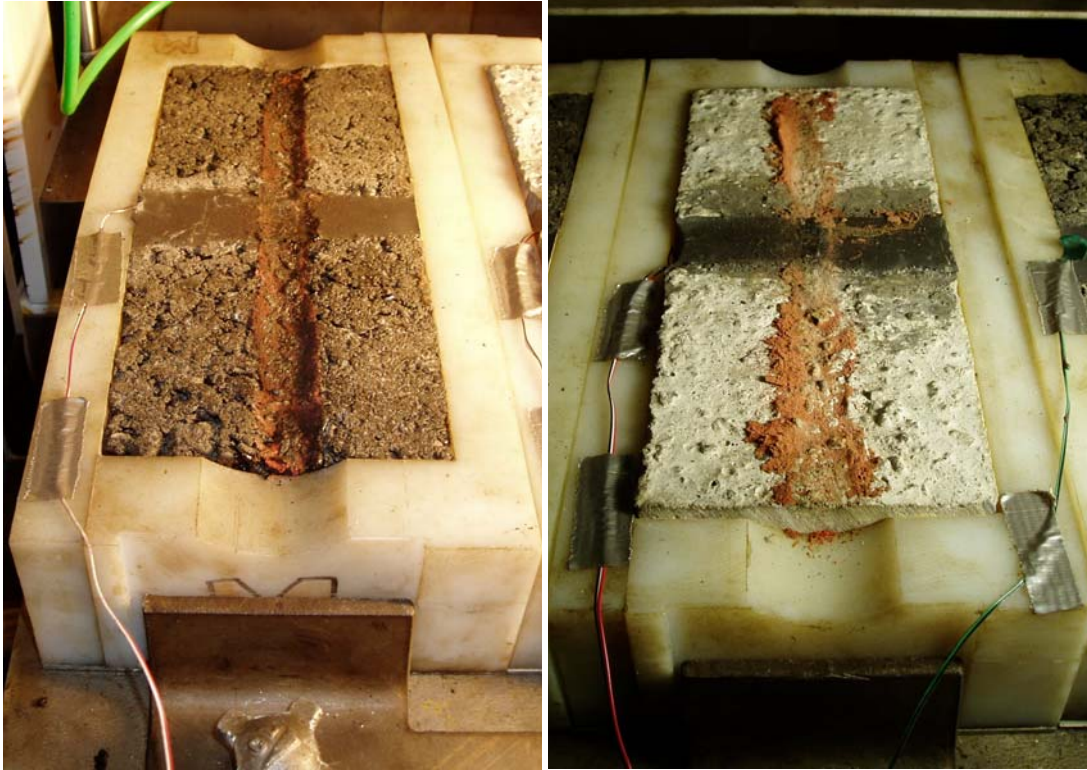
Figure 33 Photograph of rutting effects on the asphalt pavement (left) and concrete pavement (right) samples.

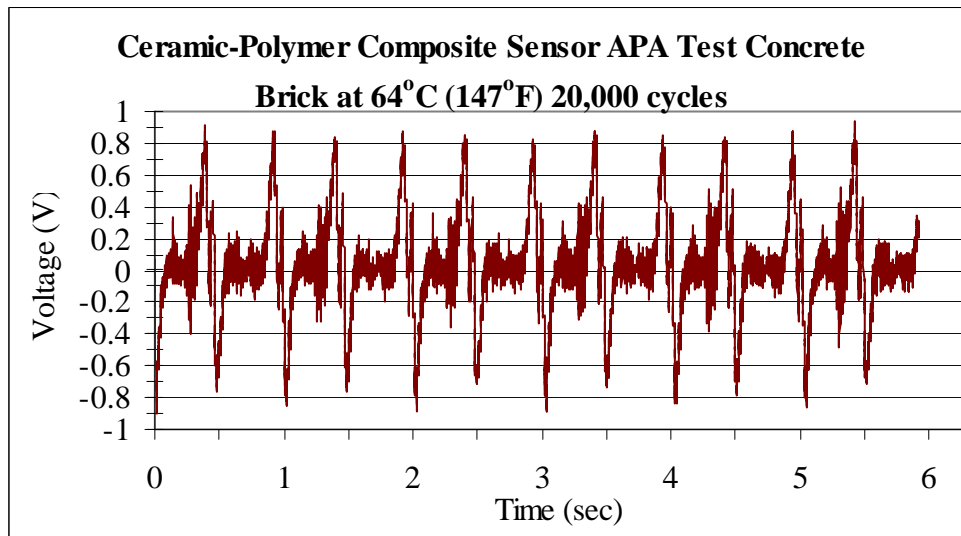
Figure 41 Voltage outputs of sensor embedded in concrete pavement at 20,000 cycles.

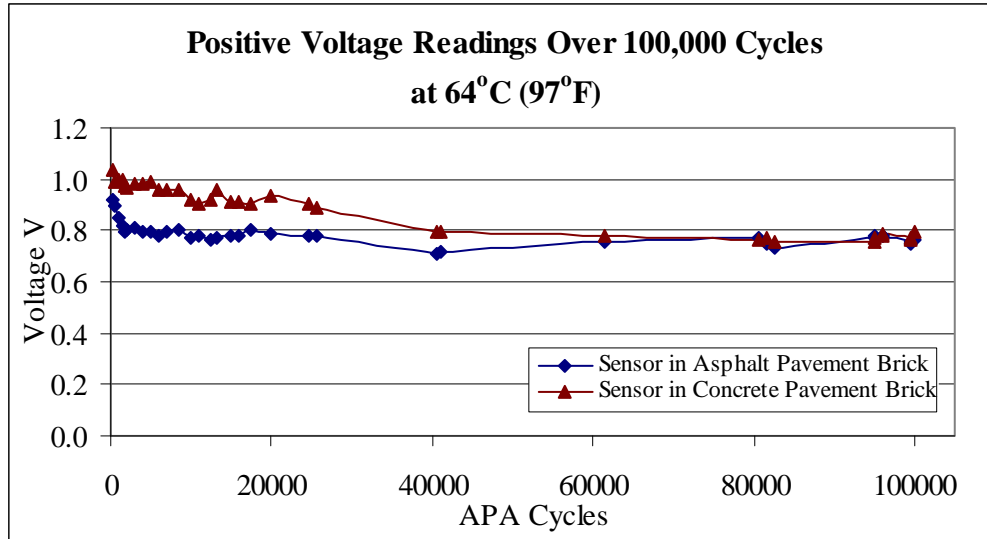
Figure 44 Graphs of maximum positive and minimum negative voltage outputs of asphalt and concrete samples over 100000 cycles.

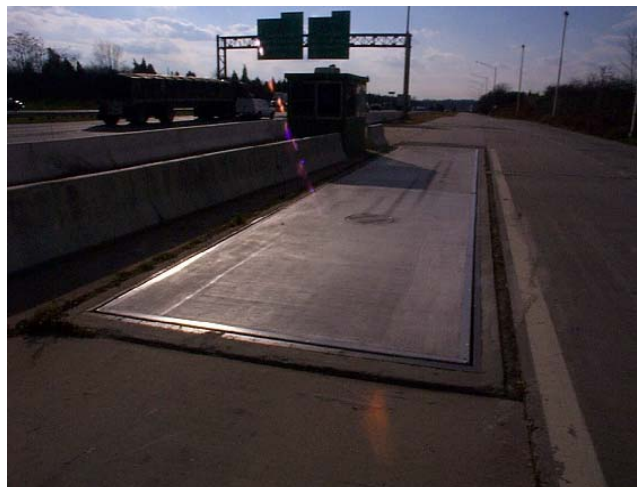
Figure 49 Route 287 weigh station static scale.

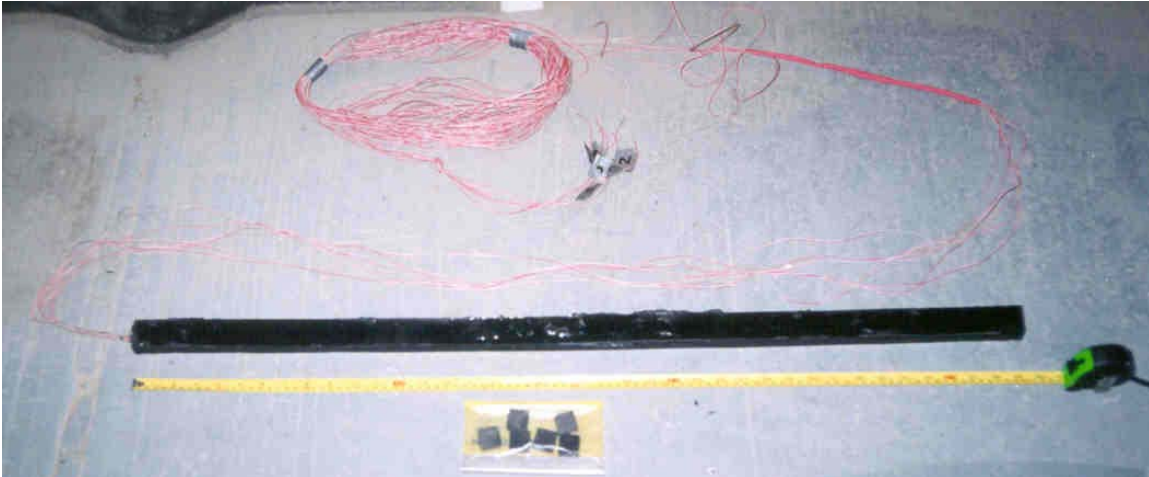
Figure 56 Photograph of ceramic-polymer composite sensor assembly and chairs laid-out in the laboratory.

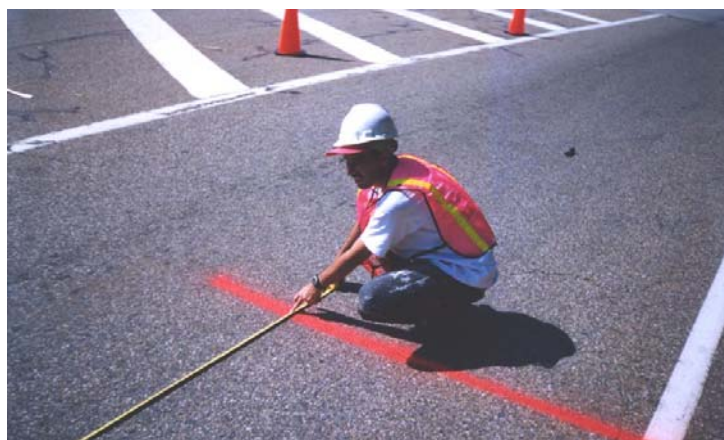
Figure 57 Photograph of the site layout for the installation of the sensors.

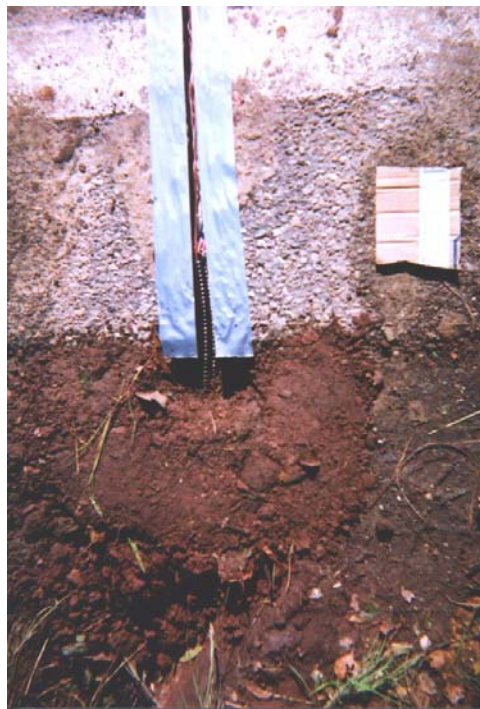
Figure 60 Photograph of the groove with the wires and plastic conduit ready for epoxy infiltration.

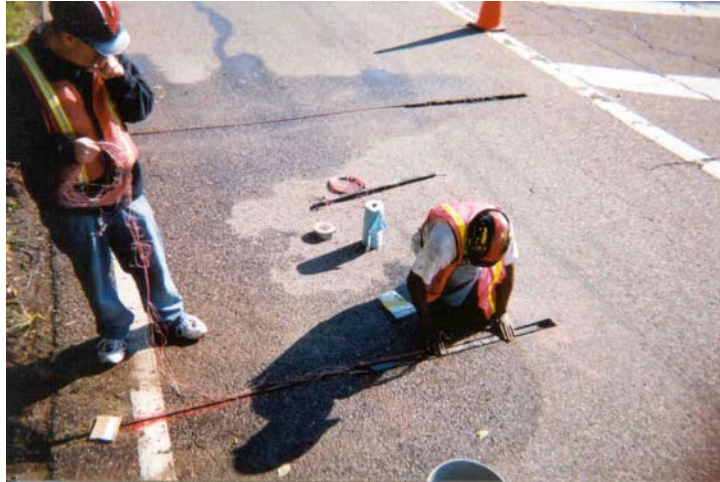
Figure 61 Photograph of ceramic-polymer composite sensor assembly being placed in groove at the Route 287 weigh station.

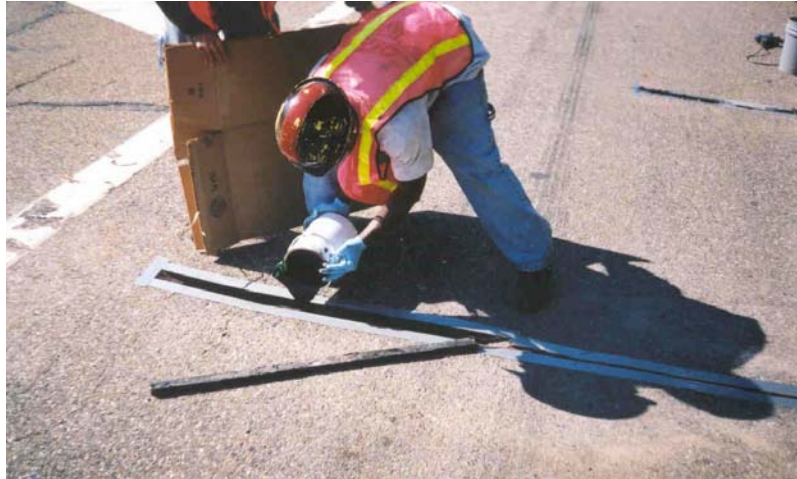
Figure 62 Photograph of PU-200 epoxy being placed in the bottom of the groove prior to final placement of the sensor assembly.

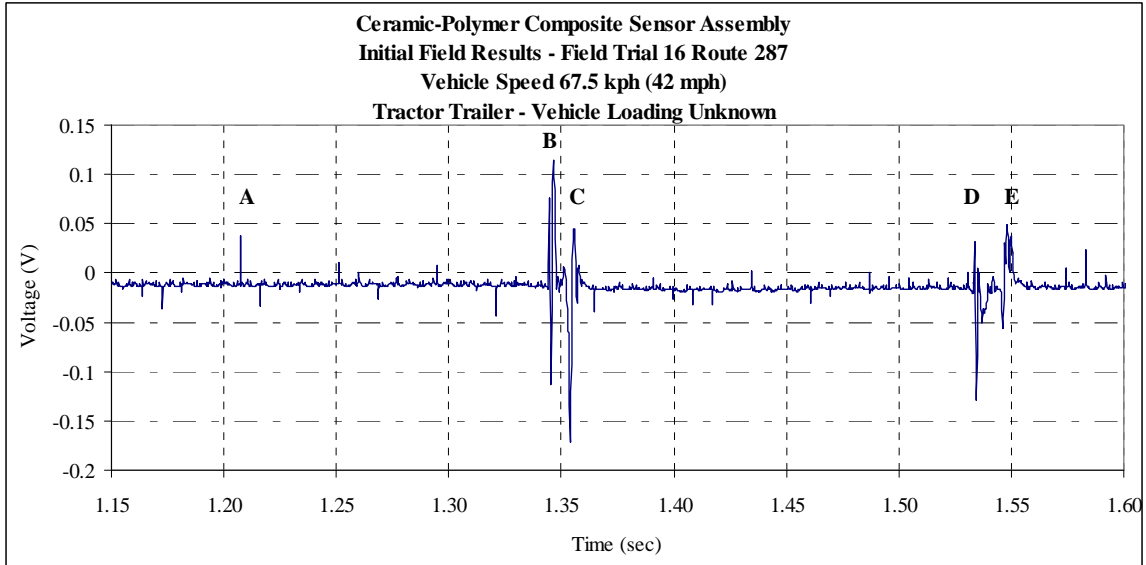
Figure 72 Ceramic-polymer composite sensor assembly field trial Rt. 287 results of tractor trailer loading, after winter season at 67.5 kph (42 mph).

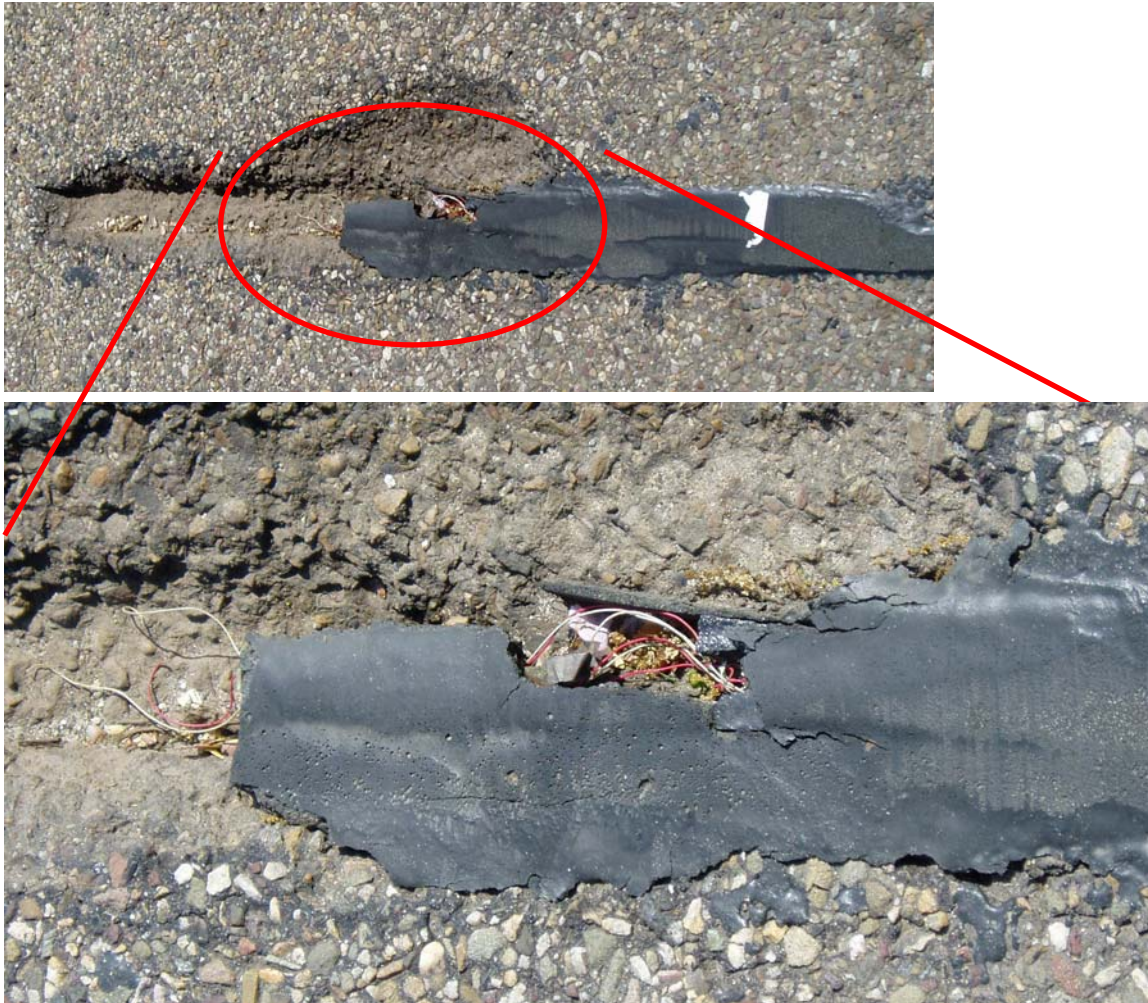
Figure 77 Close-up examination of failed outside of lane sensor assembly.
