# Evaluation of Corrosion Inhibitors

FINAL REPORT  
October 1999

Submitted by  
Dr. P. Balaguru  
Professor

Center for Advanced Infrastructure & Transportation (CAIT)  
Civil & Environmental Engineering  
Rutgers, The State University  
Piscataway, NJ 08854-8014

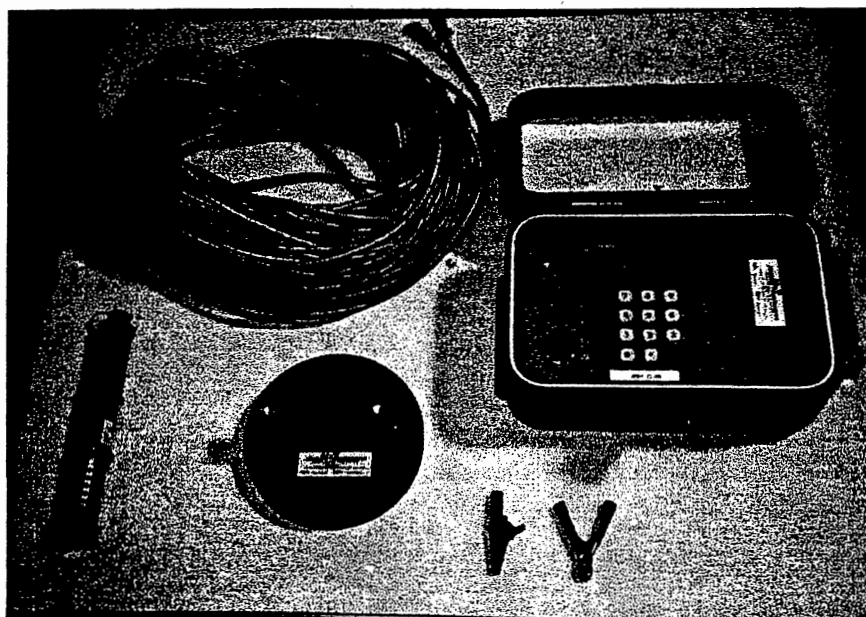
Fig. 3.1: Components of the GECOR 6 Corrosion Rate Meter

The GECOR 6 Corrosion Rate Meter has three major components, the rate meter and two separate sensors. Only the larger sensor was used during this project. The sensor is filled with a saturated  $\text{Cu}/\text{CuSO}_4$  solution for the test for half cell potential. The main components of this device can be seen in Fig. 3.1. A wet sponge is used between the probe and the concrete surface as seen in Fig. 3.2. Long lengths of wire are also provided to connect the sensor to the rate meter and to connect the rate meter to the reinforcing bar mat of the bridge deck, a necessary step for the operation of the meter.
