PAVEMENT HEATING, 1969-1975,
FINAL REPORT

Division of Research and Development
New Jersey Department of Transportation

February 1977

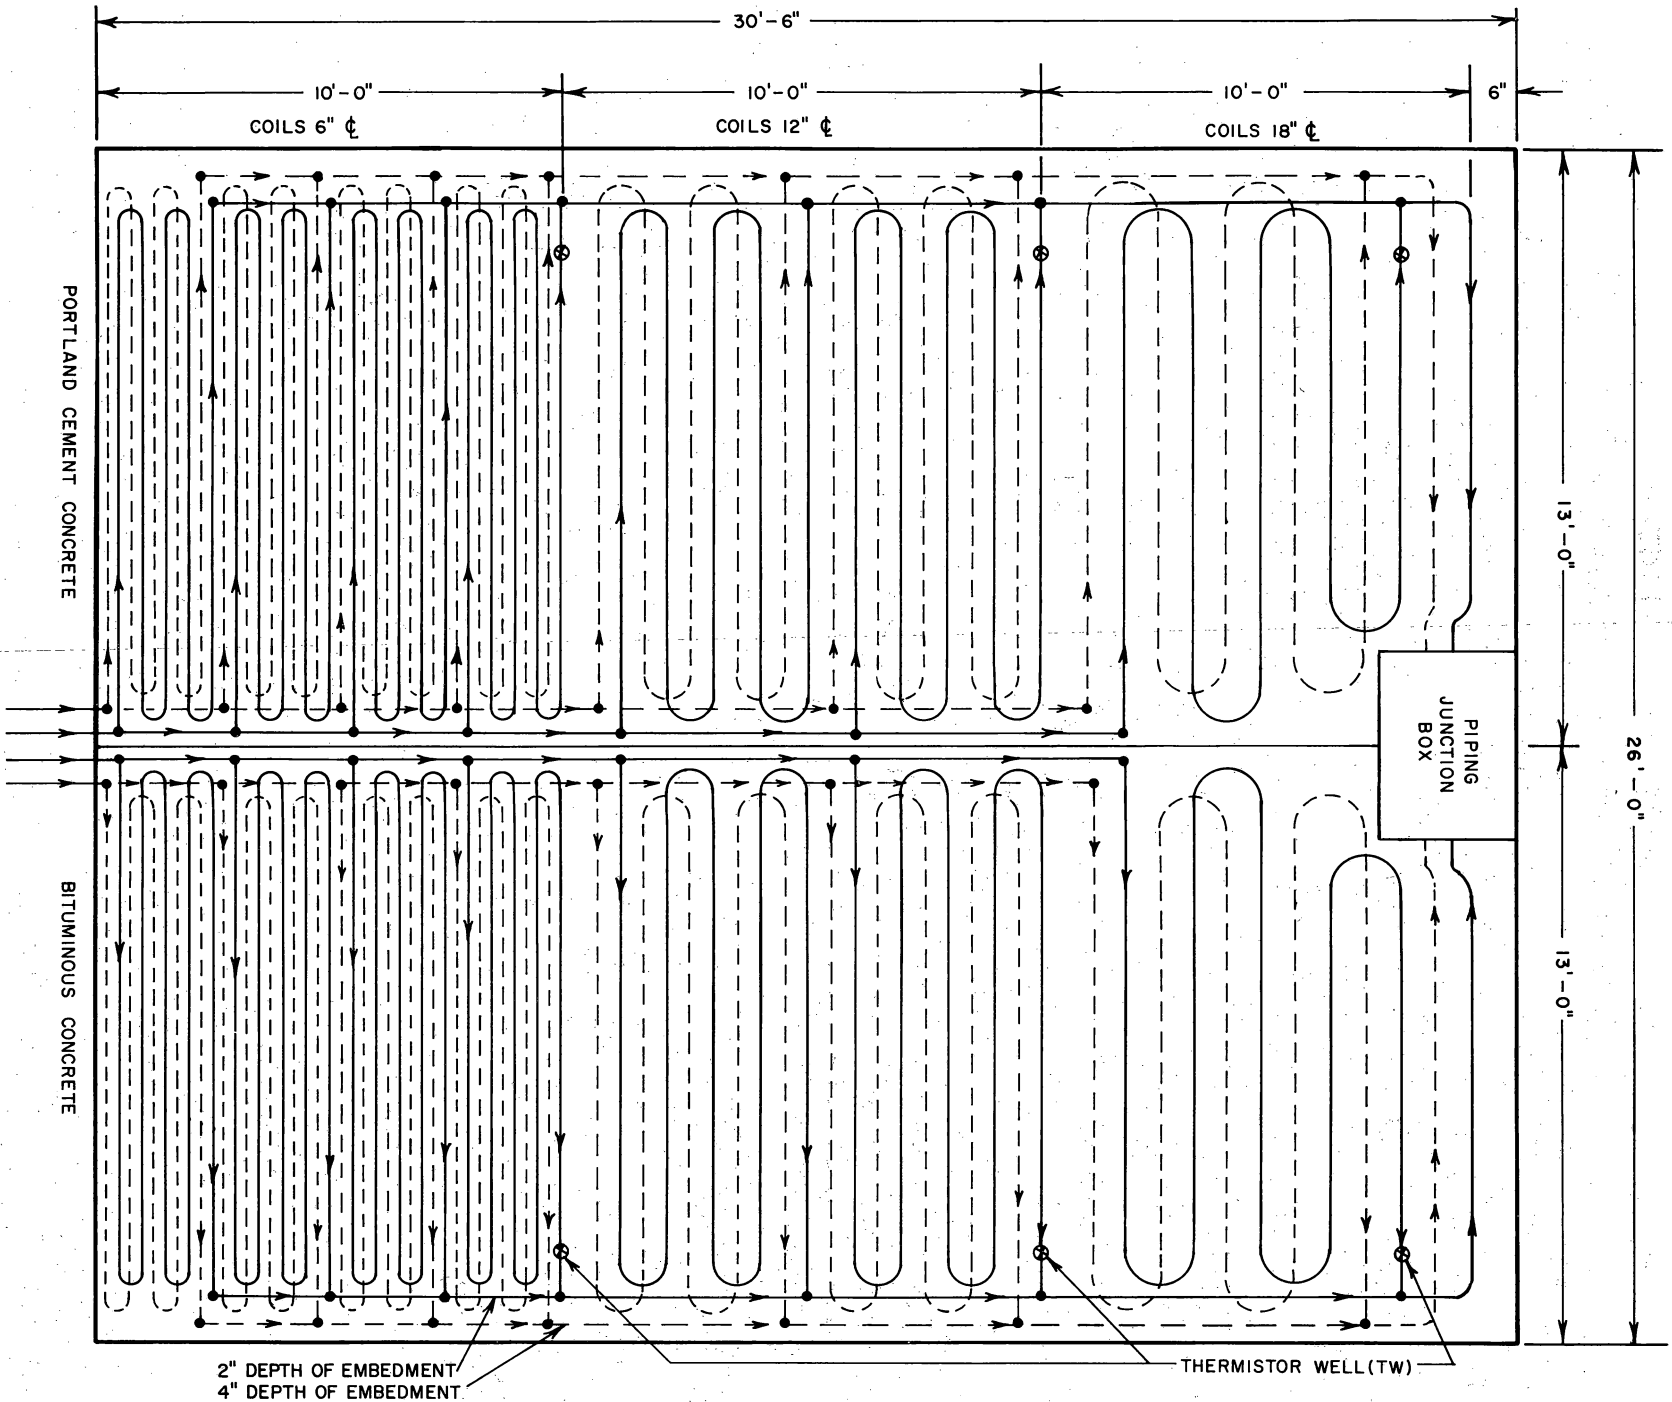
TWO TYPICAL EMBEDDED PIPE PANELS
FIGURE 3

In each of these panels, the pipe spacing is varied from 6 to 12 to 18 inch centers, and the pipes embedded at 2 inch and 4 inch depths are staggered with respect to each other as shown in Figure 3, page 13. All pipes are standard weight wrought iron with the exception of Panel #3 where a rigid polyvinyl chloride plastic pipe is used. The plastic pipe, which is resistant to chemical corrosion, was chosen in order to test its structural properties.

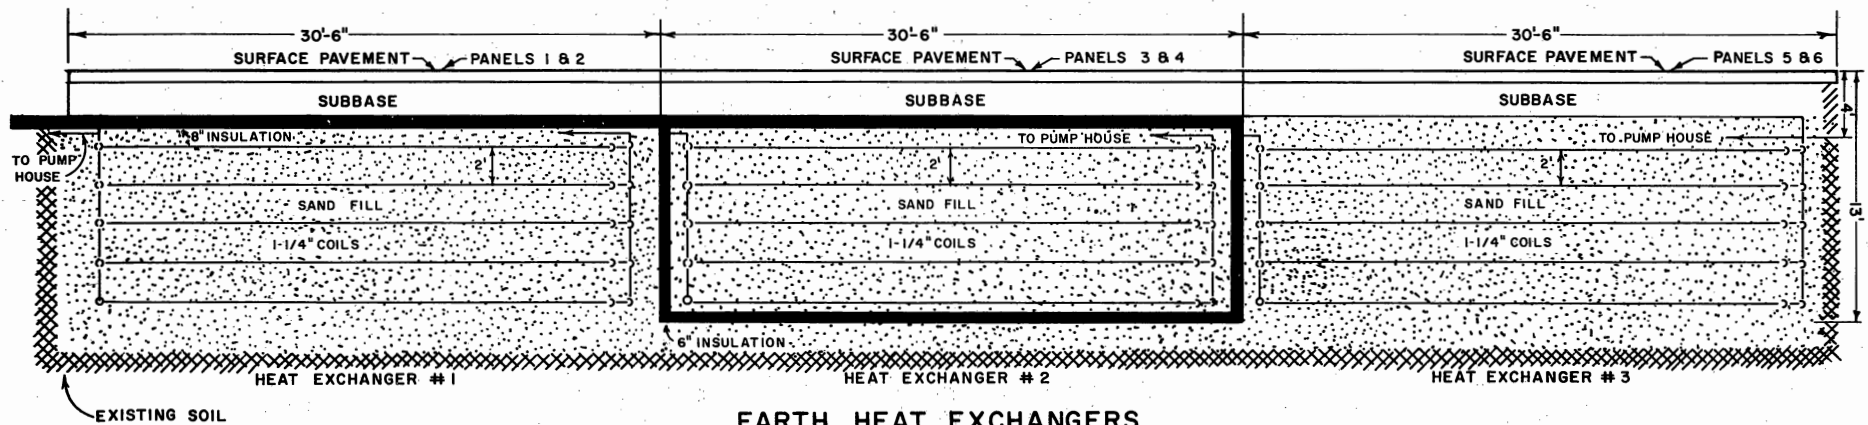
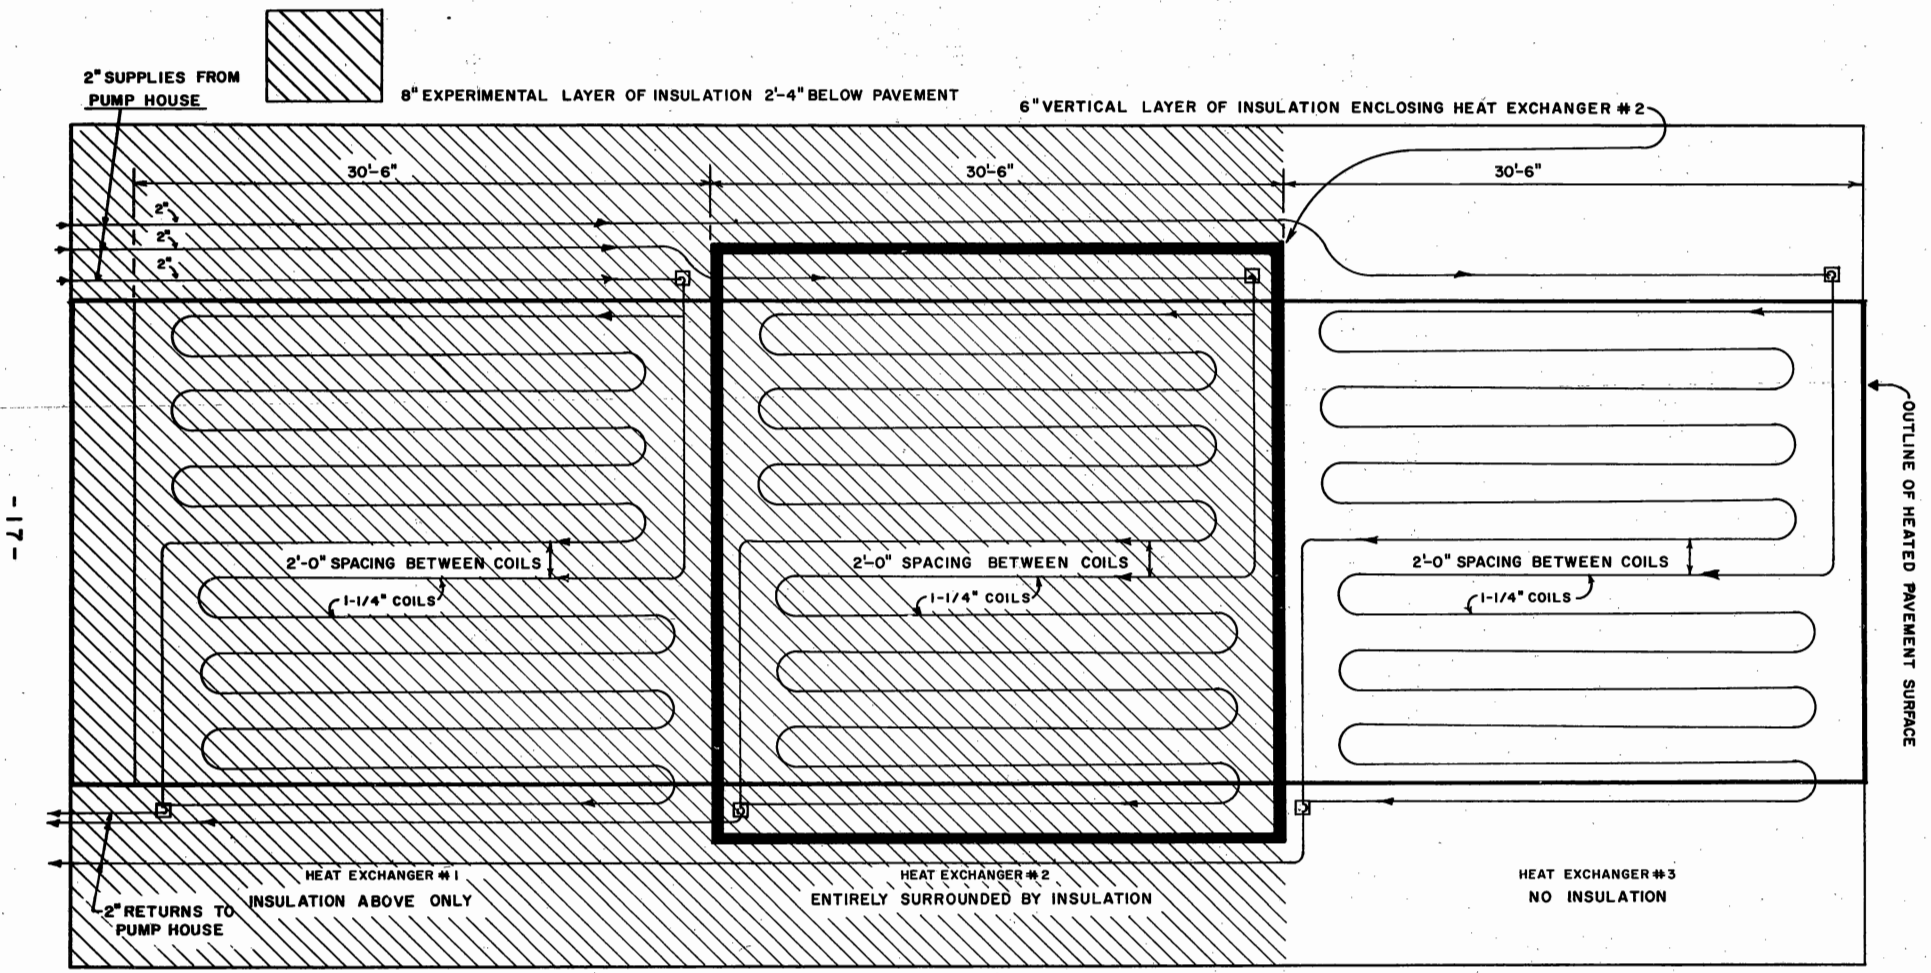
FIGURE 5

Three independent heat exchangers are buried in the ground below the six embedded pipe panels. See Figure 5, page 16. Heat Exchanger #1 is buried beneath Panels #1 and 2; Heat Exchanger #2 beneath Panels #3 and 4; and Heat Exchanger #3 beneath Panels #5 and 6, respectively. Each exchanger consists of 2,000 linear feet of 1-1/4 inch wrought iron pipe arranged in a grid and buried at a depth of 3 to 13 feet in the earth. The grid, which measures 32' x 30.5' x 10', is made up of five layers of pipe installed with a horizontal and vertical spacing of two feet between pipes (Figure 5, page 16 and Figure 6, page 17). These pipes are immediately surrounded by sand fill which extends to the boundaries of the pipe grid. An eight-inch layer of expanded polystyrene foam insulation (1.5 lbs/ft³) lies directly above Exchangers #1 and 2 and six-inch layers (1 lb/ft³) enclose the remaining sides of Exchanger #2 (Figure 5, page 16 and Figure 6, page 17). No insulation was used with Exchanger #3. The sand fill heat exchangers are surrounded by the existing soil.

EARTH HEAT EXCHANGERS

EARTH HEAT EXCHANGERS
PLAN

Construction began on April 7, 1969. A 100 feet x 40 feet area was first excavated by a bulldozer to a depth of 14 feet. All excavated material was trucked away as it was not considered suitable for backfill. The area was surveyed and the sites for the heat exchangers were laid out. Suitable sand backfill was dumped from trucks, and six inches were spread by hand over the entire area and compacted with a small hand operated compactor. For backfill gradation requirements, see Table H-1, page 188. In the area set aside for Heat Exchanger #2 a six inch horizontal layer of polystyrene insulation was placed on the sand base (Photograph 1, page 25). This layer was constructed from 4 feet x 8 feet x 3 inch blocks of insulation with all joints overlapped. Six inches of sand backfill was placed over this insulation and compacted. A layer of prefabricated 1-1/4 inch wrought iron pipe coils was then placed by hand on the compacted sand (Photograph 2, page 26). At this point a sequence of operations of placing and compacting sand backfill in 6 inch layers and the placement of 1-1/4 inch coils with a 2 feet separation between coil layers continued until all five layers of the heat exchanger were completed. See Figures 5 and 6, pages 16 and 17.

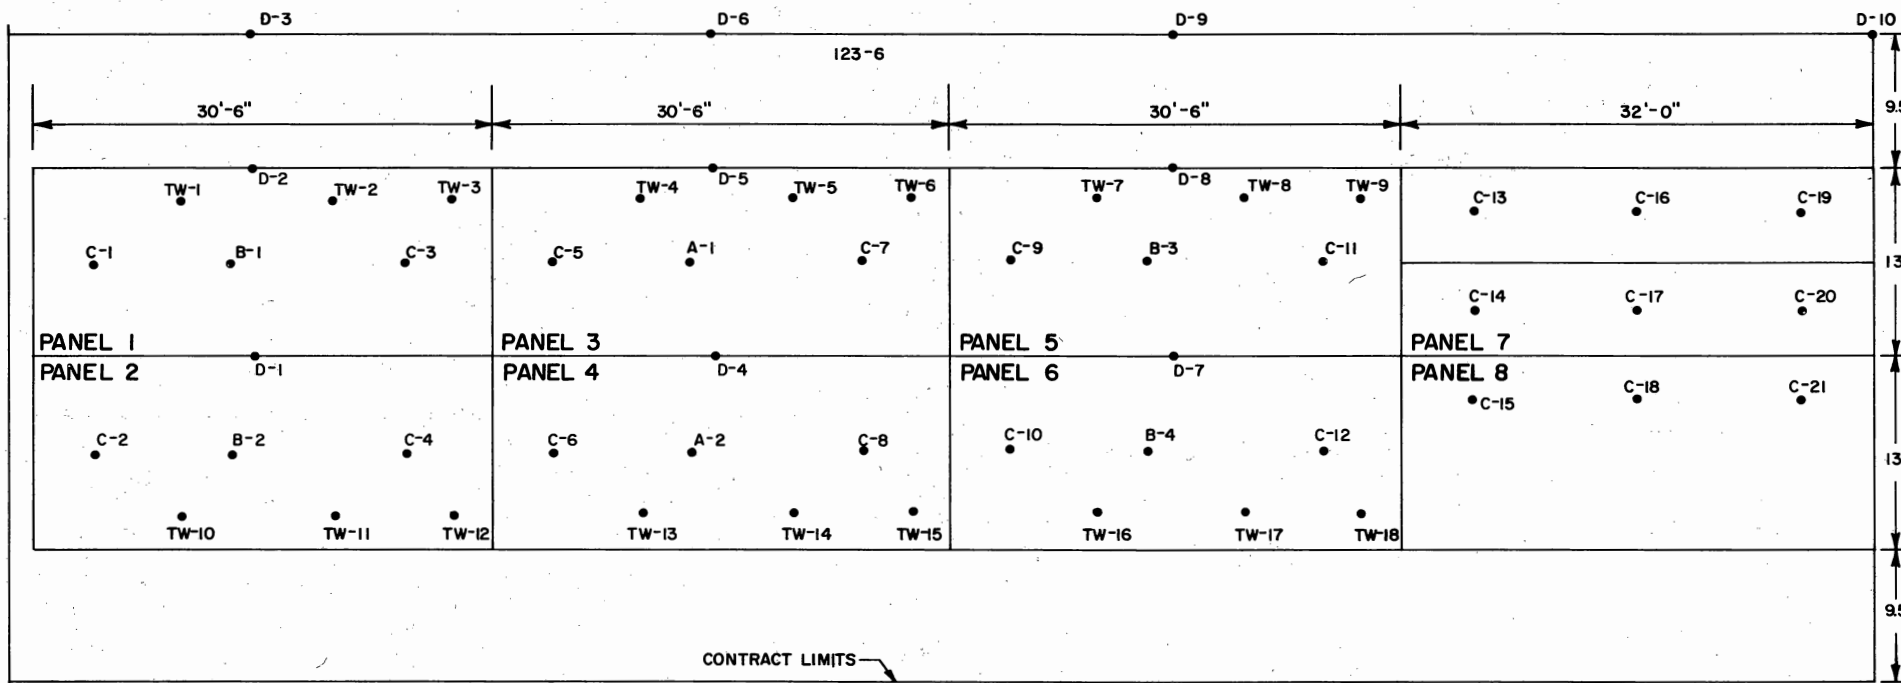
FIGURE 8.
LOCATION OF THERMISTORS

See Figure 9 and 10, next two pages for explanation of lettering code.

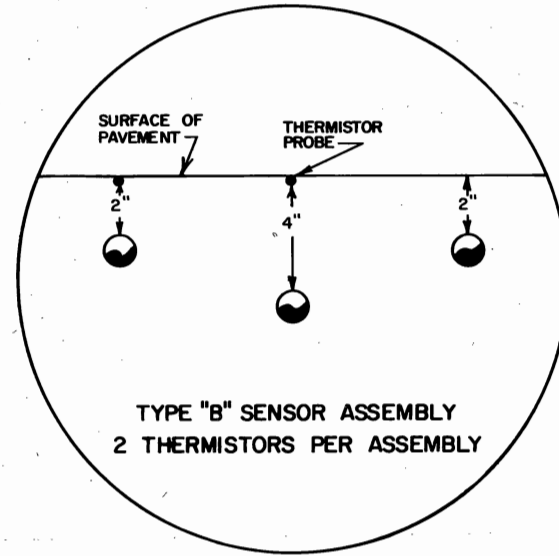
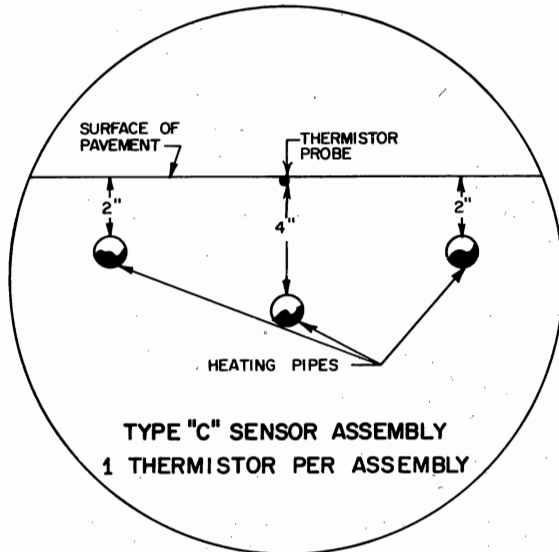
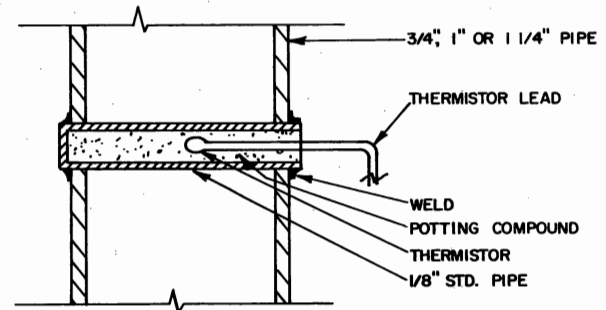
FIGURE 9.

SENSOR ASSEMBLIES - types A, B, C, & TW

(D4-2-4) - Thermistor D4 @ 2'4" depth.

The temperature of the earth, pavement, and ethylene glycol-water solution was monitored with 120, Model 401 Digitec general purpose thermistors. Air temperature was monitored with a Digitec Model No. 405 air temperature thermistor. For specifications, see page 135. These thermistors are electrical resistors which make use of a semiconductor whose resistance varies in a known manner with temperature. The locations of the thermistors in the heat exchangers, pavement, and pipes are shown in Figures 8, 9, and 10, pages 20, 21, and 22. Types A, B, and C thermistors are located in the test pavement at the depths shown in Figure 9. Type TW

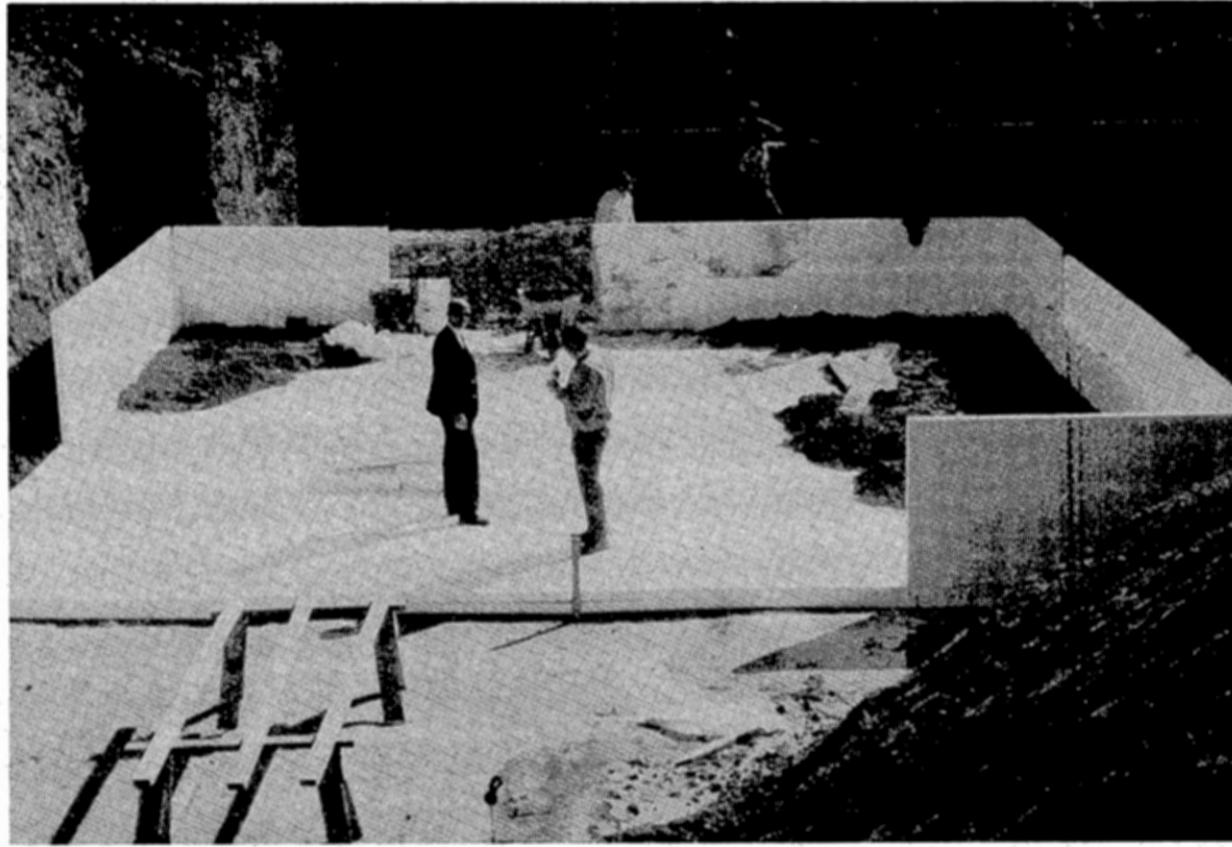
PHOTOGRAPH 1

(6-INCHES OF INSULATION ENCLOSING HEAT EXCHANGER)

HEAT EXCHANGER #1

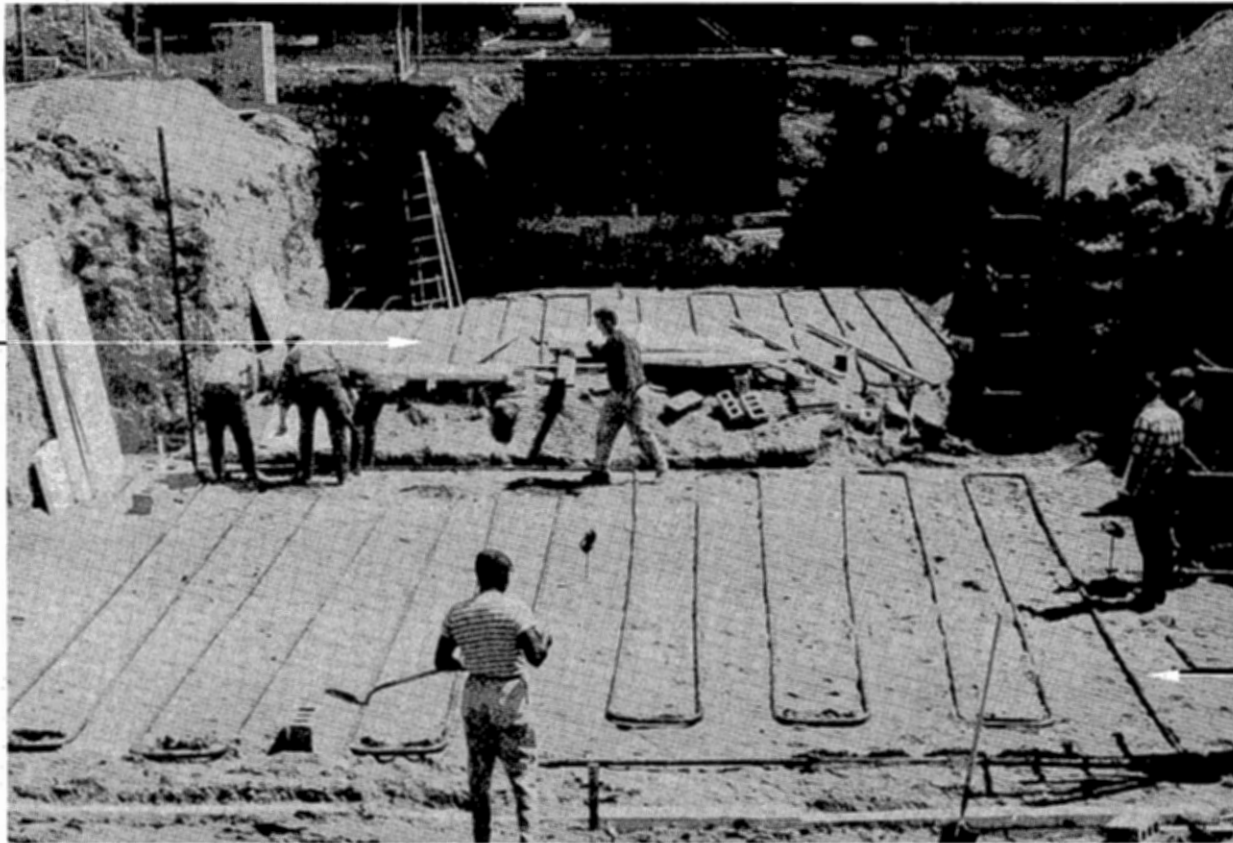
HEAT EXCHANGER #2

MAY 1969

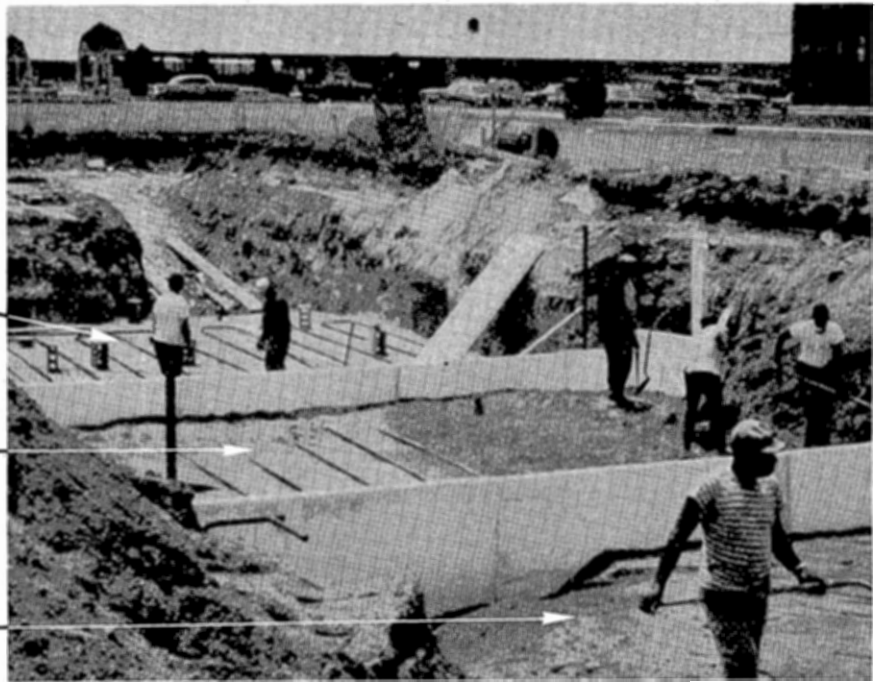
PHOTOGRAPH 3

CONSTRUCTION OF HEAT EXCHANGERS

(ONLY NO.2 AND NO.3 ARE SHOWN; NO.1 IN FOREGROUND)

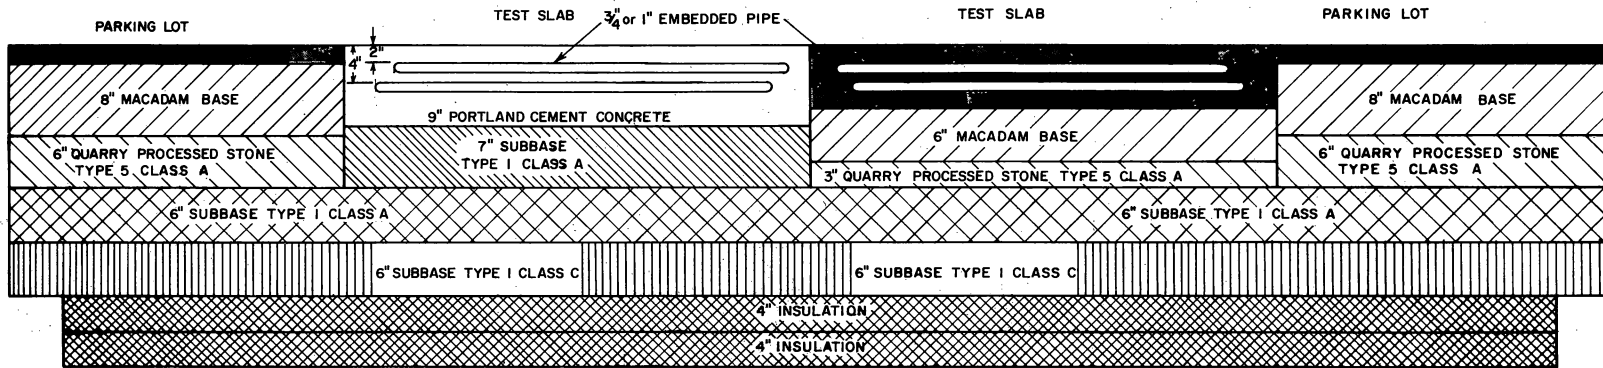
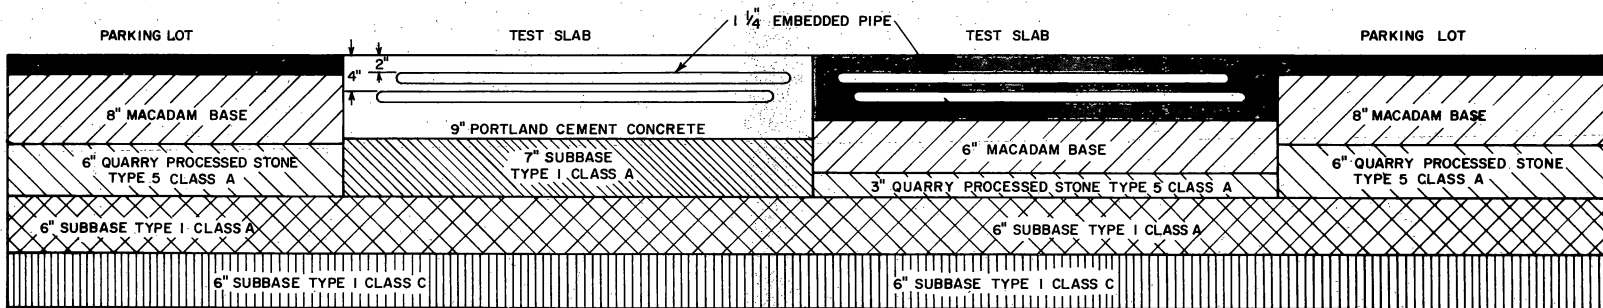
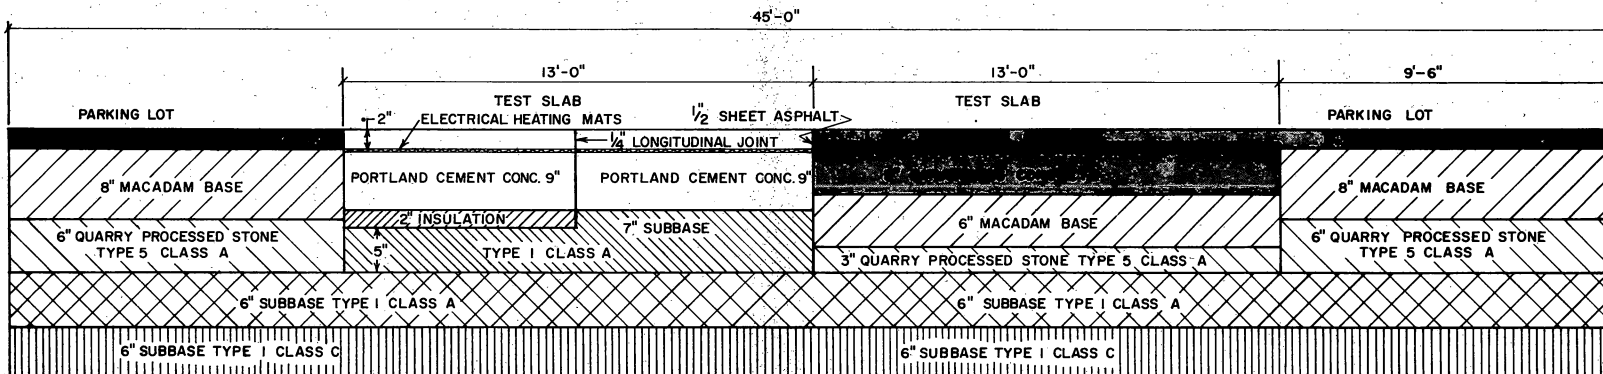
FIGURE 11

TYPICAL SECTIONS — PAVEMENT & SUBBASE

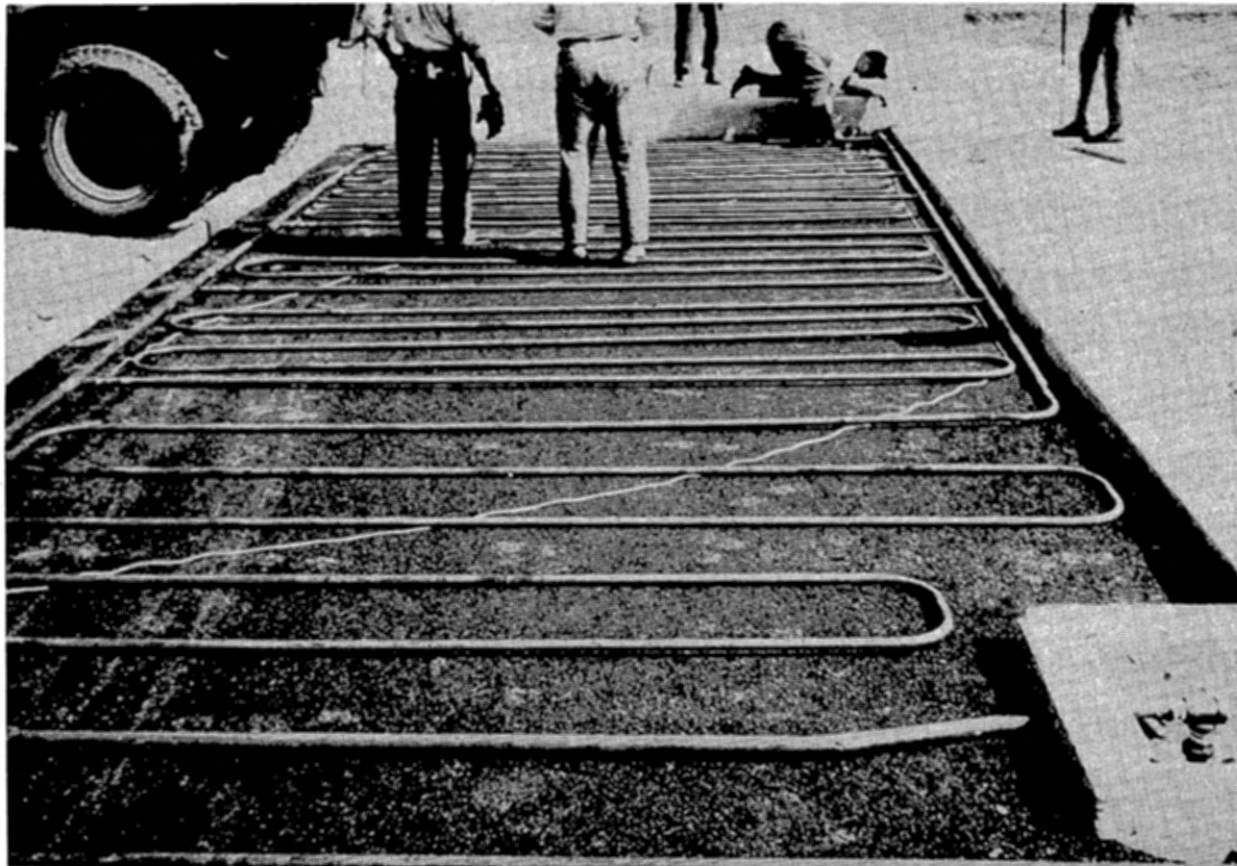
PHOTOGRAPH 5

CONSTRUCTION OF PANEL NO.2

(3/4 INCH WROUGHT IRON PIPES EMBEDDED AT A 2-INCH DEPTH
IN BITUMINOUS CONCRETE)

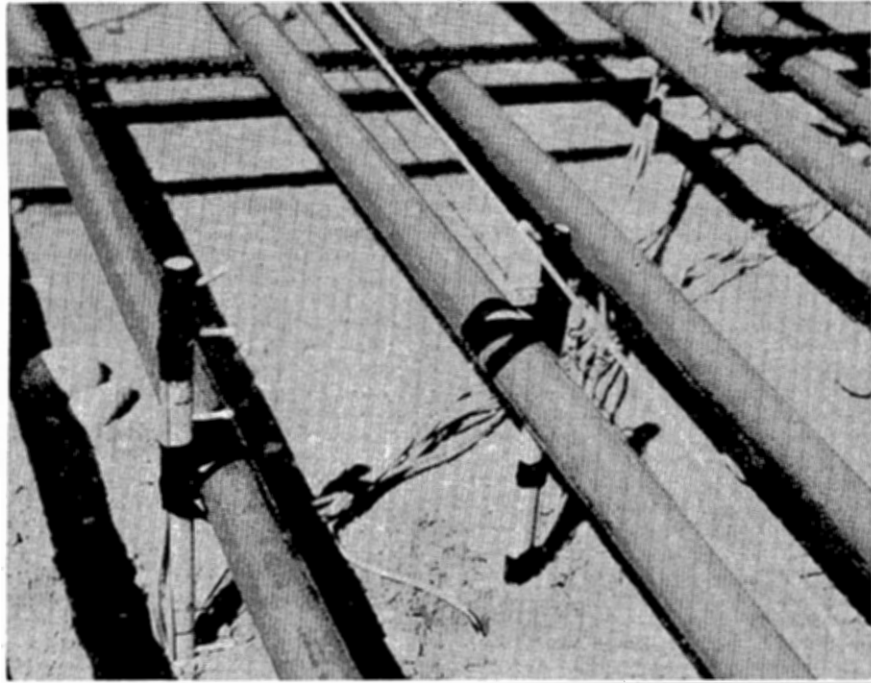
PHOTOGRAPH 6
POSITIONING OF THERMISTORS IN PAVEMENT

Thermistors within the heat exchangers were placed during the backfill operations. Thermistors in the earth adjacent to the heat exchangers were fastened to a wooden rod, at specified intervals, which was then inserted into a hole drilled to the proper depth. Positioning of the thermistors in both the P. C. C. and the B. C. (Bituminous Concrete) was by means of 1/2 inch wooden dowels driven into the base courses. The thermistors were inserted into holes drilled through the dowel and then secured with plastic tape (Photograph 6, page 34). Thermistor leads were run to junction boxes where they were connected to a multi-conductor cable which was run through conduit to the gate house. Here final connection to measuring instruments was made.

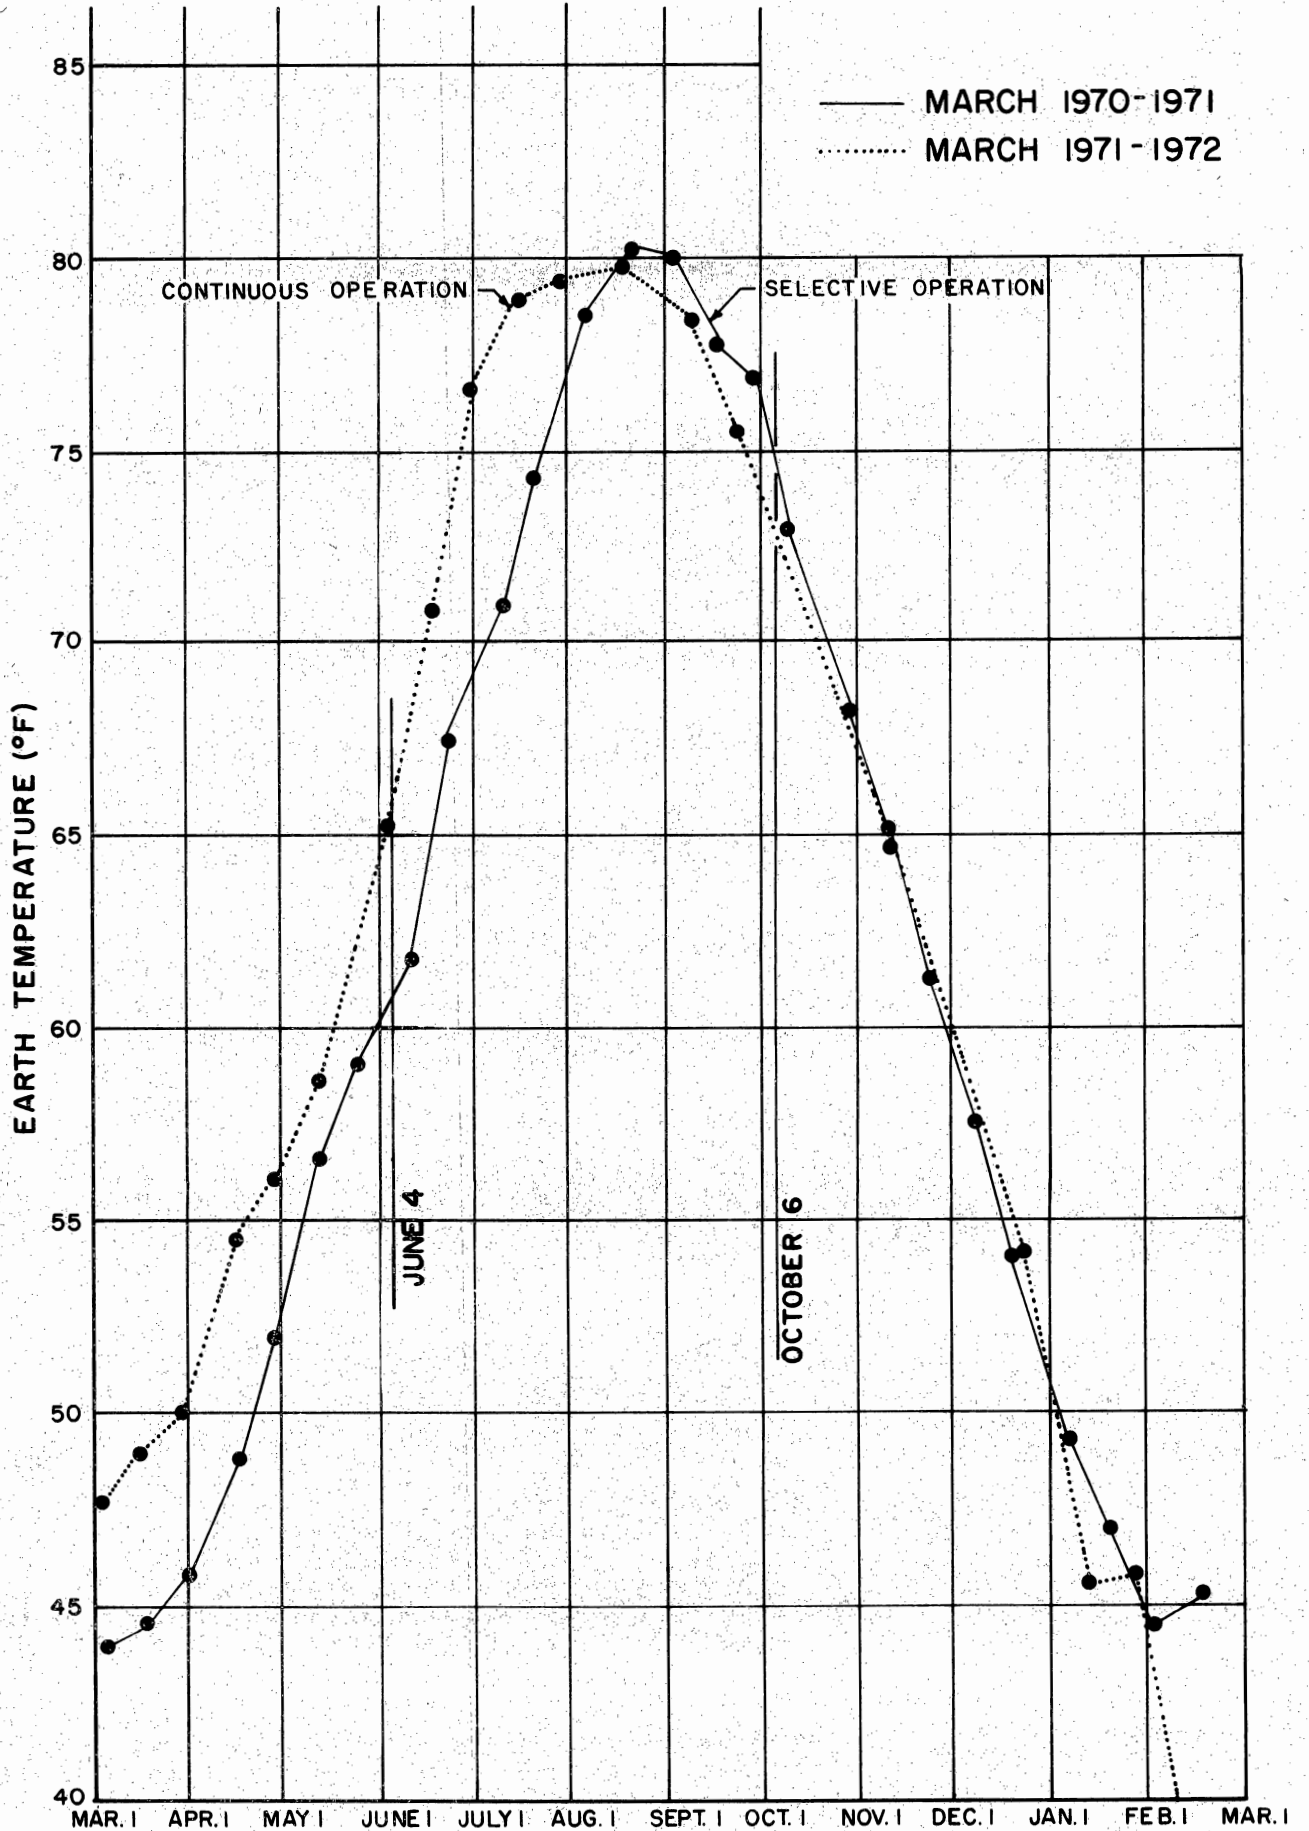
FIGURE 12

AVERAGE EARTH TEMPERATURE WITHIN HEAT EXCHANGER NO. 3

Accordingly, the temperature of Heat Exchanger #3 and the control earth temperature were examined on October 6 of both 1970 and 1971. On October 6, 1971, the average temperature of the earth within Heat Exchanger #3 was 72.5°F, and control earth temperature was 67°F; while on October 6, 1970 the average temperature of the earth within Heat Exchanger #3 was 74°F and control earth temperature was 68°F (Figures 12 and 13 pages 49 and 50). Continuous operation for 2976 hours and selective operation for 715 hours both raised the earth temperature of Heat Exchanger #3 to approximately an equal number of degrees (5.5-6.0°F) above control earth temperature, thus they are approximately equal in heat storing ability for their respective operational hours.

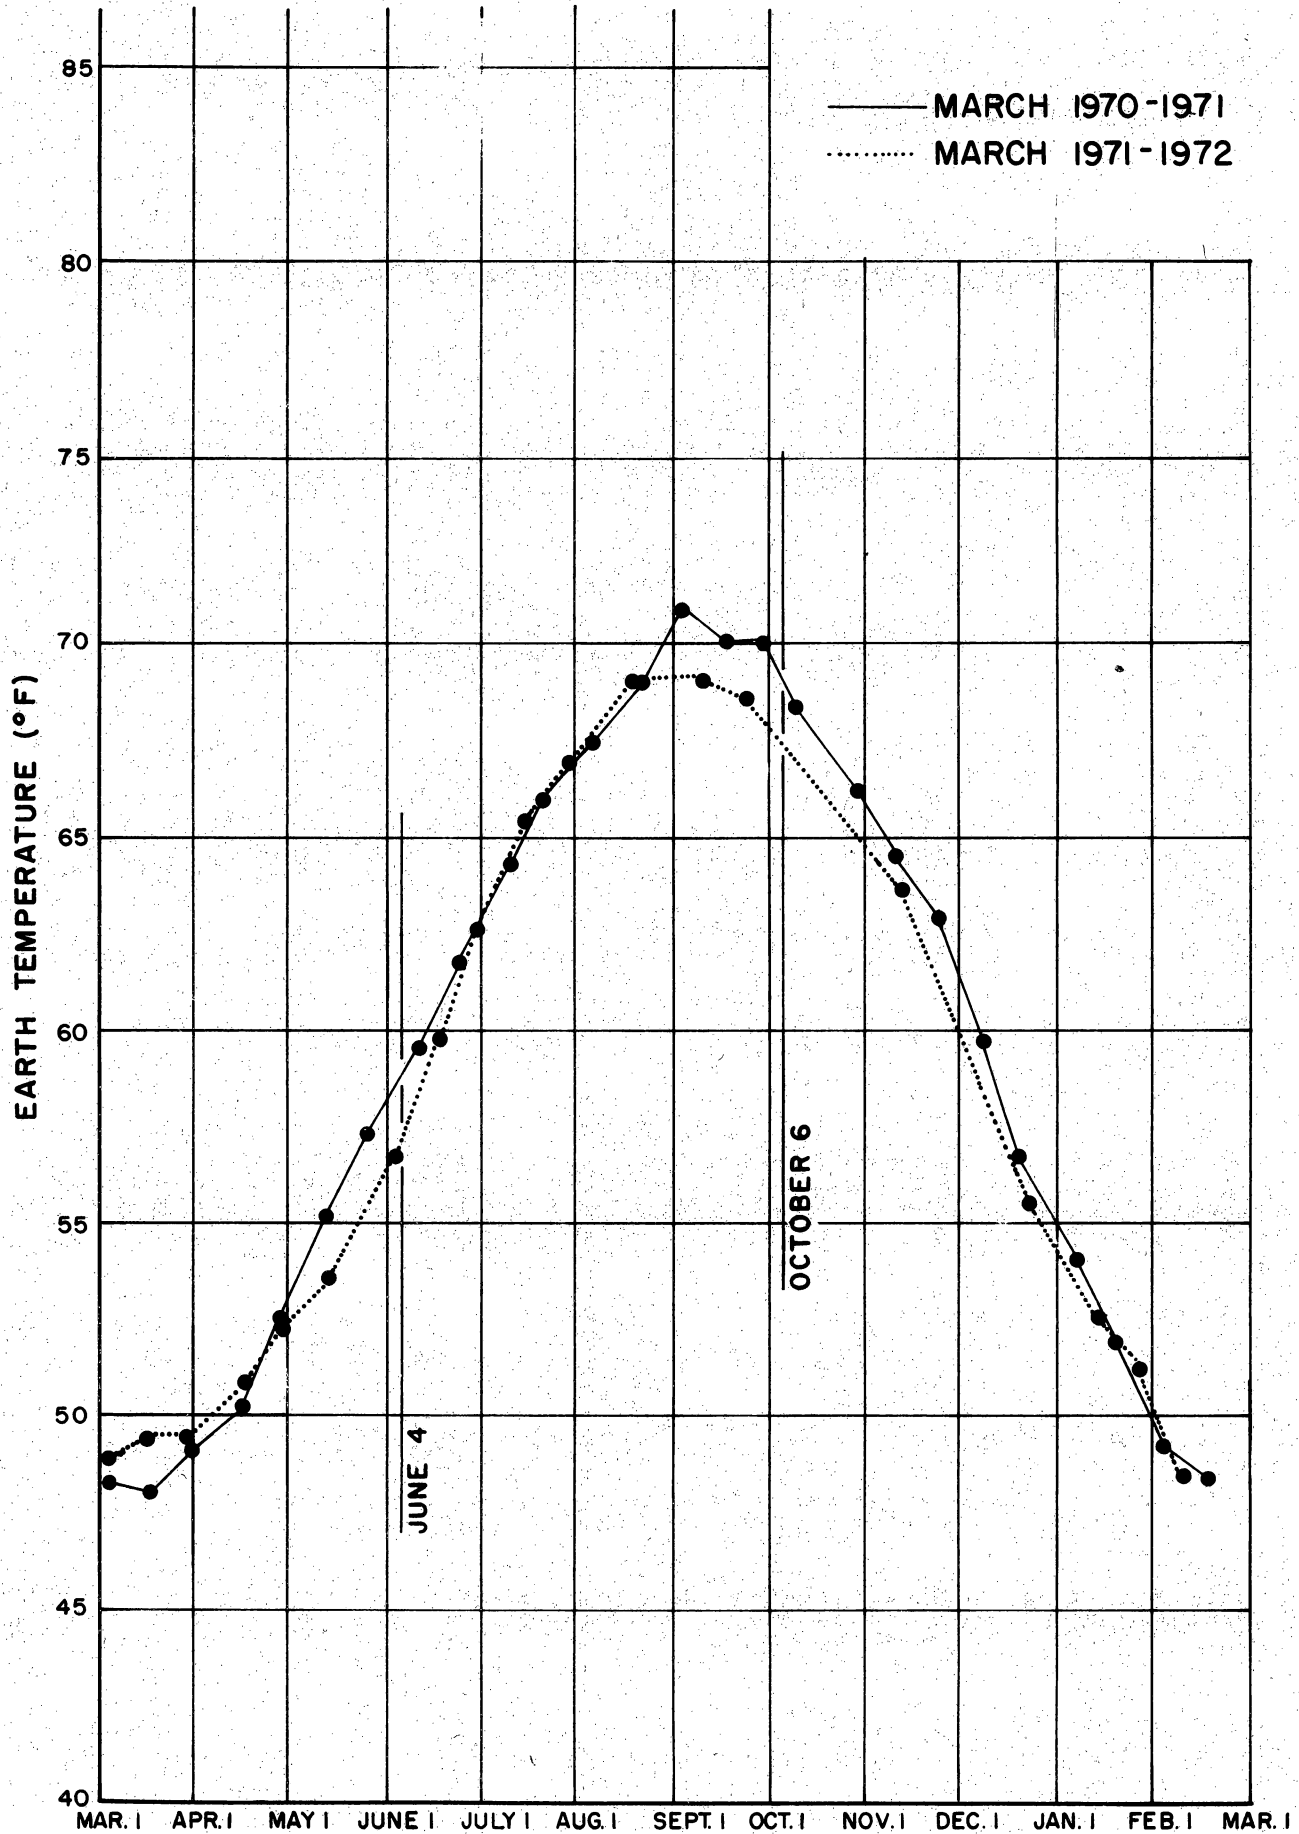
FIGURE 13
 AVERAGE TEMPERATURE OF CONTROL EARTH

the temperature difference between heat exchanger earth and control earth at the end of the test period is an indication of the heat storing ability of a particular operating method.

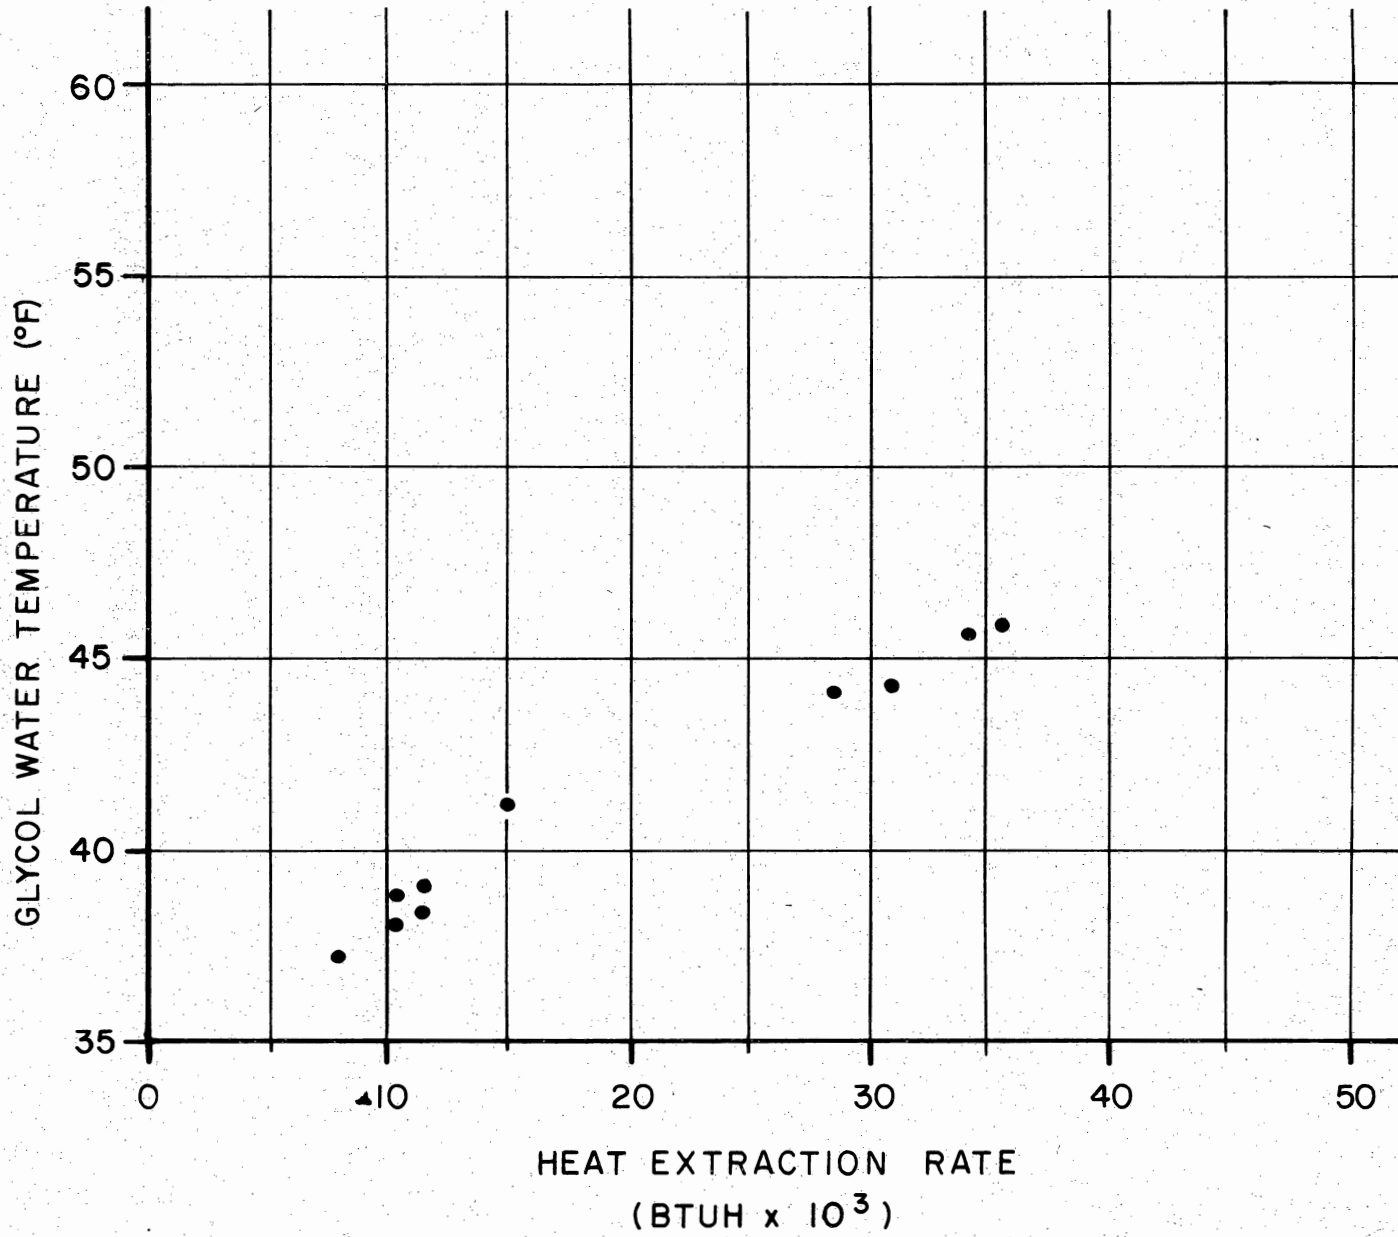
FIGURE 14 - HEAT EXTRACTION FOR HEAT EXCHANGER #3
PANELS 1, 2, 5, & 6
(WINTERS 1971-72 & 1974-75)

In summary, during the snow storms of Winters 1971-72, and 1974-75, heat was extracted from Heat Exchangers #3 at a rate of between 8000 and 35,500 BTUH (4-18 BTUH/Linear foot of heat exchanger pipe) for heating fluid temperatures in the range of 35-46°F and for at least 3 hours of continuous operation.
