PAVEMENT HEATING, 1969-1975,
FINAL REPORT

Division of Research and Development
New Jersey Department of Transportation

February 1977

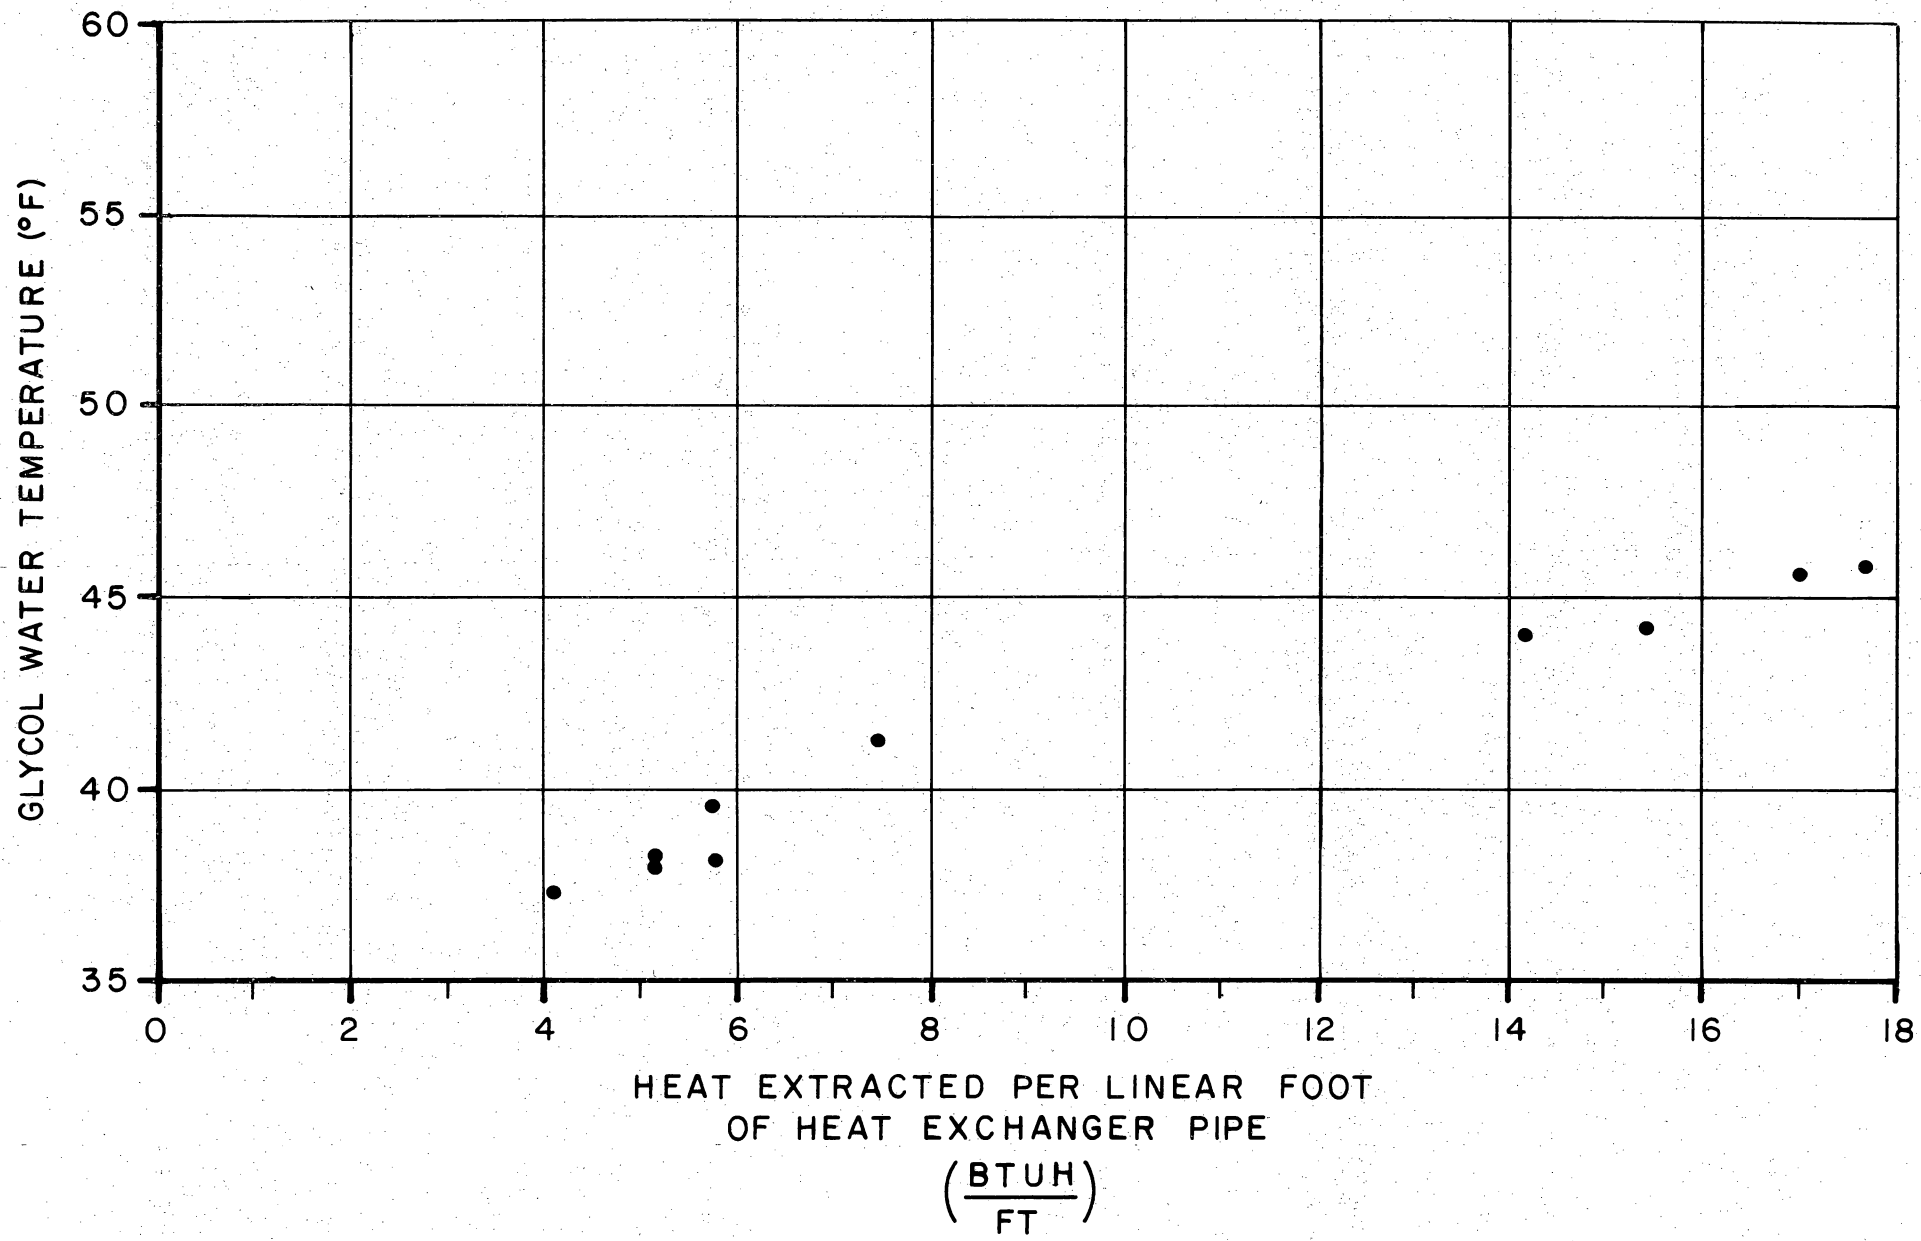
FIGURE 15- HEAT EXTRACTED PER LINEAR FOOT OF PIPE - HEAT EXCHANGER #3
PANELS 1, 2, 5, & 6
(WINTERS 1971-72 & 1974-75)

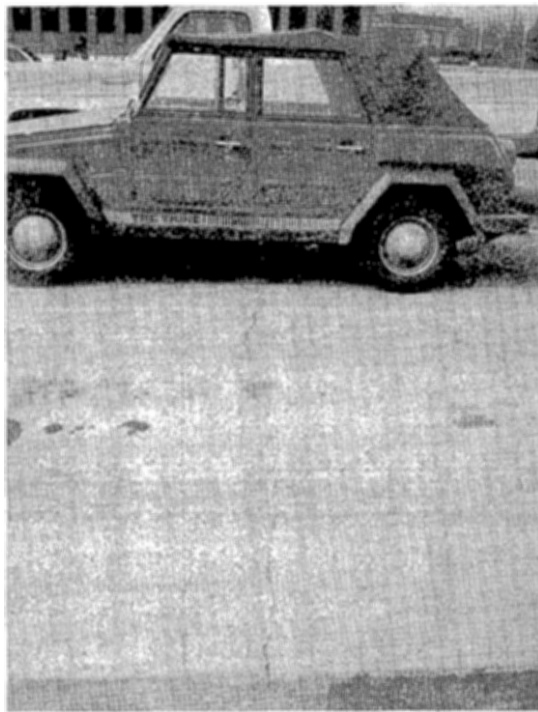
PHOTOGRAPH 7

Pavement Crack in Panel #7 (P.C.C.)

No major structural failure of the Bituminous or Portland Cement Concrete was observed. Small cracks in the pavement have occurred. The trasverse crack in Panel #7, first noted in 1970, has increased to a width and depth of approximately $3/32$ " and $3/16$ ", respectively. See Figure 16, page 63 and Photograph 7, page 61. A crack in Panel #6 runs completely across the panel and varies in width and depth from approximately $3/32$ " and $3/16$ ", respectively, near Panel #5 to a hairline crack at the outer edge (Figure 16 and Photograph 8, page 61). A $3/32$ -inch wide crack is present in Panel #8, decreasing in size to a hairline crack, it extends for 2.7 feet across the panel. Hairline cracks are also present in Panels #3 and 5 as shown in Figure 16.

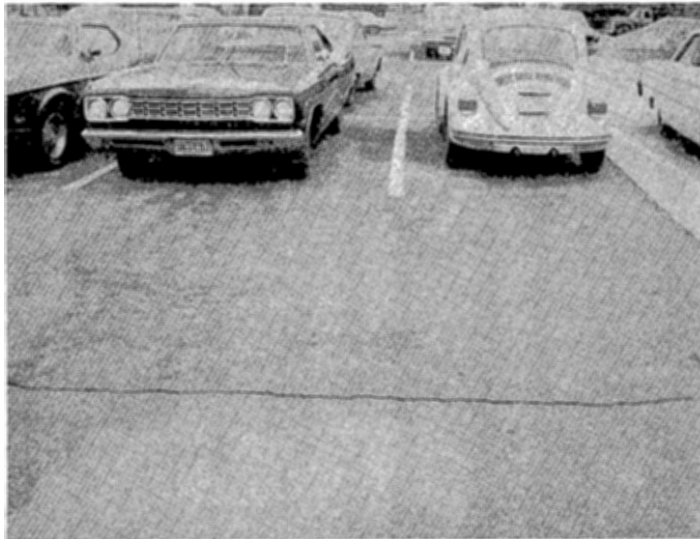
PHOTOGRAPH 8

Pavement Crack in Panel #6 (B.C.)

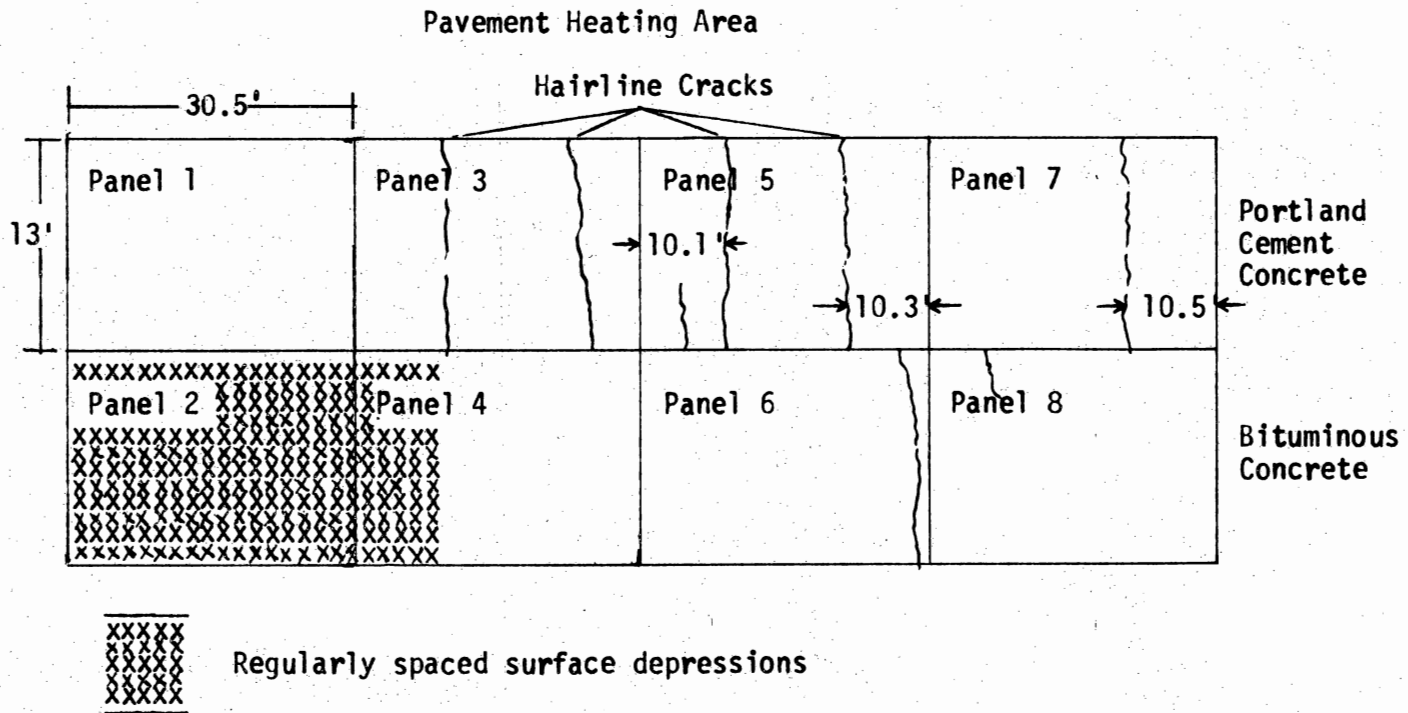
FIGURE 16

LOCATION OF CONCRETE FAILURES

Slight, regular depressions of the pavement surface were observed in Panels #2 and 4. These depressions are transverse to the length of the panel and appear to occur roughly between the heating pipes. The section of pavement where depressions are present is shown in Figure 16. This condition first became apparent in Spring, 1975.

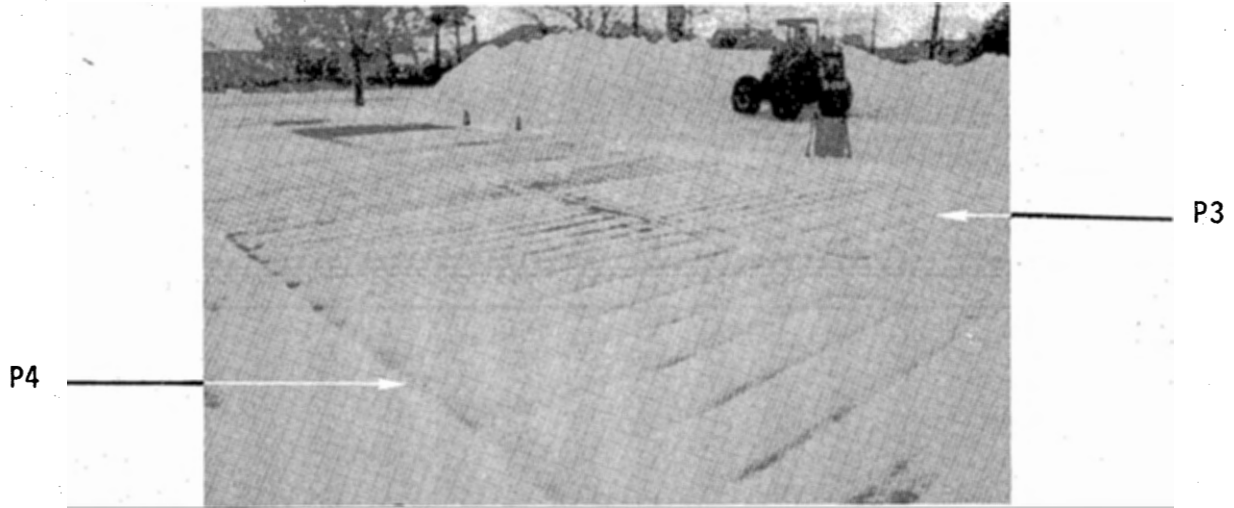
PHOTOGRAPH C-1 STORM #3

Panel #3 (Portland Cement Concrete) & Panel #4 (Bituminous Concrete)
7:30 AM - January 2, 1971
(Operated 42 hours) (Air Temp. 21.6 °F)

Table C-1, pages 121-128, lists pavement surface temperatures and related surface conditions for snowstorms #1-9. Data is presented for surface conditions varying from snow, slush, and ice covered to clear and dry; operating times, from 1-51 hours; and air temperature, from 21.6-45.9°F. The most complete data presented is for snowstorm #8; here, surface temperatures are presented on an hourly basis. Table C-2 indicates that except for readings of 31.8°F for P2 (18) on 1/2/71 (7:45 AM) and 31.7°F for P1 (18) on 1/25/71 (1:05 PM), pavement surface temperature were maintained above 32°F at all of the times listed. Surface temperatures for panels in operation fell within the 32-50°F range with the exception of the 53.4° for P1 (6) on 1/2/71 (12:37 PM). The lowest temperature measured for a panel not in operation, was 30.4°F for P3 (18) on 1/14/71 (10:15 AM).

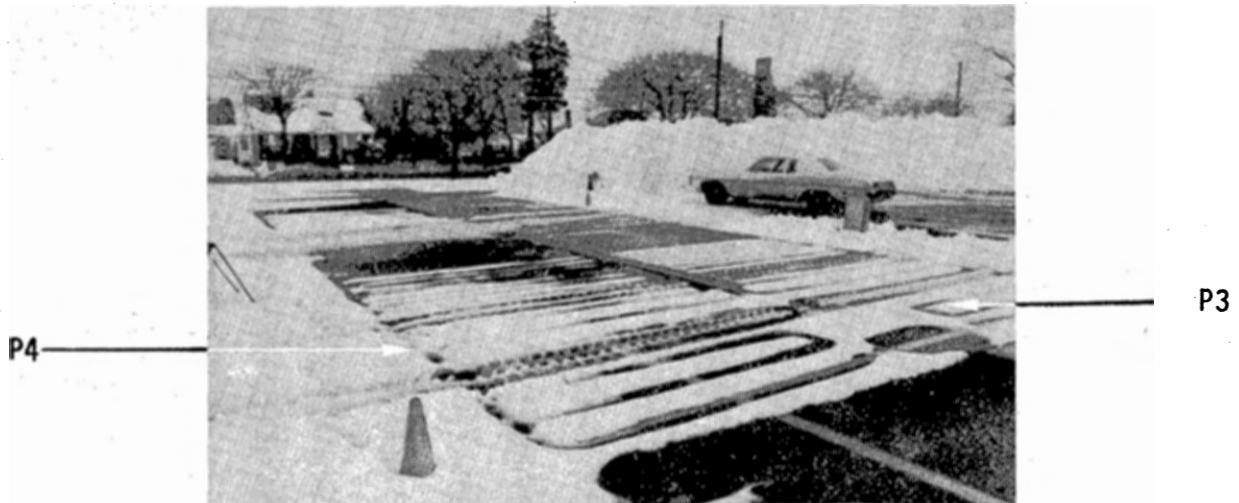
PHOTOGRAPH C-2 STORM #3

Panel #3 (Portland Cement Concrete) & Panel #4 (Bituminous Concrete)
4:15 PM - January 2, 1971
(Operated 50 hours) (Air Temp. 35.0°F)

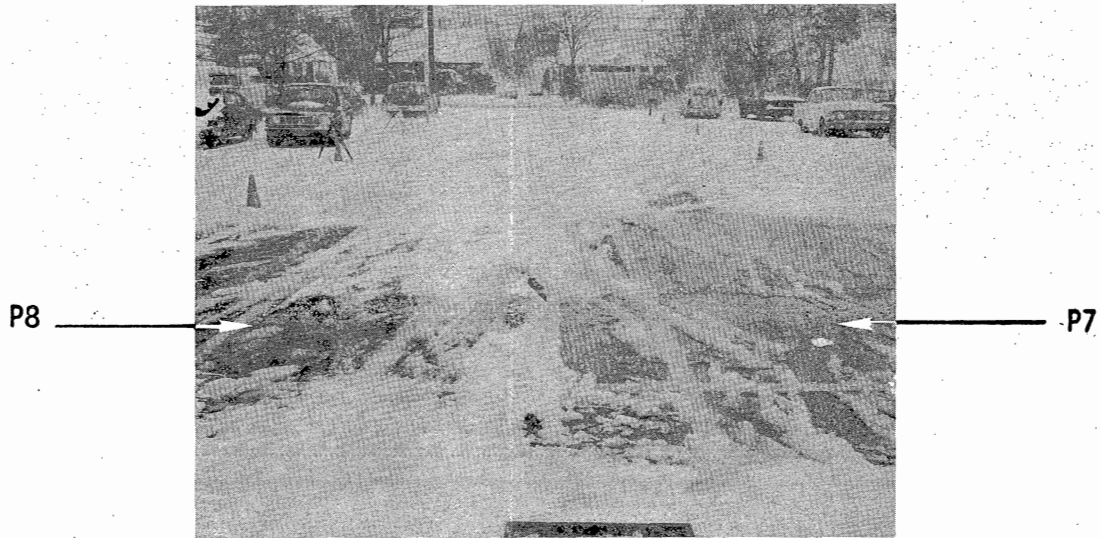
PHOTOGRAPH C-7 STORM # 8

Panel #7 (Portland Cement Concrete) & Panel #8 (Bituminous Concrete)
11:00 AM - March 4, 1971
(Operated 2 hours) (Air Temp. 29.7°F)

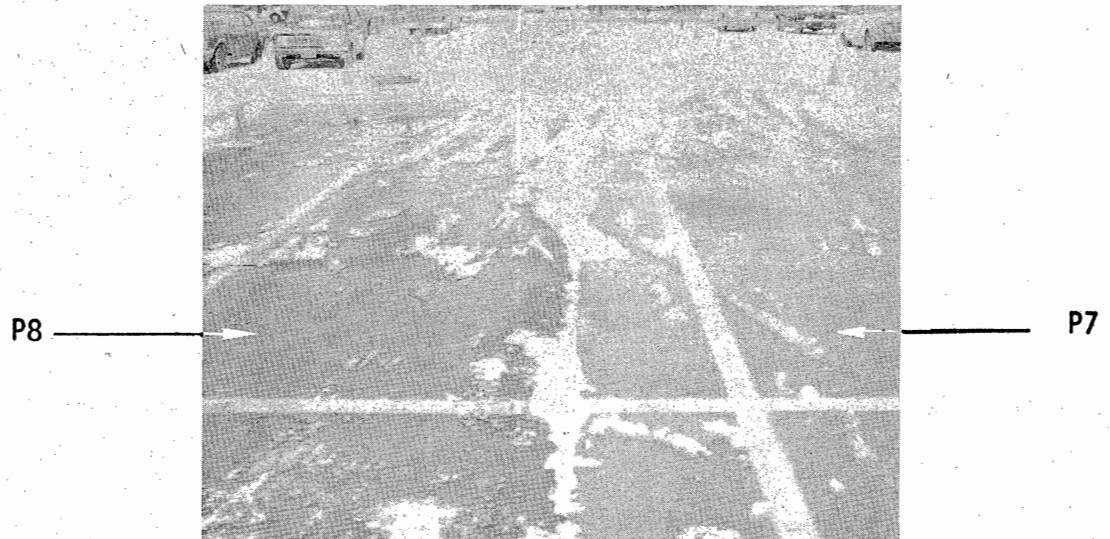
PHOTOGRAPH C-8 STORM #8

Panel #7 (Portland Cement Concrete) & Panel #8 (Bituminous Concrete)
12:00 Noon - March 4, 1971
(Operated 3 hours) (Air Temp. 29.1°F)

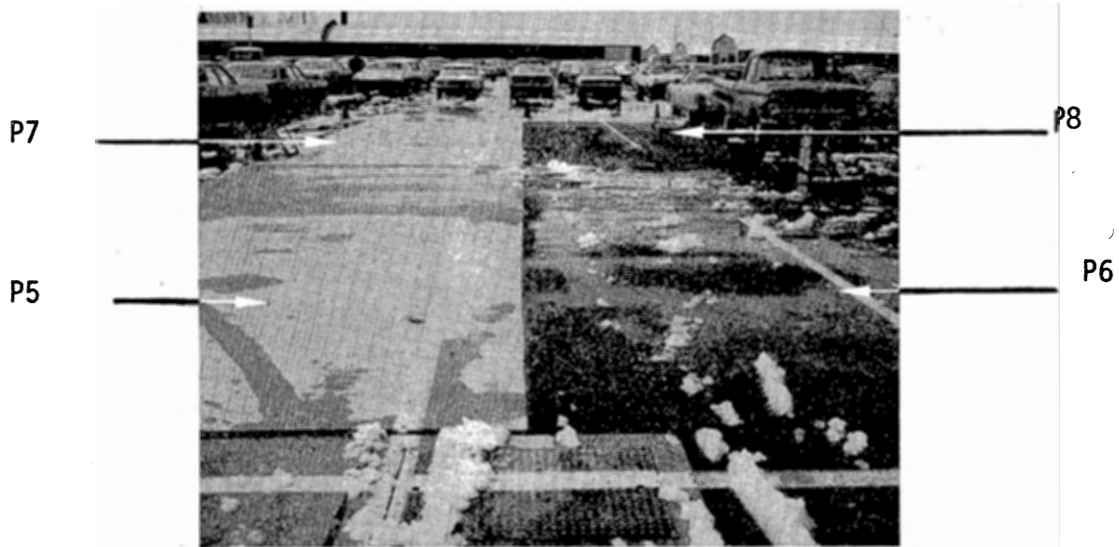
PHOTOGRAPH C-10 STORM # 9

Panels #5, #6, #7, and #8
11:45 AM - April 7, 1971
(Operated 13.5 hours) (Air Temp. 49.3°F)

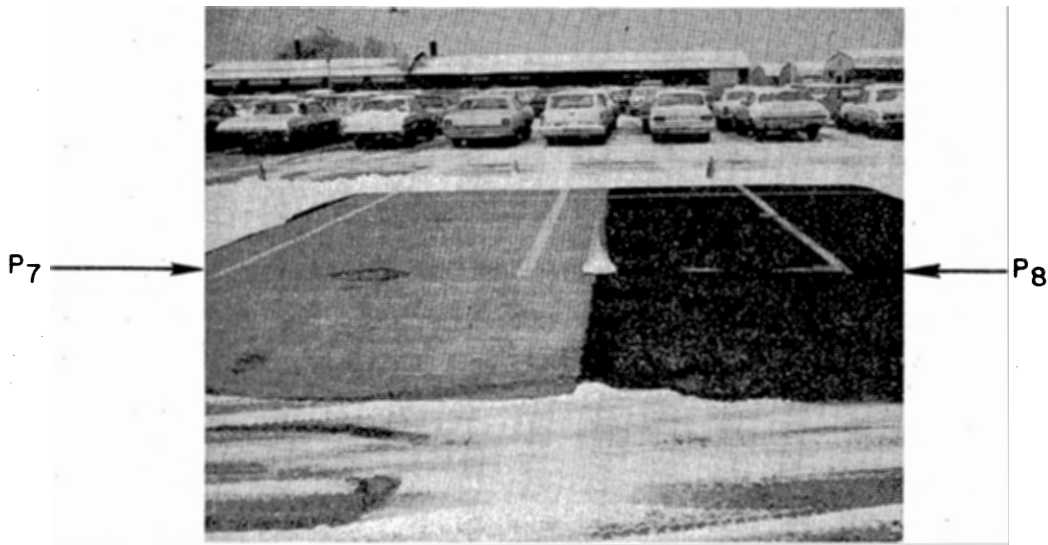
PHOTOGRAPH D-7 STORM #3
Panel #5 (Portland Cement Concrete) and Panel #6 (Bituminous Concrete)
9:00 AM - February 7, 1972
(18 hours from start of snowfall)(Air Temp. 29.3°F)

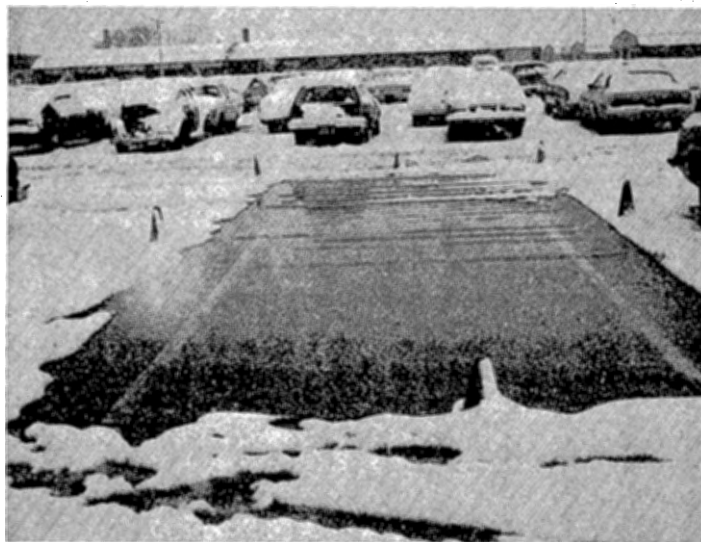
PHOTOGRAPH E-5 STORM #7

Panel #1 (Portland Cement Concrete)
HOT WATER OPERATION
12:45 PM - February 25, 1974
(Operated 3.5 Hours)(Air Temp. 33.0°F)

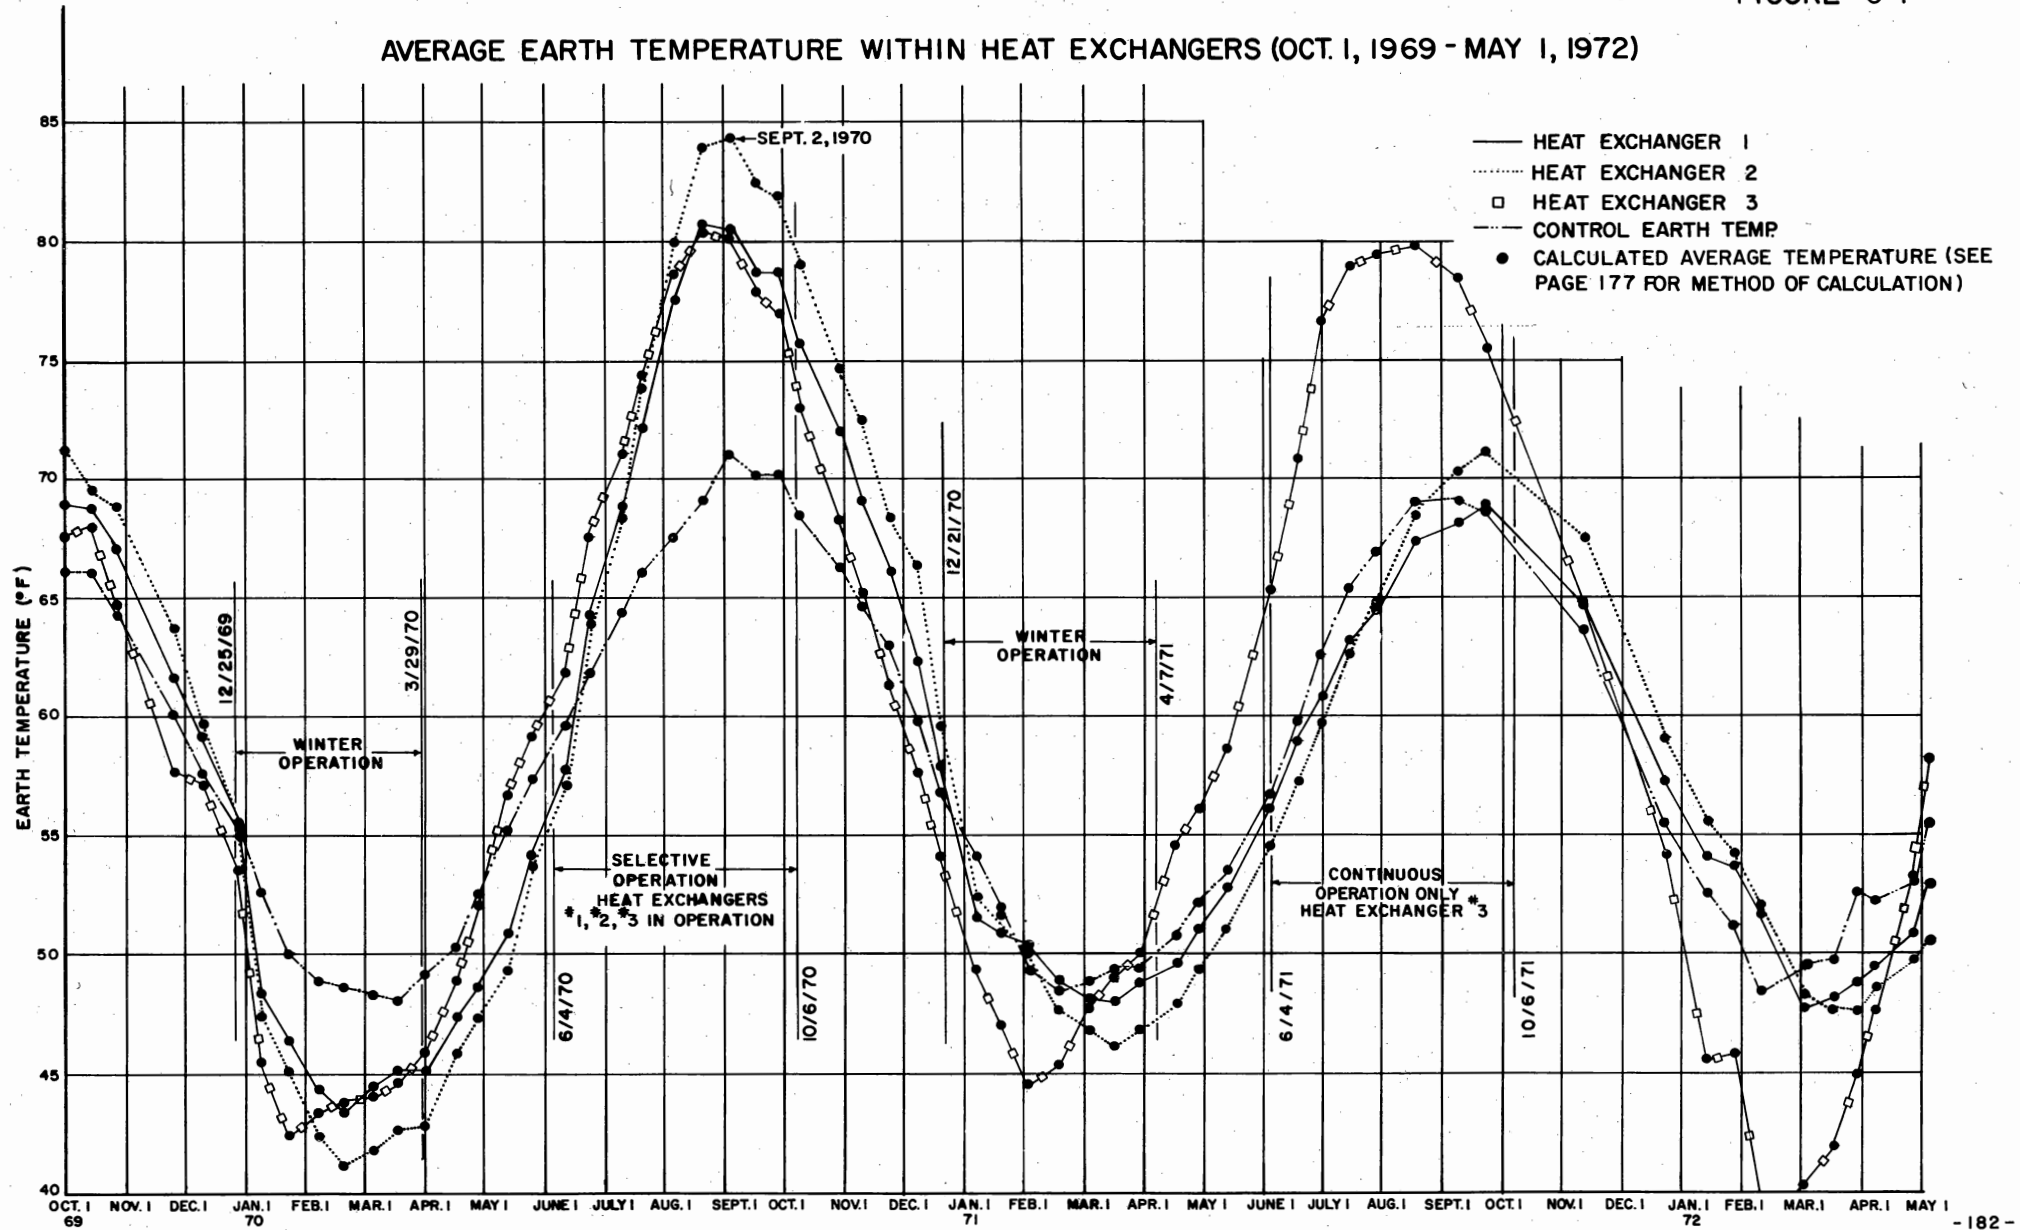
FIGURE G-1

AVERAGE EARTH TEMPERATURE WITHIN HEAT EXCHANGERS (OCT. 1, 1969 - MAY 1, 1972)

The effects of the insulation used with Heat Exchangers #1 and 2 on the heat that was stored during 1970s selective summer operation can be observed by referring to Figure G-1, page 182. As shown in this graph, the maximum earth temperatures reached during the period of summer operation were 84.5°F for Heat Exchanger #2 on September 2, 1970, and 81.0°F and 80.5°F for Heat Exchangers #1 and #3, respectively, on August 19, 1970. The greatest number of degrees that the temperature of the earth within the heat exchangers was raised above the control earth temperature occurred on August 19, 1970 and was 12°, 15°, and 11.5°F for Heat Exchangers #1, 2, and 3, respectively. Thus not only did the heat exchanger earth temperatures reached fall short of the desired 20°F rise, but the maximum earth temperatures which occurred

By again referring to Figure G-1, page 182, the inability of the insulation to reduce the rate of heat loss from Heat Exchangers #1 and 2 during the period between the end of summer operation and the first snowstorm can be observed. From October 6, 1970 to December 21, 1970 the average earth temperatures of Heat Exchangers #1, 2 and 3 fell from 76.0°F to 57.0°F, 79.5° to 59.5°, and 74.0° to 53.5°F, respectively. For this 76 day period, the rate of earth temperature decrease was approximately 0.25 degrees per day for all heat exchangers. This indicates that the rate of loss of stored heat from insulated Heat Exchangers #1 and 2 was essentially the same as that from uninsulated Heat Exchanger #3. Thus by December 21, 1970 (date of the first snowfall), the average earth temperatures in Heat Exchangers #1 and 2 were 3.5° and 6.0°F above that of Heat Exchanger #3, and consequently the heat stored in Heat Exchangers

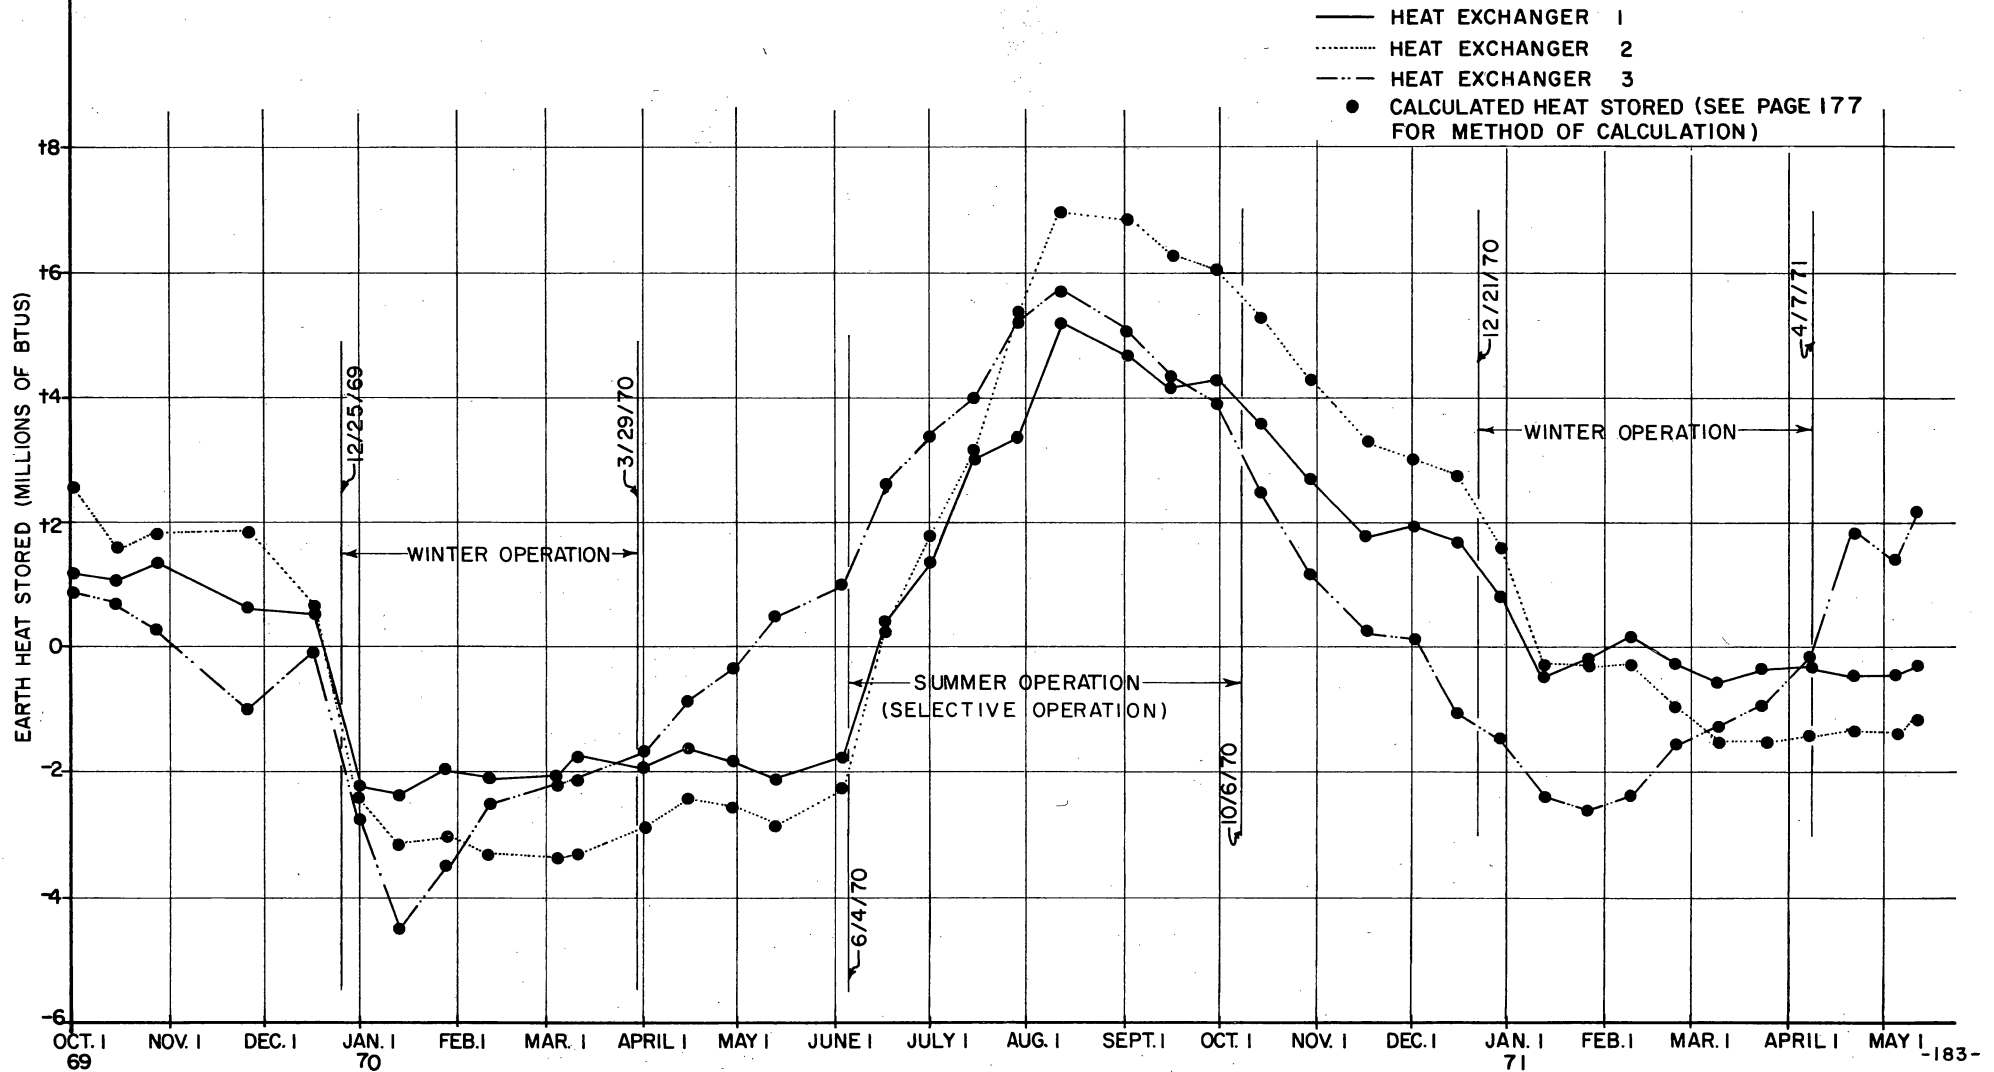
FIGURE G-2

HEAT STORED IN THE EARTH WITHIN HEAT EXCHANGERS
(OCT. 1, 1969 - MAR. 12, 1971)

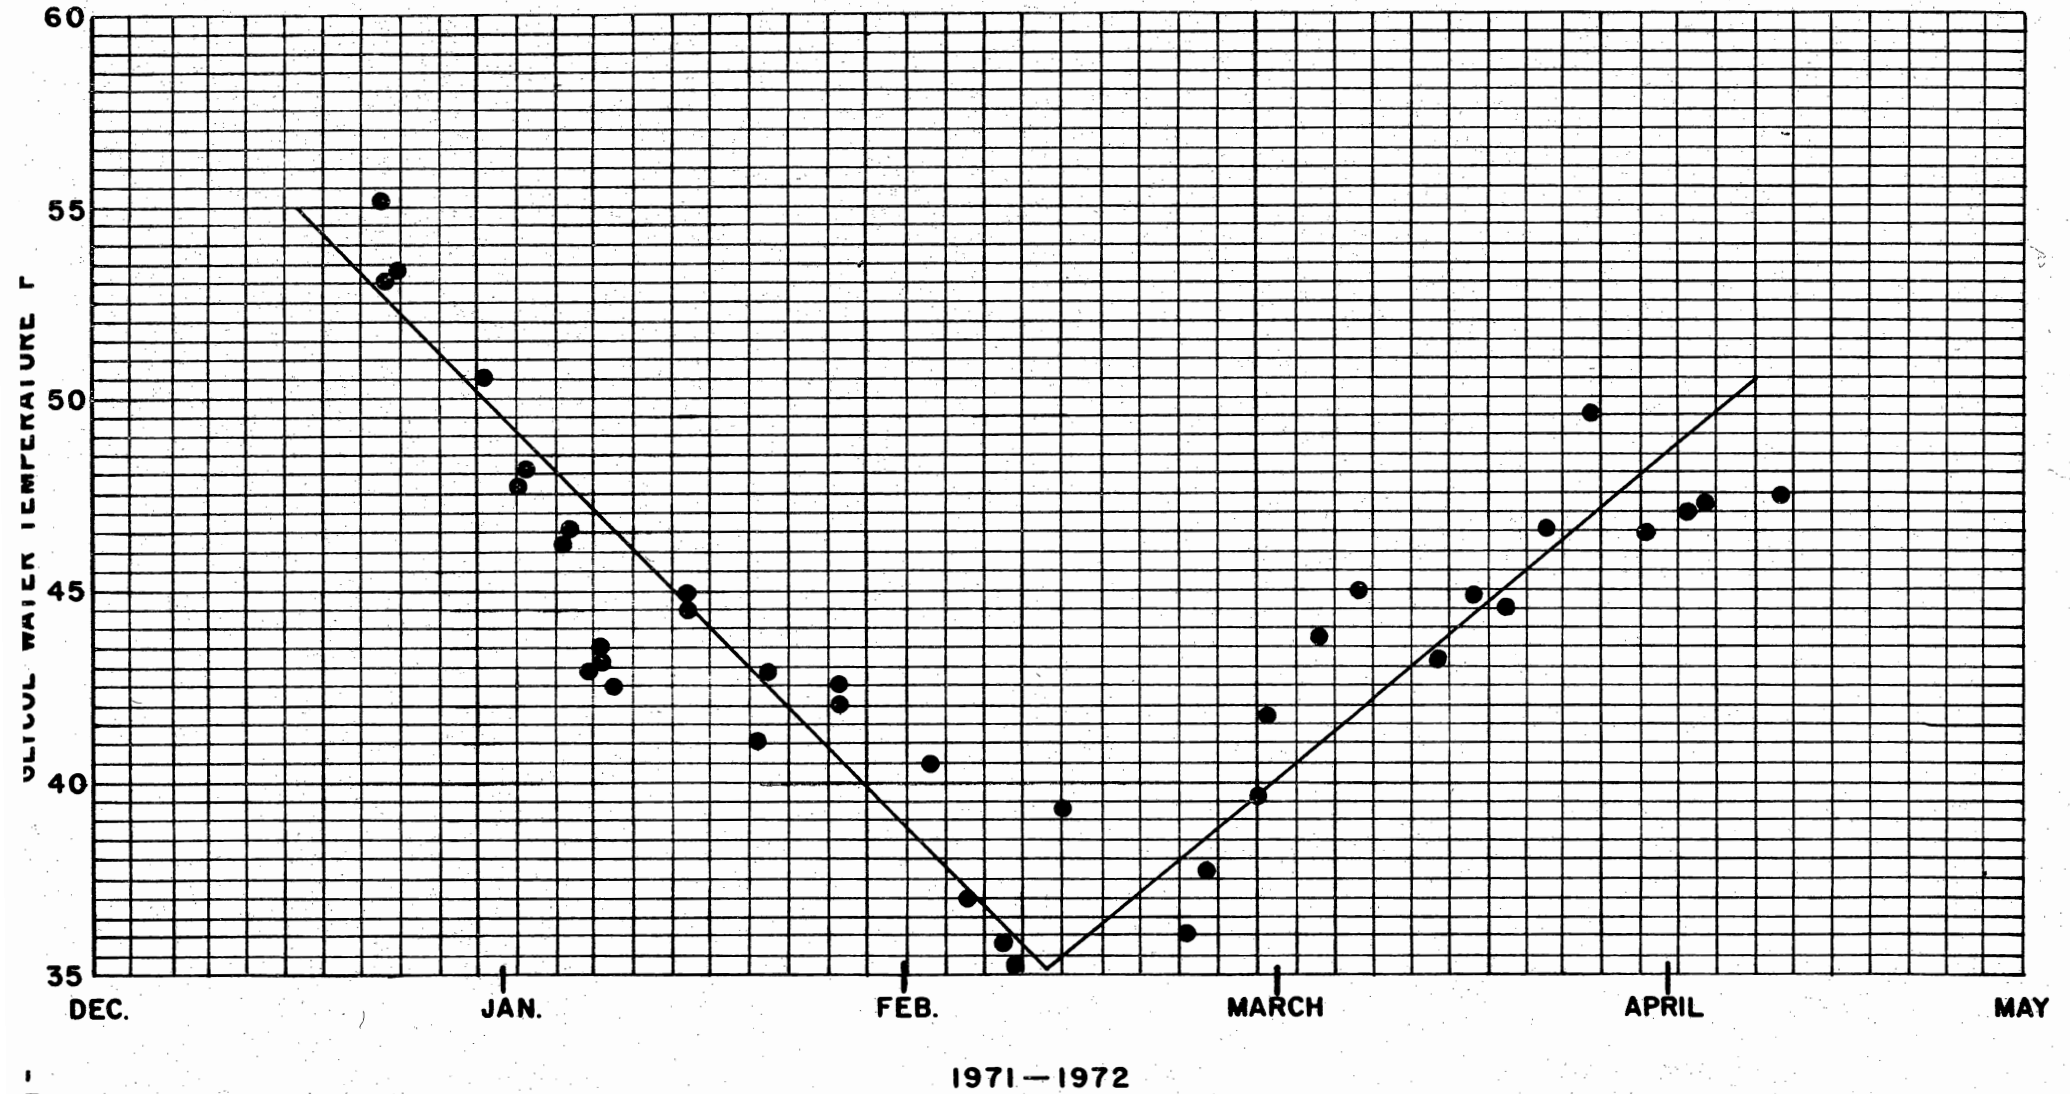
FIGURE G-3

GLYCOL-WATER TEMPERATURE (DECEMBER '71- MAY '72)

Temperate of Fluid Exiting From Heat Exchanger
No.3 and Entering Panels No.1, 2, 5 and 6.

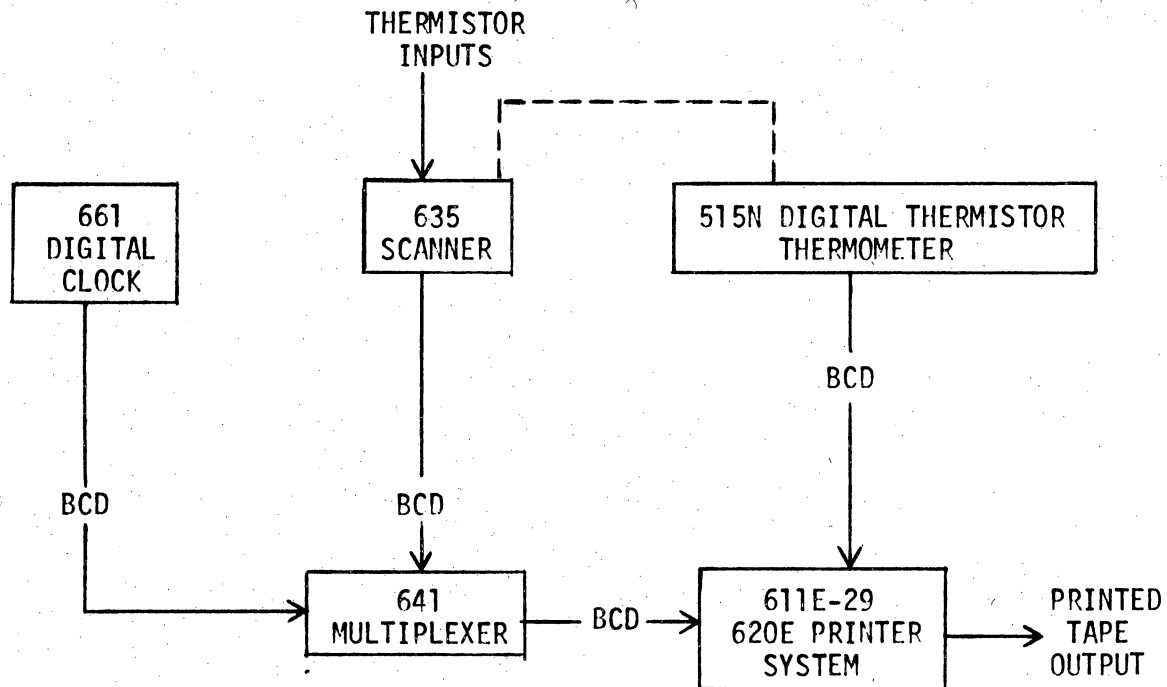
Figure G-4

DIGITEC INSTRUMENTATION DIAGRAM
