## Evaluation of the Automated Distress Survey Equipment

FINAL REPORT  
September 2009

New Jersey  
Department of Transportation  
Bureau of Research  
And  
U. S. Department of Transportation  
Federal Highway Administration

## **Pavement Distress Identification Manual**

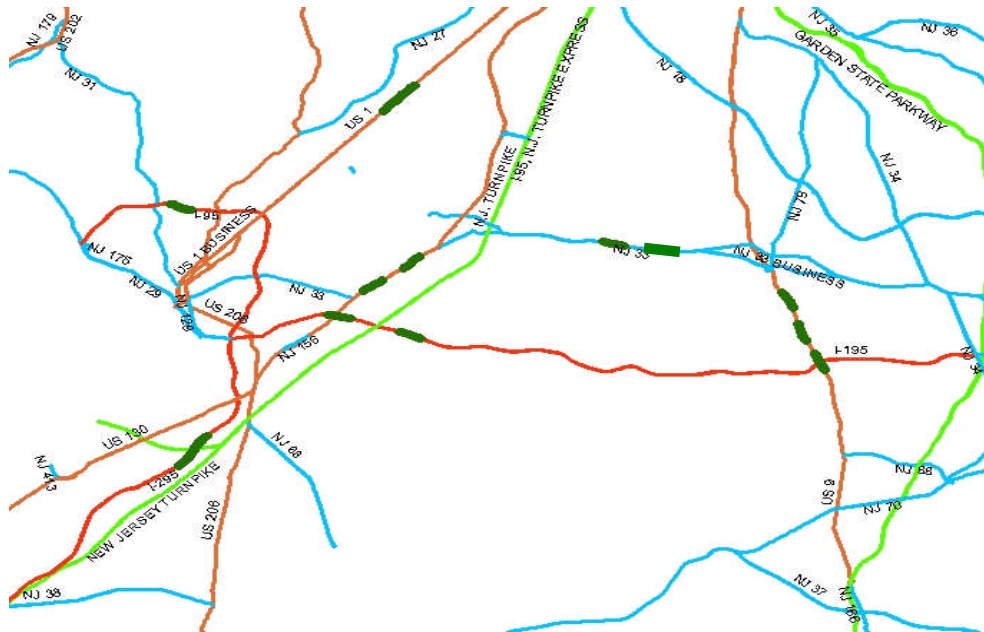
Figure 3. Test Site Map

period starting at 8:00 am, 12 noon, and 2:00 pm. Each site was tested at the posted highway speed. After the selection of test sites were finalized, route maps were developed. Table 4 is a list of the test site locations. Figure 3 provides the site map and test site locations. This allowed some variation in light conditions for the automated equipment and the PMS staff raters (e.g., east in morning or west in late afternoon or locations where shadows are a potential problem). As a part of this task, field testing plans and protocols were prepared for the use by vendors and NJDOT PMS staff.

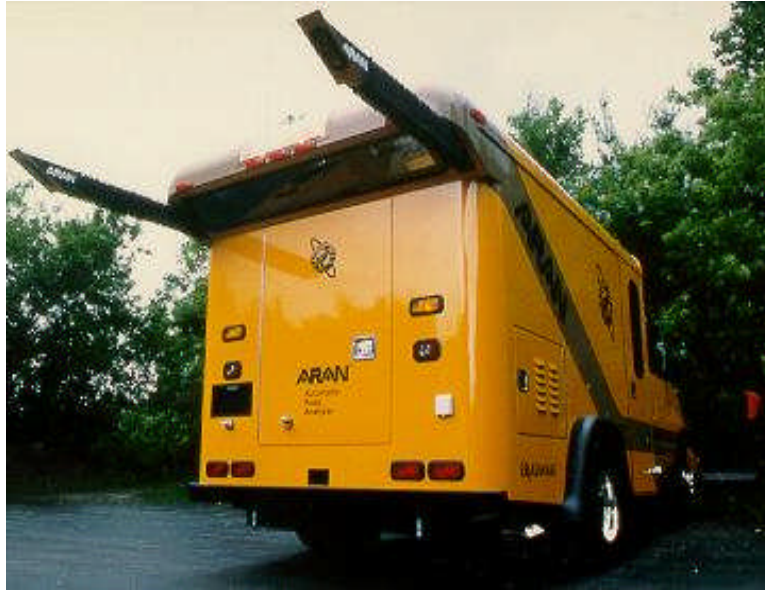
**Figure 4. ARAN Dual Camera System**

The ARAN unit's dual cameras (Figure 4) recorded continuous series of non-overlapping, area scan images that add to 4.9 ft (longitudinal) by 13 ft (transverse). The synchronized strobe lights eliminate shadows overhead objects. Images can be collected at variable highway speeds up to 50 mph.

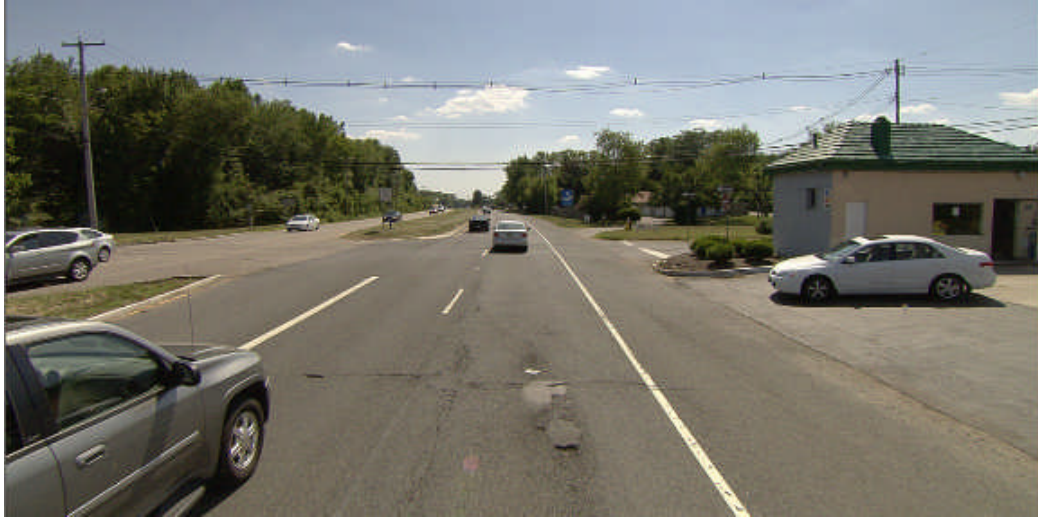
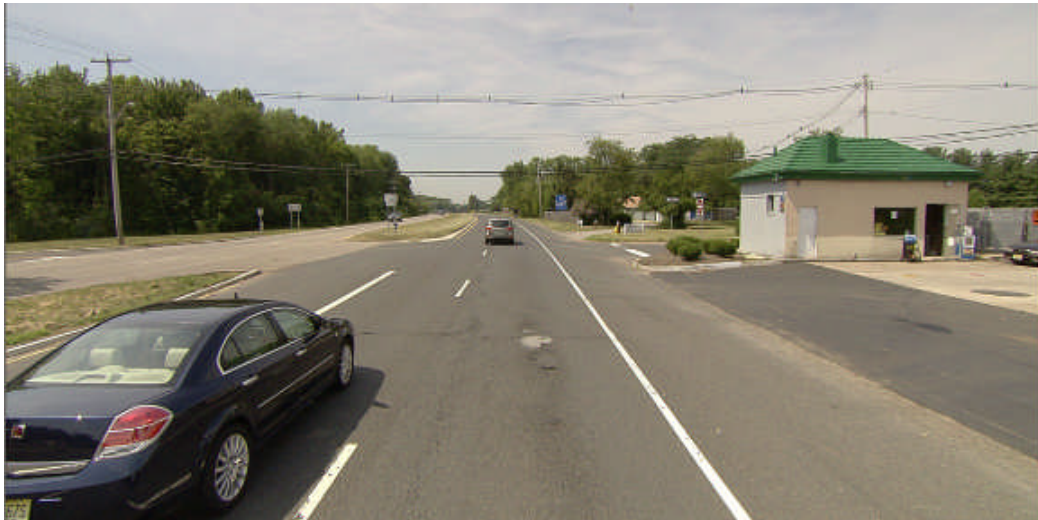
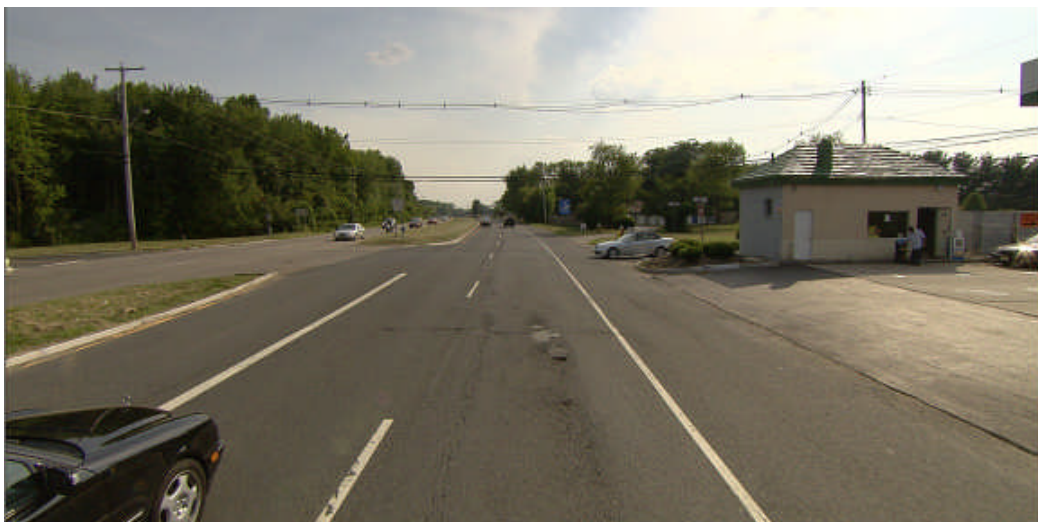
**Figure 6. Roadware-ROW images – AM, Midday, and PM**

Variations in natural lighting can affect the quality of camera images or characterization of the cracking observations for manual windshield or video ratings. Figure 6 and 7 illustrate the variations in image quality due to variations in natural lighting that affect manual windshield ratings or ratings performed from right of way video images.

The strobe system used by the Roadware area-scan imaging system and the INO laser lighting used by the Dynatest line-scan imaging system provide consistent lighting of the pavement surface. This ensured enhanced quality of the image for use in the Wisecrux and Automated Distress Analysis software systems. Figure 8 and 9 provide illustrations of the pavement images taken at the same time as the row of way image in Figure 6 and 7.

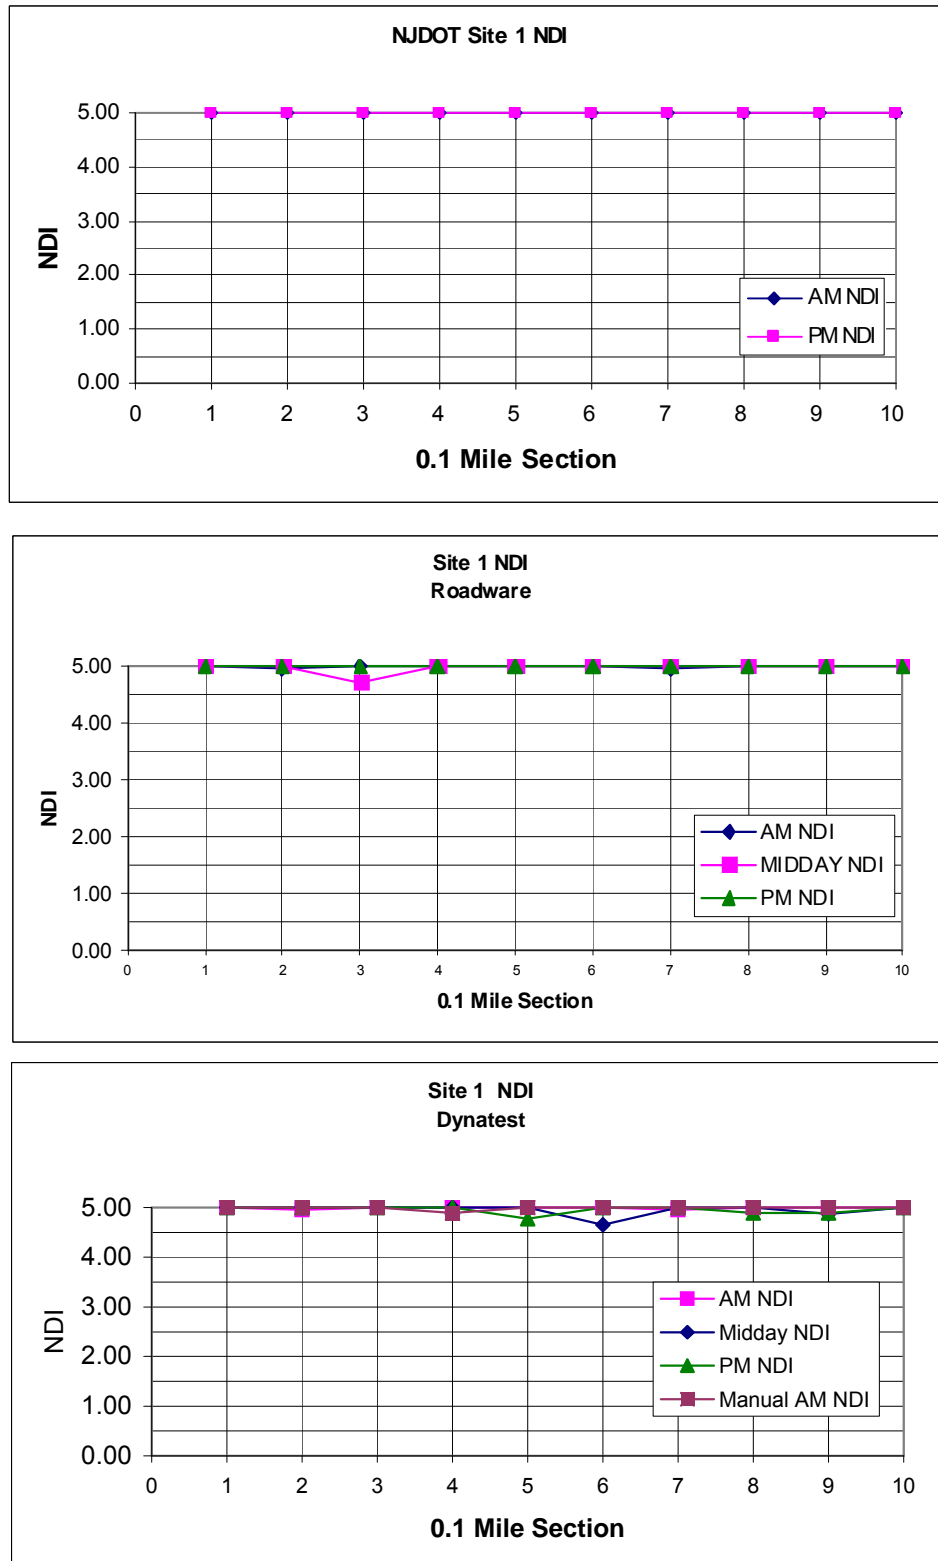
Figure 10. Site 1 Comparison of NDI

Site 1 was a new pavement. This site was included to determine if the vendor's system and analysis would detect "cracks" in the new pavement.

Figures 10-21 provides a visual comparison of the multiple runs from the NJDOT and vendor equipment and analyses.

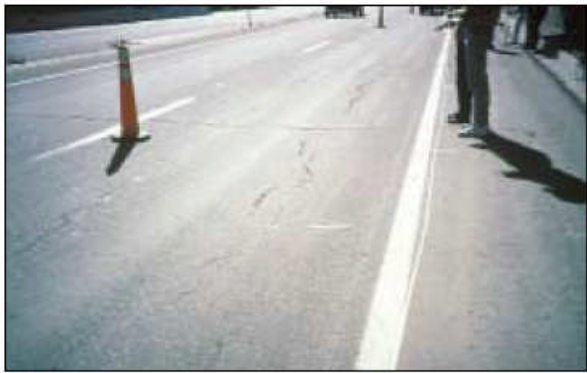
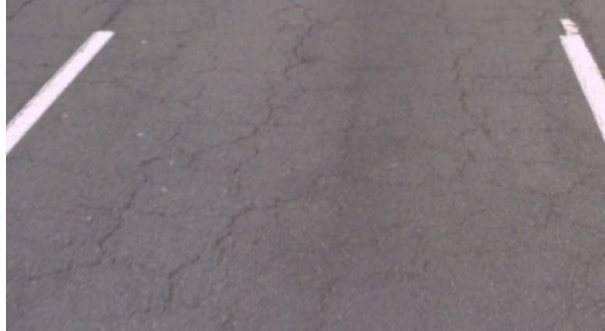
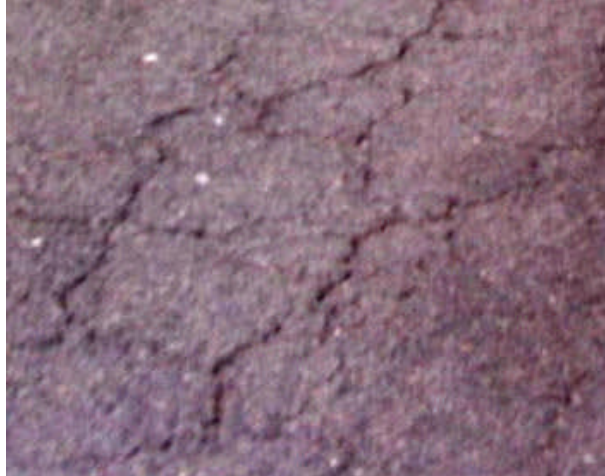
**Figure 4. Illustrations of Multiple Cracking Levels**

Rating is based on the impression of overall severity of the Multiple cracks for the pavement area. If different severity levels existing within an area, rate the distress at the highest severity level.

<p><b>Low Severity Multiple Cracking</b></p>

<p><b>Moderate Severity Multiple Cracking</b></p>

<p><b>High Severity Multiple Cracking with Spalled Interconnected Cracks</b></p>

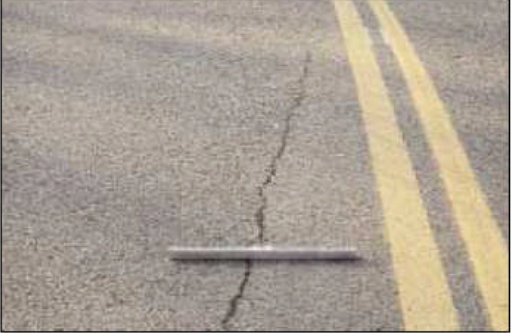
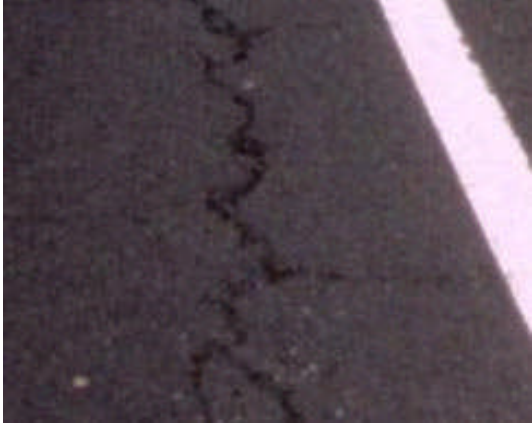
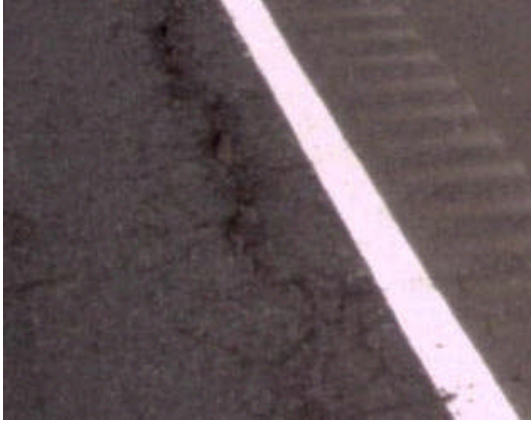
**Figure 6. Illustrations of Longitudinal Cracking Levels**

A photograph of a road surface showing a single, narrow longitudinal crack. A metal rod is placed horizontally across the crack to provide a scale reference. The crack is located between two yellow double lines.	Low Severity Longitudinal Cracking

A close-up photograph of a road surface showing a longitudinal crack that is wider and more irregular than the low severity example. A white line is visible on the right side of the frame.	Moderate Severity Longitudinal Cracking

A close-up photograph of a road surface showing a longitudinal crack that is very wide and deep, with visible raveling and crumbling of the asphalt material along the crack edges. A white line is visible on the right side of the frame.	High Severity Longitudinal Cracking

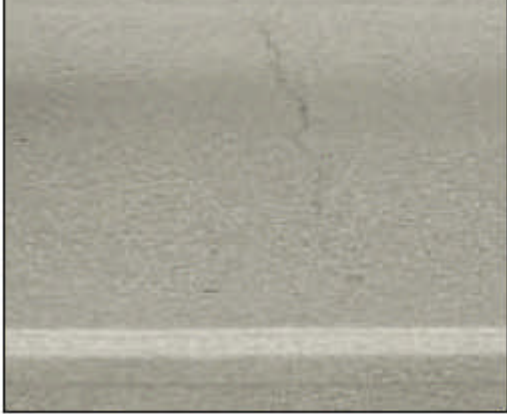
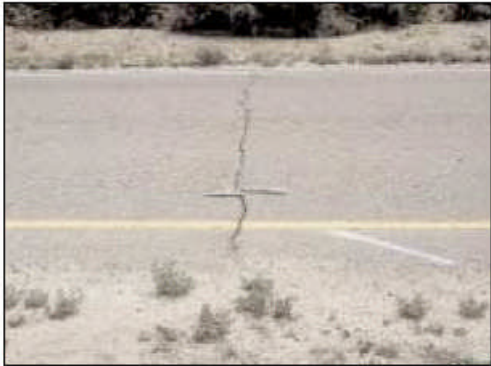
**Figure 8. Illustration of Transverse Cracking Levels**

Record number of transverse cracks at each severity level. Rate the entire transverse crack at the highest severity level present for that crack.

<b>Low Severity Transverse Cracking</b>

<b>6—Moderate Severity Transverse Cracking</b>

<b>High Severity Transverse Cracking</b>

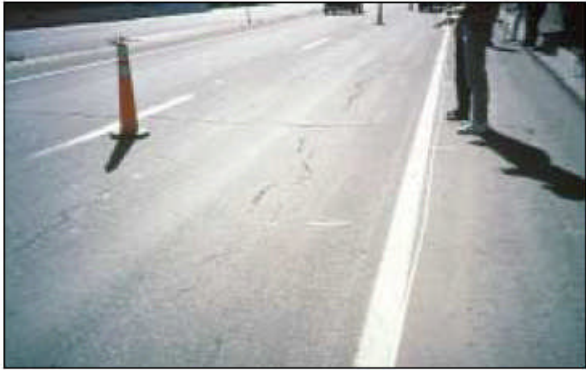
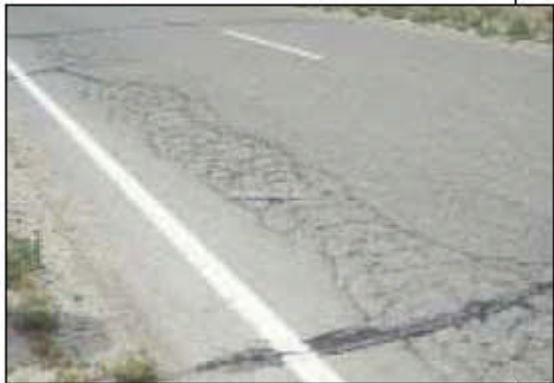
**Figure 12. Illustration of Longitudinal Multiple Cracking Levels**

Rating is based on the overall crack widths of the Longitudinal Multiple cracks for the pavement area. If different severity levels existing within an area cannot be distinguished, rate the entire area at the highest severity present.

<p><b>Low Severity Longitudinal Multiple Cracking</b></p>

<p><b>Moderate Severity Longitudinal Multiple Cracking</b></p>

<p><b>High Severity Longitudinal Multiple Cracking with Spalled Interconnected Cracks</b></p>

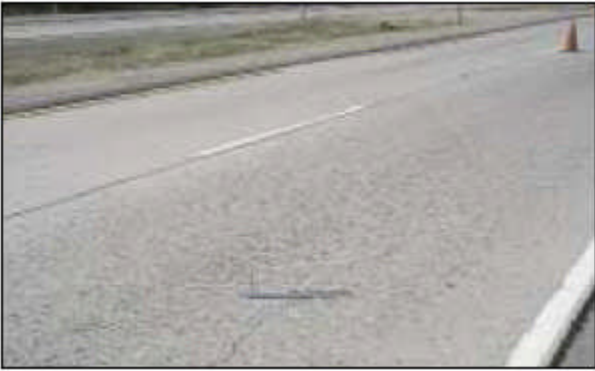
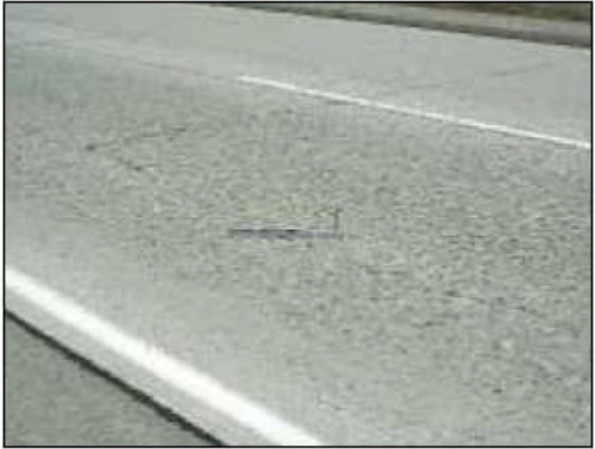
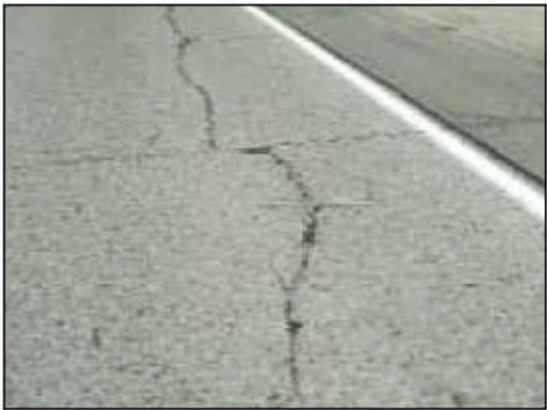
**Figure 18. Illustration of Longitudinal Cracking Levels**

Record length in feet of cracks at each severity level.

<b>Low Severity Cracking</b>

<b>Moderate Severity Cracking</b>

<b>High Severity Cracking</b>

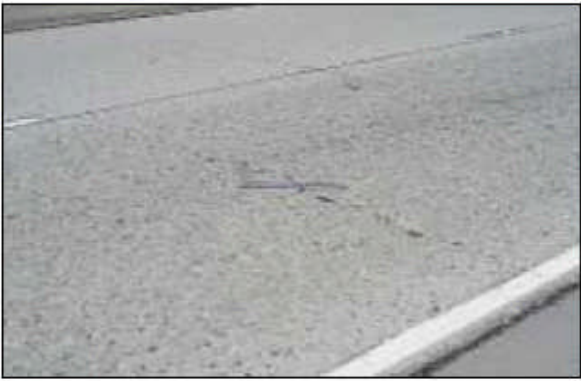
**Figure 19. Illustration of Transverse Cracking Levels**

Record number and length of transverse cracks at each severity level. Rate the entire transverse crack at the highest severity level present.

<b>High Severity Transverse Cracking</b>

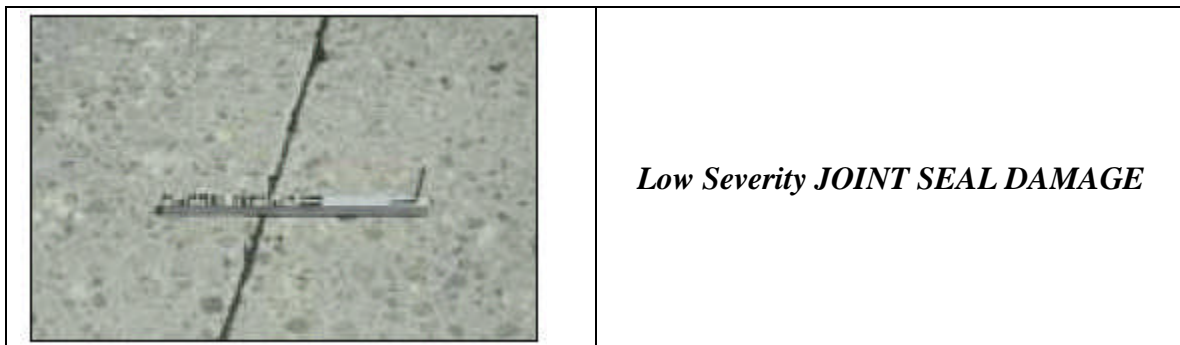
**Figure 20. JOINT SEAL DAMAGE**

Record total length of sealed longitudinal joints with joint seal damage as described above.
