**Design and Fabrication of Orthotropic Deck Details**

FINAL REPORT  
Vol. III  
February 2016

## **6. DESIGN OF FULL-SIZE SPECIMEN AND TEST SETUP**

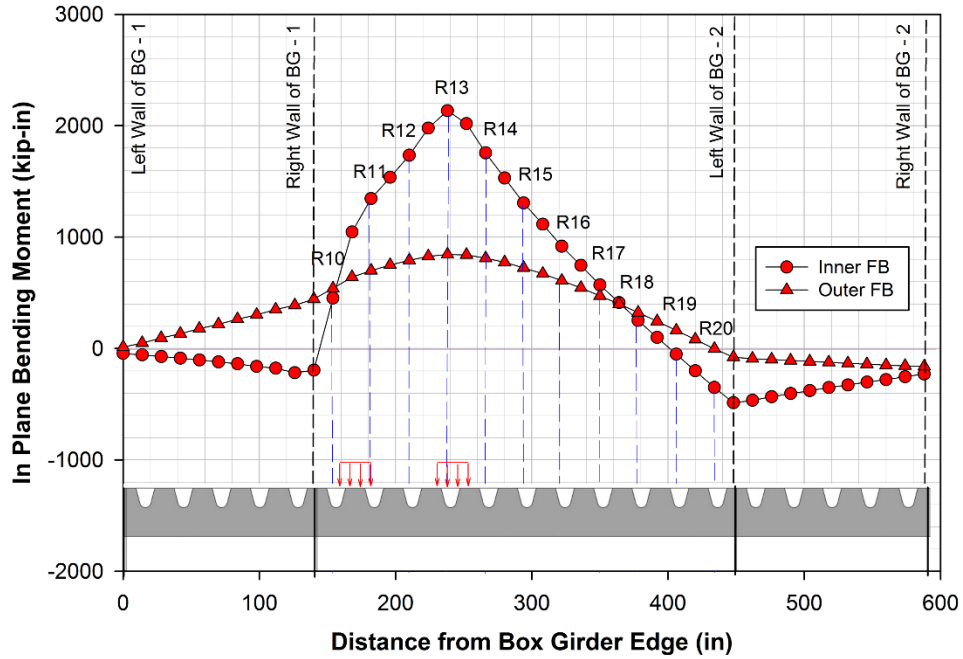
Figure 237. Variation of in-plane bending moment in floor beams

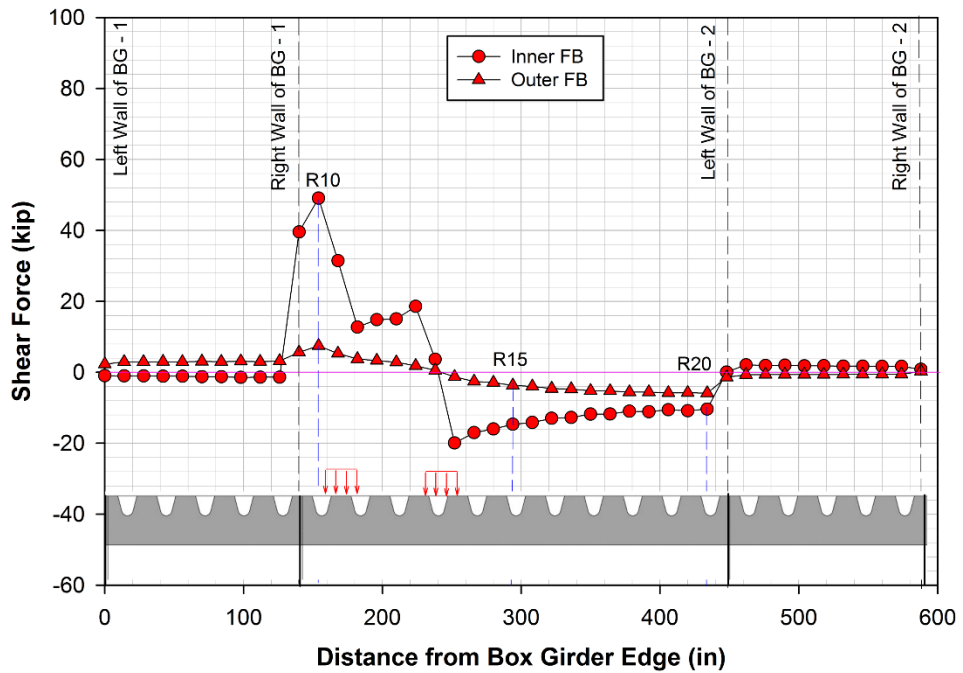
Figure 238. Variation of shear in floor beams

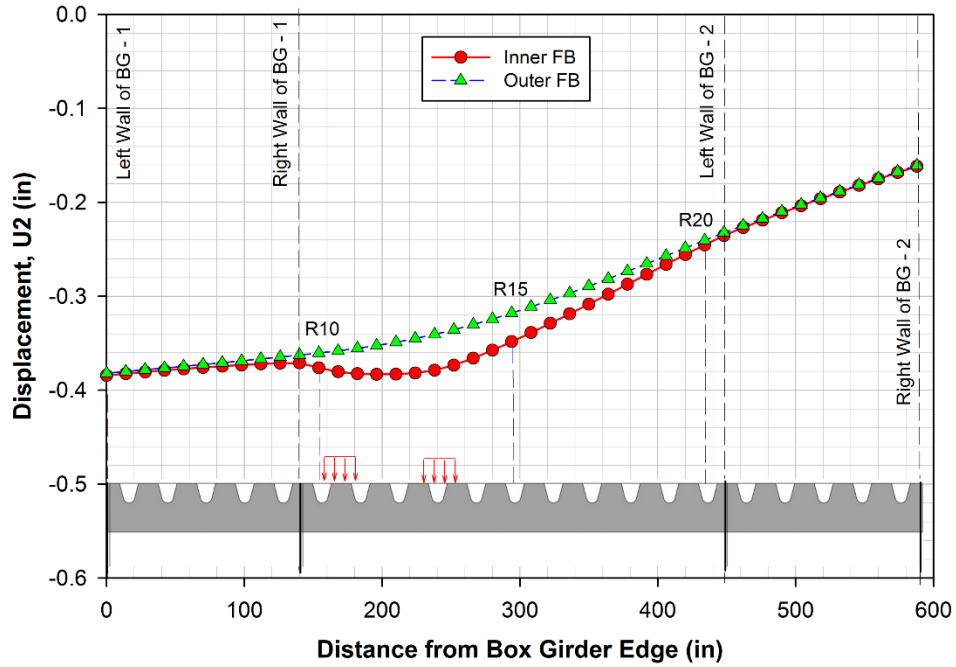
Figure 240. Comparison of deflection of inner and outer floor beam

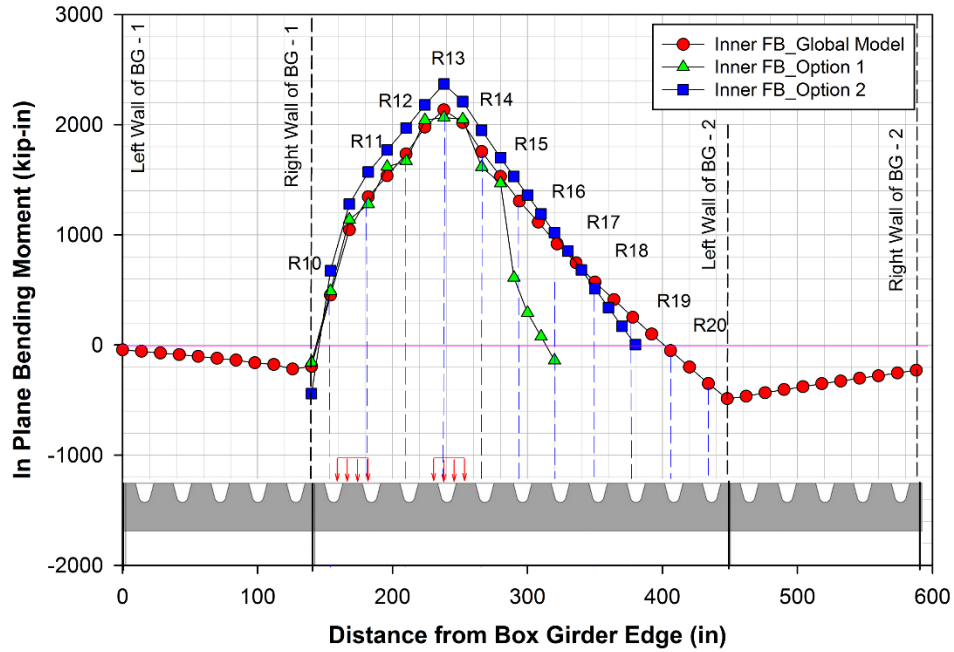
Figure 244. Comparison of in-plane bending moment of inner FB in Option 1 and Option 2 with global model

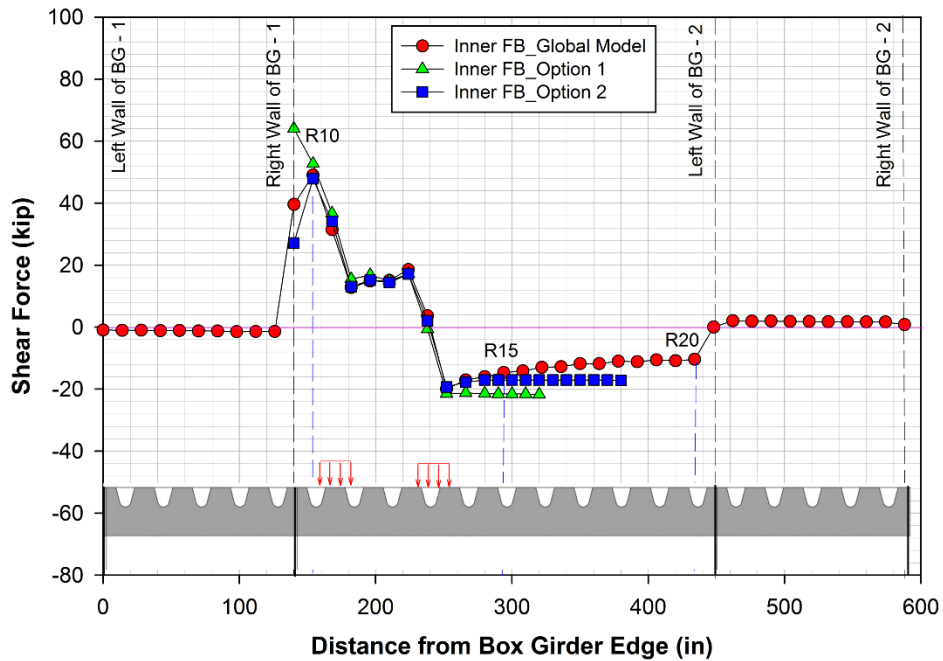
Figure 245. Comparison of shear in inner FB in Option 1 and Option 2 with global model

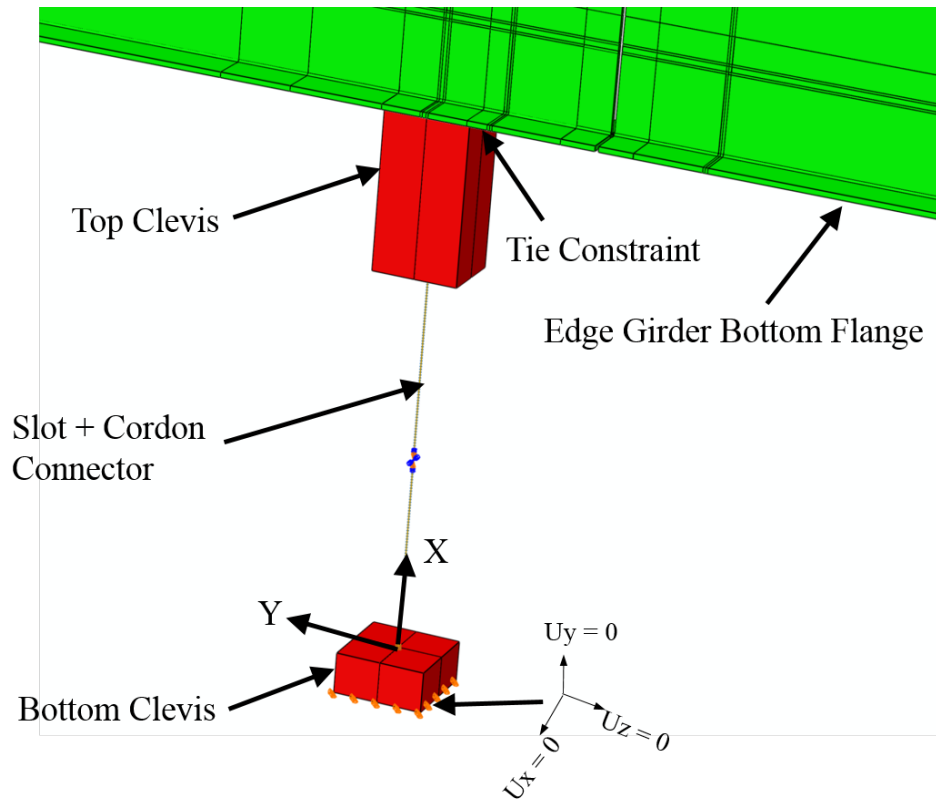
Figure 260. Under-deck actuator arrangement in specimen model

giving the design lift-up was floor mounted and the top and bottom clevises of the actuator was arrange to allow in-plane rotation of the inner floor beam. To account for this, the top and bottom clevises of the under-deck actuator were modelled as solid blocks and the hydraulic jack was modelled by a “slot and cordon” connector element. The connector element was given a vertical displacement boundary condition of 0.1 in. and rotational degree of freedom about y-axis of the element or in-plane rotation of the inner FB. The bottom surface of the bottom clevis of the simulated actuator was restrained against displacement in all three directions to simulate the condition of under-deck actuator being fixed to the lab floor through the actuator support. The bolted connection between the bottom flange of the edge girder and the top clevis of the actuator was modelled as tie constraint in the specimen model. The arrangement of the under-deck actuator in the specimen model is shown in Figure 260.

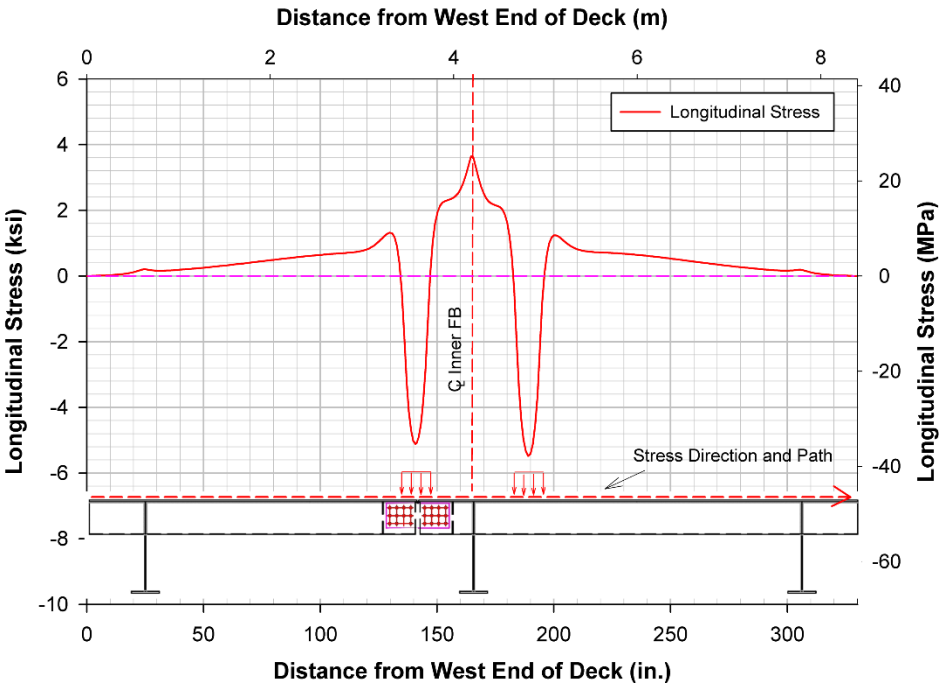
Figure 263. Variation of longitudinal stress on the top of the deck plate along a path through the south load pads

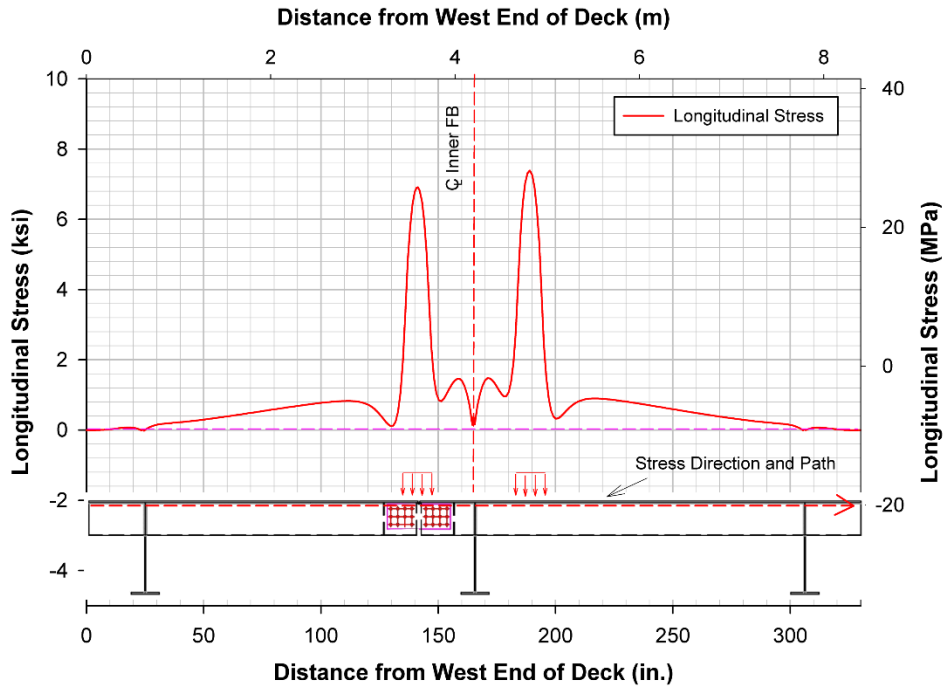
Figure 264. Variation of longitudinal stress on the bottom of the deck plate along a path through the south load pads

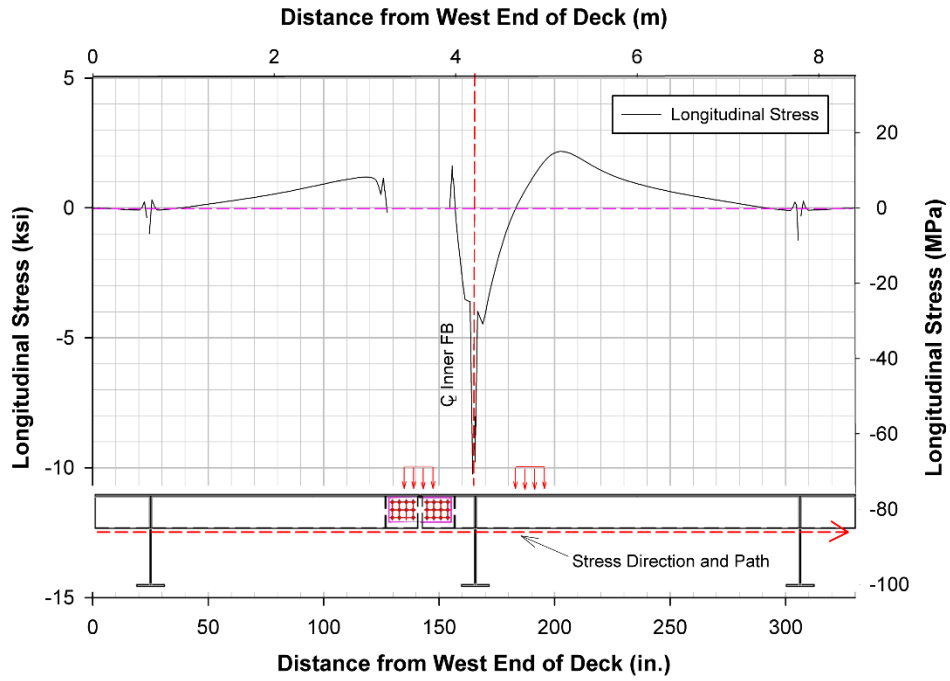
Figure 266. Variation of longitudinal stress on the bottom of Rib 4 along a path through the north load pads

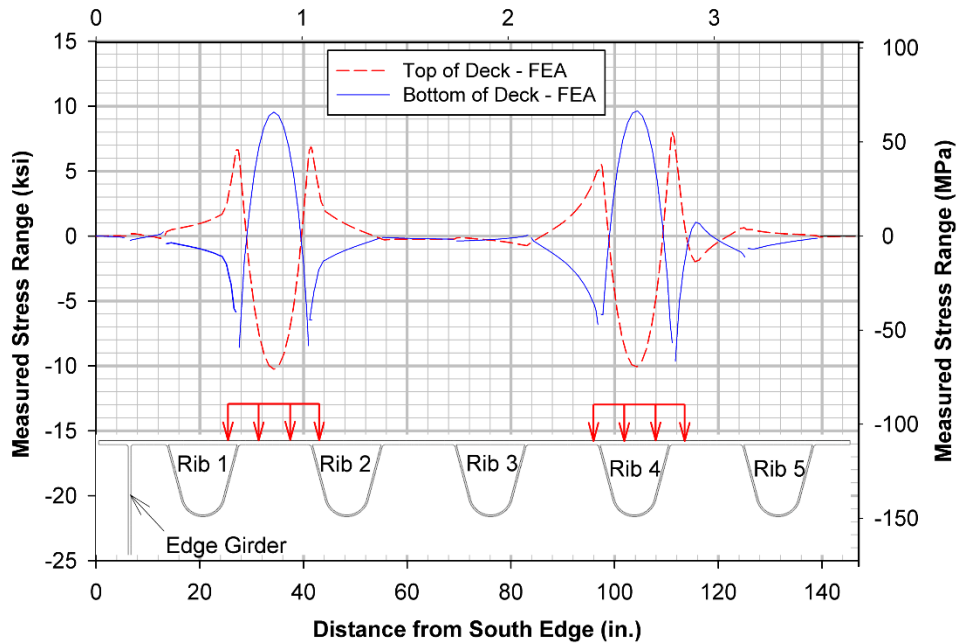
Figure 268. Transverse stress distribution of deck plate at a section through the load pads

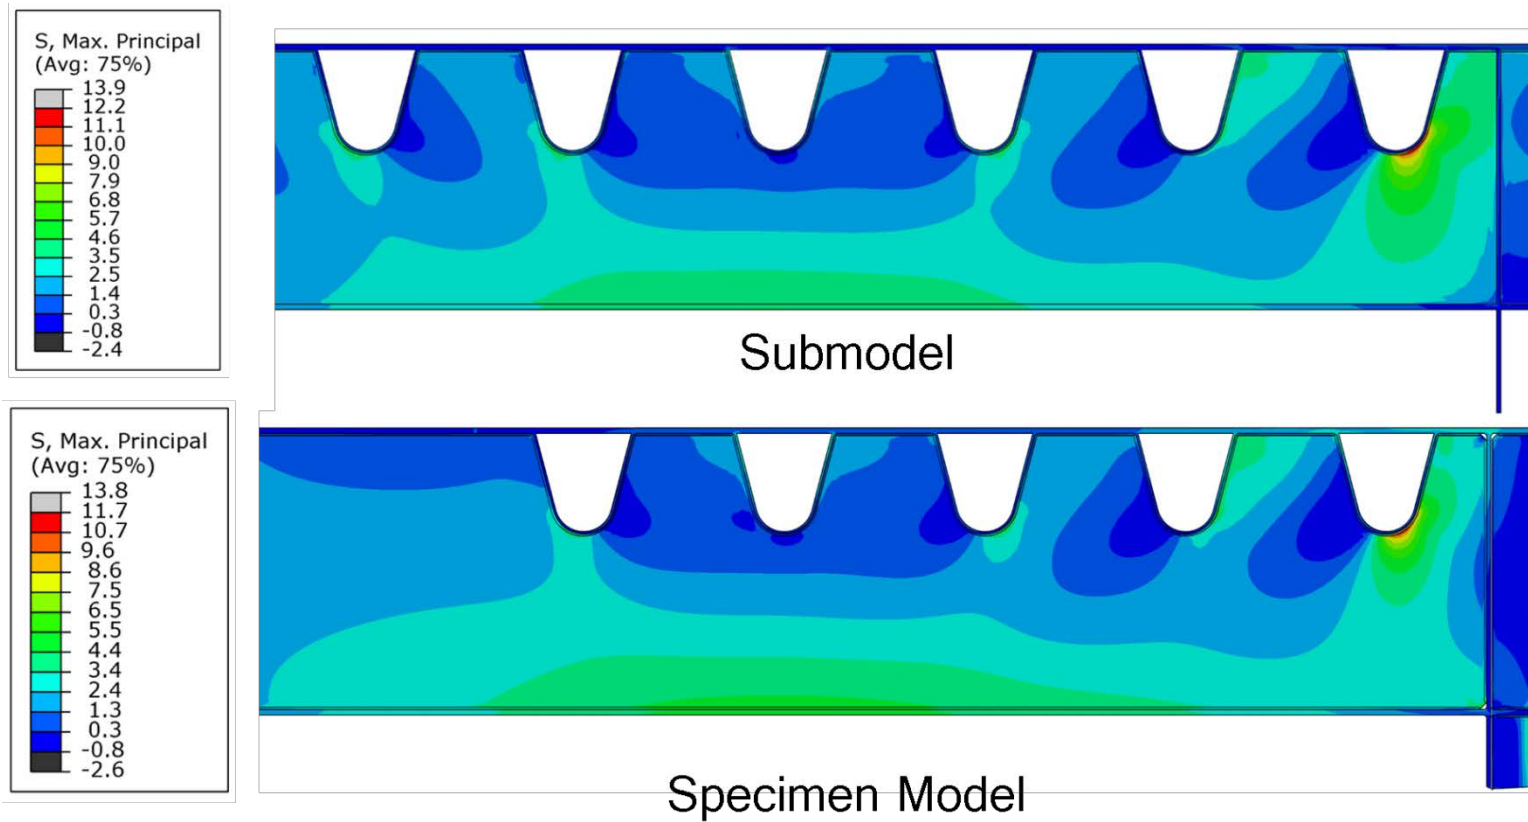
Figure 275. Principal stress comparison between specimen model and submodel

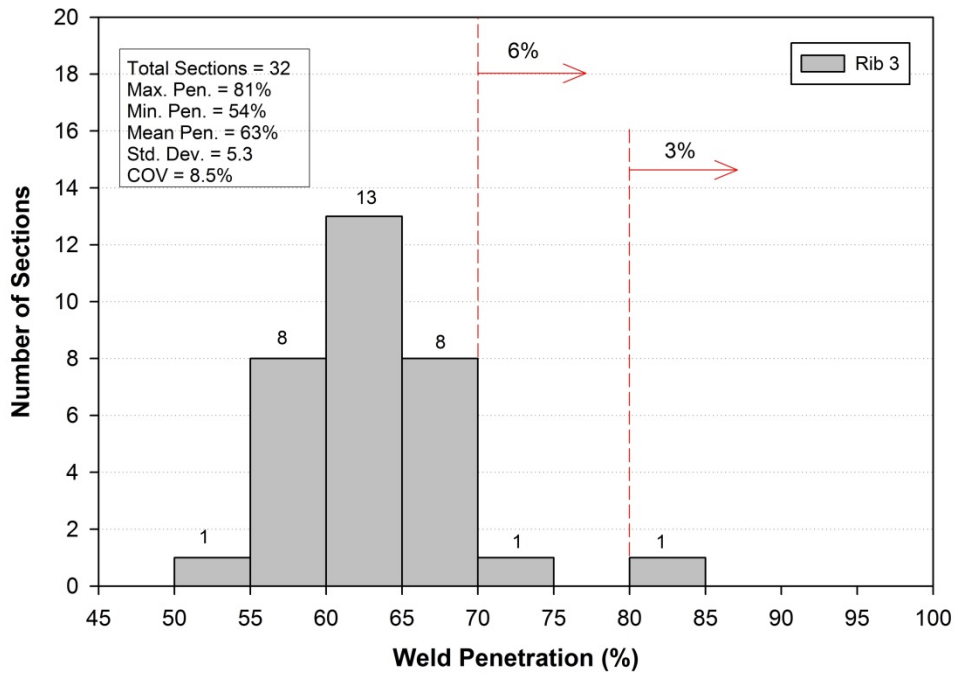
Figure 302. Distribution of weld penetrations (%) for Rib3 of MU5

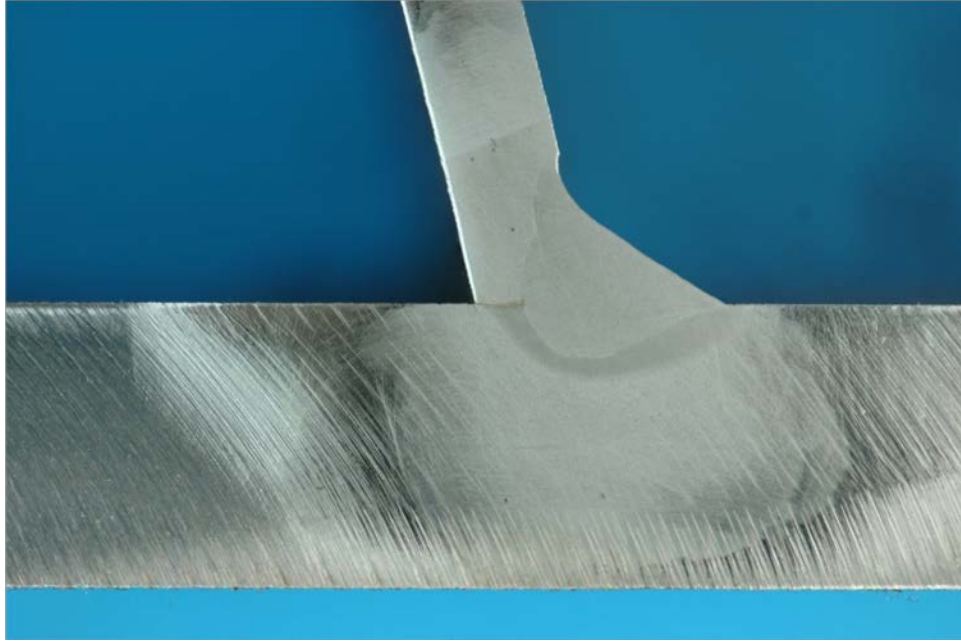
Figure 305. A typical macro-etched section for Rib 3 in MU5

deck plate end and under fill at the rib end) as MU4 and the mock up specimens of Phase 2, which is indicative of higher heat input that was used to achieve penetration without a joint preparation. The macro etched sections of Rib 3, which was welded with a lower heat input, did not exhibit the wash down profile. However, severe undercutting was noted at the rib end. Apparently, welding of this rib was not adequately performed, which was also evident by meandering of the welds between 156 in. and 180 in. on side A that was observed during PAUT measurements. The weld cross section for all ribs showed more inclination towards the deck plate, and a splay near the surface. Such splayed cross section is indicative of AC welding process that was used for these rib fabrication, and/or higher heat input or slower welding speed, as was explained in the Phase 2 studies (section 5.2, contained in Volume II).

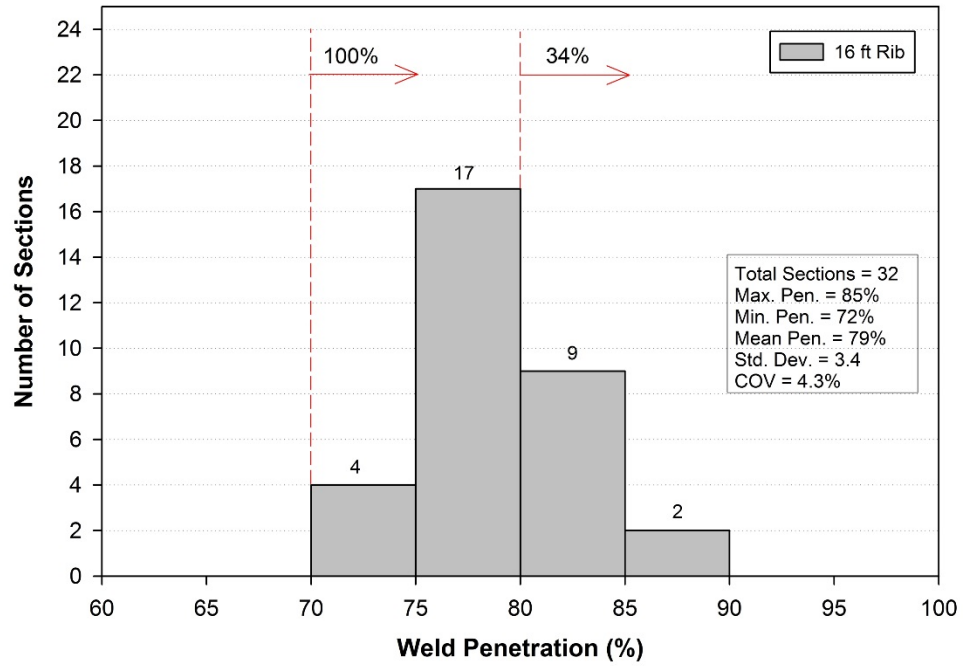
Figure 313. Distribution of weld penetration (%) of rib-to-deck plate weld for MU8

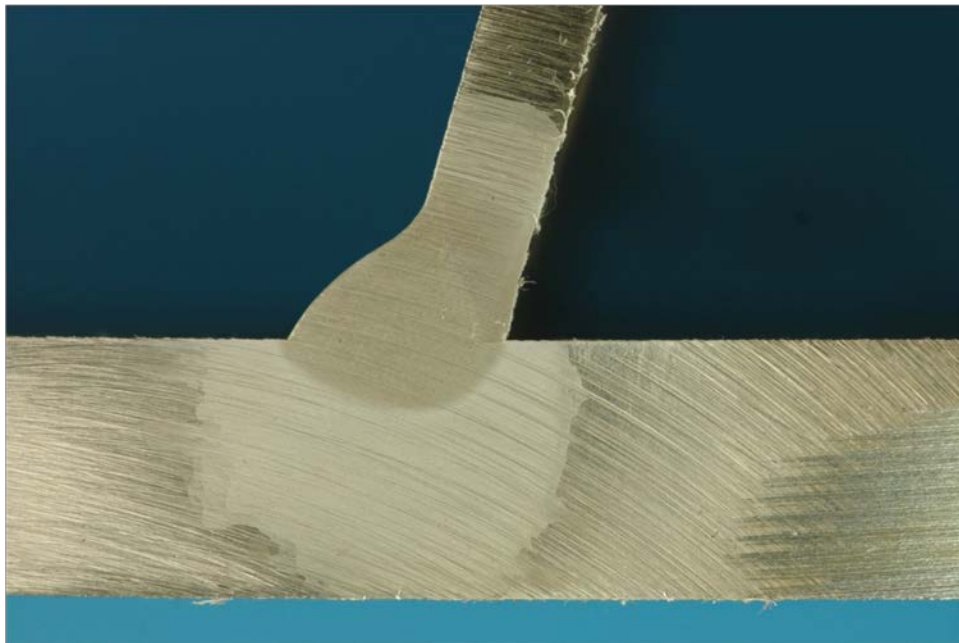
Figure 314. A typical macro-etched section for MU8

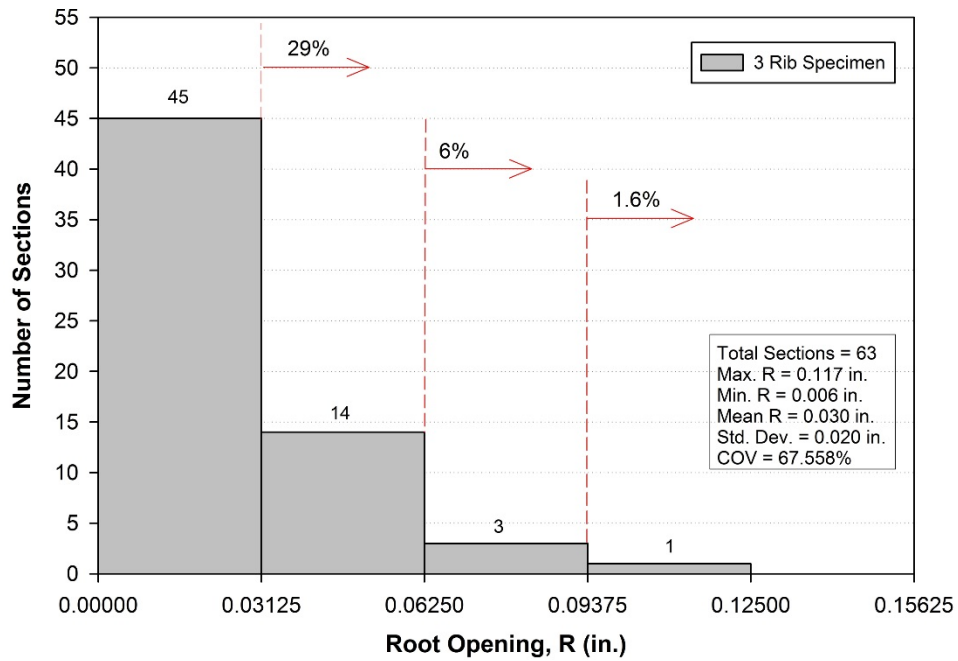
Figure 318. Distribution of R for MU5

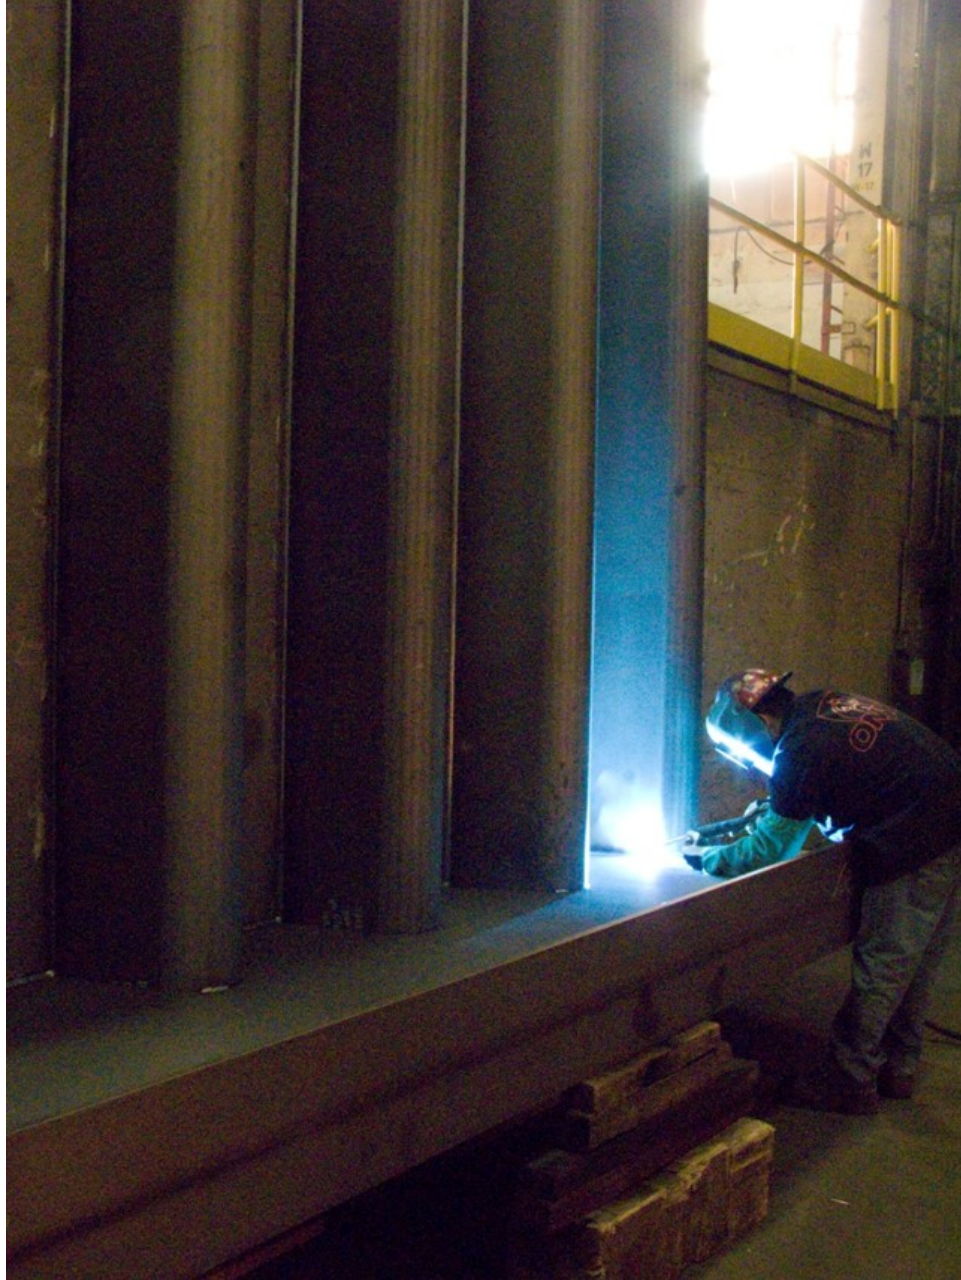
Figure 333. Rib-to-floor beam welding in 2F position
