PROJECT TITLE: IMPROVING MARSH RESTORATION

GRANTEE ORGANIZATION NAME: NJ DEPARTMENT OF ENVIRONMENTAL PROTECTION

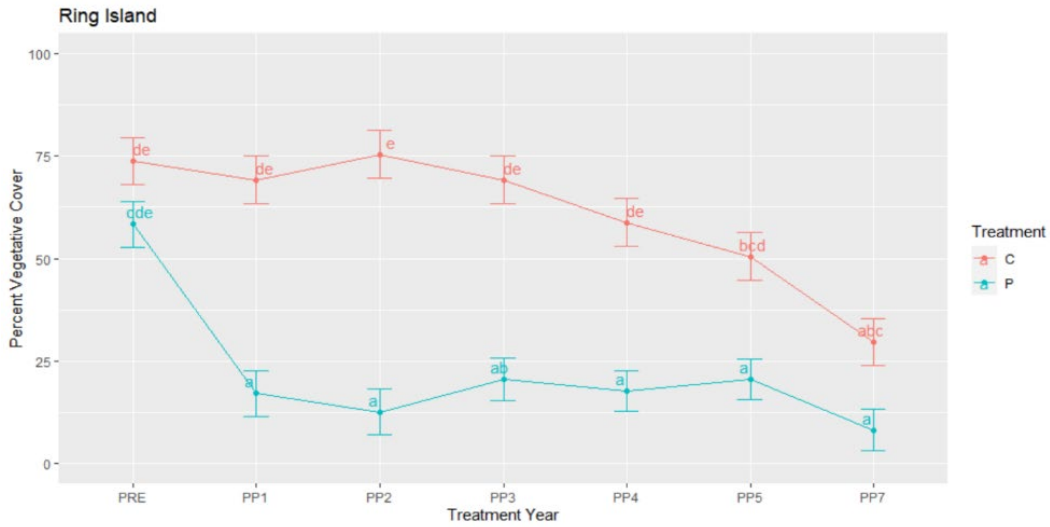
Figure 27. Percent cover by plants at Ring Island in plots in both Control (C) and Placement Areas (P) overtime. Data presented are means \pm one standard error.

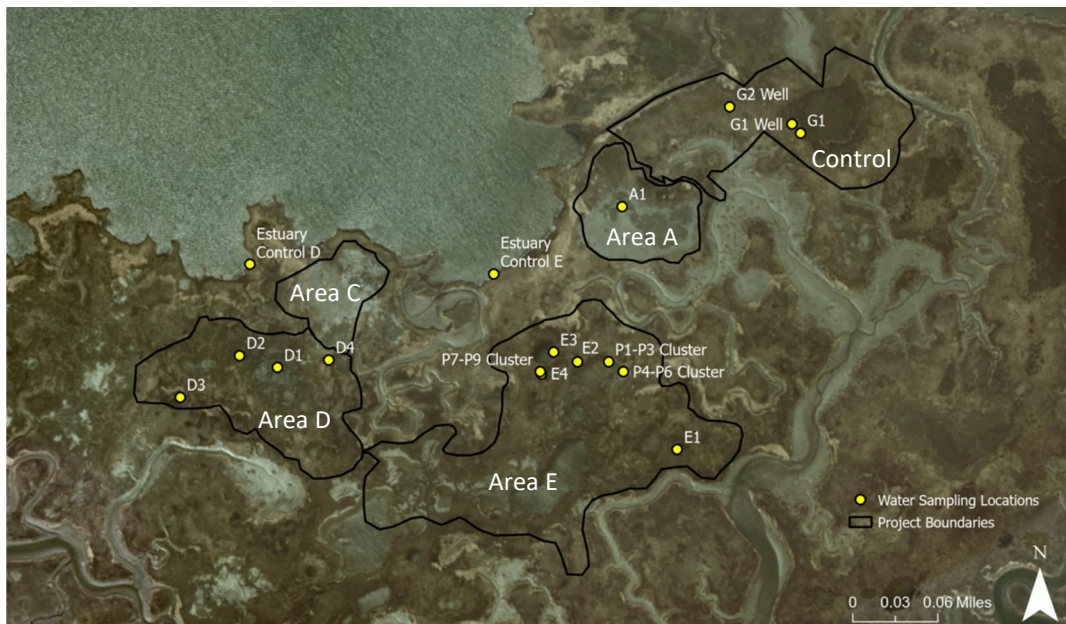
Figure 59. Map of sampling locations for groundwater and surface water.

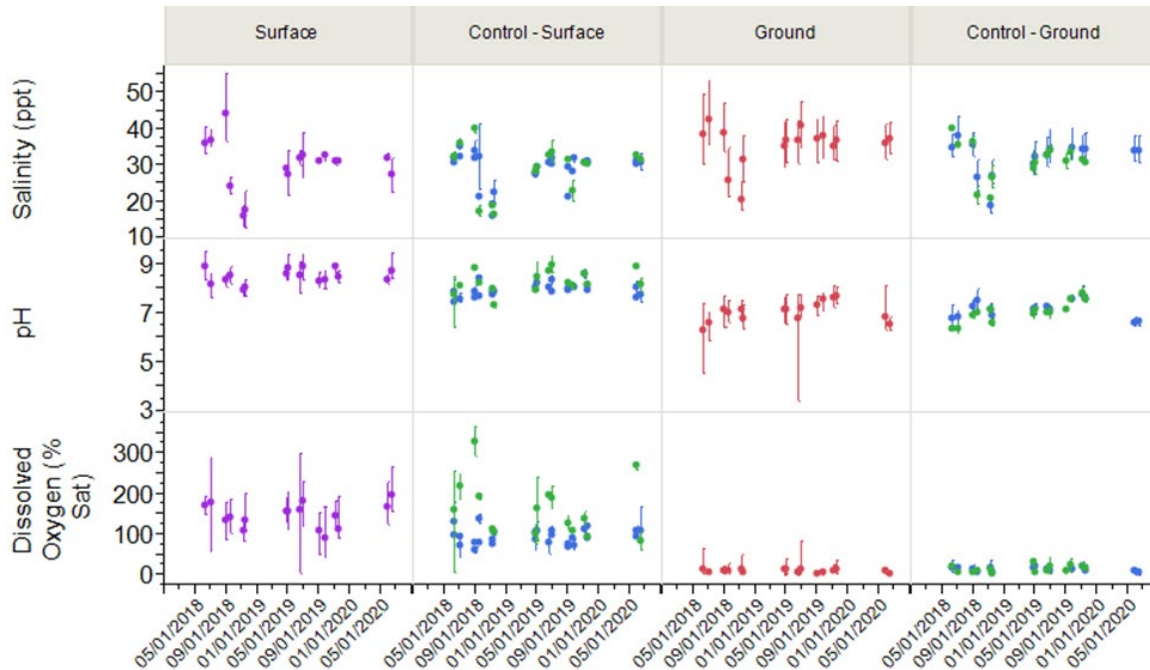
Figure 60. Graphs of mean and range of measurements for Salinity (ppt), pH, and Dissolved Oxygen (%) of Surface Water Sites, Surface Control (Blue) and Reference (Green) Sites, Groundwater Sites and Groundwater Control (Blue) and Reference (Green) Sites, 2018-2020.

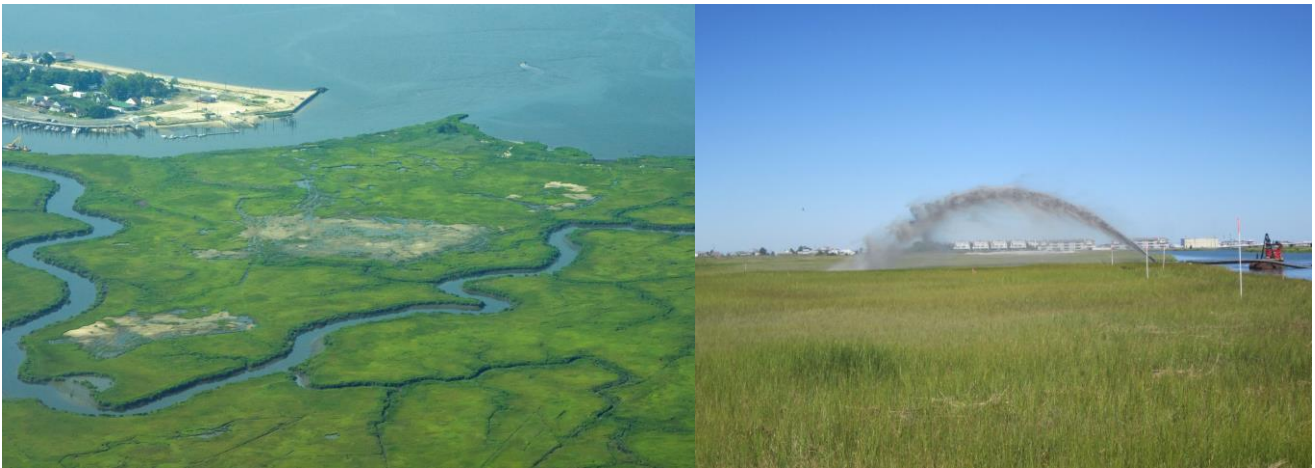
Project Summary and Lessons Learned August 2021

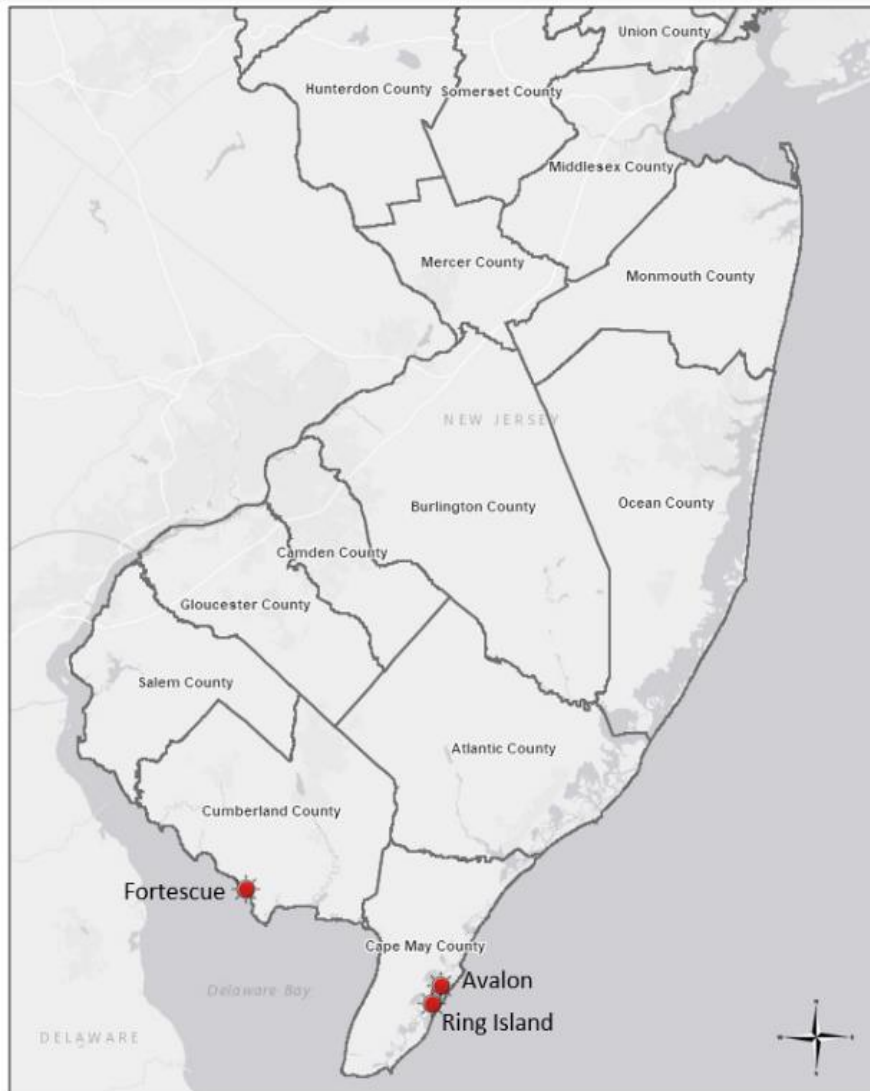
Figure 1. Pilot projects for the beneficial use of dredged material were implemented at three locations in New Jersey.

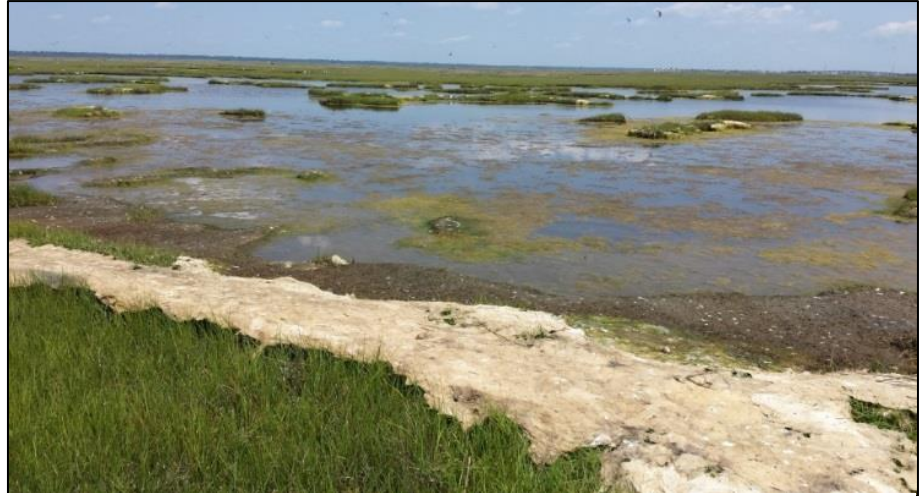
Figure 14. Expanded and degraded pools were present at the Avalon marsh. The white wrack in the picture is dried algae from the pond.

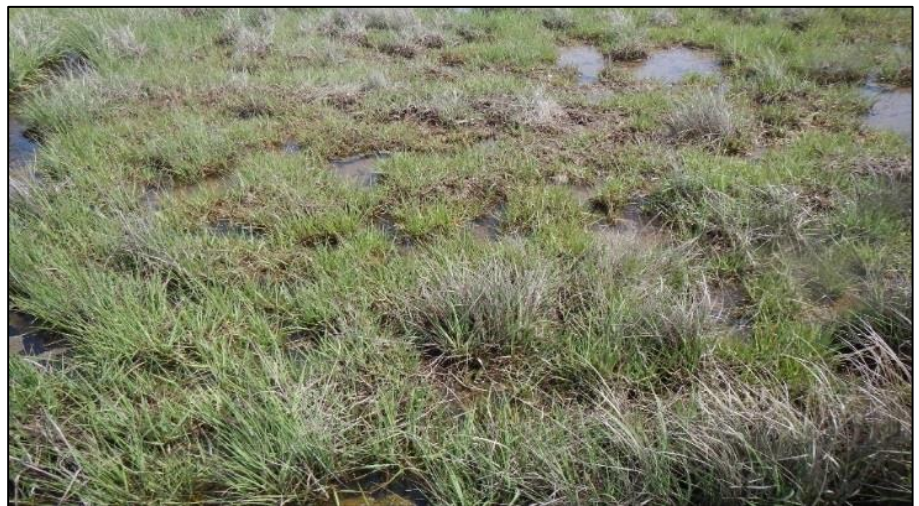
Figure 15. Vegetation at the Avalon marsh was sparse.

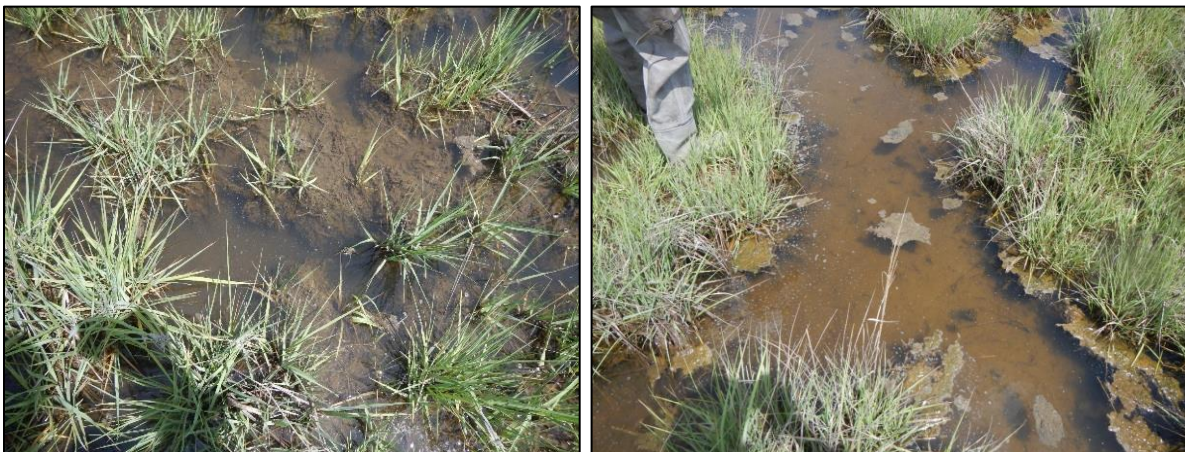
Figure 17. At Fortescue, the team noted stunted vegetation on an unstable marsh platform (wobbly hummocks of *Spartina* spp. surrounded by unconsolidated mud).

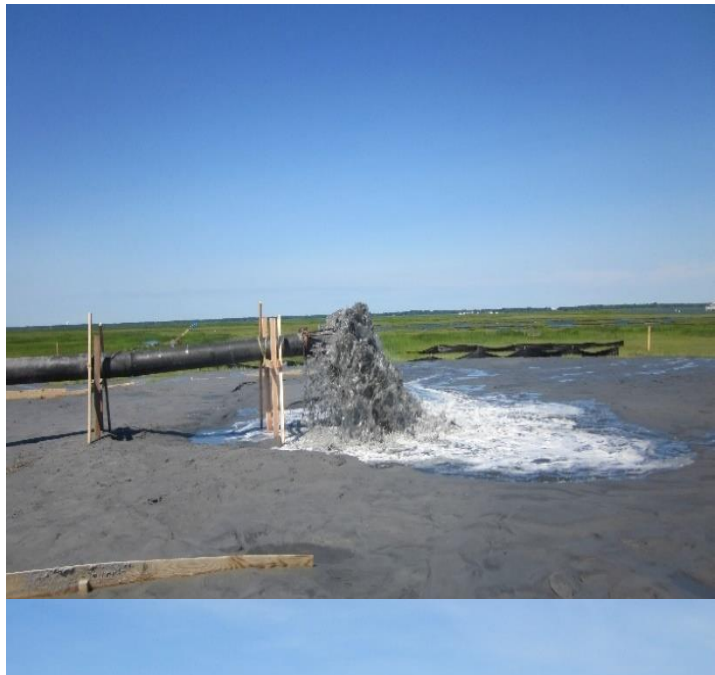
Figure 23. Containment measures were placed around the Ring Island Enhanced Nesting Habitat site.

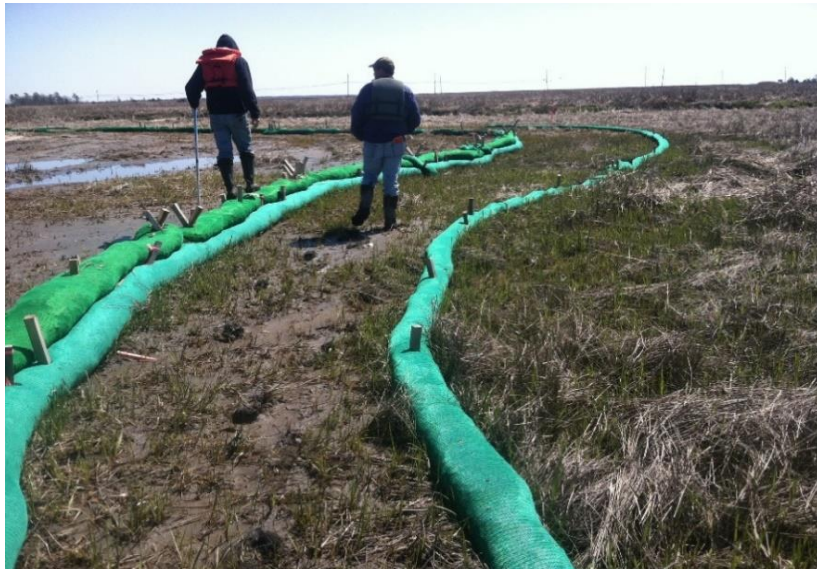
Figure 34. At Fortescue, the team installed Filtrexx SiltSoxx™ containment in two concentric rows along the perimeter of the dredged material placement areas.

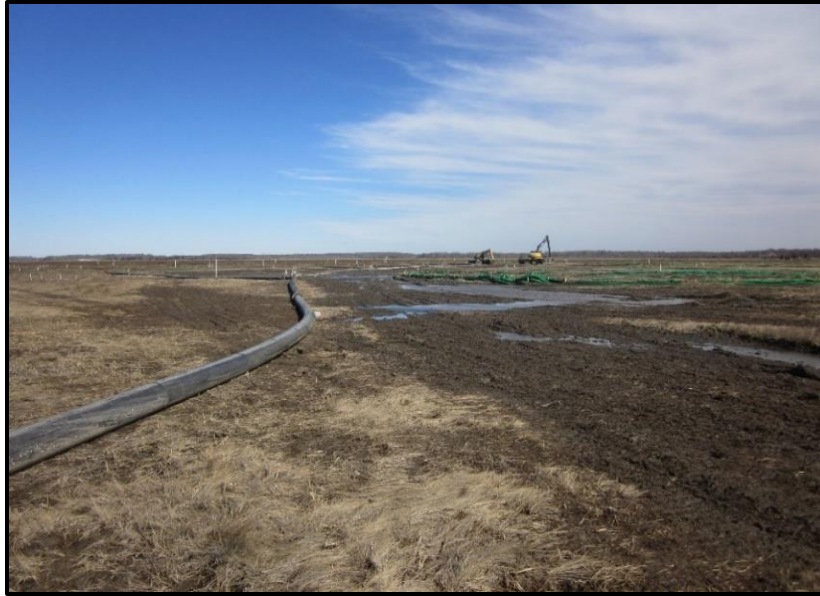
Figure 35. At Fortescue, damage to the marsh is evident in the right foreground area (darker ground) of this picture. This was caused by repeated travel and other activity over the same area.

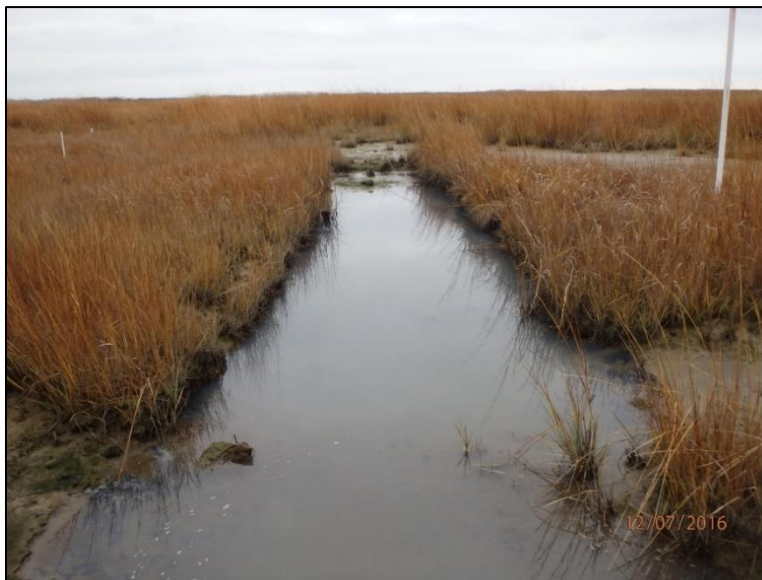
Figure 36. This long pool was created accidentally by driving an excavator on the marsh at Fortescue.

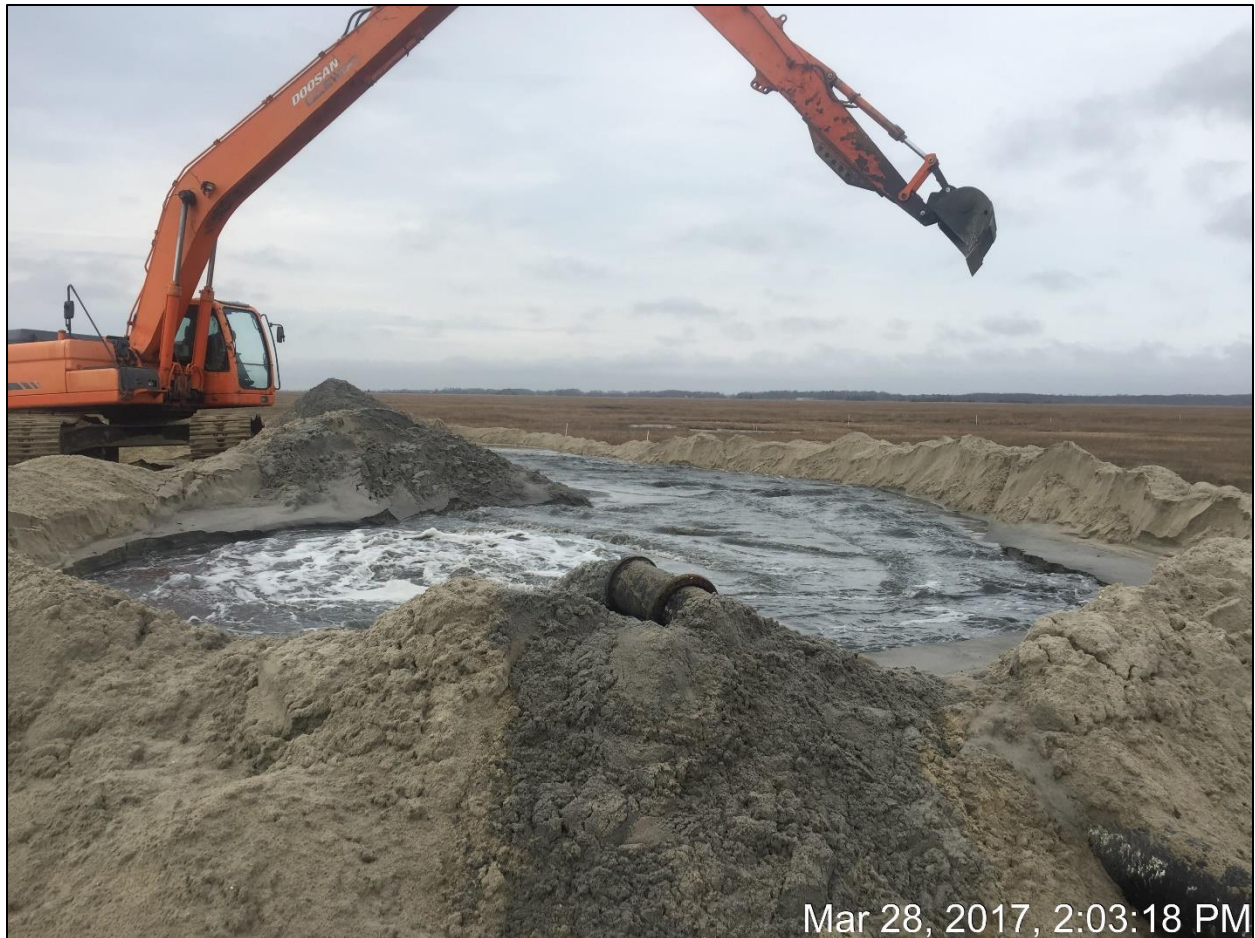
Figure 41. At the Fortescue dune restoration, berms were constructed from the first dredged sediment to create dewatering pits to retain the dredged material and to direct the dewatering discharge to the center of the placement area. Photo from NJDOT.

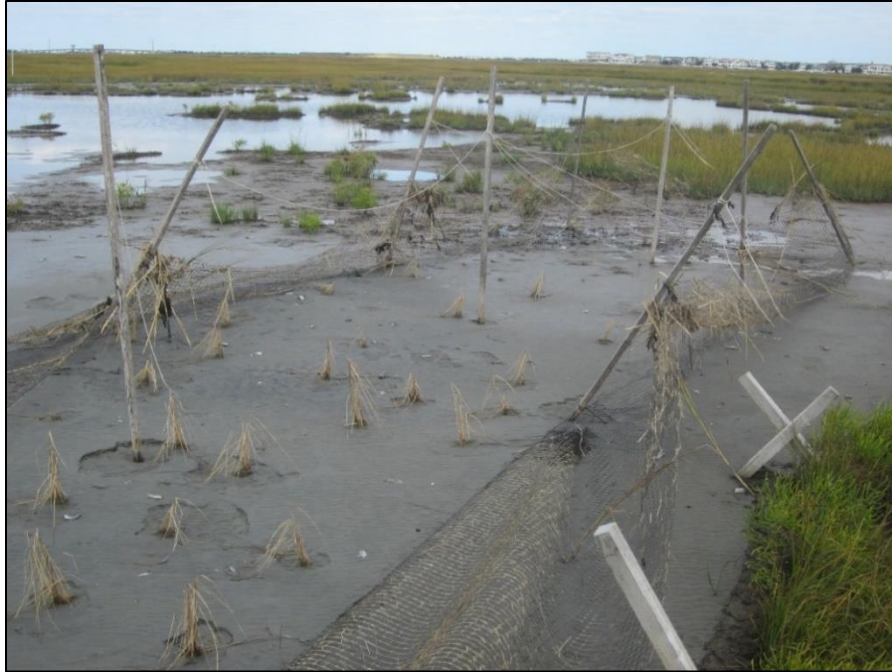
Figure 46. By October 2015, few plants survived at Avalon in dredged material placement area A.

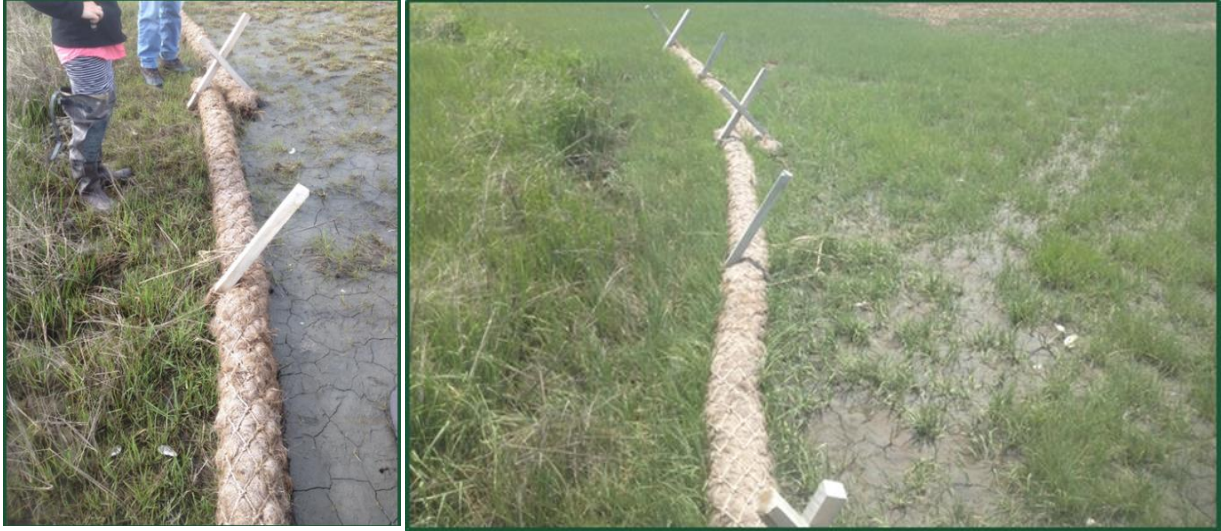
Figure 47. At Avalon, existing marsh plants grew through placed dredged material in April (left) and June 2015 (right).

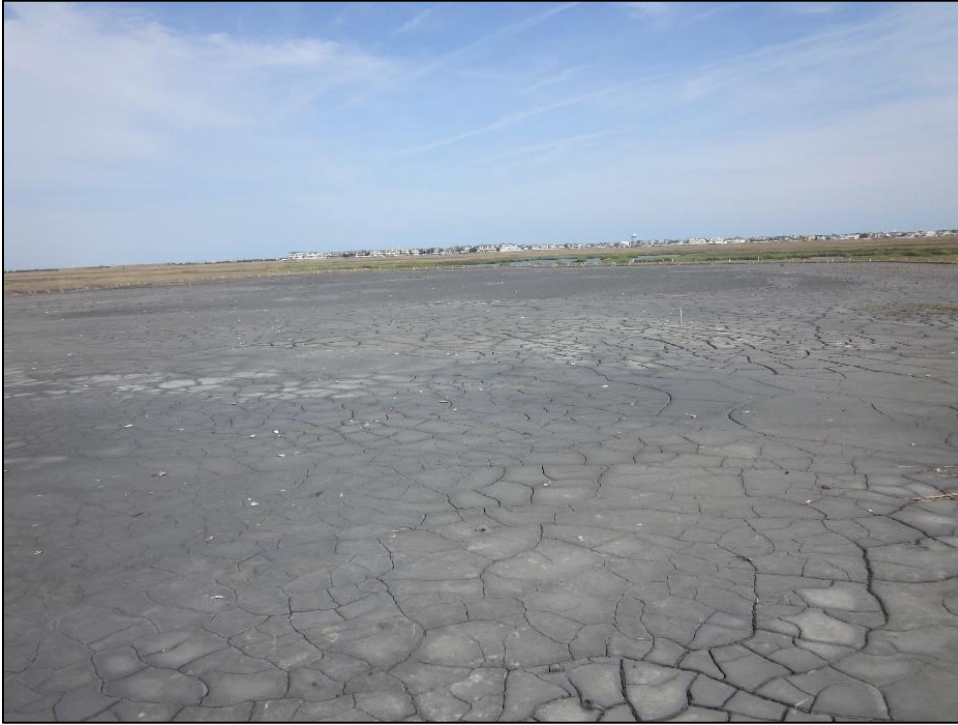
Figure 48. At Avalon, Phase 2, thick plates of drying and cracking dredged material were present in April 2016 (two months after construction was completed).

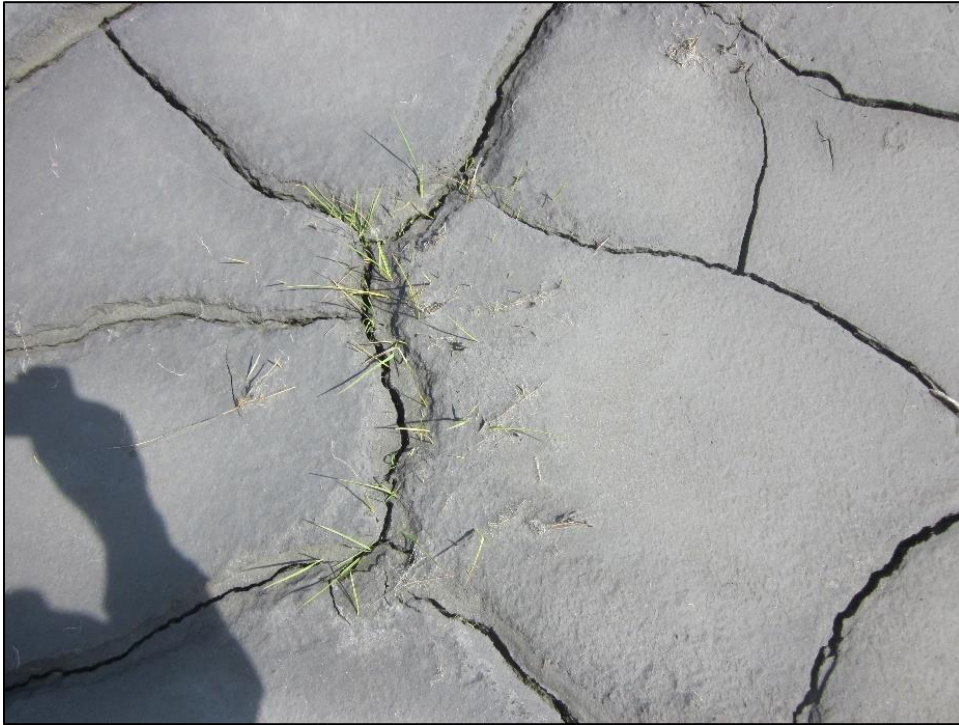
Figure 49. At Avalon, Phase 2, *S. alterniflora* grew through some of the cracks in the dredged material.

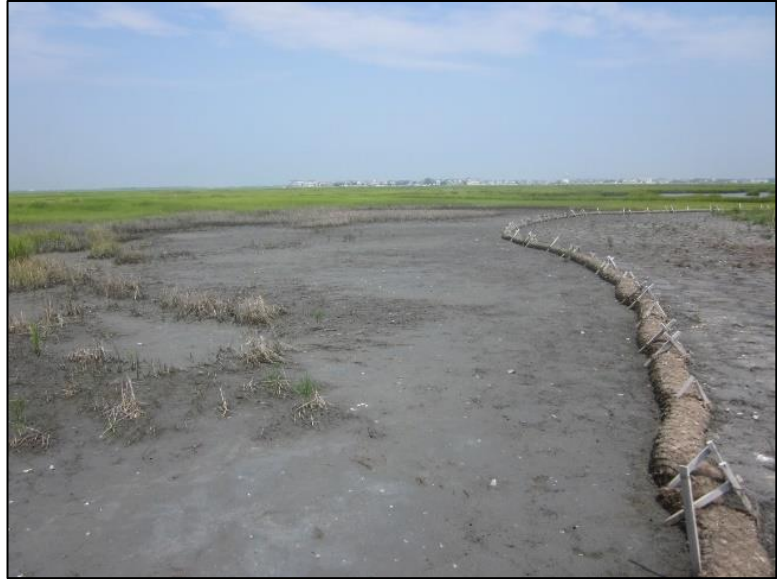
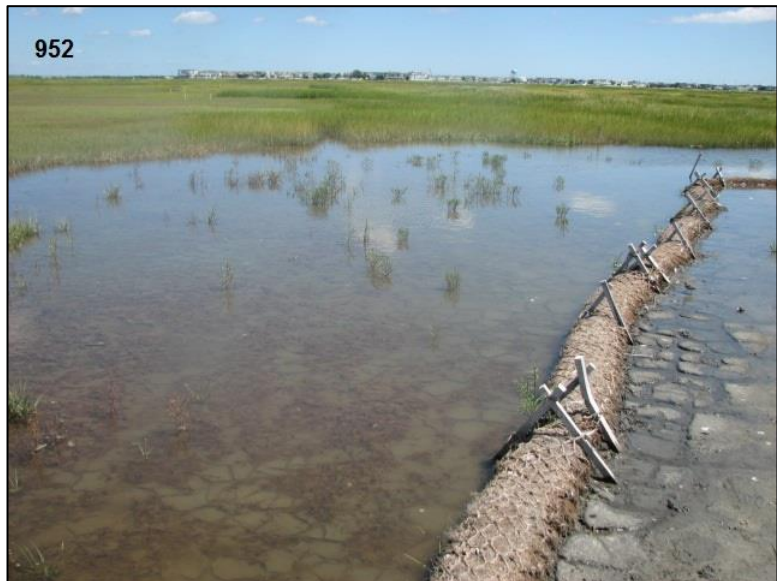
Figure 51. At Avalon Phase 2, vegetation die-off (brown areas outside containment) occurred (top). The containment restricted tidal flow, keeping water higher outside the placement area than inside it. Photos from NJDEP.

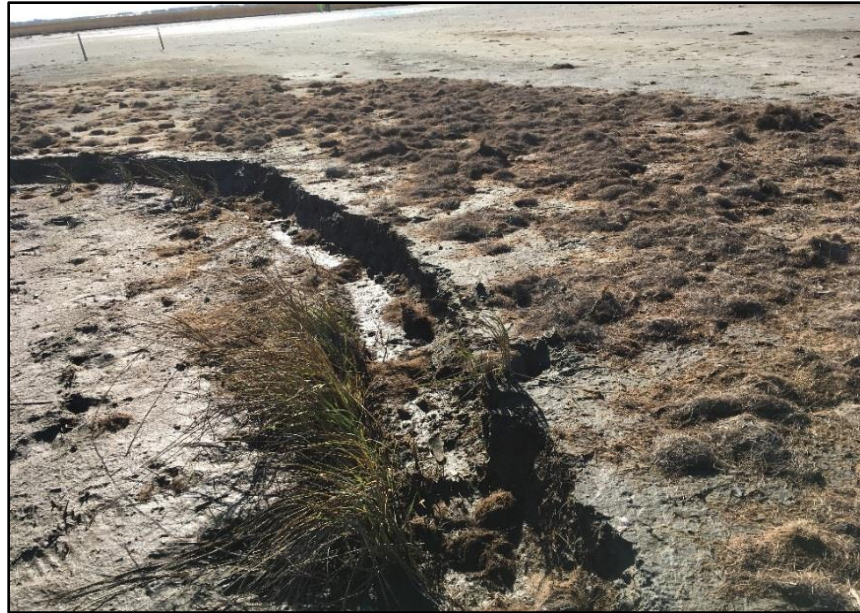
Figure 52. Avalon Phase 2: Containment was removed from this section (dark line curving from bottom center to upper left) and the biodegradable coconut fibers (right of line) from the containment were spread over the marsh. The elevated placement area is to the right.

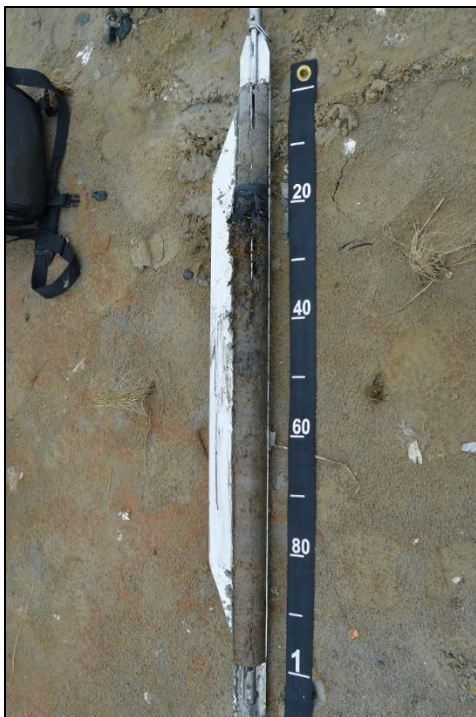
Figure 53. Acid sulfate soils with a pH below 3.8 appeared reddish and were found in the higher, drier, and sandier portions of the Avalon placement area. Photo from NRCS.

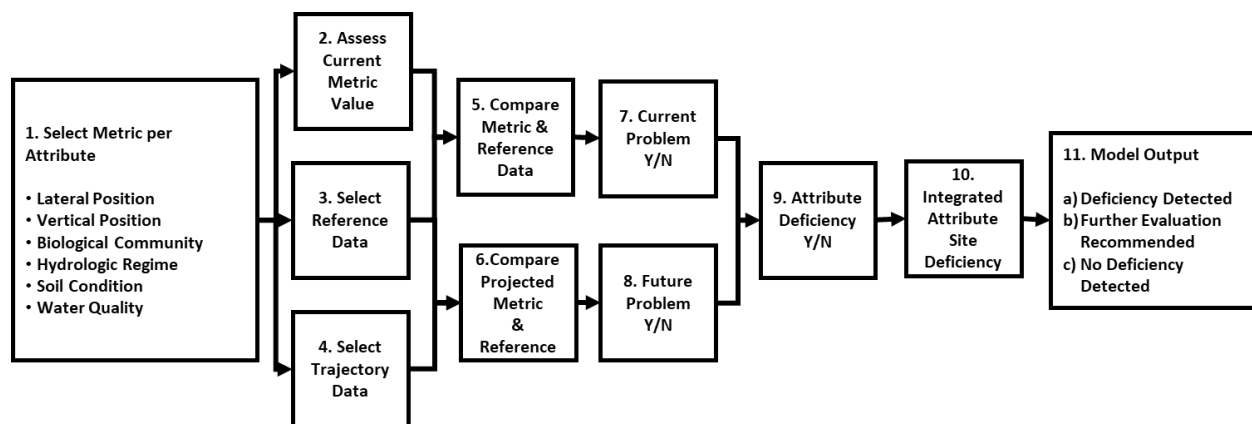
Figure 1. Workflow for the Site-Based Salt marsh Decision Tool.

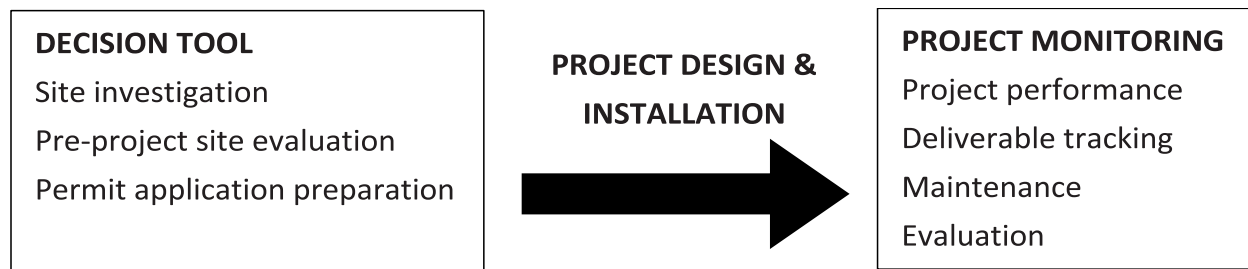
Figure 3. Metrics and methods in the Decision Tool are the same as those described in project monitoring frameworks. Data collection efforts can transition smoothly from site assessment to project monitoring.
