# CENTER — BARRIERS

SAVE LIVES

# Development of the narrow median

## Safety Curb in New Jersey

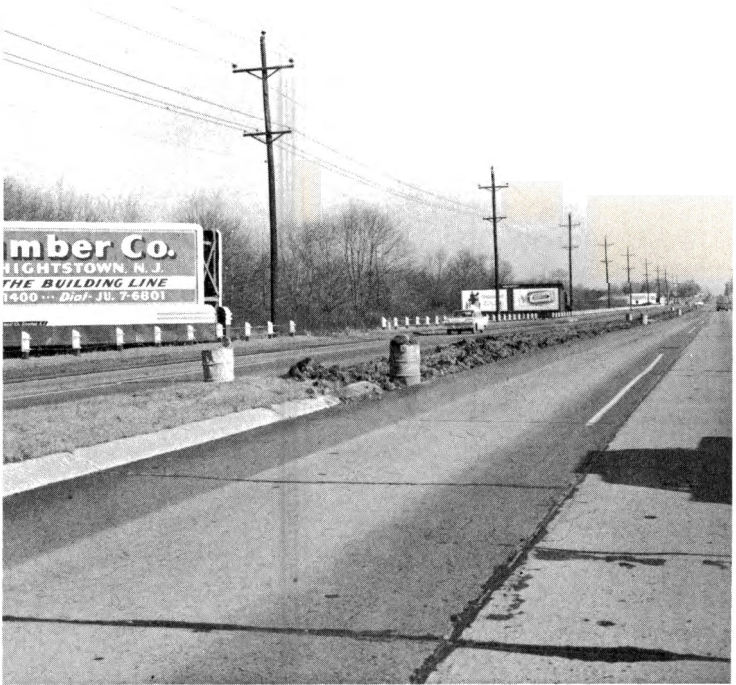
This shows a typical section early in the construction phase. The first operation involves removal of center island top soil and curbing.

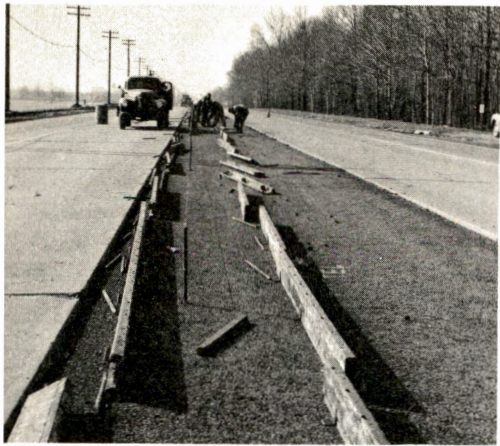
After removal of old center island is completed, subbase material is laid, over which a bituminous stabilized base and a bituminous concrete base course are placed. Workmen then position the lower rails of forms for construction of the barrier curb.

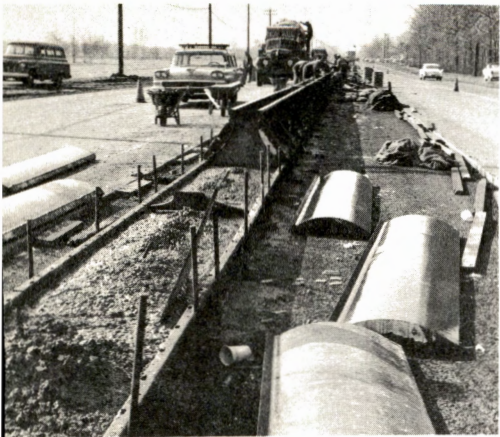
With upper sections of curb forms in place, the initial dump of gray cement has been made. Dowels have been inserted to provide a bond between the gray concrete and the white concrete which will be later placed to form the actual shell of the curb.

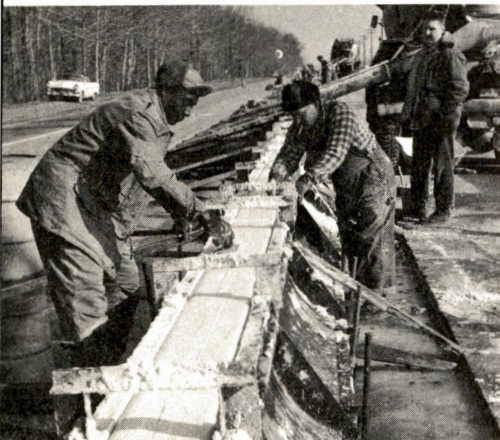
Once the white concrete has been placed, workmen finish the top surface of the barrier curb.

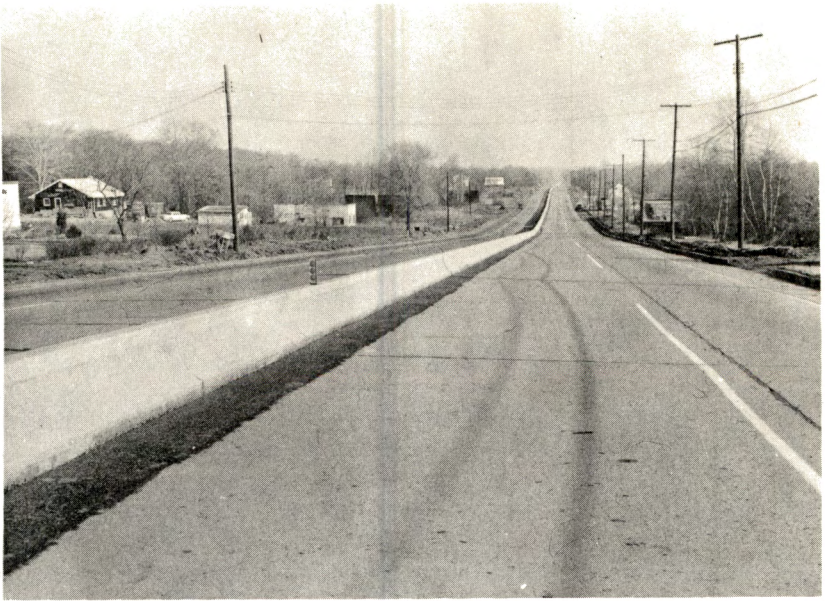
All forms being removed, the bituminous base is built up to the level of the old concrete pavement.

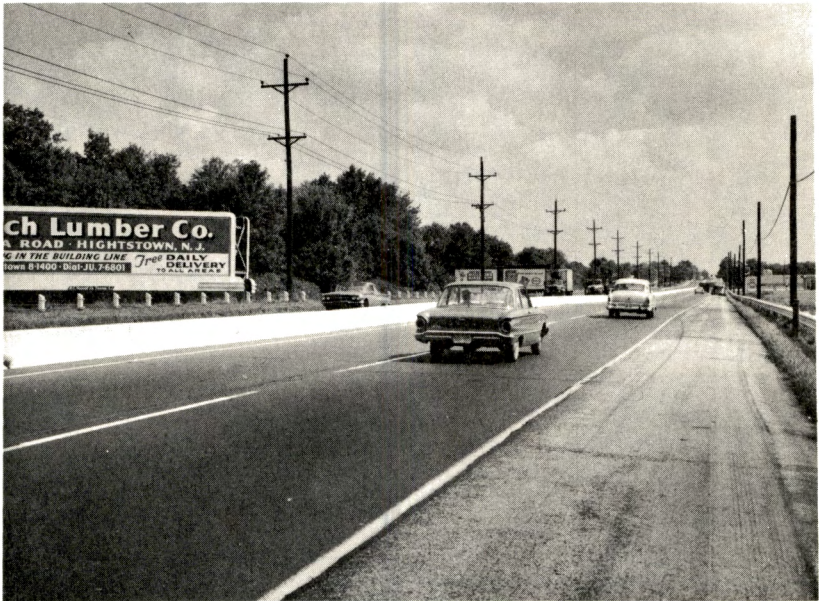
This photo shows completed highway after road has been black-topped and reflectors placed atop the barrier at 100 and 200 foot intervals depending on curvature and topography.

The type of barrier shown in the preceding photographs is 24 inches high and contains 2.93 cubic feet of concrete per lineal foot. The Department's latest 32-inch high barrier design contains 2.765 cubic feet of concrete per lineal foot, however, and costs about \$10.75 per running foot. White concrete is used to accentuate visibility.
