REPORT BY
BOARD OF COMMERCE AND NAVIGATION
NEW JERSEY
ON THE EROSION AND PROTECTION OF THE
NEW JERSEY BEACHES

1930

Erosion and Protection of the New Jersey Beaches

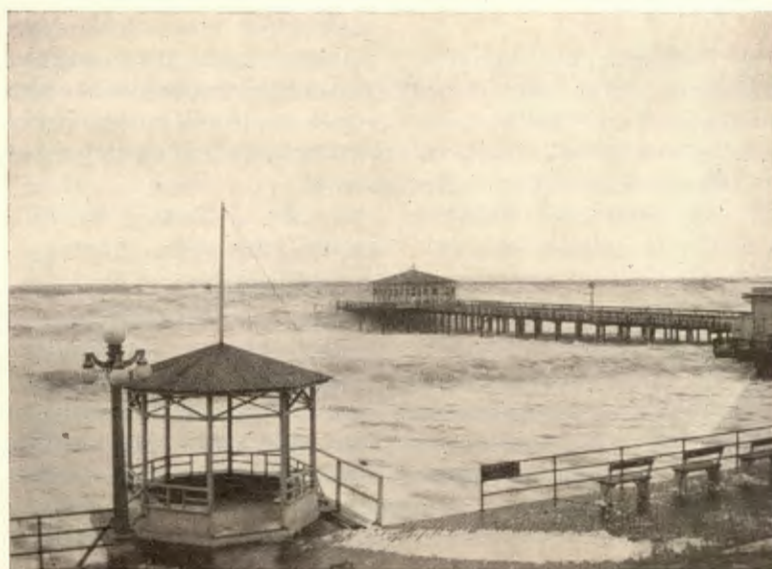
This photograph shows the abnormal height attained by the sea during an exceptionally severe storm, February 18, 1927, the wave rolling in high and striking the floor of the pier.

Comber striking floor of pier. February, 1927.

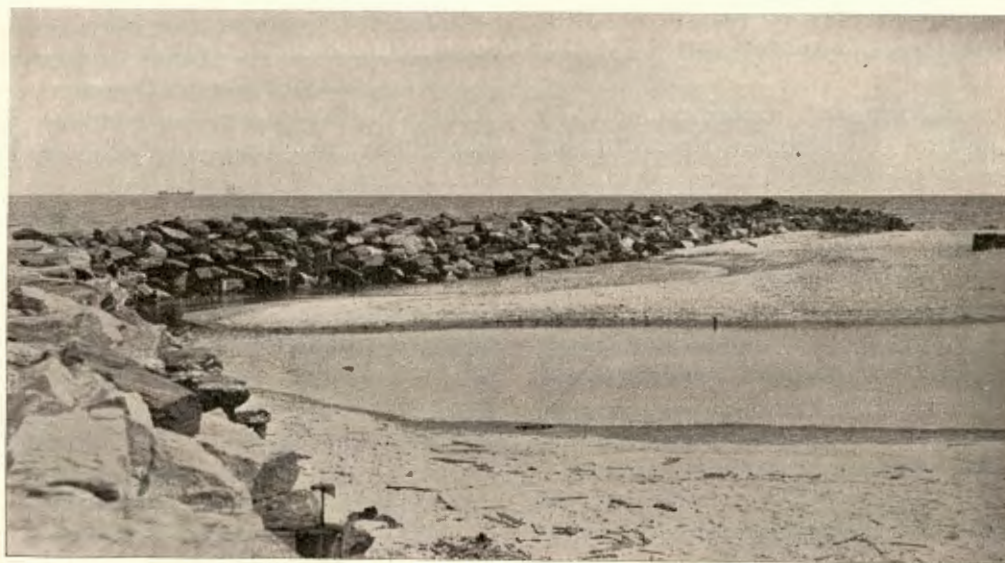
Nevertheless, with these examples before us, it is submitted that a core should be provided in these large jetties, unless it is possible, as in the case of Longport jetty, to use enormous quantities of material widely assorted as to size. Note the conditions at an inlet with the sea wall acting as a training wall. The Monmouth Beach jetty is one of the structures that demonstrates the necessity for a good tight core. The picture shows this structure and the pool that has formed because of its broken core.

Monmouth Beach jetty showing effect of leaks, September 17, 1927.

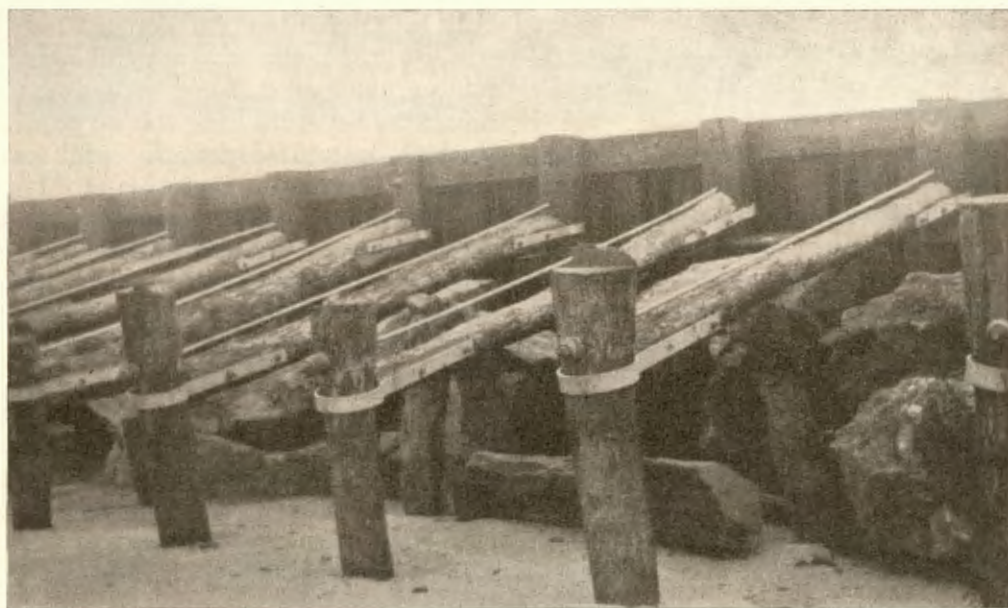
A better wall, structurally, can be obtained often at little or no greater cost by substituting one of the newer types of deep arch steel sheet piling for the timber sheeting. The Miami Beach and Sea Bright sea walls are examples. The deep arch sheet piling with its high section modulus possesses great strength. Furthermore, with particular respect to the pressure below the bottom wale, it possesses great advantages because of the continuous interlocking feature which is less certain and less impressive as to strength in the standard tongued and grooved or splined or certain other types. In other words, the engineer is assured with the steel interlocking system that the lower parts of the sheeting are in good contact; unless the driving is so unskillfully performed as to strip the interlock.

Steel Sheet Pile Seawall.

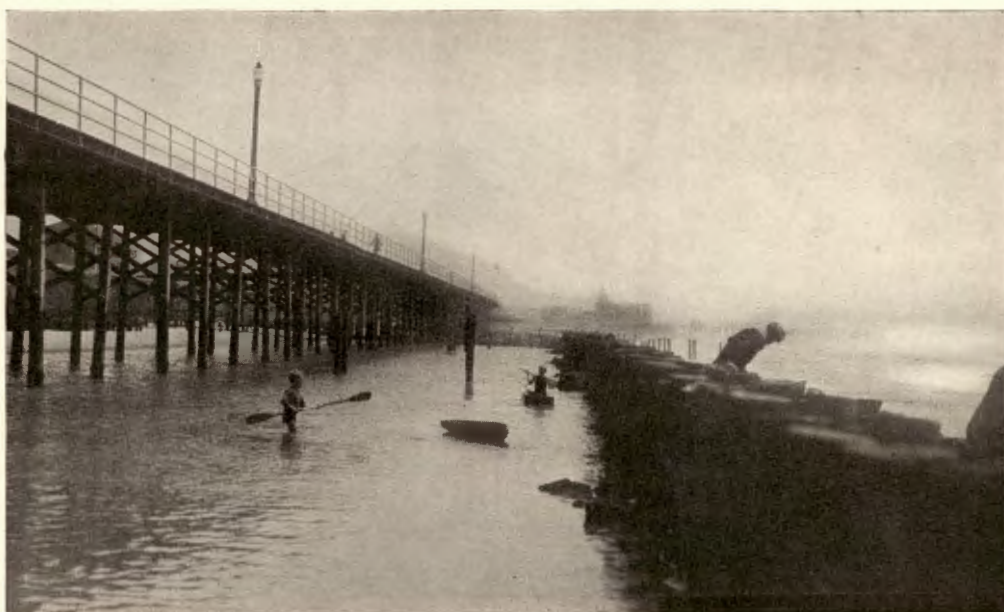
Ventnor Crib Wave Breaker. Looking N. E. (windward).

The presence of a number of jetties with which this wave breakwater is coordinated should be noted. It is not clear at this time why the jetties other than that at the leeward end were extended shoreward of the wave break structure. It is submitted that these windward jetties, at least while the filling material was at grade, tended to prevent the entrance of the littoral drift from the northeast. Probably the intention was to prevent the water thrown over by the waves from racing out laterally. On the subject of structures of this kind, Professor Lewis M. Haupt, in the Annual Report of the

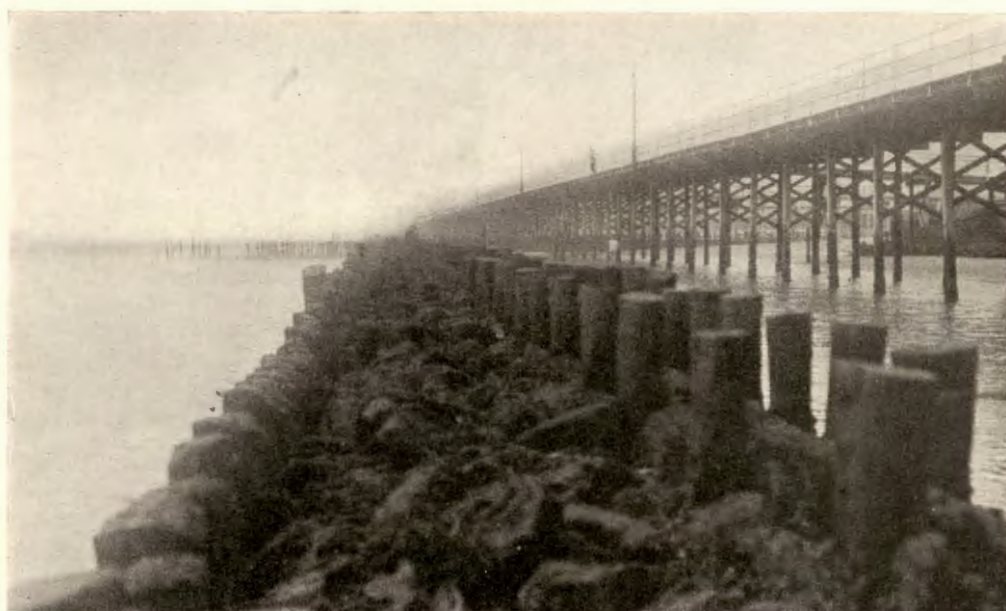
Ventnor Crib Wave Breaker, July 14, 1928. Rock and timber covered by heavy growth of mussels.

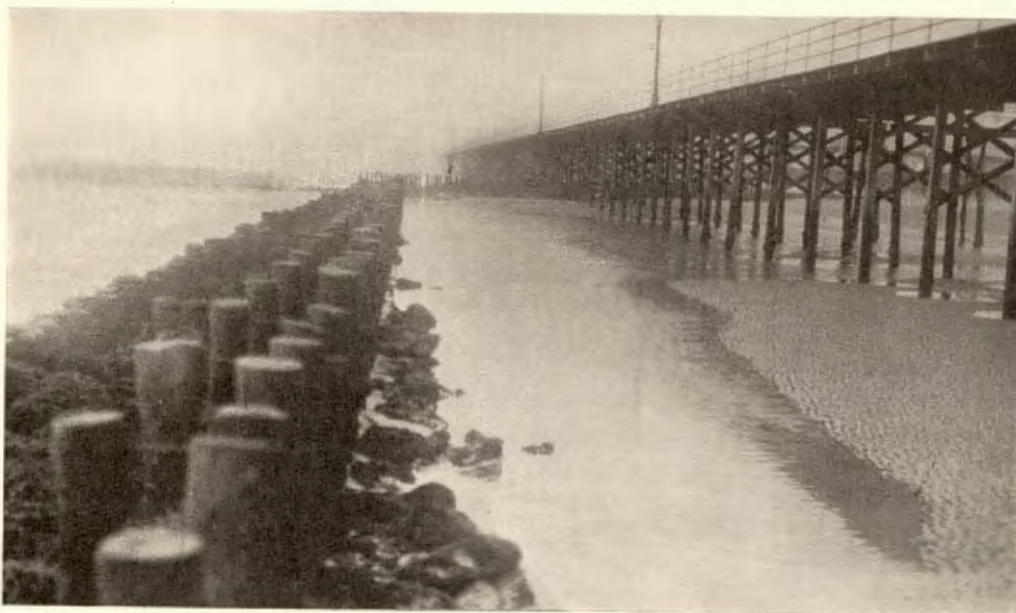
Ventnor Crib Wave-Breaker, July 14, 1928. Depression in right background caused by break in sheeting.

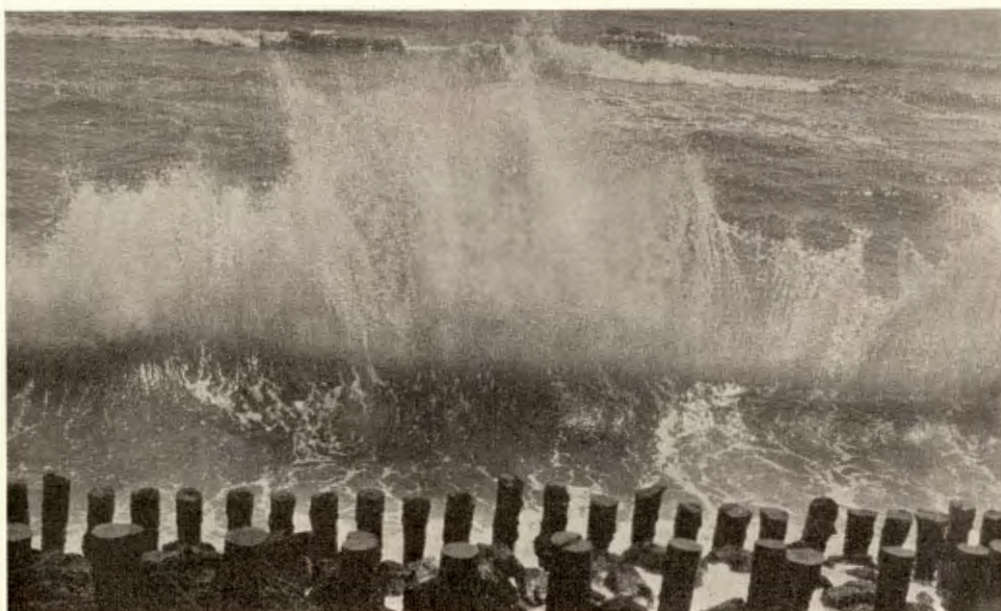
Ventnor Crib Breakwater, July, 1928. Meeting of incoming and reflected waves.
Sea calm.

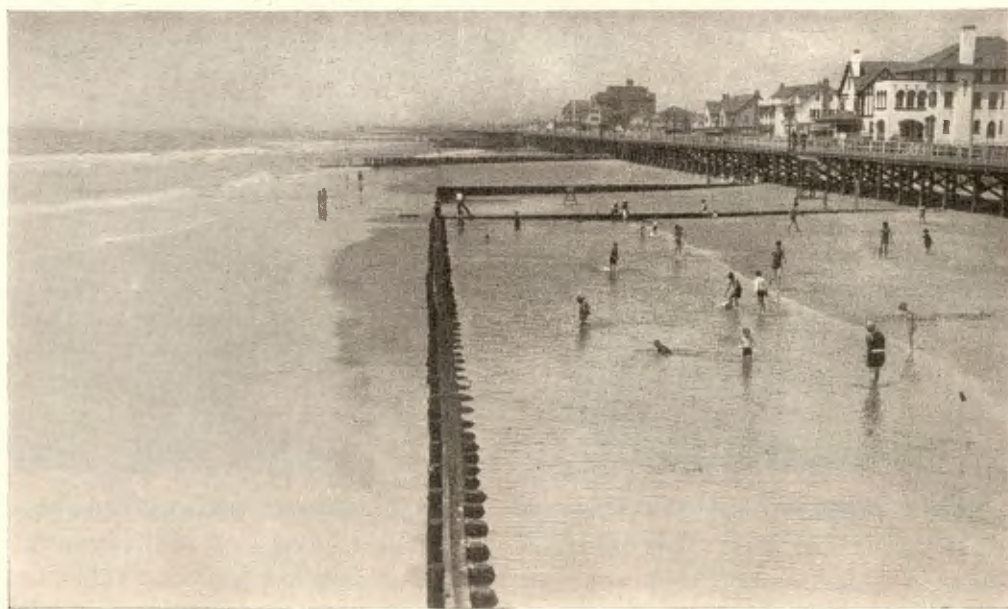
Ventnor Bulkhead Breakwater, May, 1928. Looking southwest from Municipal Pier.

If correctly located, and this is highly important, it serves as a first line of defense by definitely precluding the heavy storm seas from crashing with all their force upon the land structures. It is inferior in perhaps every re-

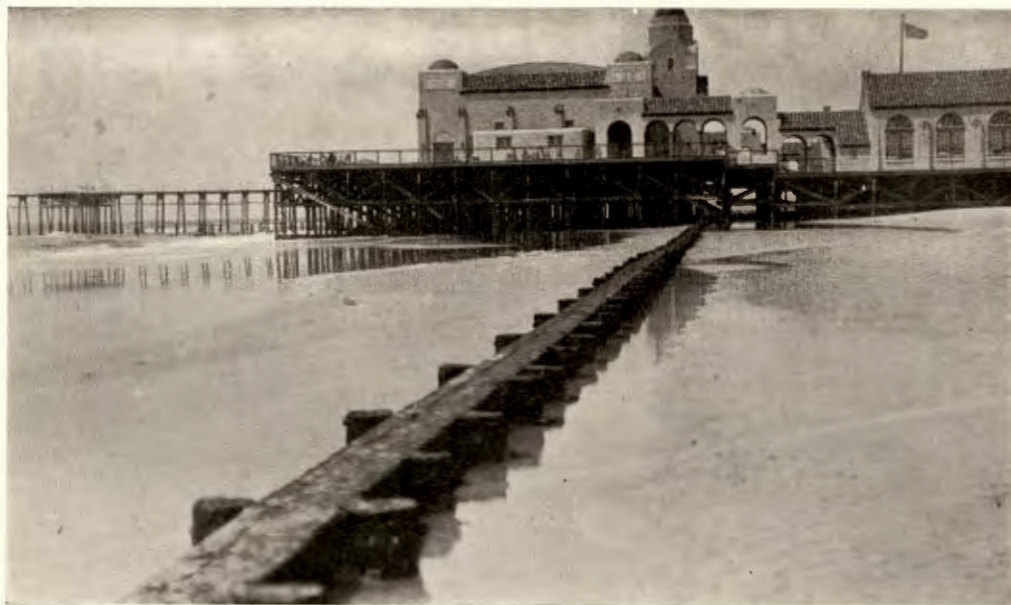
Ventnor Bulkhead Breakwater, May, 1928. Looking southwest, Municipal Pier in background.

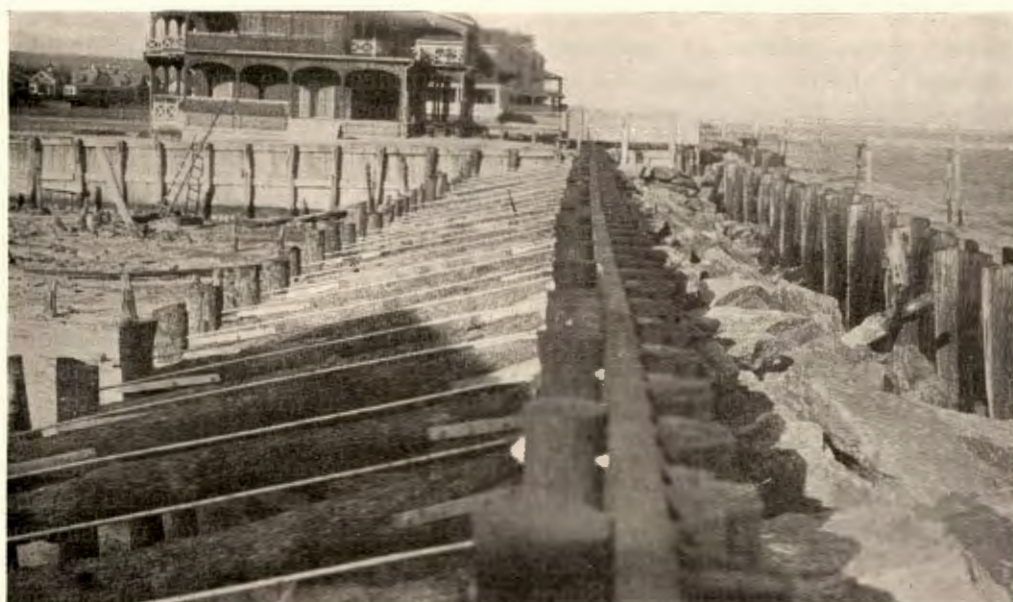
Steel Sheet Pile Seawall, Sea Bright.

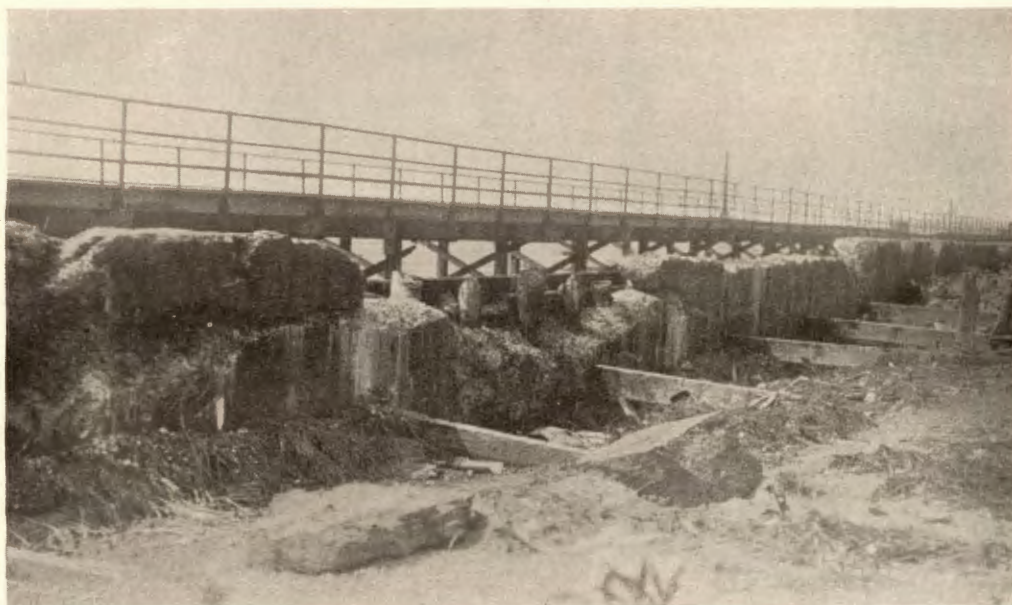
Margate Seawall, July, 1928. Original construction. Concrete deteriorating.

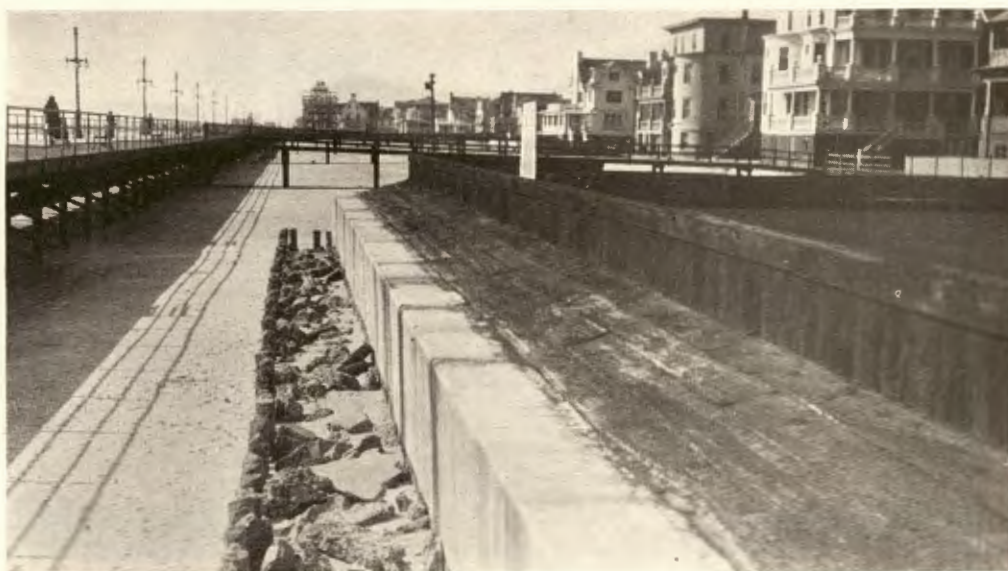
The sea wall shown in the photograph evidences determination on the part of the owner to secure protection.

Private Seawall, Ventnor.

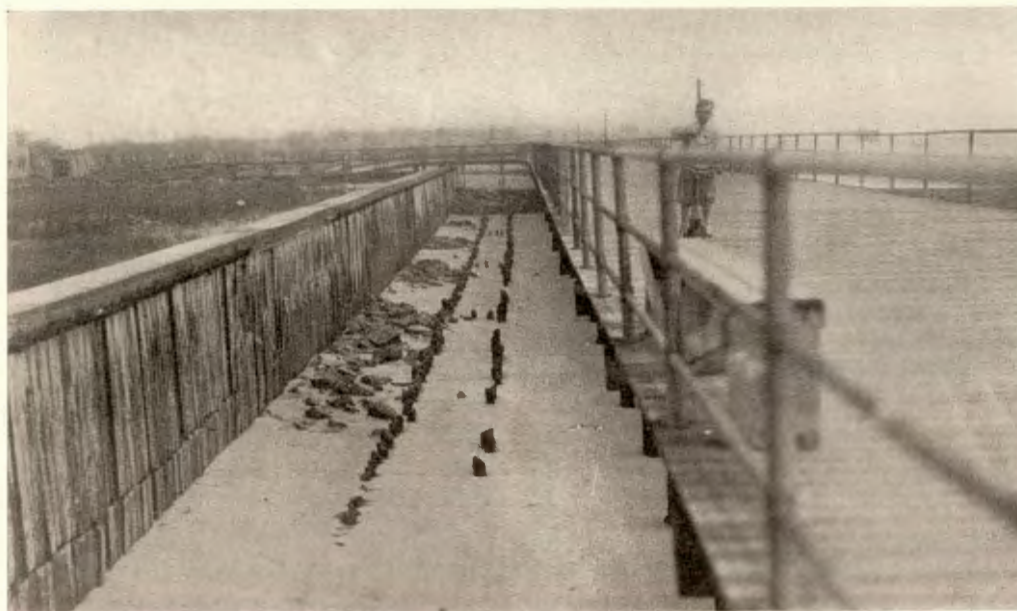
Margate Seawall, July, 1928. Coping replaced with reinforced concrete.

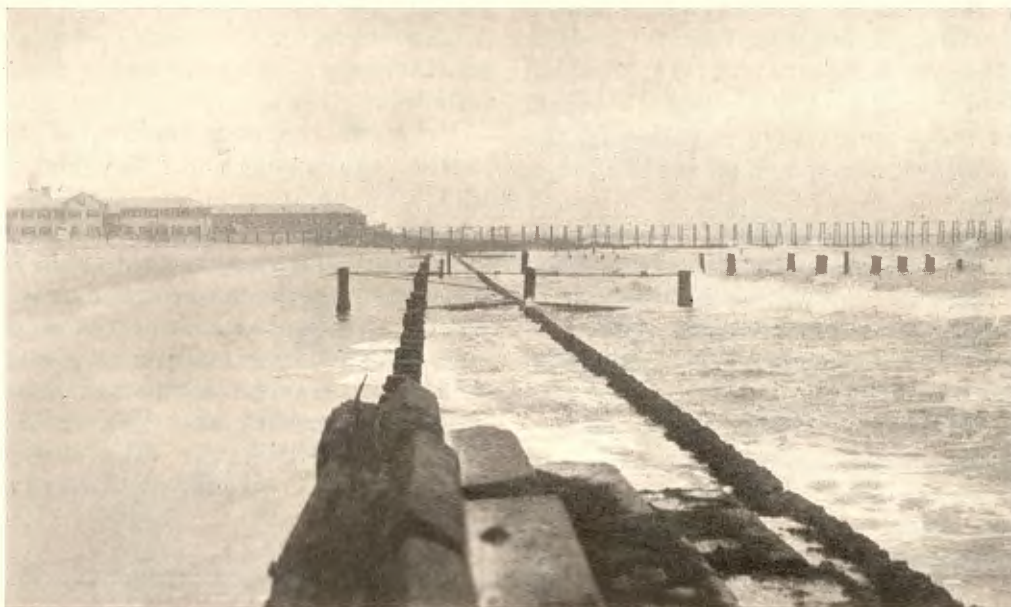
Seawall, Longport, after erosion.

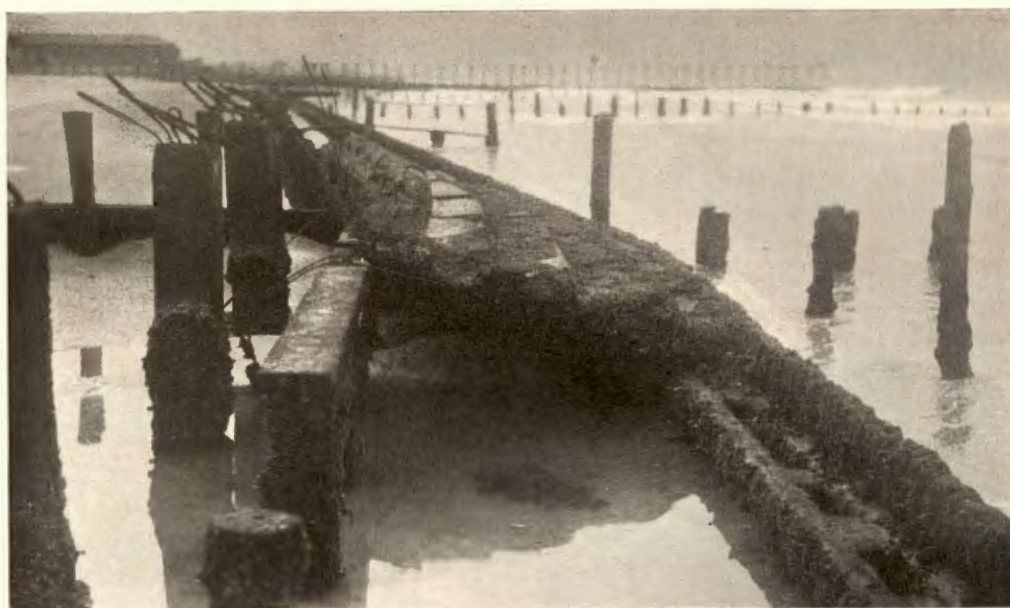
At break, Longport Seawall.

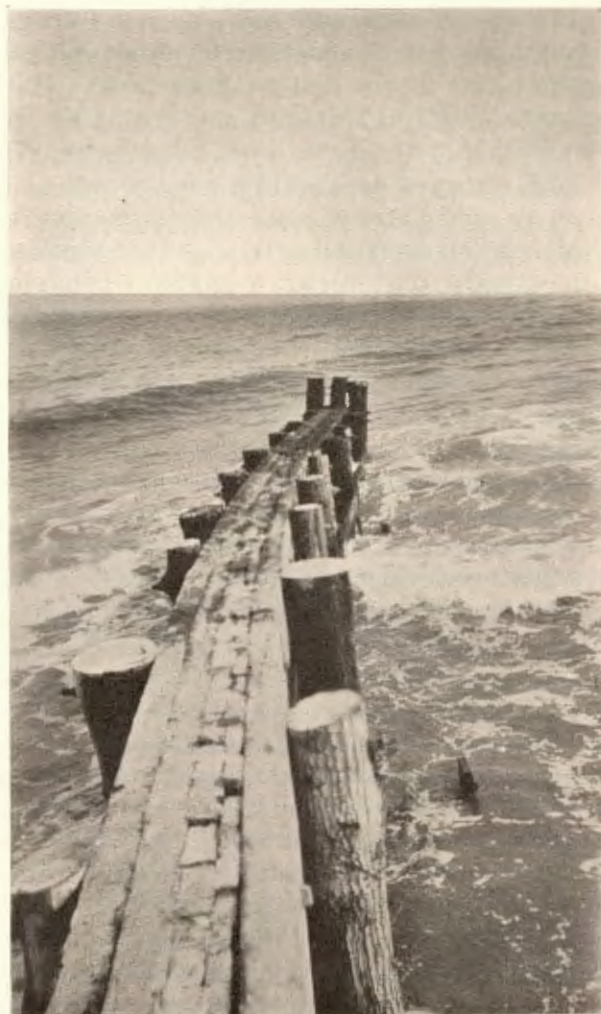
If the conditions present are more severe than indicated then timber groins will probably fail; consideration should be given to steel groins or jetties. Failure may result from an infinite number of causes. Floating wreckage is responsible for many losses, the wave and current pressure may cause the structure to fall over or the loss of frictional holding power of the soil through excessive wearing and vibration may cause the structure to fall over, or the loss of frictional holding power of the soil through excessive wearing and vibration may permit the timber to be lifted out by reason of the floating quality of this material. The "weaving" of a groin subjected to heavy waves and currents is impressive.

Distortion of outer end of groin.

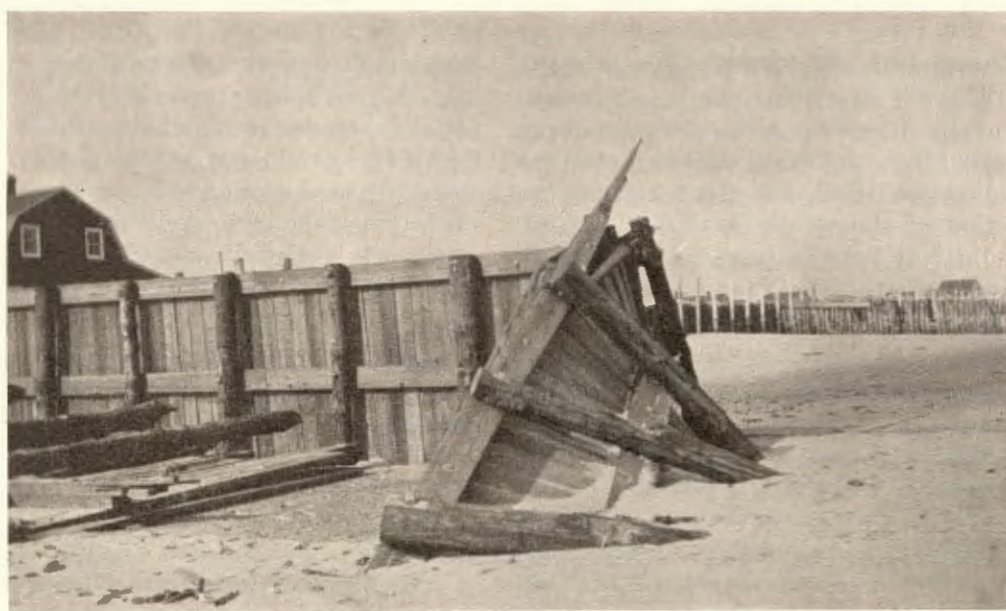
Partial destruction of groin.

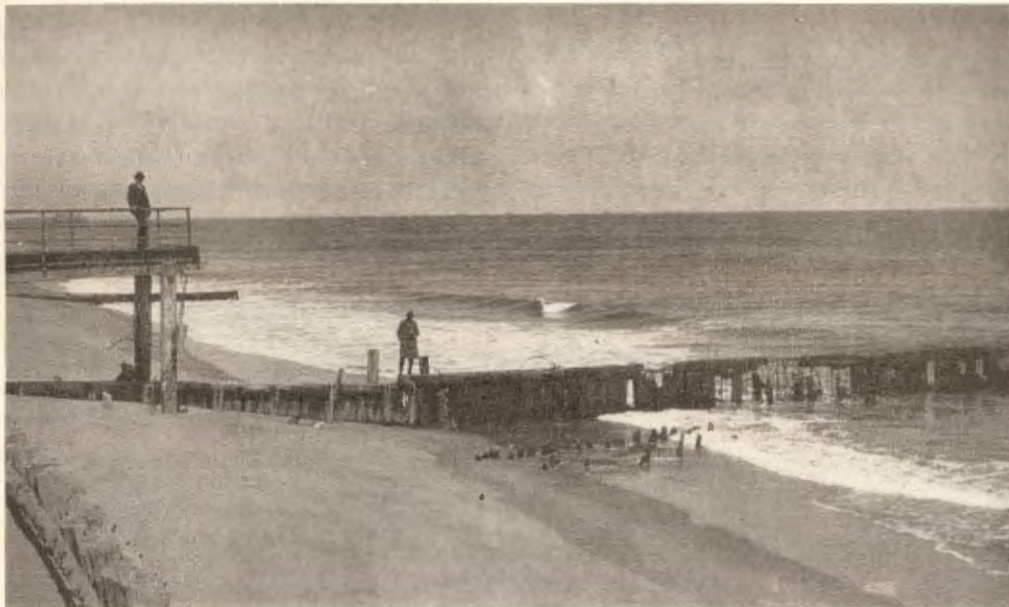
Reinforced Concrete Jetty, Long Branch.

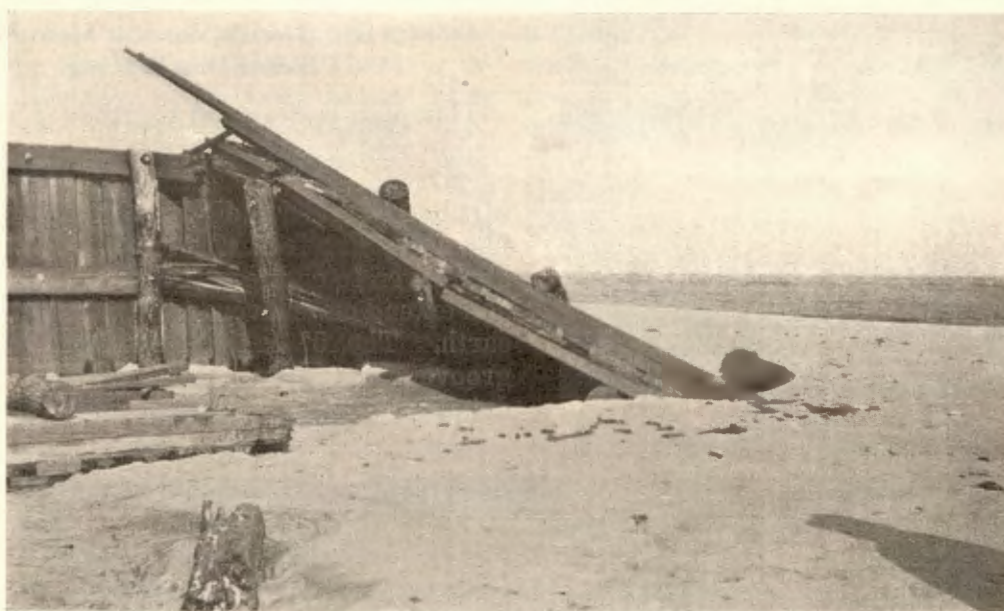
This photograph shows the failure of the outer end of a timber groin during the storm of February, 1927.

Failure of outer end of groin. Storm of February, 1927.

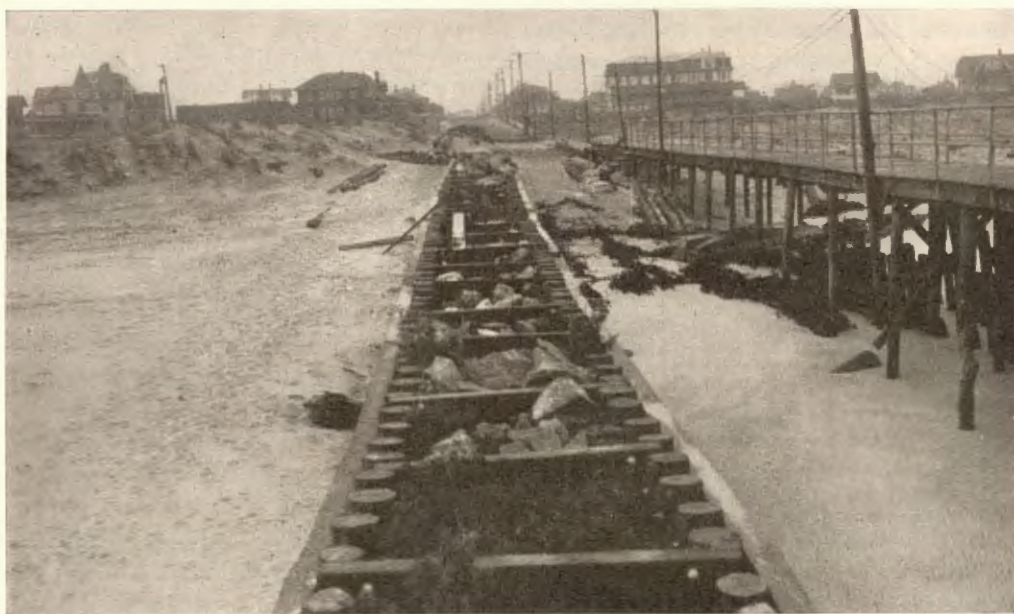
Avalon jetty inshore end.

The space between being filled with brush weighted down with small stone. The jetty follows approximately the slope of the beach up to mean high water line and from that point extends seaward, at elevation of about one foot above mean high water. This work was approximately 50% completed January 1, 1930.

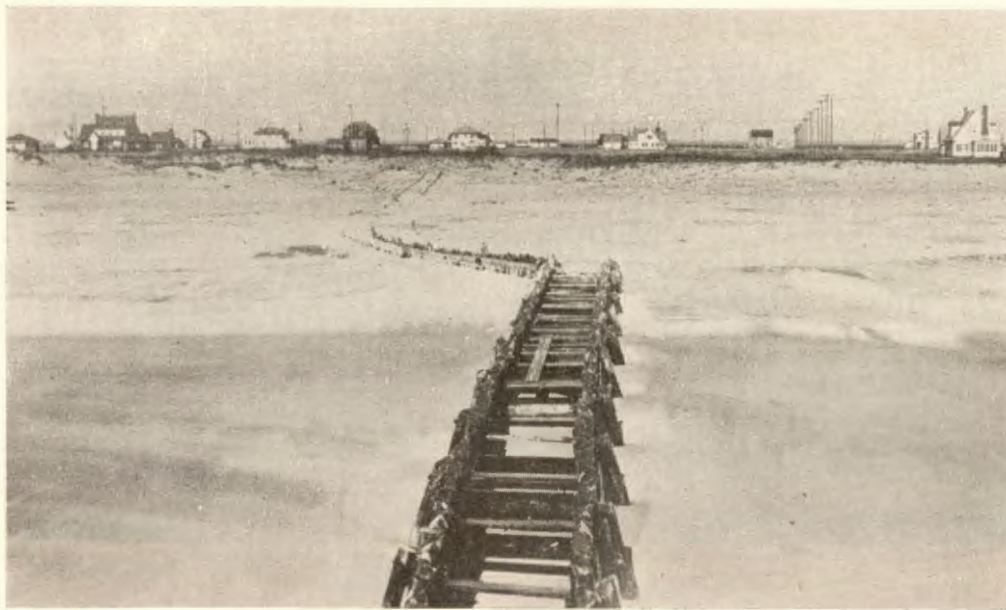
Brigantine City. Showing extension of hook jetty south of Hotel.

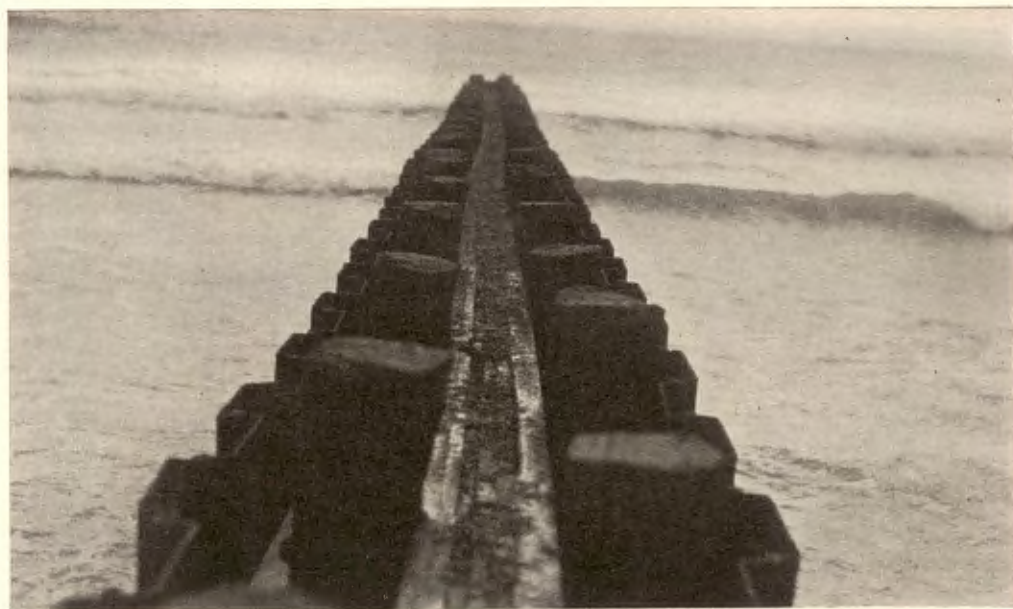
Cape May City, groin of original contract showing steel sheet piling encasement due to attack by teredo.

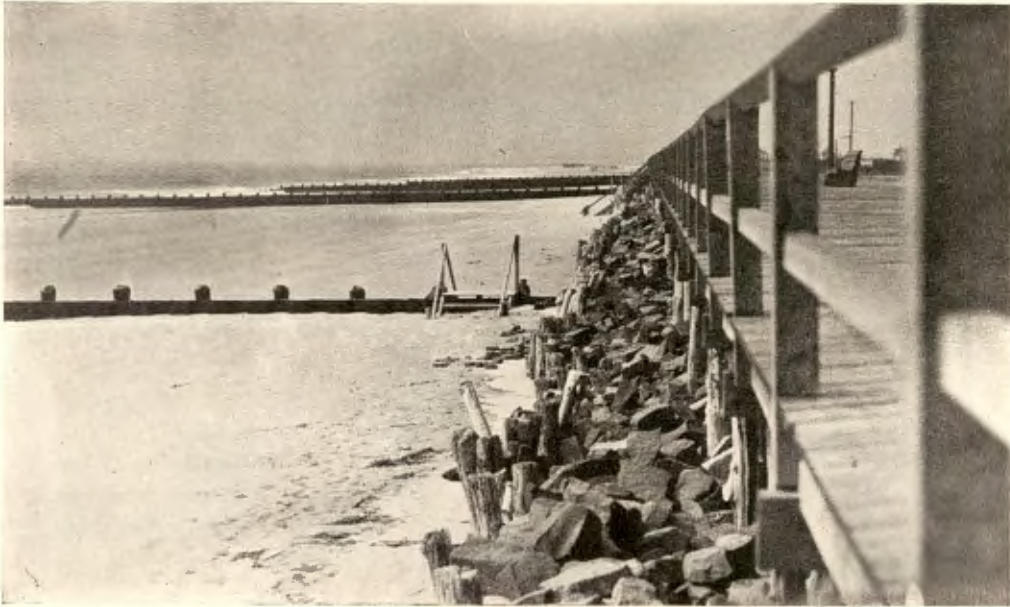
Cape May City south of Casino. Remarkable accretion where conditions were very serious prior to construction of groins. February 27, 1930.

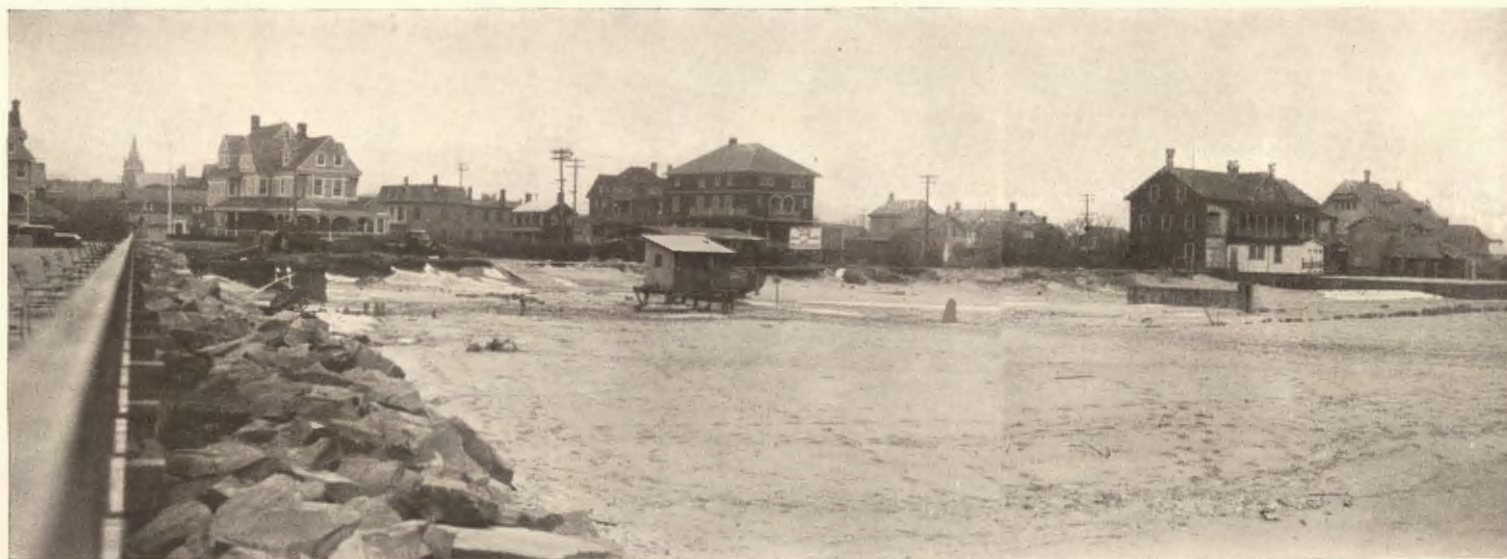
Looking west northwest from outer end of Jetty A. February 4, 1930. Note growth of sand against bulkhead and wave stockade since 1926 pictures.
