### New Jersey Department of Transportation Bureau of Research

FHWA-NJ-2012-002

### **Route 22 over Liberty Avenue and Conrail Hillside Township**, **Union County, Monitoring of Tensar MSE Walls**

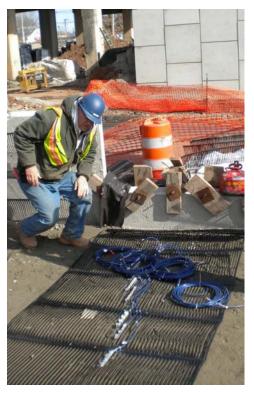
To monitor the performance of the Tensar MSE walls, geogrids at the top, middle, and bottom of two of the walls (walls 1 and 3) were selected for instrumentation. During construction, an array of 18 strain gages was installed, six gages in each of the three instrumented geogrids. In order to capture the maximum tension in the geogrids, the locations of the strain gages were

selected such that they are intersected by the theoretical line of maximum tension within the wall which corresponds to the plane of failure assumed in design. The strain gages were positioned at one third of the length of the longitudinal ribs rather than in the middle considering the fact that the width of the ribs is smallest in the middle and largest where they meet the transverse ribs. By doing so, the measured strain would be more representative of the average strain along the rib. All strain gages were installed at or near the center of the geogrid panel in the transverse direction. Also during construction, two tiltmeters were installed on each instrumented wall. The tiltmeters were mounted on the column panels to which the instrumented geogrids were attached in order to correlate the strain gage and tiltmeter data. Data is gathered automatically through a data logger and transmitted wirelessly to be viewed remotely.
