Safety Audit of Fatalities and Injuries Involving Guide Rail

Final Report
December 2006

H. Clay Gabler, Ph.D.
Douglas J. Gabauer

New Jersey
Department of Transportation
Bureau of Research
And
U. S. Department of Transportation
Federal Highway Administration

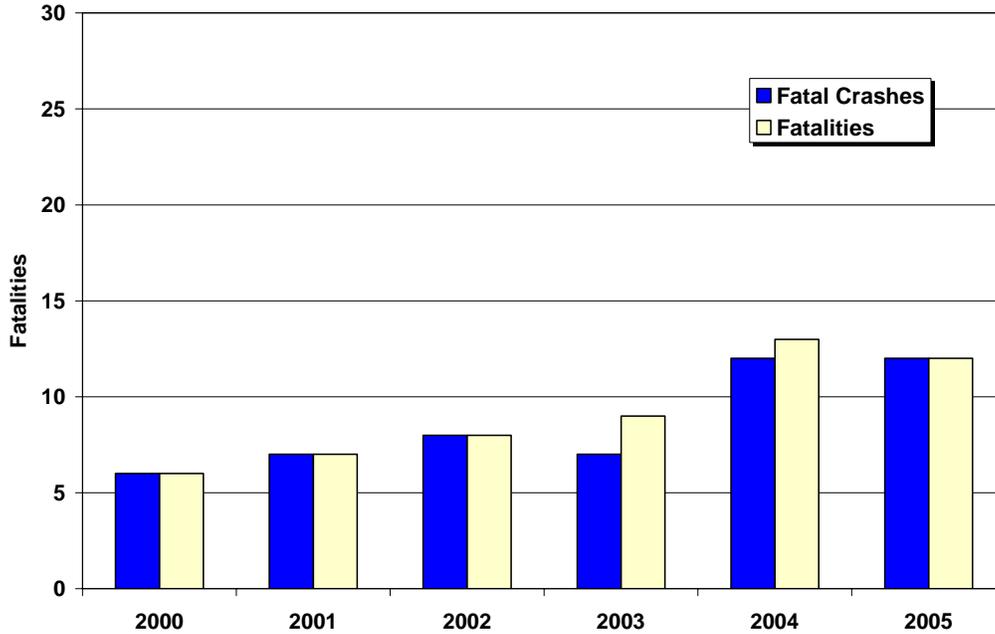
Figure 4 presents the number of fatal crashes and fatalities involving collisions with guide rail which occurred in New Jersey during the period from 2000-2005. On average during this period, there were approximately 10-12 fatalities which resulted from collisions with guide rail. Because some crashes resulted in multiple fatalities, the annual number of fatalities is slightly higher than the number of fatal crashes each year. This analysis was based upon cases from FARS for which the most harmful event was an impact with a guide rail.

Figure 4. Fatal Guide Rail Crashes in New Jersey (FARS 2000-2005)

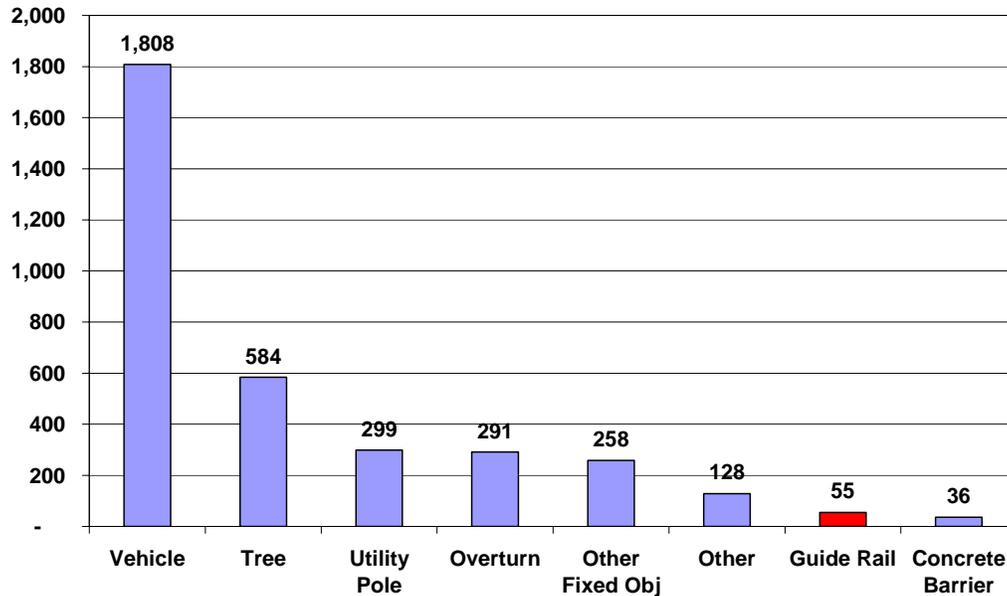
In terms of fatalities, guide rail crashes fortunately result in only a small fraction of New Jersey highway deaths. Figure 5 presents a rank ordering of all New Jersey motor vehicle fatalities by most harmful object struck for the period of 2000-2005. During this six year period, only 55 deaths occurred as a result of a guide rail crashes. This count accounts for 1.5% of all motor vehicle fatalities and less than 5% of all fatalities resulting from collisions with fixed objects. By

contrast, collisions with trees and utility poles accounted for over 25% of all traffic deaths and over 70% of all fatalities resulting from collisions with fixed objects.

Figure 5. Distribution of New Jersey Motor Vehicle Fatalities by Most Harmful Object Struck (FARS 2000-2005)

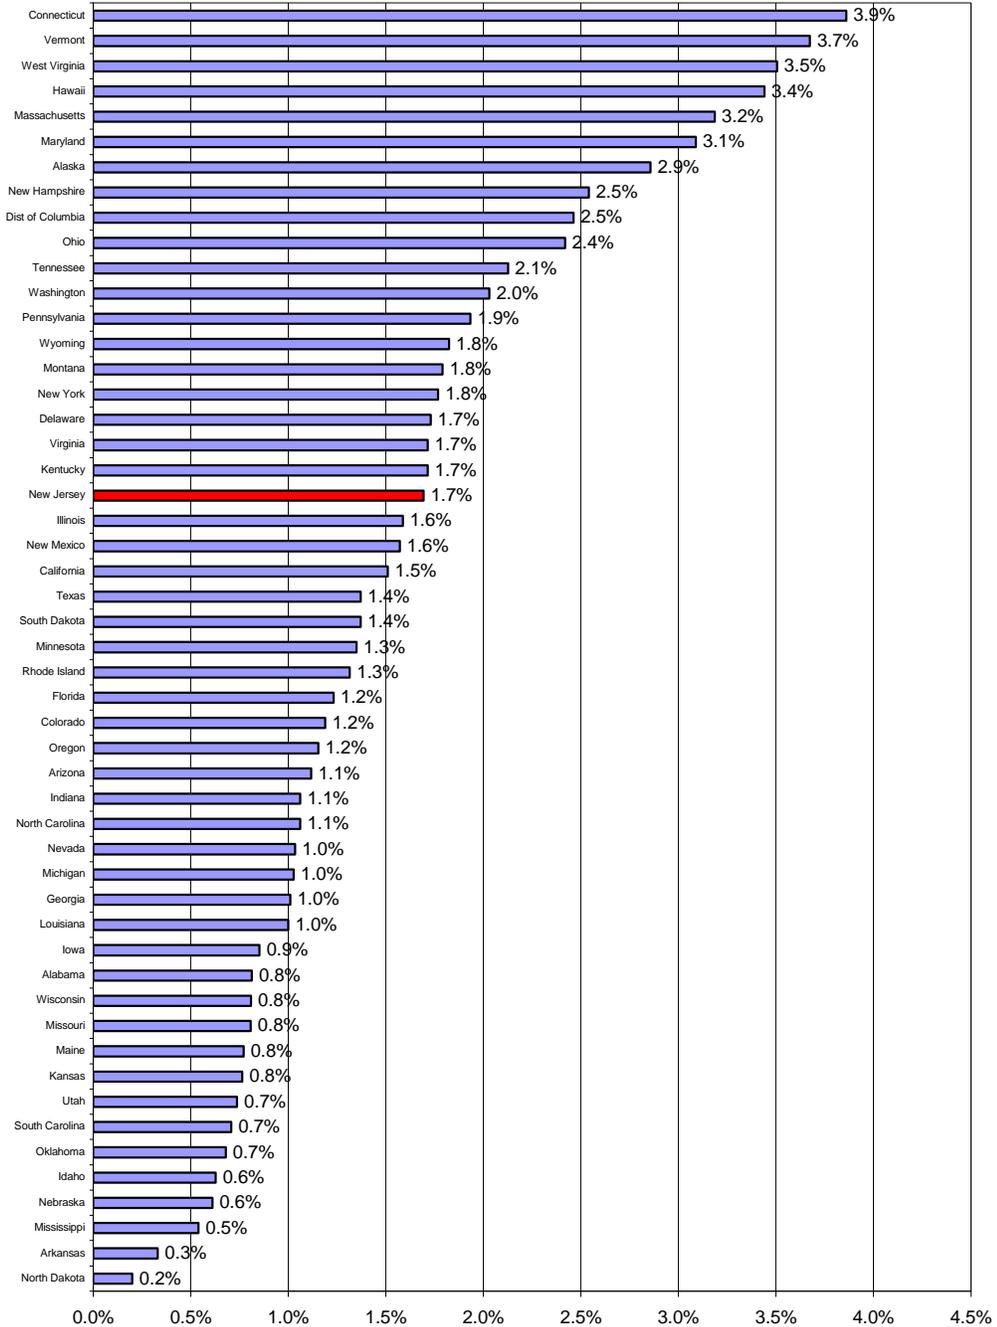
The State of New Jersey does not have an unusually high percentage of guide rail fatalities. As shown in the figure which follows, New Jersey ranks only 20th among the states in terms of guide rail fatalities as a percentage of all traffic fatalities

Figure 6. New Jersey ranks 20th among all states in Guide Rail Fatalities as a Percentage of All Traffic Fatalities (FARS 2000-2005)

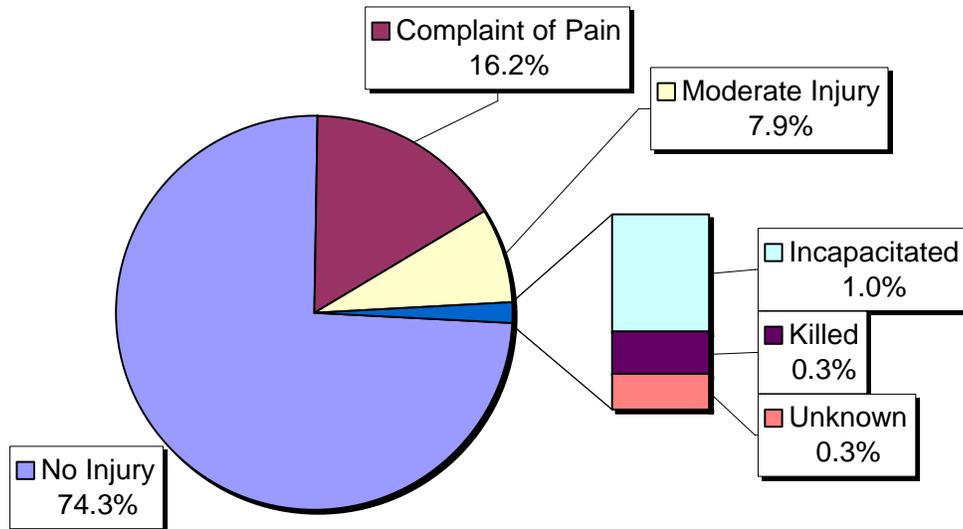
Figure 7 shows the injury severity distribution of police-reported guide rail crashes in NJ. This figure suggests that guide rail perform well in collisions. Nearly three-fourths of all occupants involved in a guide rail crash suffered no injuries. The remaining 25% of occupants exposed to guide rail crashes suffered some level of injury ranging from complaint of pain to death. Fortunately, fatal and incapacitating injuries were rare. Annually, 1.3% of occupants exposed to guide rail crashes received either a fatal or incapacitating injury.

Figure 7. Distribution of Injury Severity in Guide Rail Crashes (NJCRASH 2003-2005)

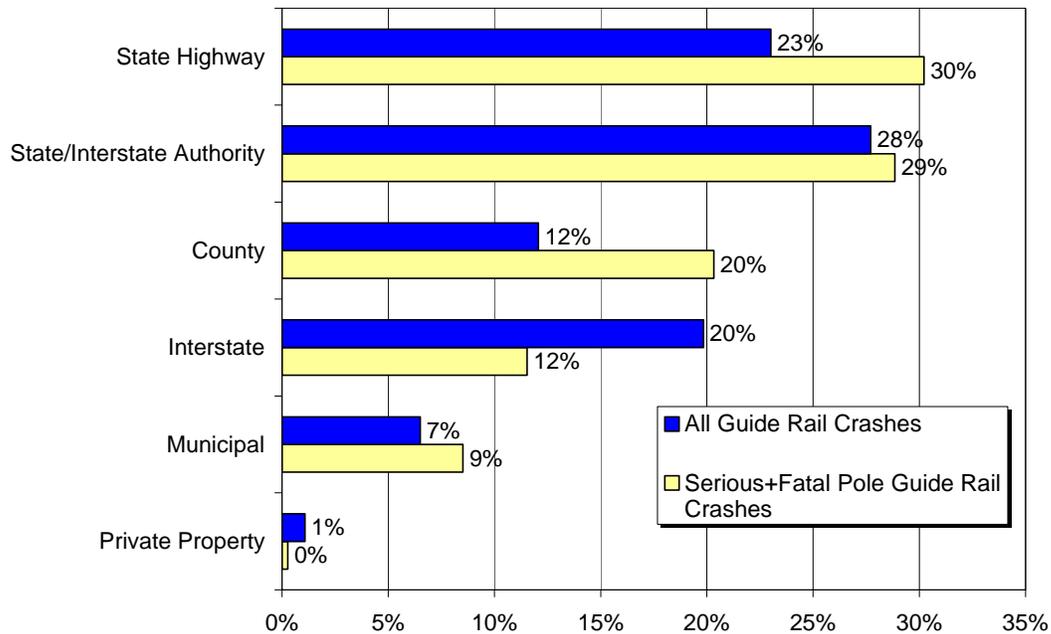
Figure 8. Fatal and Incapacitating Guide Rail Crashes by Road System (NJCRASH 2003-2005)

Figure 8 presents the distribution of serious guide rail crashes by road system. For this analysis, serious crashes are defined to be those collisions which resulted in fatal or incapacitating injury. State highways and state/interstate highways (e.g. the NJ Parkway) each account for approximately 30% of all serious guide rail crashes. State highways, however, are overrepresented in serious guide rail collisions. State highways account for 23% of all guide rail crashes, but 30% of all fatal and incapacitating guide rail crashes.

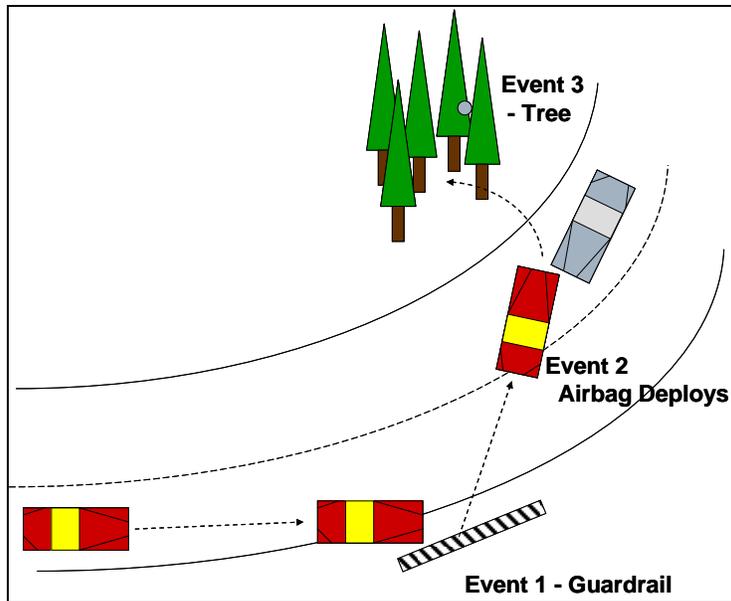
Traffic collisions are frequently composed of several impact events. For example, in the hypothetical scenario shown in Figure 9, a car first collides with a guide rail (event 1), is redirected back onto the roadway as guide rail are designed to do, collides with an oncoming car (event 2), exits the opposite of the road, and collides with a group of trees (event 3).

Figure 9. Traffic crashes are frequently composed of several events.

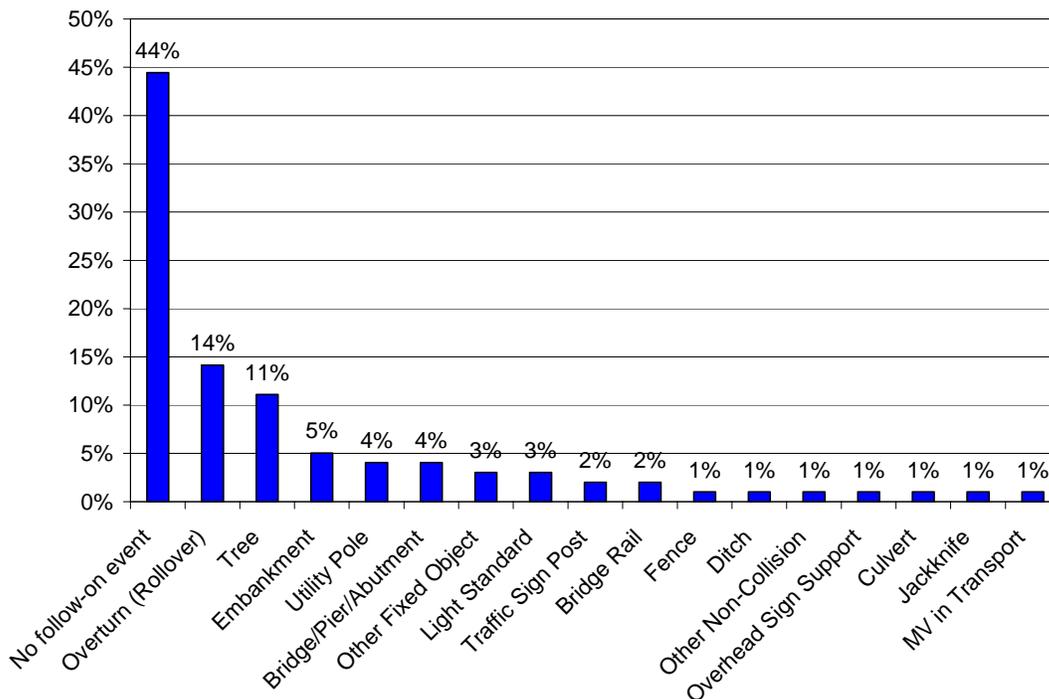
In fatal NJ guide rail crashes, Figure 10 presents what happened after the guide rail was impacted. Over half of all fatal guide rail collisions involved a secondary event – either a second impact or a rollover. Many of these secondary events, e.g. trees, poles, and rollovers, typically carry a much higher fatality risk than a guide rail impact.

Figure 10. Event occurring after the first guide rail impact (NJCRASH 2003-2005)

Figure 10 shows that 14% of all fatal guide rail collisions result in a rollover. One concern raised in the national literature is the possibility that a guide rail could act as a rollover trip hazard. In today's fleet, many light trucks have a center of gravity which is higher than the guide rail. When light trucks collide with guide rail there is a significantly greater chance of guide rail "vaulting" and roll-over [Stephens, 1996; Eskandarian, 2003]. Figure 11 presents an example of a sport utility vehicle (SUV) which vaulted over a guide-rail and then overturned.

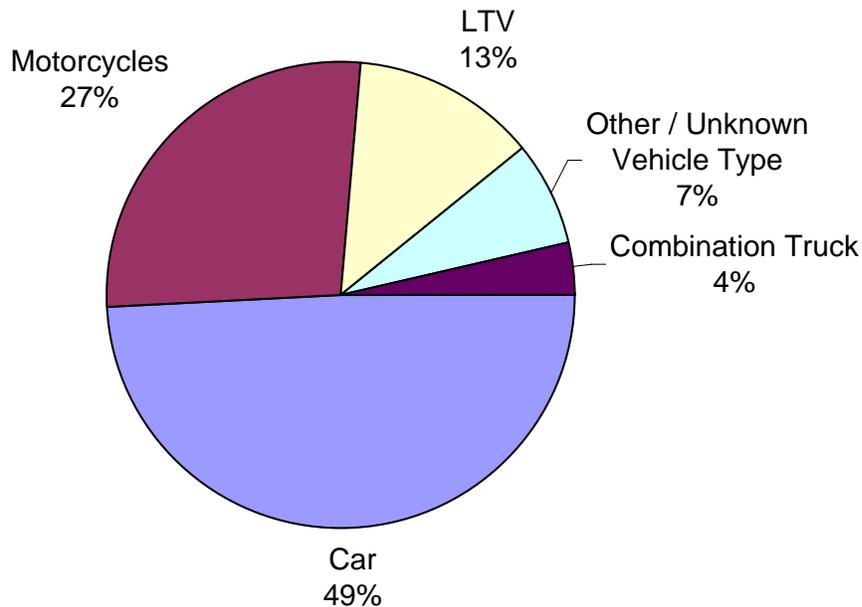
Motorcycle riders compose a surprisingly high fraction of guide rail fatalities as shown in Figure 12. In New Jersey, motorcycle riders account for over one-fourth of all guide rail crash fatalities. Cars are the most common vehicle involved in fatal guide rail crashes, accounting for approximately half of all fatal guide rail crashes. The light trucks and van (LTV) category, which includes SUVs, pickup trucks and vans, has fewer fatalities than either cars or motorcycle riders.

Figure 12. Distribution of NJ Guide Rail Fatal Crashes by Vehicle Type (FARS 2000-2005)

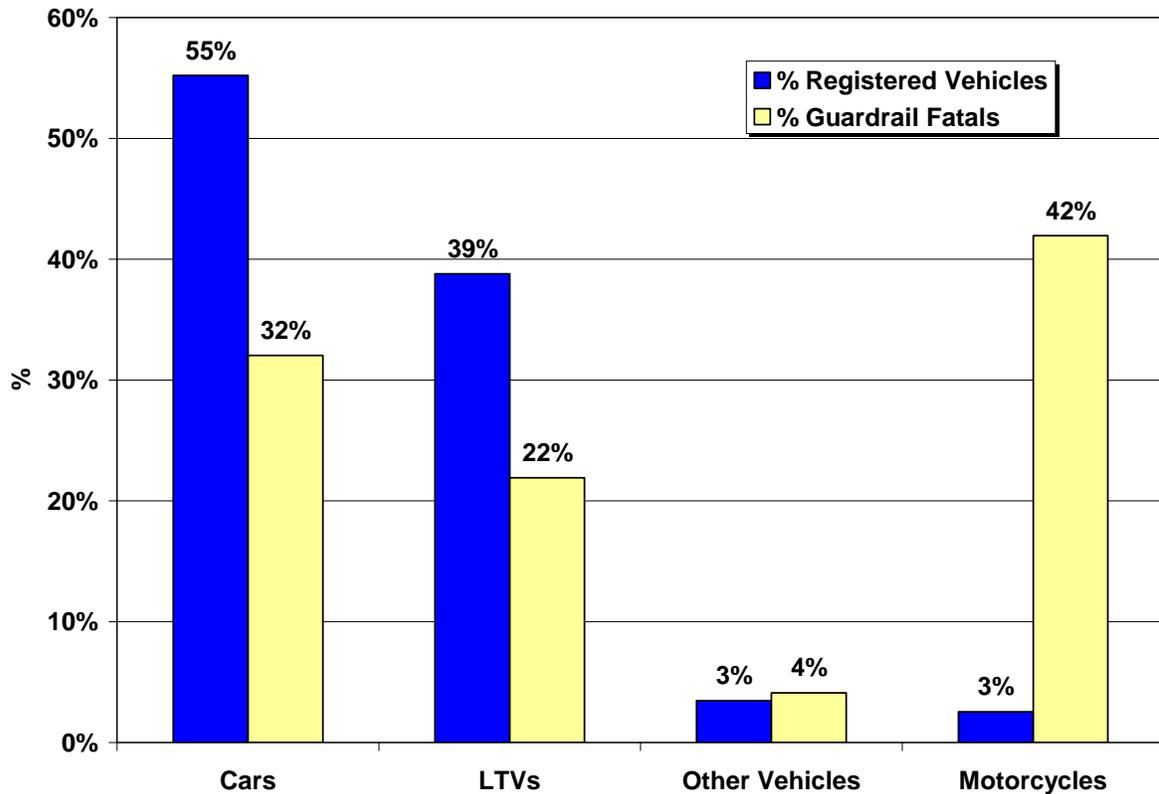
The motorcycle-guide rail crash fatality problem is not unique to New Jersey. Figure 13 presents the distribution of U.S. fatalities by vehicle body type in collisions in which a guide rail impact was the most harmful event. The distribution of fatalities and vehicle registrations are for the 2005 calendar year (NHTSA, 2006).

Nationally, motorcycle riders now account for more fatalities than the passengers of any other vehicle type involved in a guide rail collision. As shown in Figure 13, motorcycle riders accounted for 42% of all fatalities resulting for a guide rail collision in 2005. Following motorcycle riders were car occupants with 32% of all fatalities in this crash mode. This was a particularly surprising finding as cars compose over half of the vehicle fleet (56%) while motorcycles comprise only 3% of the registered vehicles. The occupants of light trucks and vans (LTVs), a category which includes pickup trucks, sport utility vehicles, minivans, and full sized vans, trailed car occupants with 22% of the guide rail crash fatalities and 30% of the registered vehicles in 2005. In terms of fatalities per registered vehicle, motorcycle riders are dramatically overrepresented in number of fatalities resulting from guide rail impacts.

Figure 13. Guide rail Crash Fatalities vs. Registrations by Vehicle Body Type (FARS 2005; NHTSA, 2006)

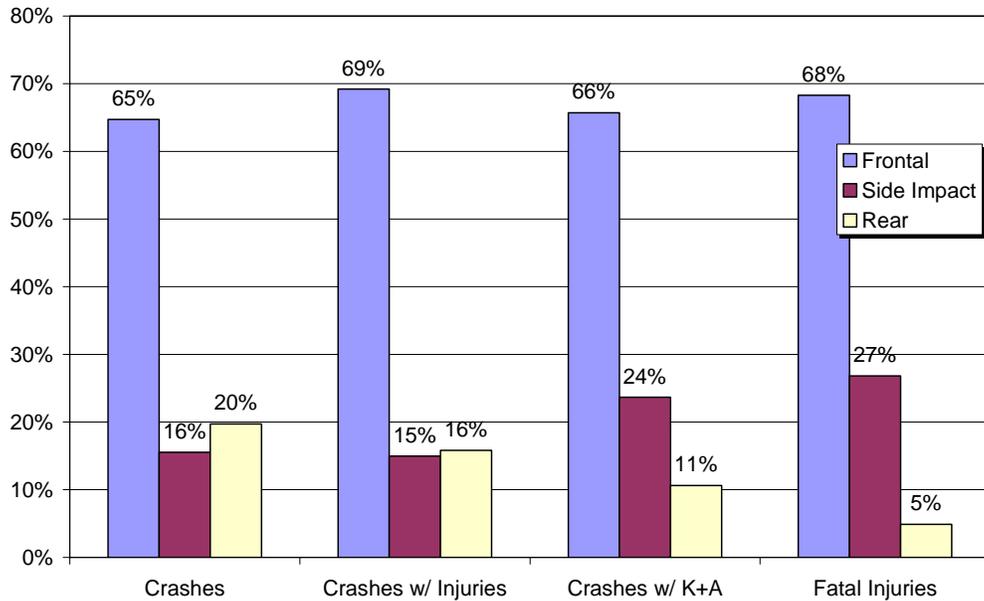
Frontal impacts are the most common type of guide rail impact, but side impacts are the most lethal crash mode. Figure 14 presents the distribution of guide rail crashes by crash mode. Frontal impacts account for 65% while side impacts account for 16% of all guide rail crashes regardless of injury severity. For fatal crashes, however, frontal impacts account for 68% while side impacts account for 27% of all fatal guide rail crashes.

Side impacts are overrepresented in terms of fatality risk. Side impacts are only 16% of all crashes, but result in 27% of all fatal guide rail crashes. One would expect that most guide rail would be struck by the front of a car. However, if a vehicle loses control and begins to spin, a non-tracking vehicle may actually strike the guide rail in the side or rear. Particularly dangerous is a side impact to the end treatment of a guide rail. Guide rail end treatments are designed to breakaway under the loads which are typical of a frontal impact. Because the side of a vehicle, unlike the front, has so little structure to protect an occupant, side impacts to a guide rail end treatment can be especially dangerous.

Figure 14. Distribution of Guide Rail Crashes by Crash Mode (NJDOT 2003-2005)
