**Design and Fabrication of Orthotropic Deck Details**

FINAL REPORT

Vol. II

Sougata Roy, Ph.D.  
Former Principal Research Scientist  
ATLSS Center  
Lehigh University

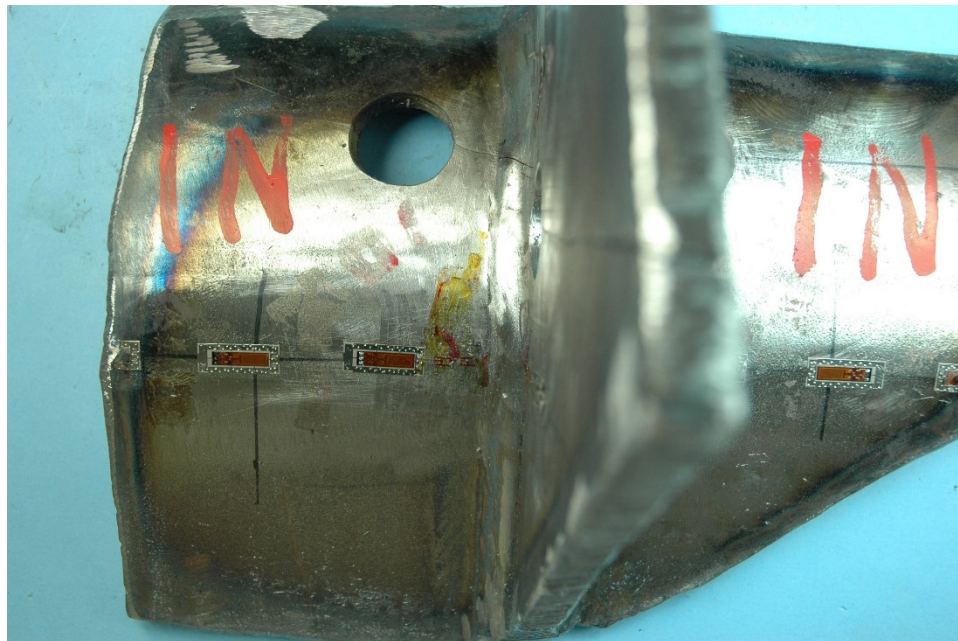
Fatigue cracks at the rib-to-floor beam connection for MU1 has already been identified in section 4.2.1. A schematic of the fatigue cracks in MU1 is shown in Figure 203. After the fatigue test, the cracks at the rib-to-floor beam connections were exposed to characterize their origin and growth. Figures 204 and 205 show a typical portion of the floor beam and the rib containing the north and the south side cracks respectively, that was cut out of MU1. Figures 206 and 207 show the exposed mating fracture surfaces of the cracks to the north and the south sides of the rib respectively. The cracks grew on two different planes through the rib wall and the floor beam by transitioning through the rib-to-floor beam weld. As shown in Figure 203, the cracks grew in the rib wall and in the floor beams on planes subtending approximately 30 and 75 degrees to the vertical. Through the weld, the crack plane transitioned between the two, forming approximately 50 degrees with the vertical at around the weld root. It is also evident from Figures Figure 206 and Figure 207 that the cracks grew in two different planes through the rib wall and the floor beam. Figures Figure 208 and Figure 209 show an enlarged view of the fracture surfaces, photographed perpendicular to the camera to clarify the lack of fusion (LOF). Classical fatigue crack growth on multiple planes and in multi-stages was evident on the fracture surfaces. The cracks initiated at both edges of the LOF at the fillet weld root and grew in the first stage as circular (penny-shaped) cracks through the weld metal and the base metal. The two circular cracks coalesced on the floor beam web and grew as a larger single crack in the second stage at a much higher rate.

Figure 204. Portion of rib and floor beam containing the north side crack cut out of the mock-up specimen MU1

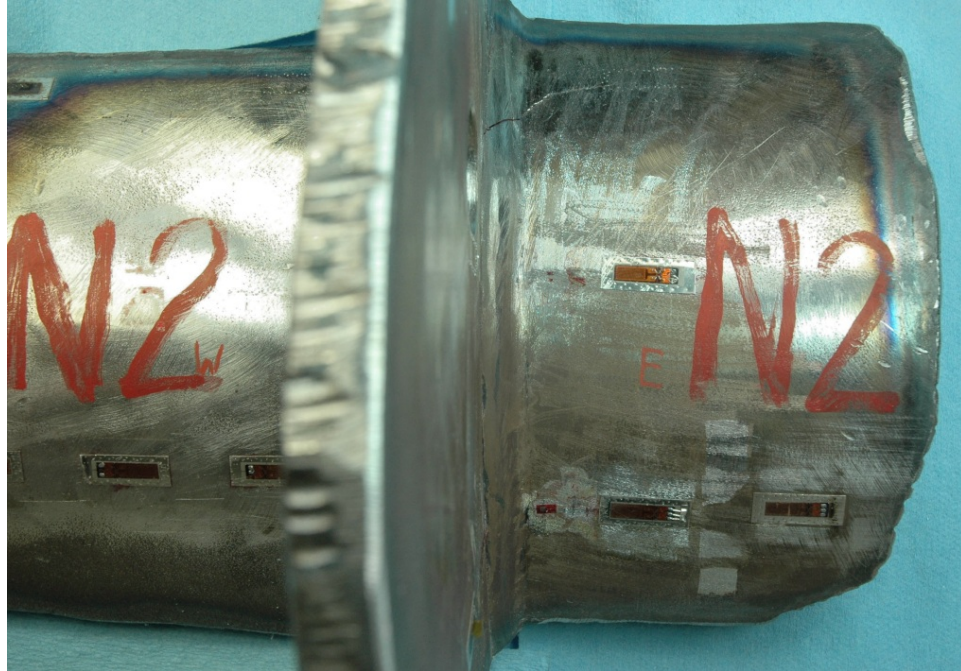
Figure 211. Portion of rib and floor beam containing the north side crack cut out of the mock-up specimen MU2
