EMPIRE STATION COMPLEX

Neighborhood Conditions Study

February 2021

FOR
Empire State Development

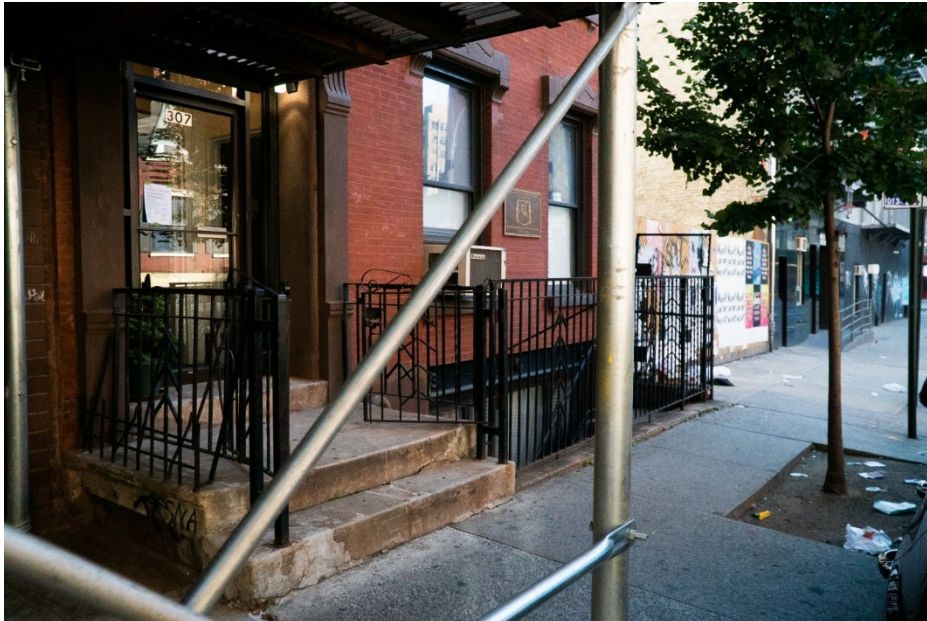
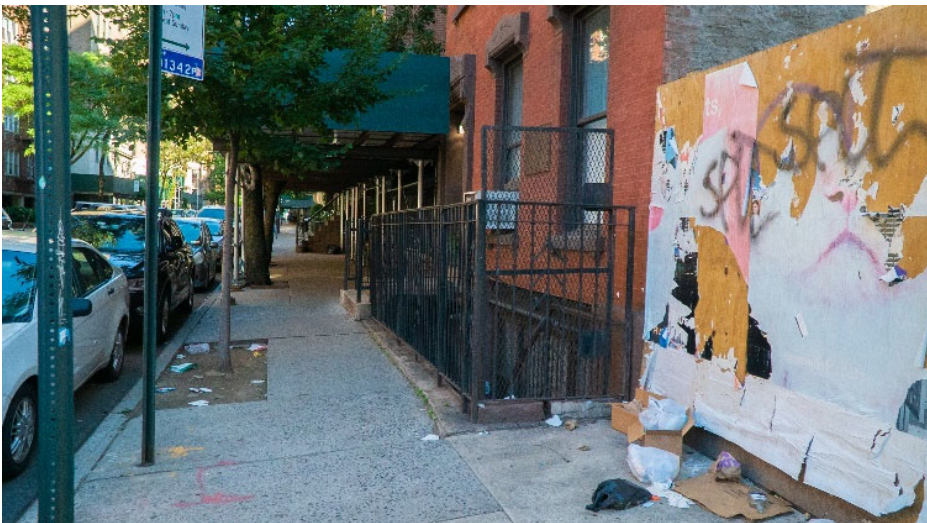
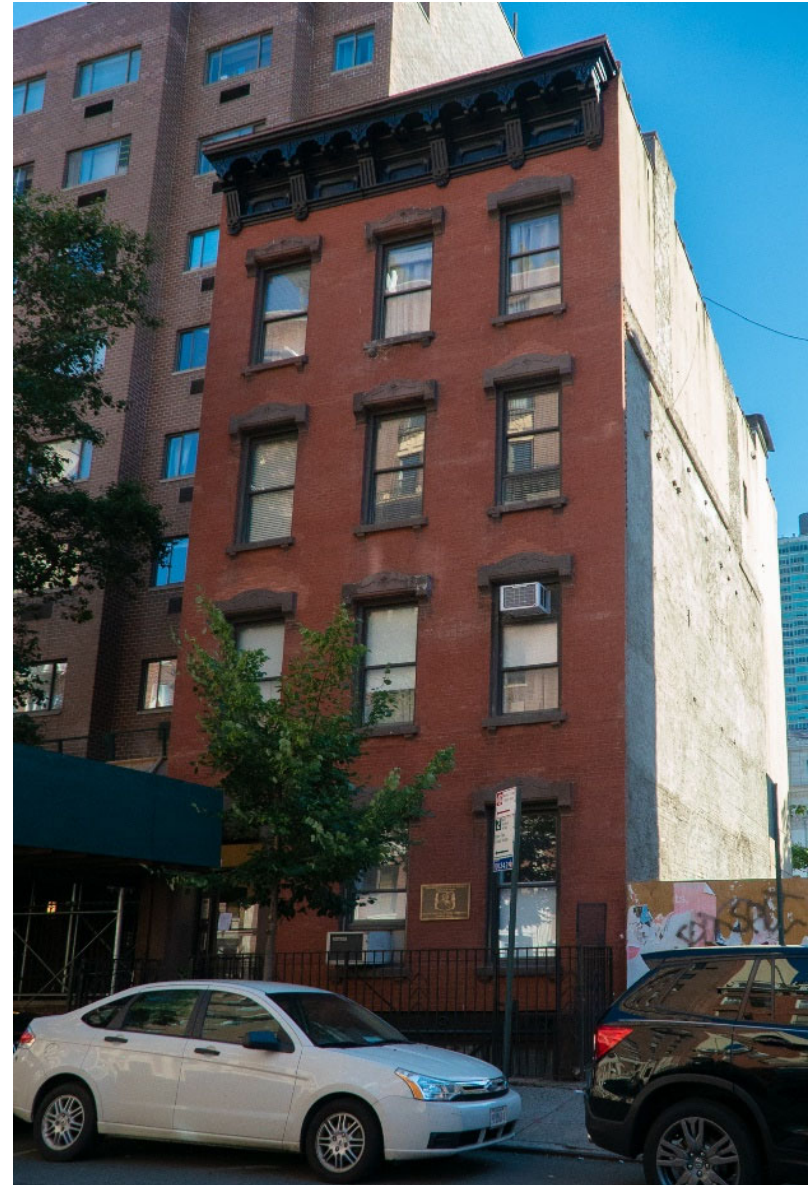
Figure 1-3 Block 754, Lot 34 Photographs

Based upon a review of the EDR database report, DOB records, and DOHMH records, there is no evidence to suggest that significant environmental concerns exist at this property. In addition, according to FDNY records, there are no tanks or violations associated with this property.

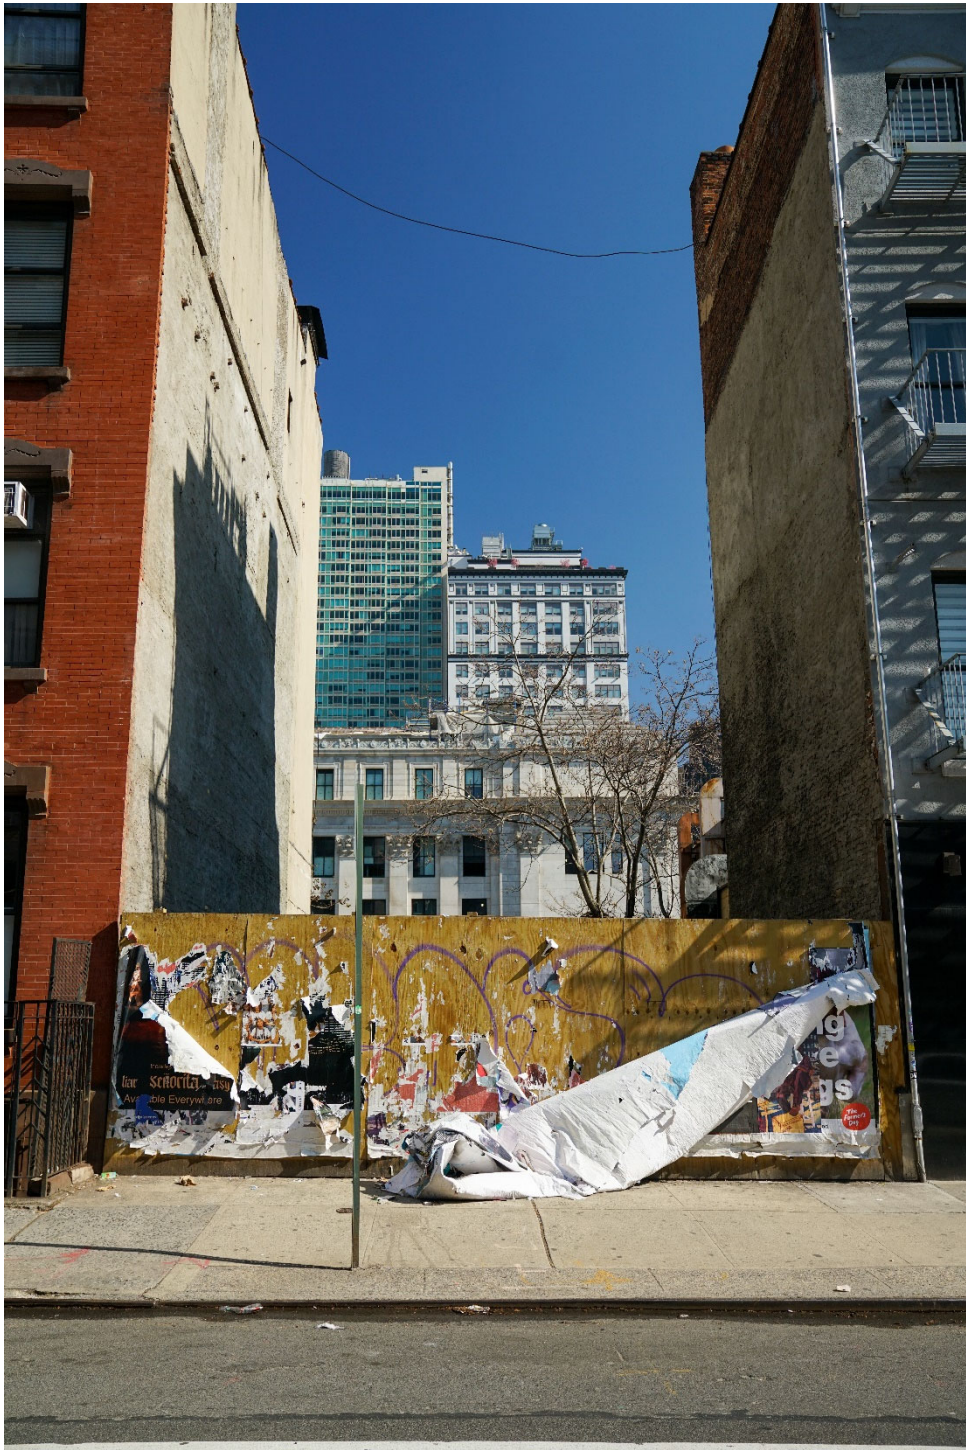
Figure 1-4 Block 754, Lot 35 Photographs

There is potential for subsurface contamination associated with the property's historic use as a gasoline service station in 2014, according to the EDR database report. In addition, no records were maintained by DOHMH, indicating that no reported insanitary conditions exist at this property. Further, according to FDNY records, there are no tanks associated with this property.

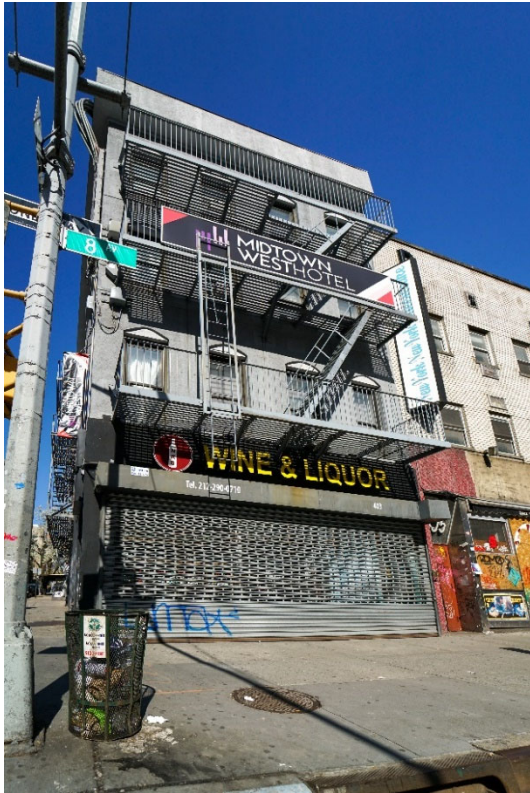
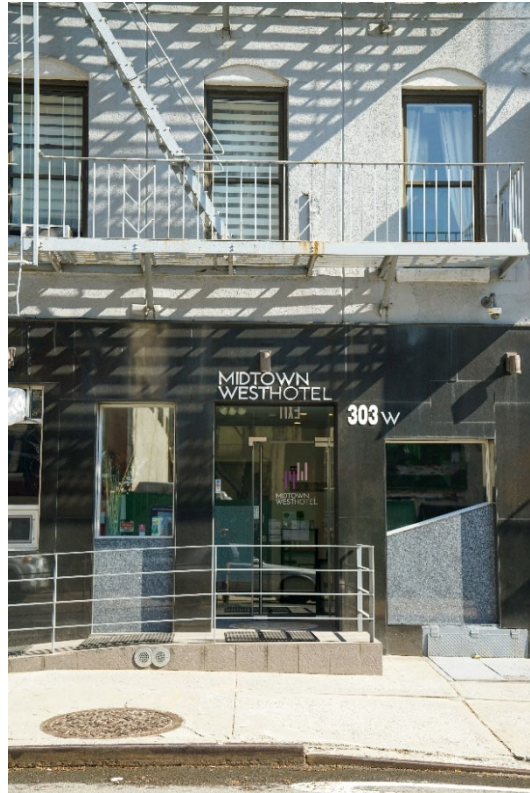
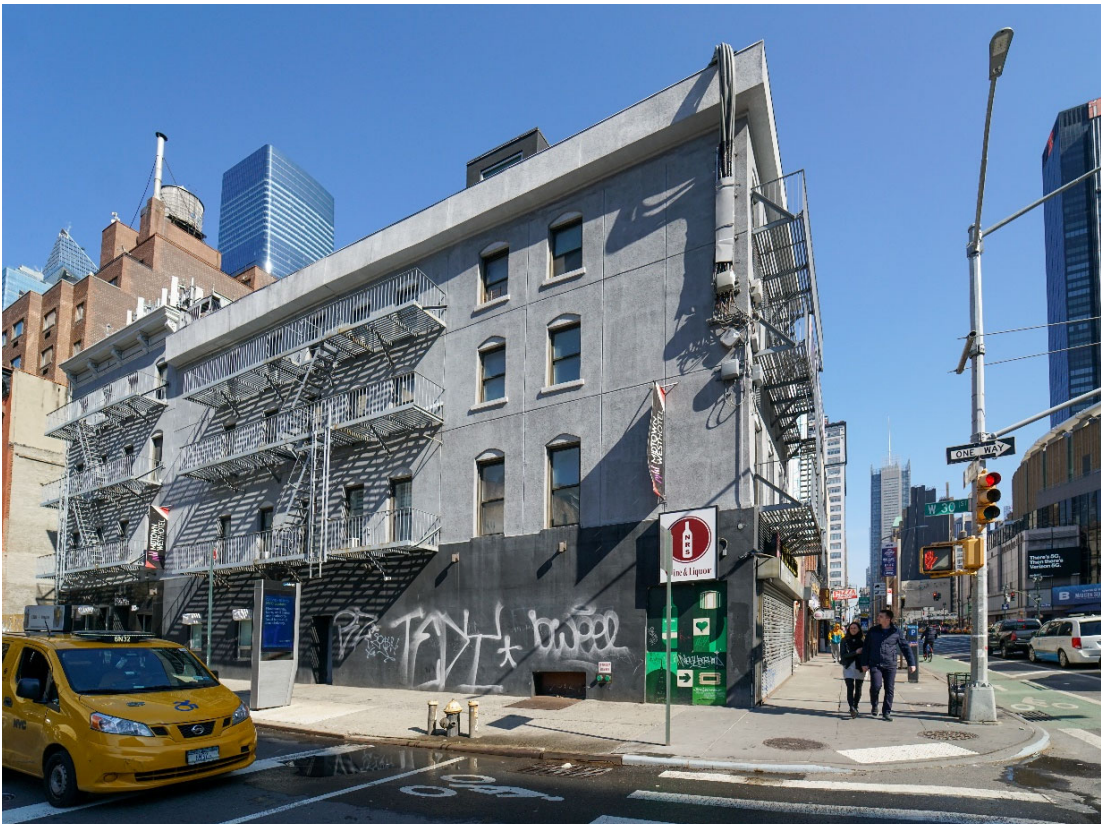
Figure 1-5 Block 754, Lot 36 Photographs

Based upon a review of the EDR database report, DOB and DOHMH records, there is no evidence to suggest that significant environmental concerns exist at this property. According to FDNY records, this property is registered with a 550-gallon fuel oil tank which was abandoned in 1994 when the property converted to natural gas.

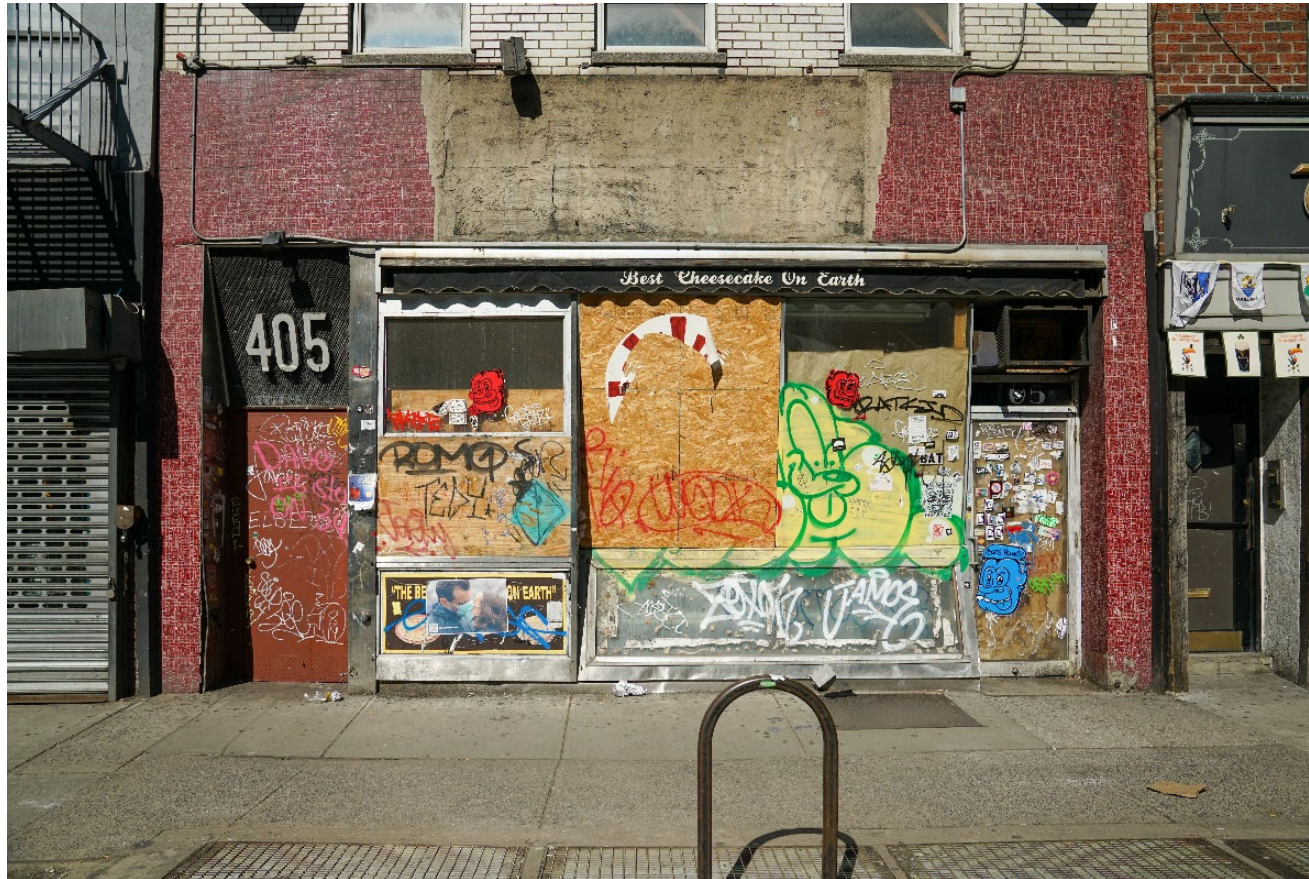
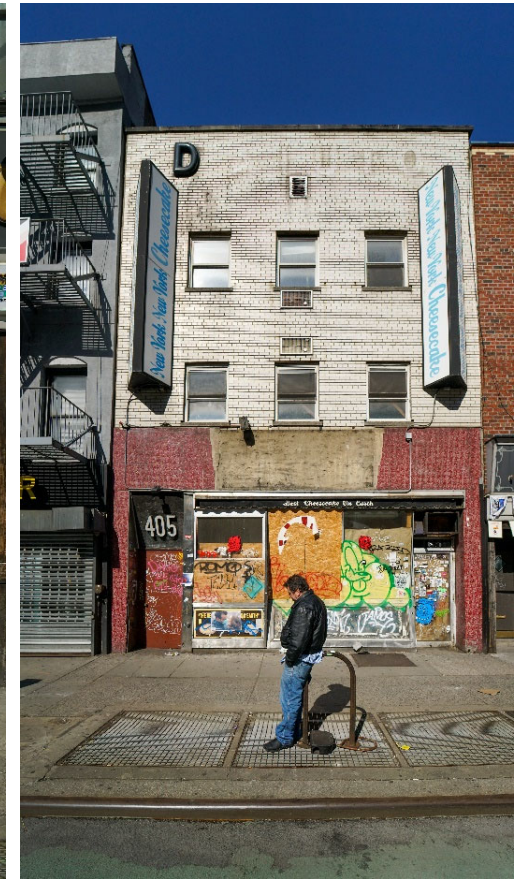
Figure 1-6 Block 754, Lot 37 Photographs

DOB records indicate suspected fuel oil storage tanks, however according to FDNY records, there are no tanks or violations associated with this property. In addition, no records were maintained by DOHMH.

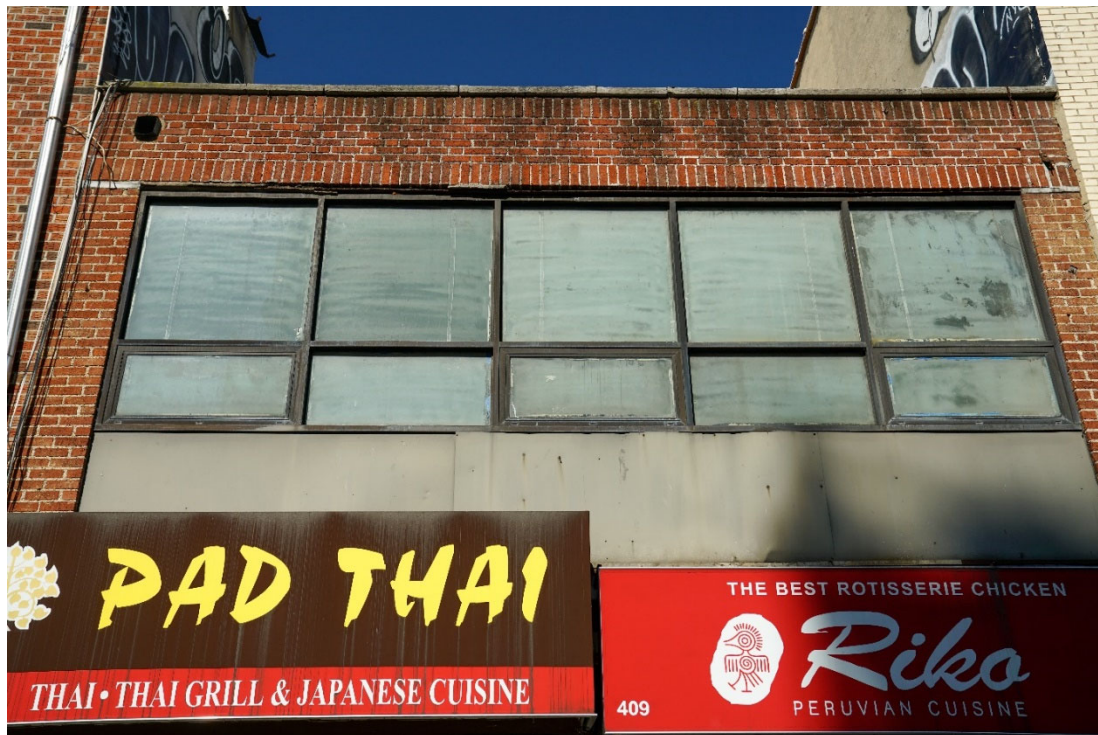
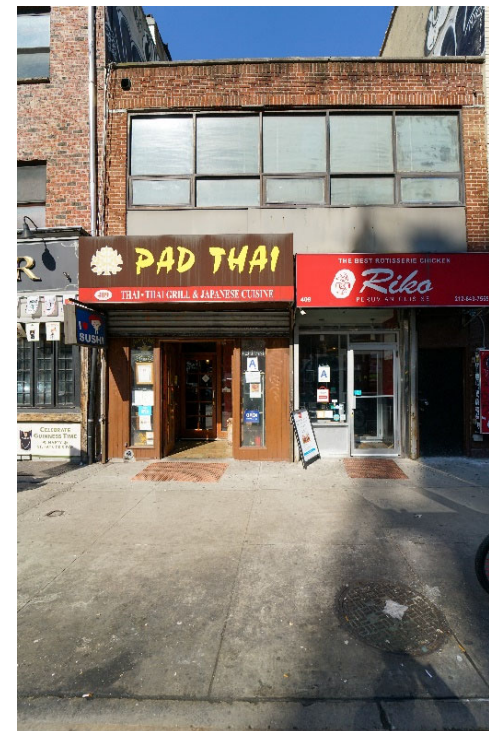
Figure 1-8 Block 754, Lot 39 Photographs

Based upon a review of the EDR database report, DOB and DOHMH records, there is no evidence to suggest that significant environmental concerns exist at this property. In addition, according to FDNY records, there are no tanks or violations associated with this property.

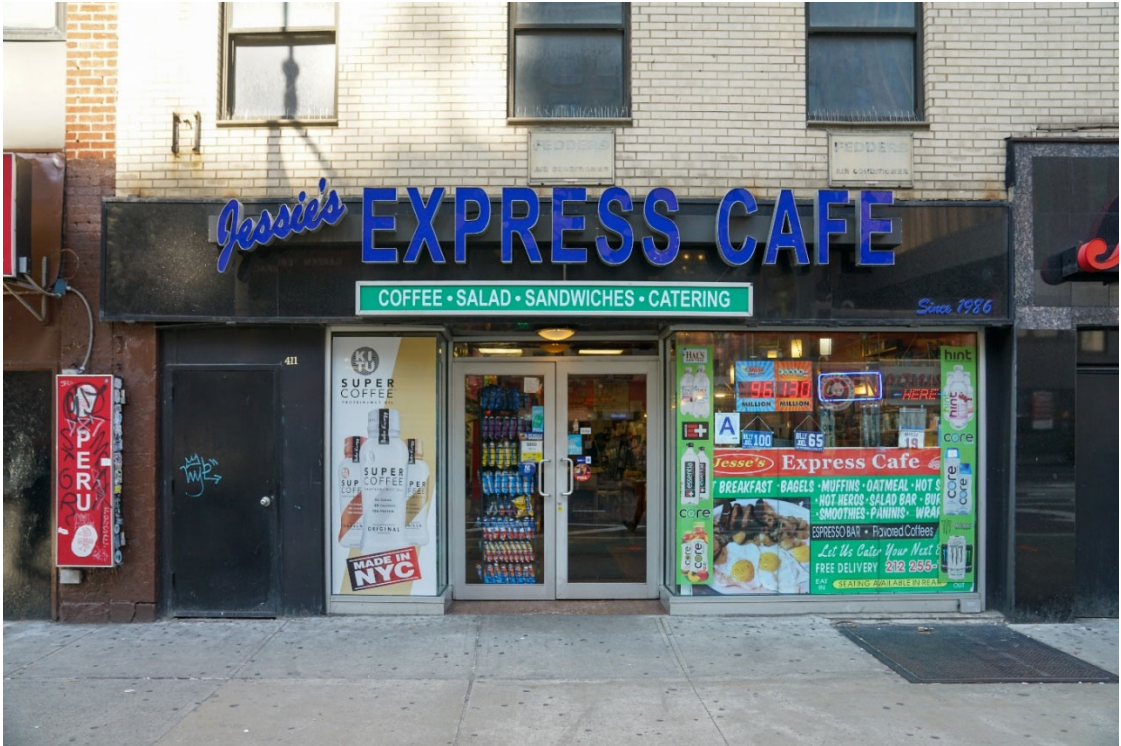
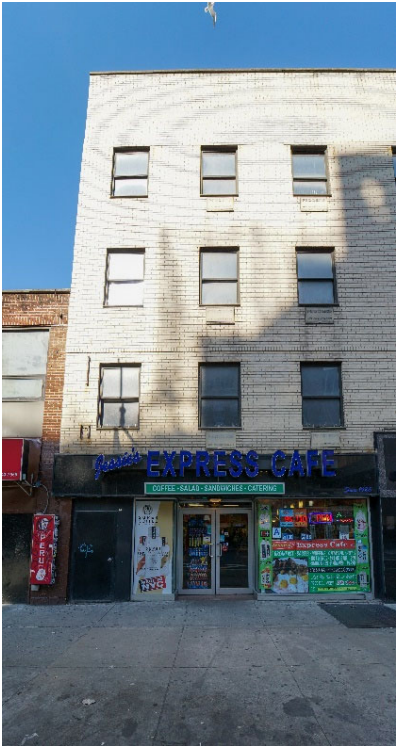
Figure 1-9 Block 754, Lot 40 Photographs

There is potential for fuel oil tanks located at this property, as indicated by DOB records. According to FDNY records, this property is registered with two (2) 275-gallon fuel oil tanks that were abandoned in 1996 when the property converted to natural gas. Further, Lot 40 was issued a violation notice in 2016 for failing to provide extinguishers within the building. In addition, no records were maintained by DOHMH.

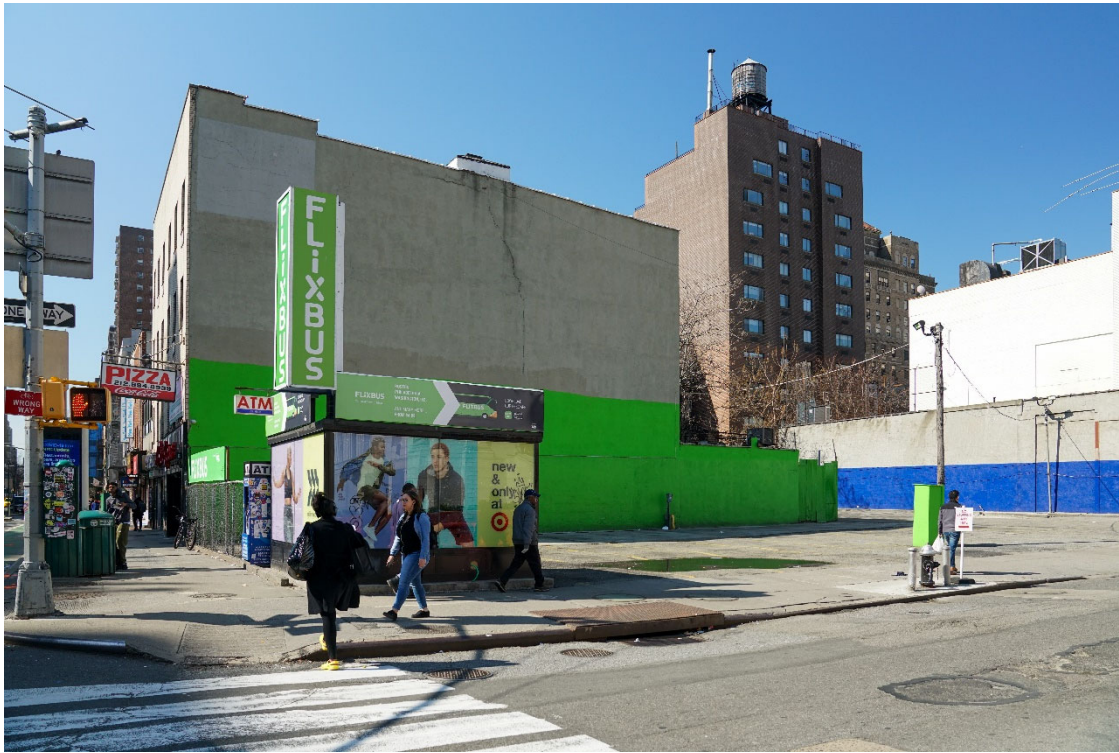
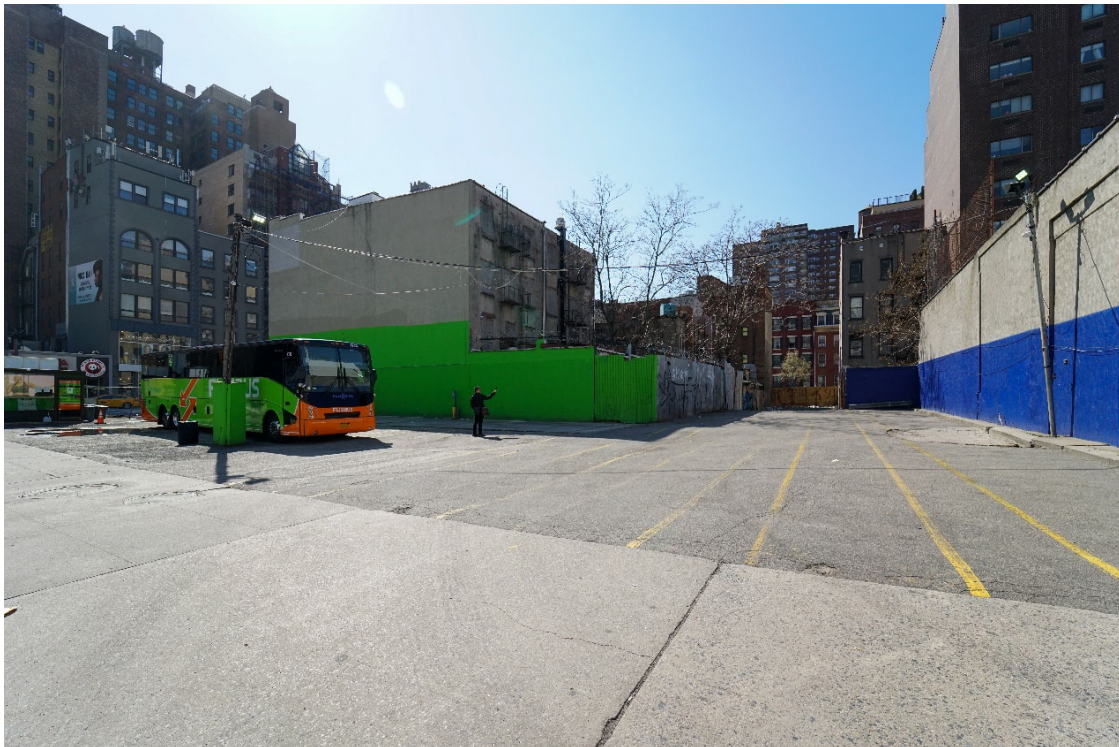
Figure 1-11 Block 754, Lot 44 Photographs

Lot 44 contains a paid parking lot with a small one-story ticket booth made of metal and glass. While there is some graffiti at the site, the structure—including its doors and windows—is in good condition. The security fence, yard surface, sidewalk, and lighting are in fair condition. The curb cuts are in poor condition with areas of cracking and crumbling. Overall, the building and site conditions were given a rating of fair condition.

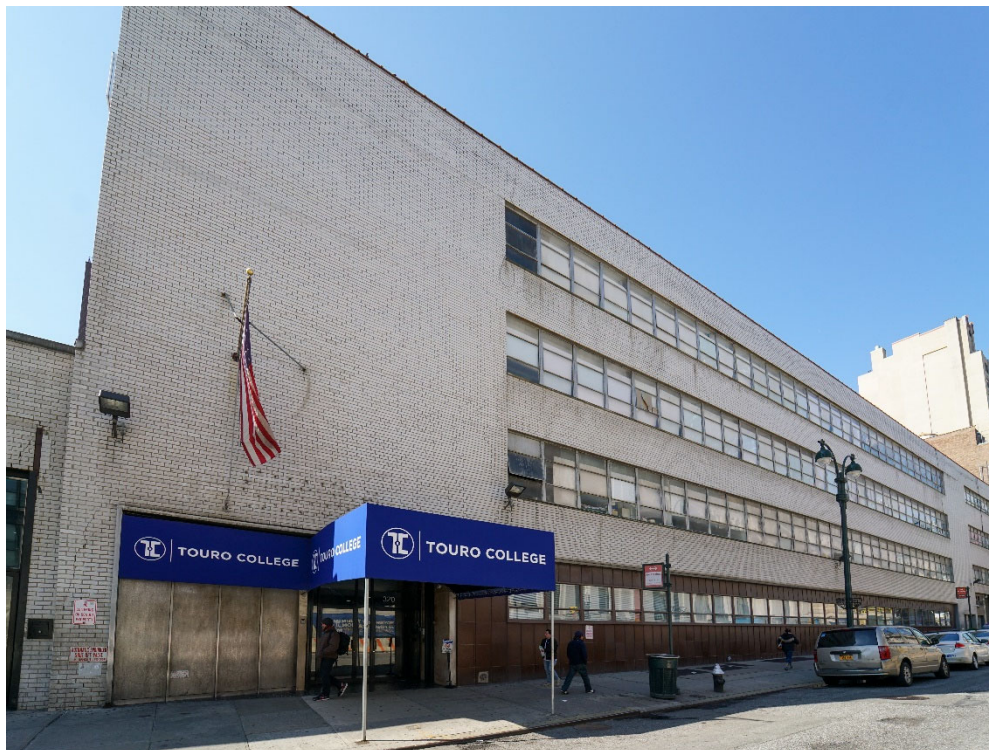
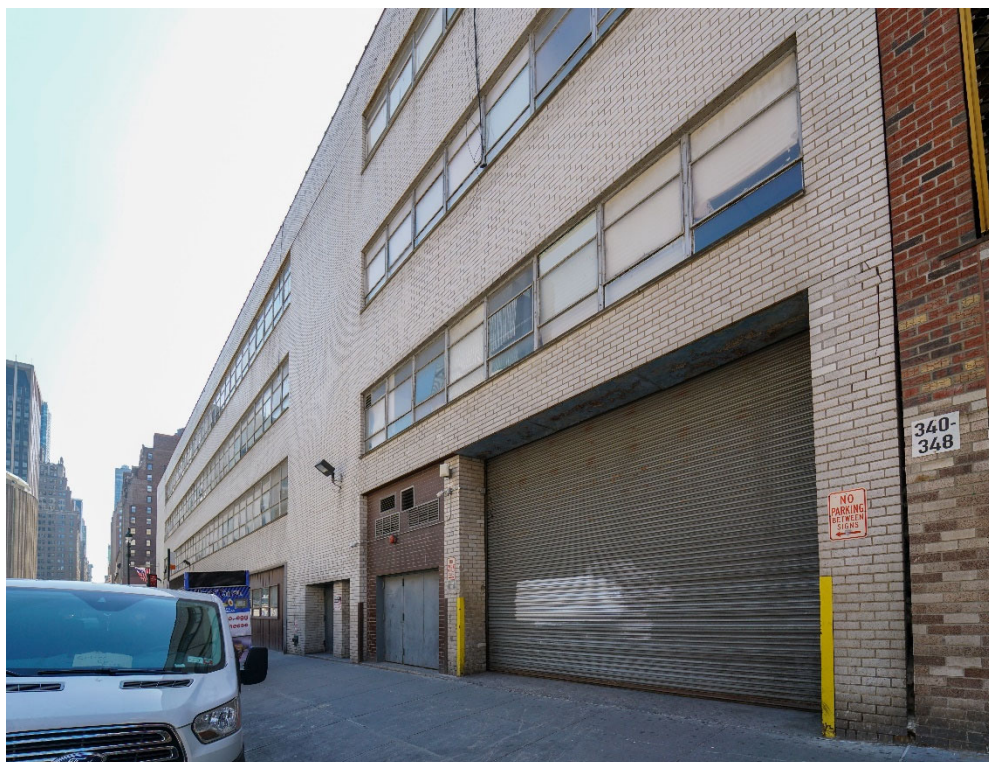
Figure 1-12 Block 754, Lot 51 Photographs

Lot 51 contains a four-story academic building. The façade is mostly exposed brick, with metal panels on the ground floor and an awning at the building entrance. The doors are in good condition. The windows show some damage and cracking but are in fair condition. The main entrance shows no barrier to accessibility. The sidewalk and curb cuts are in fair condition, with some cracking and corrosion. The building has an energy efficiency grade of B, as reported by the Mayor's Office of Sustainability. Overall, the building and site conditions were given a rating of good condition.

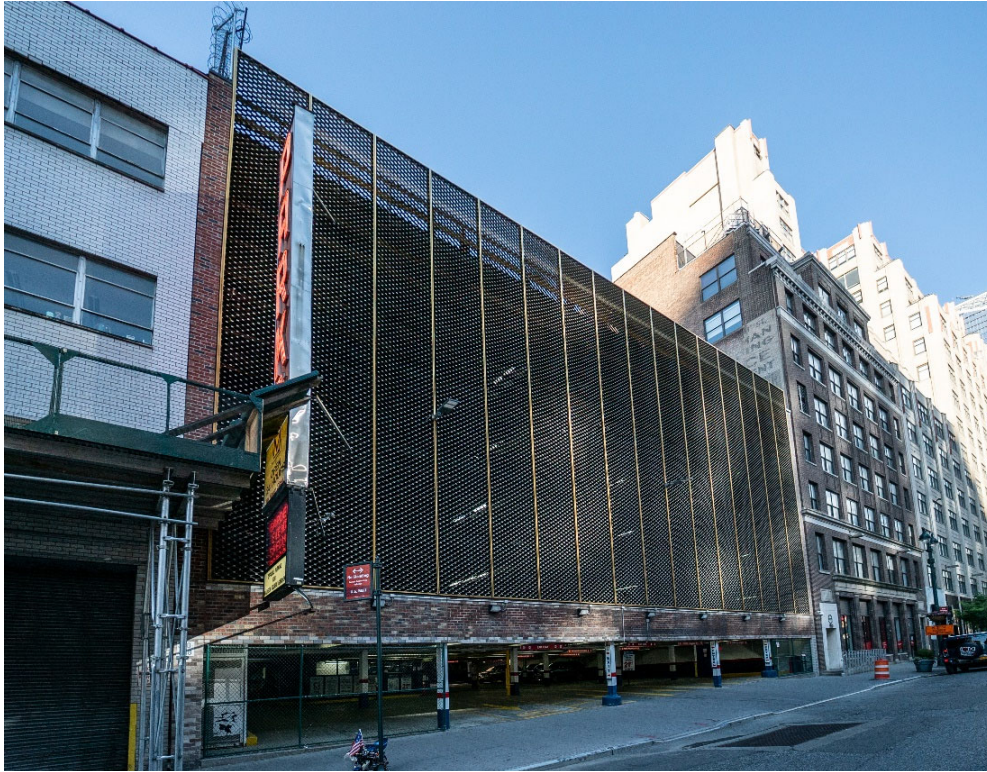
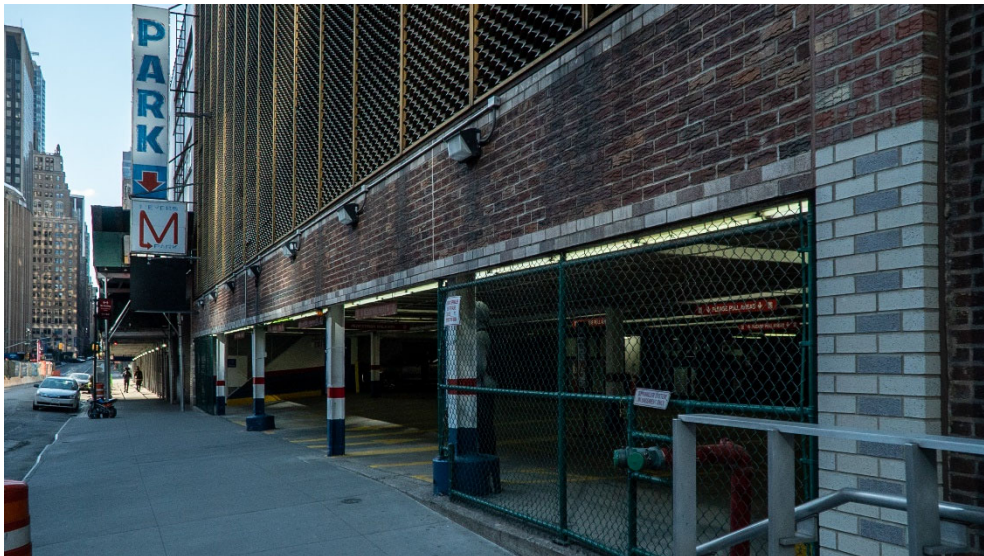
Figure 1-13 Block 754, Lot 63 Photographs

Lot 63 has an eight-story parking garage building. The building is ADA accessible at its entry. The façade consists of bricks and metal. The exterior walls and windows are in good condition, while the gate is in fair condition with moderate corrosion and staining. The sidewalk and curb cuts are in fair condition with minor cracks, stains and debris. Overall, the building and site conditions were given a rating of good condition.

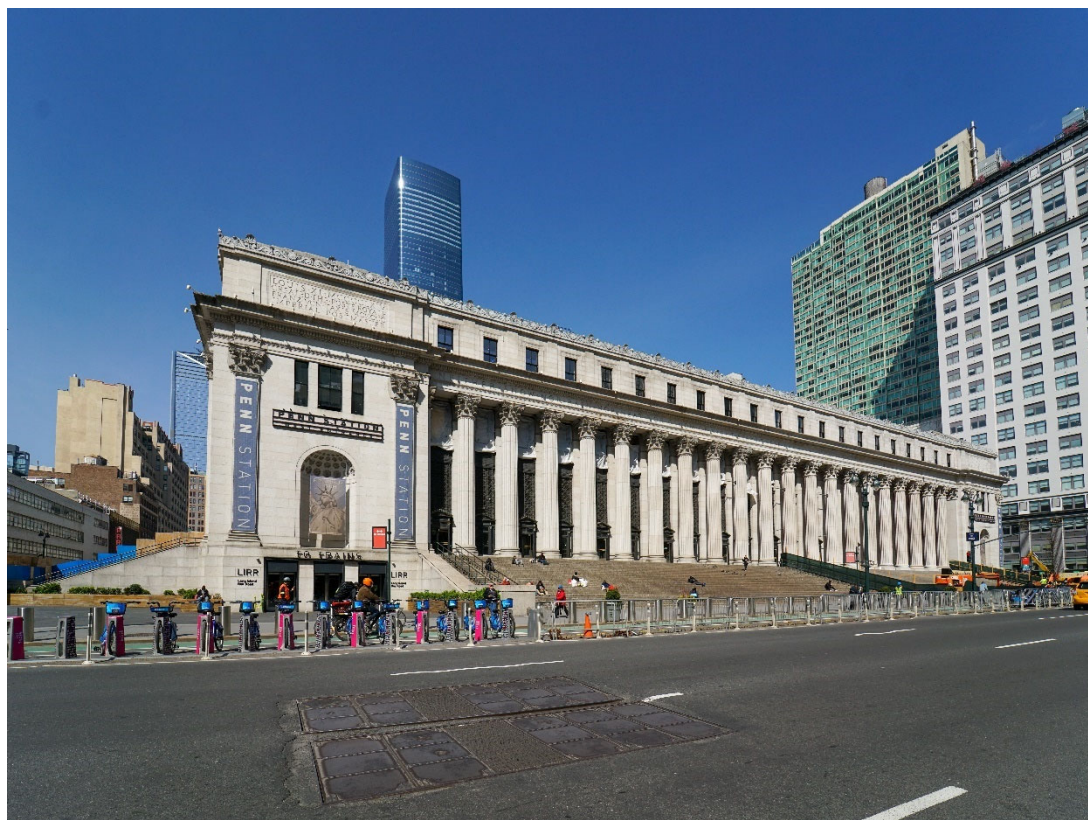
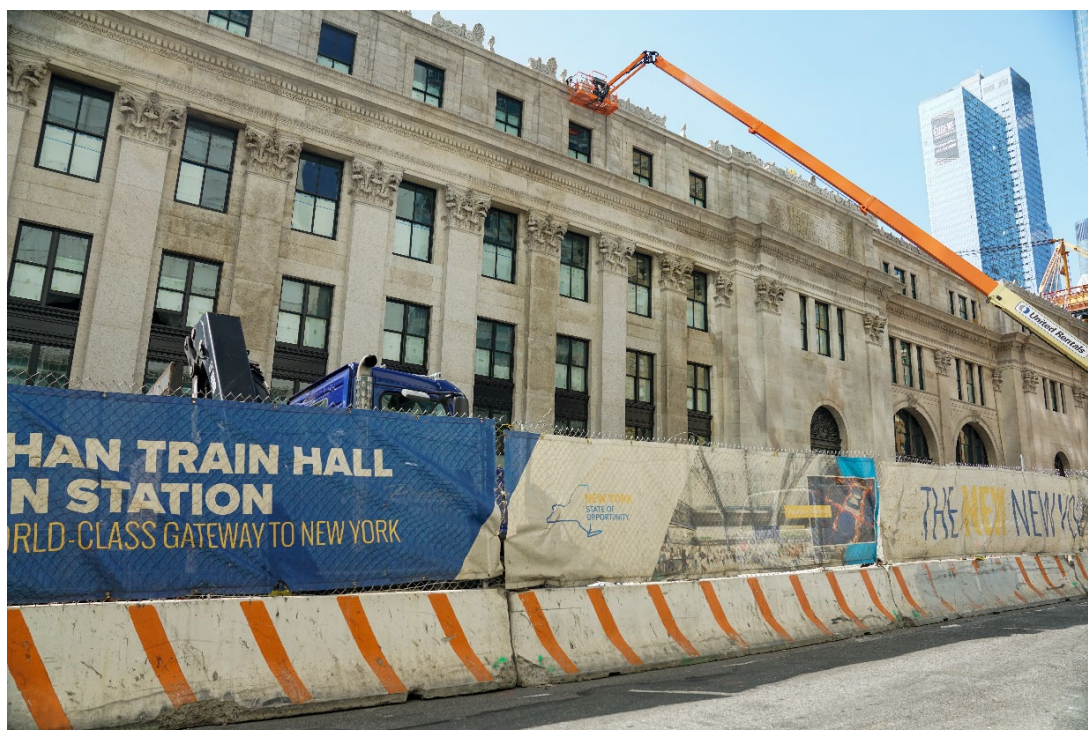
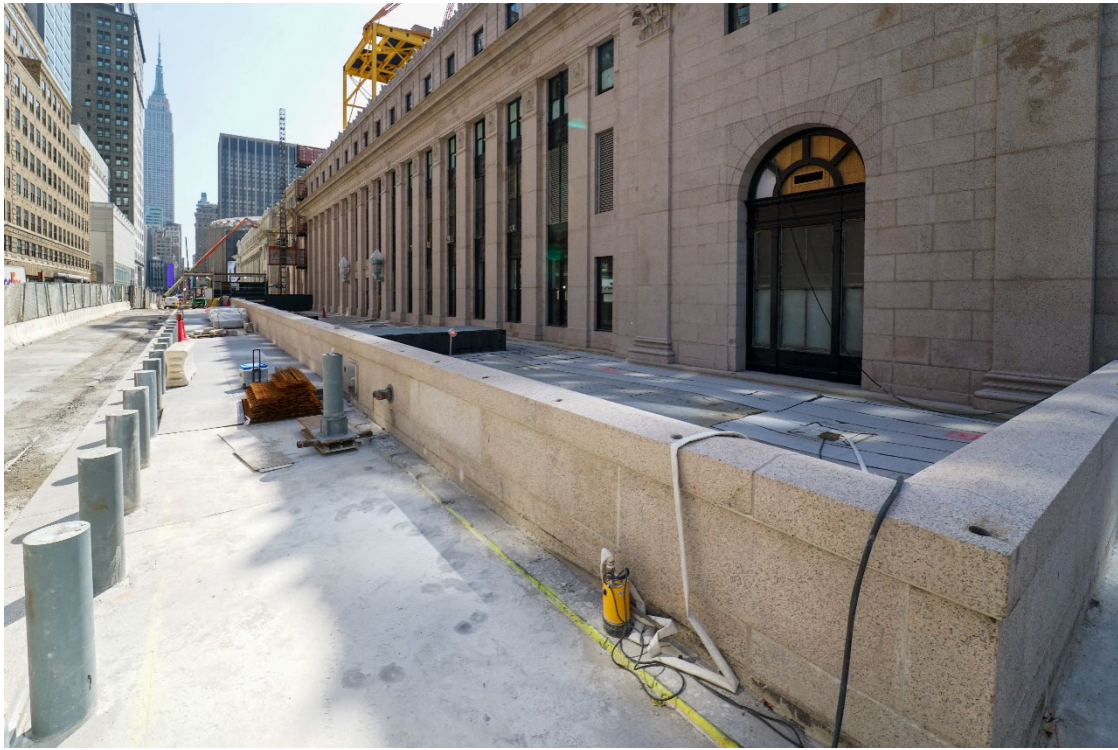
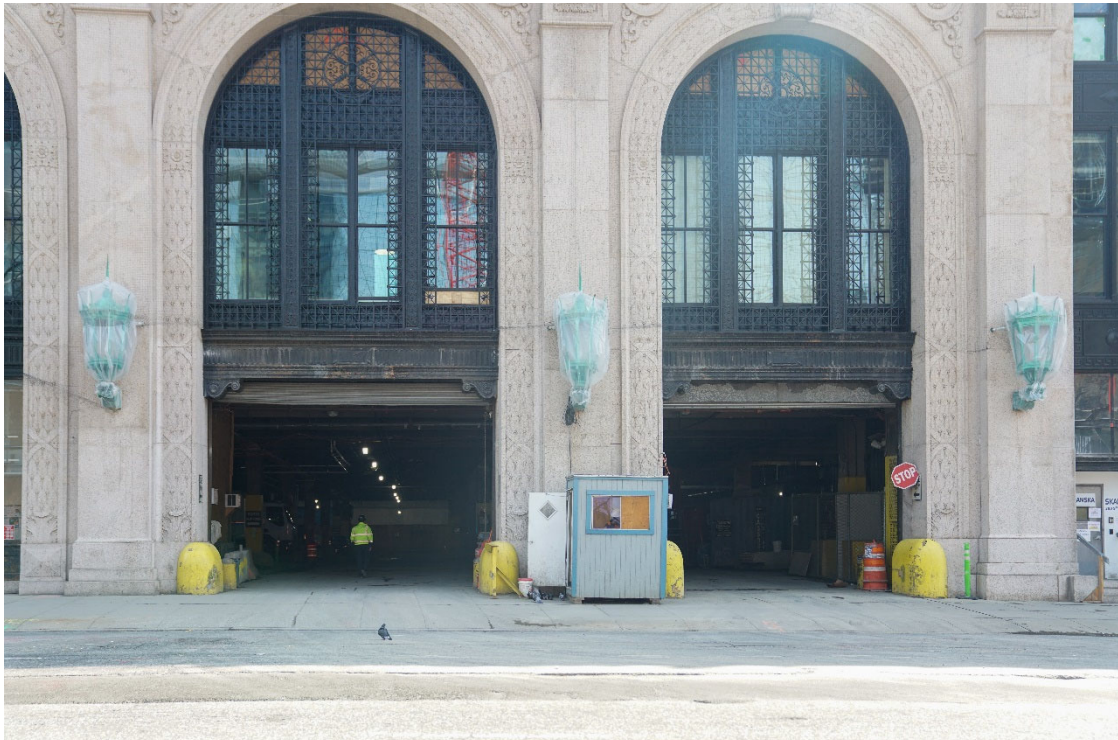
Figure 1-15 Block 755, Lot 40 Photographs

The building on Lot 40 occupies the entire block. It is five-stories and contains entrances to Pennsylvania Station at its southeast and northeast corners. It also functions as a post office. The building's façade, doors, and windows are all in good condition. The sidewalk and curb cuts are in good condition on the east side of the building. However, elsewhere they are in fair condition, with some cracking and crumbling. A portion of the sidewalk is under construction. Overall, the building and site conditions were given a rating of good condition.

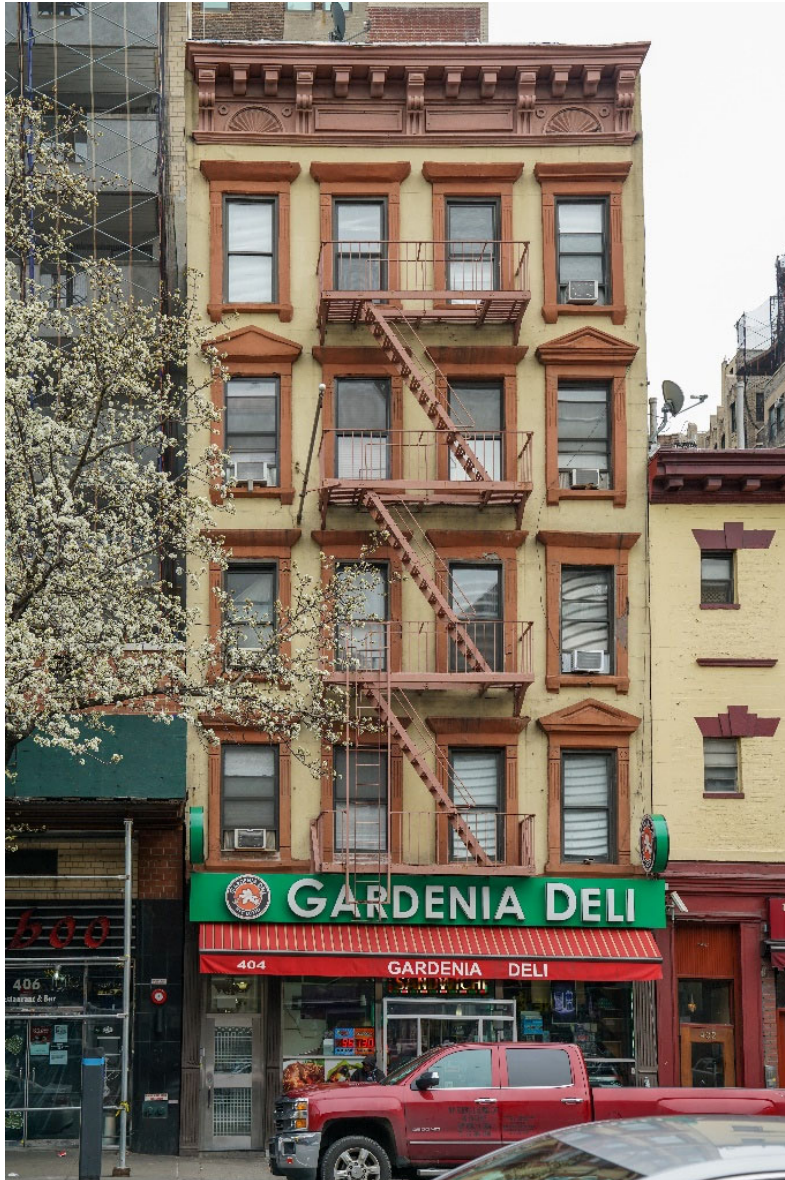
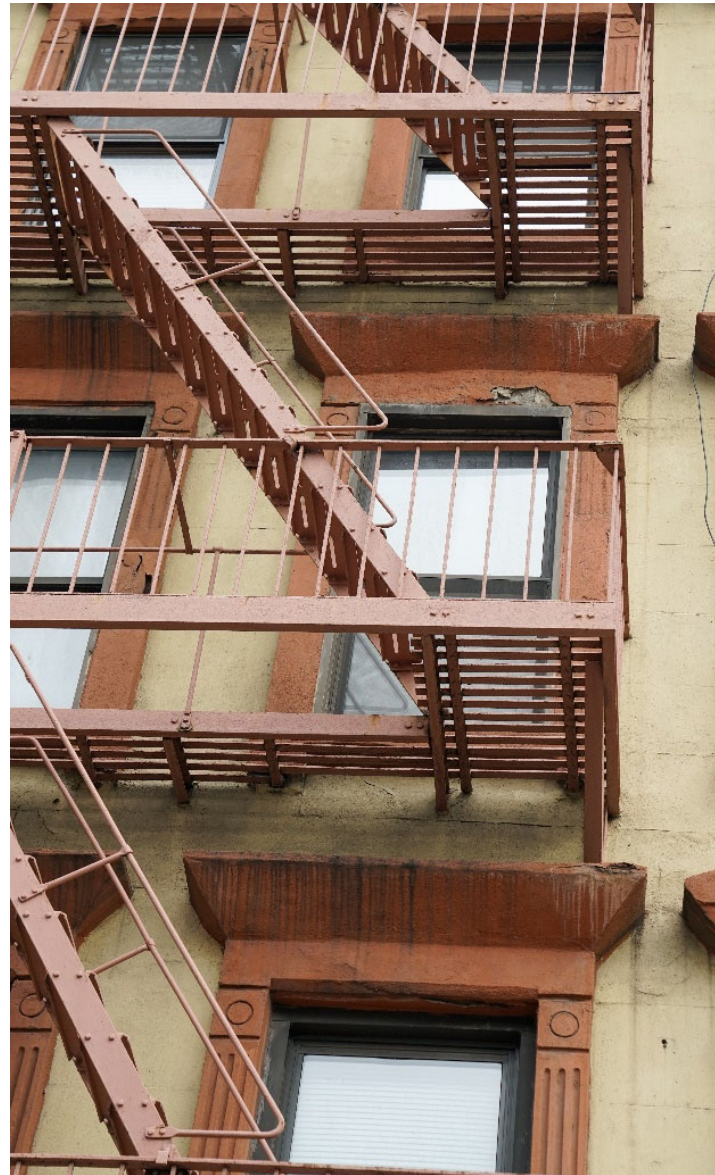
Figure 1-18 Block 780, Lot 2 Photographs

Lot 2 contains a five-story building, with retail on the ground floor and residential uses on the upper floors. The façade consists of wood and glass at the ground floor, and wood and stucco on the upper floors. The exterior wall is in fair condition, with minor cracks in the painted wall and window lintels. Windows and doors are in good condition. Sidewalk and curb cuts show minor cracking, staining, and debris. The building shows no barrier to ADA accessibility at the ground-floor entrance. Overall, the building and site conditions were given a rating of good condition.

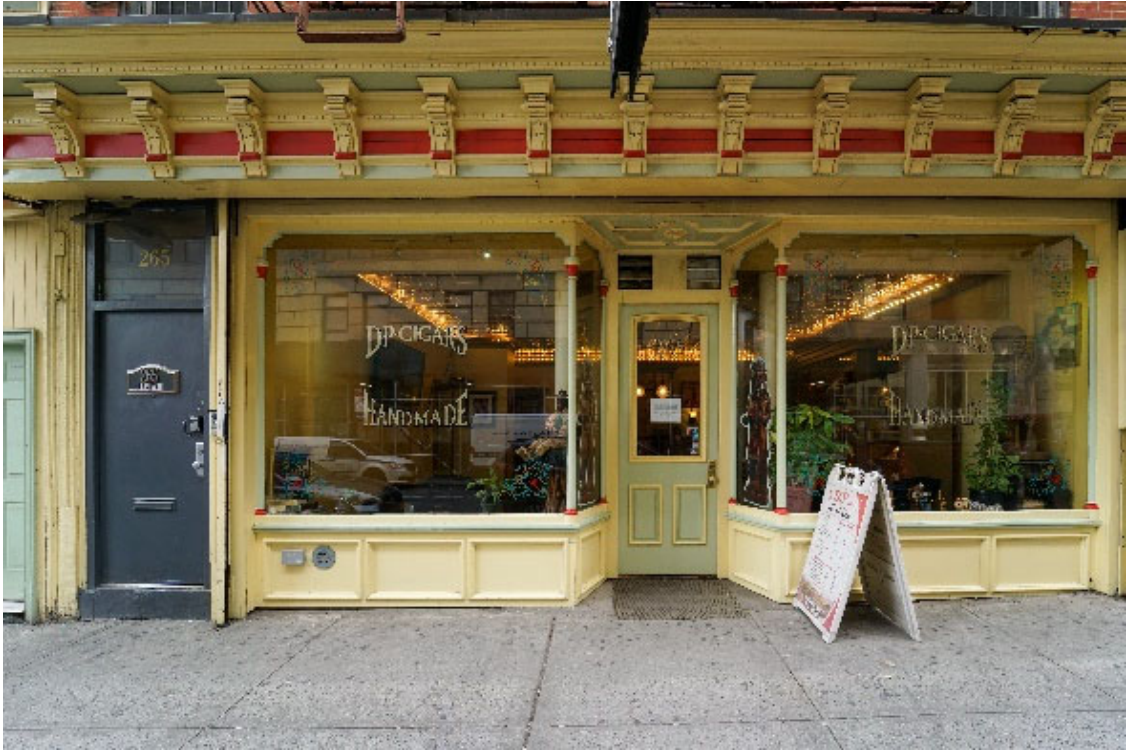
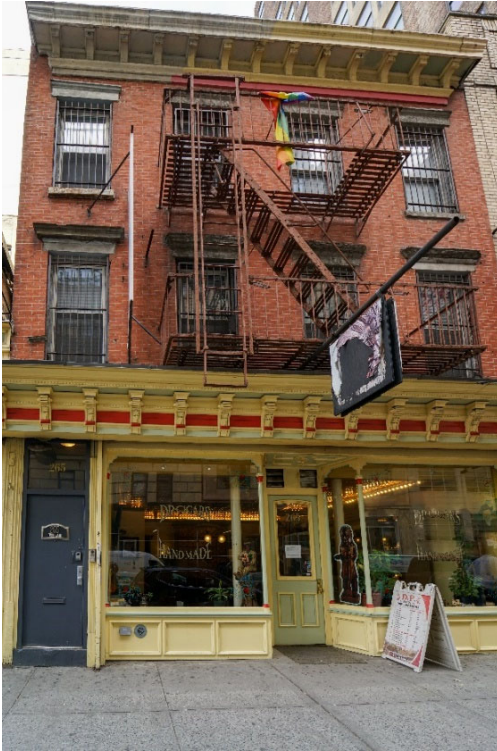
Figure 1-19 Block 780, Lot 5 Photographs

Lot 5 contains a three-story building, with retail at street level and residential uses on the upper floors. The façade consists of painted wood and glass on the ground floor and brick and wood on the upper floors. The exterior wall is in a fair condition, with minor corrosion and cracks in the paint on the window lintels. Windows and doors are intact and undamaged. The sidewalk is in fair condition, showing minor cracking, staining, and debris. The ground floor retail entrance shows no barrier to accessibility, but the door accessing the upper floors is not accessible due an existing step at its entry. Overall, the building and site conditions were given a rating of good condition.
