EMPIRE STATION COMPLEX

Neighborhood Conditions Study

February 2021

FOR
Empire State Development

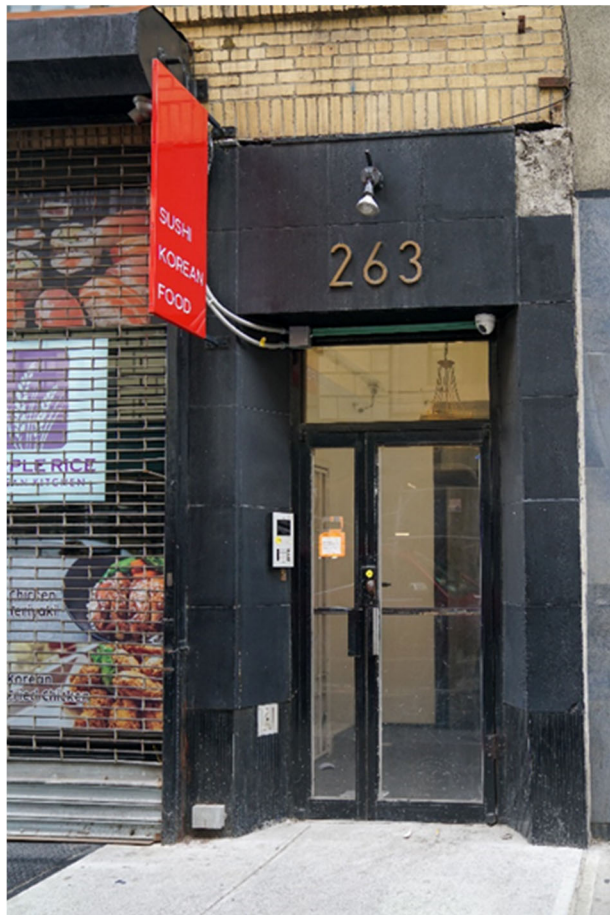
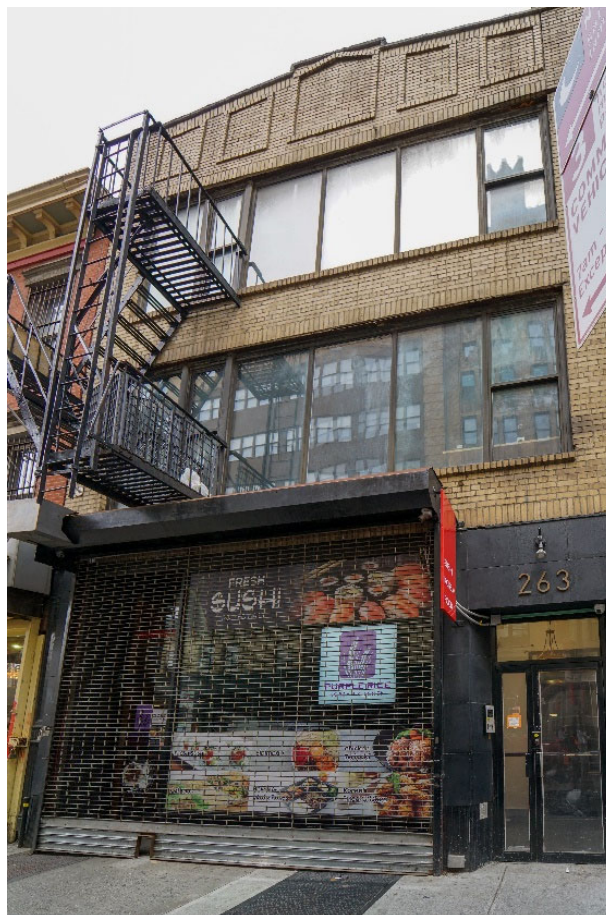
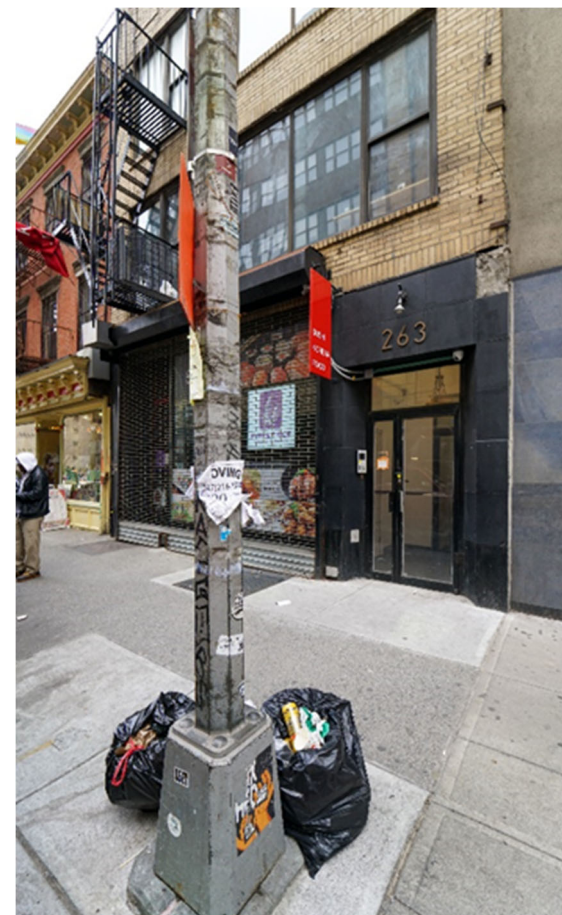
Figure 1-20 Block 780, Lot 6 Photographs

Lot 6 contains a three-story building, with retail at street level and residential uses on the upper floors. The façade consists of a stone-tile and glass storefront on the ground floor and brick, metal, and glass on the upper floors. The exterior wall is in poor condition, with a missing stone tile, moderate corrosion, and stains. Windows are also in poor condition, with heavy corrosion showing on their frames. The doors are in fair condition with moderate stain. Currently, the first-floor façade has a rolled down security gate that is in fair condition. The sidewalk is in fair condition, showing minor cracking and staining. The building shows no barrier to accessibility at the street-level entry. Overall, the building and site conditions were given a rating of fair condition.

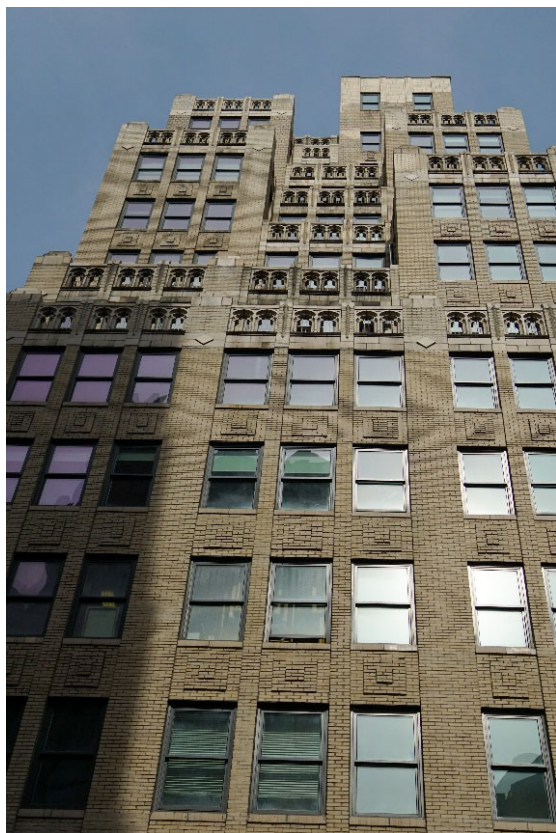
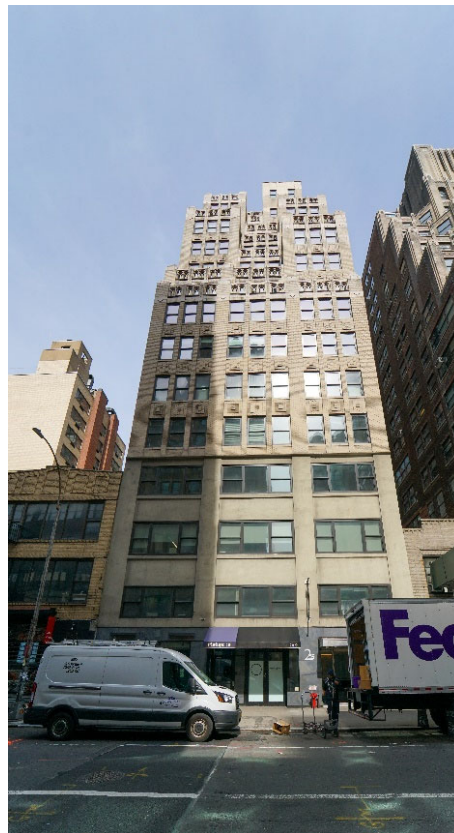
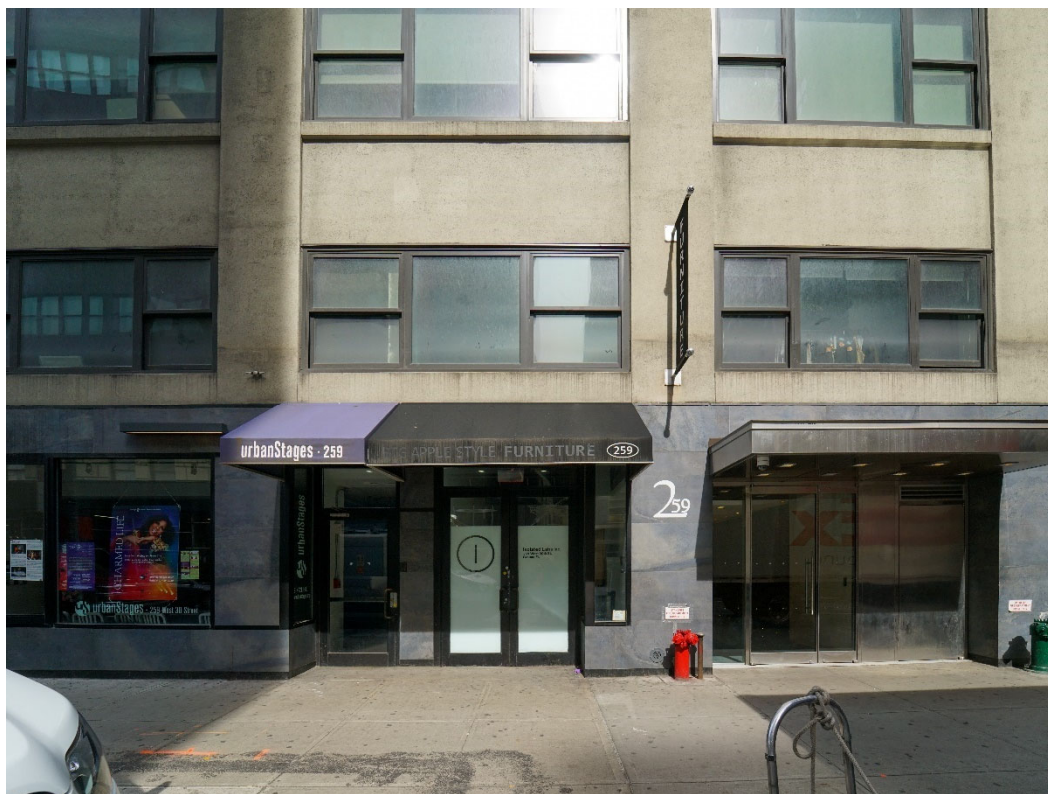
Figure 1-21 Block 780, Lot 7 Photographs

Lot 7 contains a 17-story building, with retail at the ground floor and office space on the upper floors. The façade consists of stone tiles on the ground floor and brick and stone on the upper floors. The exterior wall, windows, and doors are in fair condition, showing moderate staining. The sidewalk is in fair condition, with minor cracking, staining, and debris. The building has an energy efficiency grade of C, as reported by the Mayor's Office of Sustainability. The building shows no barrier to accessibility at the ground-floor entrance. Overall, the building and site conditions were given a rating of good condition.

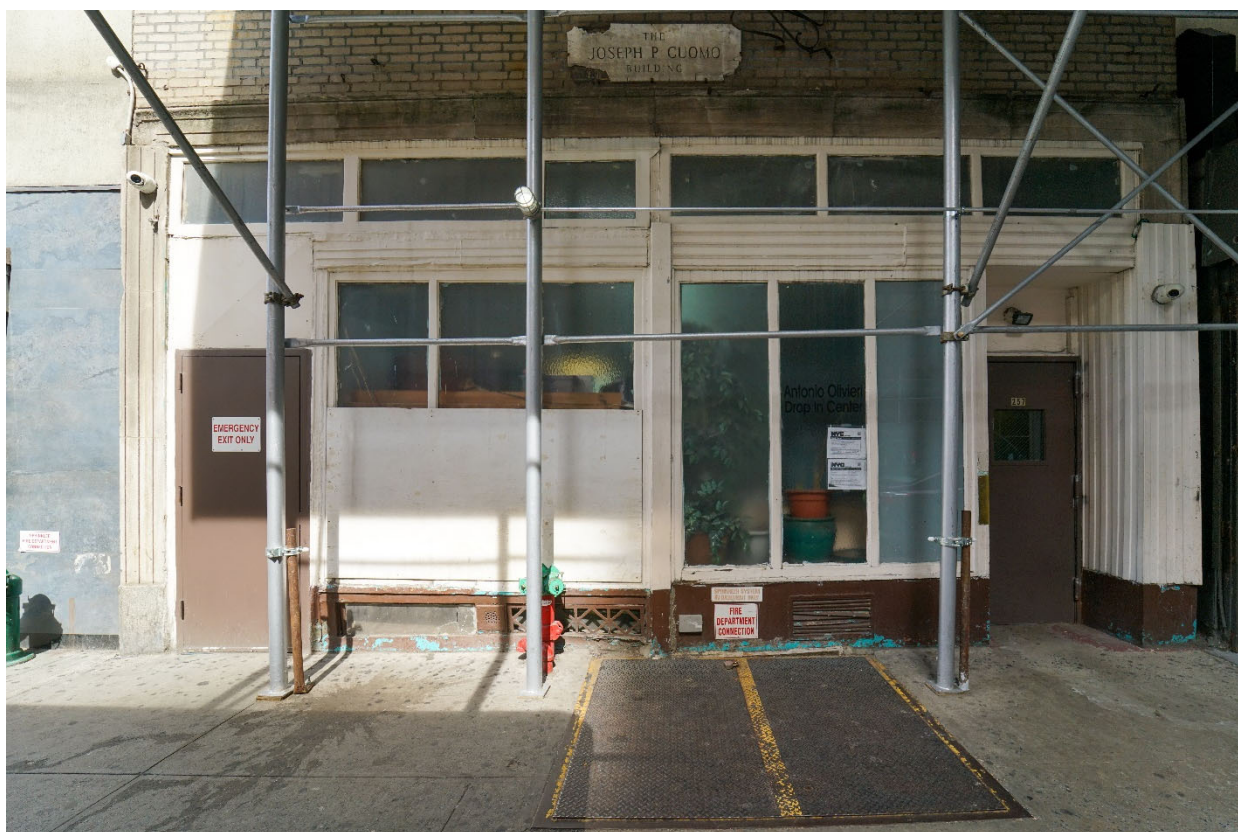
Lot 9 contains a two-story social-services building. The façade consists of wood and glass at street level and brick on the upper floor. The exterior wall appears to be in critical condition; showing noticeable damage, it's currently boarded up, and scaffolding canopies the sidewalk. The doors are in fair condition and the windows are in poor condition, showing heavy staining and corrosion. The sidewalk is in poor condition, showing cracking, staining, and debris. The building shows no barrier to ADA accessibility at the ground-floor entry. Overall, the building and site conditions were given a rating of poor condition.

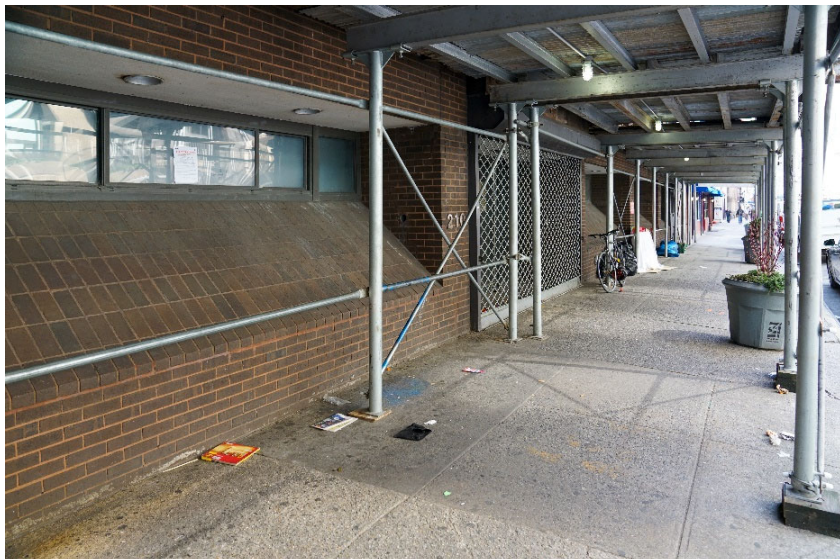
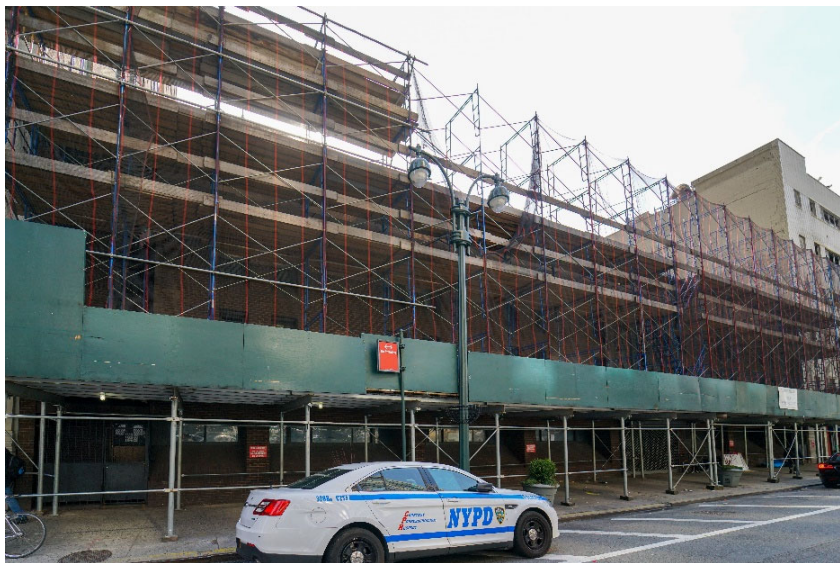
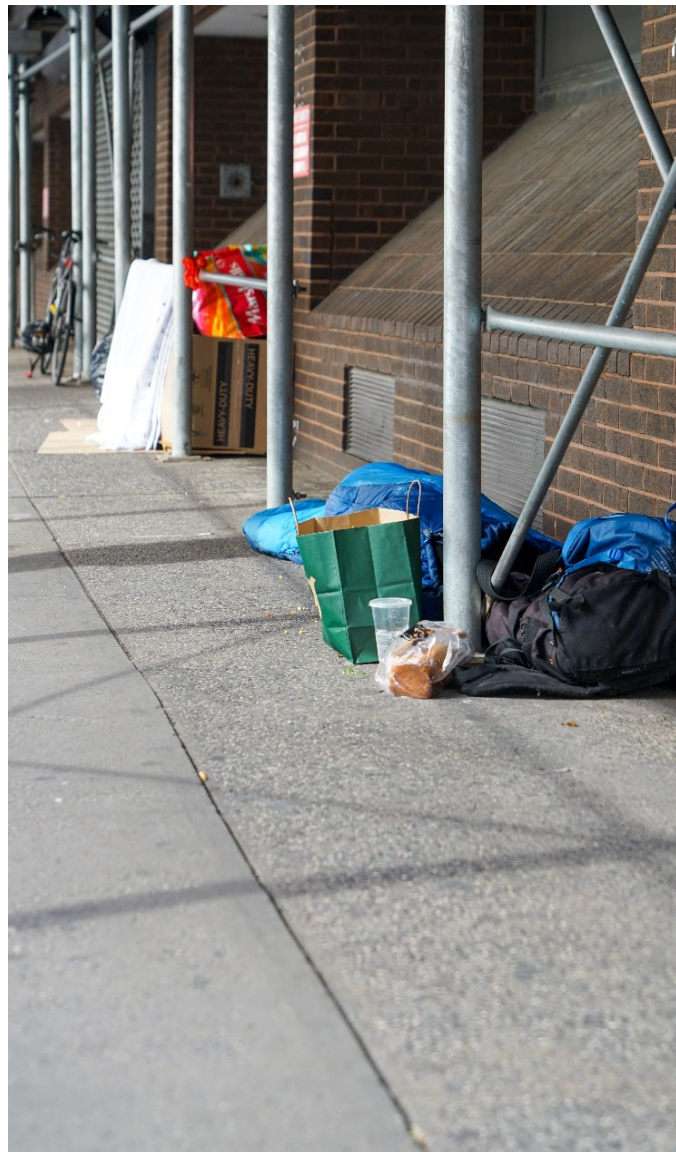
Figure 1-29 Block 780, Lot 45 Photographs

Lot 45 contains a three-story building that is currently under construction; it is surrounded by scaffolding. The façade consists of bricks that are in poor condition, showing large cracks and heavy stains. The doors and windows on the ground floor are in fair condition, though covered with dirt and staining. The upper windows are not visible and their condition is unknown. The sidewalk is in fair condition, showing minor cracking, staining, and debris. At the time of this assessment, there was an encampment in front of the building. Overall, the building and site conditions were given a rating of poor condition.

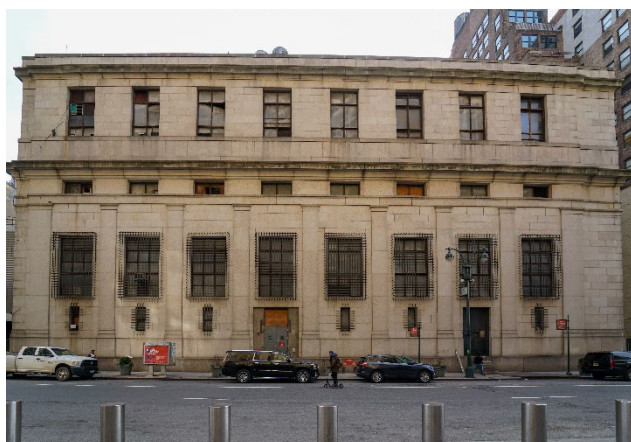
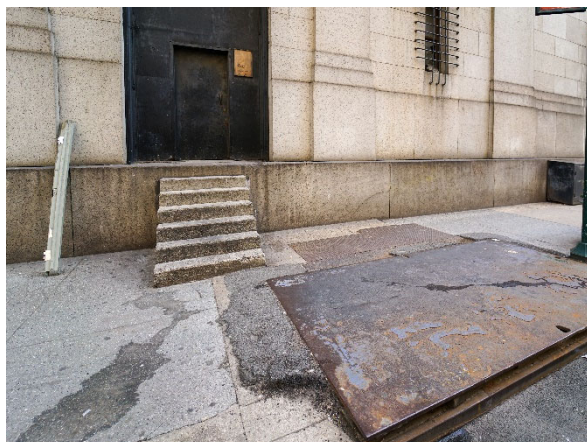
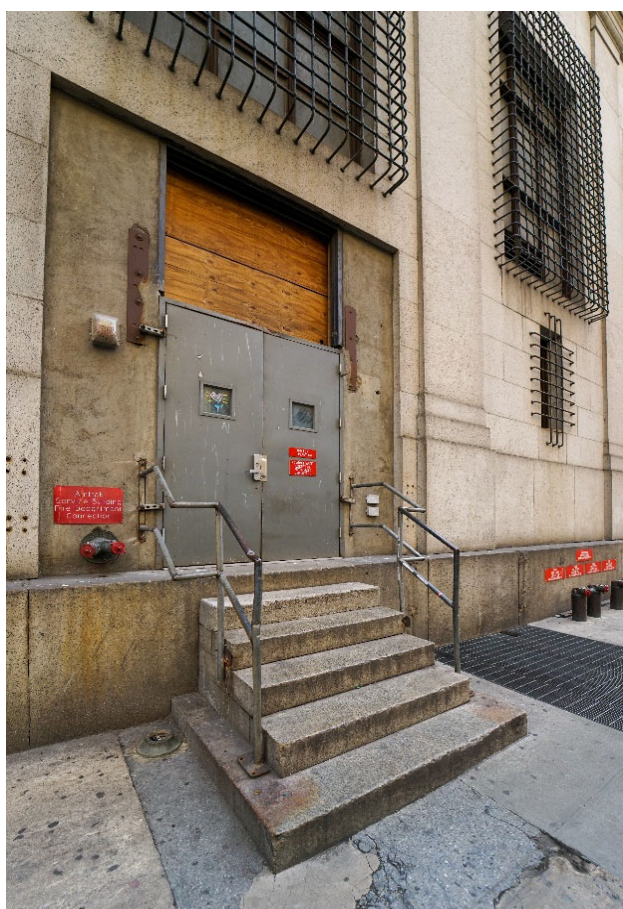
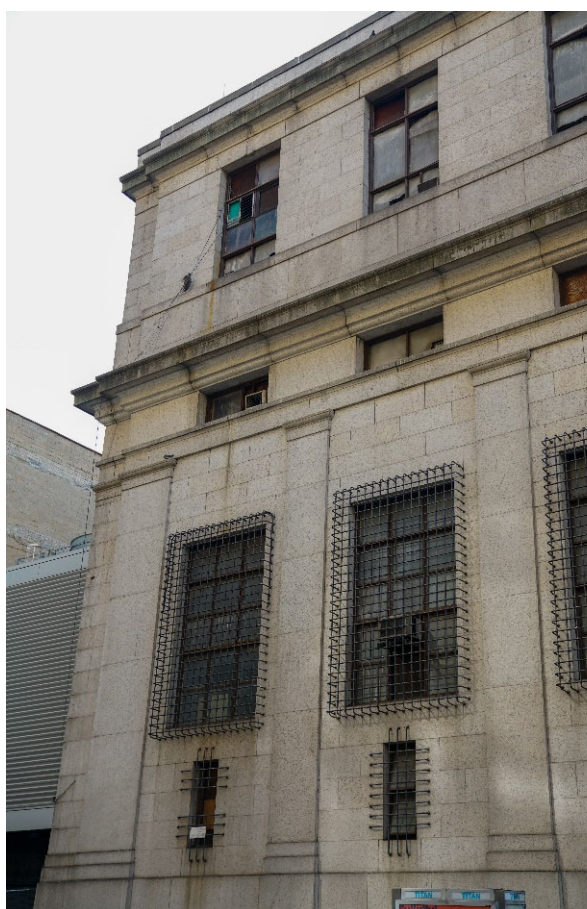
Figure 1-30 Block 780, Lot 60 Photographs

Lot 60 contains a four-story railroad service facility. Its façade consists of stone that is in fair condition, showing moderate cracking and heavy staining. The doors and windows are in critical condition; many are damaged, missing, or boarded up with wood panels. The sidewalk is in critical condition, showing large cracks and uneven patches, and curb cuts are in poor condition, with heavy cracking and damages. The security bars on the building are in generally poor condition, as the metal surfaces are heavily corroded. The building is not accessible, because its entrance is elevated from the street level and can only be accessed by stairs. Overall, the building and site conditions were given a rating of critical condition.

Lot 60 has eight open building code violations. One of the eight violations was issued by ECB and relates to the “failure to maintain exterior building wall,” which creates a hazardous condition. The parapet masonry was noted to be cracked and “bulging outward.” The remaining seven violations were issued by DOB and relate to the building’s elevator and construction. The construction violations and four of the elevator violations were issued prior to 2015. The remaining two elevator violations were issued in 2019.

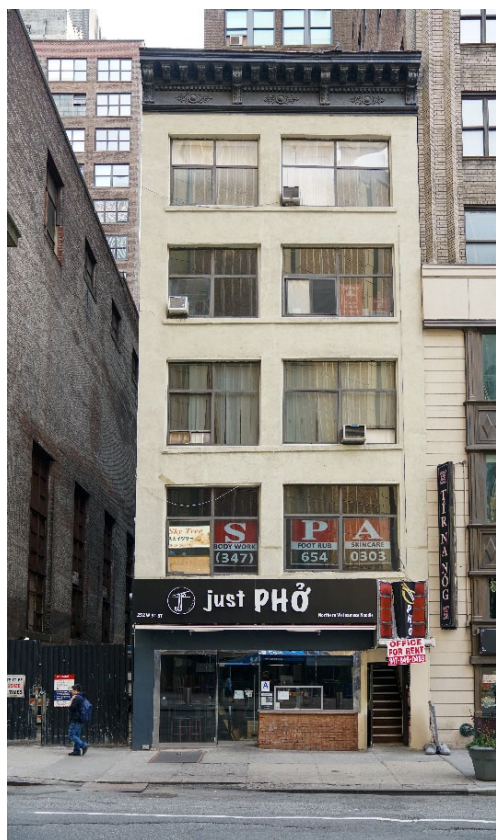
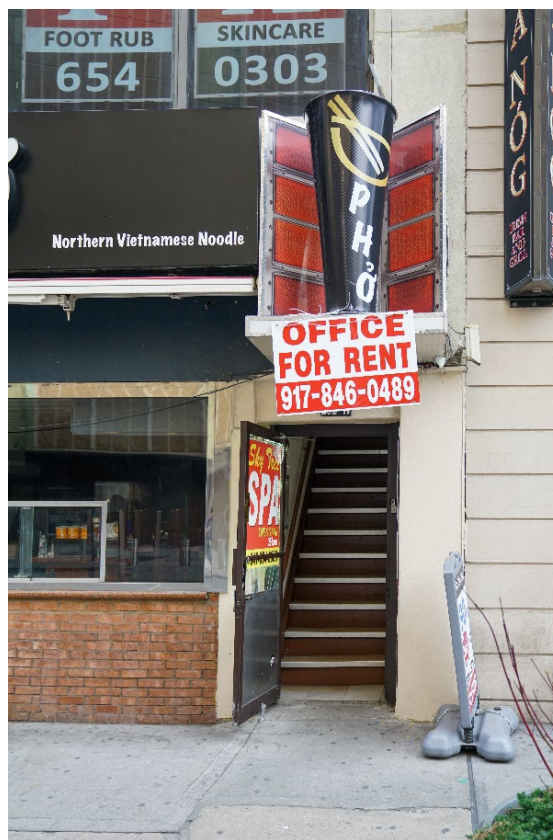
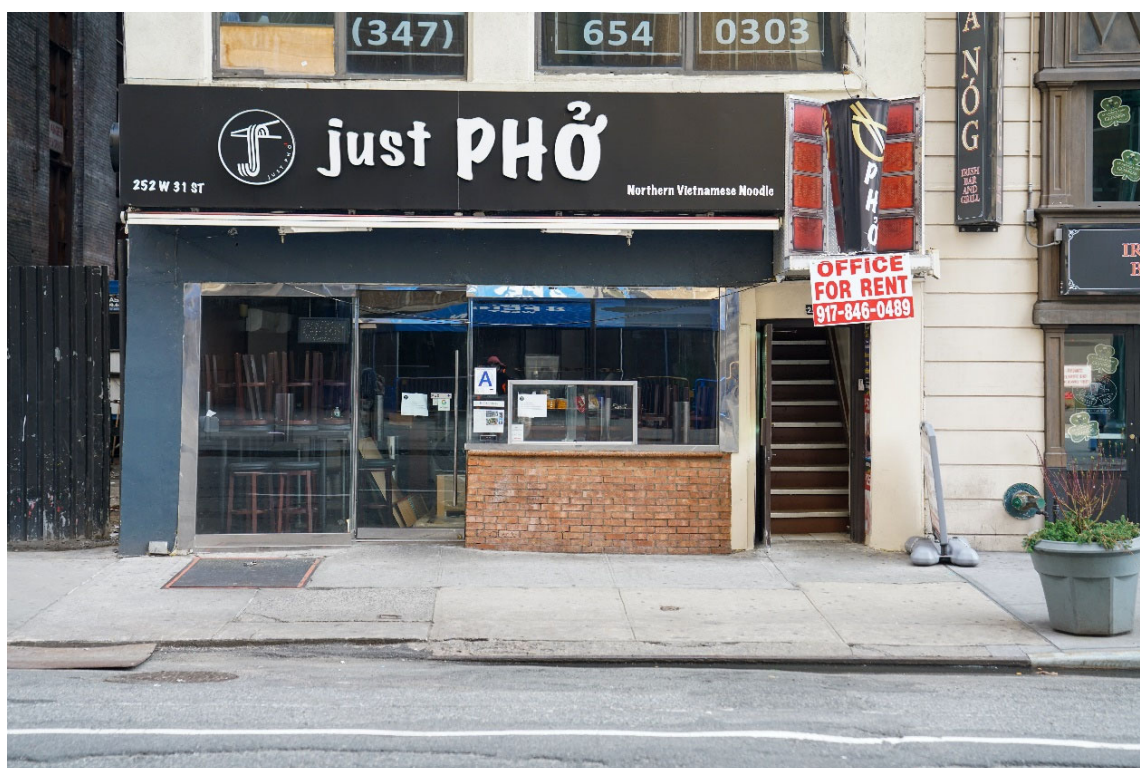
Figure 1-31 Block 780, Lot 70 Photographs

Lot 70 contains a five-story building, with retail on the ground floor and office on the upper floors. The façade consists of a glass storefront and stucco at the street and upper levels. The exterior wall and doors are in fair condition, with some cracks and stains. The windows are in poor condition, showing heavy corrosion on their frames. The sidewalk is in poor condition, with large cracking, moderate staining, and debris. The ground floor entrances show no barrier to accessibility. A sign over the upper-level entry advertises an office for lease. Overall, the building and site conditions were given a rating of poor condition.

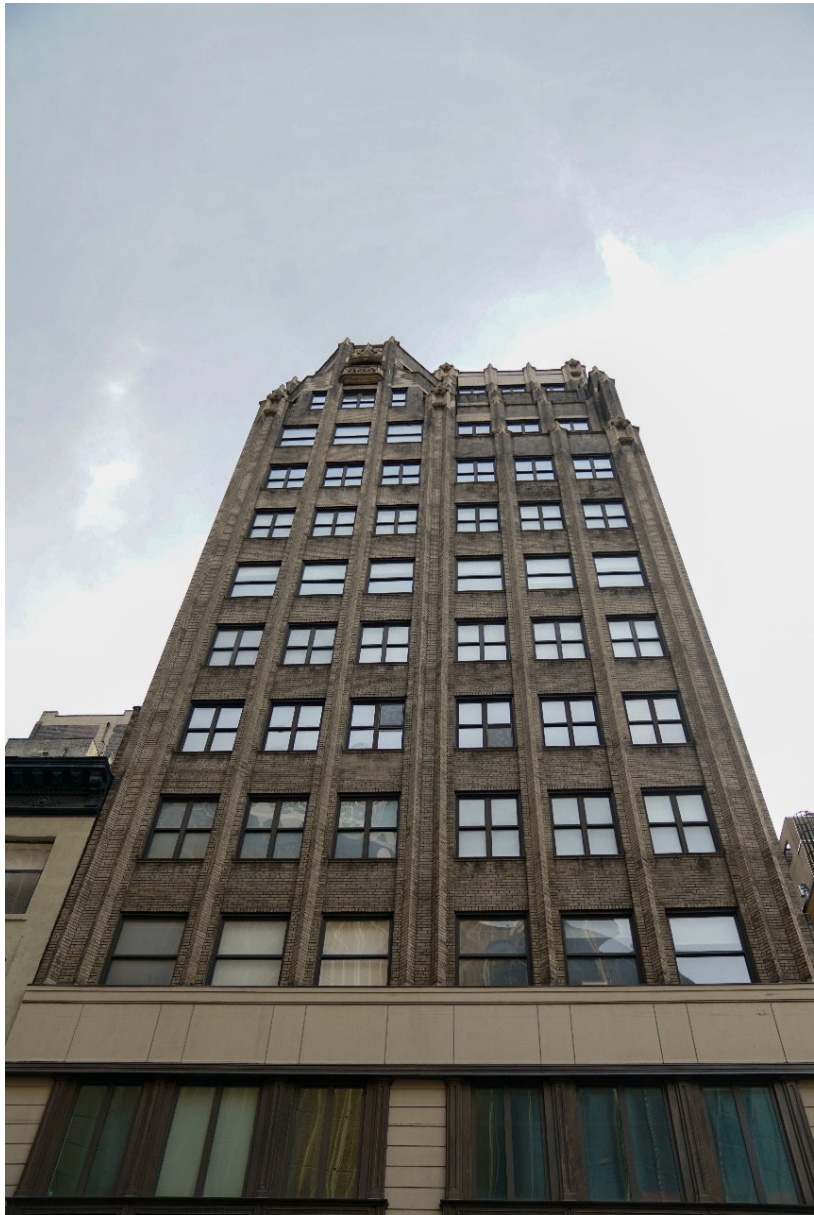
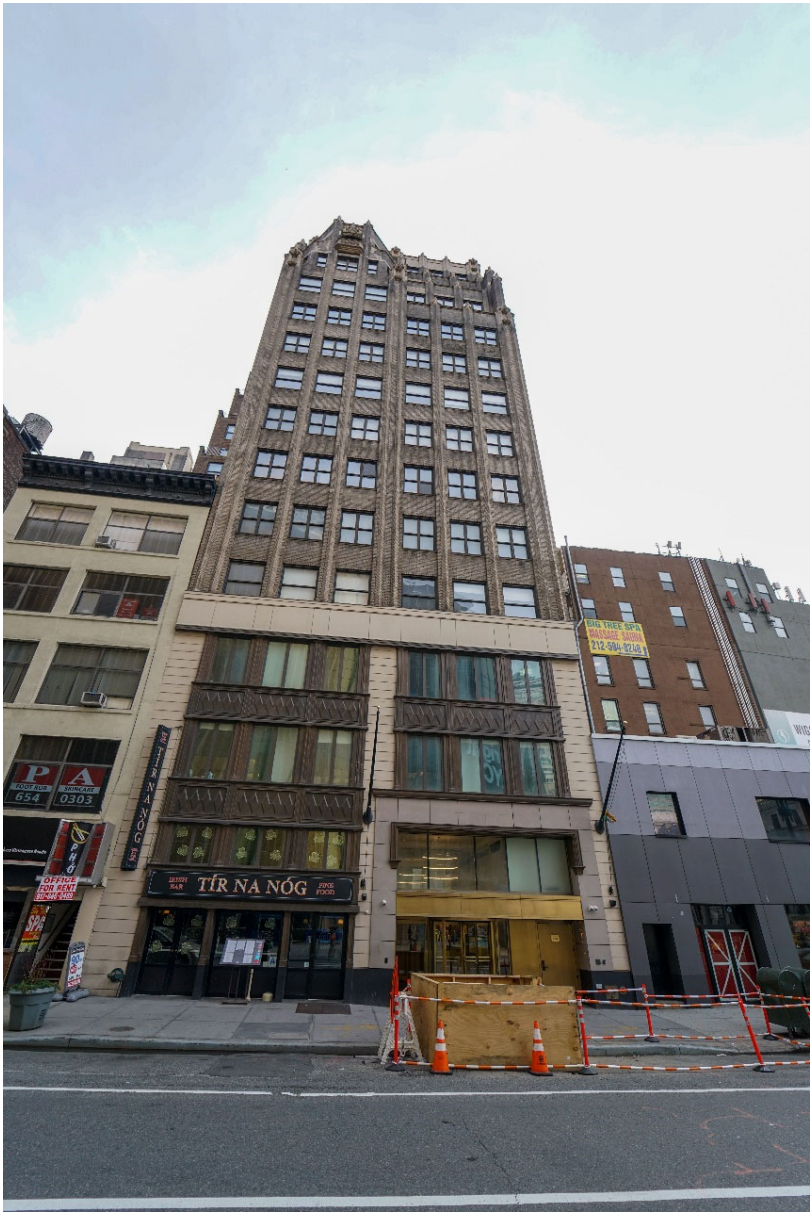
Block 780, Lot 71 Photographs

Lot 71 contains a 15-story building, with retail and an office lobby on the ground floor and office space on the upper floors. The façade consists of a stone, metal, and glass storefront at the base and brick on the upper floors. The exterior wall on the ground floor is in good condition, but the upper floors are in fair condition, as the brick wall has moderate corrosion and staining. The windows and doors are in good condition. The sidewalk is in fair condition, showing minor cracking, staining, and debris. The building has an energy efficiency grade of B, as reported by the Mayor's Office of Sustainability. The building shows no barrier to accessibility at the ground-floor entrances. Overall, the building and site conditions were given a rating of fair condition.

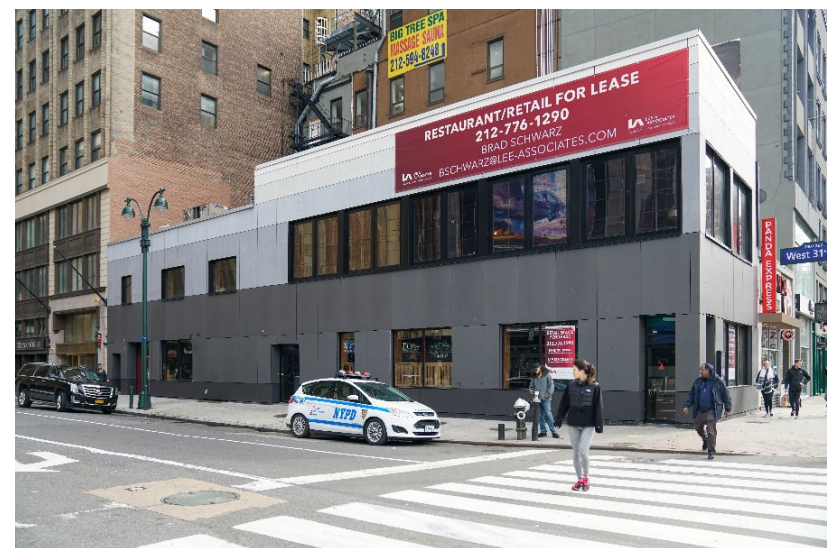
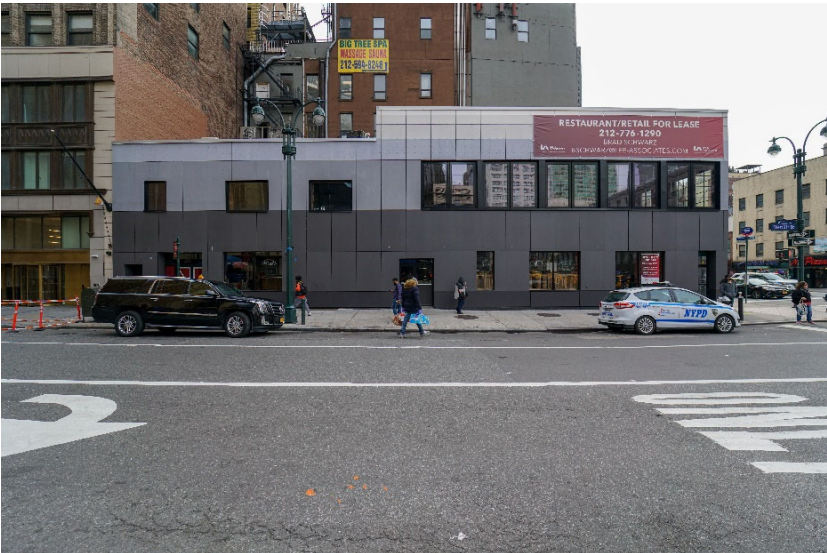
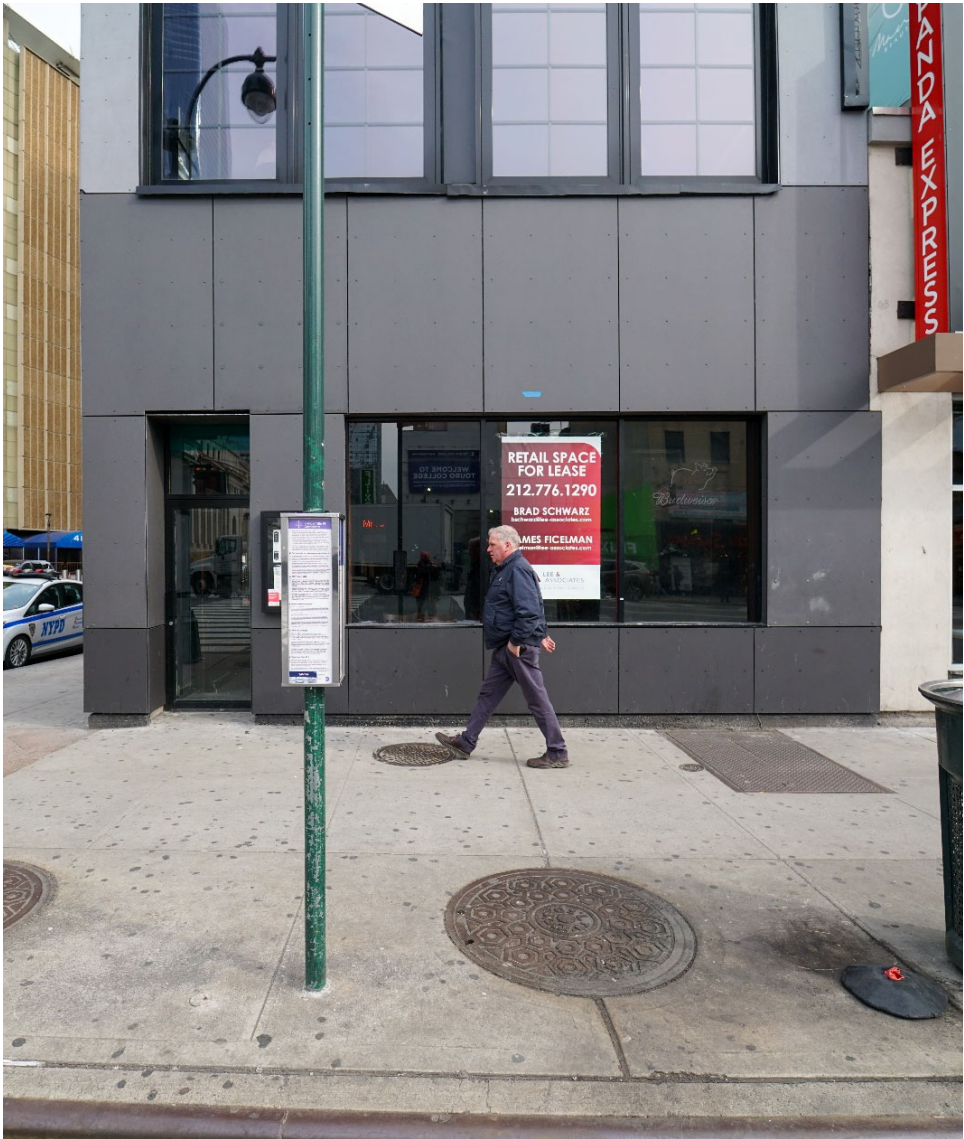
Figure 1-32 Block 780, Lot 73 Photographs

Lot 73 contains a two-story retail store that is currently unoccupied and advertised for lease. The façade consists of metal panels and glass and is in fair condition, showing one or two minor stains, while the windows and doors are in good condition. The sidewalk and curb cuts are in fair condition, showing minor cracking, staining, and debris. The building shows no barrier to accessibility at the ground floor entrance. Overall, the building and site conditions were given a rating of good condition.

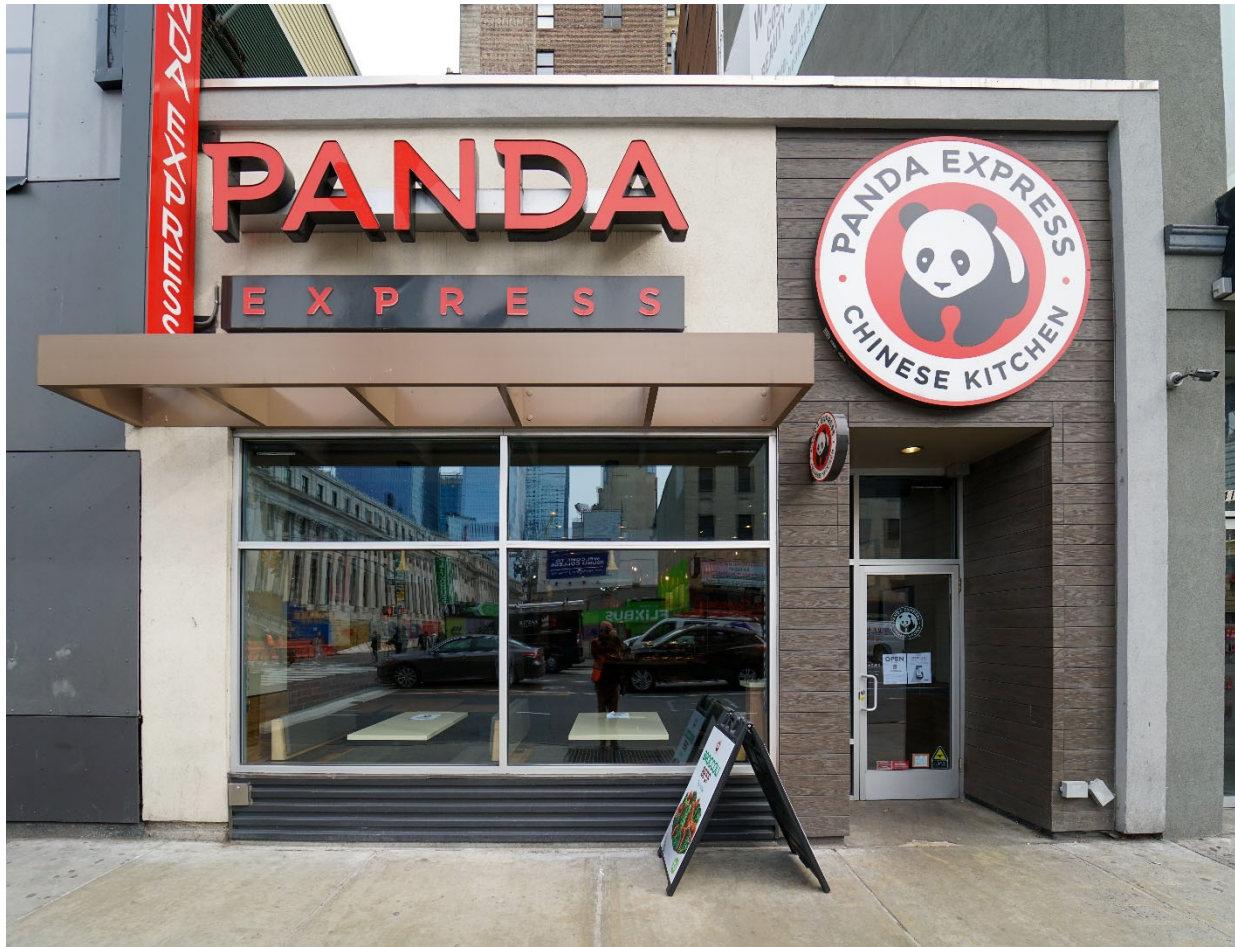
Figure 1-33 Block 780, Lot 74 Photographs

Lot 74 is occupied by a one-story retail store. The façade consists of a stucco, stone, metal, and glass storefront. The exterior wall, doors, and windows are in good condition. The sidewalk is in fair condition, showing minor cracking, staining, and debris. The building shows no barrier to accessibility at the entrance. Overall, the building and site conditions were given a rating of good condition.

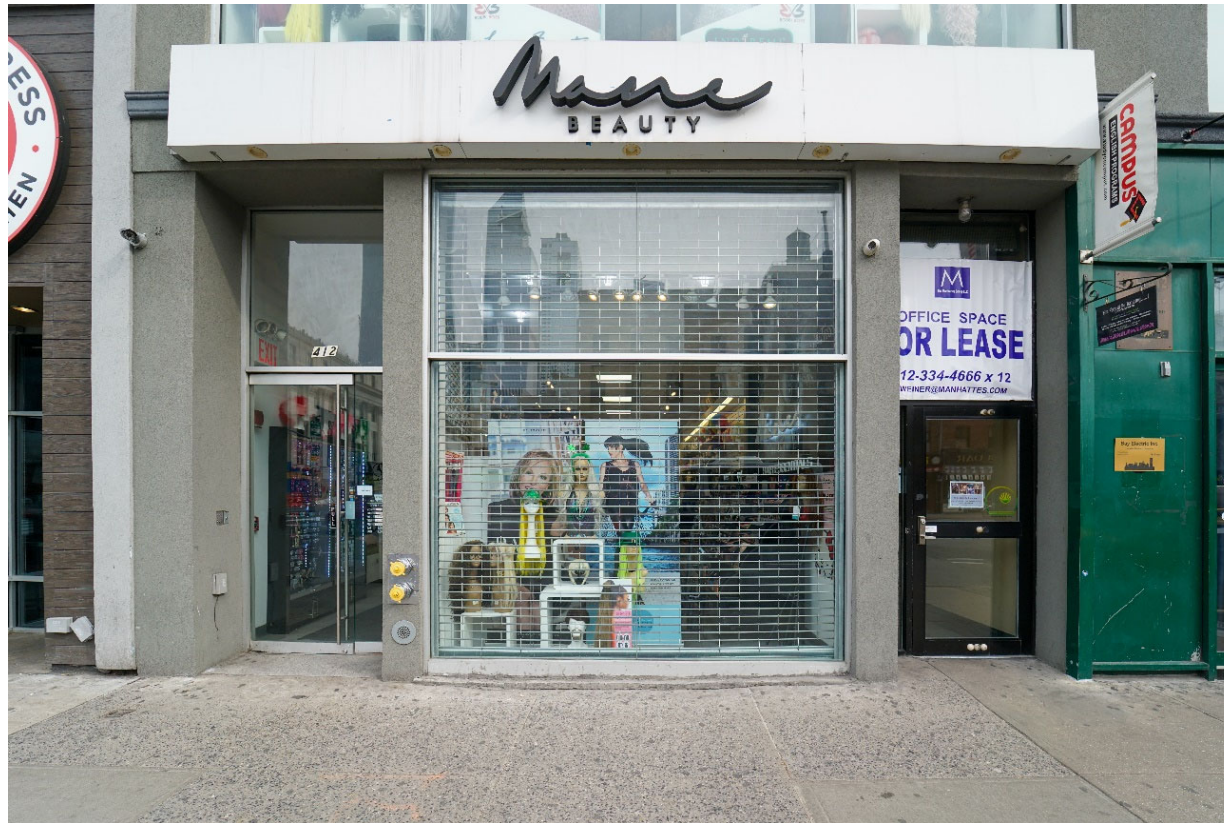
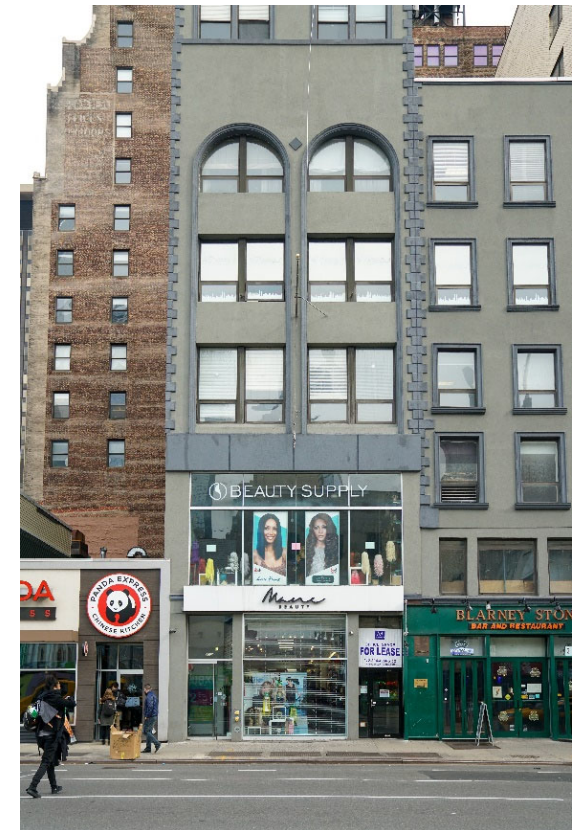
Figure 1-34 Block 780, Lot 75 Photographs

Lot 75 contains a seven-story building, with retail on the ground floor and second floor, and office space on the upper floors. The façade consists of a stucco, concrete, and glass storefront on the lower levels and stucco and concrete on the upper levels. The exterior wall, doors, and windows are in good condition. The sidewalk is in fair condition, showing minor cracking, staining, and debris. The building shows no barrier to accessibility at the ground-floor entrance. The upper office is for lease. Overall, the building and site conditions were given a rating of good condition.

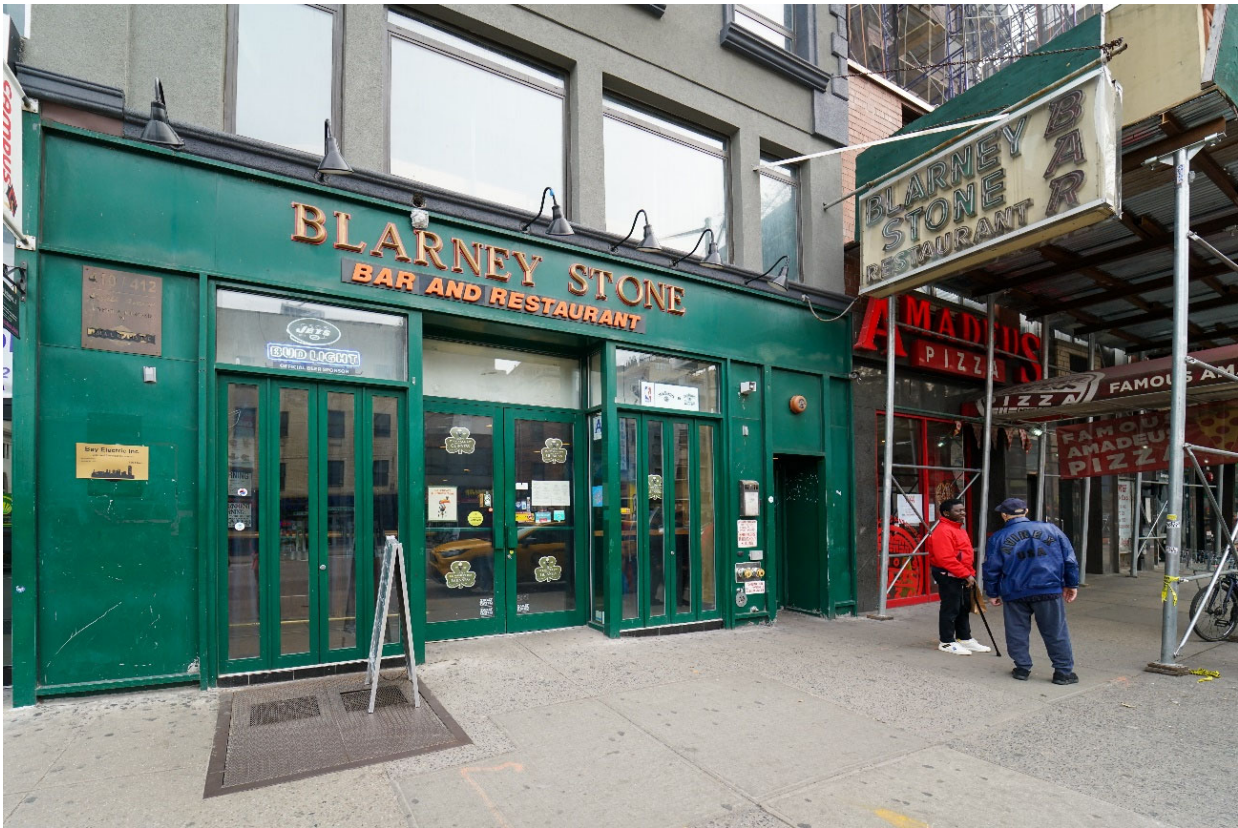
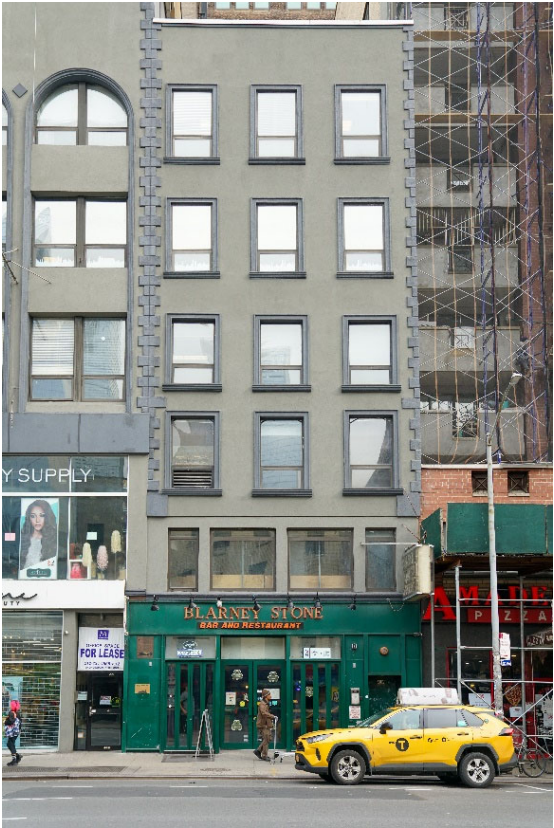
Figure 1-35 Block 780, Lot 76 Photographs

Lot 76 contains a six-story building, with retail on the ground floor, and office or residential space on the upper floors. The façade consists of a metal and glass storefront at the ground floor and stone, stucco, and glass on the upper floors. Its exterior wall is in fair condition, showing minor damage, while the windows and doors are in good condition. The sidewalk is in fair condition, showing minor cracking, staining, and debris. The building shows no barrier to accessibility at the ground floor entrances. Overall, the building and site conditions were given a rating of good condition.

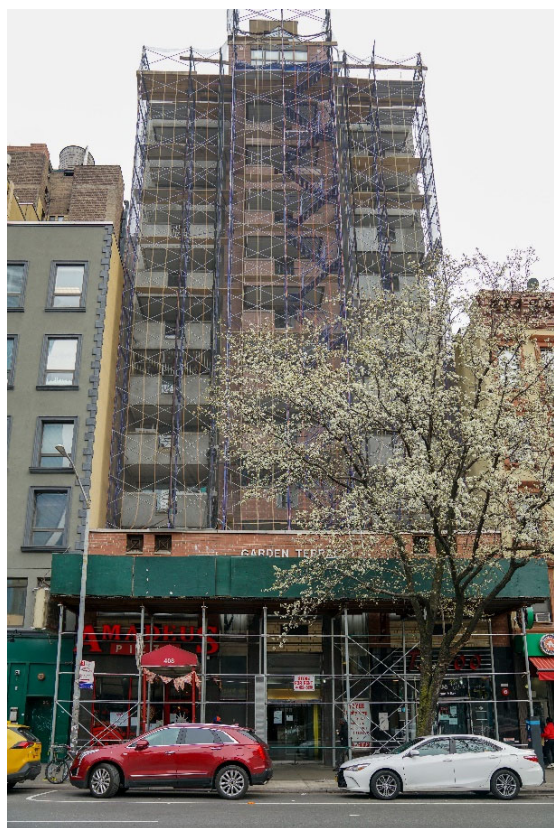
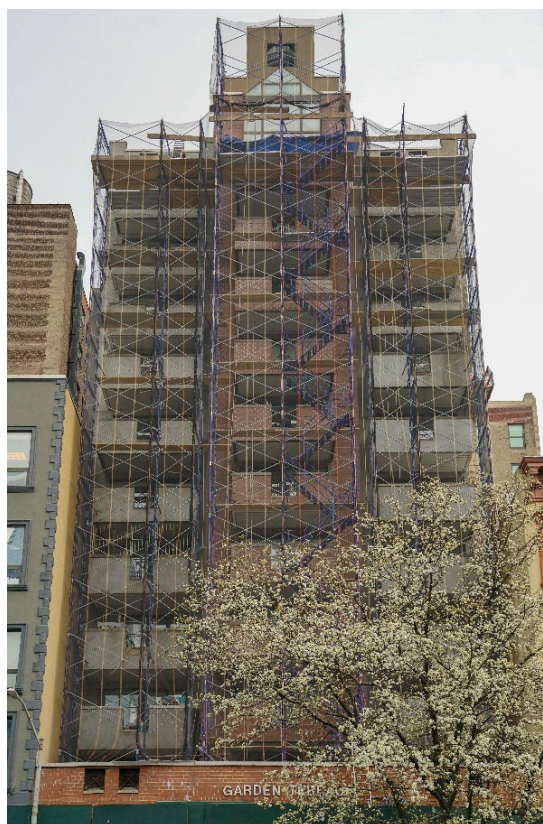
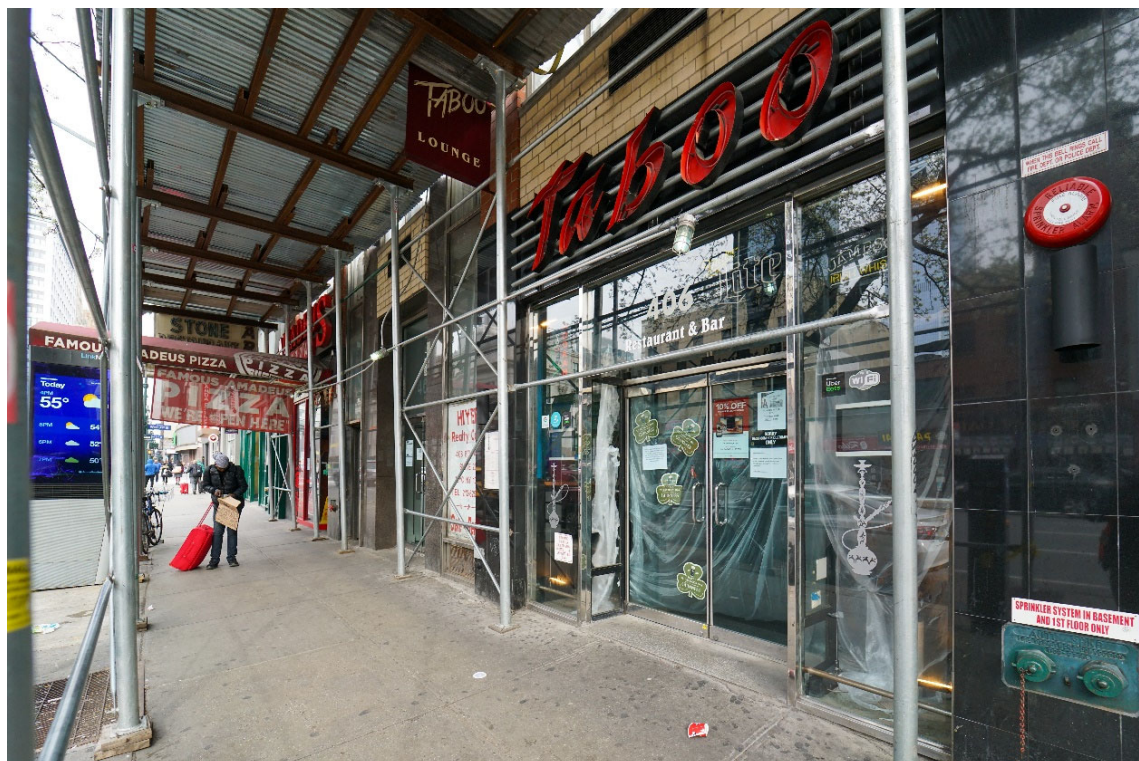
Figure 1-36 Block 780, Lot 7501 Photographs

Lot 7501 contains a 12-story building, with retail on the ground floor and residential space on the upper floors. The façade consists of stone, metal, and glass on the ground floor and brick and stucco on the upper floors. Because the building is currently under construction and surrounded by scaffolding, the façade and window conditions of the upper levels is unknown. However, at the street level, the exterior wall is in poor condition, showing heavy corrosion, and the doors are in fair condition. The sidewalk is in fair condition, showing minor cracking, staining, and debris. The ground floor entrances show no barrier to accessibility. Overall, the building and site conditions were given a rating of poor condition.

Lot 7501 has 19 open building code violations. Six of the 19 violations were issued by ECB, of which two are classified as hazardous and relate to the building's unsafe façade. The remaining four violations issued by ECB relate to the building's boiler, elevator, and failure to safeguard the public. The most recent violations (issued within the last five years) include the failure to maintain the building in a code-compliant manner in 2016 and the failure to safeguard the public from an unsafe façade in 2019. Thirteen of the 19 violations were issued by DOB and relate to construction and the building's boiler and elevators. One of the 13 DOB violations is classified as hazardous, due to the "failure to certify correction on immediately hazardous ECB violation." While most of the DOB violations were issued prior to 2015, two elevator violations were issued in 2017, façade violations were issued in 2018 and 2019, and a failure to benchmark violation was issued in 2019.
