EMPIRE STATION COMPLEX

Neighborhood Conditions Study

February 2021

FOR
Empire State Development

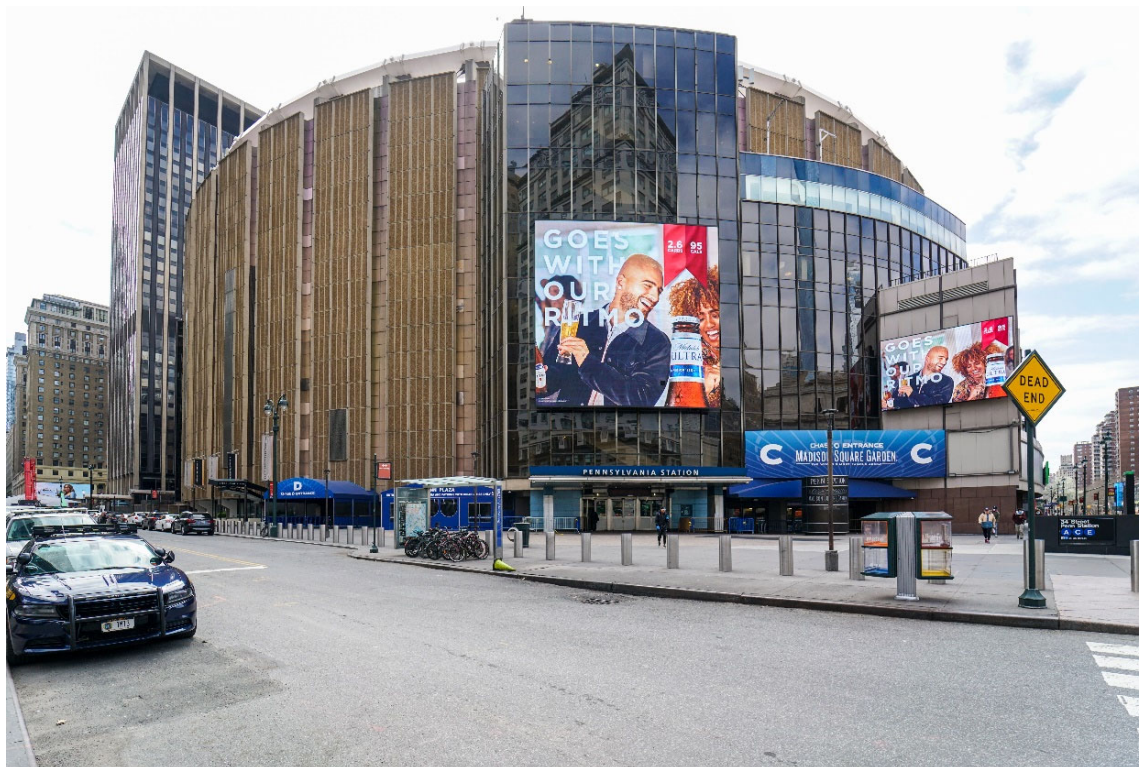
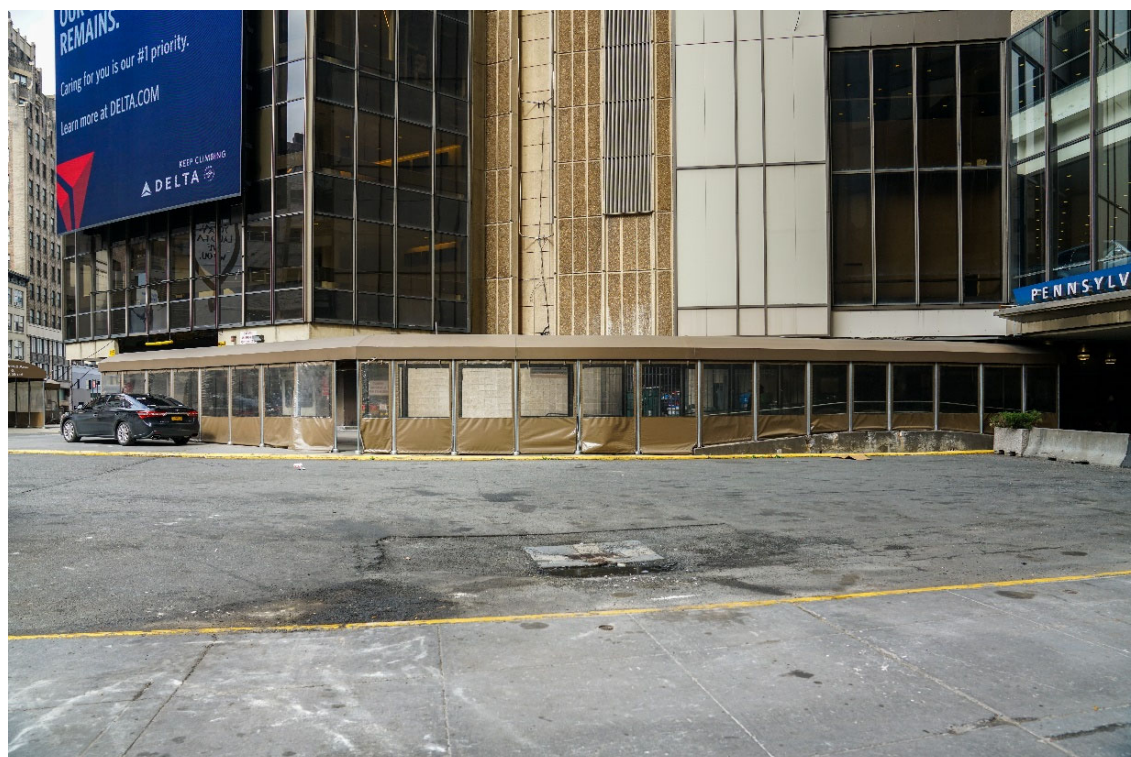
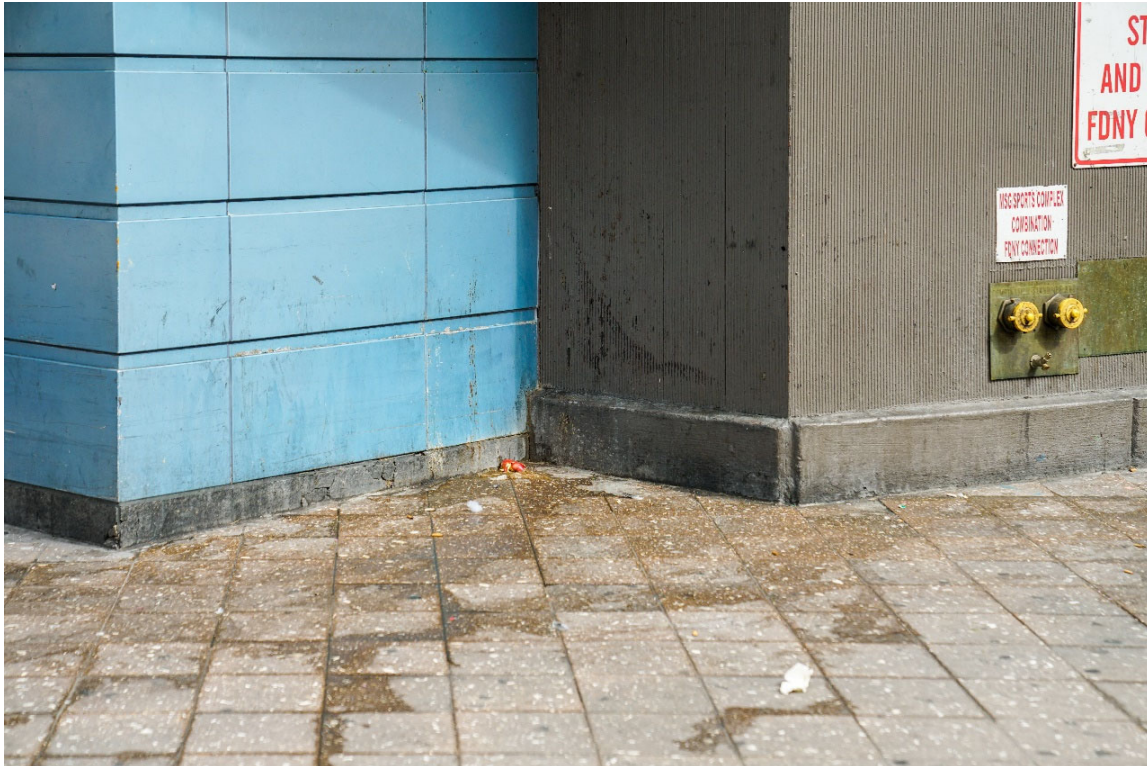
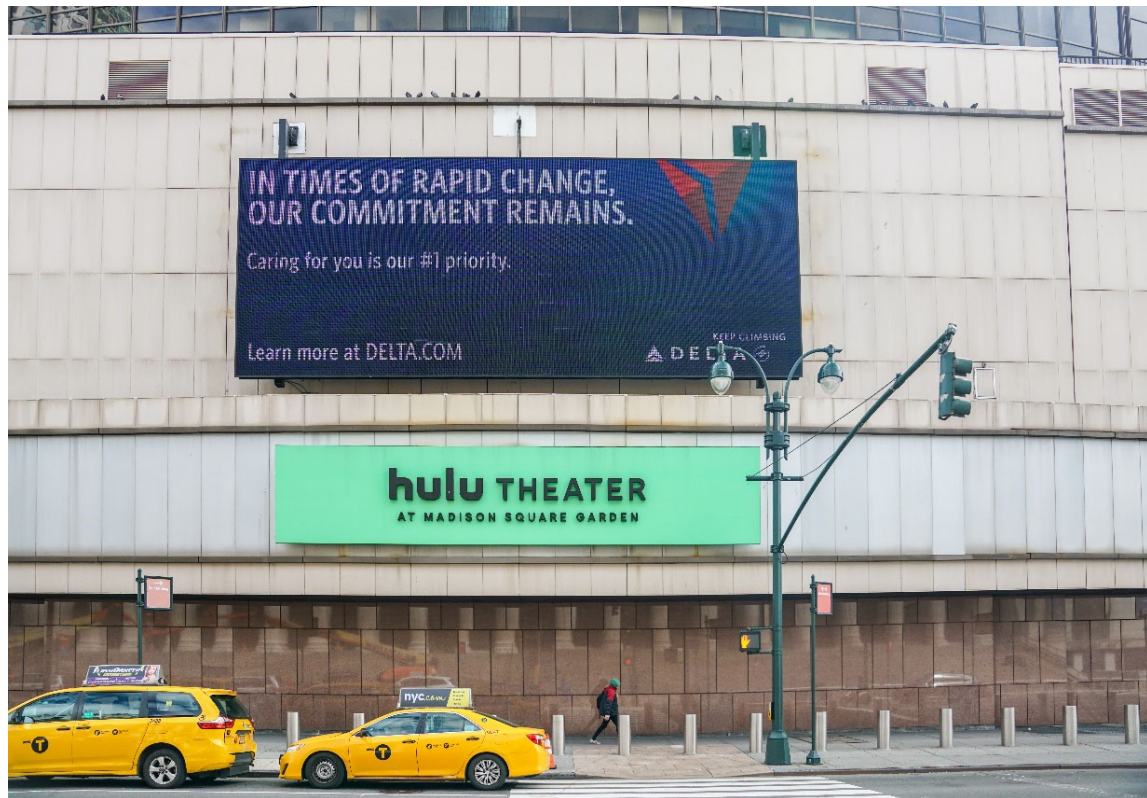
Figure 1-38 Block 781, Lot 1 Photographs

The building façade consists of a metal and glass curtain wall system alternating with sections of stone. The exterior walls are in fair condition, with moderate corrosion, staining, and peeling paint. The doors and windows are in fair condition, showing minor corrosion and staining. The sidewalk is in fair condition with minor cracking, staining, and debris, and the curb cuts are in good condition. The paved yard surface at some building corners is in poor condition, showing corroded tiles and an unsanitary environment. There are streetlights, planter boxes, and bollards adjacent to the building. The ground floor entrances show no barrier to accessibility. Overall, the building and site conditions were given a rating of fair condition.

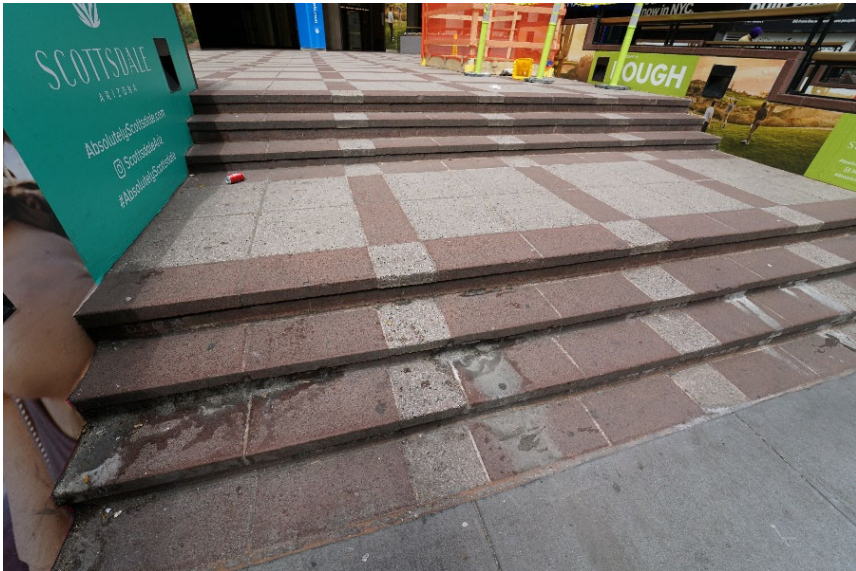
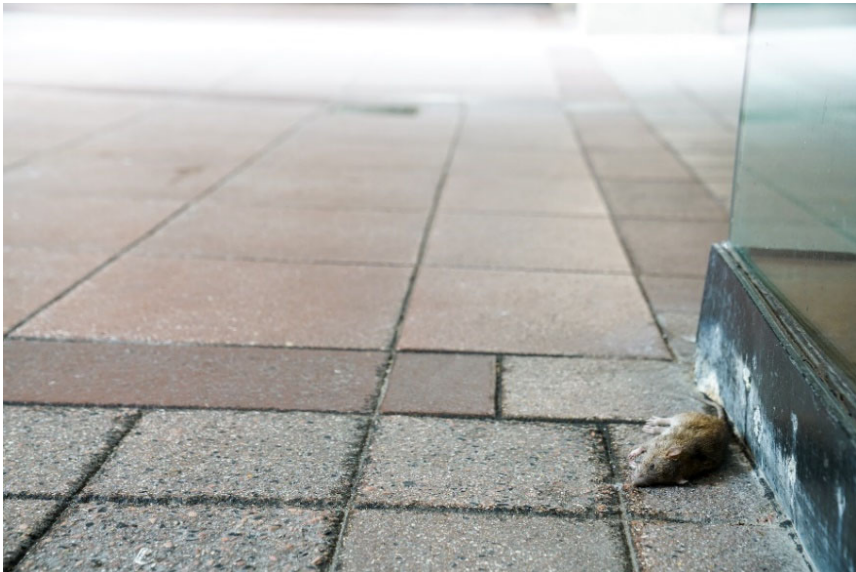
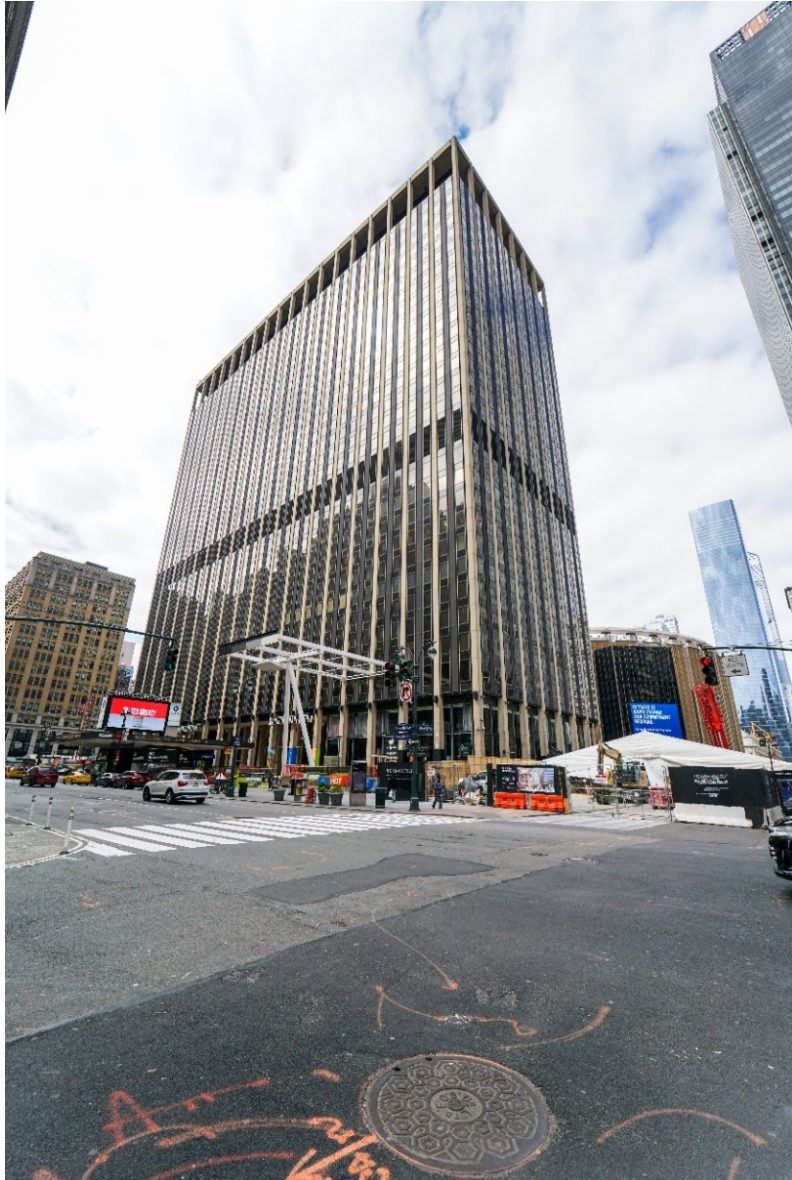
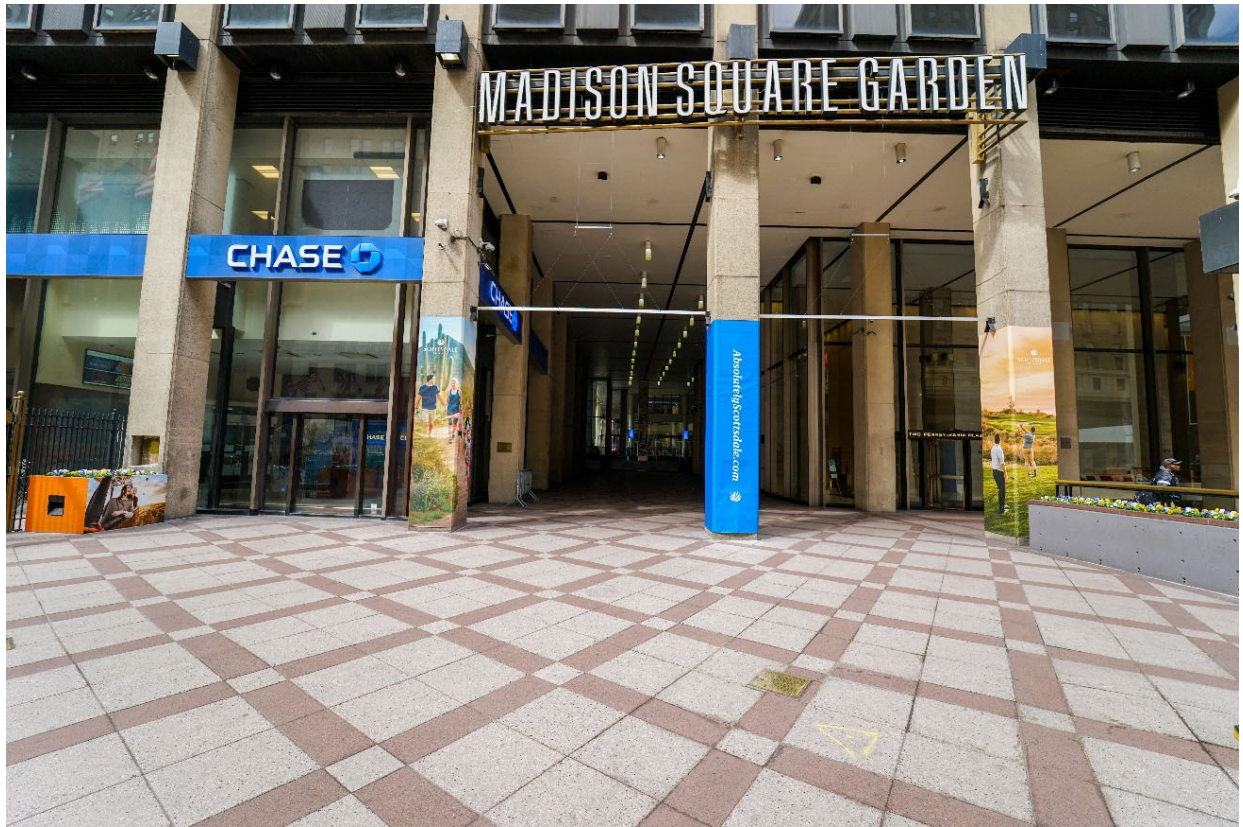
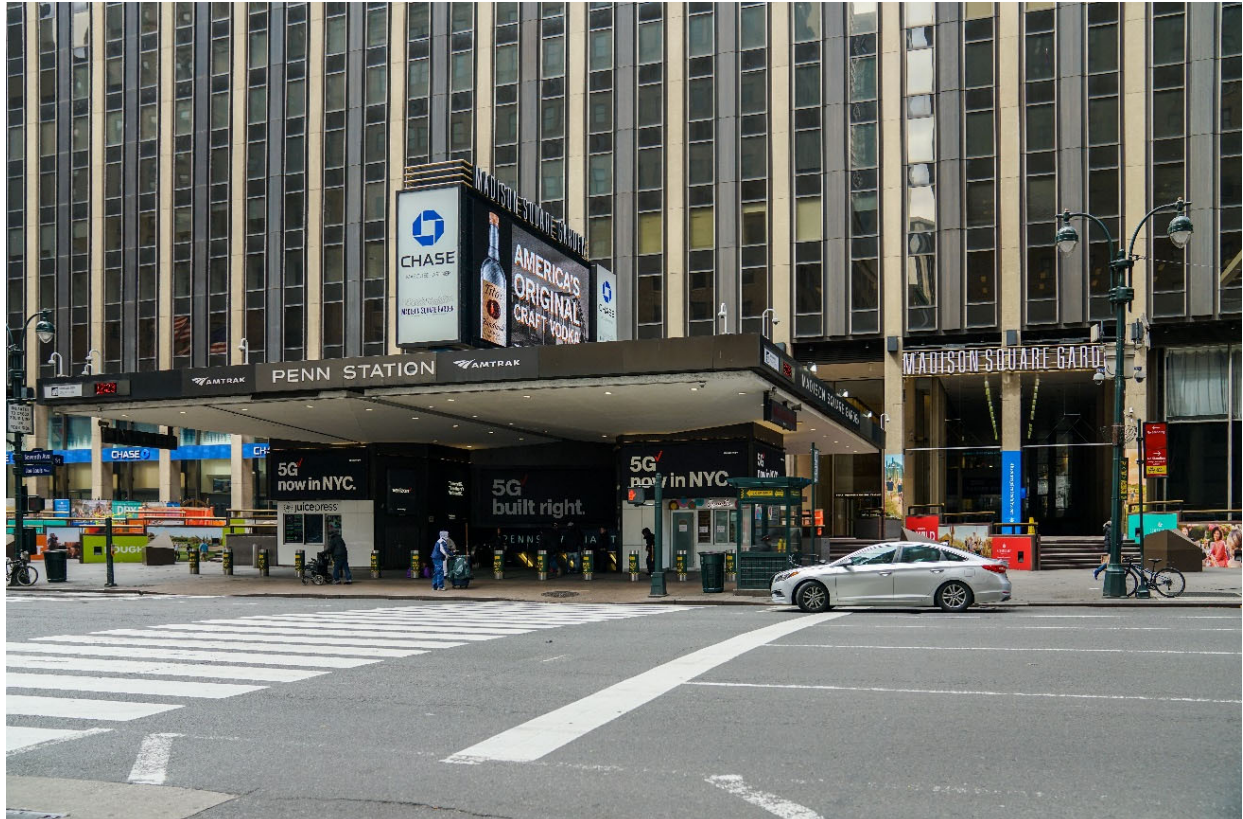
Figure 1-39 Block 781, Lot 2 Photographs

The lot is primarily occupied by an office building, entrances to Penn Station and Madison Square Garden, and open plaza space. The 31-story office building, known as 2 Penn Plaza, leases ground floor space to several retail stores. The façade consists of concrete panel, metal panel, and glass curtainwall. The exterior walls, doors, and windows are in good condition. The sidewalk is in fair condition, showing minor cracking and staining, and the curb cuts are in good condition. A fair amount of garbage and debris litter the area around the building, but the plaza is in good condition, with minor cracking. There are streetlights, planter boxes, and benches adjacent to the building. The building has an accessible ramp leading to its elevated first floor. This building was rated in good condition.

In front of the office building, at West 32nd Street, is an entrance to Penn Station. It features several retail stores. The façade of the entrance consists of glass, concrete, and tiles. The exterior walls are in fair condition, showing moderate corrosion and staining. The paved yard surface on the plaza is in good condition, with minor cracking. However, there is a considerable amount of garbage as well as dead rodents. This building was rated in fair condition. Overall the building and site conditions were given a good/fair rating.

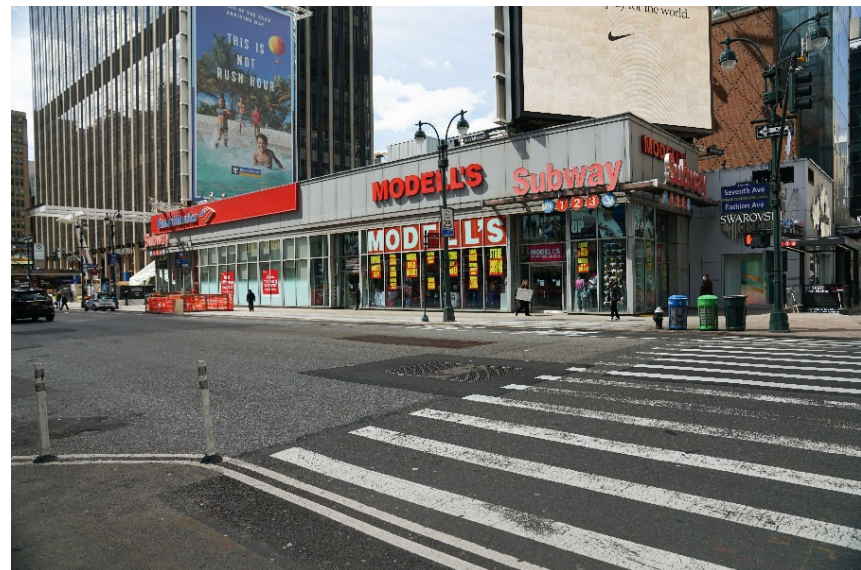
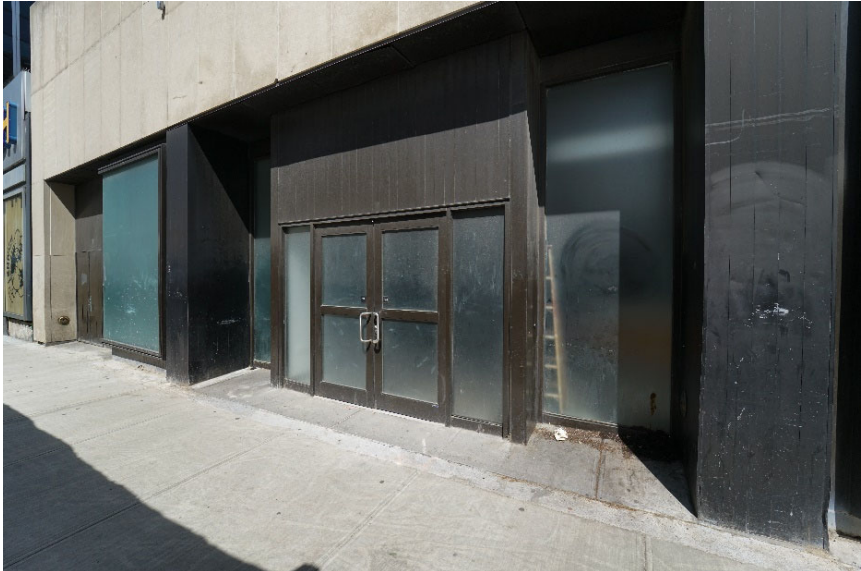
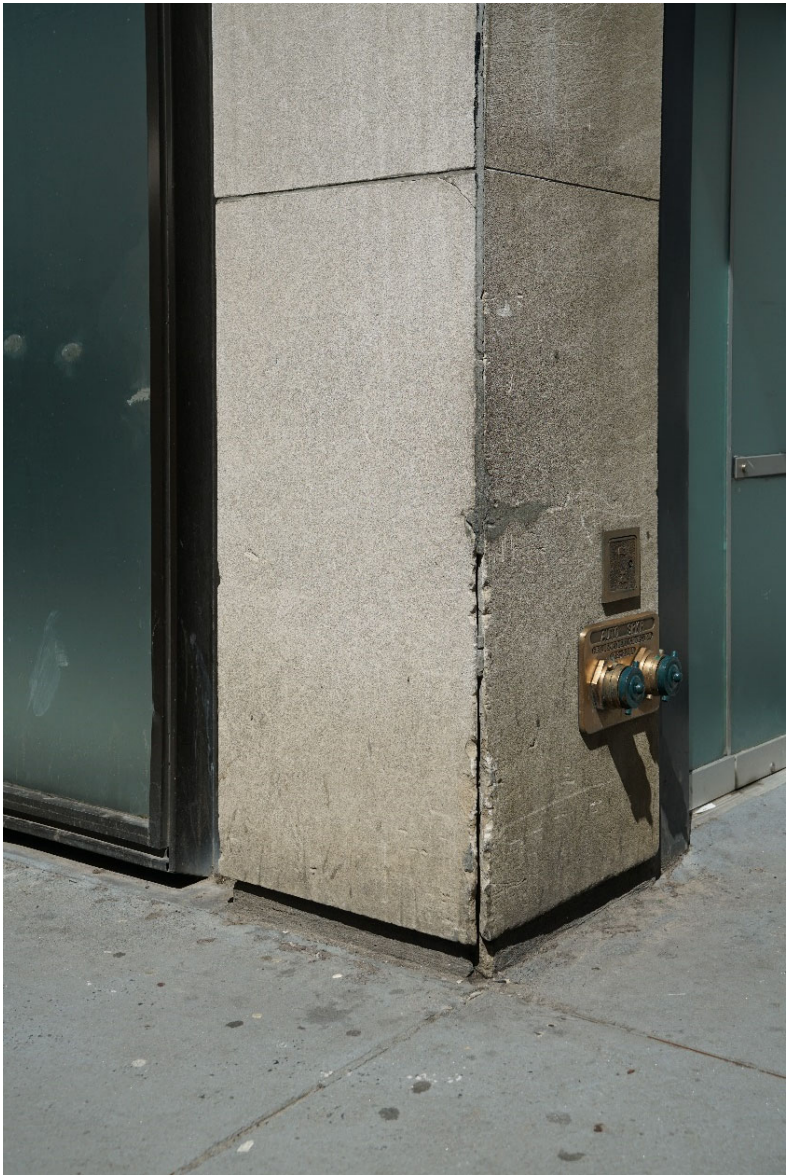
Figure 1-43 Block 783, Lot 34 Photographs

There is potential for fuel oil tanks located at this property, as indicated by DOB records. However, according to FDNY records, there are no tanks registered with this property. In addition, five FDNY violation notices were issued in 2009 and 2015 for the following repeat offenses: failed to provide extinguishers, failed to provide good housekeeping practices, failed to maintain fire suppressant system, failed to provide instruction signage, failed to provide adequate egress, failed to conduct required test and failed to maintain electrical equipment. Further, DOHMH records indicated a claim that parasites are in the drinking water. No further details are provided.

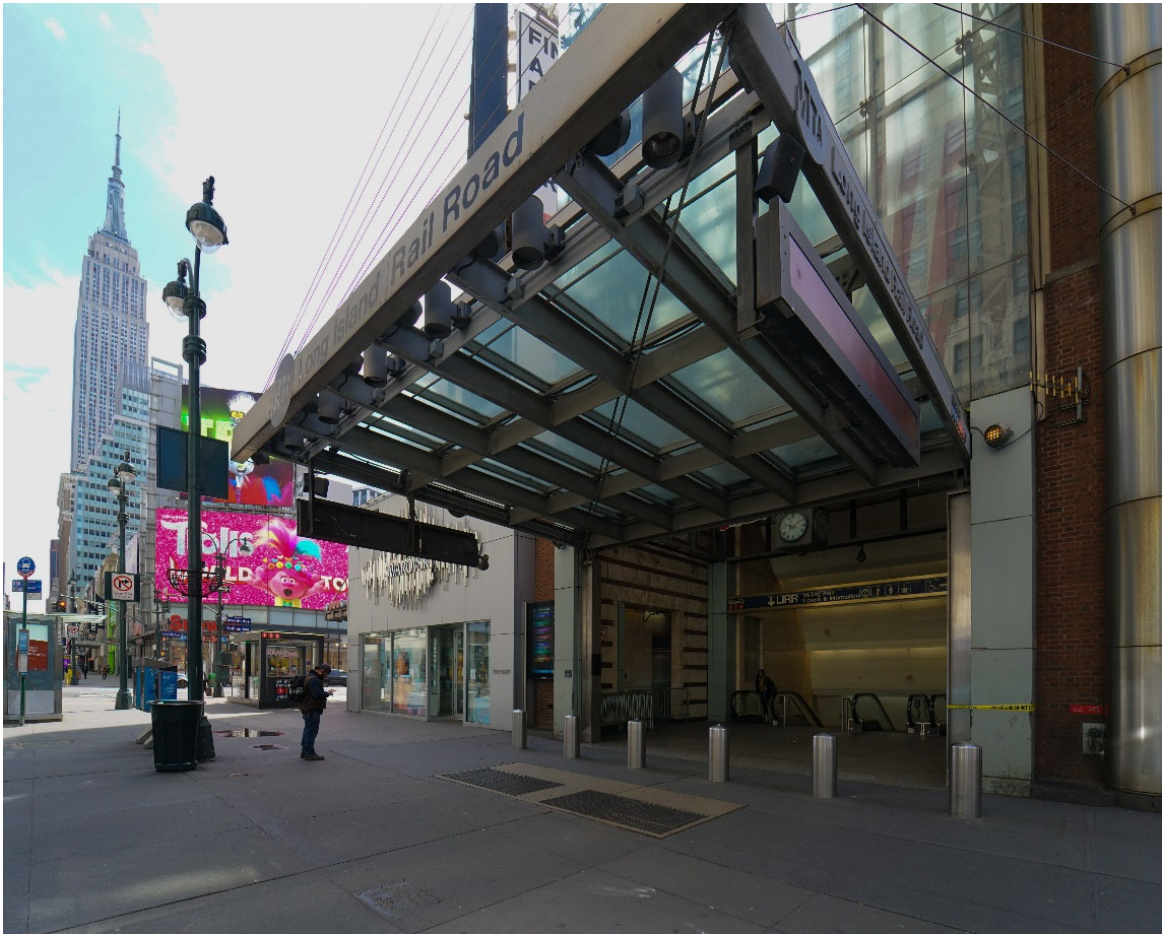
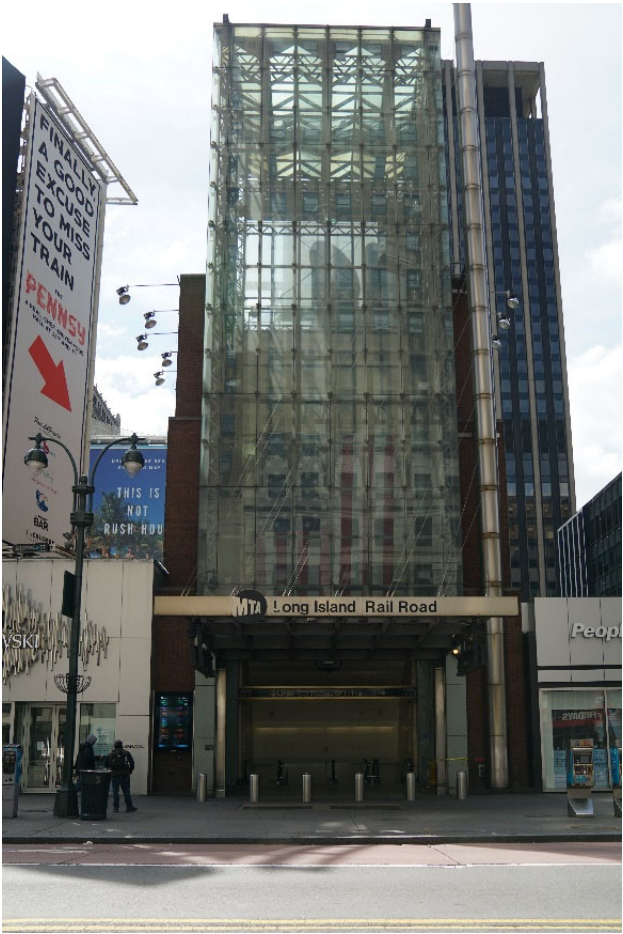
Figure 1-44 Block 783, Lot 48 Photographs

Lot 48 contains an entrance to Penn Station, which is underground. The façade consists of metal and terracotta on the ground floor and metal and glass curtainwalls on the upper structure. Its exterior wall is in fair condition, showing moderate corrosion and staining. The sidewalk is in fair condition, showing minor cracking, staining, and debris. Overall, the building and site conditions were given a rating of fair condition.

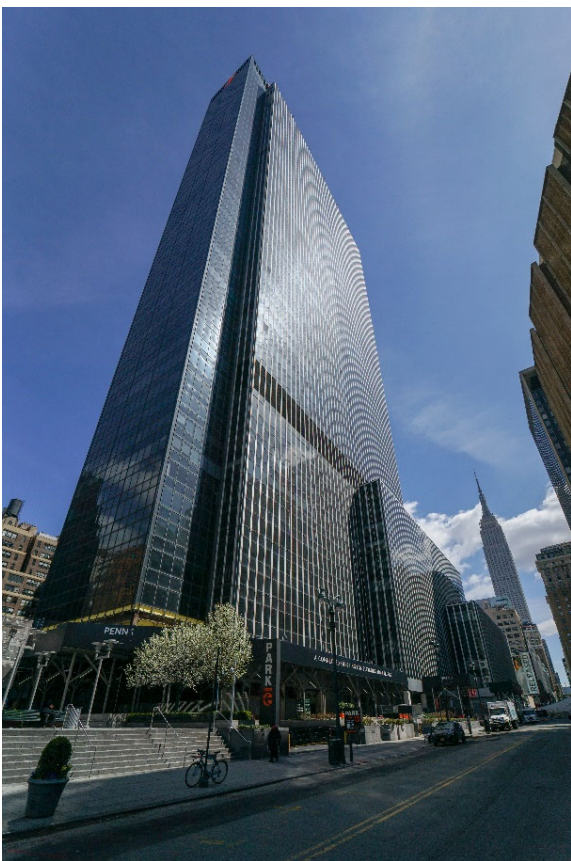
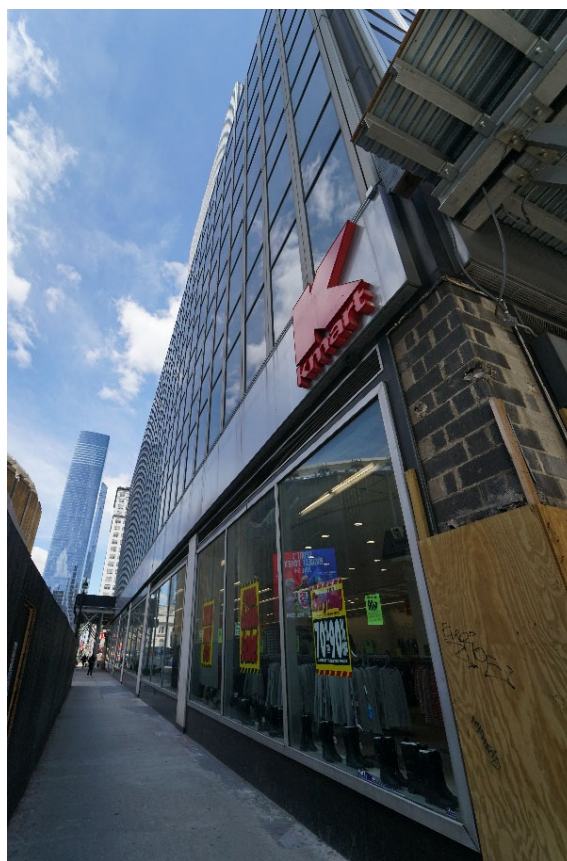
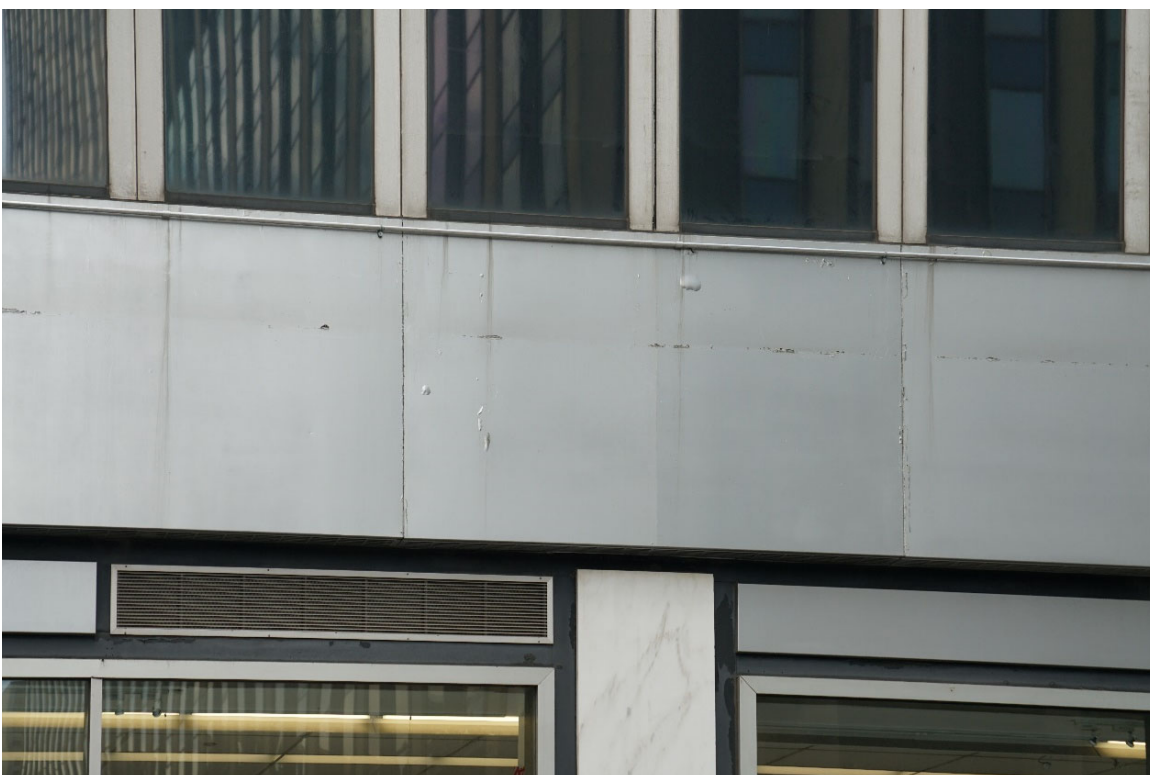
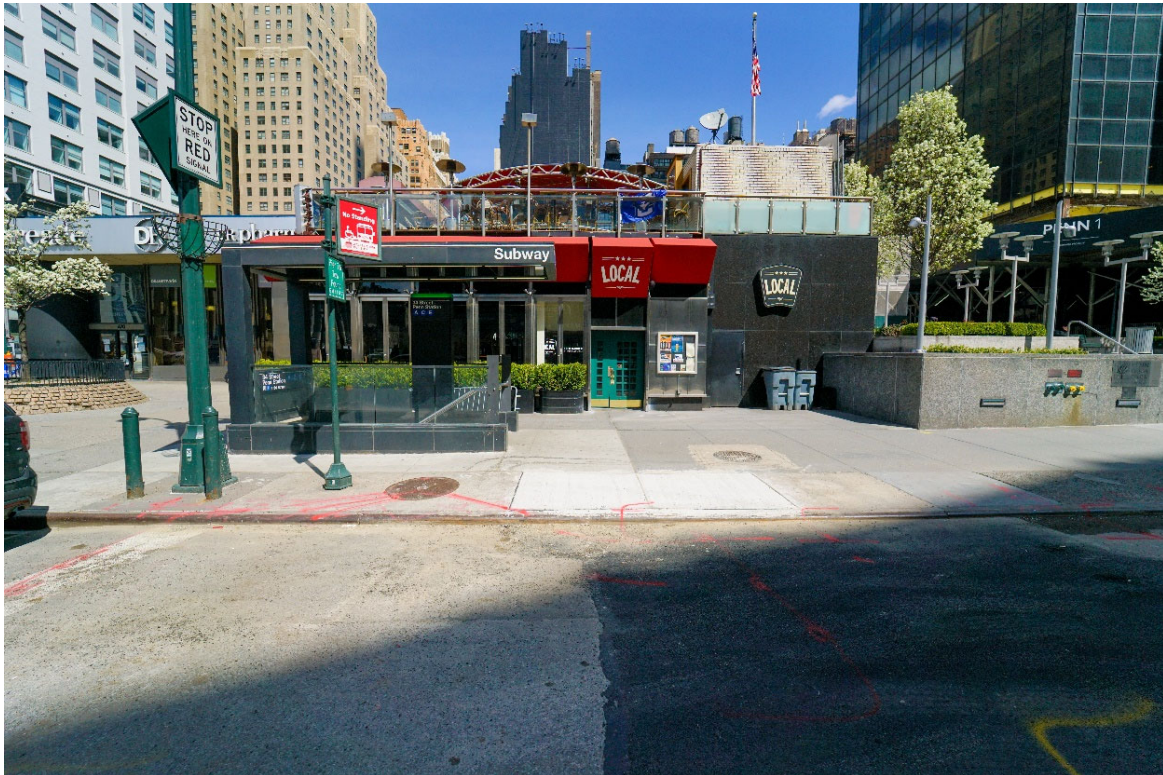
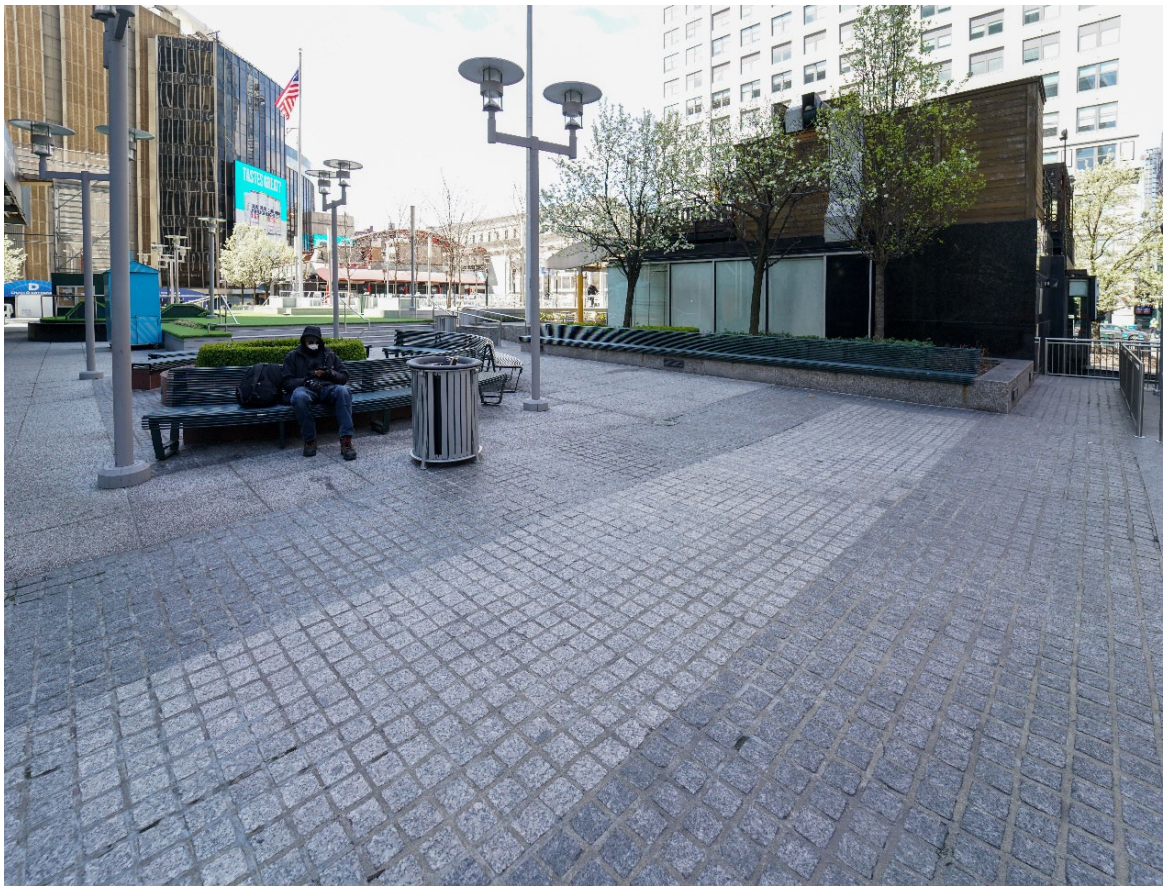
Figure 1-45 Block 783, Lot 70 Photographs

Lot 70 contains a 57-story office building known, two two-story retail buildings, and two public plazas areas. The office building, known as 1 Penn Plaza, has retail space on the ground floor. The façade consists of a metal and glass curtain wall system, a portion of which is undergoing construction and covered by scaffolding. The exterior walls, doors, and windows are in fair condition, showing moderate corrosion and staining. The building has an energy efficiency grade of B, as reported by the Mayor's Office of Sustainability.

The two-story retail store on the northwest portion of the lot (with frontage on West 34th Street) is occupied by a restaurant. The façade consists of a terracotta, metal, and glass storefront. The exterior walls, doors, and windows are in a fair condition, showing moderate cracking, staining, and corrosion. The building shows no barrier to accessibility at the ground-floor entrance.

The two-story retail store on the southwest portion of the lot (with frontage on West 33rd Street) is also occupied by restaurant. The façade consists of a stone, metal, and glass storefront. The exterior walls and doors are in fair condition, showing moderate corrosion and staining, while the windows are in good condition. Sidewalks are in fair condition, showing minor cracking, staining, and debris, while curb cuts are in good condition. Its ground floor entrance shows no barrier to accessibility.

The paved yard surface on the plaza is appears to be well-maintained, with minor staining.

Overall the building and site conditions were given a rating of fair, with each building being rated in fair condition.

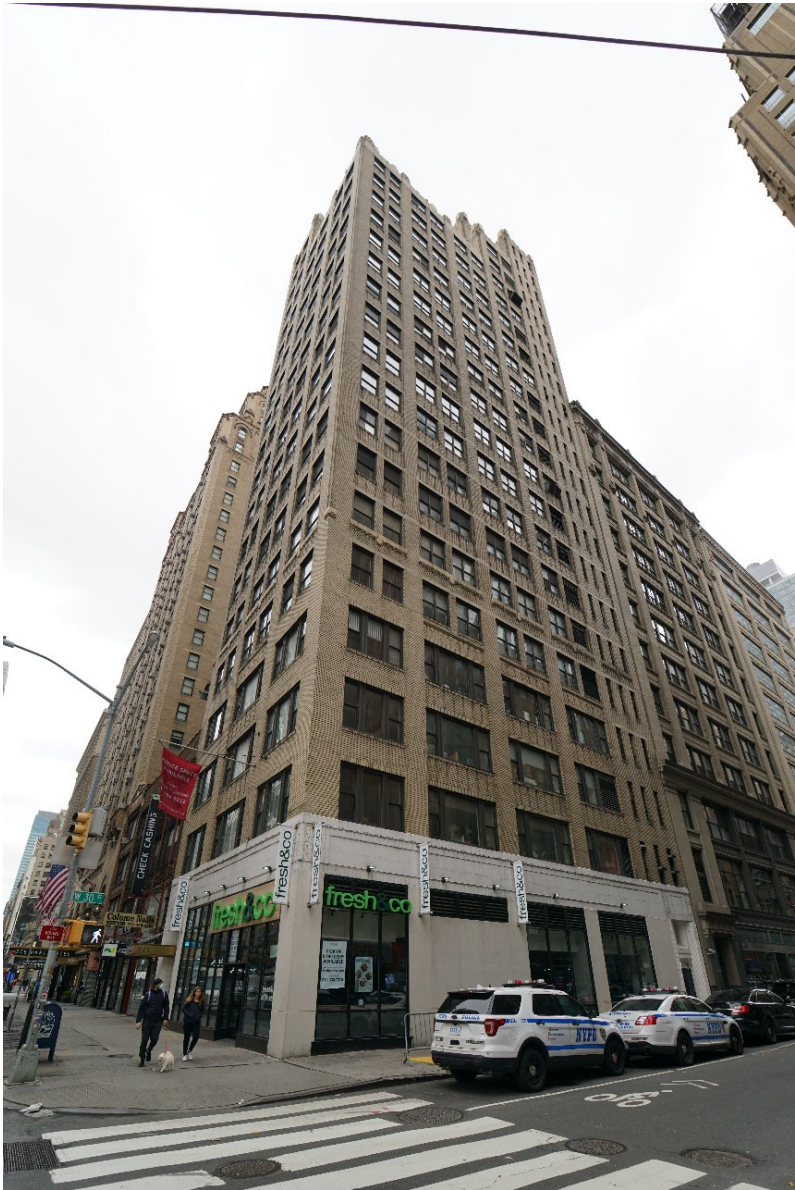
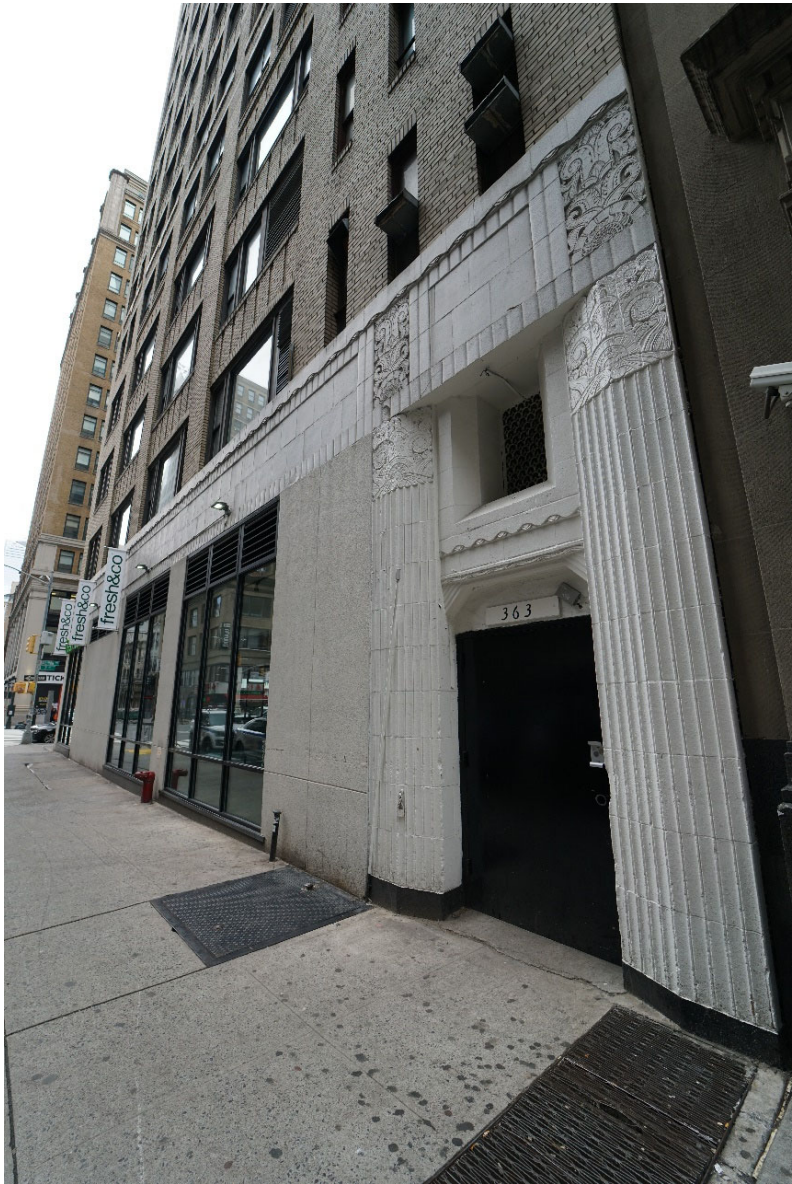
Figure 1-47 Block 806, Lot 1 Photographs

Lot 1 contains a 22-story building, with retail and an office lobby on the ground floor and office space on the upper floors. The façade consists of a metal, glass, and stone storefront on the lower floors, with bricks on the upper floors. The exterior wall on the lower floors is in good condition, but the upper brick wall is in fair condition, showing moderate corrosion and staining. The windows and doors are all in good condition. The sidewalk is in poor condition, showing cracking and staining, while curb cuts are in fair condition. The building shows no barrier to accessibility at the ground-floor entrance. Overall, the building and site conditions were given a rating of fair condition.

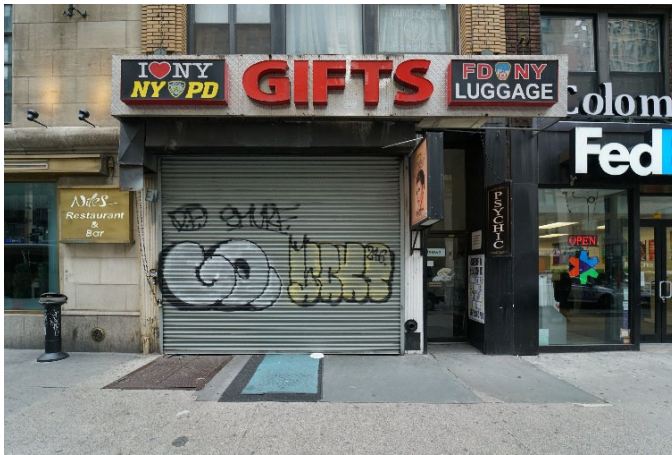
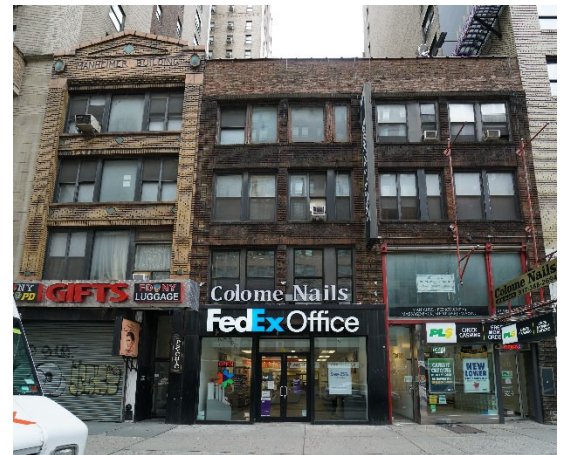
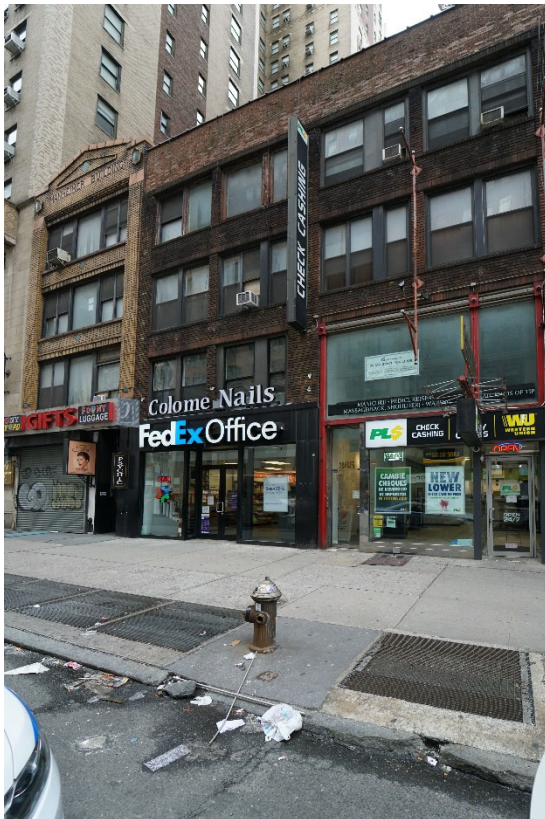
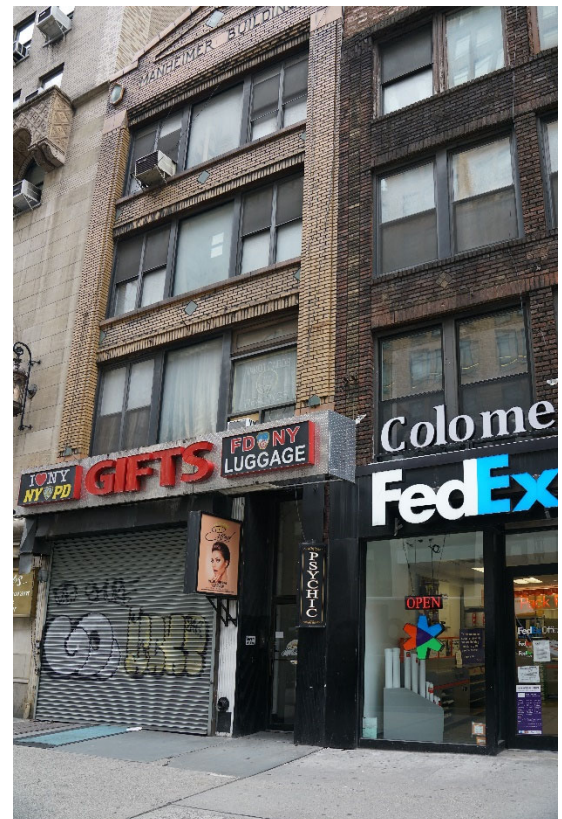
Figure 1-48 Block 806, Lot 3 Photographs

Lot 3 is shared by two four-story buildings, with retail on the ground floor and residential space on the upper floors. The façades of both buildings consist of a metal and glass storefront on the ground floor and brick on the upper floors. Building 101155's exterior wall is in poor condition, showing cracking, staining, and corrosion. Its doors are in good condition, and its windows in fair condition. The exterior wall of Building 101156 is in poor condition, showing cracking, staining, and corrosion. Its windows and doors are in fair condition. There are multiple spots of graffiti on the building's security shutter. Upper office space at Building 101156 was advertised for lease. The sidewalk is in fair condition, showing some cracking and staining, but has excessive amounts of garbage along the curb. Neither building shows a barrier to accessibility at the ground-floor entrance. The overall building and site condition was rated fair/poor with the two buildings scoring across both categories.

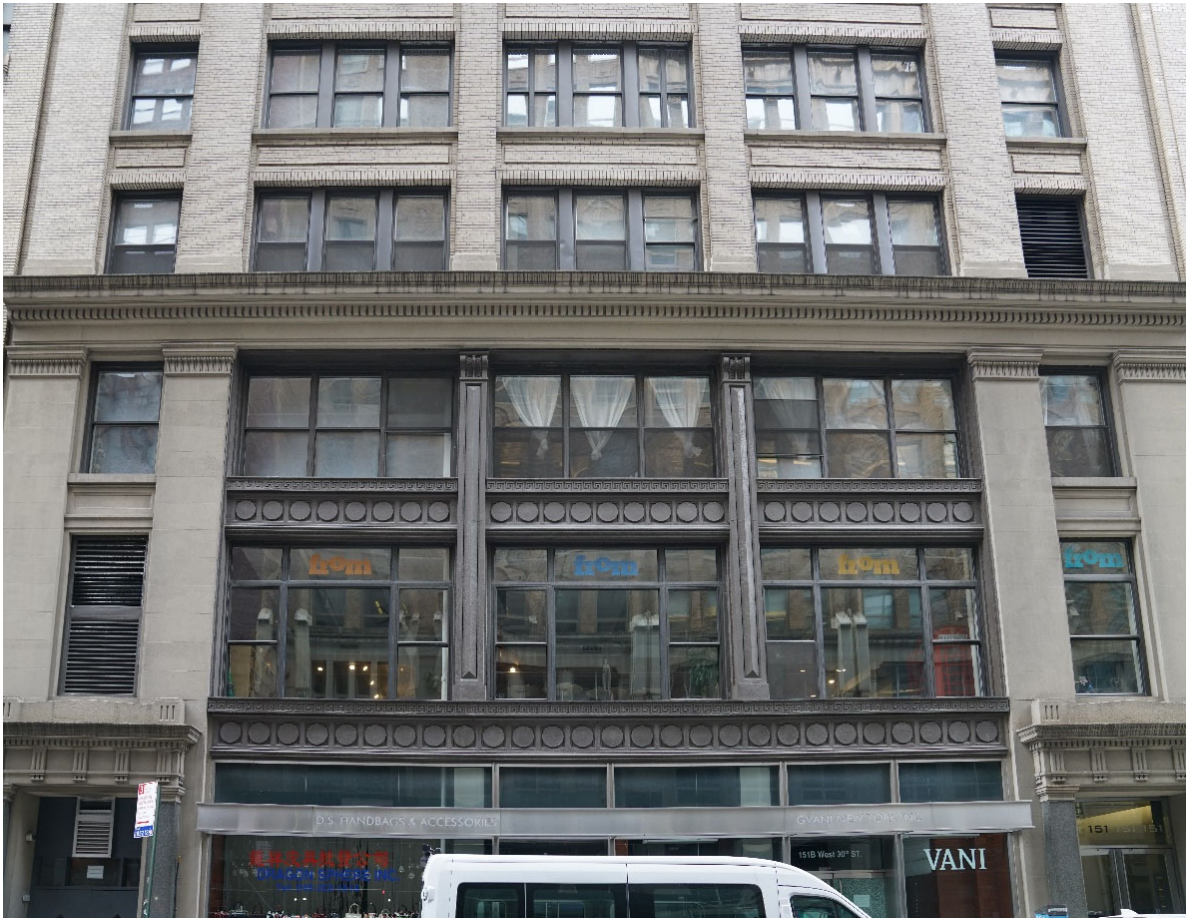
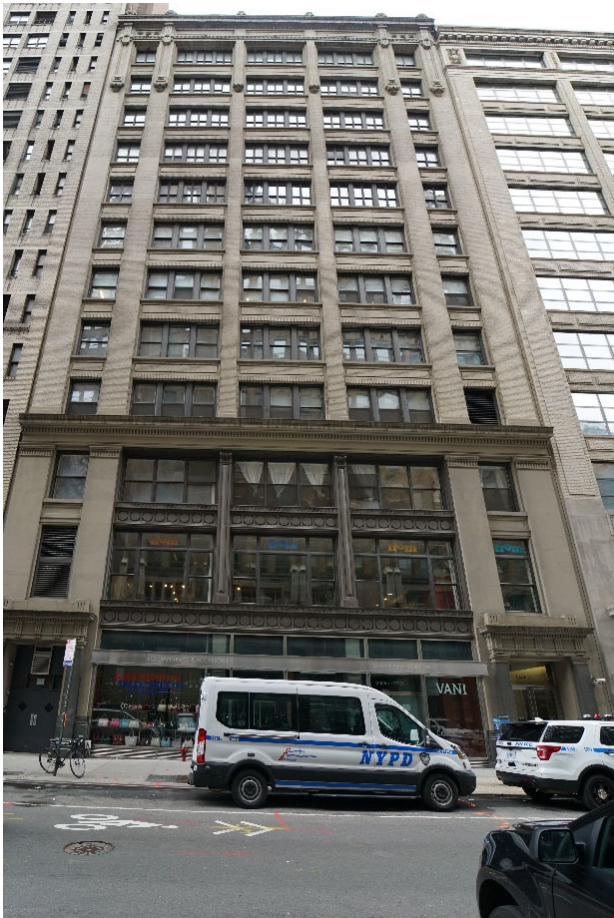
Figure 1-49 Block 806, Lot 6 Photographs

Lot 6 contains a 12-story building, with retail and an office lobby on the first three floors and office space on the upper floors. The façade consists of a metal, glass, and stone storefront on the lower floors and brick and stucco on the upper floors. The exterior walls are in fair condition, showing some staining and corrosion of the brick on the upper floors. The windows and doors are in good condition. The sidewalk is in fair condition, showing minor cracking and staining. The site is littered with a large amount of debris and garbage. The building has an energy efficiency grade of D, as reported by the Mayor's Office of Sustainability. The building shows no barrier to accessibility at the ground-floor entrance. Overall, the building and site conditions were given a rating of good condition.
