EMPIRE STATION COMPLEX

Neighborhood Conditions Study

February 2021

FOR
Empire State Development

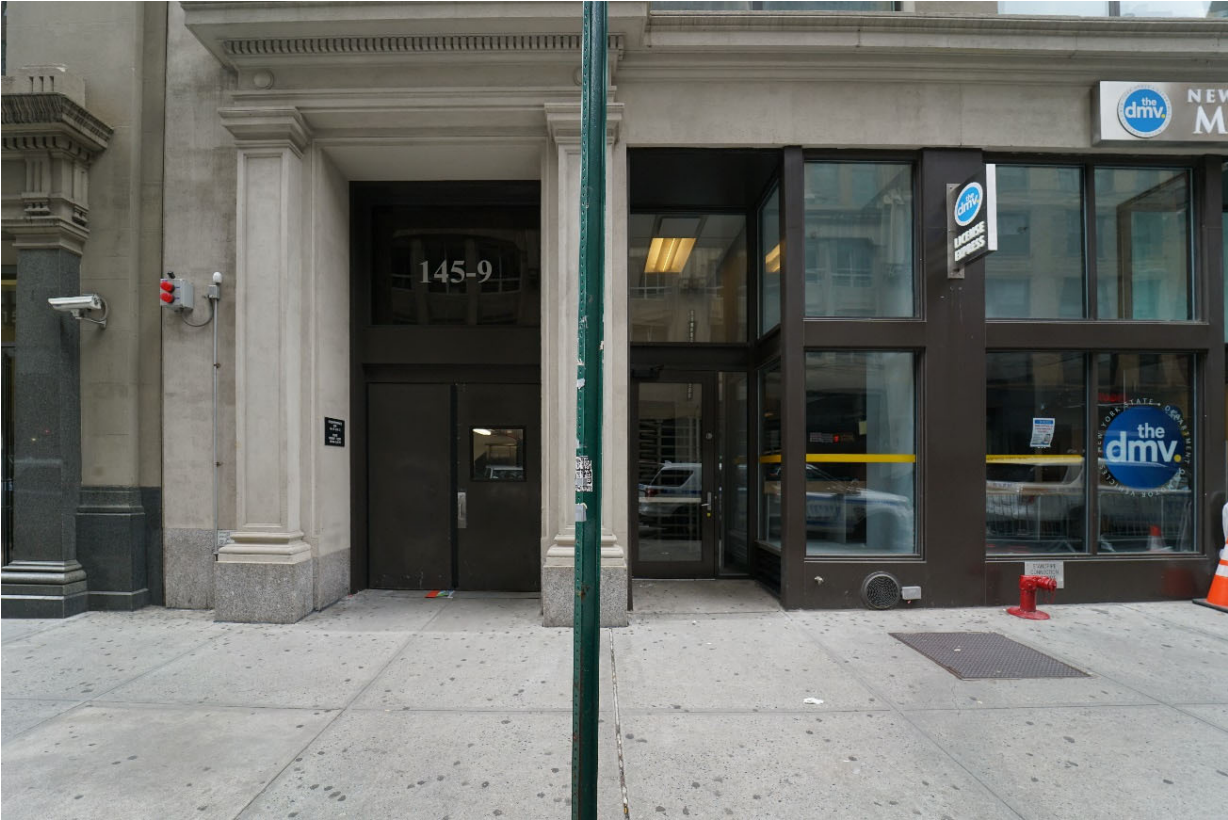
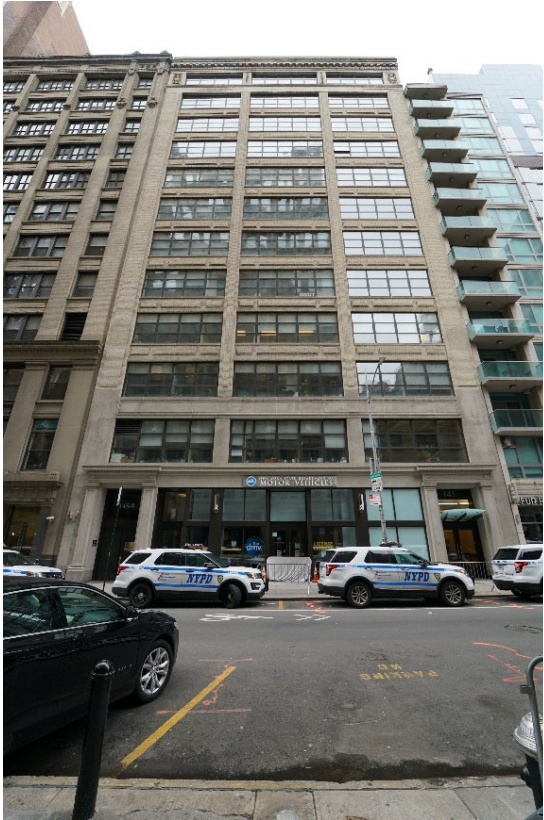
Figure 1-50 Block 806, Lot 9 Photographs

Lot 9 contains a 12-story building with a public office (the New York State Department of Motor Vehicles) and an office lobby on the ground floor, and office space on the upper floors. The façade consists of a metal, glass, and stone storefront on the ground floor and brick on the upper floors. The exterior walls, windows, and doors are in good condition. The sidewalk is in fair condition, showing minor cracking and staining, and is littered with a fair amount of debris and garbage. The building has an energy efficiency grade of A, as reported by the Mayor's Office of Sustainability. The building shows no barrier to accessibility at the street-level entrances. Overall, the building and site conditions were given a rating of good condition.

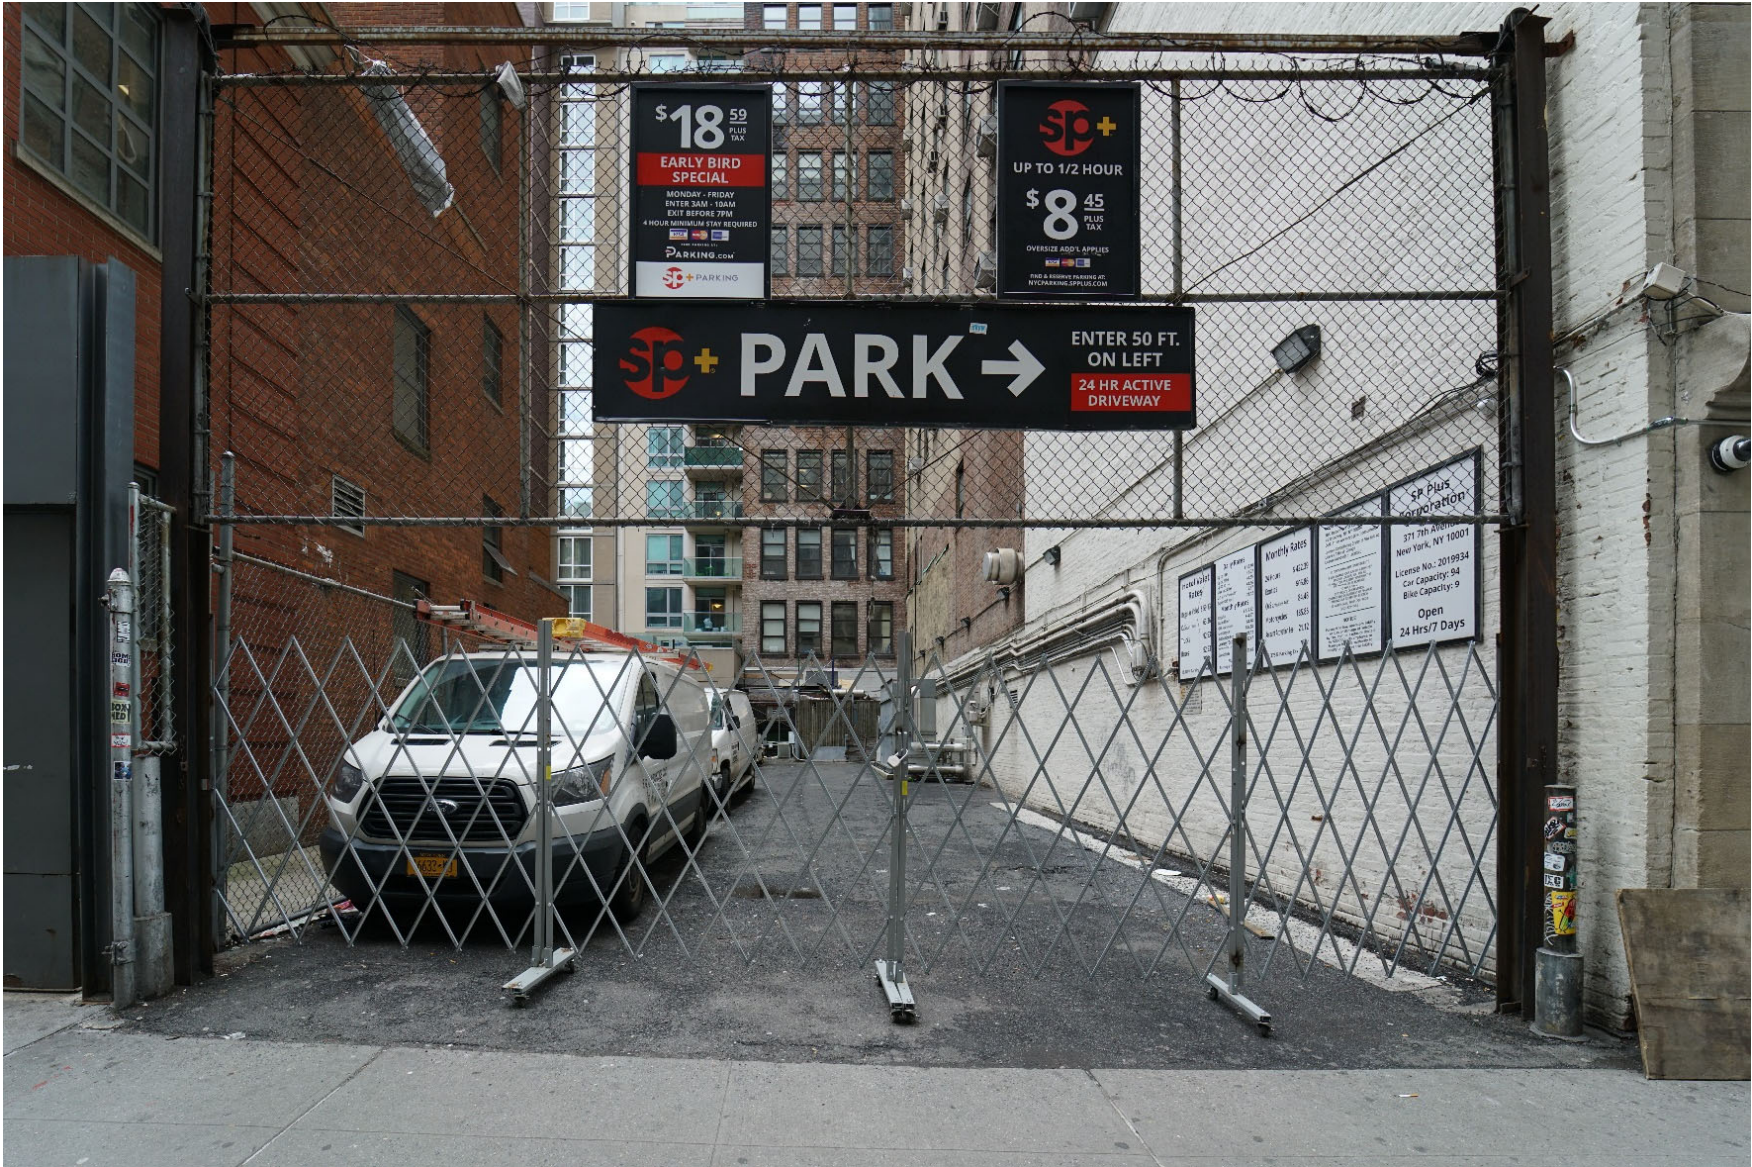
Figure 1-51 Block 806, Lot 69 Photographs

Lot 69 contains a parking lot. The sidewalk and curb cuts are in fair condition, showing some cracking. The security fence is also in fair condition, showing minor damage. The lot's surface is in poor condition and the cracking concrete has been covered with gravel. The sidewalk is littered with a moderate amount of garbage and debris. Overall, the building and site conditions were given a rating of fair condition.

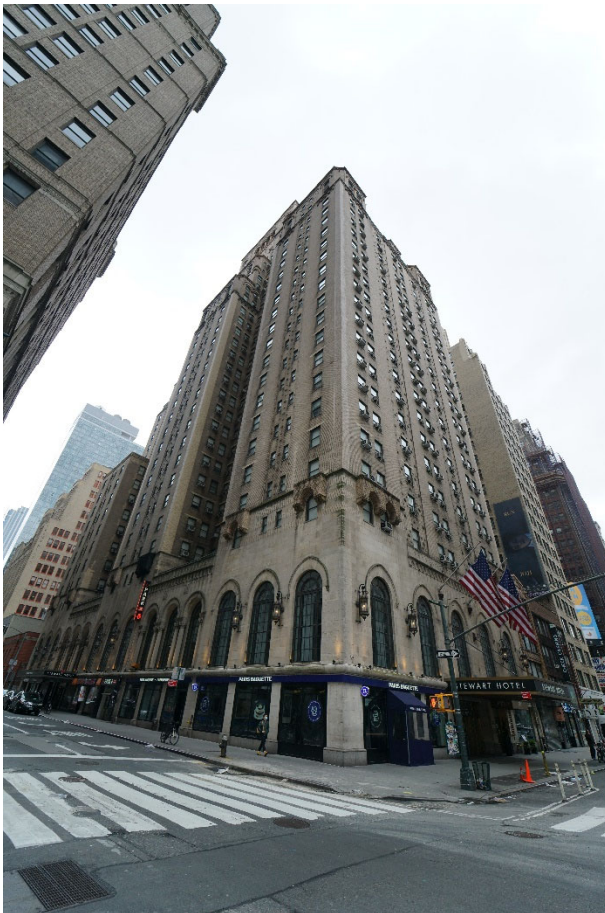
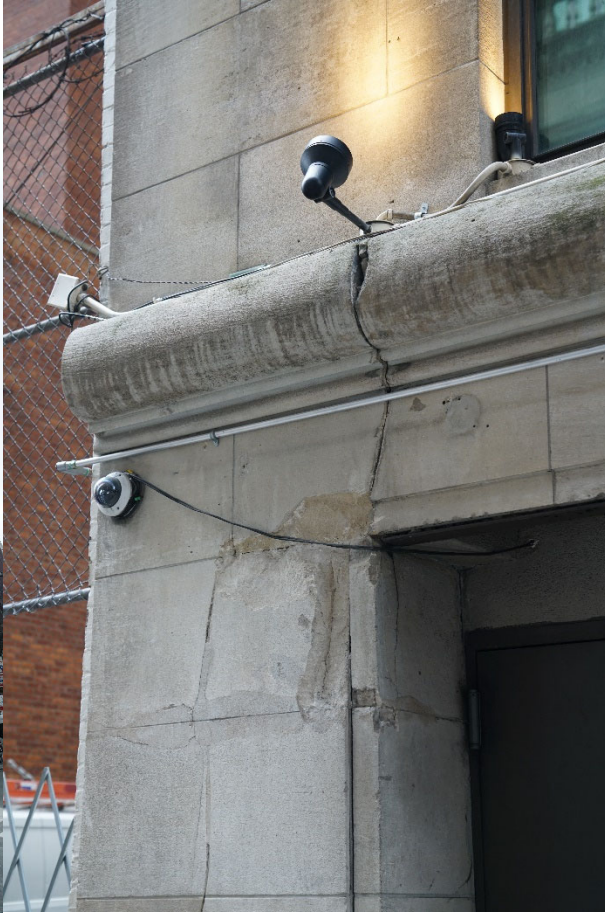
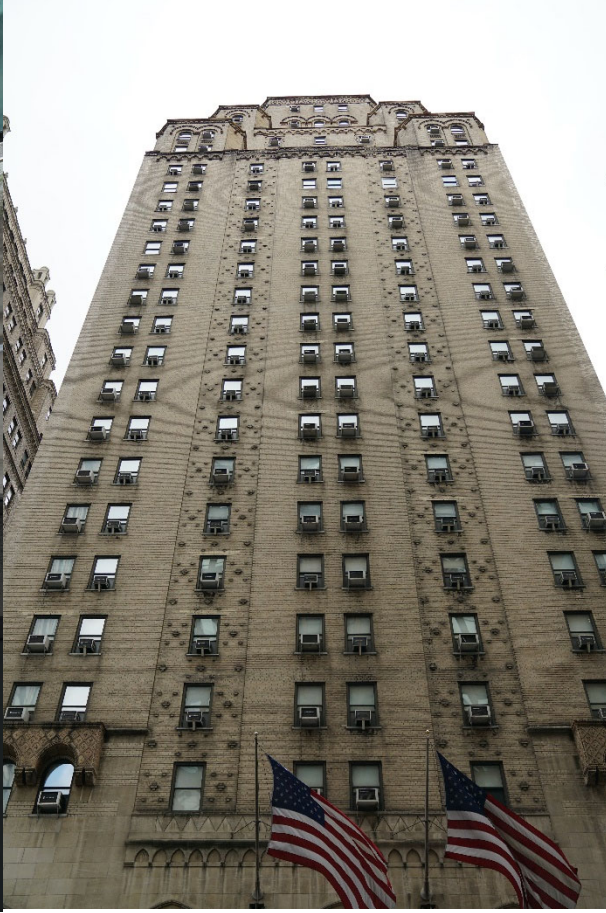
Figure 1-52 Block 806, Lot 76 Photographs

Lot 76 contains a 28-story building, with retail and a hotel lobby on the ground floor and a hotel on the upper floors. The façade consists of metal and stone on the first six levels and brick on the upper floors. The exterior walls are in poor condition, showing cracking, staining, and corrosion. The windows are in fair condition and the doors are in good condition. The sidewalk is in fair condition, but the curb cuts are in poor condition, showing cracking and staining. A large amount of garbage and debris can be found around the building. The building has an energy efficiency grade of D, as reported by the Mayor's Office of Sustainability. The building shows no barrier to accessibility at its ground-floor entrances. Overall, the building and site conditions were given a rating of poor condition.

Lot 76 has four open building code violations that were issued by ECB in 2018. These violations relate to construction at the property. A hazardous condition was identified associated with an unsafe façade and "failure to take required measures to secure public safety."

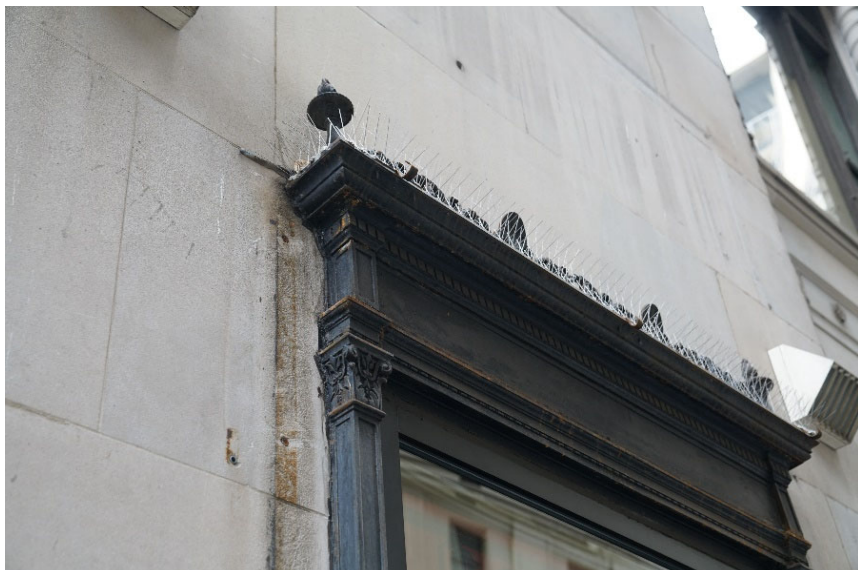
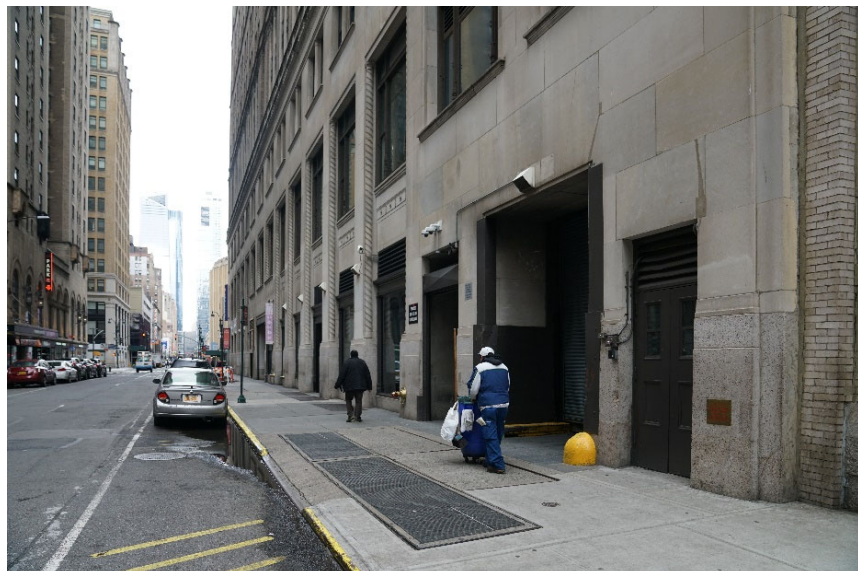
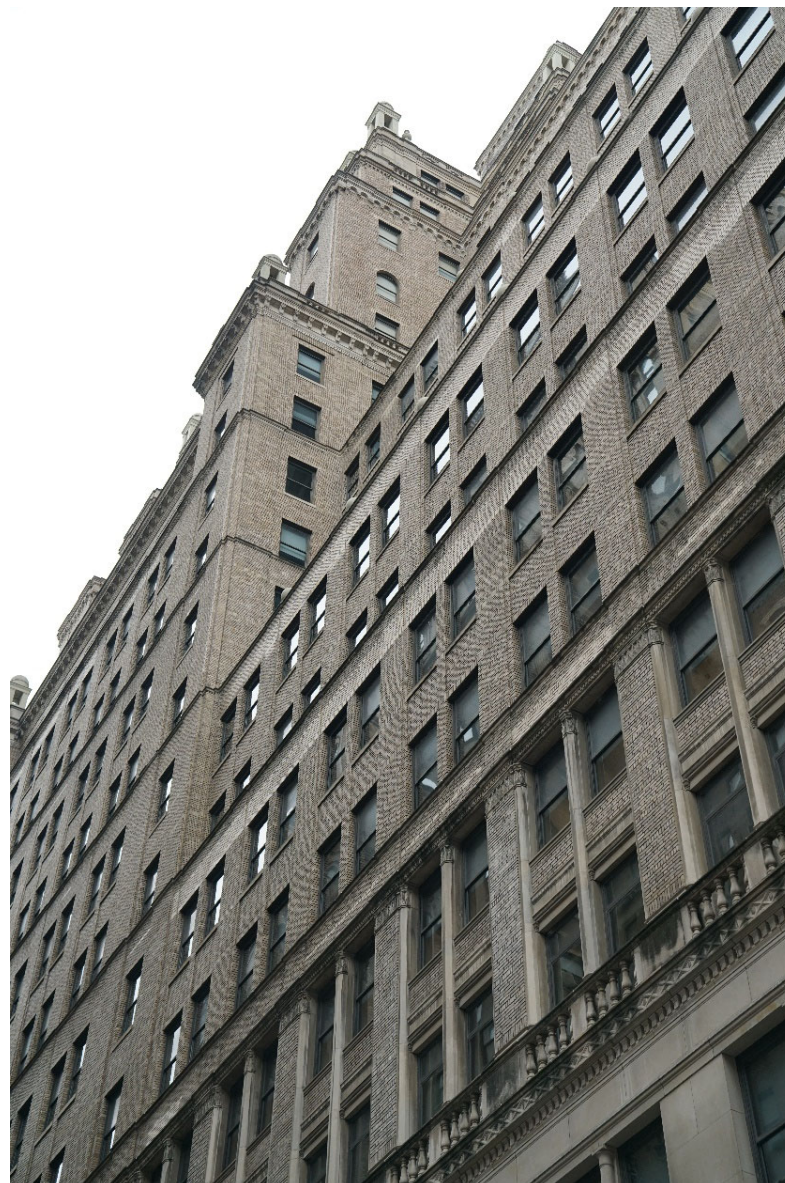
Figure 1-54 Block 807, Lot 1 Photographs

Lot 1 contains a 26-story building, with retail on the ground floor level and office space on the upper floors. The façade consists of a metal and glass storefront and stone at the lower three floors, and stone and brick on upper floors. The exterior walls are in fair condition, showing some cracking, erosion, and staining. The windows are in fair condition and the doors are in good condition. The sidewalk and curb

cuts are in fair condition, showing some cracking and staining. The building has an energy efficiency grade of B, as reported by the Mayor's Office of Sustainability. The building shows no barrier to accessibility at its ground-floor entrances. Overall, the building and site conditions were given a rating of good condition.

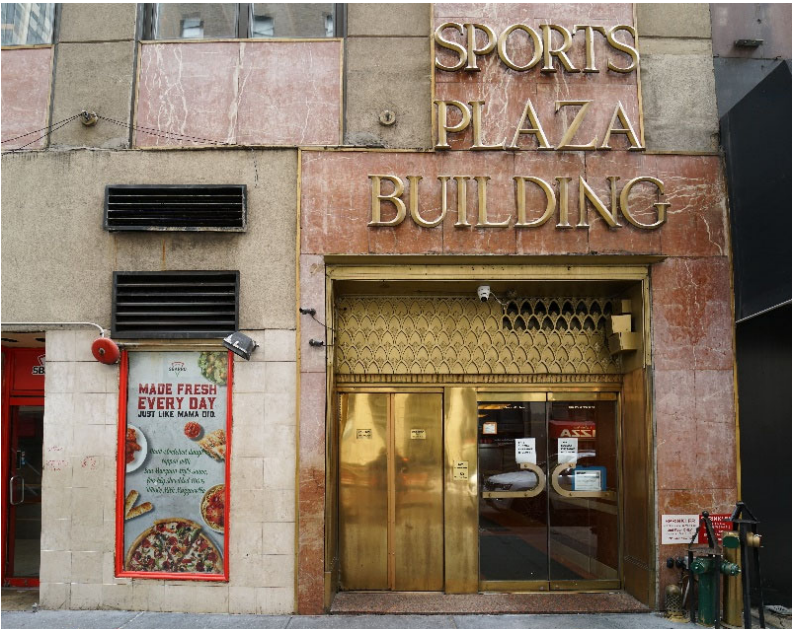
View of entrance on West 33rd Street

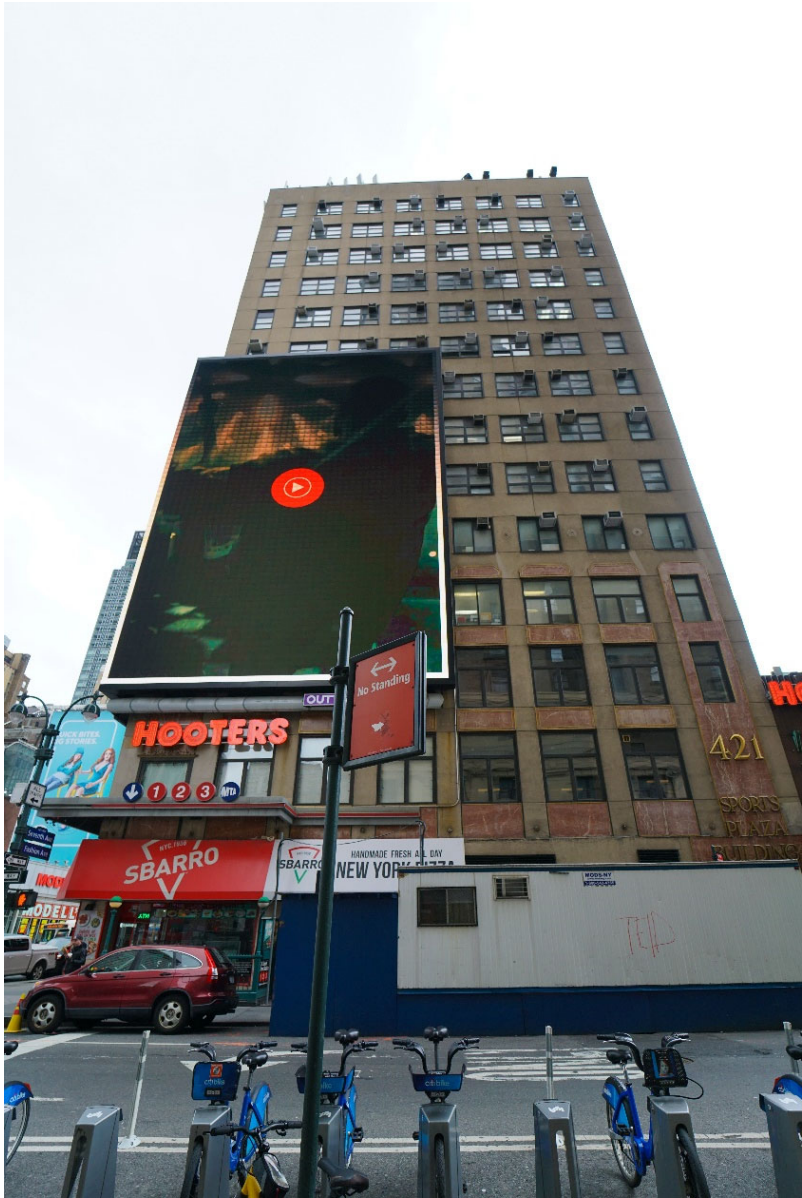
View facing north on West 33rd Street

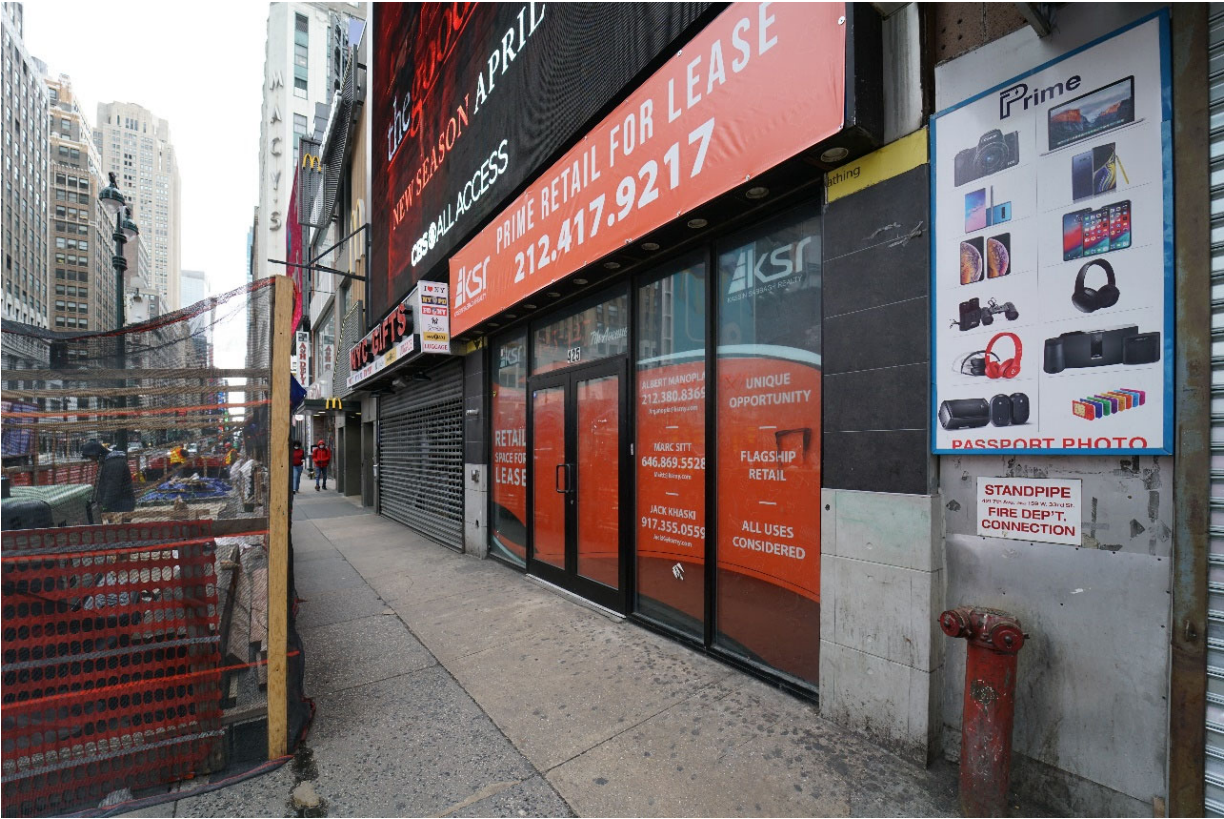
Figure 1-60 Block 809, Lot 3 Photographs

Lot 3 contains a three-story building, with retail on the ground floor and residential space on the upper floors. The façade consists of a metal and glass storefront on the ground floor and a digital display on the upper levels. The retail store appears to be vacant, showing a sign for lease. The exterior walls are in poor condition and the storefront is damaged. The windows are in fair condition and the doors are in good condition. The sidewalk is in poor condition, showing cracking and staining; it appears to be under construction. A fair amount of garbage litters the sidewalks. The building has an energy efficiency grade of D, as reported by the Mayor's Office of Sustainability. The building entrance shows no barrier to accessibility. Overall, the building and site conditions were given a rating of good condition.

Lot 3 has five open building code violations that were issued by DOB and relate to construction and zoning at this property. No other details are provided by DOB. Of the five violations, each were issued prior to 2015.

View facing north on 7th Avenue

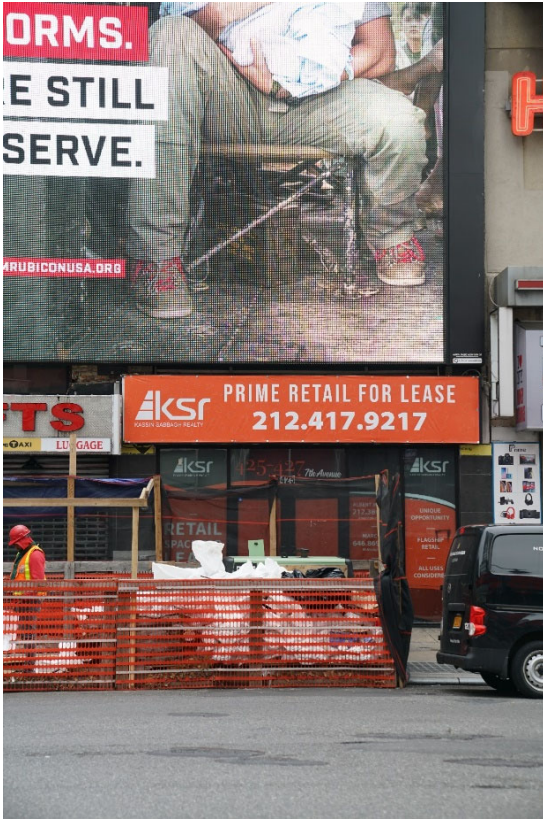
View facing east on 7th Avenue

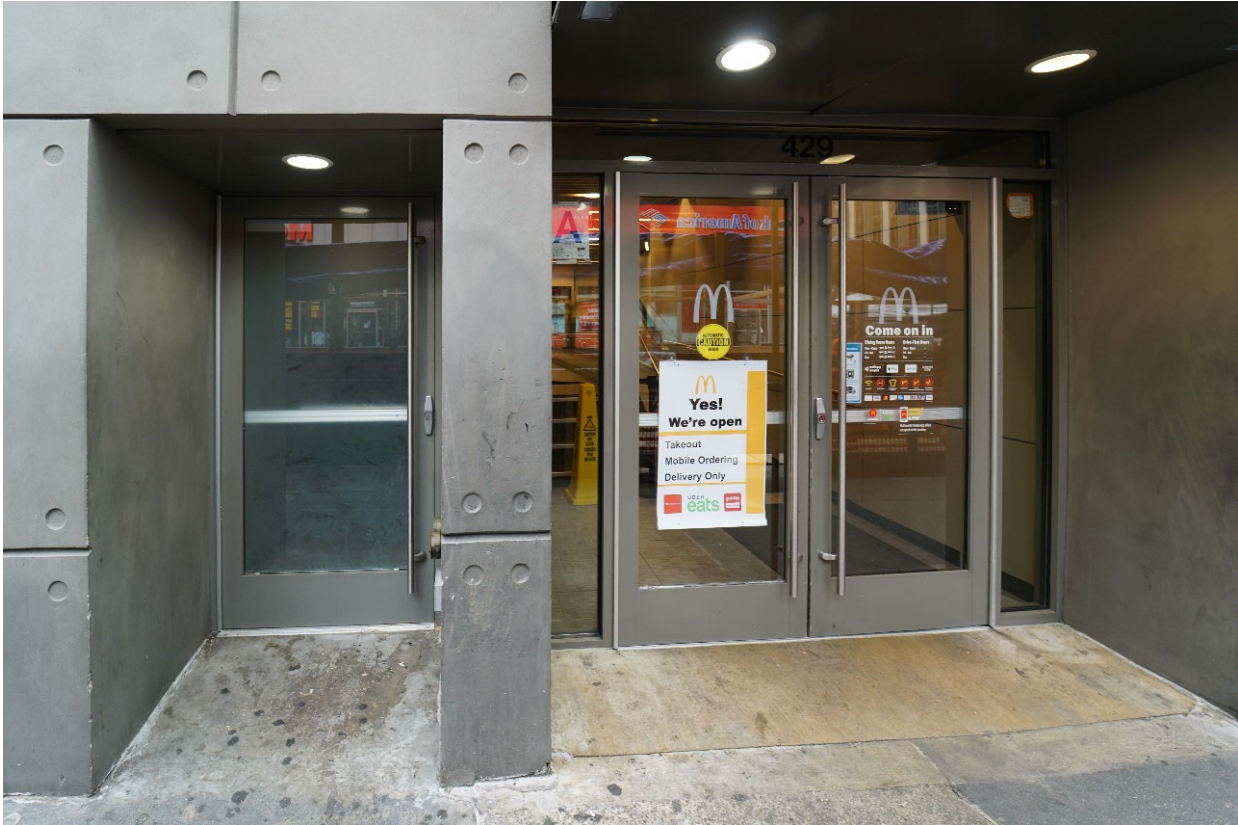
Figure 1-62 Block 809, Lot 5 Photographs

Lot 5 contains a three-story retail building. The façade consists of a metal and glass storefront, with some decorative wood. The exterior walls, windows, and doors are in good condition. The sidewalk is in fair condition, showing some cracking and staining, and appears to be under construction. A fair amount of garbage litters the sidewalks. The building shows no barrier to accessibility at the ground-floor entrance. Overall, the building and site conditions were given a rating of good condition.

View of entrance

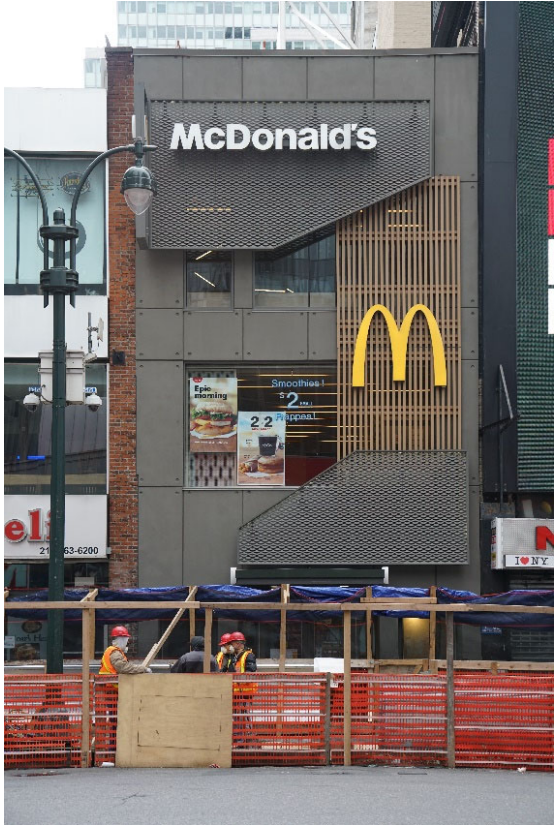
View facing east on 7th Avenue

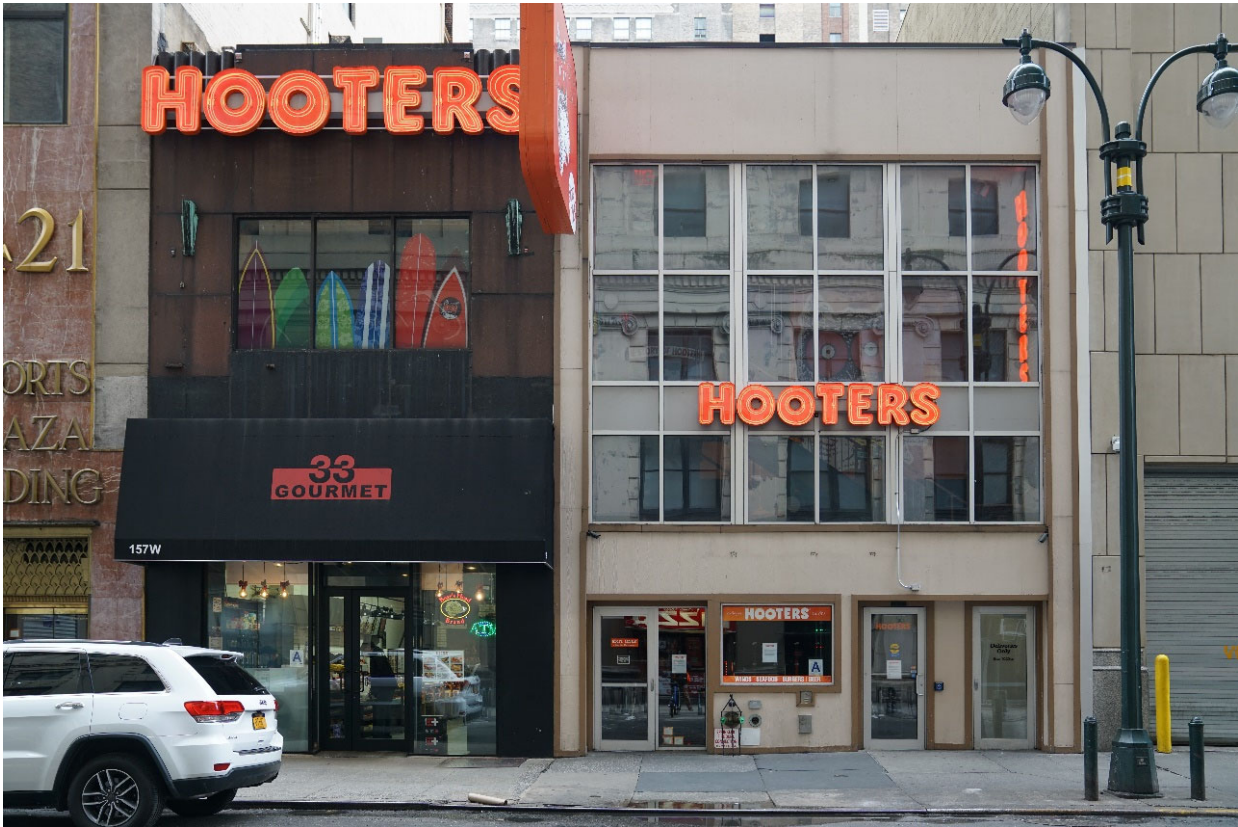
Figure 1-63 Block 809, Lot 8 Photographs

Lot 8 appears to contain two two-story retail buildings leased by the same tenant. The westernmost building's façade consists of a metal and glass storefront on ground floor and stone on the upper floors. The easternmost building's façade consists of stucco and glass on the ground floor and stucco, metal, and glass on the upper floors. The exterior walls, doors, and windows are in fair condition. The sidewalk is in poor condition, showing large cracking and staining. A fair amount of garbage litters the sidewalk. Both buildings show no barrier to accessibility at their ground floor entrances. Overall, the building and site conditions were given a rating of fair condition.

View facing north on West 33rd Street

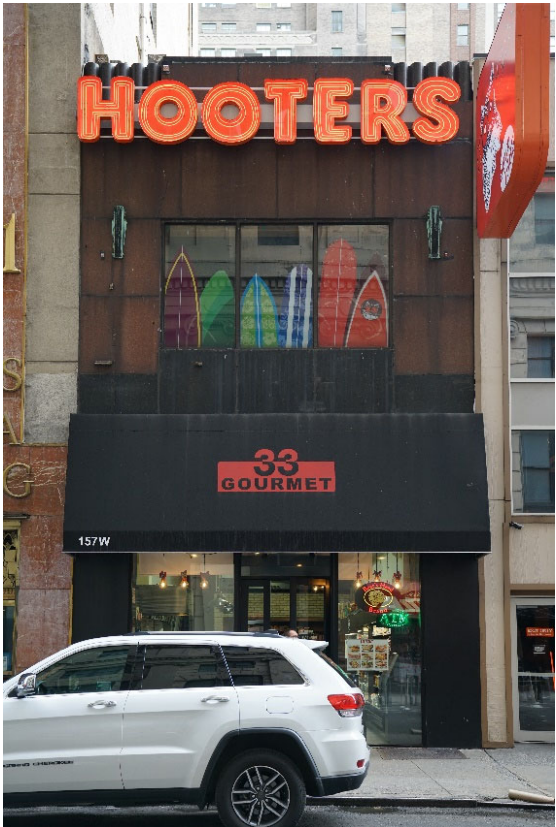
View facing north on West 33rd Street

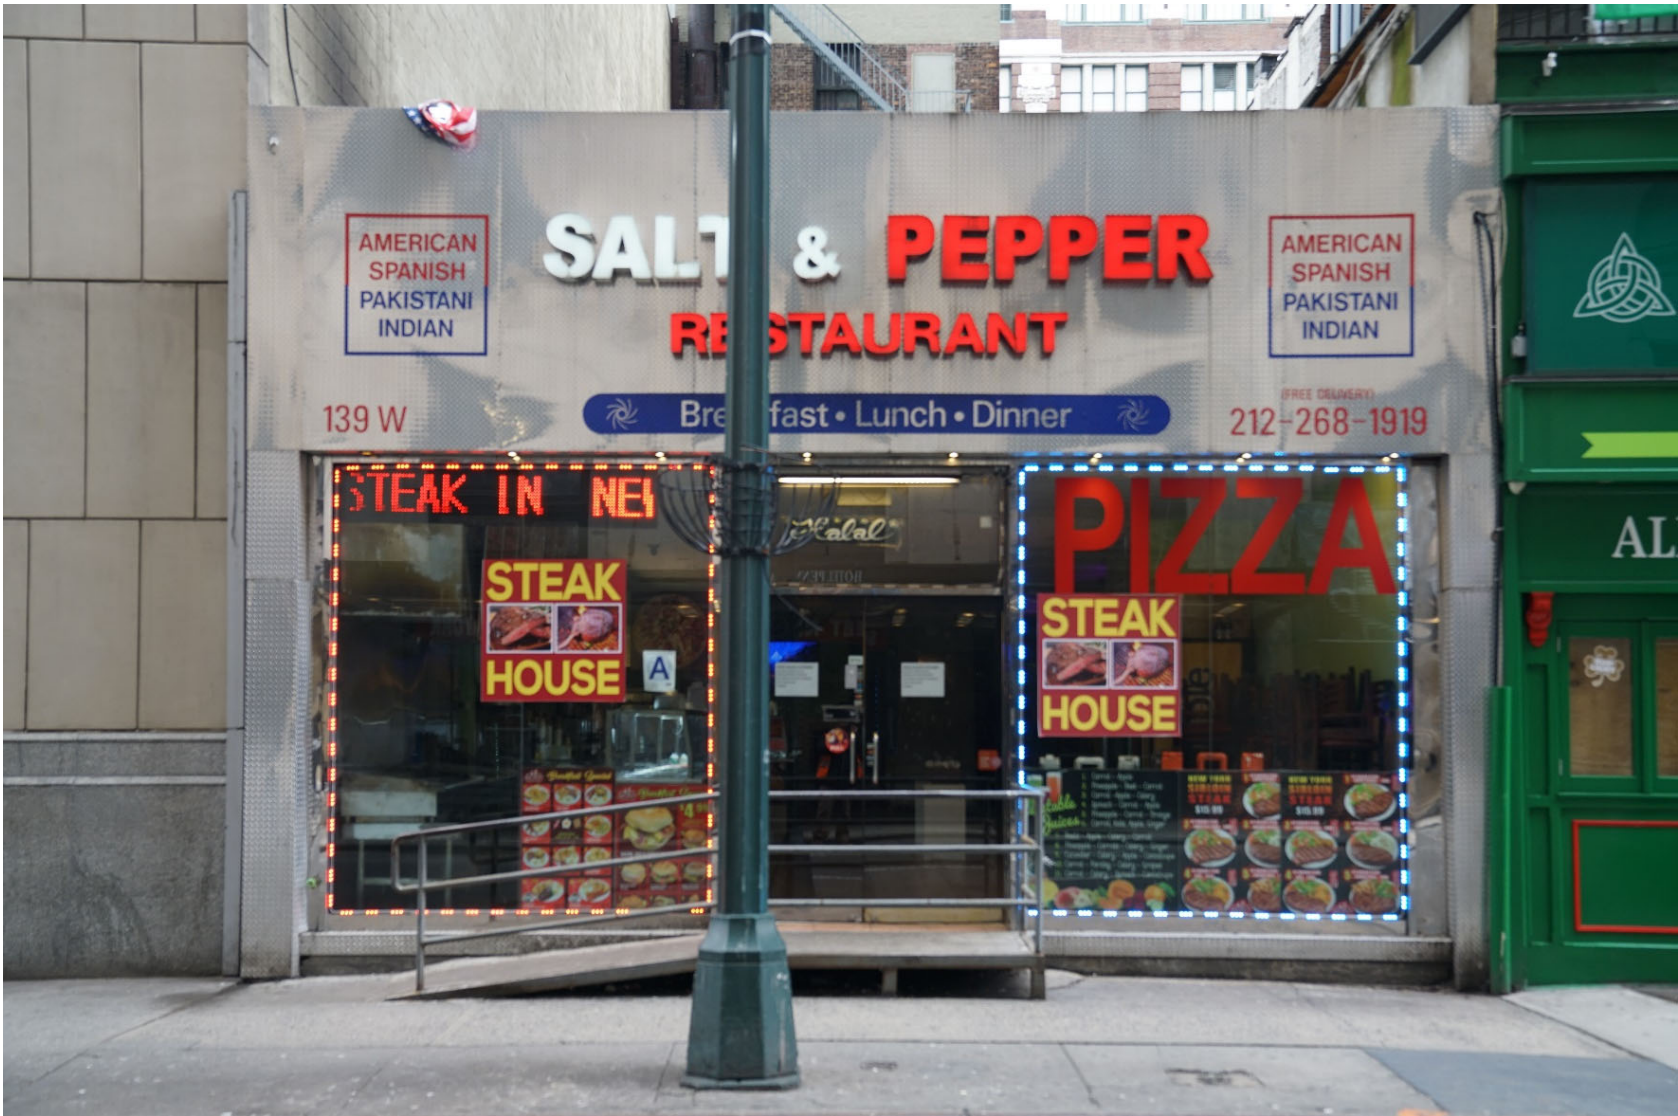
Figure 1-64 Block 809, Lot 16 Photographs

Lot 16 contains a one-story retail store. The façade consists of a metal and glass storefront. The exterior walls, windows, and doors are all in fair condition. The sidewalk is in fair condition, showing some cracking and staining. A fair amount of garbage litters the sidewalks. The building is accessible via an entry ramp. Overall, the building and site conditions were given a rating of fair condition.

Lot 16 has one open building code violation that was issued by ECB in 2011. This violation is for “failure to maintain building in code-compliant manner.” Although not classified as hazardous by ECB, the violation notes a large vertical crack in the eastern concrete and brick wall. In addition, an approximately 12-inch section of brickwork on the front facing façade was dislodged.

View facing north on West 33rd Street

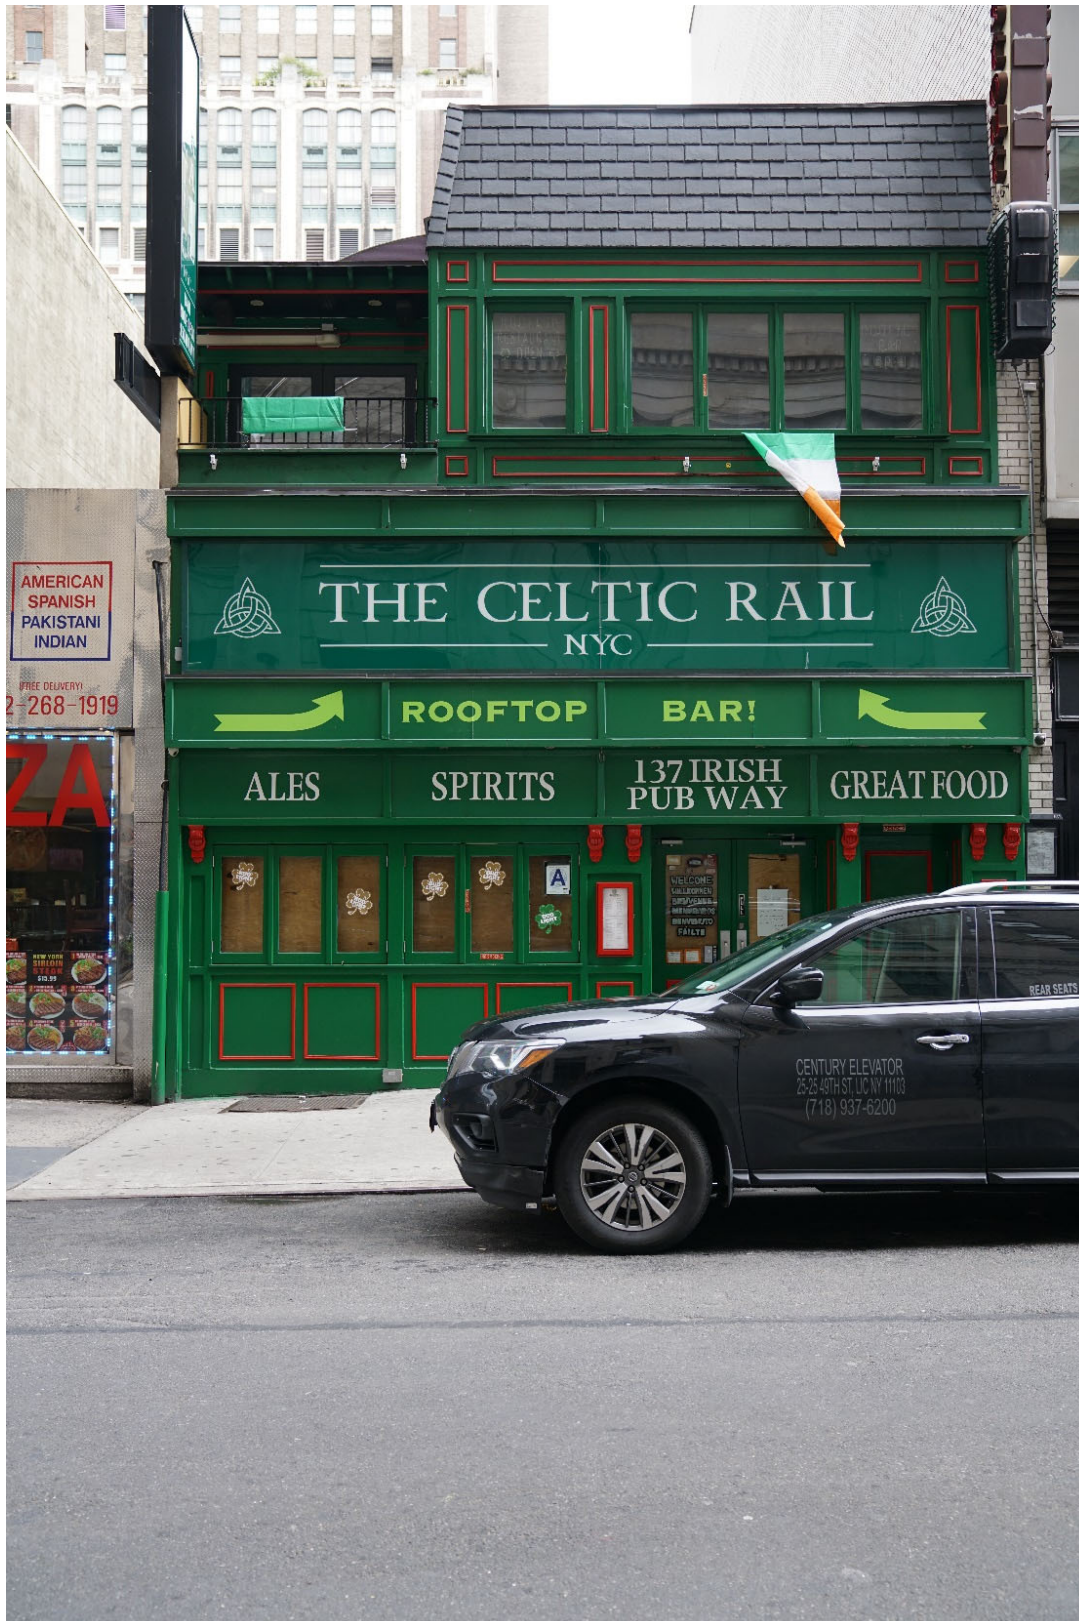
Figure 1-65 Block 809, Lot 17 Photographs

Lot 17 contains a two-story retail building. The façade consists of a glass and wood-paneled storefront. The exterior walls, windows, and doors are all in good condition. The sidewalk is in good condition, though there was a fair amount of garbage. The entrance shows no barrier to accessibility at the street level. Overall, the building and site conditions were given a rating of good condition.

View facing north on West 33rd Street

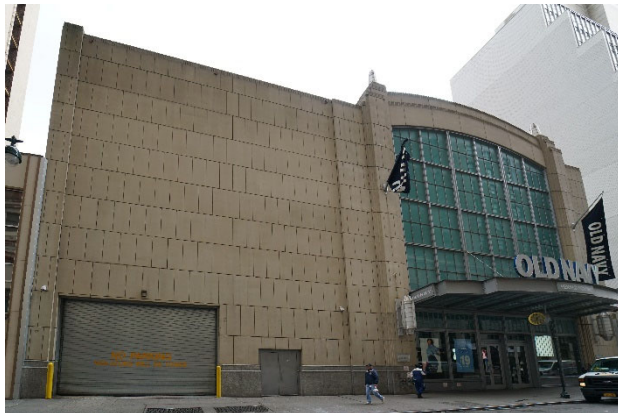
Figure 1-66 Block 809, Lot 69 Photographs

Lot 69 contains a three-story retail building, with entrances on West 33rd Street and West 34th Street. The façade consists of stone, metal, and glass. The exterior walls and windows are in fair condition, showing some corrosion and staining. The doors are in good condition. The sidewalk is in fair condition, showing some cracking and staining, and a fair amount of garbage litters the sidewalk. The building shows no barrier to accessibility at the ground-floor entrance. Overall, the building and site conditions were given a rating of fair condition.

View facing north on West 33rd Street

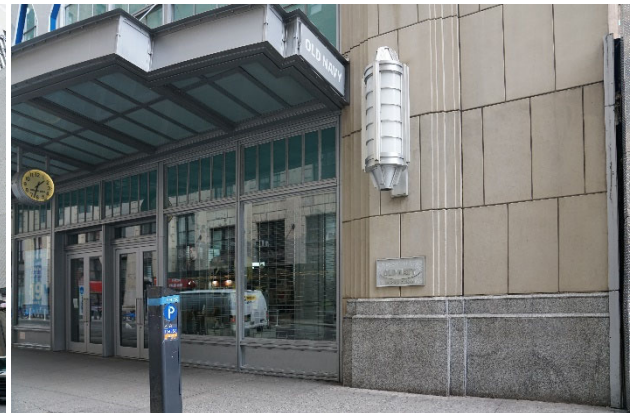
View facing north on West 33rd Street

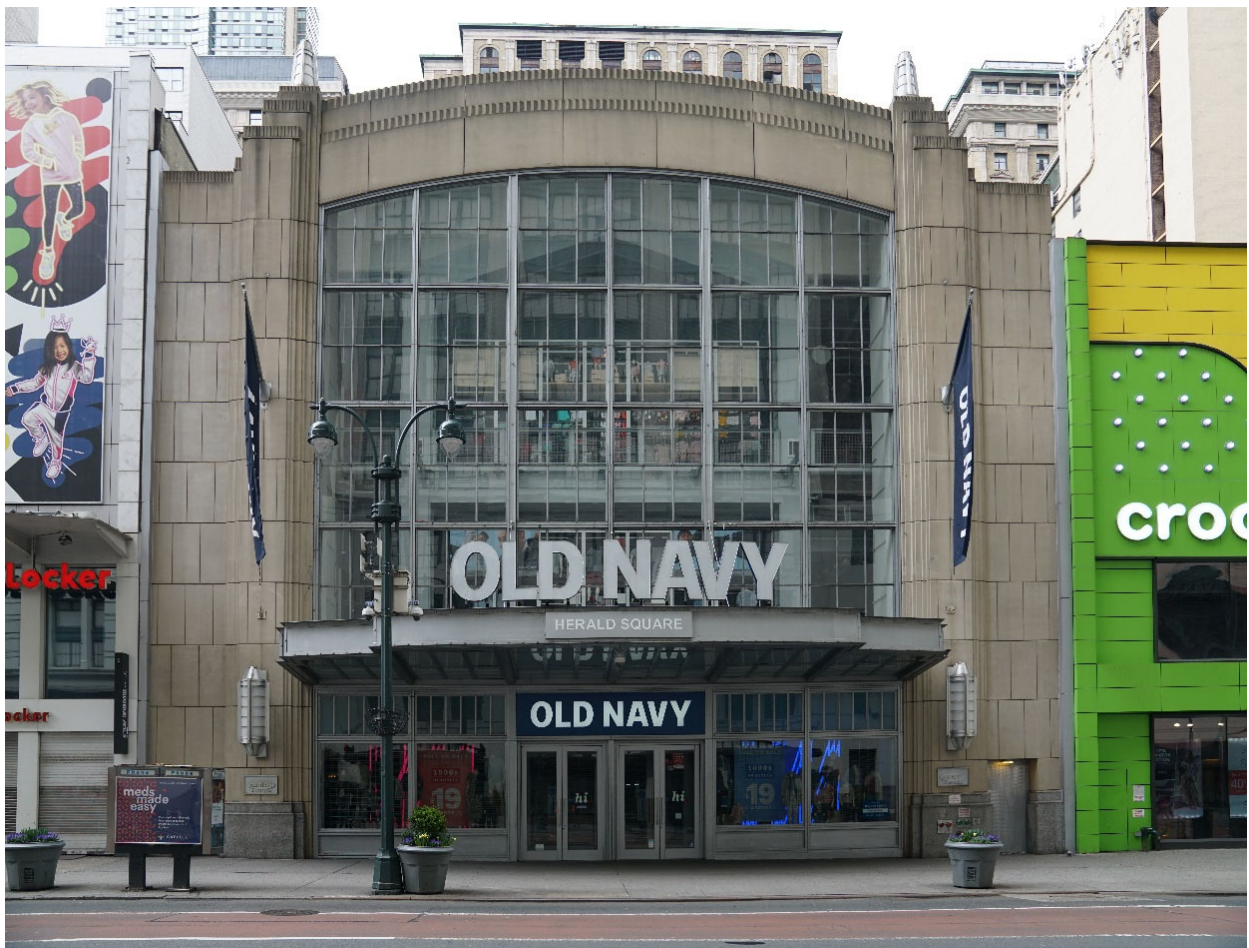
View facing south on West 34th Street

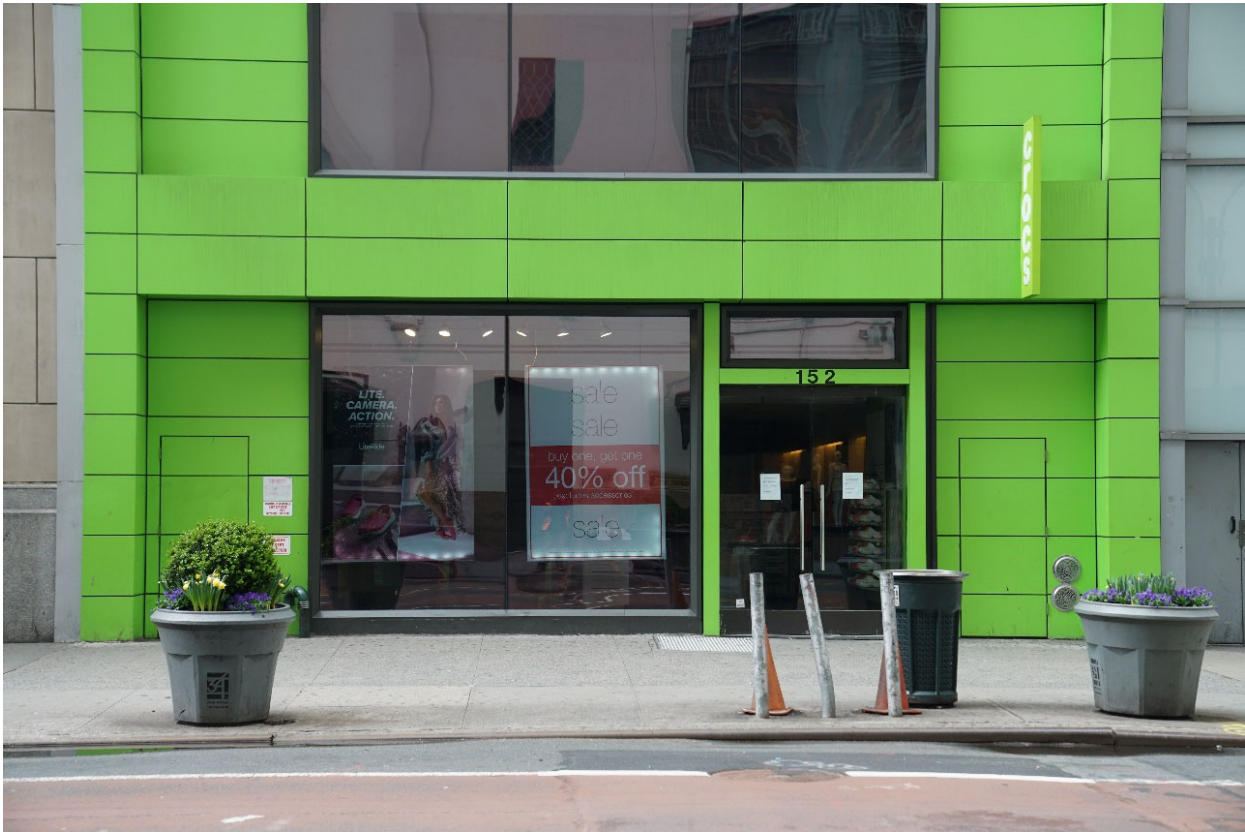
Figure 1-67 Block 809, Lot 73 Photographs

Lot 73 contains a three-story retail building. The façade consists of metal panels and a glass storefront on the ground floor. The exterior walls, doors, and windows are in good condition. The sidewalk is in fair condition, showing some cracking and staining, and is littered with a fair amount of garbage. The building shows no barrier to ADA accessibility at its ground-floor entry. Overall, the building and site conditions were given a rating of good condition.

View facing south on West 34th Street

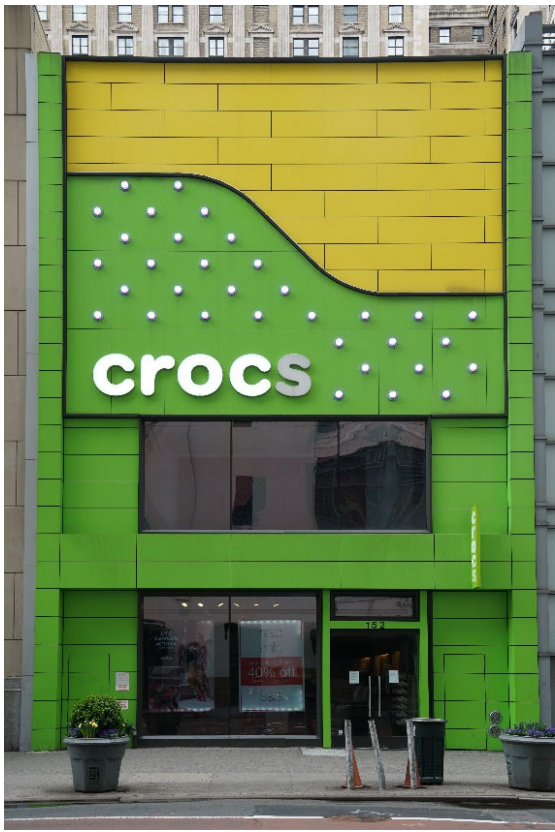
View facing south on West 34th Street
