EMPIRE STATION COMPLEX

Neighborhood Conditions Study

February 2021

FOR
Empire State Development

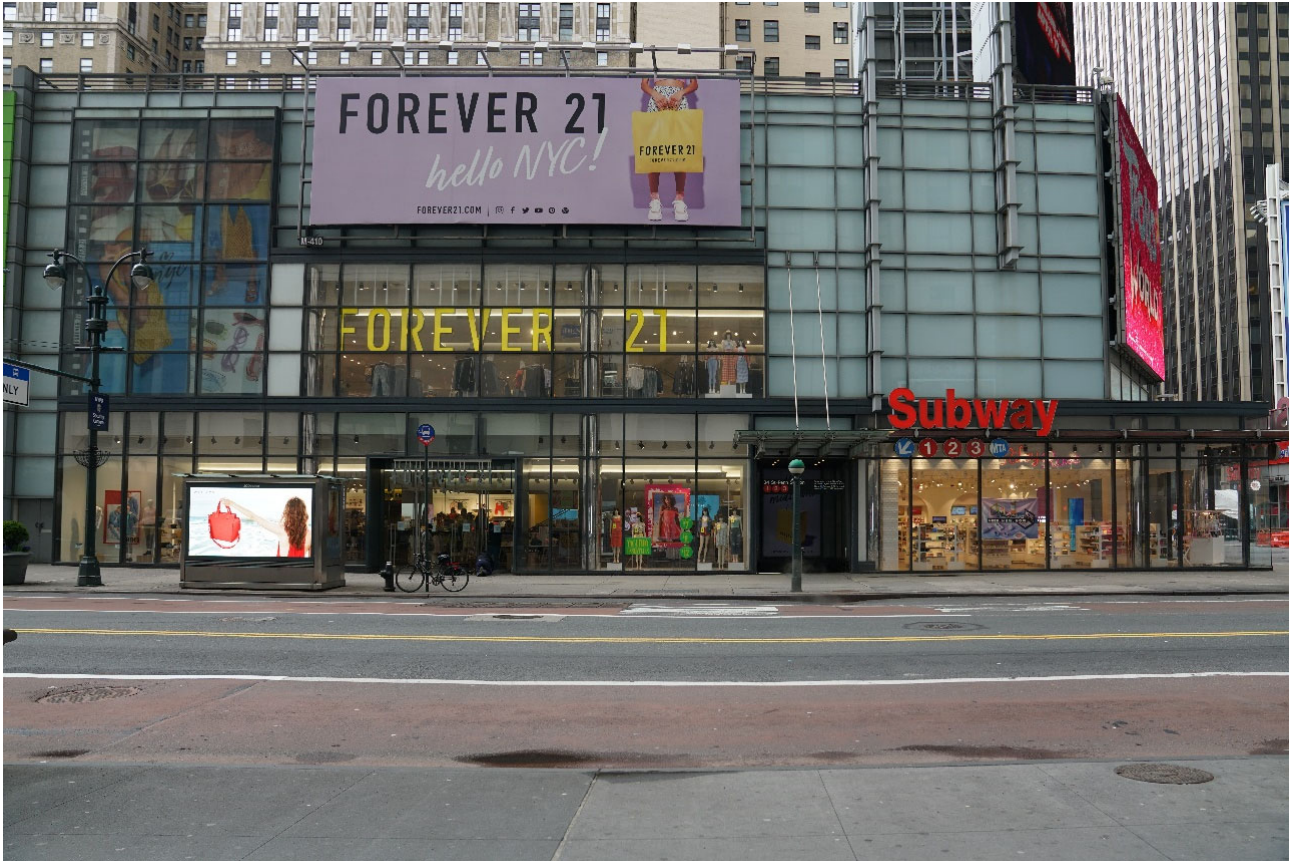
Figure 1-68 Block 809, Lot 80 Photographs

Lot 80 contains a three-story retail building. Part of the ground floor is also occupied by a subway station entrance. The façade consists of metal and glass. The exterior walls and doors are in fair condition. The building's doors are in good condition. The sidewalk and curb cuts are in fair condition, showing some cracking and staining. They are littered with a large amount of garbage and debris. The building shows no barrier to ADA accessibility at its ground-floor entrance. Overall, the building and site conditions were given a rating of fair condition.

View facing south on West 34th Street

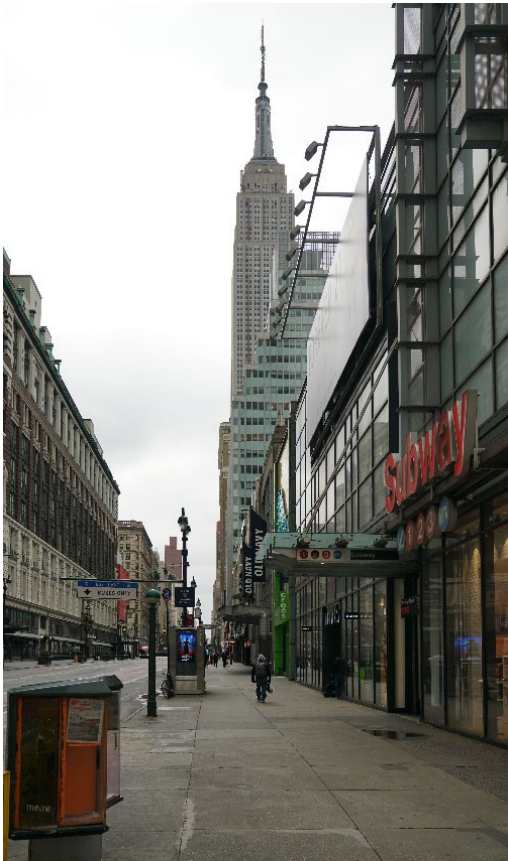
View facing east on West 34th Street

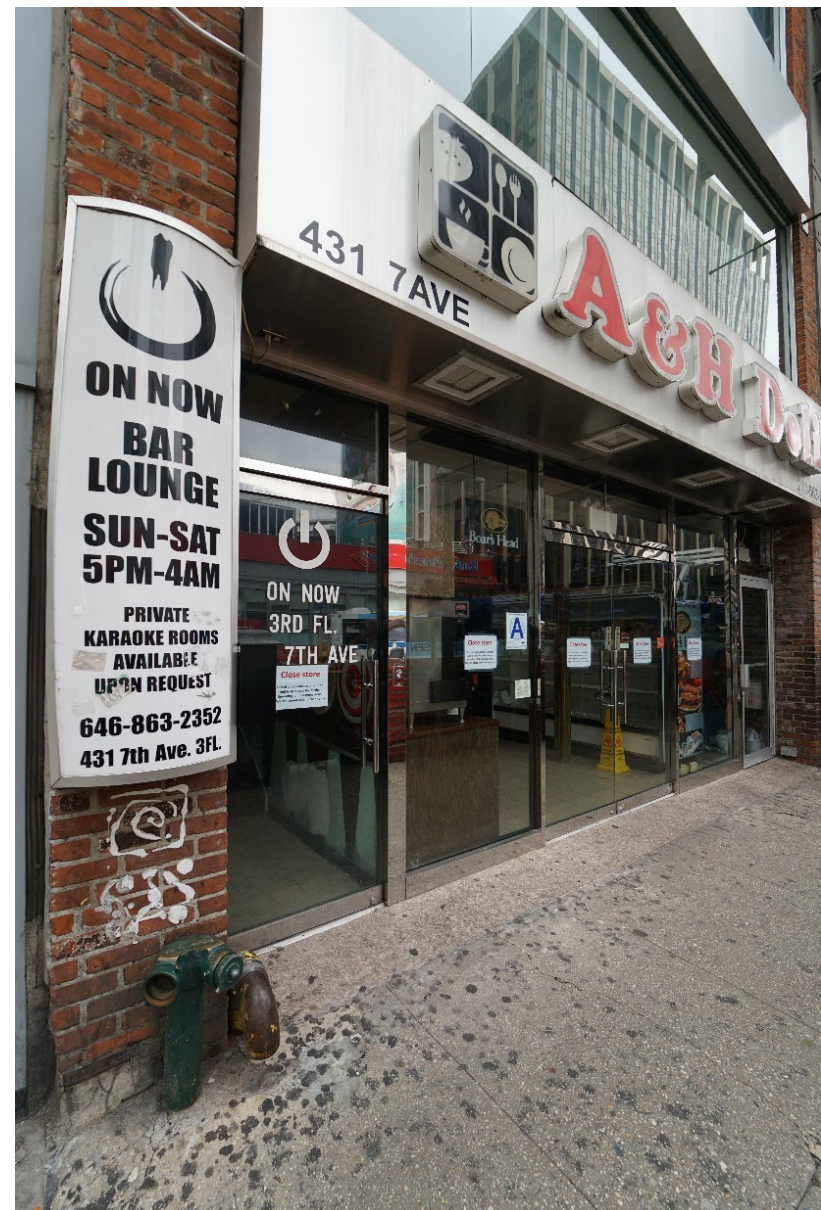
Figure 1-69 Block 809, Lot 82 Photographs

Lot 82 contains a three-story building with retail stores on the ground floor and mixed commercial and residential space on the upper floors. The façade consists of brick, metal, and glass. The exterior walls are in fair condition, showing some damage. The windows and door are intact and show no signs of damage. The sidewalk has minor cracking, staining, and debris. The building shows no barrier to ADA accessibility at its ground-floor entry. Overall, the building and site conditions were given a rating of good condition.

View facing east on 7th Avenue

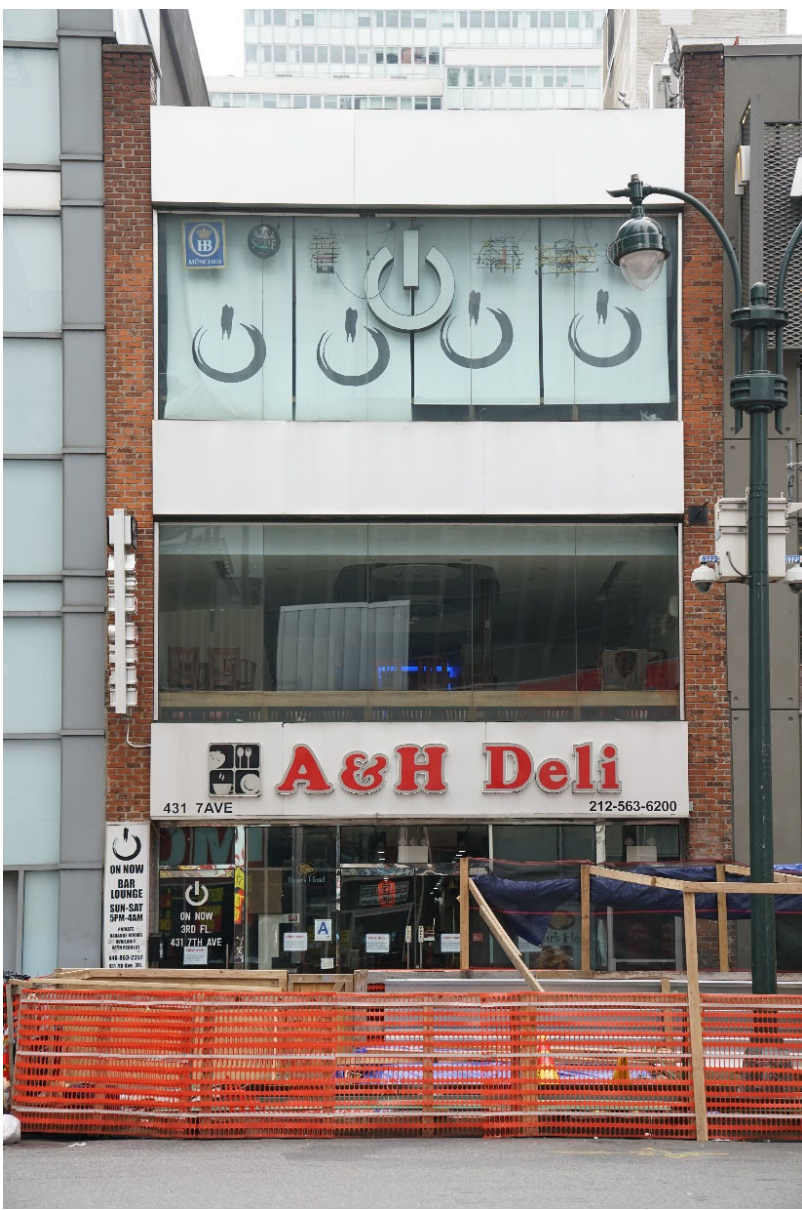
View facing east on 7th Avenue
