Design and Fabrication of Orthotropic Deck Details

FINAL REPORT
Vol. IV
February 2016

1. Report No. NJ-2016-002-4	2. Government Accession No.	3. Recipient's Catalog No.	
4. Design and Fabrication of Orthotropic Deck Details FINAL REPORT Vol. IV of VII Volumes		5. Report Date February 2016

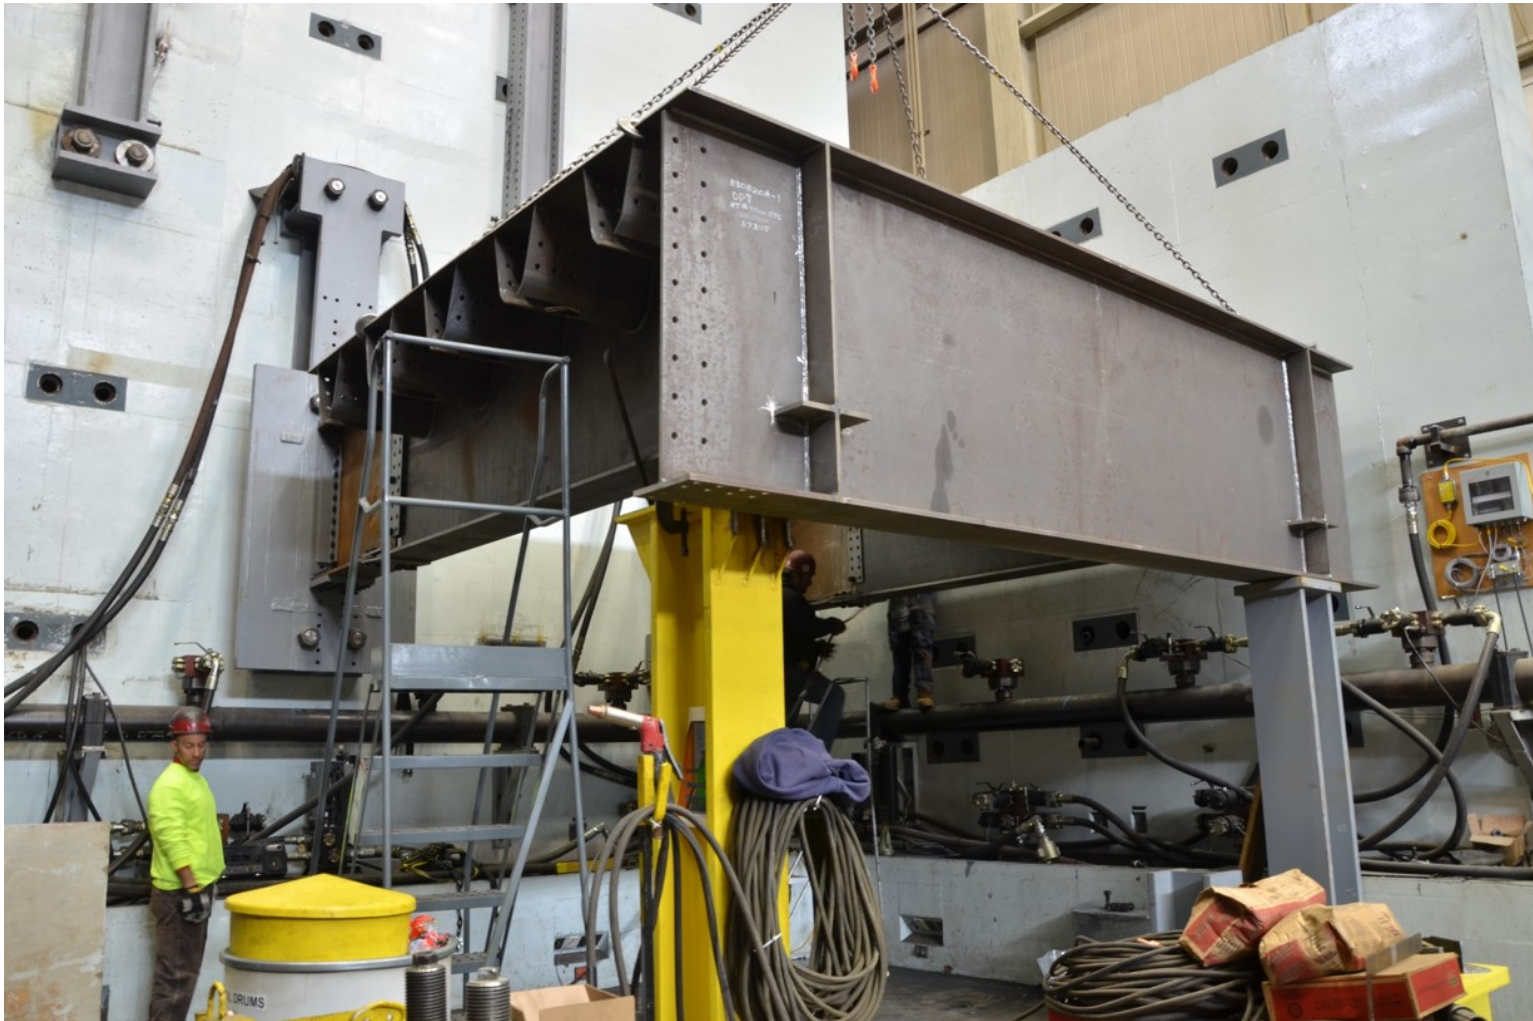
Figure 344. Installation of the east panel

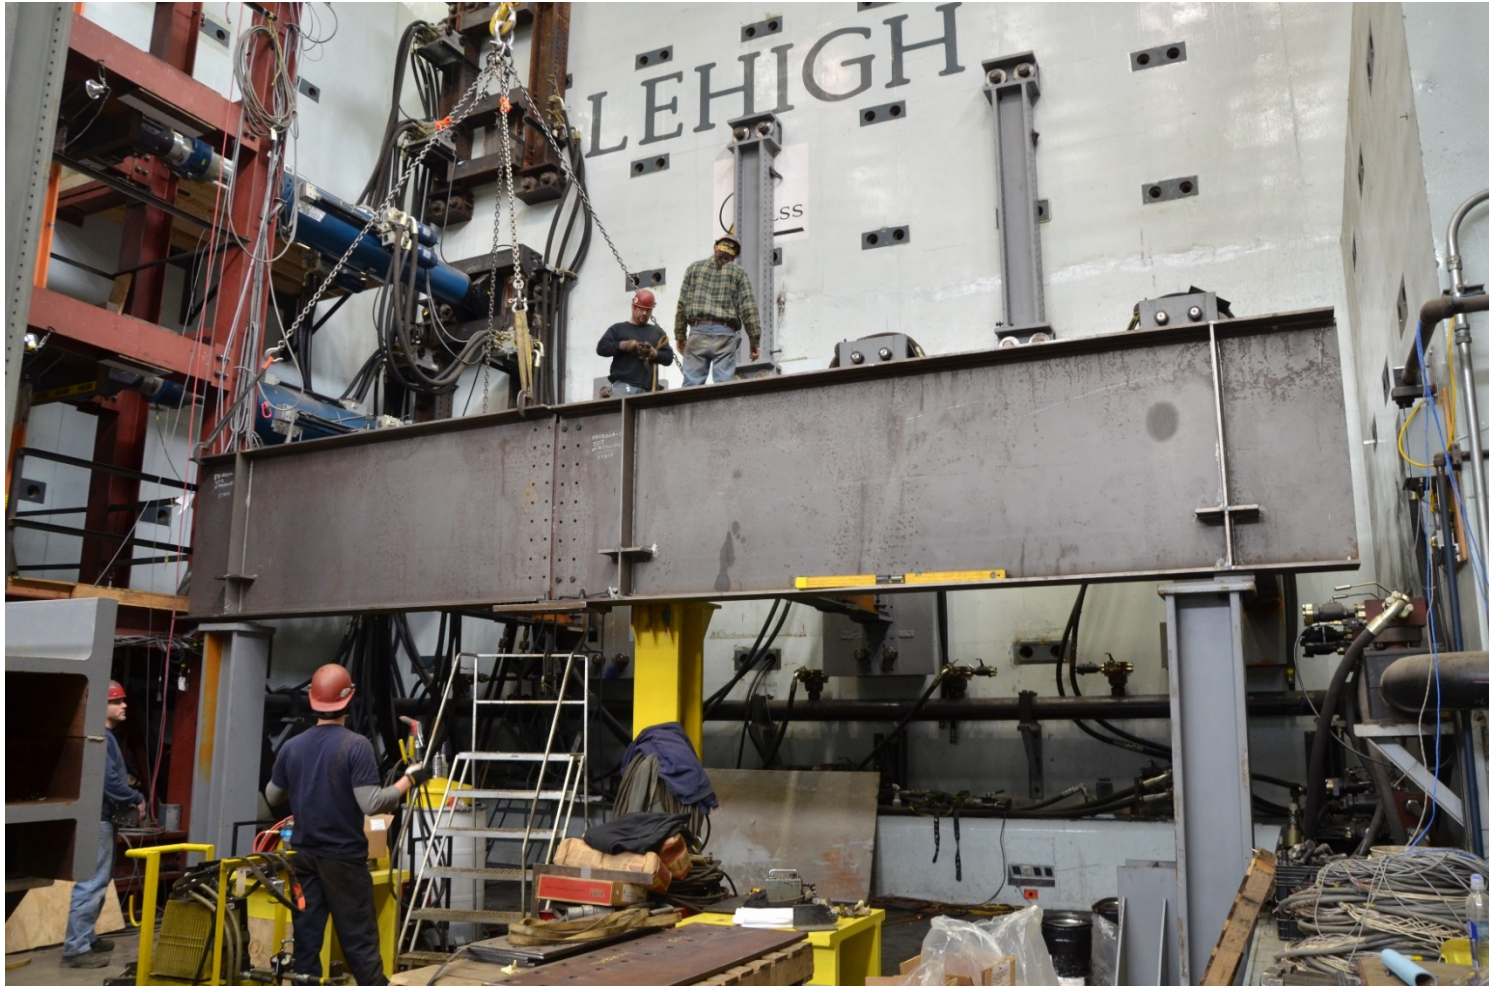
Figure 345. Installation of the west panel

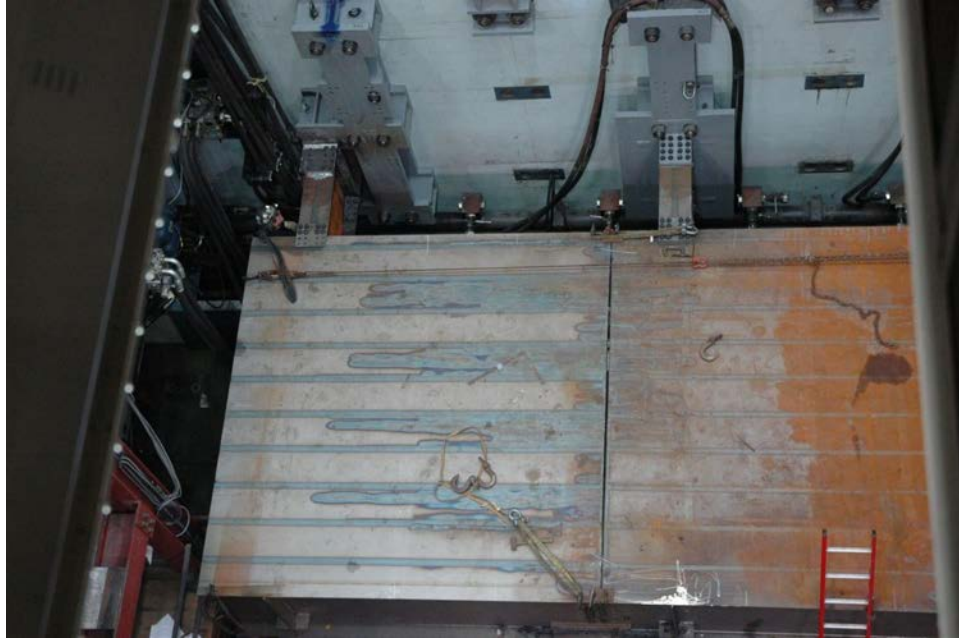
Figure 346. Heat marks on the deck after heat treatment

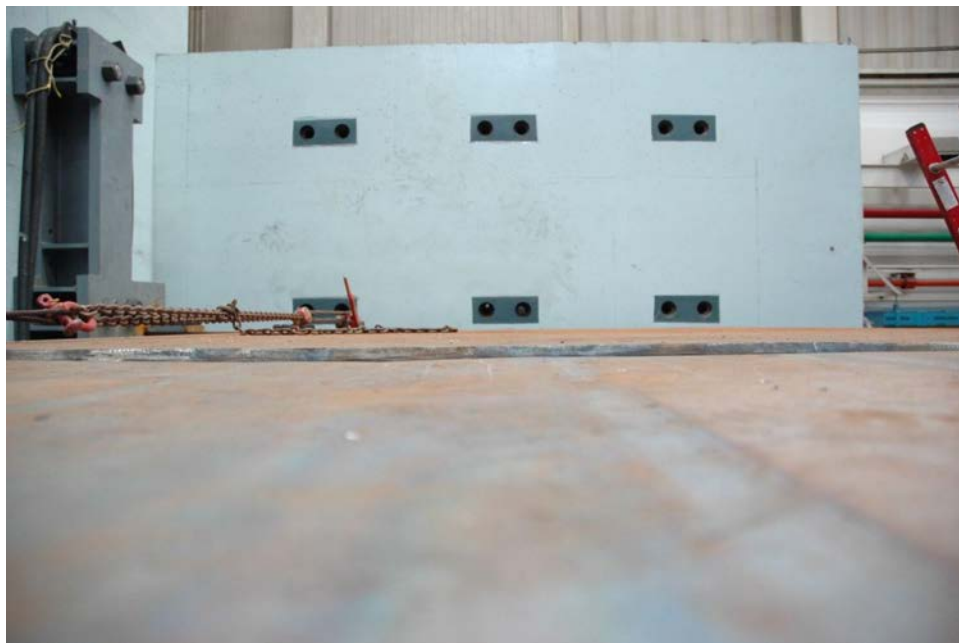
Figure 347. Elevation difference at splice location before tacking

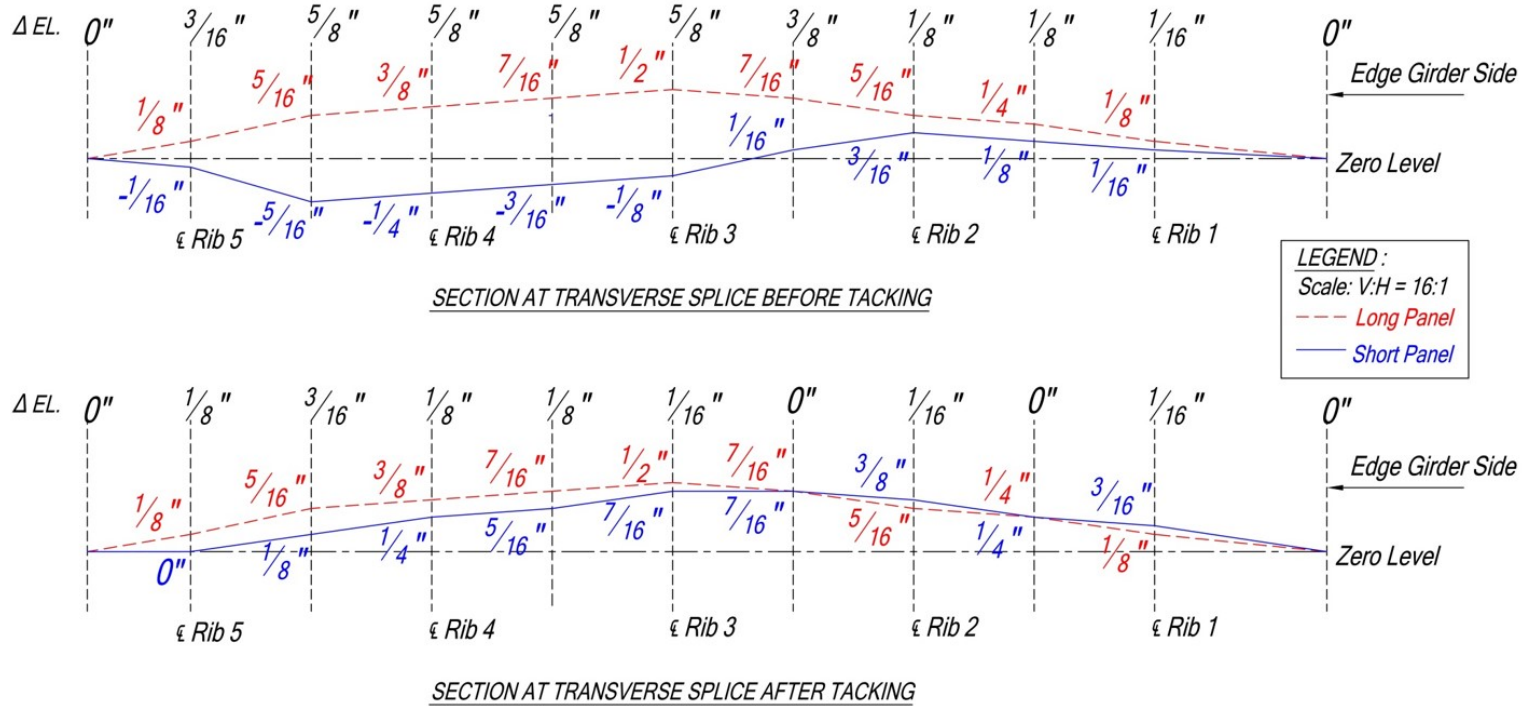
Figure 348. Comparison of elevation difference at transverse splice location before and after tacking

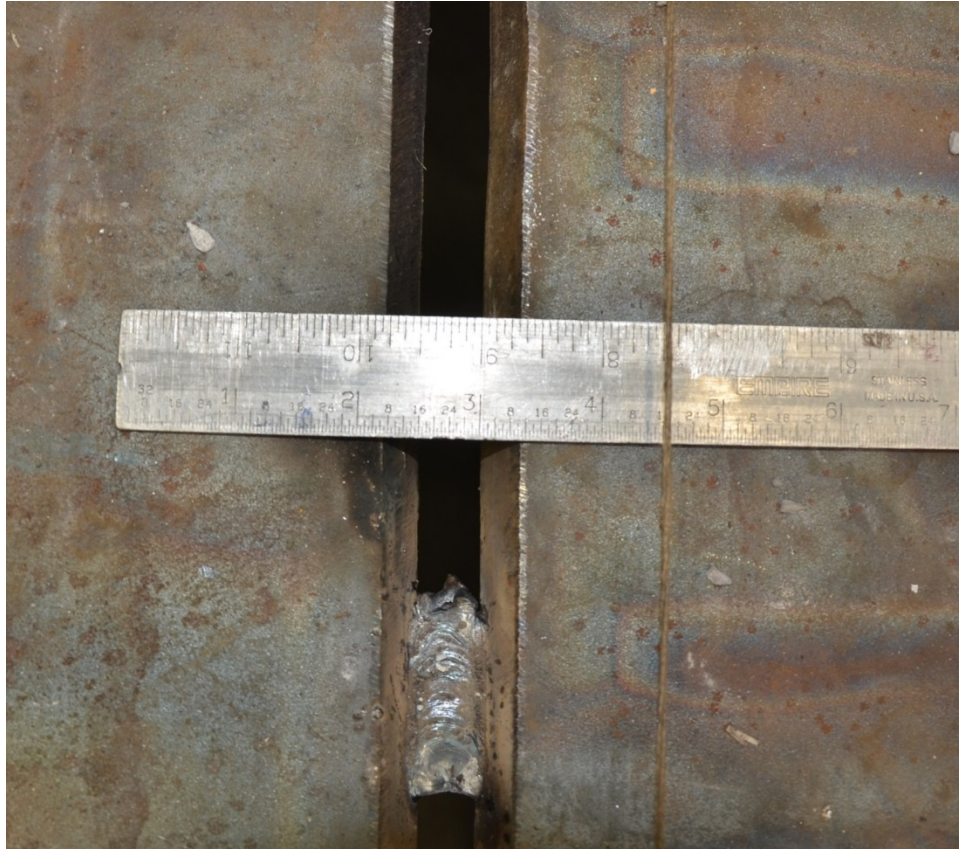
Figure 350. Maximum root gap of ½ in.

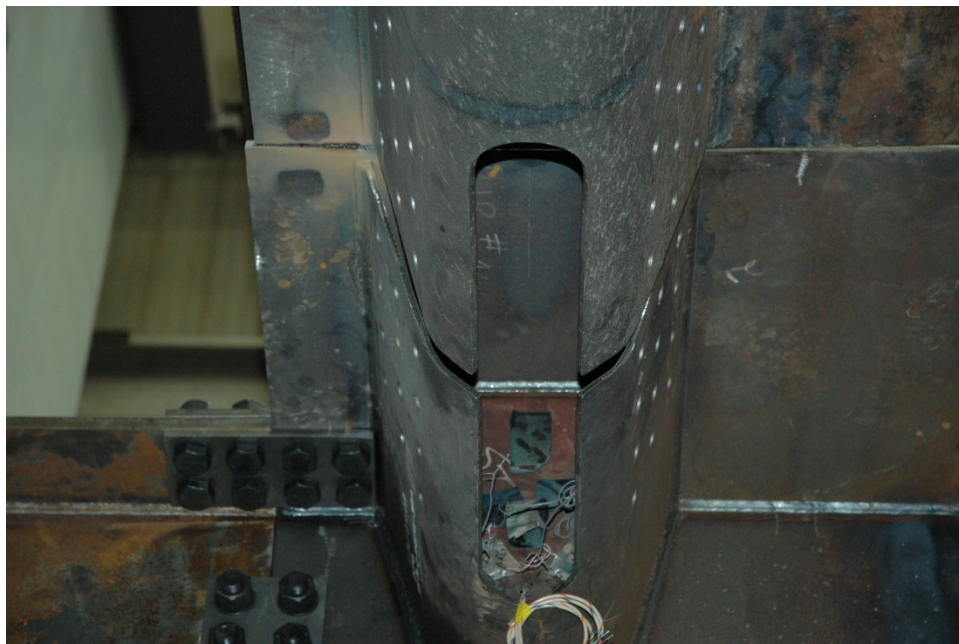
Figure 351. Lack of alignment of the ribs

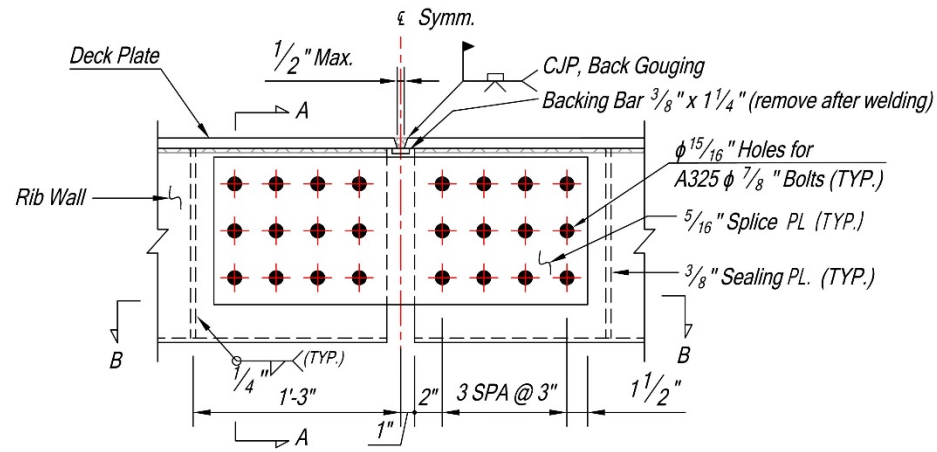
DETAILS OF TRANSVERSE SPLICE

SECTION A-A

SECTION B-B

Figure 352. Details of transverse splice

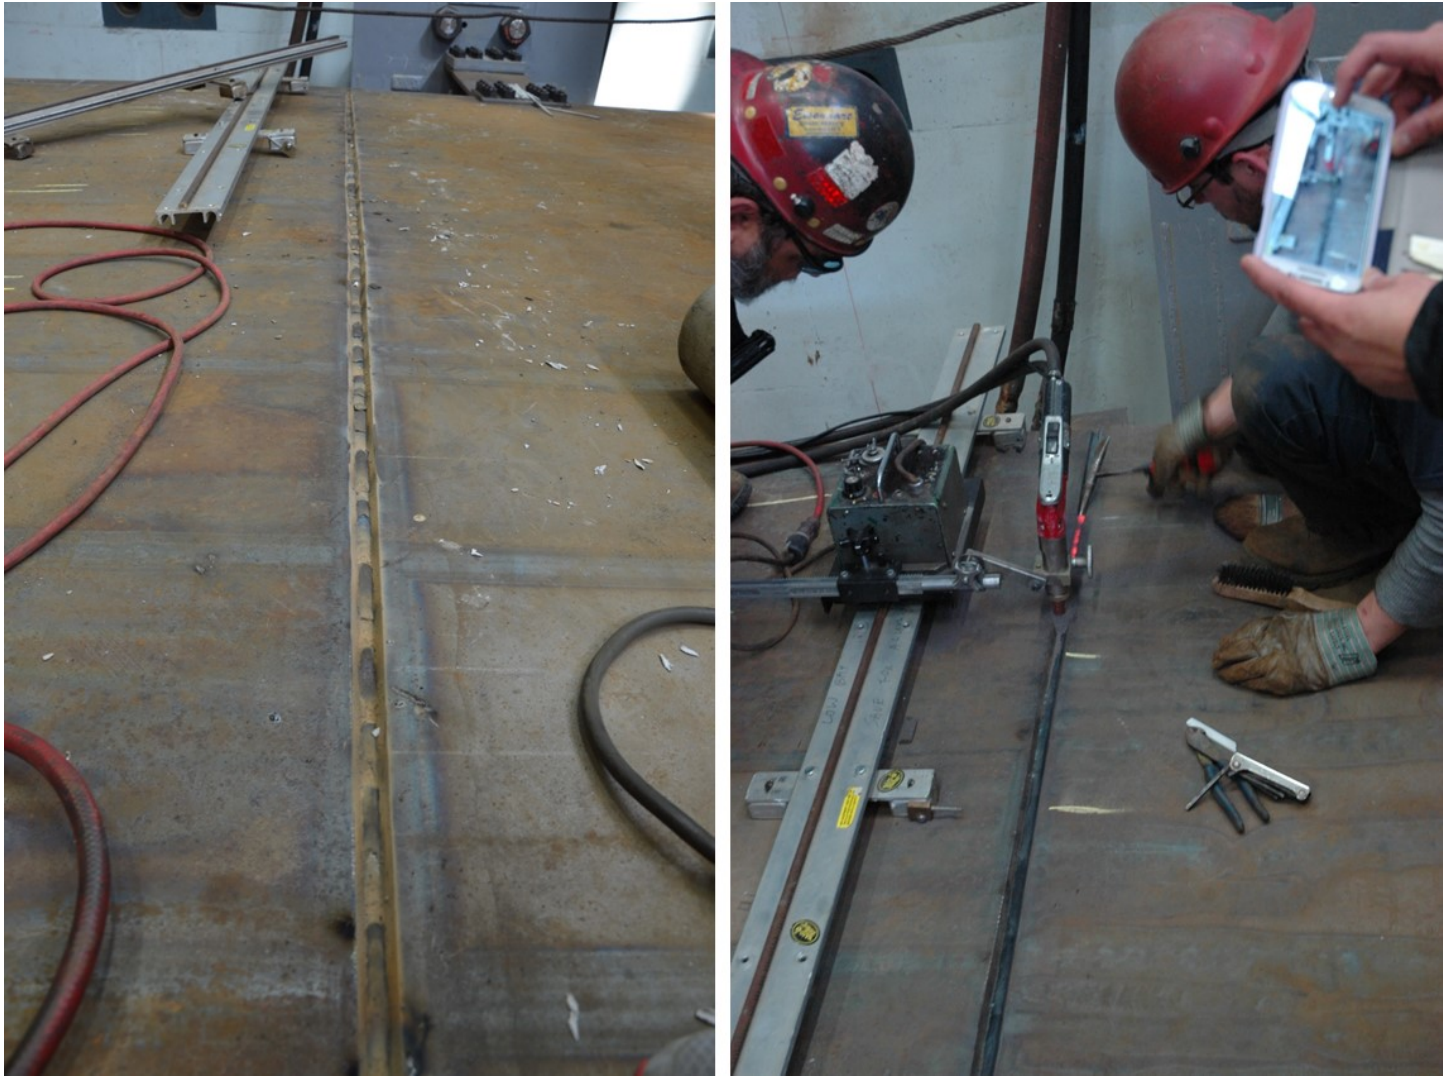
Figure 353. Root pass and fill pass for the CJP weld at the transverse deck splice at deck plate

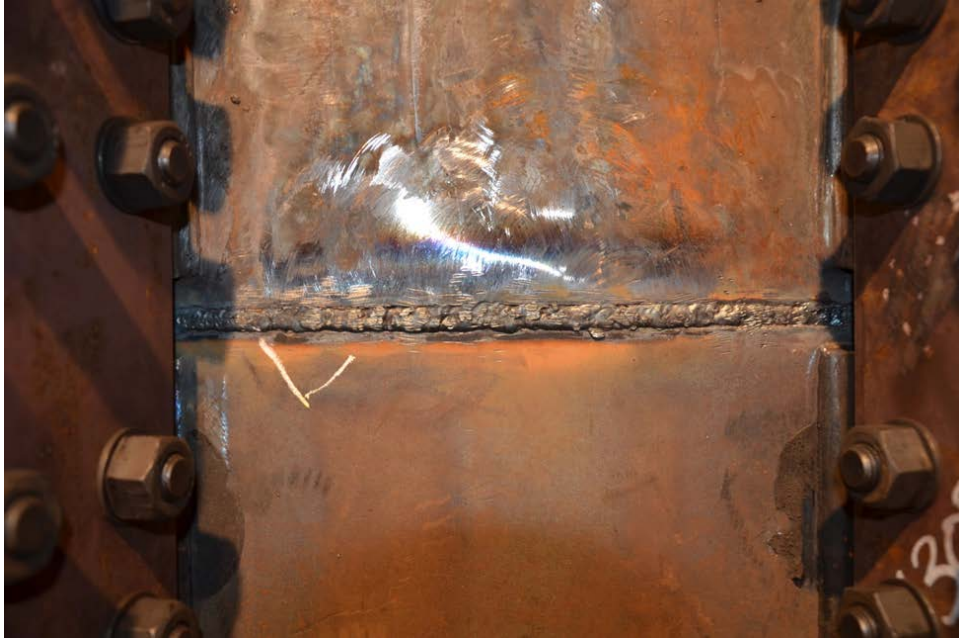
Figure 354. Weld root after removing of backing bar

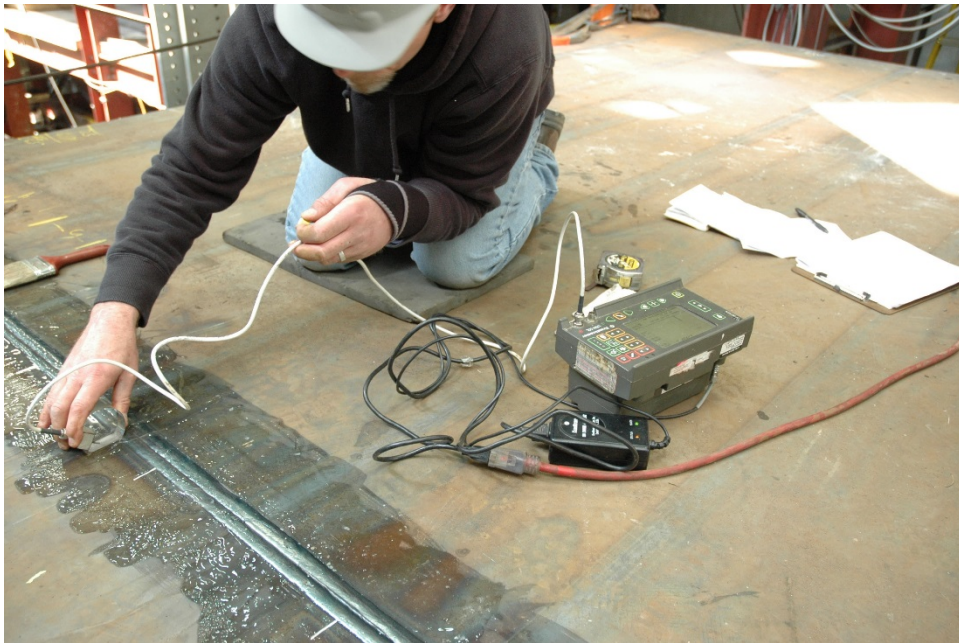
Figure 355. UT of CJP Deck Splice

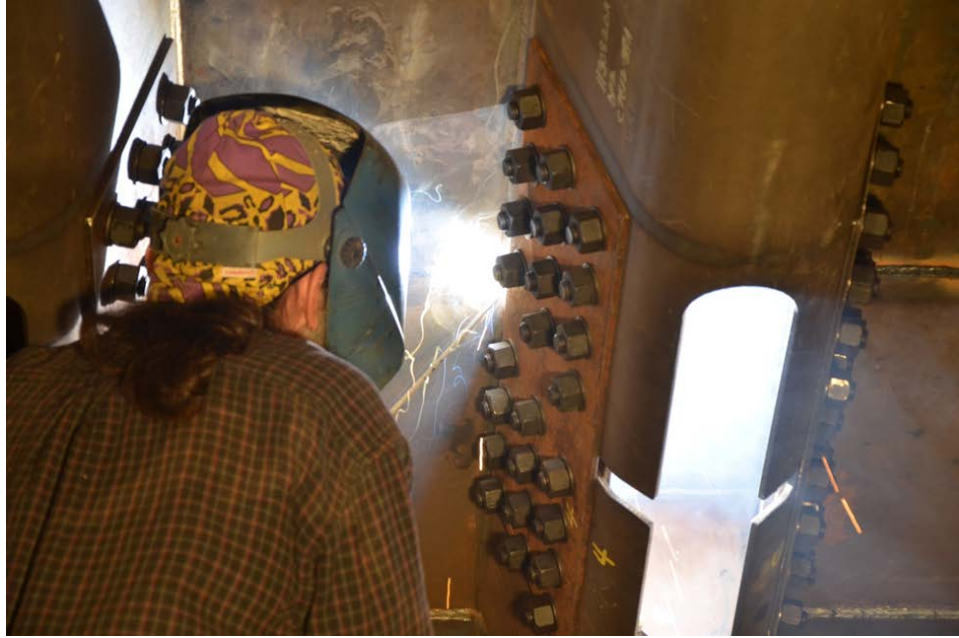
Figure 356. Back gouge and re-welding in between the ribs

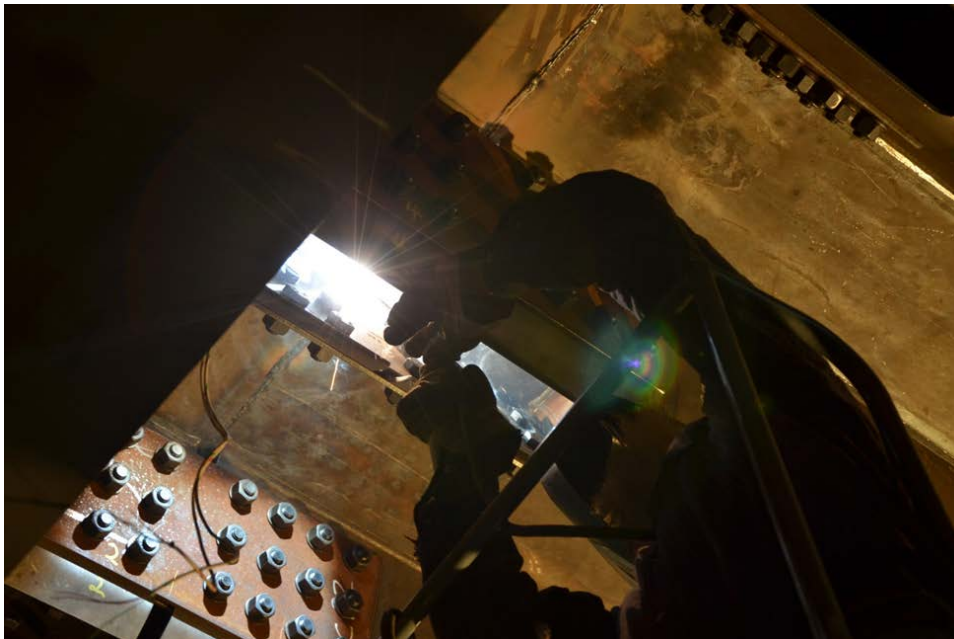
Figure 357. Extensive efforts for back gouge and re-welding inside the rib

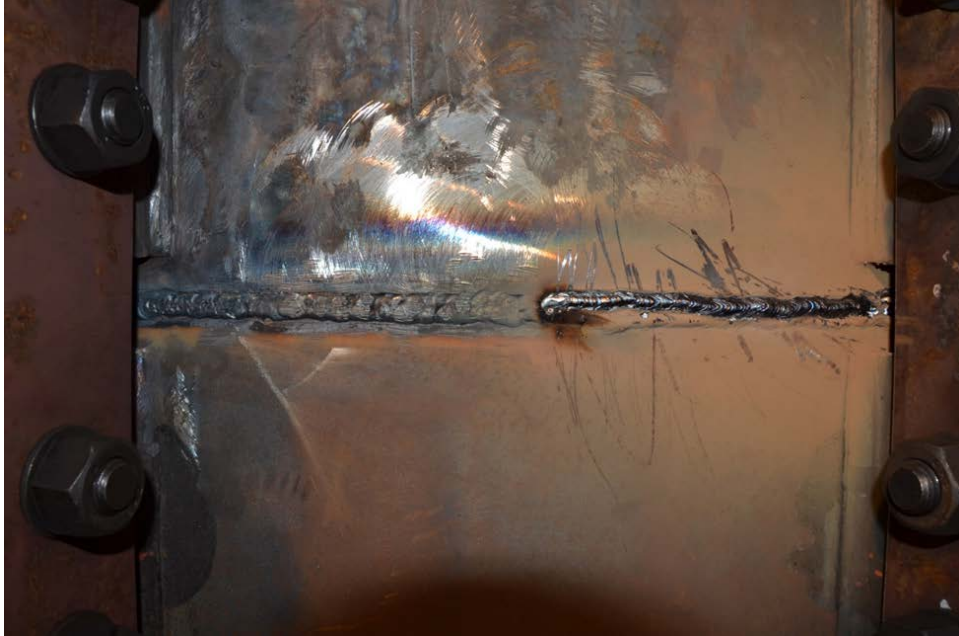
Figure 358. Weld root after re-welding

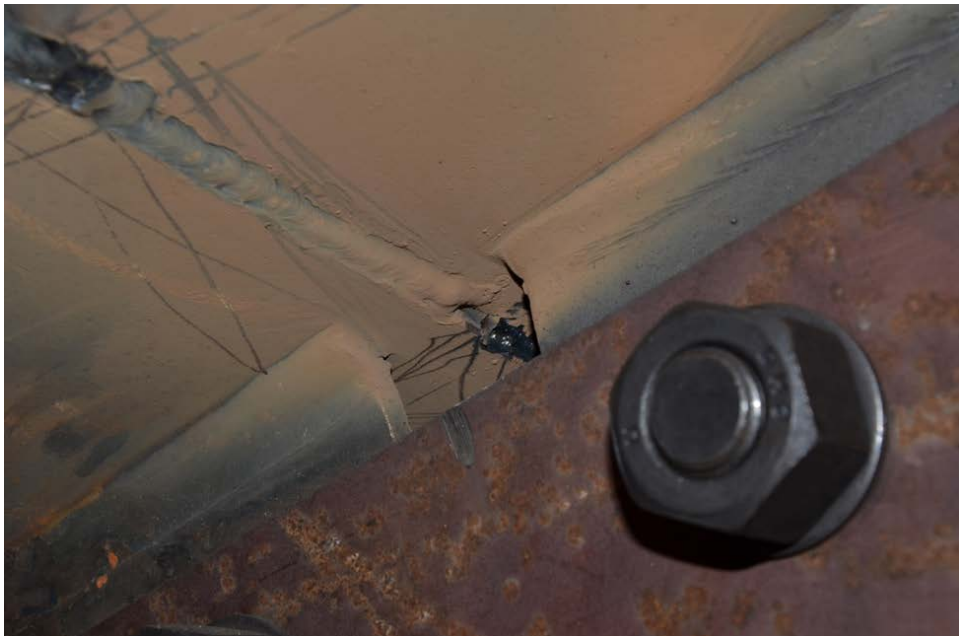
Figure 359. Lack of access over the rib wall for re-welding

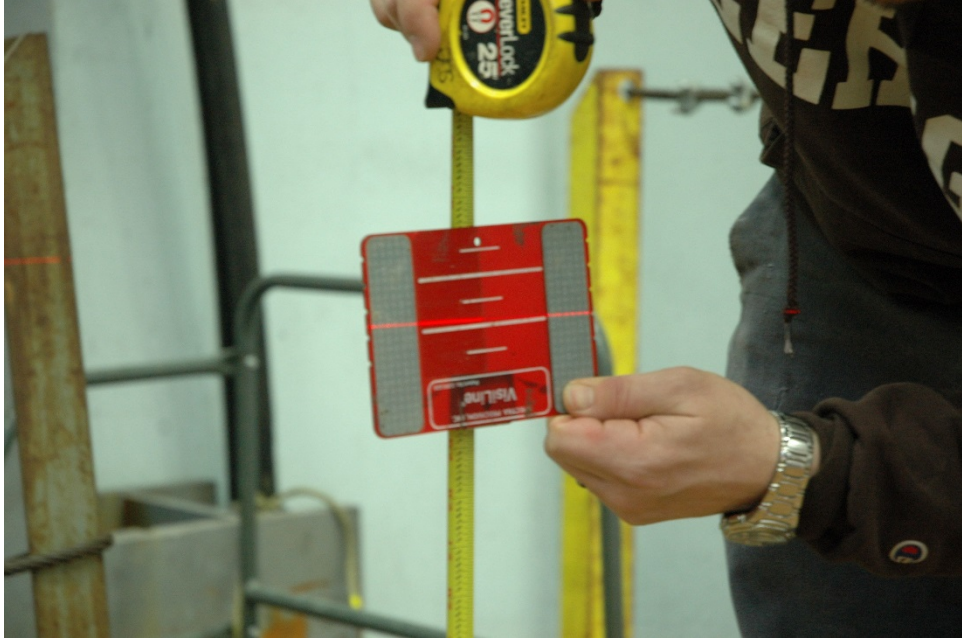
Figure 360. Deck level measurements using laser

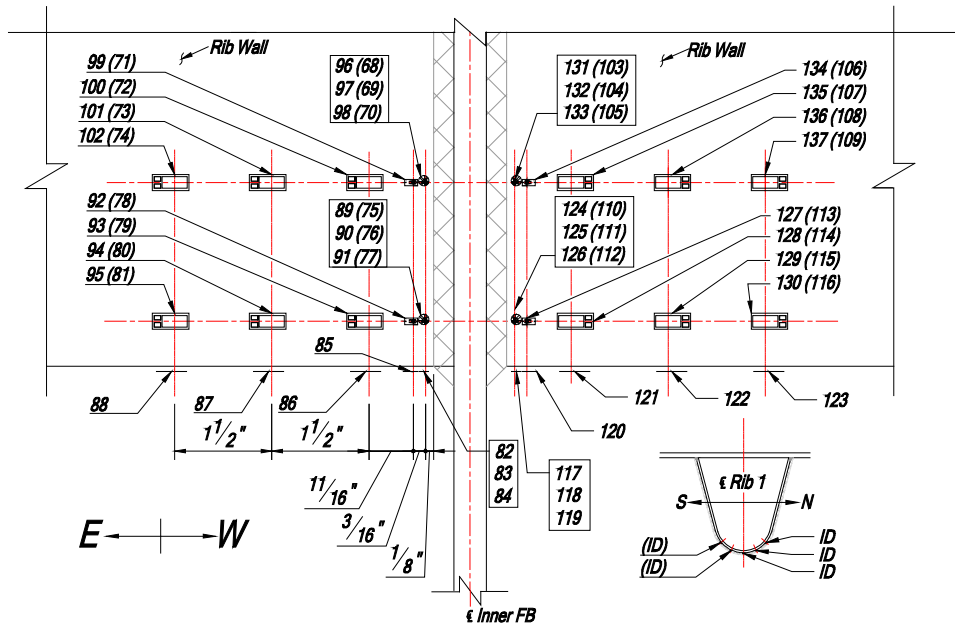
Figure 367. Gauges on north wall of Rib 1 wall at inner FB (gauges on south wall are shown in parenthesis)

3D FEA of the full bridge deck identified the rib 1-to-inner floor beam connection as the most fatigue critical. All the gauges on the Rib 1 wall at the junction with the inner floor beam were installed on the north and south walls symmetric with respect to the centerline of Rib 1, both to the east and the west sides of the rib (channels 68 to 137 in Figure 367). The figure shows the north wall of Rib 1. The channel numbers of the gages installed on the south wall of Rib 1 are shown in parenthesis. Fatigue cracking at the weld toe is primarily attributed to the crack growth from the micro discontinuities at the weld toe subject to the stress range normal to the weld toe. FEA results showed that the maximum stress in the Rib 1 wall normal to the rib-to-floor beam weld toe occurred at a section of the rib wall at about 50° from the centerline of the rib soffit. So the weld toe at 50° was identified as the potential zone for fatigue cracking and it was decided to install gages extensively at that location. Accordingly, a bondable rectangular rosette gauge of 1 mm gauge length was installed abutting the rib-to-floor beam weld toe on the rib wall at a distance of 0.4t or 1/8 in. (3.2 mm) from the weld toe, to capture the complex stress distribution at that location and to determine the magnitude and direction of principal stresses at that location. One of the arms of the rosette was aligned normal to the weld toe. Due to the presence of steep stress gradient close to the weld toe, it was needed to capture the peak localized strains to have the correct stress distribution normal to the weld toe along the 50° radial line. Accordingly, a uniaxial gauge of 1 mm gauge length was installed on the rib wall next to the rosette, at t or 5/16 in. from the weld toe measured normal to the weld toe on the rib. The uniaxial gauge was oriented normal to the weld toe. The rationale behind having gauges at 0.4 t and t was to extrapolate the stress values from these two measurements to the weld toe. In order to get the complete distribution of stress normal to weld toe along the 50° radial line, three more uniaxial gauges of 1/4 in. gauge length were installed at a distances of 1 in., 2 1/2 in. and 4 in. respectively, oriented normal to the weld toe on the rib. The stress obtained from the gauge measurements at 4 in. from the weld toe was essentially the nominal stress on the rib wall due to global longitudinal bending of the rib, free from the notch effect of the weld toe. Gages were also installed in identical pattern along the 25° radial line and also at the soffit of Rib 1. Though 50° was the location of highest stresses normal to the weld toe, weld root at 25° was identified from FEA as the location of maximum principal stress. Maximum principal stress is critical for crack growth from volumetric discontinuities as was observed from the fatigue tests of small-size mockups. However, it is not possible to measure the stress at weld root with the available technology. So, gages were installed along 25° radial lines and also at the rib soffit to capture the entire stress distribution at the weld toe near the rounding of Rib 1 wall at the junction with inner floor beam.

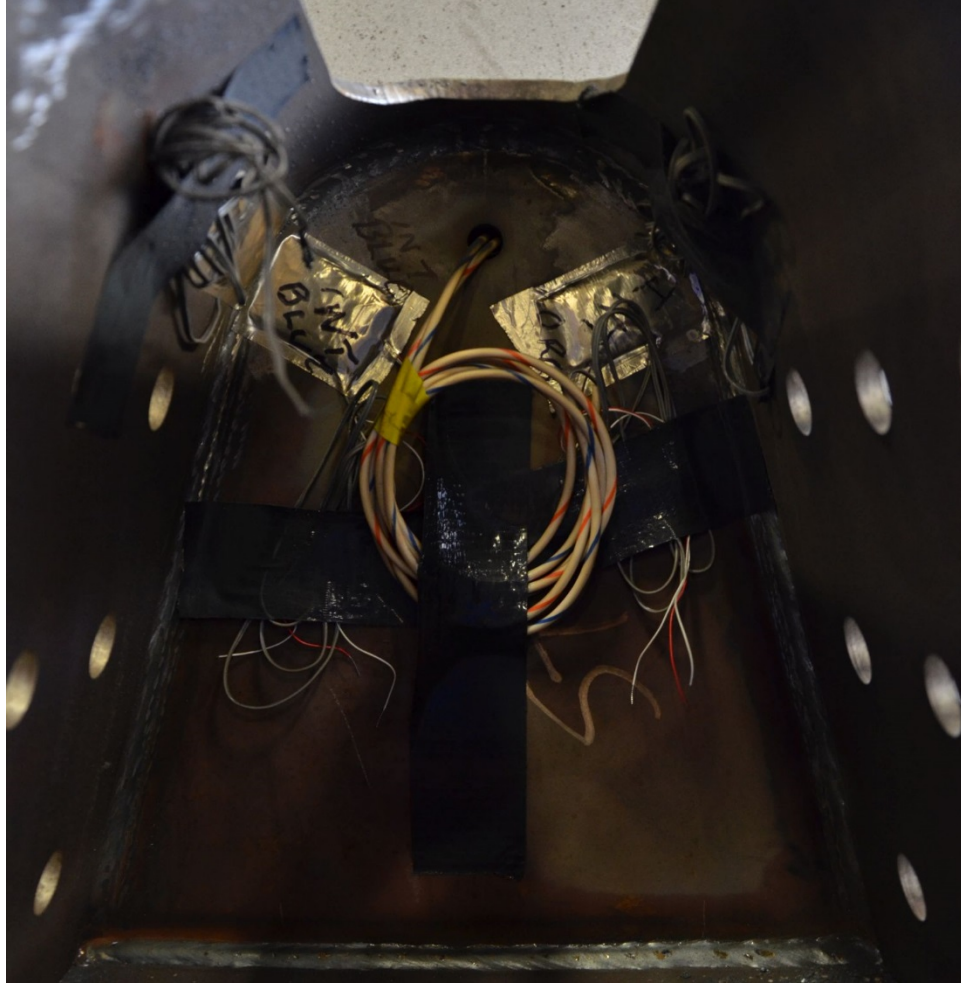
Figure 369. Installation of gauges on rib wall and sealing plate at rib-to-sealing plate connection at HIS facility

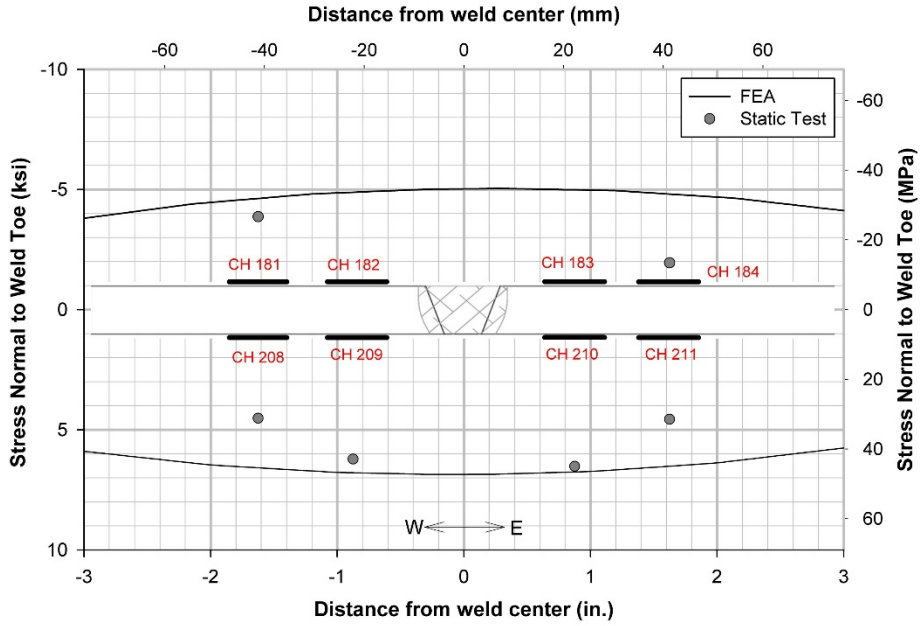
Figure 417. Stress ranges at the transverse deck splice under south-west load pads

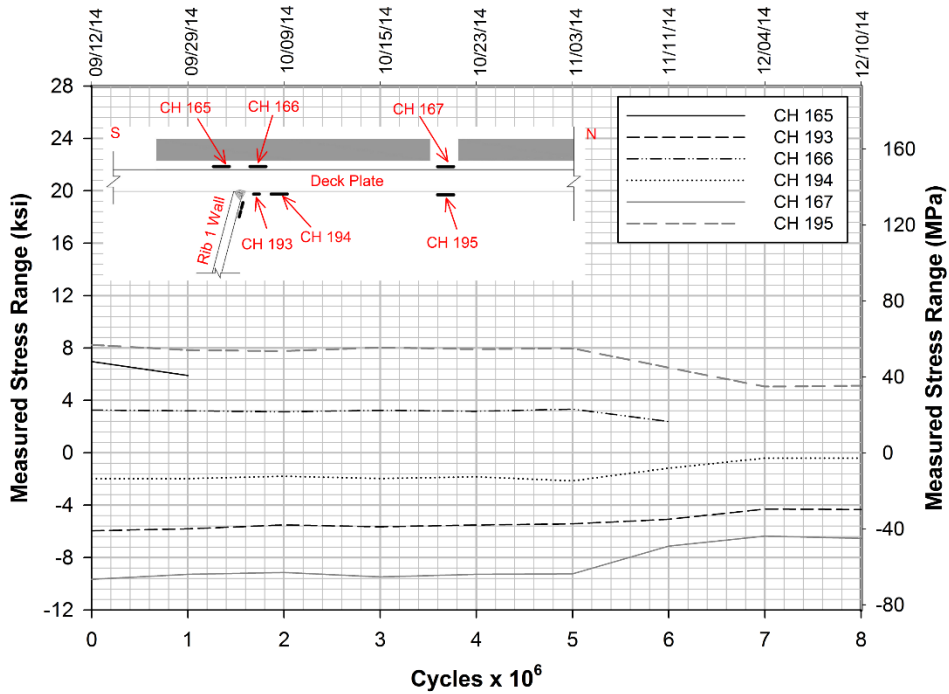
Figure 422. Changes in static test stress ranges at the deck plate gauges near Rib 1 at rib-to-deck plate connection

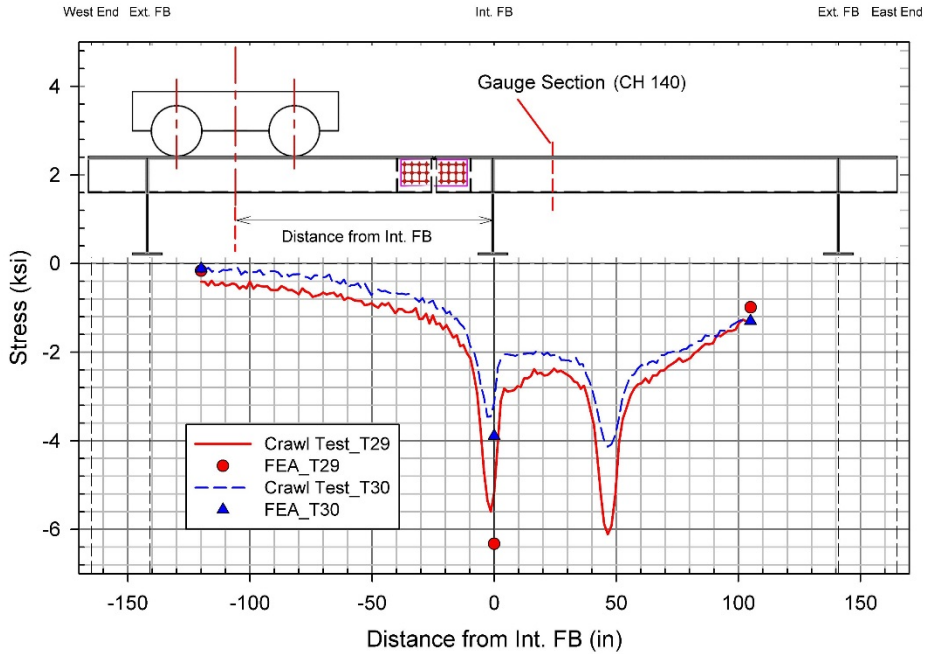
Figure 434. Transverse stress on the north wall of Rib 1 (channel 140) at section Z-Z for different crawl test positions

Figure 434 shows the normal stress measured at the gauge (channel 140) on the outer surface of Rib 1 north wall at the rib-to-deck plate connection. Figure 435 shows the normal stress measured at the gauge (channel 147) on the outer surface of Rib 2 south wall at the rib-to-deck plate connection. The stresses were insignificant until the test truck crossed the inner FB and approached the gauged section. Bimodal responses, manifesting the effects of each axle of the tandem, were noted when the axles were close to the gauged transverse section. This indicated that the transverse stresses and the deck response were highly localized under the wheel. The stresses measured from the gauges on the outer surface of the rib walls were compressive as connection underwent local out-of-plane deformation under the wheel loads. The stresses measured from the crawl tests were comparable with the FEA results. The maximum stresses occurred for transverse load position T29 when the south side wheel pair was placed centrally between the ribs causing out of plane bending of the rib-to-deck plate connections. However, for the transverse position T-30, the south side wheel moved away from the channel 140 (at north wall of Rib 1) and caused symmetric bending of rib-to-deck plate connection for Rib 2 south wall (channel 147). Consequently, stress peaks were reduced, further signifying the localized effect of wheel loads on the rib-to-deck plate connections.
