CENTER — BARRIERS

SAVE LIVES

Development of the narrow median

Safety Curb in New Jersey

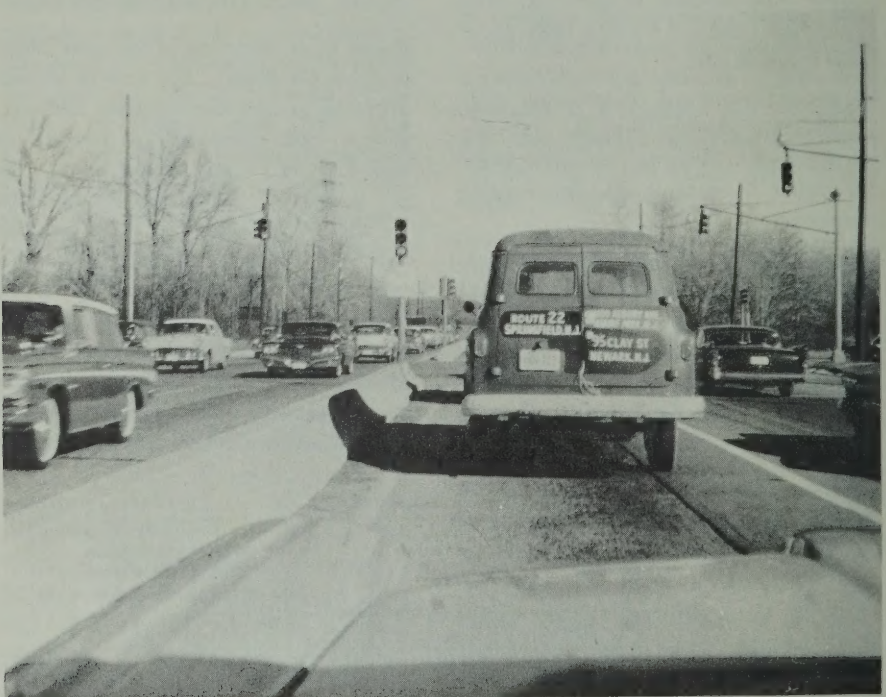
Figure 1 illustrates the design of this barrier curb. Drivers have not hesitated to ride very close to it. Figure 2 shows vehicle placement at night.

Route U. S. 22 is one of the older highways in the State. The eastern section operates at absolute capacity and carries a high percentage of trucks. It had a curbed center island about nine feet in width. This island was replaced by a 20-inch high parabolic concrete curb after the installations on Route 4 were tested. The shape of this curb, curving down and out from the top, was determined by the distance the body of a vehicle normally projects beyond the left wheels. The curb was shaped so that no part of the body of the car

would hit the curb at flat angles of impact.

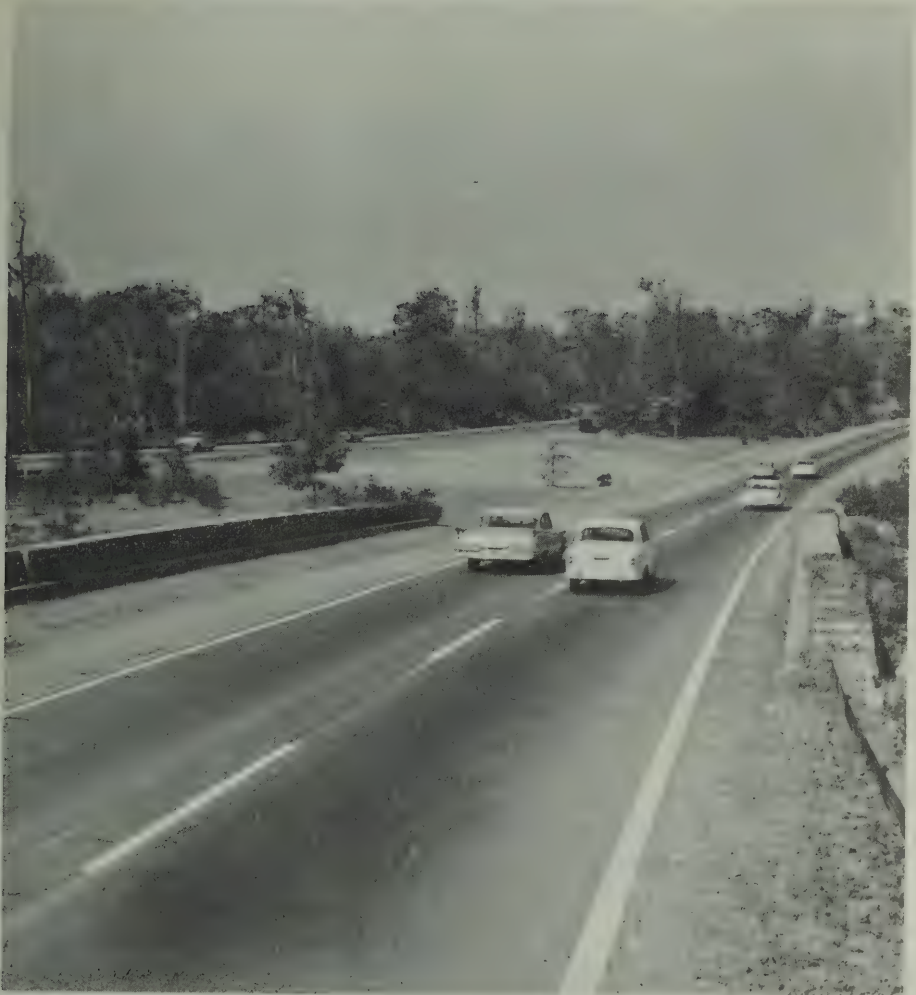
With this design, most of the benefits of a center median are lost and additional hazards are introduced. As far as operation is concerned, it can be considered as probably the worst type of narrow median.

The New Jersey State Highway Department also seeks to avoid that type of median treatment in which opposing roadways are placed at radically different elevations but close proximity to each other. A driver cannot retain control of the vehicle if it leaves the upper roadway under such conditions and a severe accident will probably result.

With the guard rail at the edge of the shoulder, there is no elbow room for emergencies. The guard rail itself is a hazard.

sents a serious hazard to traffic on the lower roadway.

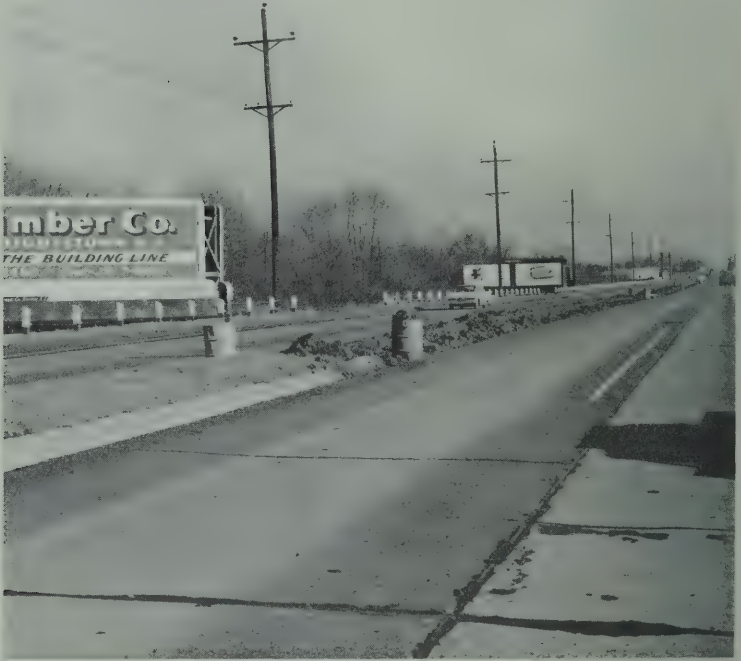
This shows a typical section early in the construction phase. The first operation involves removal of center island top soil and curbing.

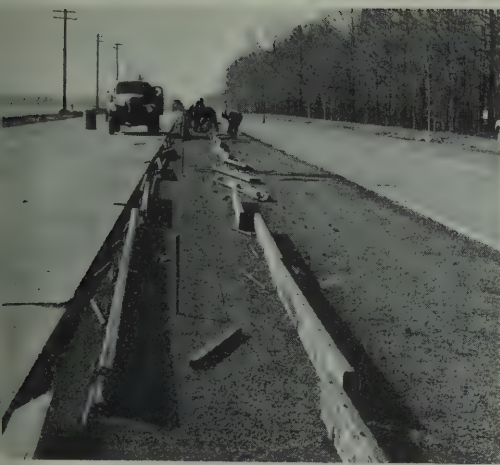
After removal of old center island is completed, subbase material is laid, over which a bituminous stabilized base and a bituminous concrete base course are placed. Workmen then position the lower rails of forms for construction of the barrier curb.

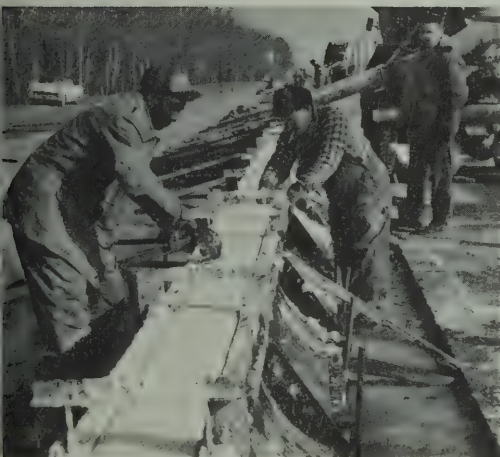
Once the white concrete has been placed, workmen finish the top surface of the barrier curb.

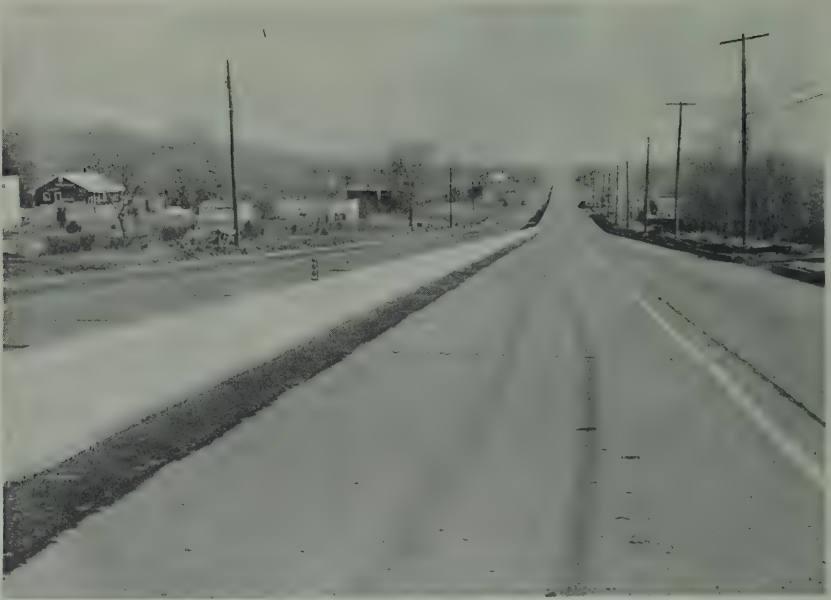
All forms being removed, the bituminous base is built up to the level of the old concrete pavement.

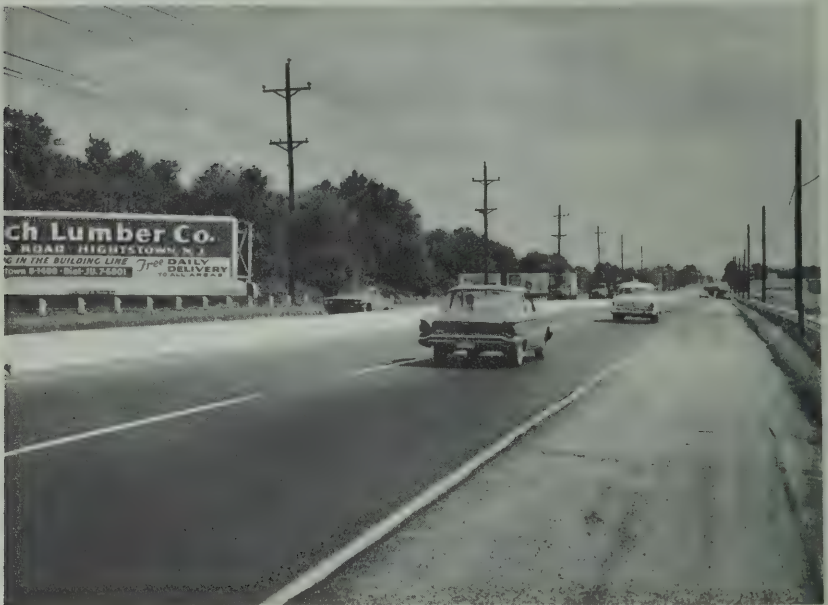
This photo shows completed highway after road has been black-topped and reflectors placed atop the barrier at 100 and 200 foot intervals depending on curvature and topography.

The type of barrier shown in the preceding photographs is 24 inches high and contains 2.93 cubic feet of concrete per lineal foot. The Department's latest 32-inch high barrier design contains 2.765 cubic feet of concrete per lineal foot, however, and costs about \$10.75 per running foot. White concrete is used to accentuate visibility.
