NJ-2018-003

**High Mast Drone Inspection**

FINAL REPORT.

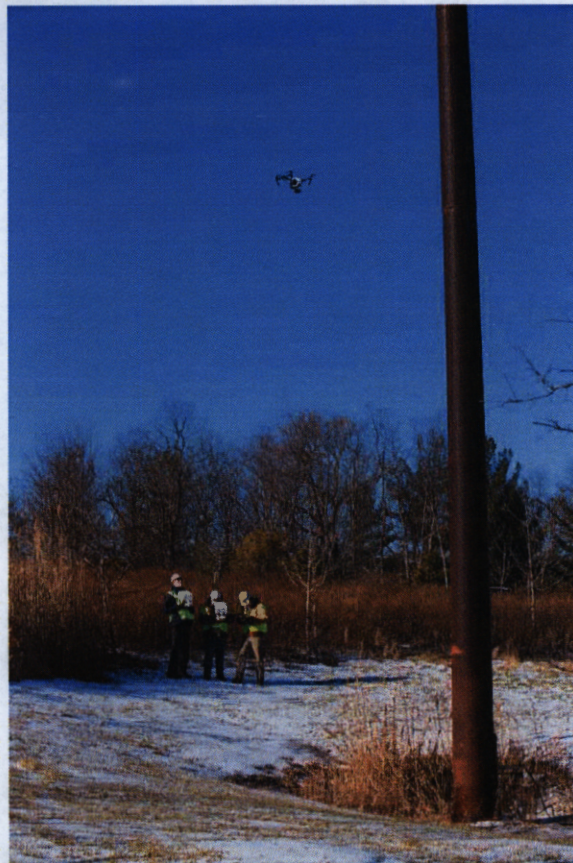
Figure 4. High Mast Light Pole Inspection Team

Using the traditional approach, the initial inspection of each high mast light pole is conducted by a pair of engineers, typically contractors working for NJDOT. The inspection of the high mast light pole covers a number of elements including:

The inspection of the light pole itself takes approximately 15-20 minutes and is conducted from the ground with binoculars and photographs of the pole are taken from the ground using a hand-held camera. The entire inspection, including all pole elements, takes approximately two hours to complete.

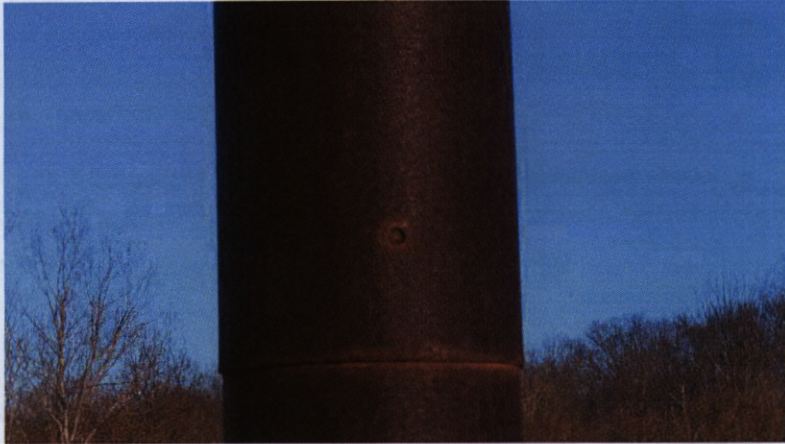
Figure 5. UAS Photograph of Potential Defect  
Source: NJDOT Aeronautics, 2016.

The UAS uses a high definition video camera during the inspection process to identify in real-time potential defects on the high mast light pole. The flight path of the UAS is consistent from pole-to-pole, reducing the variability between inspections. The UAS pilot and engineer on the ground monitor the feed and can take 20 megapixel (mp) photographs of any potential defects from close range (approximately 10 feet) during the initial inspection.<sup>11</sup> Figure 5 shows a picture taken via UAS of a potential defect. The traditional approach relies on engineers on the ground using binoculars or taking photographs from a camera with zoom during the initial inspection, or engineers in a bucket truck with a single vantage point to the pole using a hand-held camera during the secondary inspection. During both phases, the image quality is lower than available using UAS due to the need to utilize a zoom feature. While sufficient to meet inspection requirements, the higher quality data available from UAS is preferred and offers a better record to compare against future inspections.

The still images captured by the UAS also provides more redundancy during inspections as multiple people can examine the photographs in the office after the inspection. This helps control for differences in experience, eye strength, and other
