Innovative Pothole Repair Materials and Techniques Volume II: Concrete Structure

Final Report

January 2024

1. Report No. FHWA-NJ-2024-002		2. Government Accession No.		3. Recipient's Catalog No.	
4. Title and Subtitle Innovative Pothole Repair Materials and Techniques Volume II: Concrete Structure		5. Report Date January 2024		6. Performing Organization Code CAIT/Rutgers

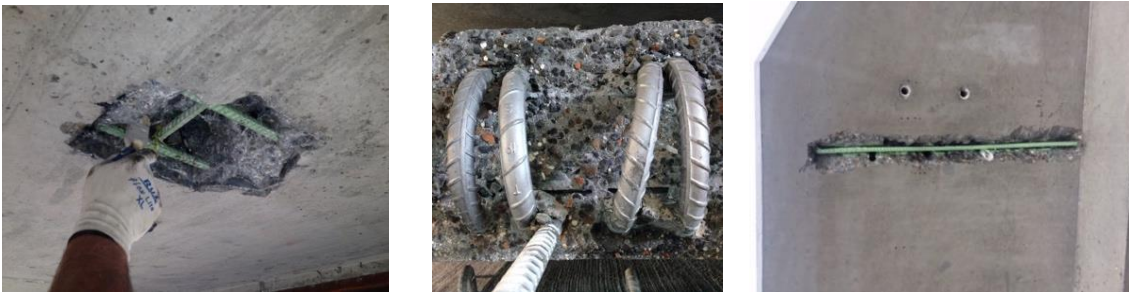
Figure 2. Overhead repair (left), vertical repair (middle), horizontal repair (right)

Typical cases for overhead, vertical, and narrow horizontal repairs are shown in Figure 2. New repair materials for overhead and vertical applications should have low flowability (stiff) so that they can be applied without the need of formwork in the field. On the other hand, for horizontal repairs (similar to the one shown on the right in Figure 2), to fill a very small size void in concrete, the material composition with very high flowability and low viscosity is needed so that the void can be fully filled. The ideal workability can be especially meaningful at the construction level.

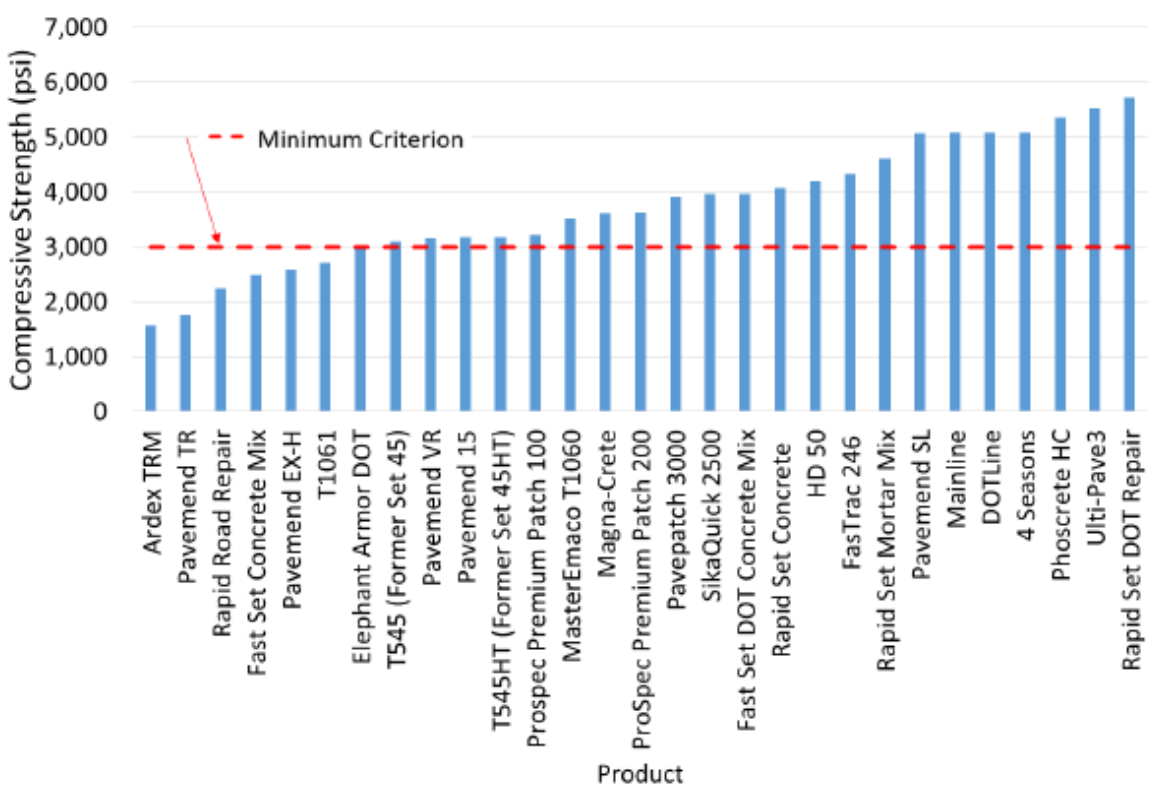
Figure 5. Summary of 3-Hr compressive strength of various products ⁽¹⁰⁾

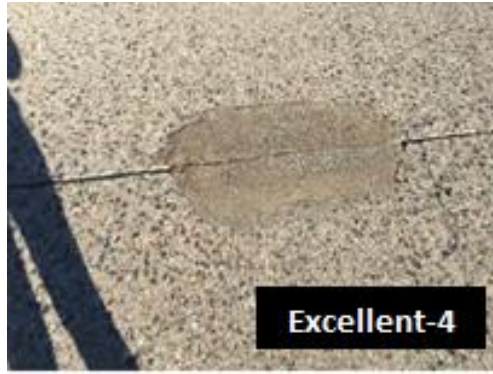
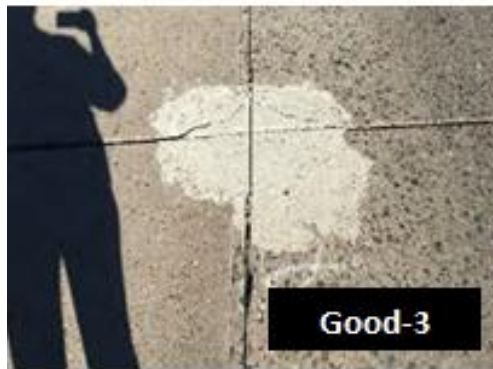
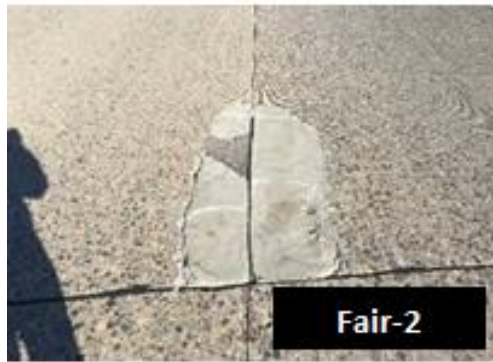
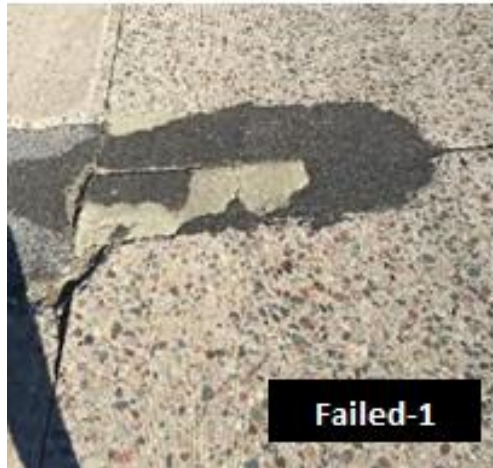
Figure 7. Photos showing condition ratings (adapted from ⁽⁷⁾)

Rating	Patch Condition Description
4	Excellent; 100% of patch is intact, only shrinkage cracks present
3	Good; distresses (cracking and debonding) exist, but 100% original patch is in place
2	Fair; less than 50% of the original patch is gone/ been replaced
1	Poor; over 50%of the original patch is gone/been replaced
0	Failed; Original Patch no longer exists

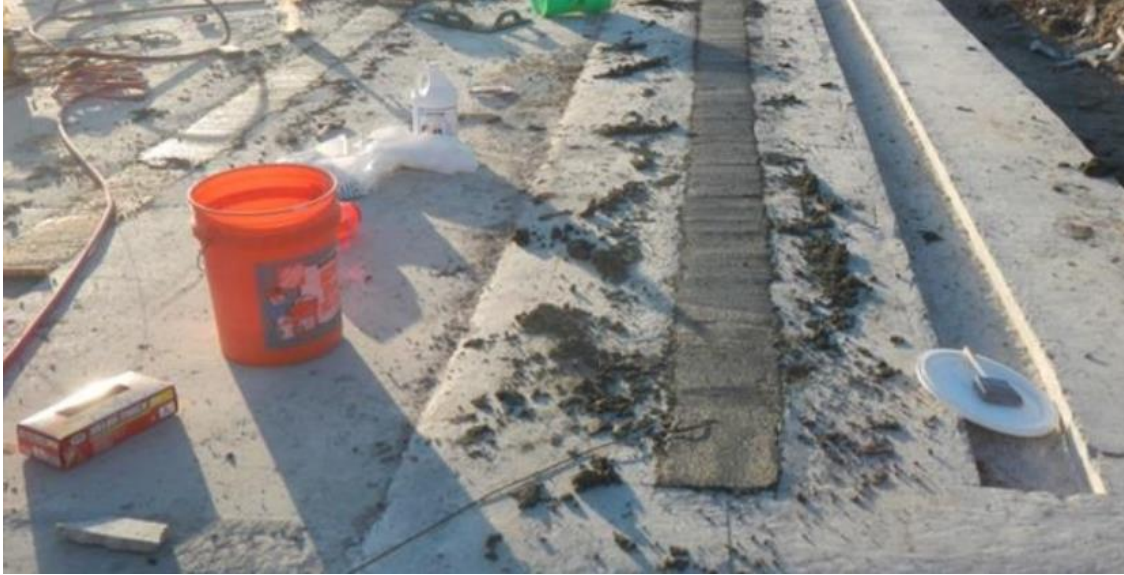
Figure 8. Field test slab with long rectangular defects being repaired similar to partial depth ⁽¹³⁾

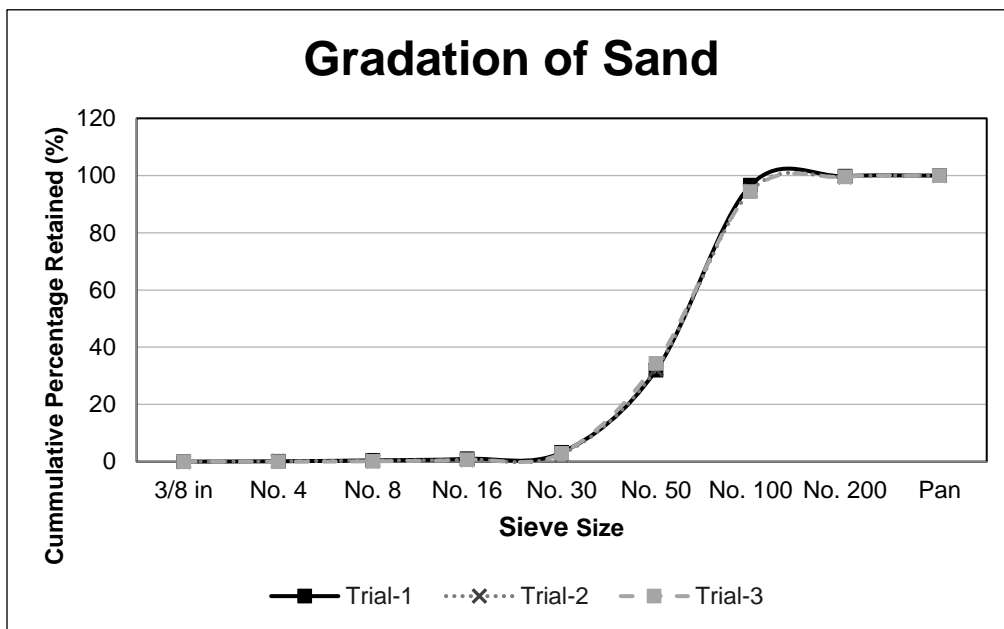
Figure 11. Gradation of sand used in the repair mix formulations

Sand was added in the mix formulations to increase the yield of the mix and to reduce the shrinkage. All the formulations contained oven dried sand to avoid interference of the sand moisture with w/c ratio of the formulations. Figure 11 shows the gradation of the sand utilized in the experiments. It should be noted that commercially available processed sand having majority of particles between the sieve sizes of No. 30 and No. 100 was chosen to avoid compromising the workability with the presence of finer particles. The dosage of sand used in the repair formulations was 15 percent by weight of cement-water paste.

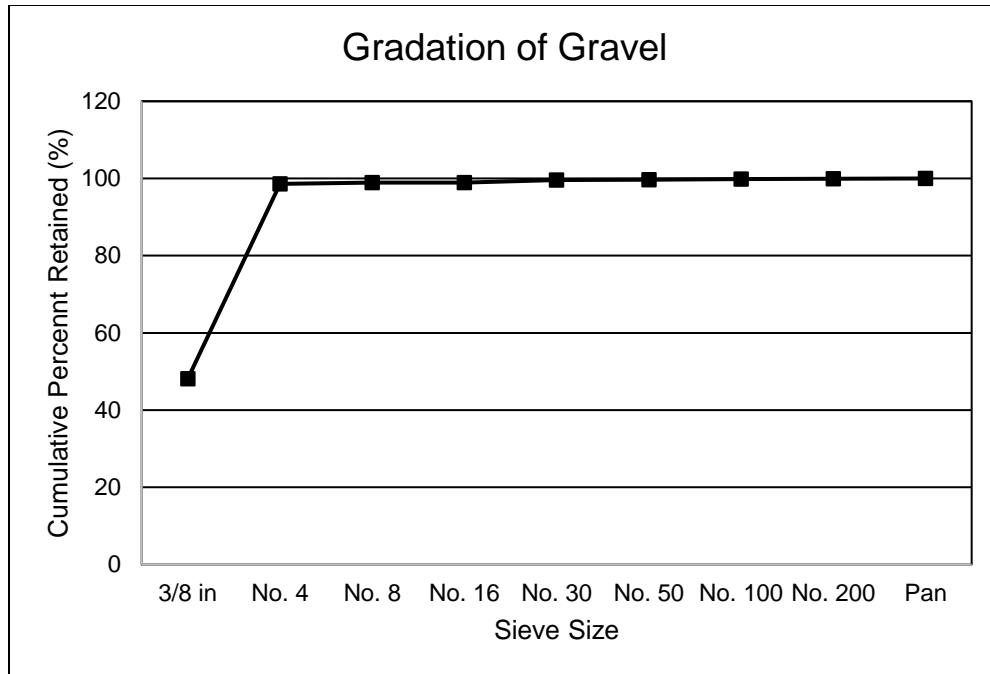
Figure 12. Gradation of gravel used in repair mix formulations

Gravel was also considered necessary to extend the mix formulations for larger volume. In addition, pea gravel is well known for its natural internal curing effect through which it can retain moisture during the fresh state and release it later in the hardened state. (28) This helps in reducing the shrinkage of the repair formulations. Figure 12 shows the gradation of the gravel used in the repair mixes. The nominal maximum size of the pea gravel particles used was less than 0.735 in and more than 0.187 in.

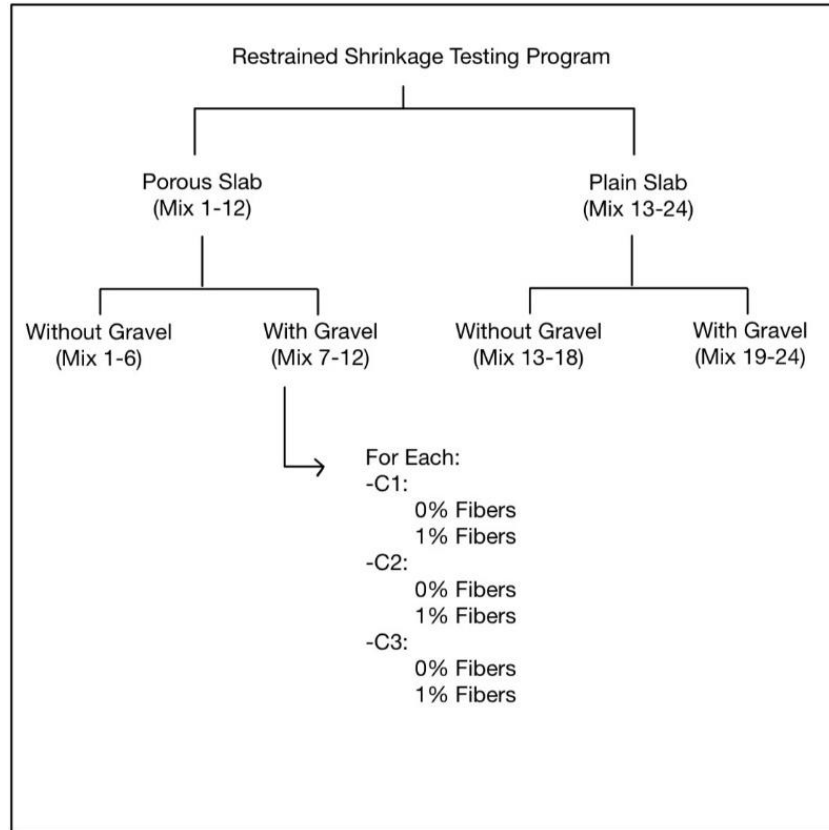
Figure 13. Restrained shrinkage testing program

The RS samples were first cast over the porous concrete slab surface using mix formulation no. 1-12. The same mix formulations were then replicated on the plain mortar slabs to compare the development of cracks over each slab surface. Hence, formulation no. 1 to 12 were used to cast RS samples over porous concrete slab surfaces. Whereas the formulations 13 to 24 were repetitions on plain mortar slab surfaces. The strength samples cast from mix formulations 1-12 were tested at 24 hours whereas the ones cast from mix formulation no. 13-24 were tested at 3 hours. Figure 13 shows an overview of the restrained shrinkage testing program.

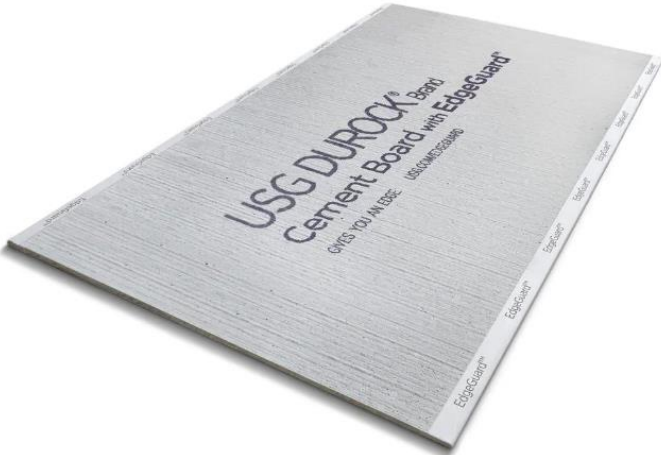
Figure 14. Plain mortar slab (31)

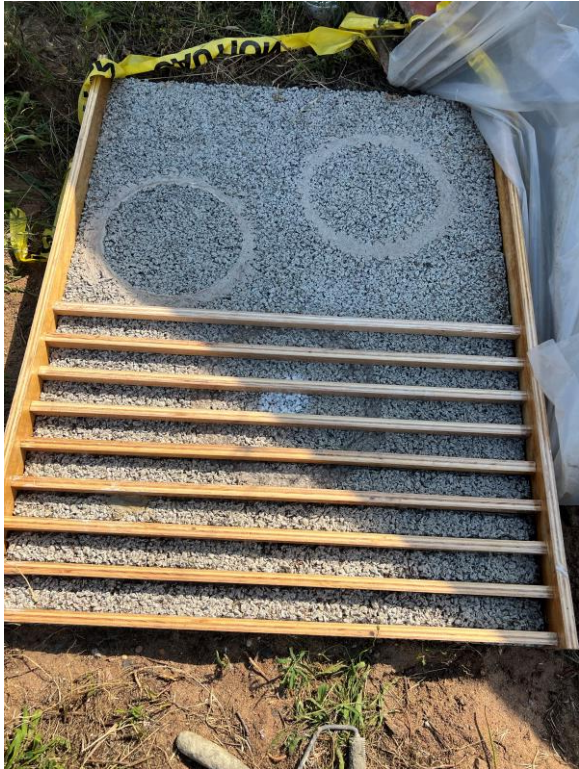
Figure 15. Formwork for porous slab

movement of samples along the edges in longitudinal direction. Additionally, the inside bottom edge of formwork was sealed with a typical silicone-sealant to ensure no leakage of fresh material. Figure 14 shows the plain mortar slabs used. (31) Figure 15 and Figure 16 shows the form work for the two slabs before the beams were cast.

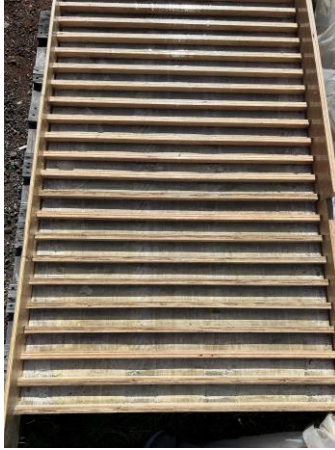
Figure 16. Formwork for Plain Slab

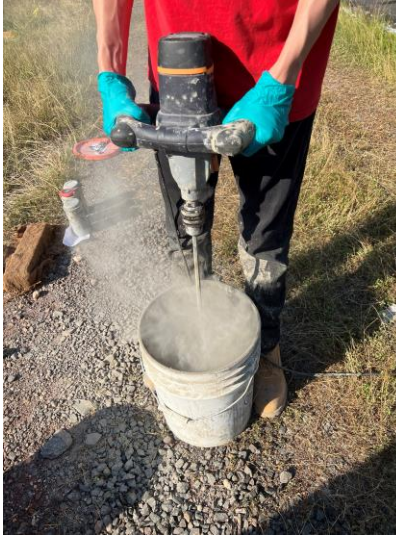
Figure 17. Dry mixing

The beam and cylinder samples for strength testing were also cast in similar fashion as RS samples, except that for cylinders, the sides were tapped according to ASTM C192 to close the voids after vibration. ⁽³²⁾ Figure 17 and Figure 18 shows the dry mixing and vibration process being carried out for a typical mix.

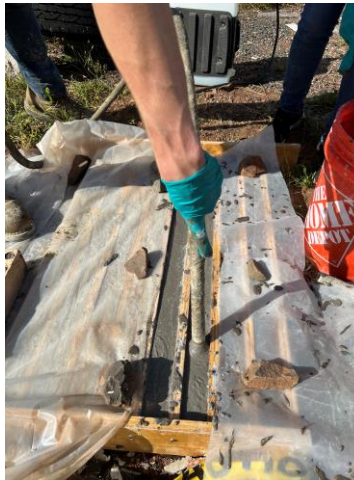
Figure 18. Vibrating the layers of concrete

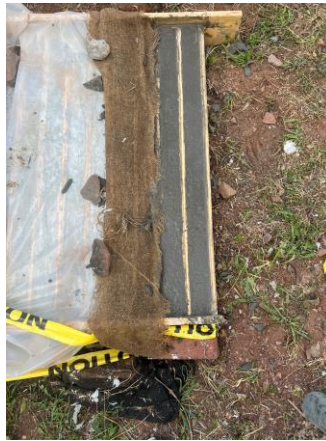
Figure 19. RS samples curing with burlap

The samples were covered with saturated wet burlap approximately 30 minutes after casting when they were visibly losing plasticity. More water was sprinkled over the wet burlaps after the samples were covered. The burlap was sprinkled with water again after 15-20 minutes of placing wet burlap over the samples. However, it was not sprinkled further and repeatedly for the next 24 hours to simulate the real conditions. It should be noted that the burlap stayed wet naturally for 2-3 hours, after which repair can be expected to open to traffic in a real application. Figure 19 and Figure 20 shows the curing of typical samples using burlaps. The burlap was covered with a plastic sheet to prevent evaporation of water.

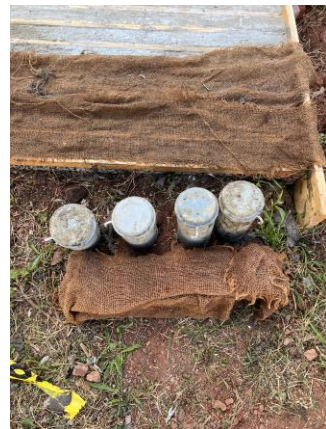
Figure 20. RS flexural and compressive samples curing with burlap

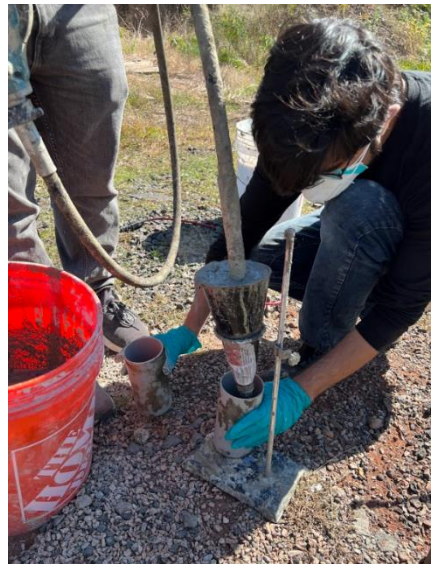
Figure 21. Inverted slump test

stand about 1 to 1.5-ft above the ground. The height of the cone above the ground is not a concern since the time was measured only to empty the cone and not to measure the time it took the mix to fall on ground, see Figure 21. Next, one of the two operators would lock the bottom 1-inch opening of the cone and the second operator would pour the mix from the top 4.5-inch opening to fill up the cone completely. Once filled up, a battery-driven needle vibrator would be inserted from top, and the first operator would let the bottom open at the same time. The time would be measured from the start of vibration (or opening of the bottom hole) until the entire cone gets empty. If the mix is having a thick consistency, it will take more time to empty the cone and vice versa. However, in some cases, the mix would be very thick, and a small chunk of the repair material would get stuck at the bottom. In such cases, comments were made during the slump test. While the needle vibrator was moved vertically during the slump test, it was not used to force any such chunk stuck at the bottom opening. Slump test was not performed for samples with gravel due to the aggregate getting stuck in the cone when slump test would not be valid for a highly fluid mix since in such a case, cone would empty within a few seconds. Being emptied.

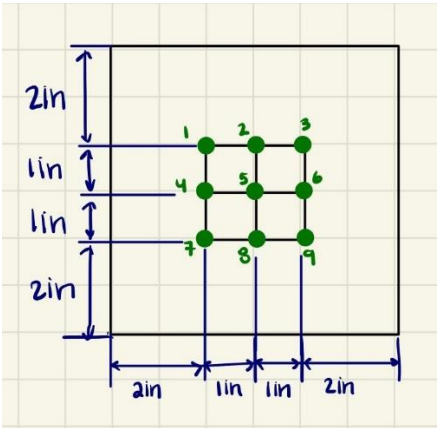
Figure 24. Schematic of the hit locations for the hammer

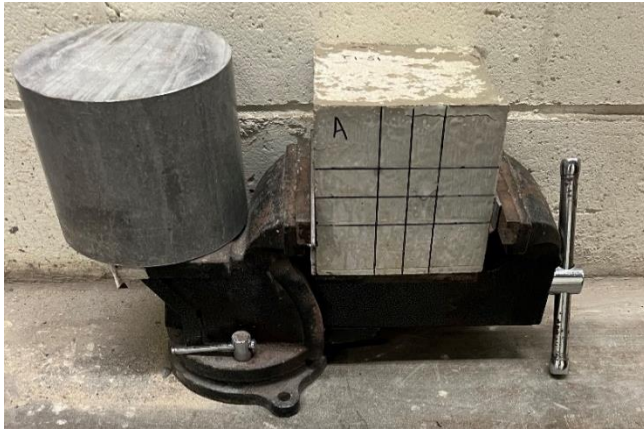
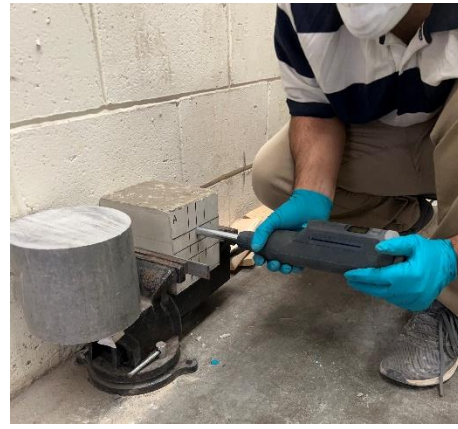
The test set ups were designed differently for hitting the sides of the cube verses hitting the top of the cube. Figure 26 shows the test set up for hammer testing in horizontal orientation. For hitting the sides, the hammer orientation was horizontal to the ground as seen in Figure 26 (b). Simulating the behavior of testing a large slab, the sample was clamped on the sides not being tested and braced against a concrete wall. This was repeated for both sides A and B.

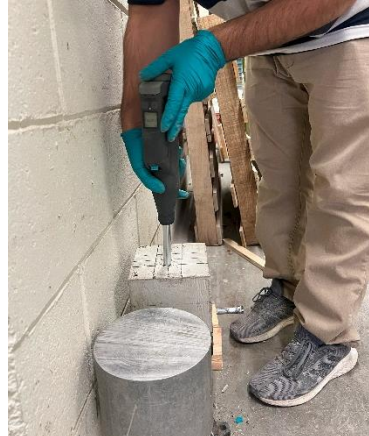
Figure 27 shows the test set up for orienting the hammer 90 degrees downward to the ground to test the top surface of the cube. Testing the cube samples from top required them to be clamped on the sides to provide a restraint on side. Since the hammer would hit the cube vertically downward the cube was rested on thick pieces of wood so that the readings would not be affected by vibrations at bottom of the steel clamp.

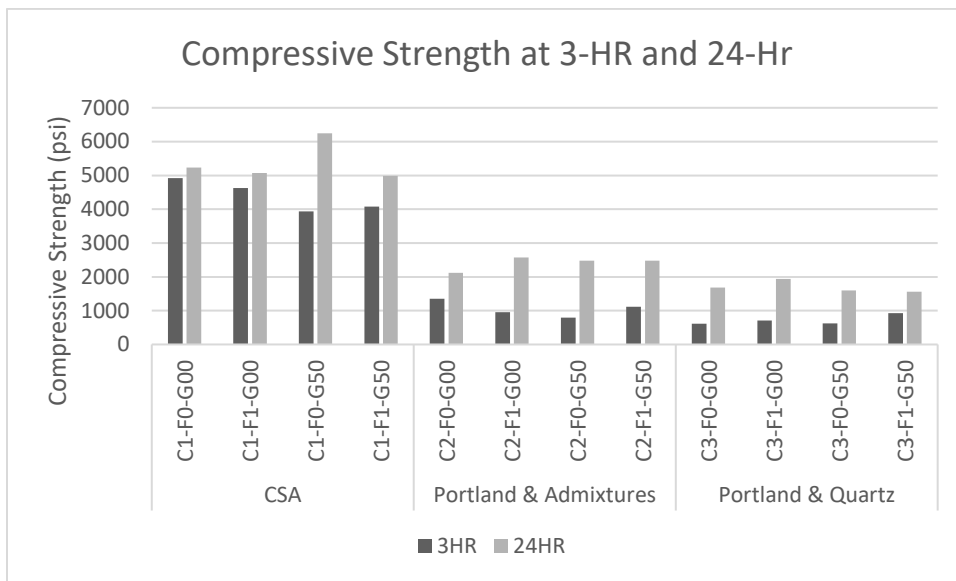
Figure 29. Average compressive strength at 3 and 24 hours

Figure 29 show the average compressive strength of cylinder samples tested after 3 hours and 24 hours. It should be noted again that 3-hour strength data is from plain slab mixes while the 24-hour strength data is from porous slab mixes. The mix proportions for the porous and plain samples were identical.

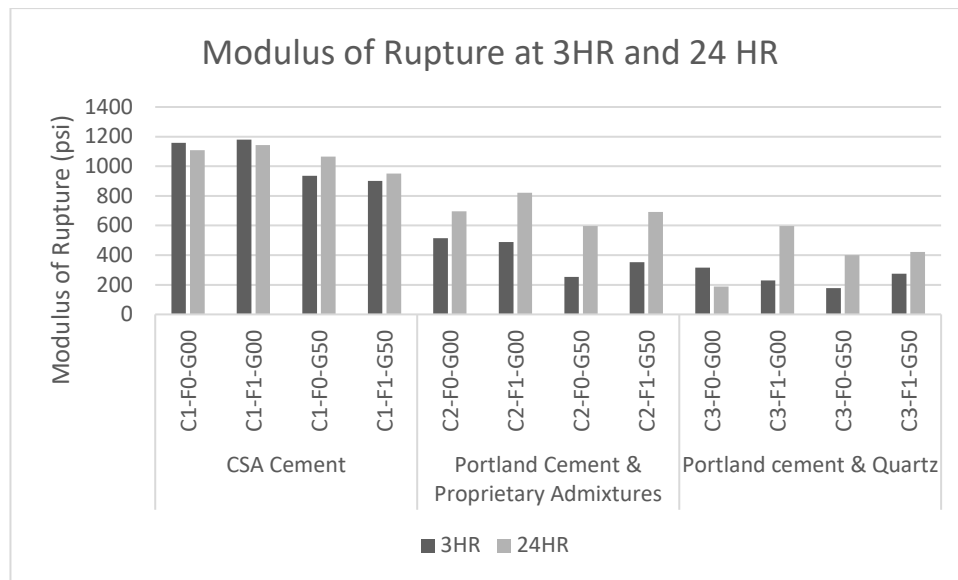
Figure 30. Modulus of rupture at 3 and 24 hours

Figure 30 shows the modulus of rupture of the mix formulations experimented at 3 hours and 24 hours. Except the C3 mix samples without fibers and gravel, all the other formulations reached modulus of rupture values 400 psi and above at 24 hours. All the C1 mix formulations showed higher rupture modulus than C2 which was followed by C3 formulation samples. Moreover, non-gravel formulations showed on average higher rupture modulus than their gravel counterparts for C1 and C2 cement formulations. C3 mix formulations with 1% fiber and without gravel showed exceptionally higher modulus of rupture compared to the other three C3 formulations.

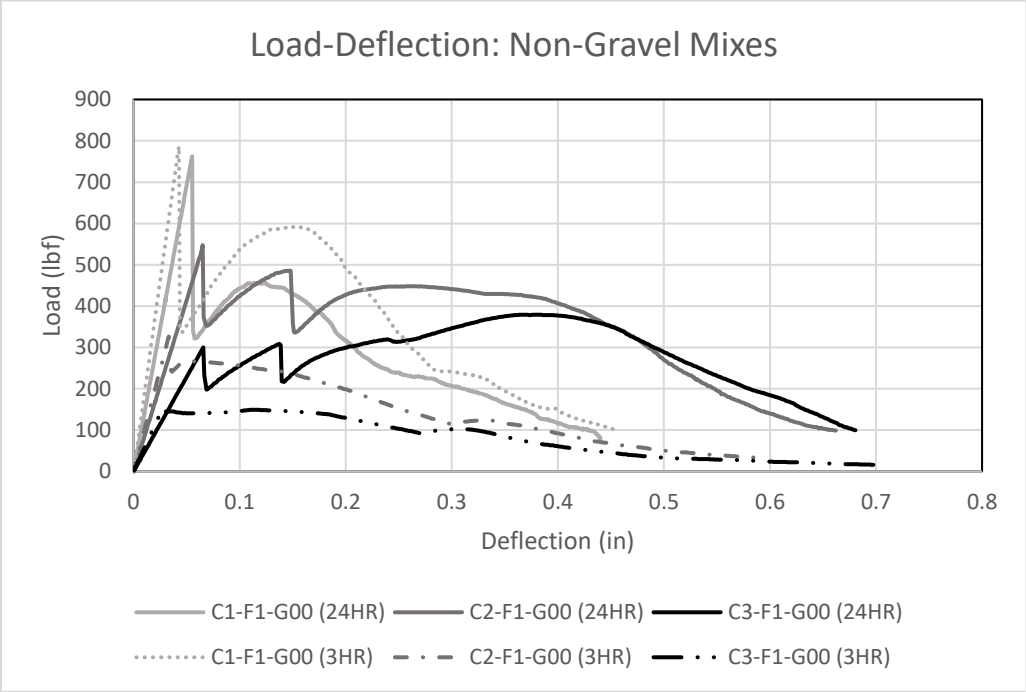
Figure 31. Load deflection curves for mixes without gravel

load rebound or load retention post cracking. However, gravel mixes are expected to perform better in terms of shrinkage cracking since the pea gravel is expected to restrain the cement paste from shrinking. Additionally, some researchers also reported that pea gravel provides internal curing effect due to hidden moisture in its pores. This can reduce shrinkage cracking and is investigated in restrained shrinkage experimentation in this research.

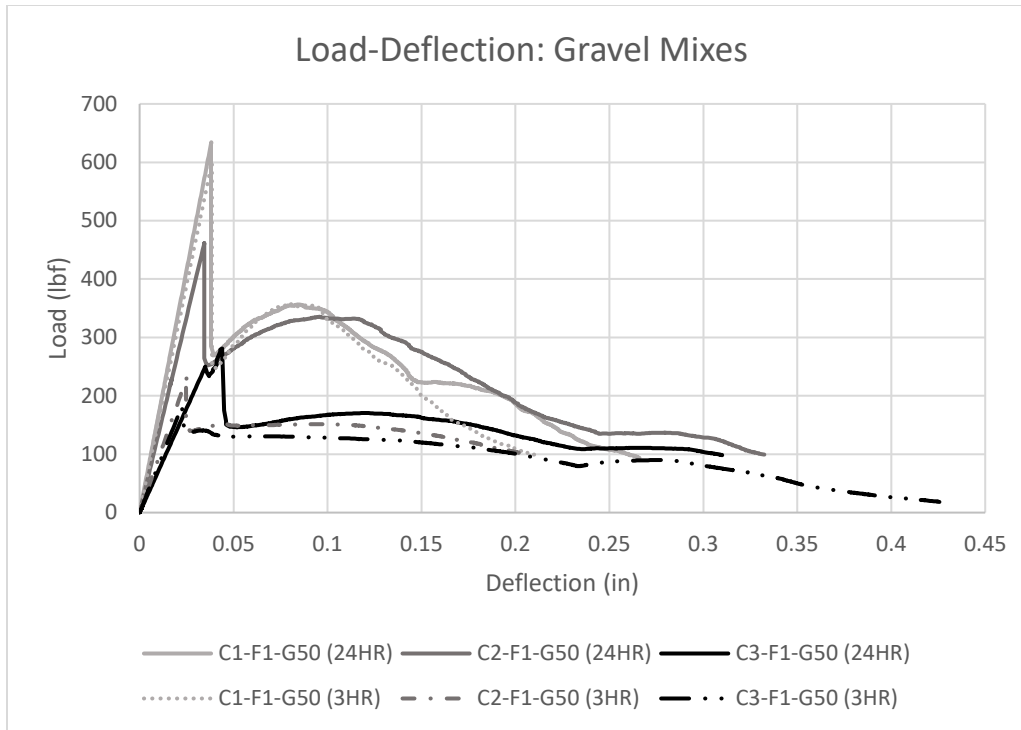
Figure 32. Load deflection curve for mixes with gravel

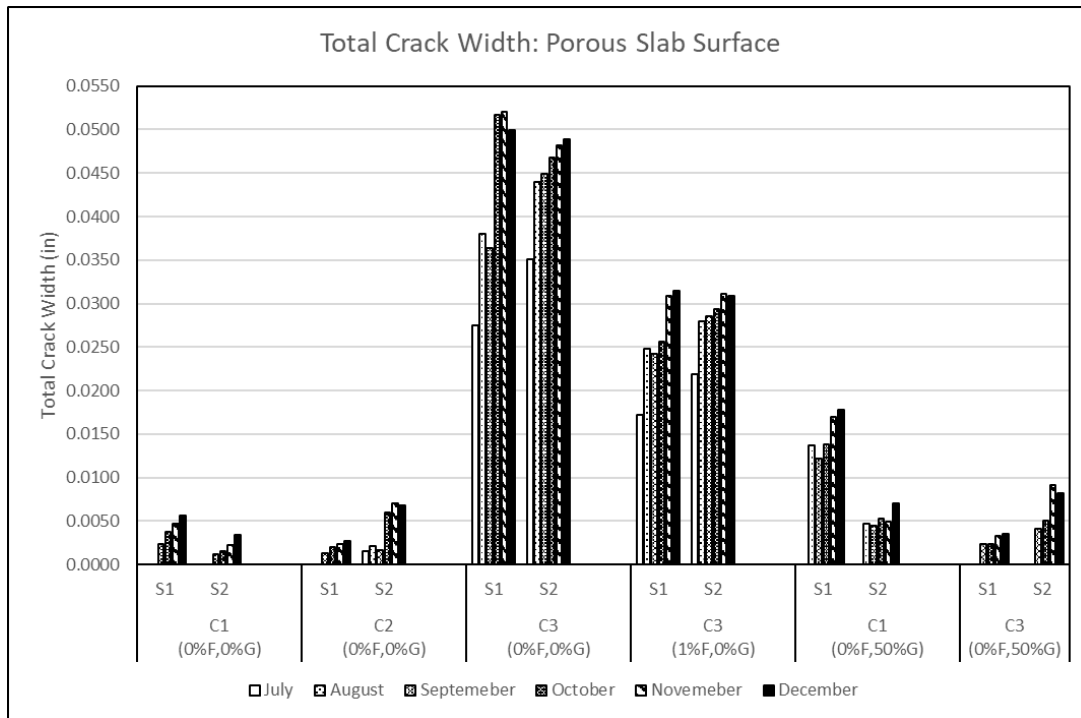
Figure 33. Growth of total crack width over porous slab surface

crack widths between the 2 samples. Overall, addition of fibers was more pronounced in reducing and preventing crack widths than the addition of gravel.

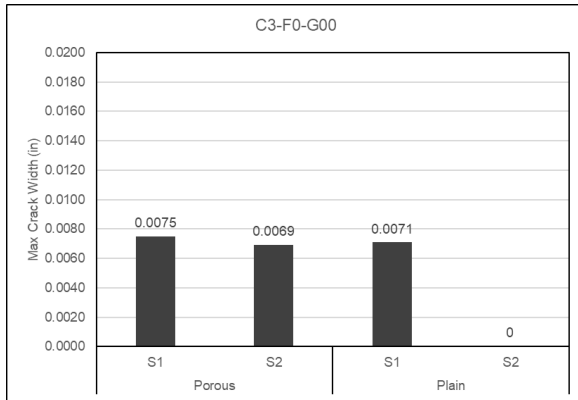
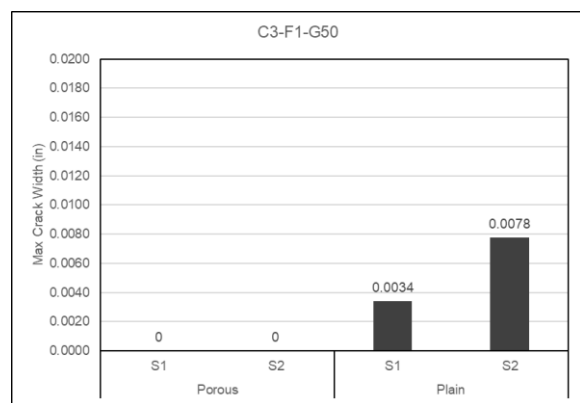
The average maximum crack width in C3 base matrix was over two times higher than both the C1 and C2 base matrices. The addition of 1 percent PVA fibers in C3 base matrix led to reduction of average maximum crack width by about 17 percent for porous slab samples while about 80 percent for plain slab samples. Similar behavior was observed upon adding 1 percent PVA fibers to C3-F0-G50 samples. The samples over plain slab showed a 46 percent reduction of maximum crack width from C3-F0-G50 to C3-F1-G50. Samples over porous slab were able to successfully resist the cracks for C3-F1-G50 compared to 0.0035-inch maximum crack width in C3-F0-G50. Moreover, the C3-F1-G00 formulation showed the widest crack width among all the three cement-formulations with fibers but no gravel. This crack width, 0.0071 inch is about 23 percent of allowable maximum crack width in NJDOT specifications.

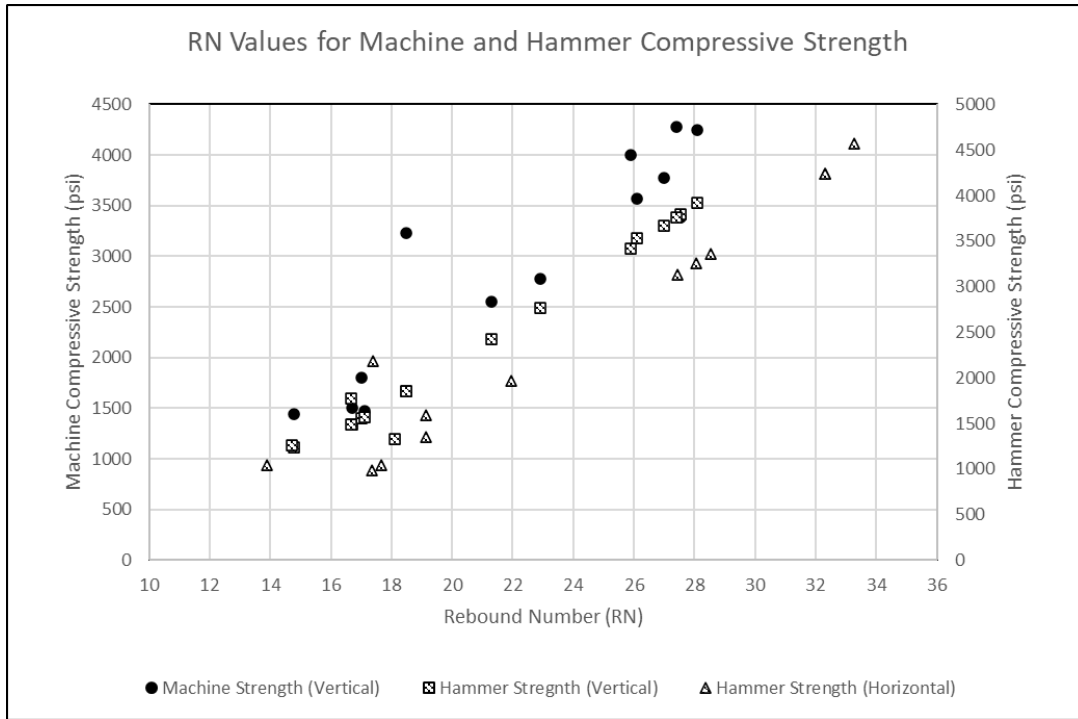
Figure 41. Compressive strength verses rebound number for all three rapid cements.

hammer nine times on each of the two side faces considered for experimentation, see Figure 23. Hence, from each cube sample, two data points were generated corresponding to RN values each in vertical and horizontal direction. Using the available RN vs Strength curves, the hammer compressive strength was obtained corresponding to the two RN values. Additionally, machine compressive strength was also obtained for each cube.

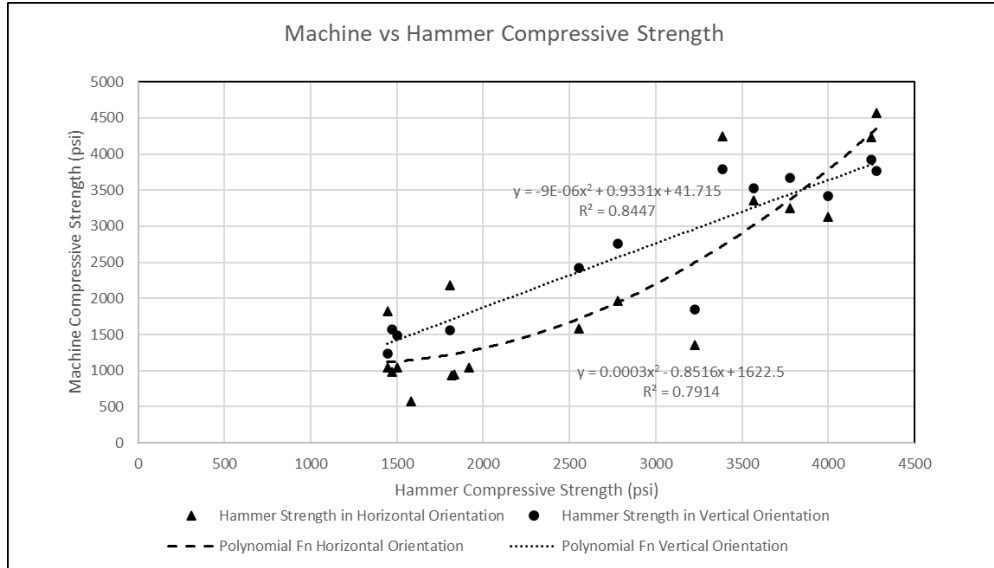
Figure 42. Comparison of machine and hammer compressive strengths

It can be observed that the same rebound numbers corresponded to higher strengths when the strength was obtained using machine rather than using the available RN vs strength curves. This is likely as the rapid set class of materials may not lie in the same range of compressive strength and elastic modulus as for which the available curves were generated. Additionally, the vertical orientation of hammer predicted the compressive strength more closely to the actual compressive strength in comparison to the horizontal orientation. This can be visualized more clearly from Figure 42. The compressive strength predicted by hammer when in vertical orientation yielded a nearly straight regression line when regressed using a polynomial function. Whereas the horizontal orientation yielded a curve that is visibly deviated from the straight-line behavior. It should be noted that ideally, the hammer predicted strength should be equal to the actual compressive strength, with a straight-line equation.
