Tech Brief

Evaluation of Automated Distress Survey Equipment

FHWA/NJ-2009-007

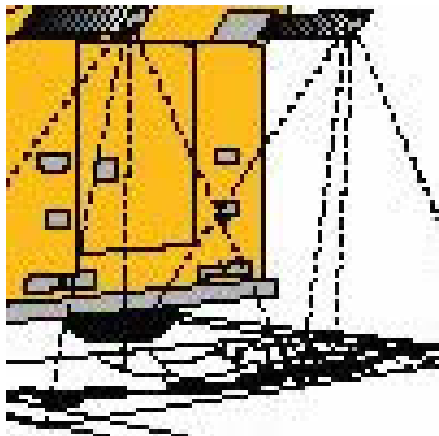
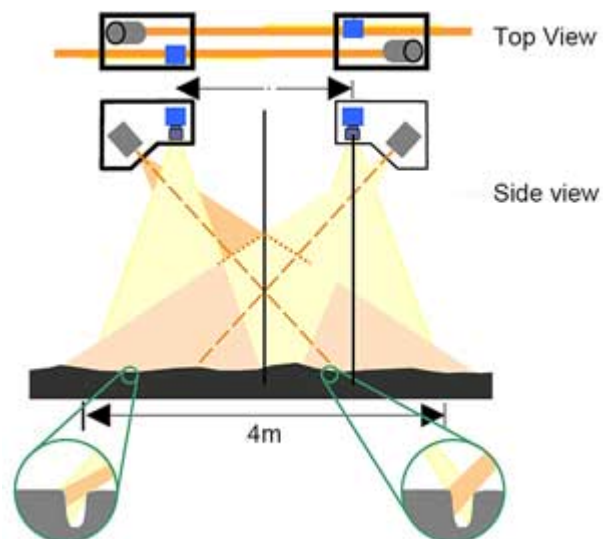
- Recorded continuous series of non-overlapping, area scan images that add to 4.9 ft (longitudinal) by 13 ft (transverse).
- Synchronized strobe lights eliminate shadows overhead objects.
- Collected at variable highway speeds up to 50 mph.

- Used INO Laser road imaging system (LRIS) that combines a line scan camera with laser illumination imaging system.
- Recorded 1.15 mm (0.045") wide (longitudinal) images across the 13 foot pavement lane width. (The laser system eliminates shadows from overhead object collected at variable highway speeds up to 50 mph).

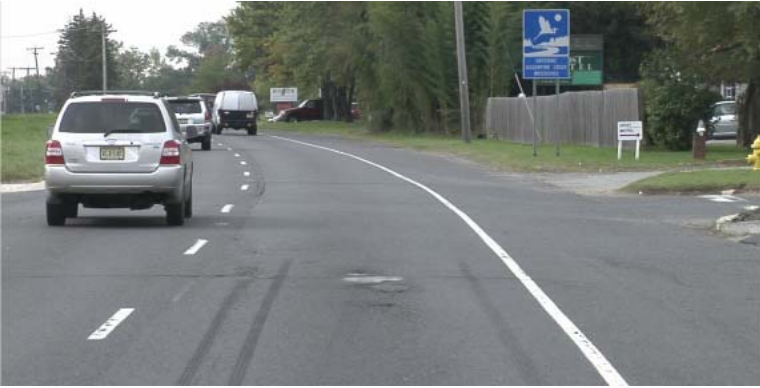
Morning Image

The NJDOT current visual distress assessment program is dependent on visual image quality to rate pavement distress severity and extent.

The lighting and direction affect the manual rating.

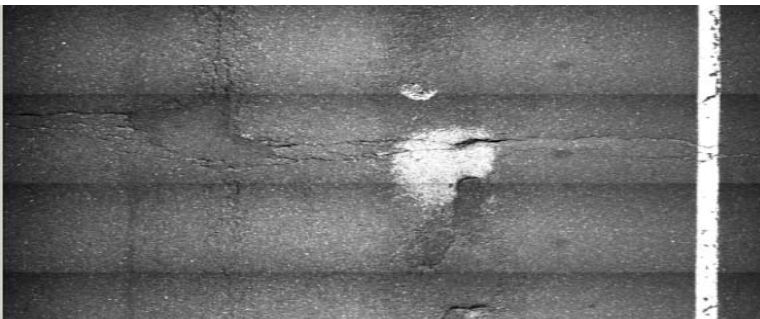
Morning Pavement Image

The strobe lighting used on the ARAN and the laser lighting used on the INO imaging system produce high quality pavement images at any time of the day.

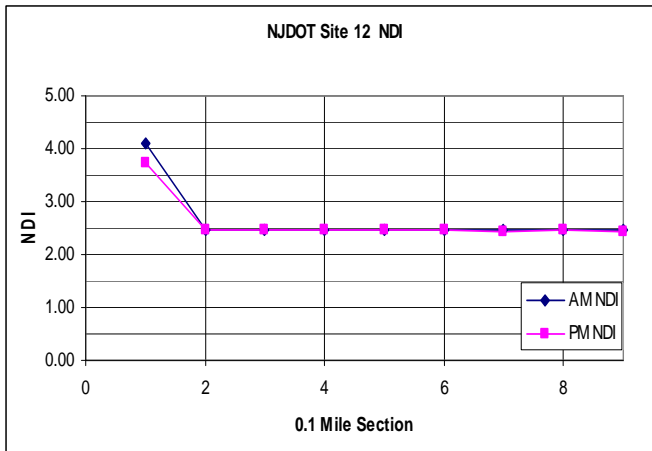
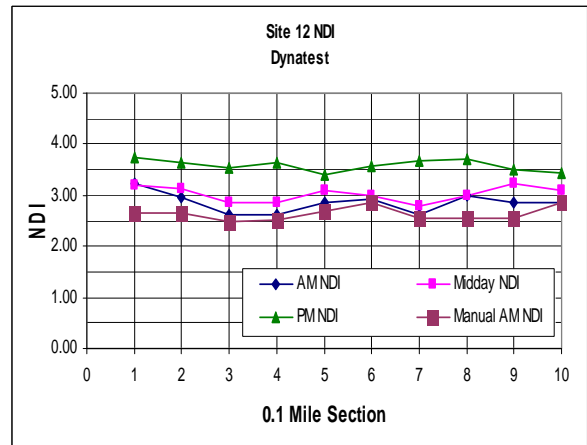
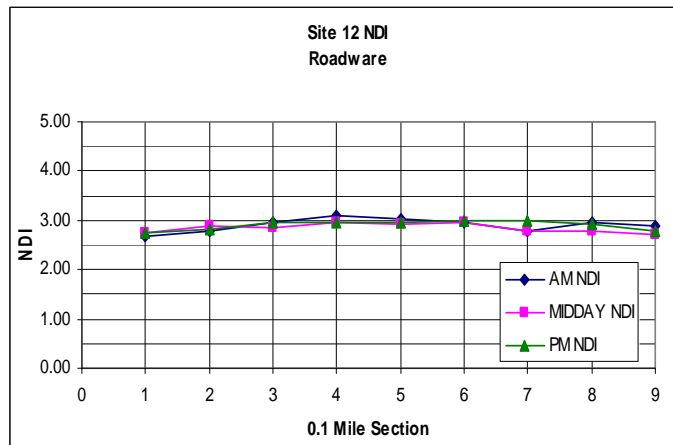
Repeatability of the analysis for different sites, distresses, and severity levels was assessed on a visual and statistical basis for the fully automated, semi-automated, and fully manual procedures.

The statistical assessment of repeatability of NDI used T-Test of Differences to determine the effects of lighting, imaging equipment, and analysis software.

<u>Dynatest (Fully Automated)</u>		
Ho	17	47%
H1	19	53%
 <u>Roadware (Semi-Automated)</u>		
Ho	23	64%
H1	13	36%
 <u>NJDOT (Manual)</u>		
Ho	9	75%
H1	3	25%
 Overall		
Ho	59	55%
H1	49	45%
