WINTER SHUTDOWN FISH SAMPLING REPORT

GPU Nuclear Corporation

February 1985

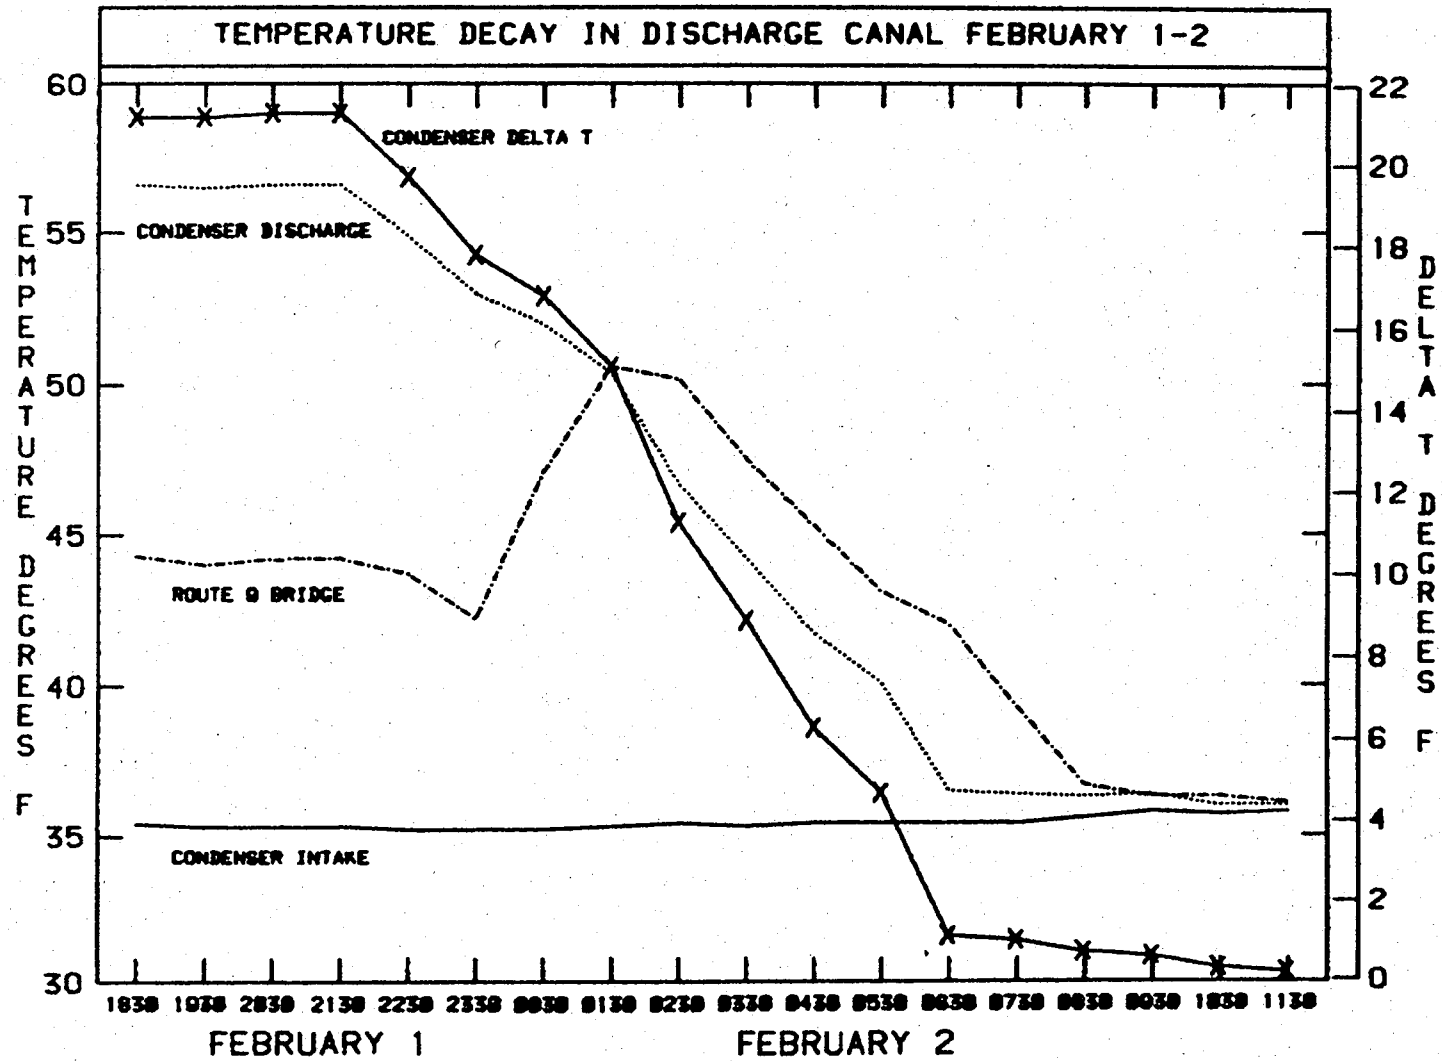
Figure 2

The menhaden and herring that were observed prior to the shutdown remained in the heated condenser discharge waters throughout the evening of February 1. As the condenser discharge water temperature began declining at 2200 hours (Fig. 2) the fish appeared to form tighter schools but did not appear stressed and were easily able to avoid dip nets.

changed so that by 0130 hours the Route 9 bridge temperature exceeded the condenser discharge temperature indicating a relatively warm water mass slowly moving down the discharge canal (Fig. 2). A small pocket of relatively warm water was also observed in the dilution pump discharge bays, presumably the result of warm condenser discharge water being trapped in this area rendered stagnant by the cessation of dilution pump activity.

Surveys of the discharge canal indicated that the herring had made their way down the canal to the Route 9 bridge where they were observed swimming normally at 0520 hours. The water temperature at Route 9 was 44°F at that time or approximately 3 degrees higher than that at the condenser discharge (Fig. 2). Apparently the herring were following the warm water mass described above as it moved down the discharge canal.
