Flexible Overlays for Rigid Pavements

FINAL REPORT

February 2010

Dr. Thomas Bennert
Senior Research Engineer

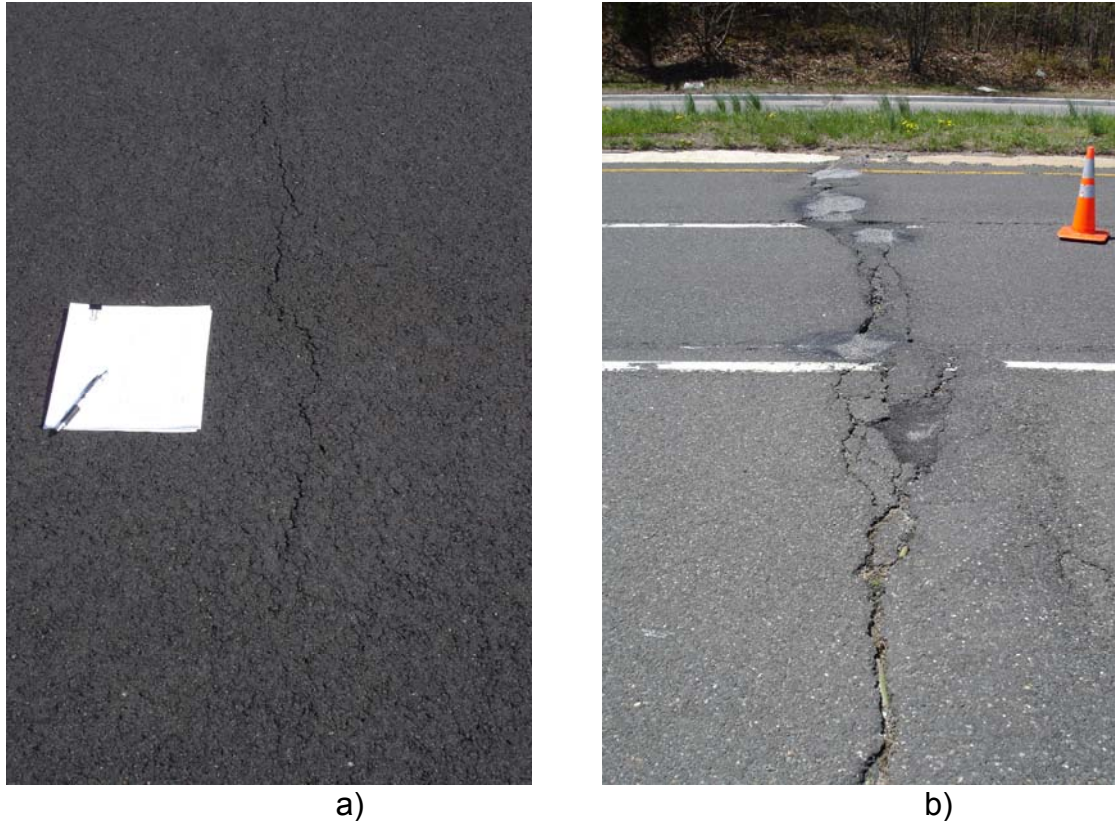
Figure 1 – Reflective Cracking on Existing Composite Pavement, a) Early Reflective Cracking and b) Reflective Cracking After 8 Years of Service

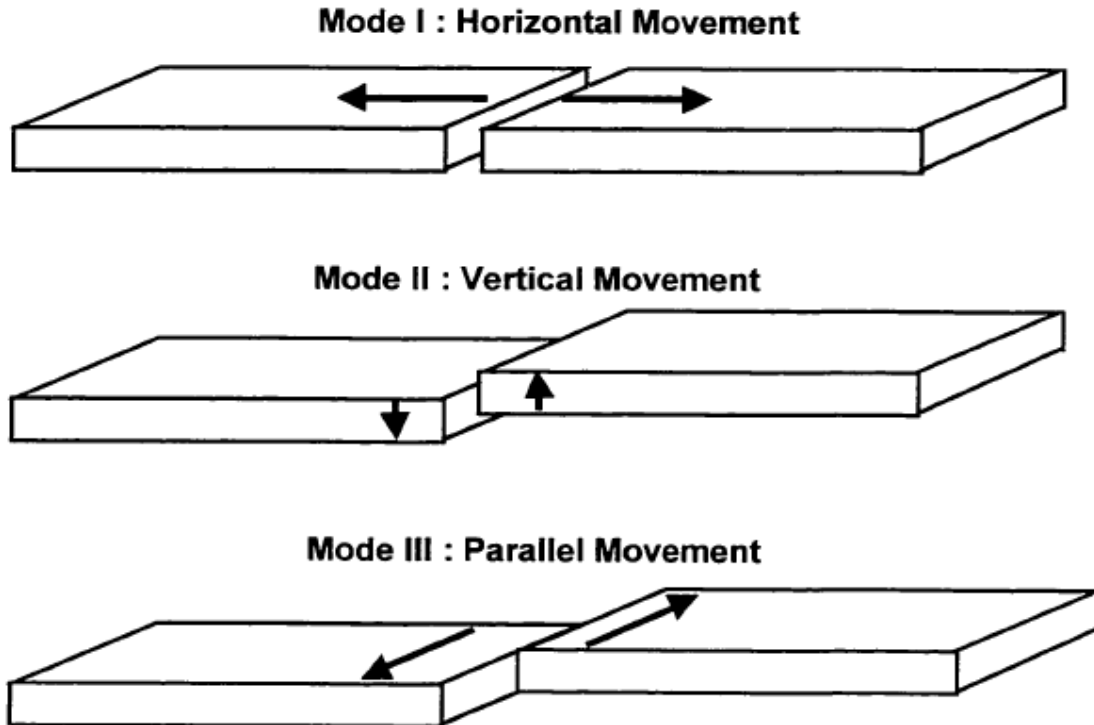
Figure 2 – Movements in Underlying Pavement Layers that Contribute to Reflective Cracking (After Mukhtar and Dempsey, 1996)

Any type of movement taking place within the vicinity of the joint/crack will produce stress and strains in the overlay that can cause it to physically tear. This is purely based on the magnitude of the applied stress being higher than the overlay's resistance to fracture. There are generally three common modes of failure movements associated with reflective cracking (Figure 2):

- Horizontal Movement of Slab – Usually temperature associated and causes tensile and bending stresses to develop in the overlay.
- Vertical Movement at the Joint/Crack Area – Primarily load induced and creates shear and tensile stresses within the overlay.
- Parallel Movement of the Slab – Not common, however, the parallel movement may occur if the slab is structurally unstable with minimal frictional resistance.

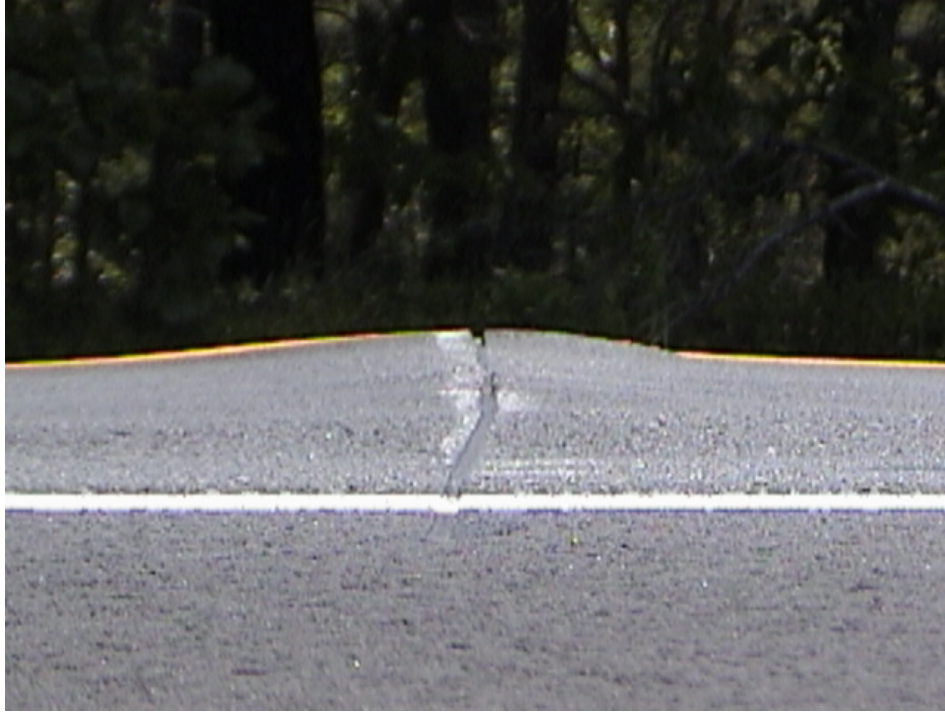
Figure 5 – HMA Overlay Failure at Joint Area Due to Excessive Curling Forces (Route 34 MP 11.5 Southbound)

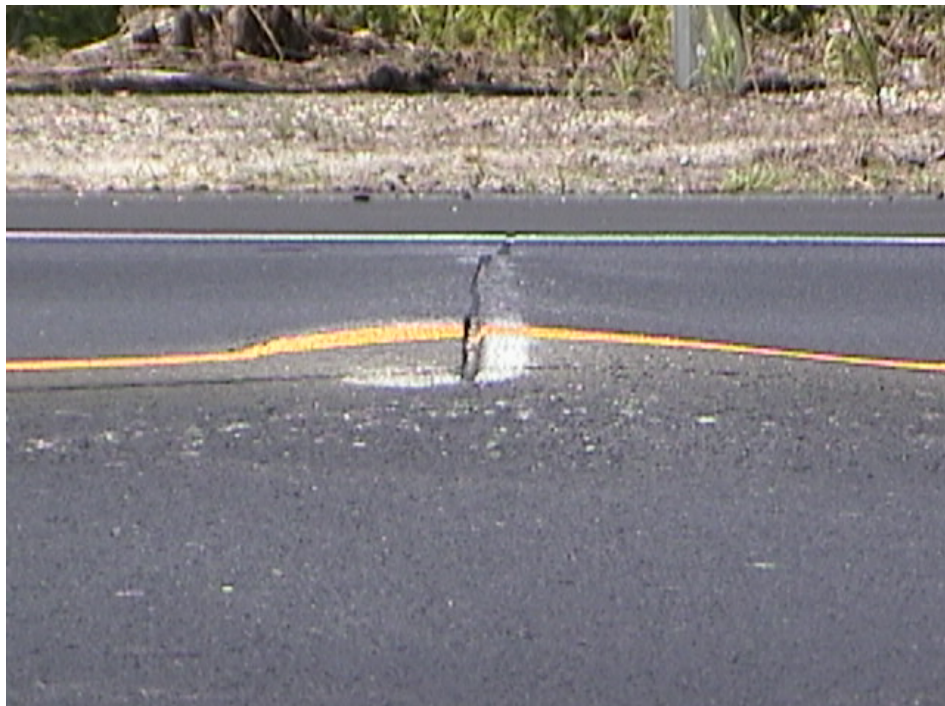
Figure 6 – HMA Overlay on Route 34 (Picture taken from Northbound Side showing the joint was only sawed and sealed on the Southbound Side)

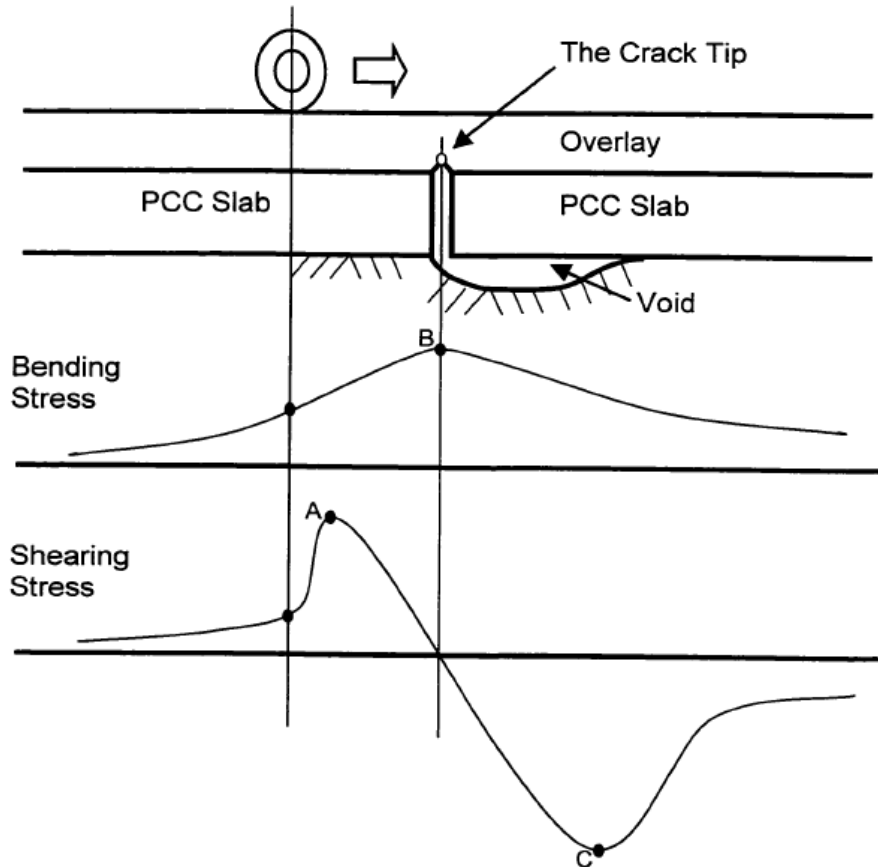
Figure 8 – Stresses Developed in the Joint/Crack Area Due to Traffic Loading (After Kohale and Lytton, 2000)

As the wheel load moves across the PCC joint/crack, three high stresses pulses are developed in the HMA overlay, shown in Figure 8 (After Lytton, 2000). The stress pulse at points A and C occur as shear stress, with point B occurring as a bending stress. The shear stress at point C can potentially be greater than point A if a void exists under

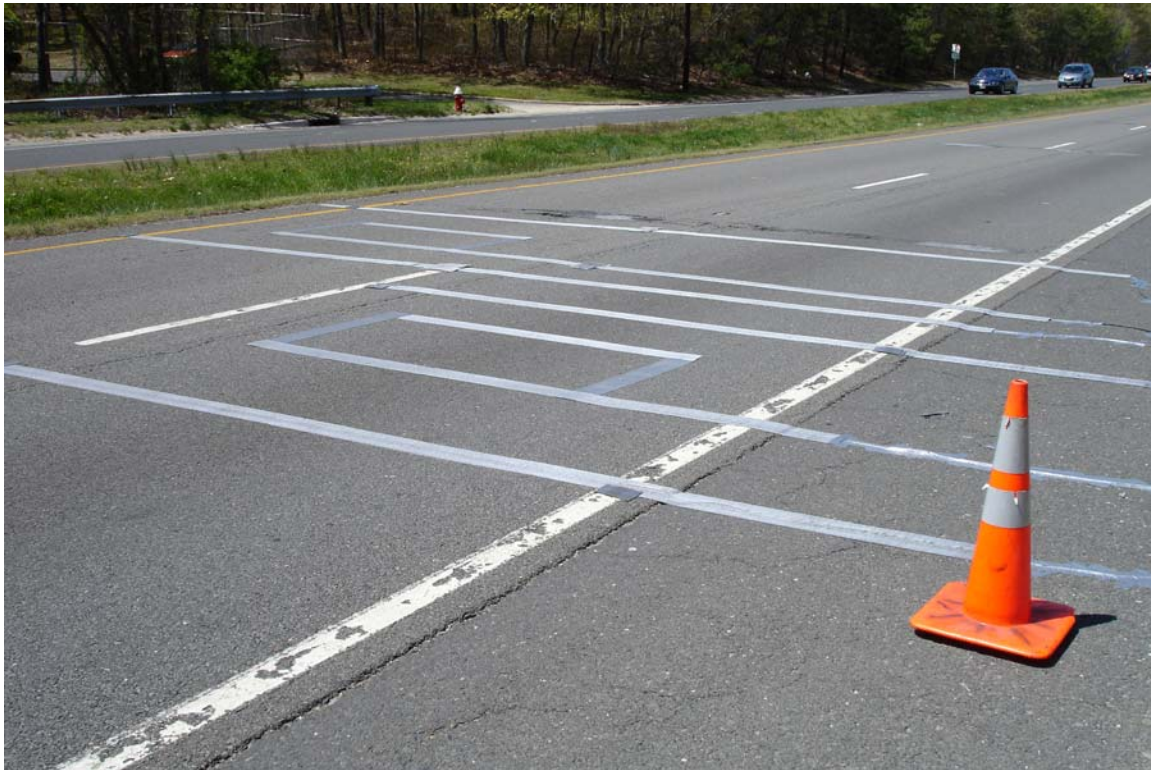
Figure 19 – Weigh-in-Motion/Automated Vehicle Classifiers (WIM/AVC)

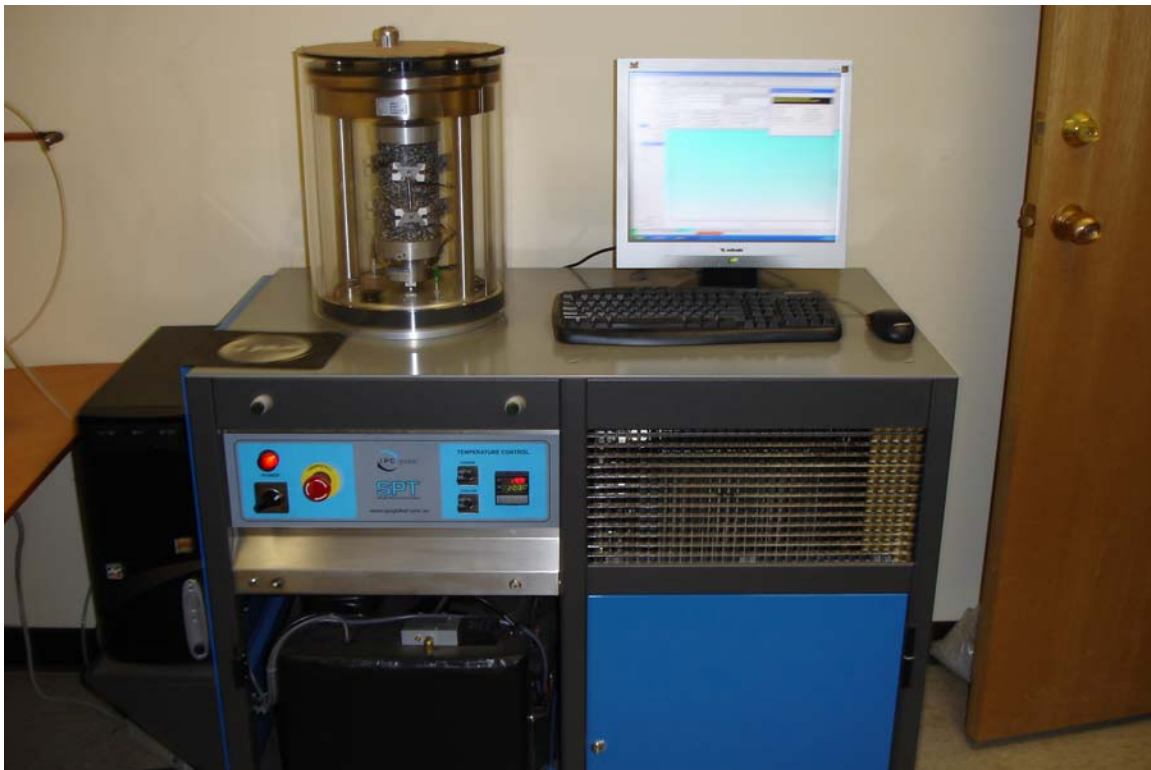
Figure 22 – Dynamic Modulus Test Device

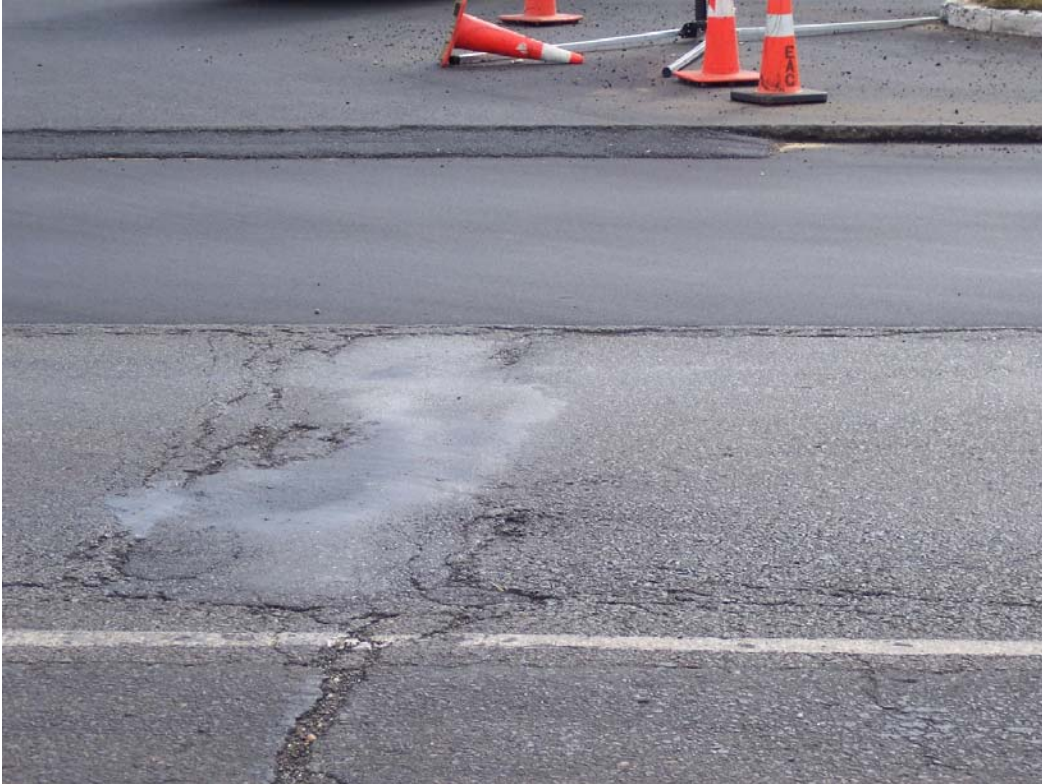
Figure 27 – Photo of Reflective Crack Relief Interlayer (RCRI) Mix, shown in far lane, and Existing HMA Patch Over Deteriorated Reflective Crack

In the summer of 2006, a maintenance resurfacing program consisting of using a reflective crack interlayer mix (RCRI) was specified. The project limits of the resurfacing project were from milepost 0.2 to milepost 7.6. The pavement design recommendation consisted of milling to a constant depth of 76.2 mm (3 inches) prior to the overlay. Photos of some of the construction are shown in Figures 27 and 28.

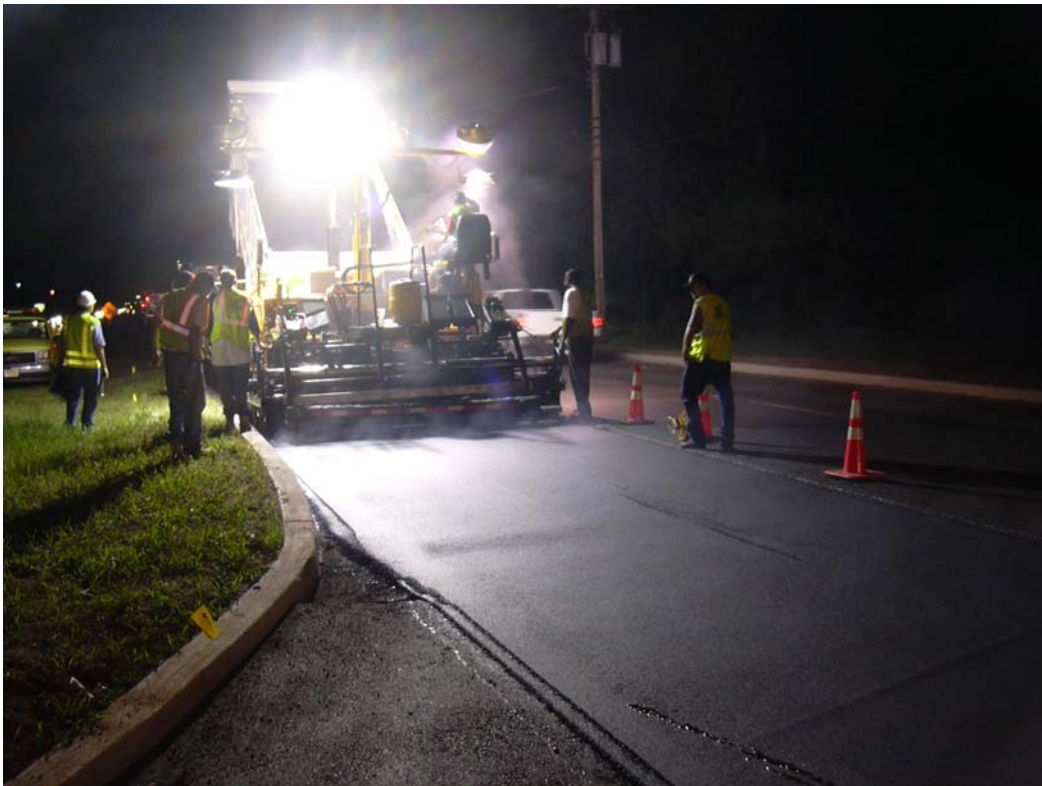
Figure 28 – Paving RCRI Mixture on Rt 34N in New Jersey

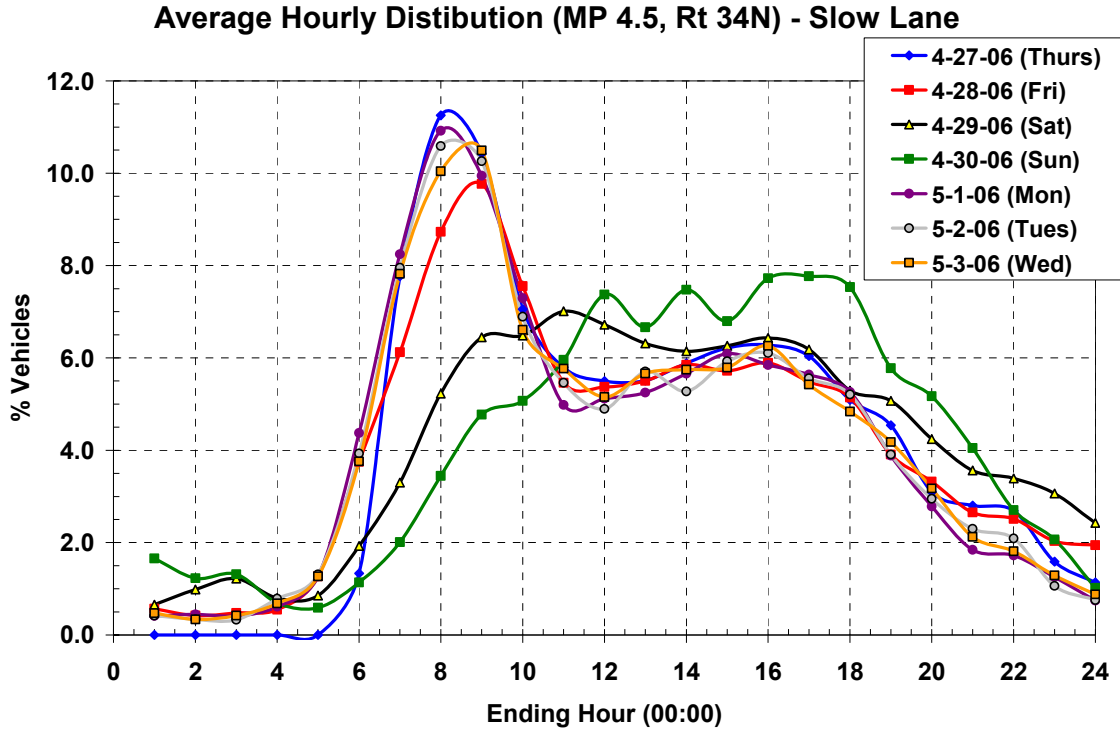
Figure 30 – Hourly Distribution on Rt. 34N in New Jersey

higher traffic volumes during colder time periods of the day (usually during the morning rush hour). The HRD for Rt 34N in New Jersey is shown in Figure 30. As can be seen in the figure, the highest level of traffic is occurring during the morning rush hours, which may increase the potential of cracking in the test section.

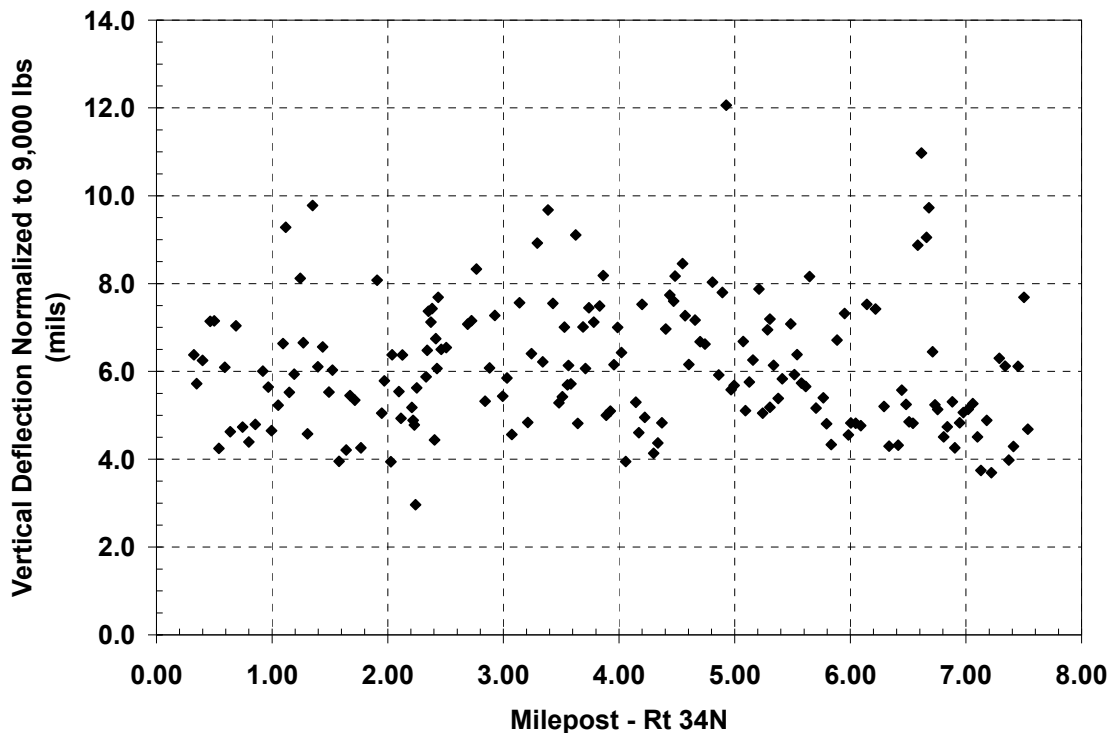
The measured vertical deflections at the PCC joint/crack, normalized to 9,000 lbs for comparison purposes, are shown in Figure 32. On average, the vertical deflection normalized to 9,000 lbs was 6.08 mils with a standard deviation of 1.47 mils.

Figure 32 – Vertical Deflections at PCC Joint/Crack

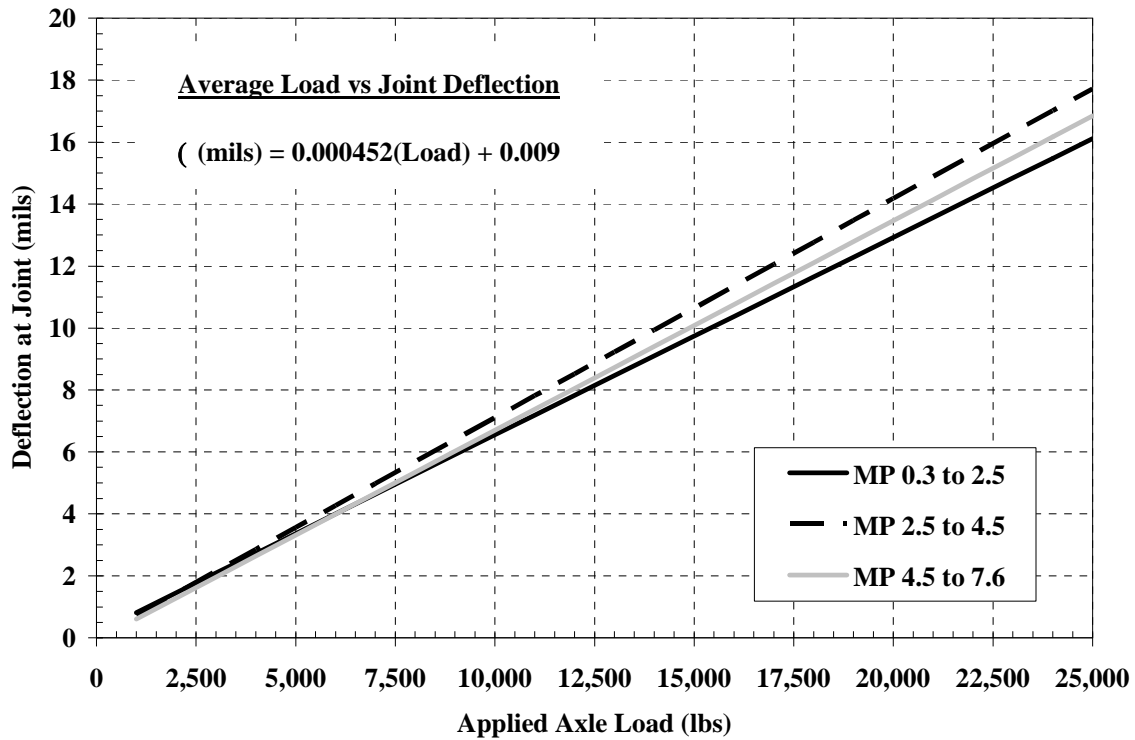
When conducting FWD testing at different load magnitudes, the relationship between the vertical deflection at the joint (measured immediately under the load) and the applied load can be represented by a linear regression, thereby, allowing for the direct substitution of any known applied axle load to determine the resultant deflection at the joint. The relationship for each Test Section, along with the average, is shown as Figure 34.

Figure 34 – Applied Load vs Resultant PCC Joint/Crack Vertical Deflection

Once the relationship between applied load and vertical joint deflection is established, the axle load measurements recorded by the WIM/AVC sensors can be directly inputted into the regression equation to generate a PCC Vertical Joint Deflection Spectra. In this research, a PCC Vertical Joint Deflection Spectra is defined as the amount and magnitude of vertical deflections that are assumed to occur due to daily traffic volumes. The PCC Vertical Joint Deflection Spectra developed for Test Section #1 is shown as Figure 35. Figure 35 provides valuable information regarding the magnitude of the vertical deflection due to the individual axle load. More detail on the use of the PCC Vertical Joint Deflection Spectra and how it can be applied to laboratory testing is discussed later in this report.

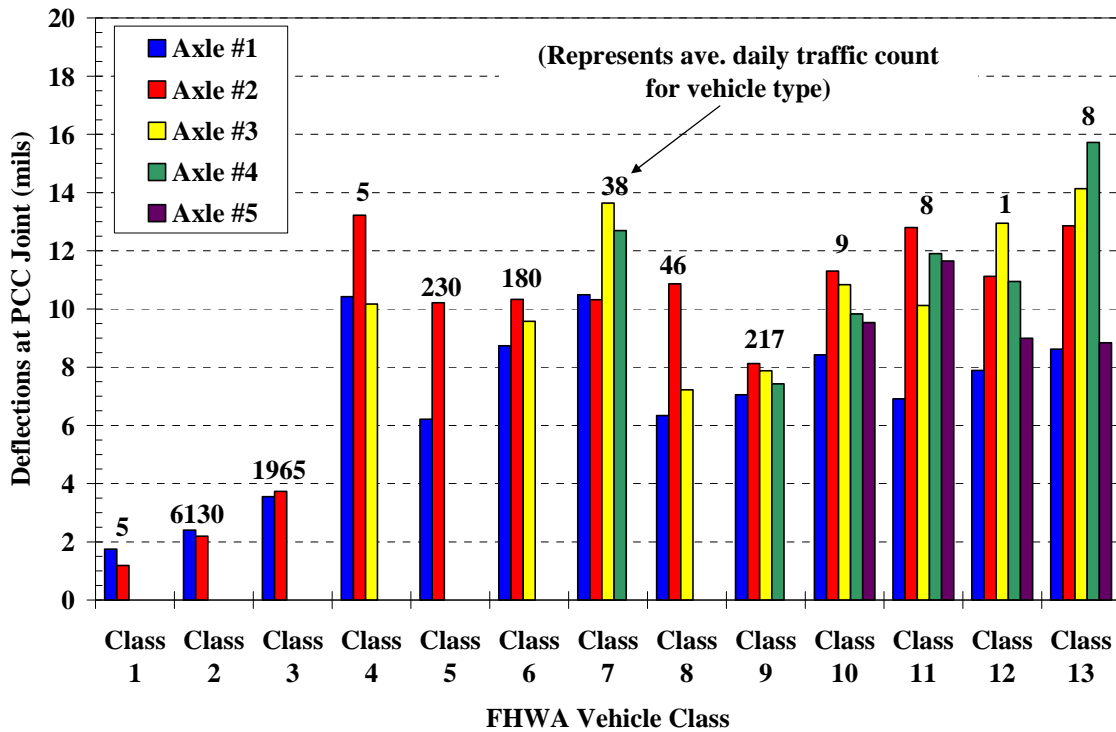
Figure 35 – PCC Vertical Joint Deflection Spectra for Test Section #1

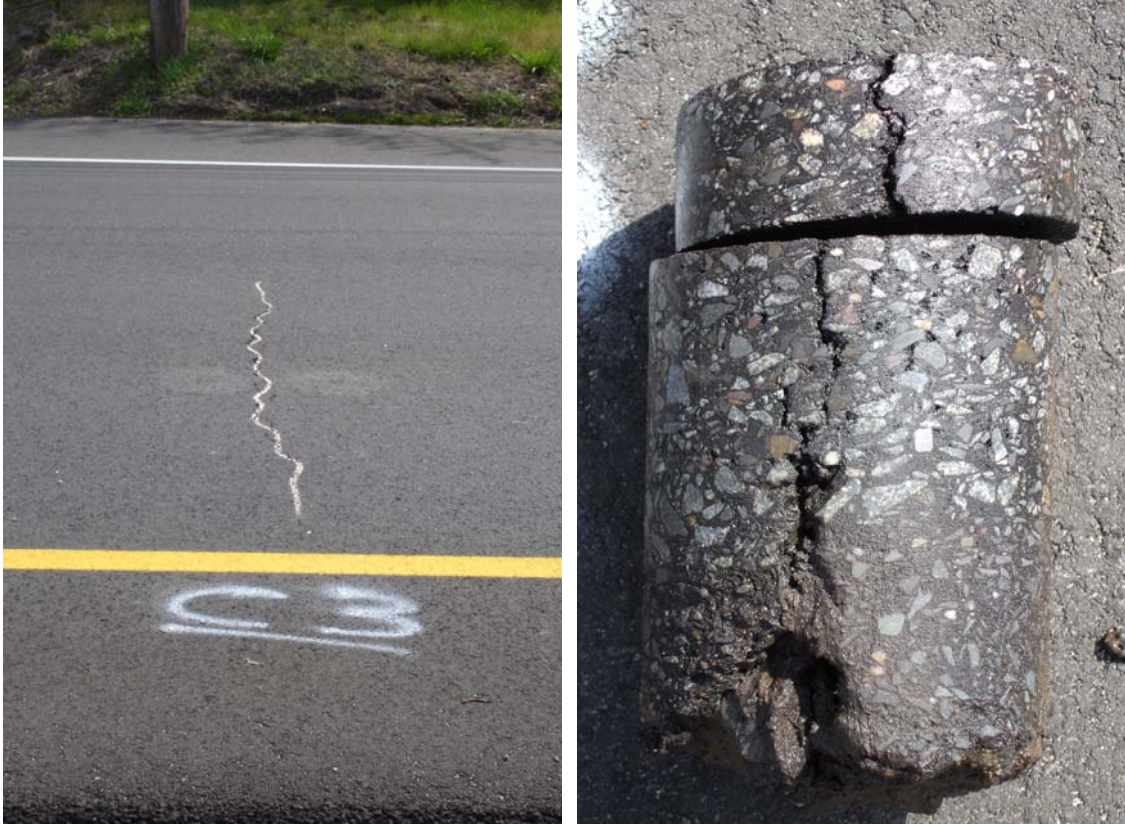
Figure 39 – Early Reflective Cracking in Test Section MP 2.5 to 4.5

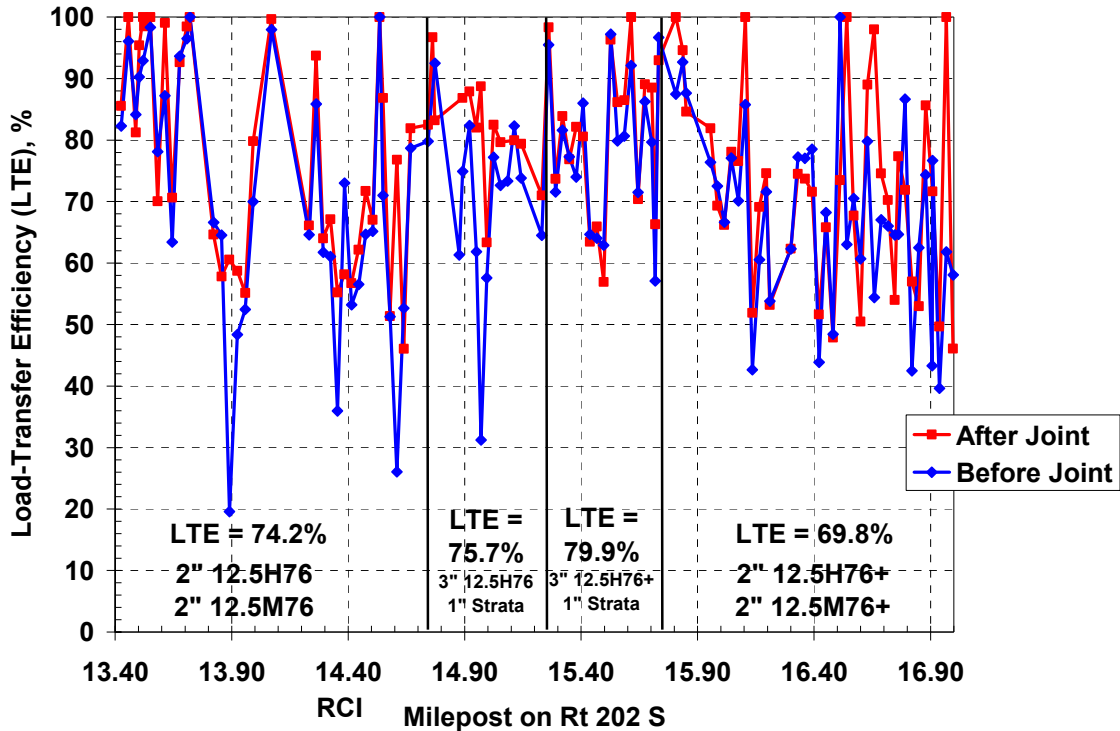
- Test Section #1 (2" 12H76 over 2" 12M76) = 74.2%
- Test Section #2 (3" of 12H76 over 1" RCRI) = 75.7%
- Test Section #3 (3" of 12H76+ over 1" RCRI) = 79.9%
- Test Section #4 (2" 12H76+ over 12M76+) = 69.8%

Figure 45 – Load Transfer Efficiency (LTE) of the Different Test Sections on Rt. 202S

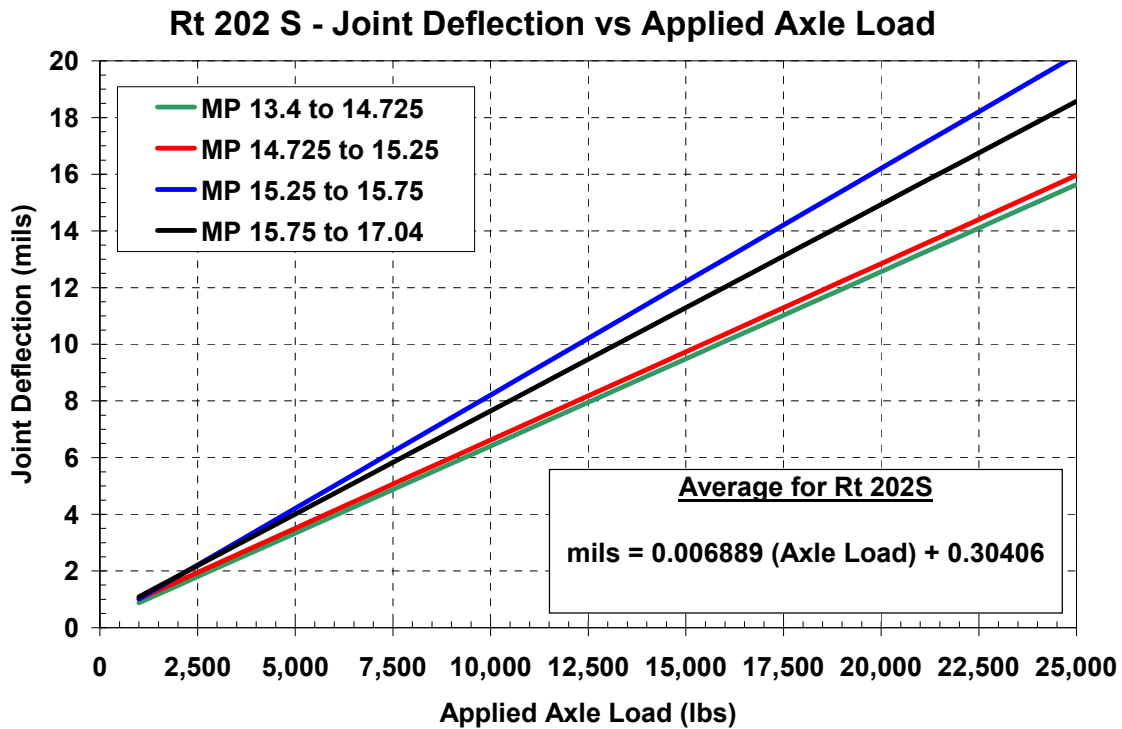
Figure 46 – PCC Joint Deflection vs Applied Axle Load for Rt 202S in New Jersey

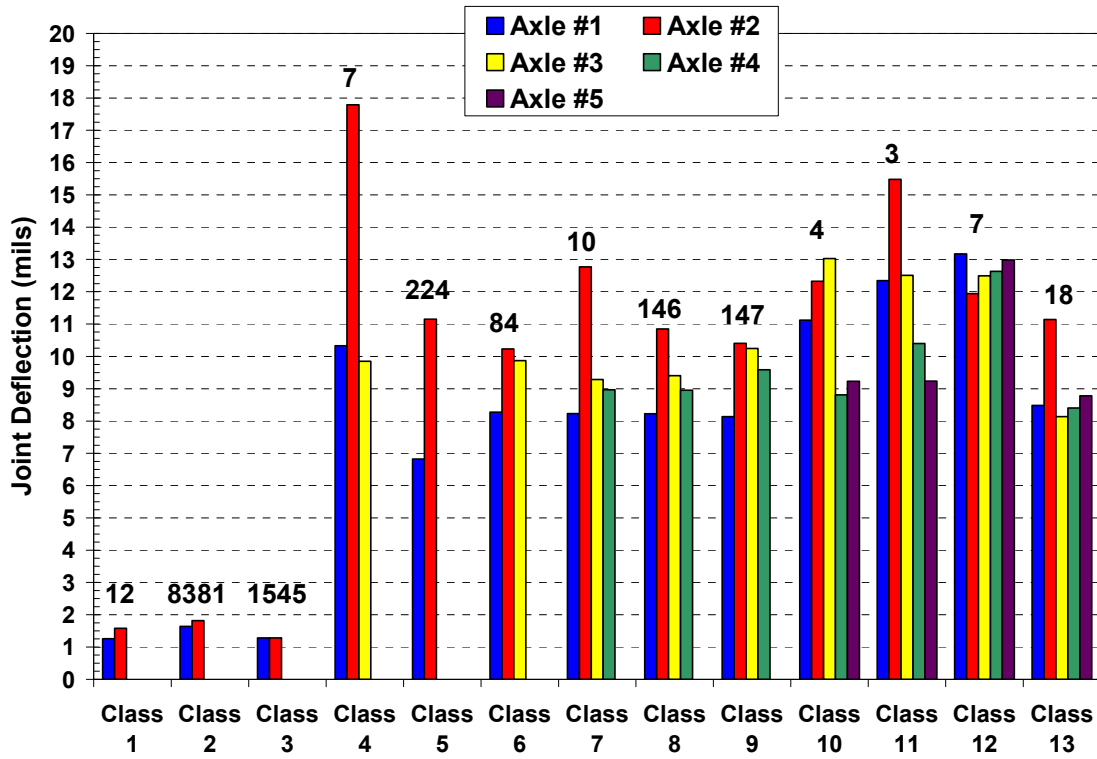
Figure 47 – PCC Vertical Joint Deflection Spectra for Test Section #2 (Rt 202S)

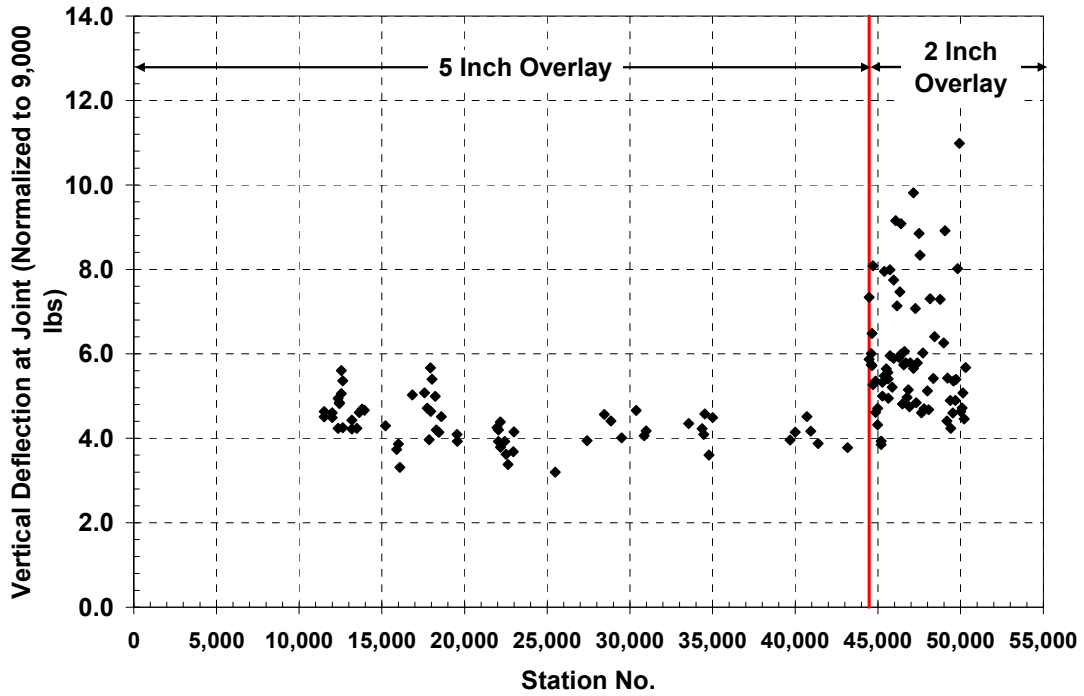
Figure 53 – Vertical Deflection at PCC Joint/Crack Normalized to 9,000 lbs

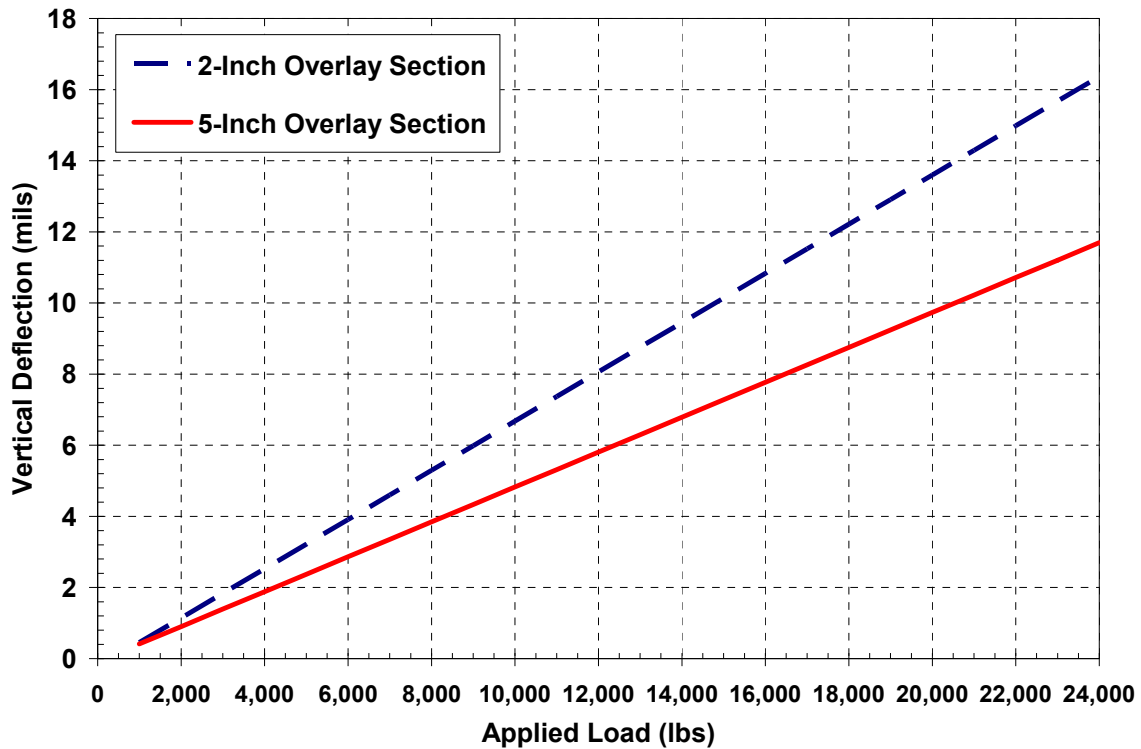
Figure 55 – Applied Load vs PCC Vertical Deflection Relationship for Interstate 495

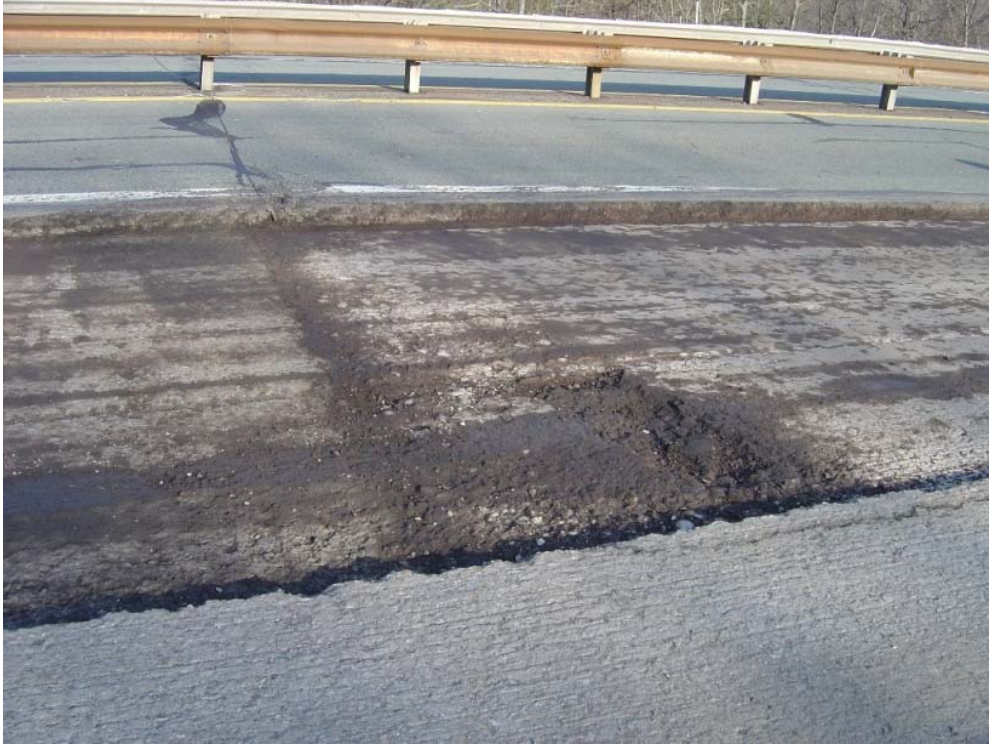
Figure 60 – Milled and Unmilled Surface of Interstate 476 in Pennsylvania

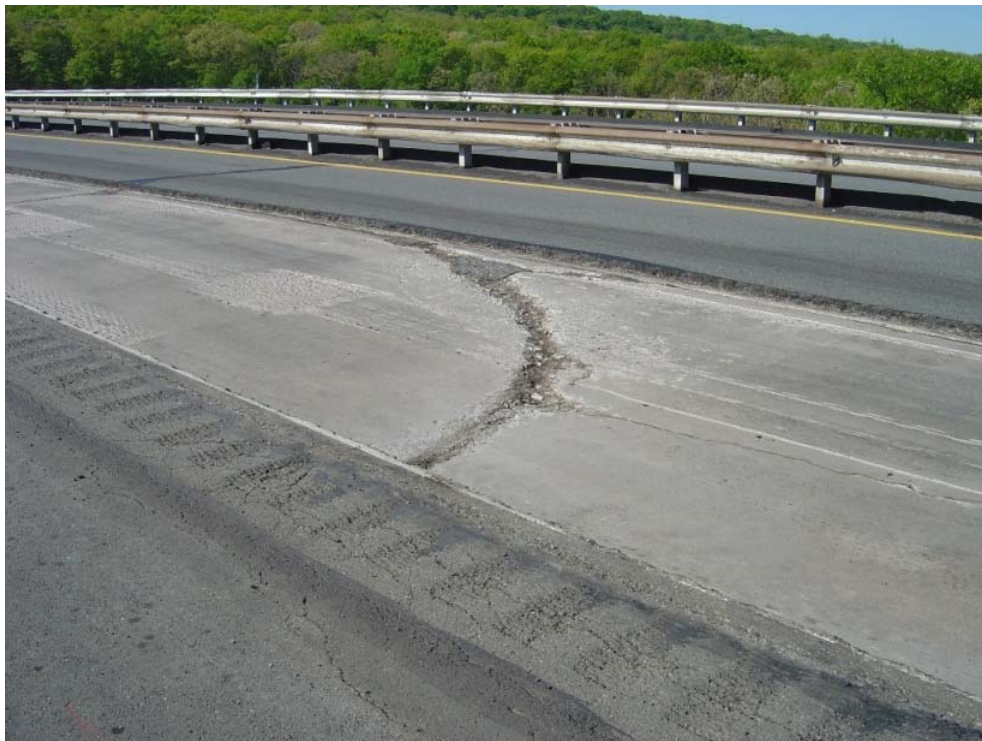
Figure 61 – Exposed Surface of Underlying PCC Pavement on Interstate 476 in Pennsylvania

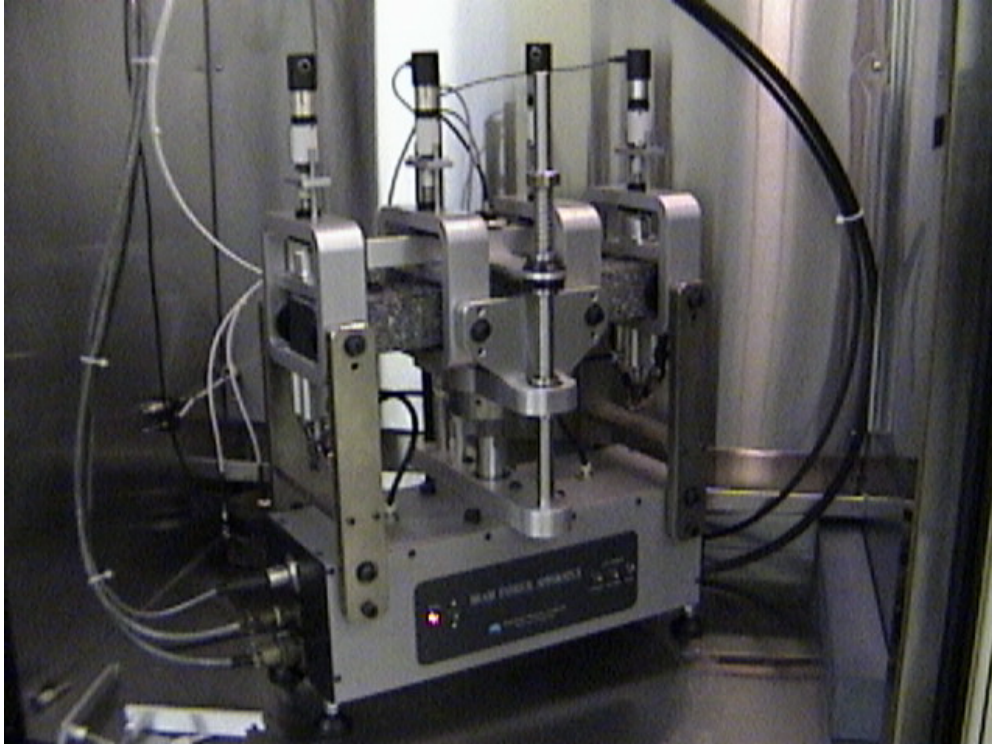
Figure 62 – Flexural Beam Fatigue Device for AASHTO T321

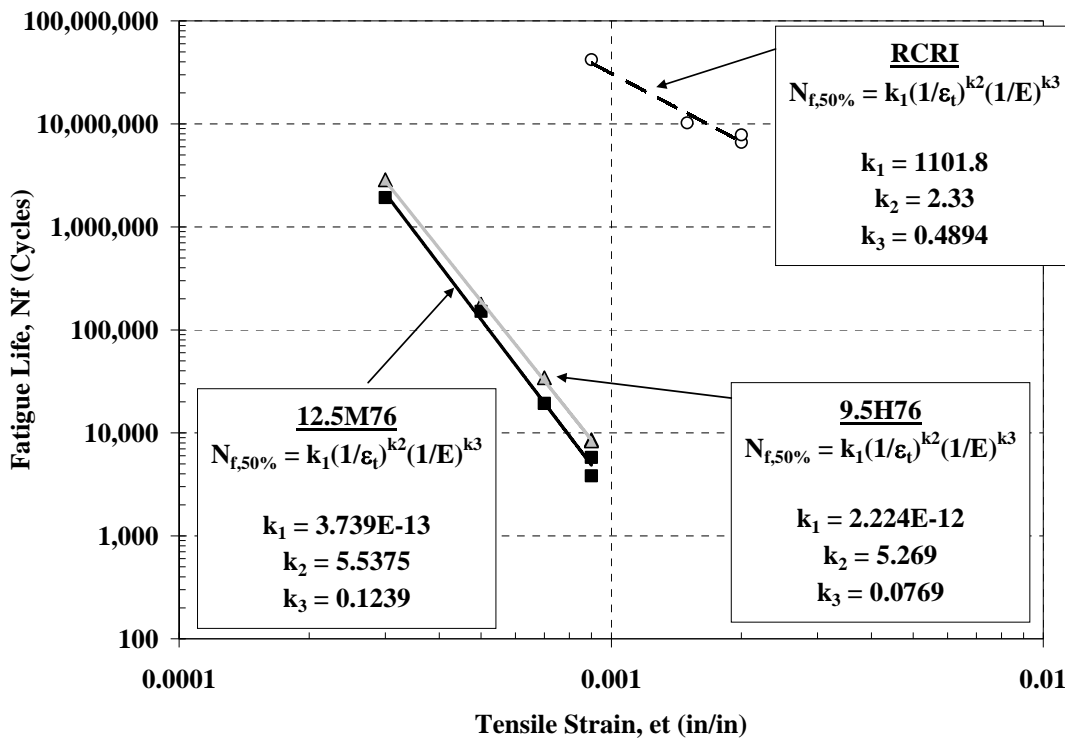
Figure 63 – Flexural Beam Fatigue Life of Asphalt Mixture from Rt 34N, New Jersey

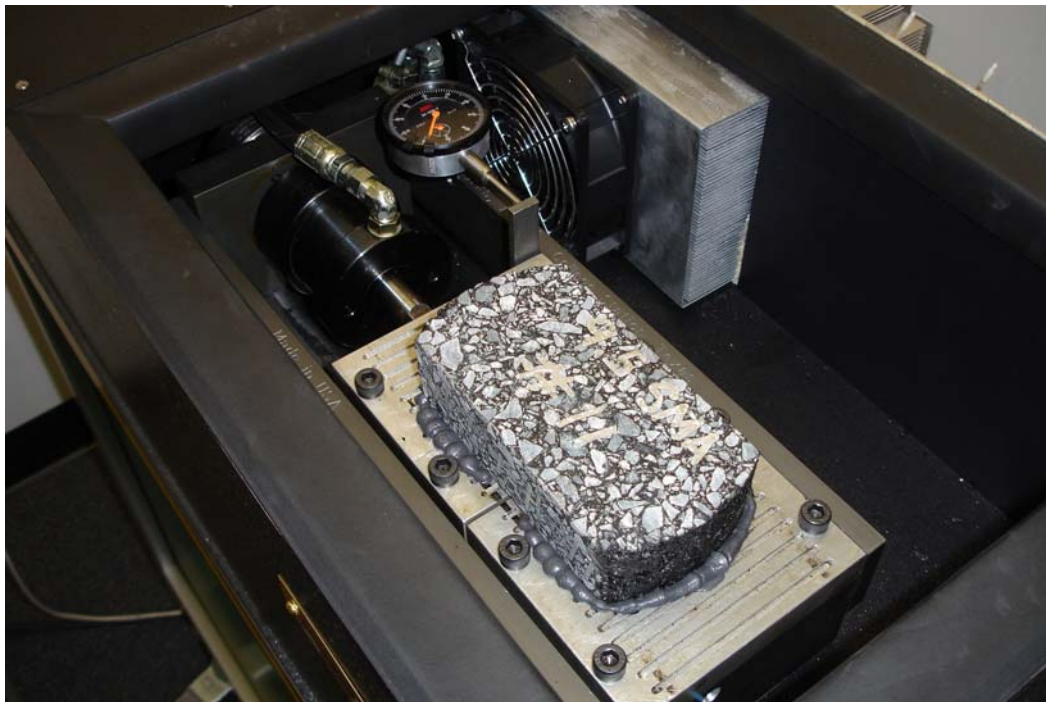
Figure 67 – Photo of the TTI Overlay Tester

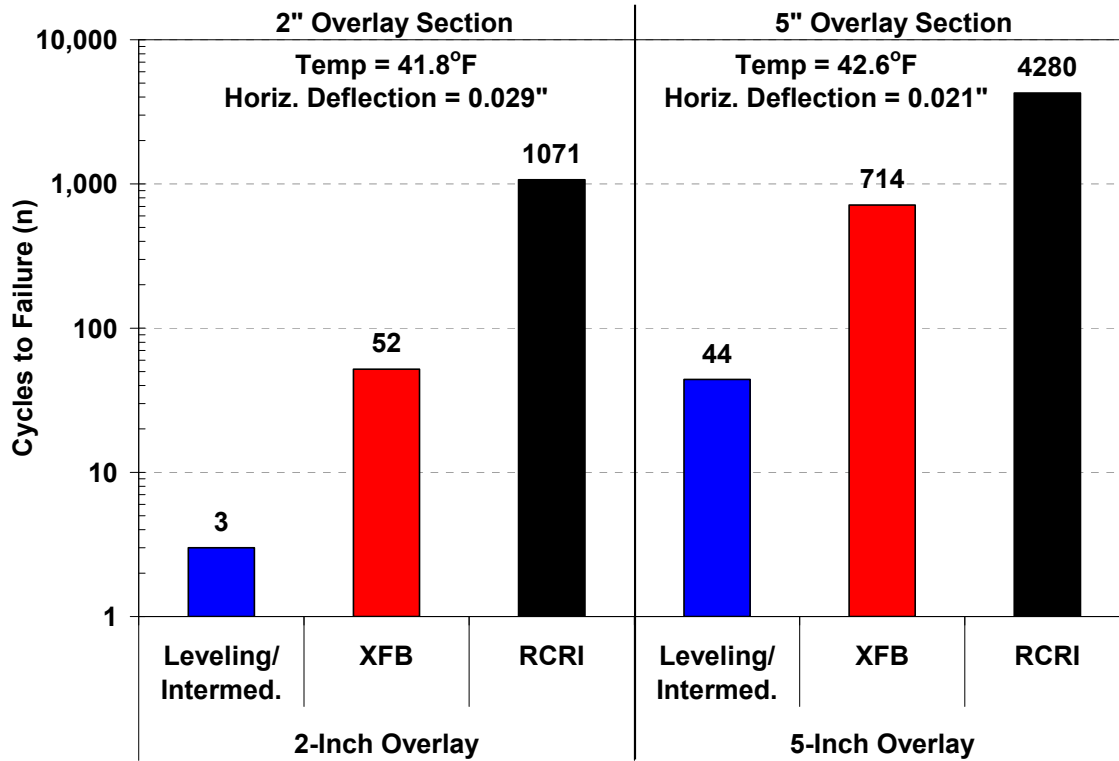
Figure 70 – Overlay Tester Test Results for 2” and 5” Overlay Sections

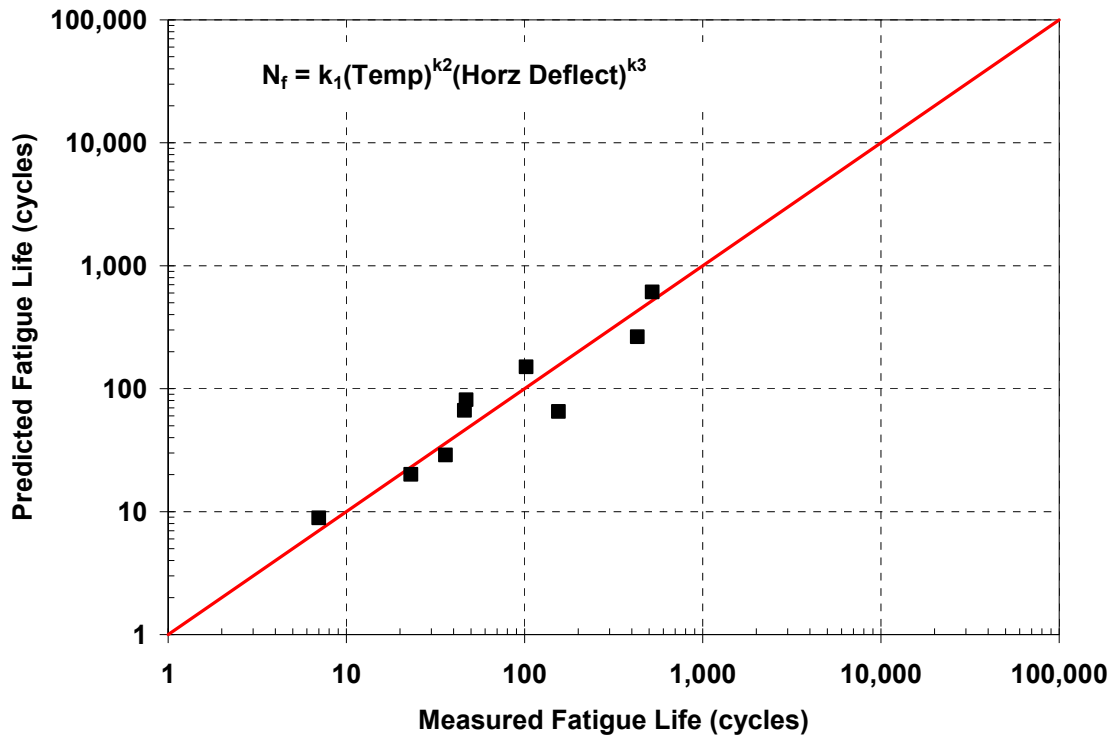
Figure 72 – Example of Horizontal Fatigue Life Determined in the TTI Overlay Tester
