Flexible Overlays for Rigid Pavements

FINAL REPORT

February 2010

Dr. Thomas Bennert
Senior Research Engineer

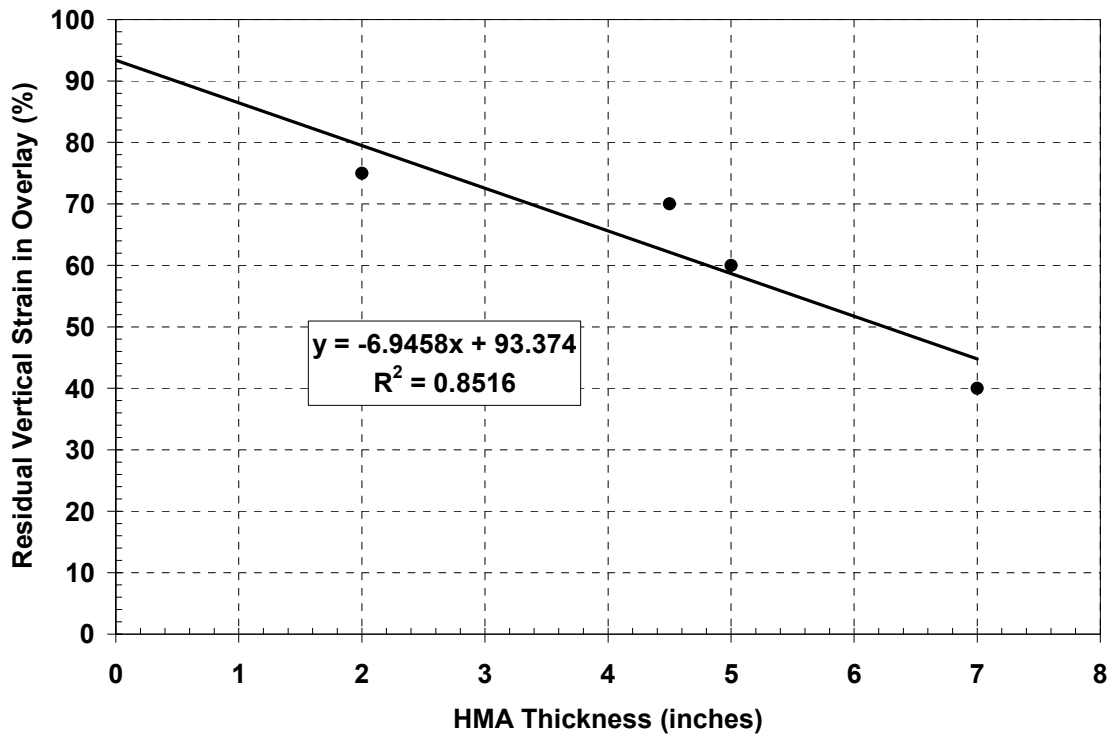
Figure 78 – Determination of Residual Vertical Strain from FWD Field Testing

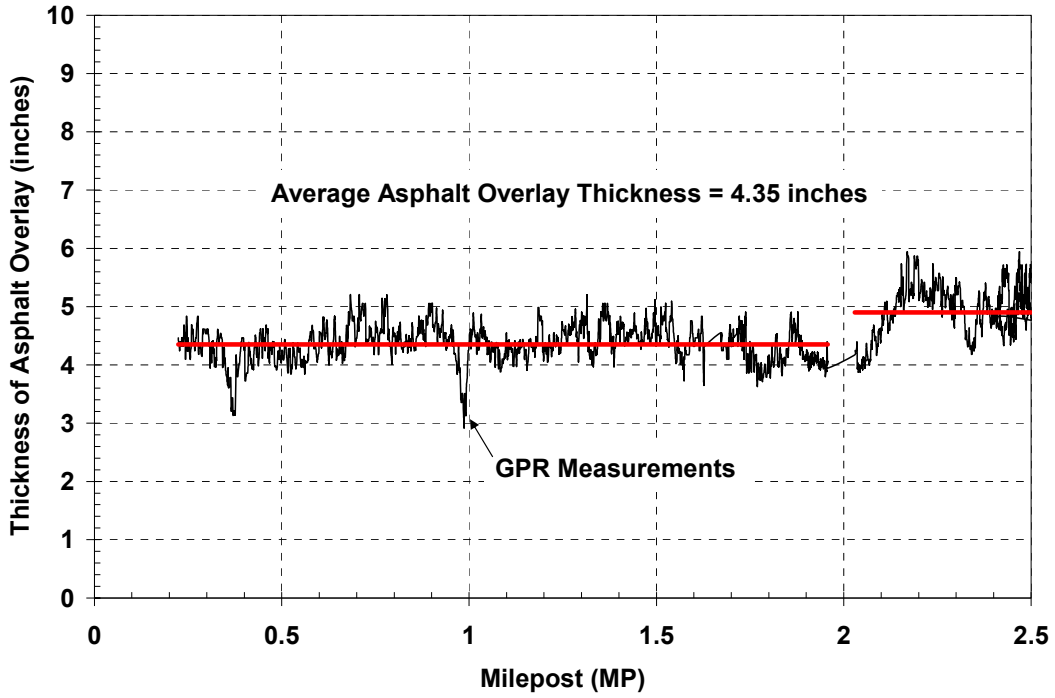
Figure 79 – Ground Penetrating Radar (GPR) Test Results for Section #1 of Rt 34N New Jersey

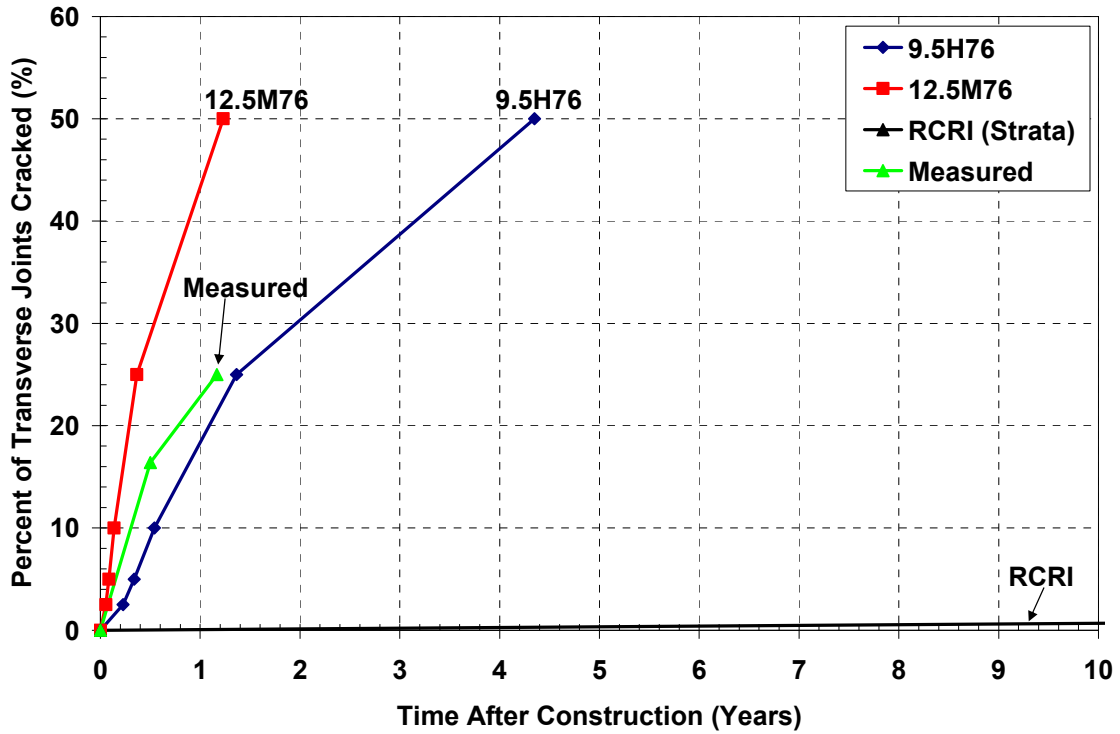
Figure 83 – Predicted versus Measured Reflective Cracking of Test Section #1 on Rt 34N New Jersey

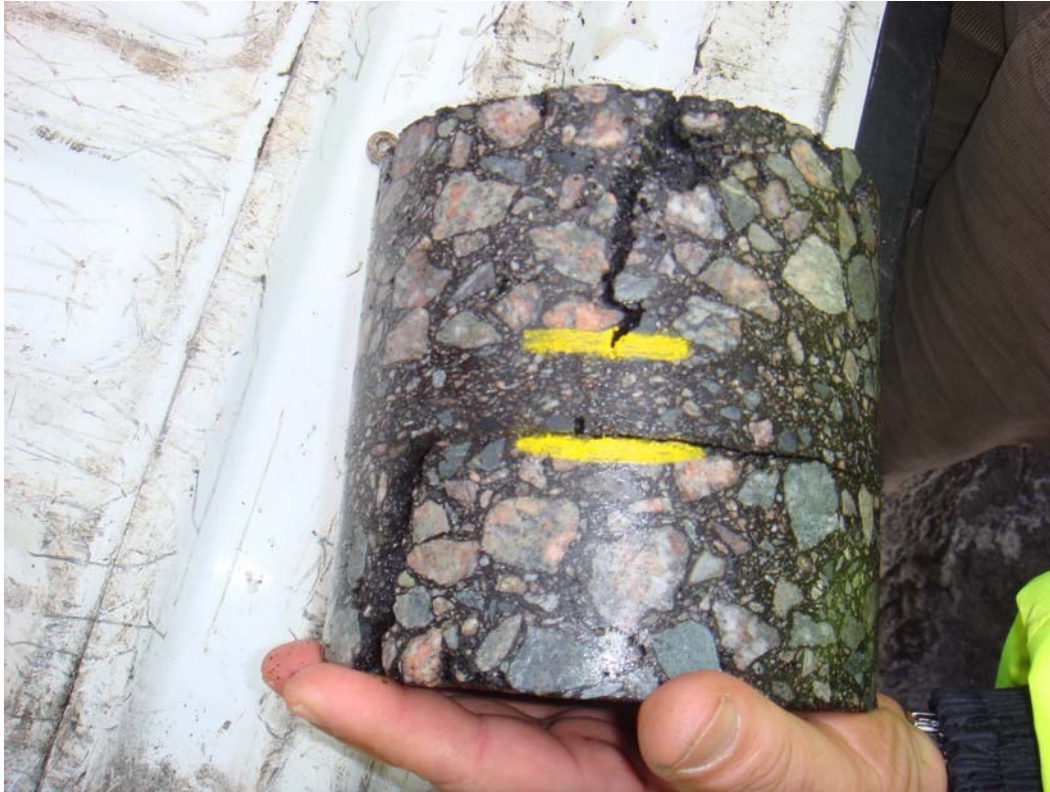
Figure 94 – Photo of Core Taken Through Surface Crack on I495 in Massachusetts

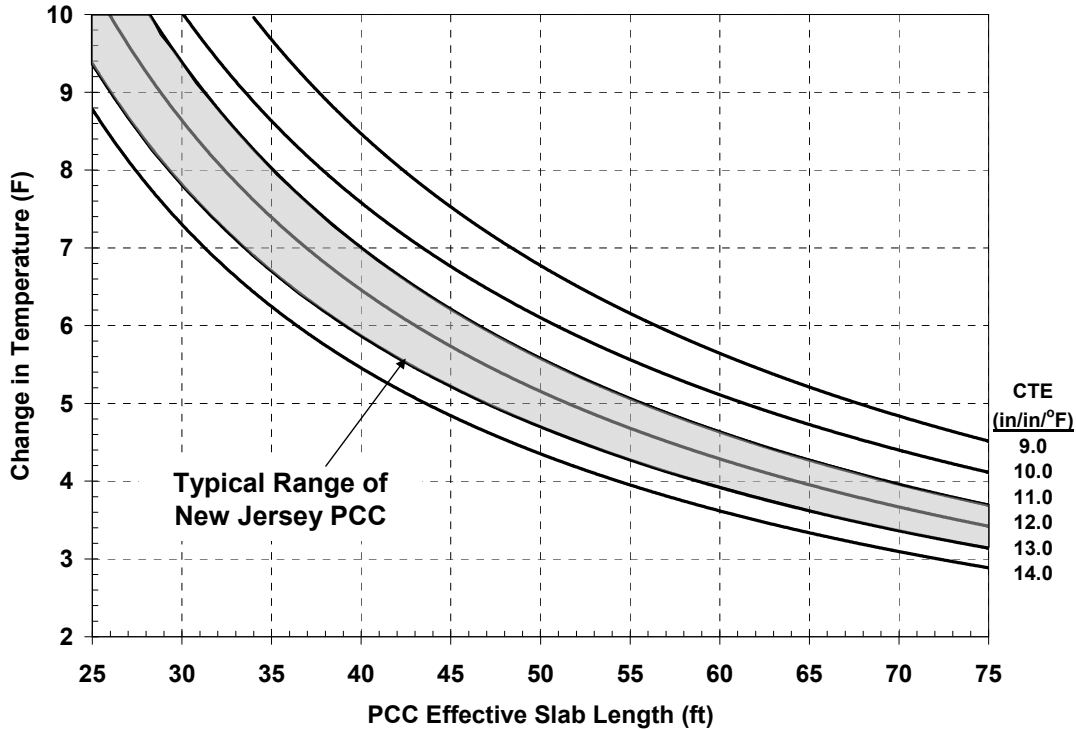
Figure 98 – Proposed Guideline to Limit Horizontal Deformation-Related Fatigue Cracking

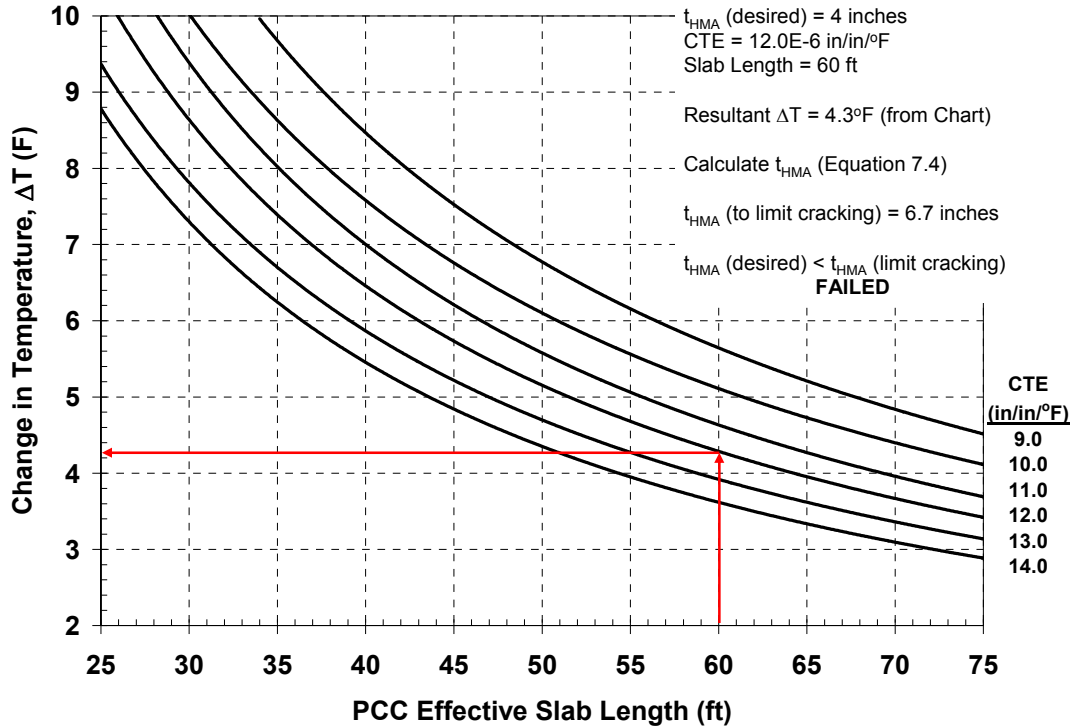
Figure 99 – Example of Using Proposed Guideline to Limit Horizontal Deformation-Related Fatigue Cracking – Required Asphalt Overlay Thickness

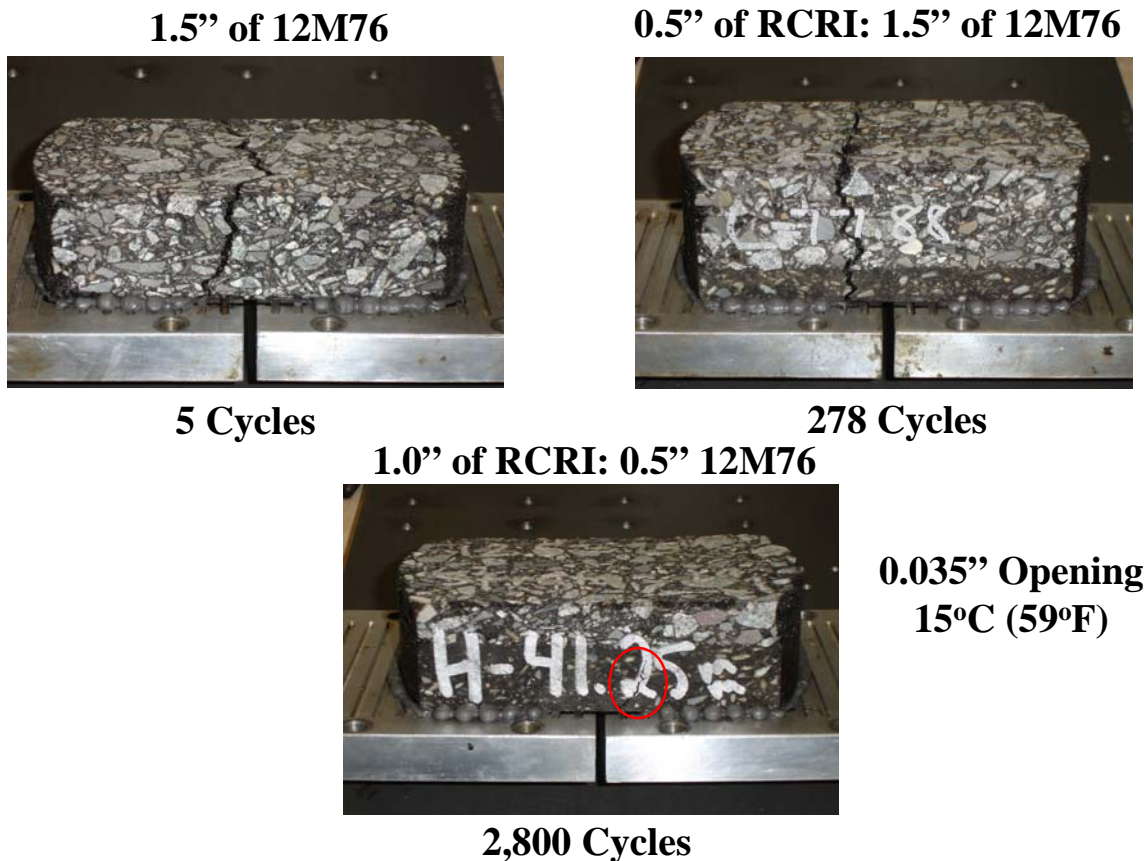
Figure 101 - Assessing RCRI Horizontal Strain Absorption and Thickness Impact on Fatigue Life Using the TTI Overlay Tester
