**Implementation of Construction Quality Assurance (CQA)  
Measures for Harbor Sediments and Processed Dredged  
Material (at Encap Golf Site Meadowlands, New Jersey)**

FINAL REPORT  
June 2007

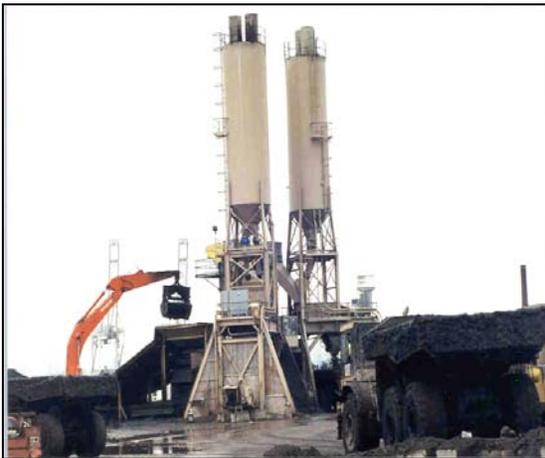
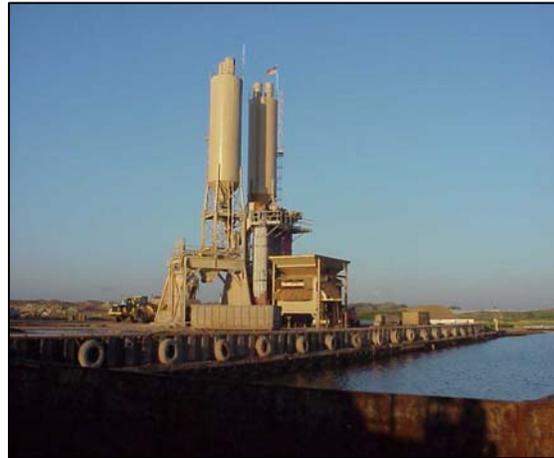
**Figure 3. Off-loading and Processing of PDM in Pug Mill**

Raw dredged material and additives are mixed into a pug mill with a retention time of approximately  $\frac{1}{2}$  to 1 minute. Pug mill mixing produces a more uniform product than in-scow mixing since the mixing is achieved by a more controlled process. For this project, following mixing, sediments were allowed to cure for 48 hours at the processing facility before being transported by highway trucks to the Site (Figure 3).

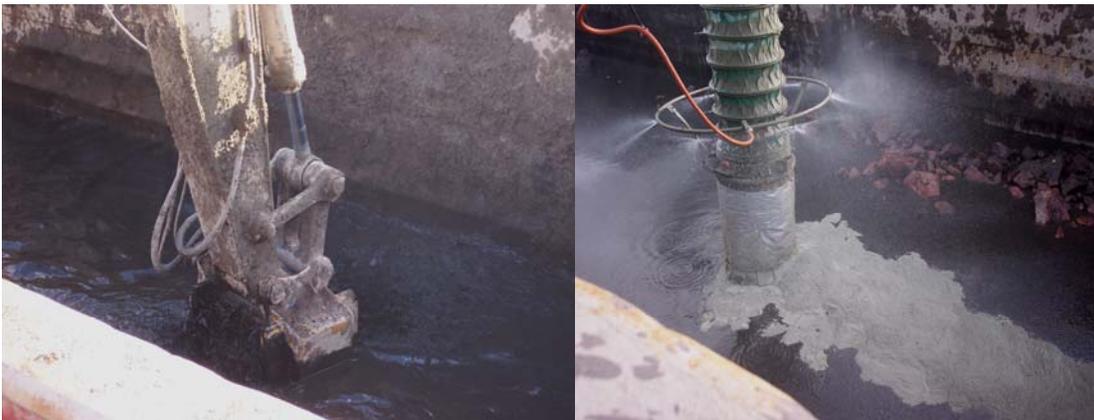
**Figure 4 - Cement Addition (Right) and In-scow Mixing (Left)**

The in-scow mixing method utilizes a rotating mixing head mounted on the arm of a long-reach hydraulic excavator. Similar to the pug mill mixing process, the excess water is decanted into an empty scow to be discharged at the dredging site. Scows are raked to remove large debris, while small debris is left in the mix. Large pieces of debris can severely damage the mixing head so it is crucial to remove them prior to in-scow mixing. Following debris removal, cement in slurry form is injected into the dredged sediments in scow through hoses attached to the excavator arm. Recently modifications have been made to the system to also allow addition of cement in dry form. Concern related to dispersion of cement dust had been the rationale for adding cement in slurry form.

The mixing head is then submerged into the dredged material, and its revolutions blend the cement and dredged material (Figure 4). Before the mix is transported to the final destination, enough time is allowed for hydration of the cement (initial curing). Mixed material can be unloaded directly to hauling trucks and transported to the placement site or remain in the scow to be transported in-scow to the placement site. For this project, the PDM was allowed to cure for 48 hours before being transported to the Site.

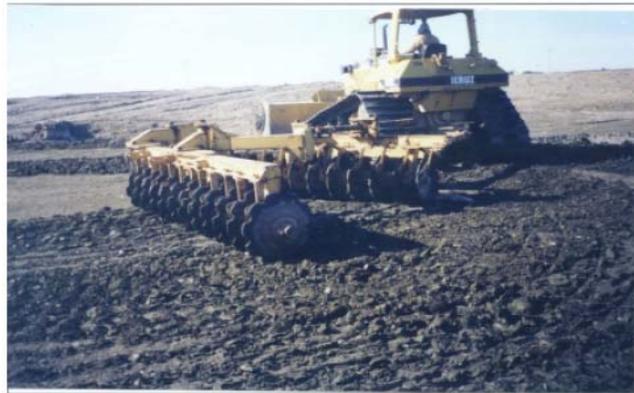
**Figure 5 - Moisture Conditioning Using Harrowing Disks**

In June 2005, MACTEC began moisture conditioning of the PDM placed over Kingsland Landfill. Moisture conditioning consisted of periodic displacement of PDM by bulldozers, exposing it to sun and air for moisture reduction (Figure 5). PDM previously placed on Kingsland was graded as per the proposed final grading plan. Significant moisture reduction occurs following 2-3 days of moisture conditioning during favorable weather conditions. The process is significantly slower in cold seasons. PDM from Port Jersey that had been processed by the pug mill system was placed at Kingsland upon delivery, since it met the trafficability requirement (based on MACTEC testing). As stated previously, dredged material processed by the pug mill system was generally more uniformly mixed, contained less moisture, and could be placed faster than in-scow mixed PDM (Figure 6). Also starting in June 2005, PDM delivered to the Site was placed over Rutherford East Landfill. Grubbing and clearing had taken place in April and May 2005 and placement of PDM from Arthur Kill followed in July 2005. The PDM was moisture conditioned for 2-3 days before it could be compacted. PDM layers in the range of 12 to 24 inches were placed and compacted using a smooth wheel roller. Pulverized masonry was placed over some areas on top of PDM for the construction of finger roads to facilitate truck traffic.

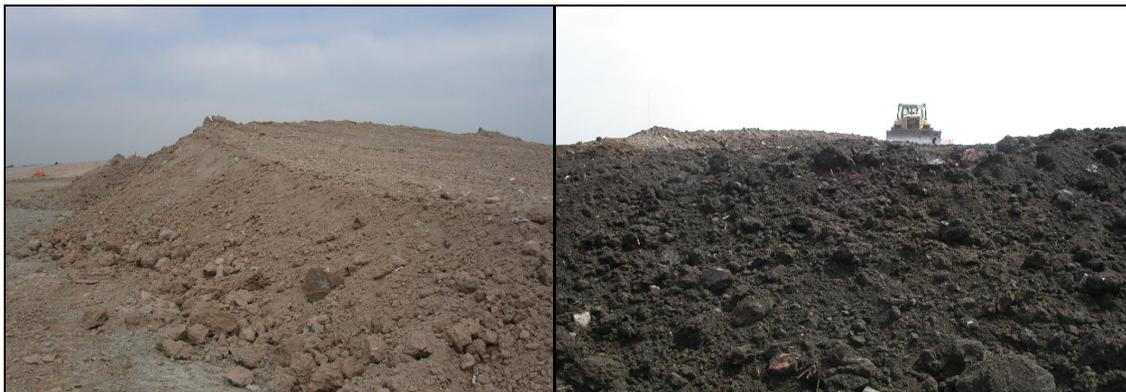
**Figure 6 – Dredged Material Processed in Pug Mill (left) and In-Scow (Right)**

Based on visual field observations, dredged material mixed in pug mill was more uniform and contained less moisture than in-scow mixed PDM. On occasion, pockets of raw dredged material, poorly mixed material, or cement pockets were observed in the in-scow mixed PDM, specifically within the first two months of PDM delivery. During the summers of 2005 and 2006, the pug mill mixed PDM required 2-3 days of moisture conditioning prior to rolling, while in-barge mixed PDM required 4-5 days. No data to quantify this difference was produced; the above conclusion is based solely on field observations.
